## Keenesburg inspection report

**PERMIT INFORMATION**

| <b>Permit Number:</b> C-1981-028<br><b>Mine Name:</b> Keenesburg Strip Mine<br><b>Operator:</b> Coors Energy Company<br><b>Operator Address:</b><br>Mr. Ben Moline<br>P.O. Box 4030<br>Golden, CO 80402 | <b>County:</b> Weld<br><b>Operation Type:</b> Surface<br><b>Permit Status:</b> Permanent Cessation<br><b>Ownership:</b> Private |

| <b>Inspection Start Date:</b> June 21, 2023<br><b>Inspection Start Time:</b> 08:00<br><b>Inspection End Date:</b> June 21, 2023<br><b>Inspection End Time:</b> 09:00 | | <b>Inspection Type:</b> Coal Partial Inspection<br><b>Inspection Reason:</b> Normal I&E Program<br><b>Weather:</b> Foggy | |

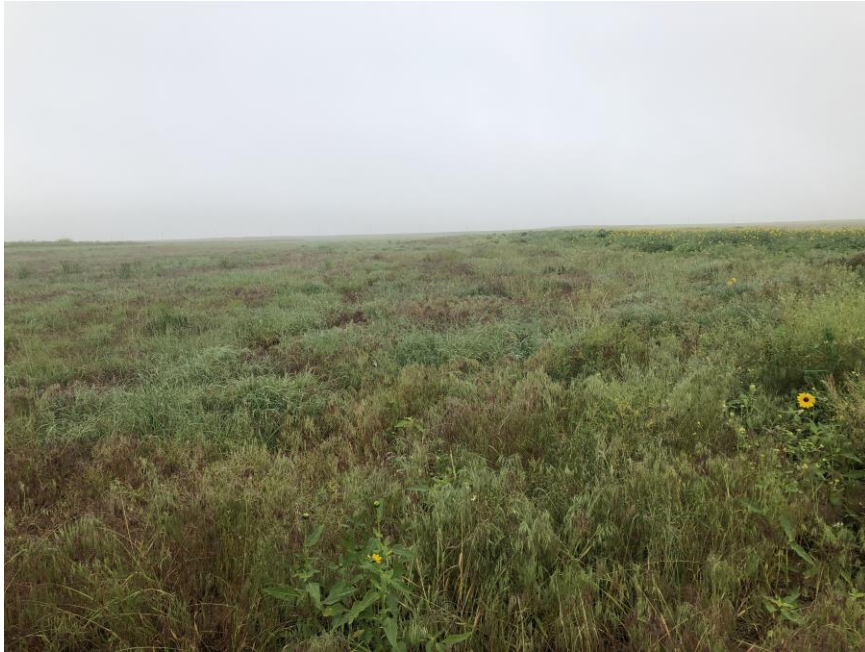
Area 33 has good cover dominated by desirable grass species.

**Grass cover in Area 33**

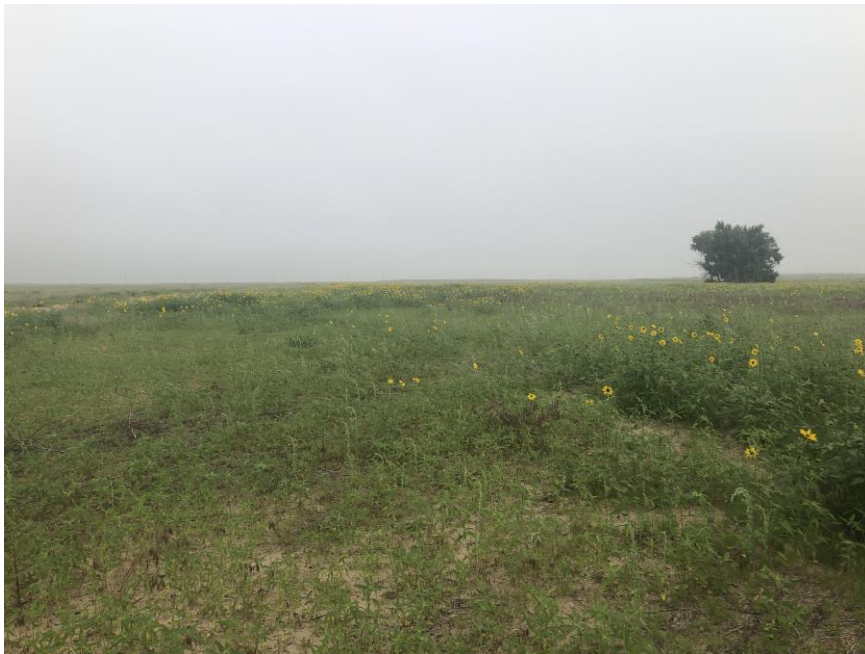
In many of the recently reclaimed areas, the vegetation cover is dominated by sunflowers. Cheatgrass and Russian thistle continue to be a problem at the site, and some thistle plants were seen.

**Sunflowers dominating Area 36, eastern portion**

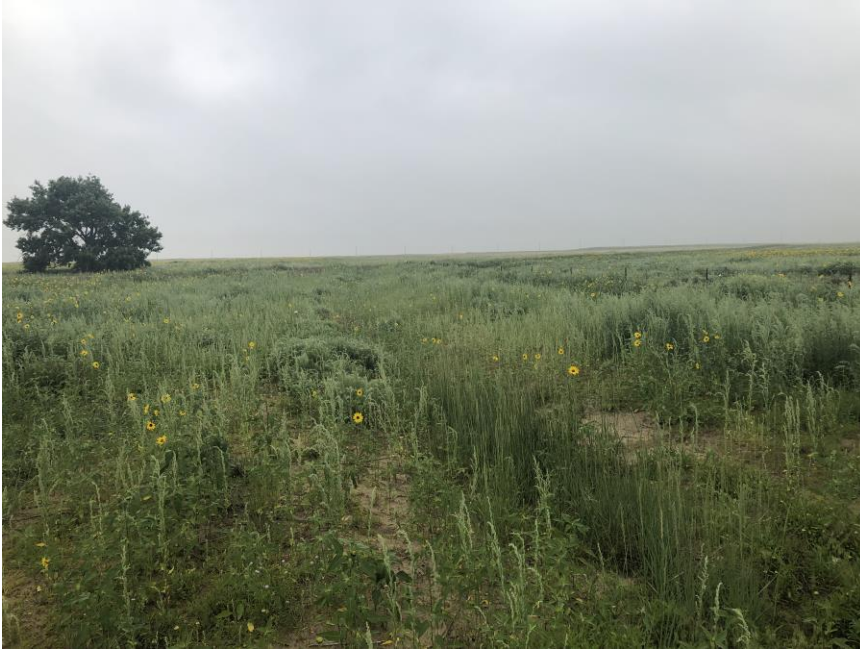
**Northern boundary, facing west**

The northern boundary of the site (east side) was observed, and no signs of pollutant loading from the mine site, or any other problems, were seen.
