Bowie #1 inspection report

Permit Number: C-1981-038 Mine Name: Bowie No. 1 Mine Operator: Bowie Resources, LLC Operator Address: Mr. Basil R Bear P.O. Box 1488 Paonia, CO 81428 County: Delta Operation Type: Underground Permit Status: Active Ownership: Private

Inspection Start Date: June 22, 2023 Inspection Start Time: 07:00 Inspection End Date: June 22, 2023 Inspection End Time: 09:30			Inspection Type: Coal Partia Inspection Reason: Normal I Weather: Clear	1
Joint Inspection Agency:		Joint Inspection Contacts:		
None				
Post Inspection Agency:		Post	Inspection Contacts:	
None				
Inspector(s):	Inspecto	r's Sig	gnature:	Signature Date:
Robert Zuber, P.E.	Phot	D.	24	
				6/23/2023

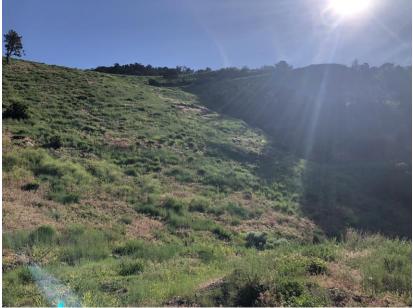
The recent slide at the East Mine was observed and it has not gotten worse in recent weeks. The rills seen at the West Mine during recent inspections are not a problem; they have healed.

Recent slide at the East Mine

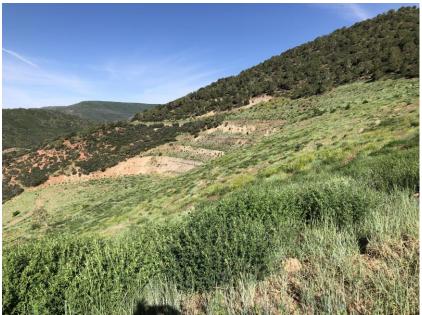
Steep slope at upper portion of the East Mine

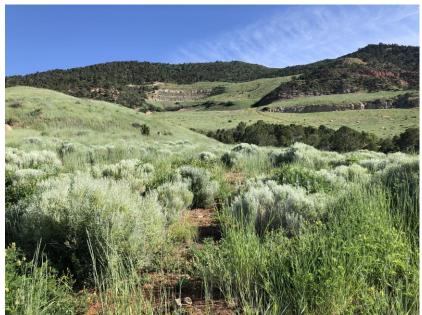
Vegetation at the East Mine looked excellent, except for bindweed and cheat grass, which were seen in many areas. The reclaimed pond below the Refuse Disposal Area is in good shape.

Reclaimed pond below the Refuse Disposal Area

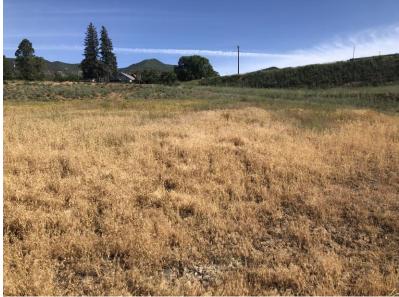
A large amount of cheat grass was seen at the Coal Storage Area by Black Bridge Road. At the loadout, many weeds were seen including cheat grass, bindweed, and thistle. Some of the thistle has been sprayed, it appears.

Cheat grass at the Coal Storage Area by the highway

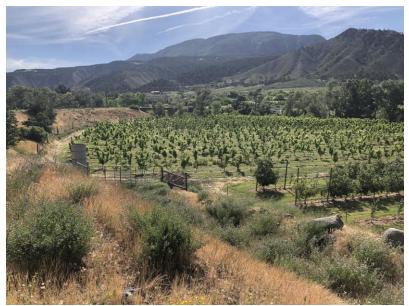
No erosion was seen at the loadout, including the steep slope between the loadout and the orchard below. The trestle across the river appears stable. There was no sign of subsidence over the long culvert at the loadout, which conveys the Farmers Ditch.

Area below the loadout, with bridge in background
