COLORADO

Division of Reclamation,
Mining and Safety

MINERALS PROGRAM INSPECTION REPORT

MINE NAME: Edmundson Clay Mine	MINE/PROSPECTING ID#: M-1985-203	MINERAL: Clay (general)	COUNTY: Pueblo
INSPECTION TYPE: Monitoring	WEATHER: Clear	INSP. DATE: May 16, 2023	INSP. TIME: 12:00
OPERATOR: Summit Brick & Tile Co.	OPERATOR REPRESENTATIVE: Julie Welte	TYPE OF OPERATION: 110c - Construction Limited Impact

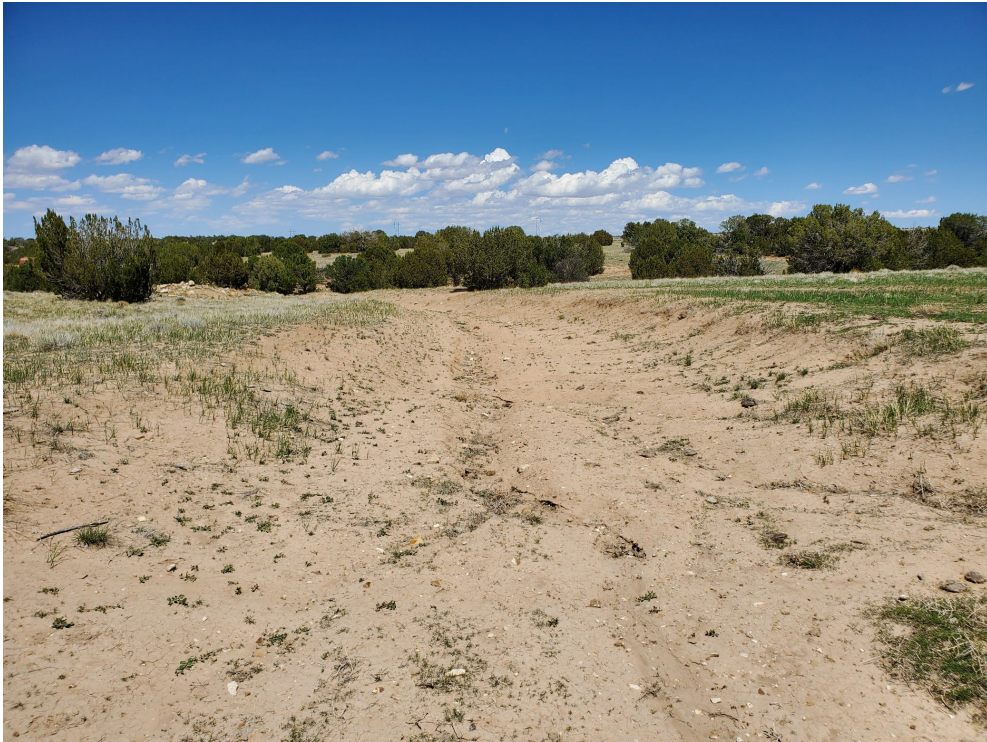
The Operator stated that the west fork of the entrance road (the access road) has been reseeded per the landowners request (Photo 2). The east fork or the entrance road has been left as-is for the use by the landowner (Photo 1), with the exception of the portion within the south-eastern corner of the site which has been reseeded (Photo 41). A road was constructed to the west of the permit boundary (Map 1), but when

Photo 1: Looking north-east at the east fork of the entrance road.

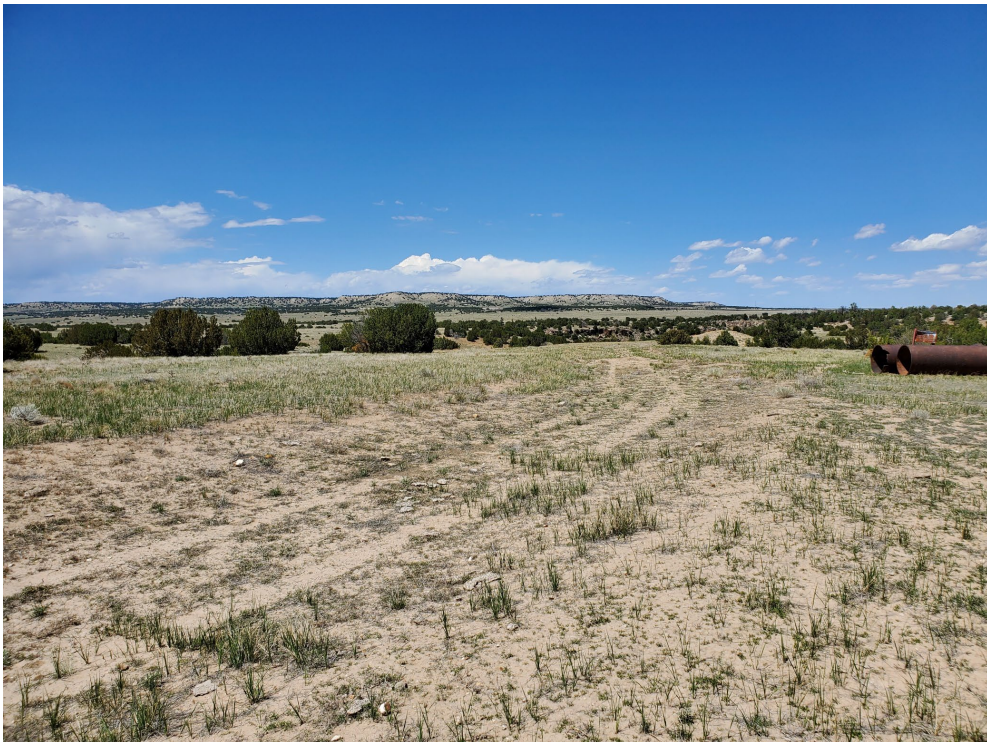
Photo 2: Looking north-west along the west fork of the entrance road used for site access.

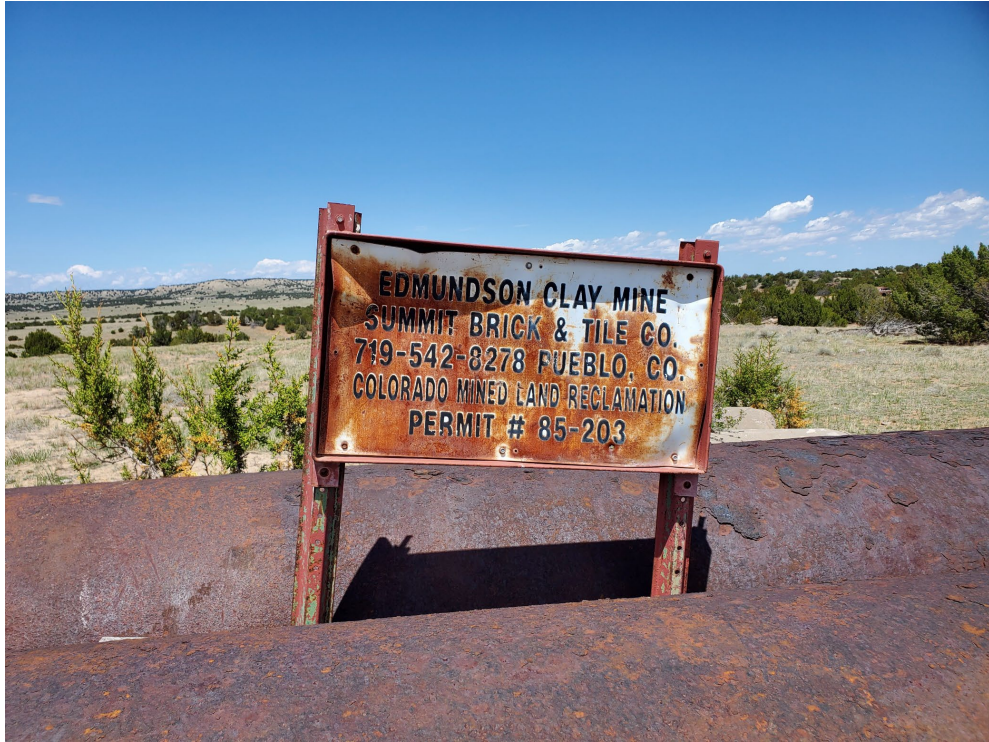
A permit sign posted in compliance with Rule 3.1.12 was observed at the entrance to the site (Photo 3).

Photo 3: Looking north at the mine sign posted before the entrance to the site.

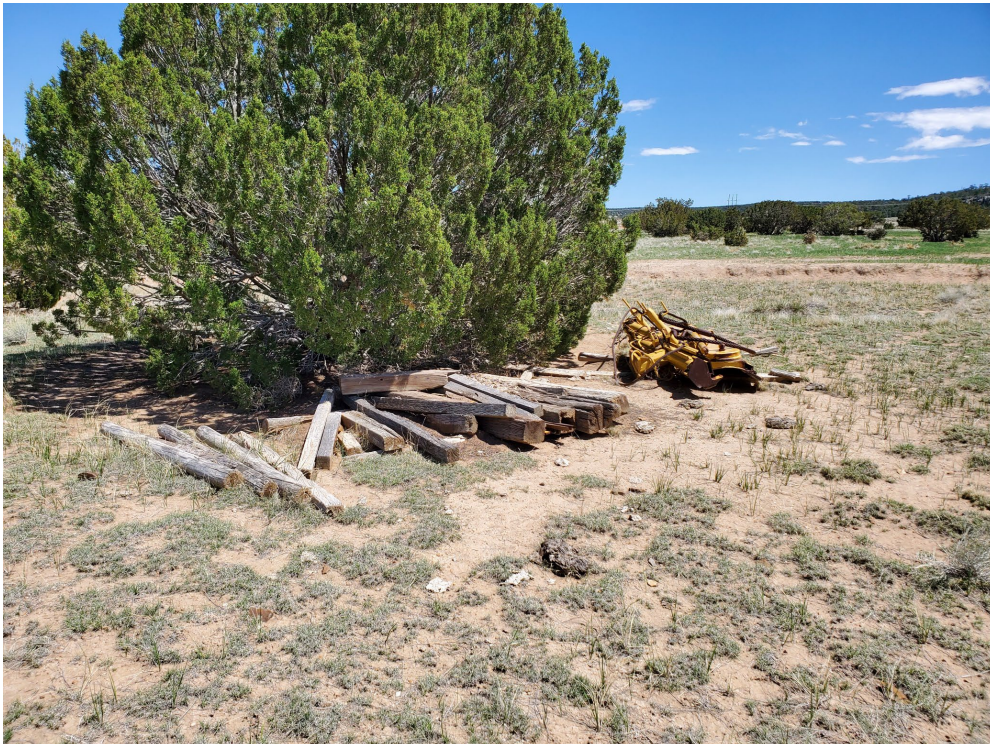
Metal and concrete cylinders located near the mine sign at the site entrance, as well as a pile of wood to the north-east of the sign were observed during the inspection (Photos 5: Map 1). When asked, the Operator was not sure who placed them there or when, but stated she would find out. If placed there by the Permittee/Operator, and not the landowner, they will need to be removed prior to a release request.

Photo 4: Looking east at the small wood pile located north of the mine sign and south of the mine site.

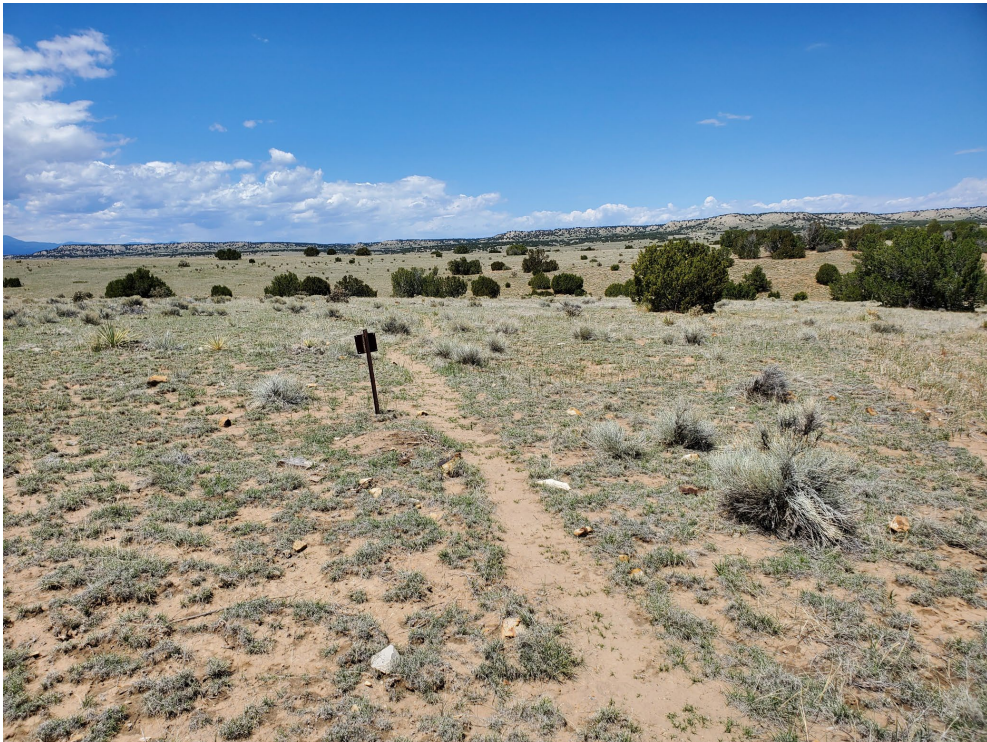
asked, the Operator stated that the road was made by the electrical company. This road has since been reclaimed (Photos 9 and 10).

Photo 9: Looking north-west along the remainder of the road constructed to the west of the permit boundary.

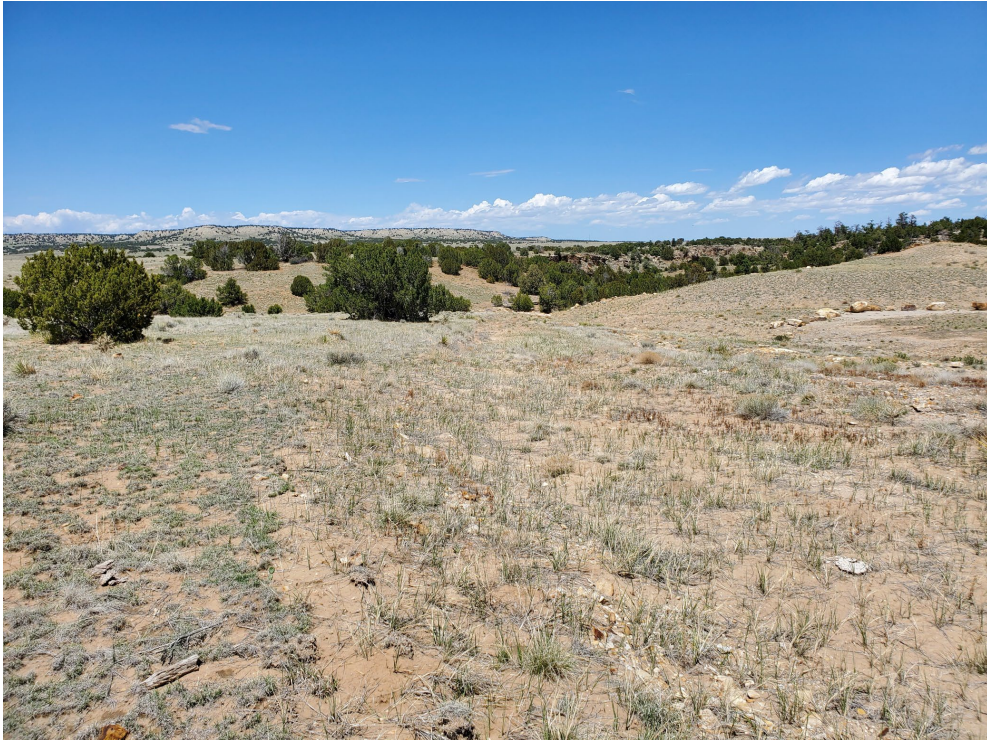
Photo 10: Looking north along the remainder of the road constructed to the west of the permit boundary.

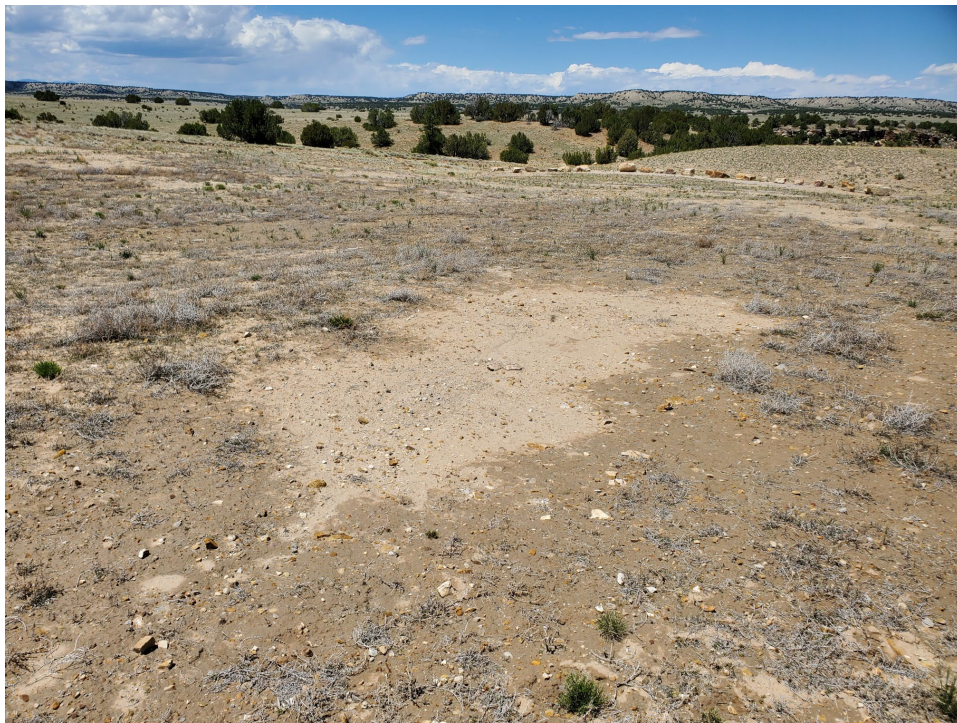
Photo 11: Facing north-west, looking at one of the bare patches observed throughout the most recently reclaimed portion of the site.

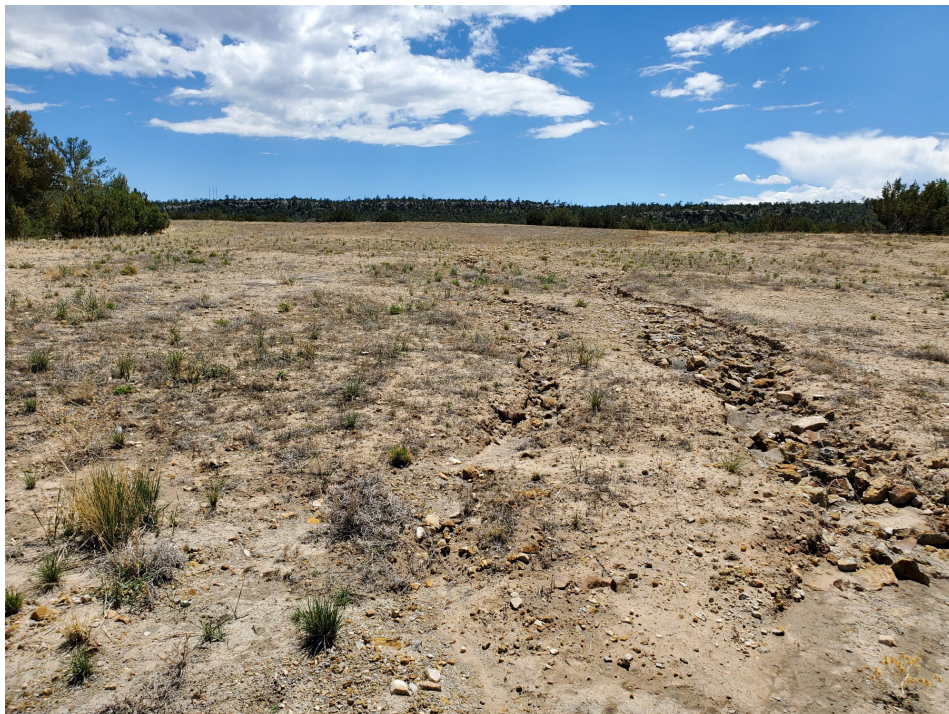
The reclamation onsite has been conducted in a manner that facilitates natural drainage patterns. The natural drainage channel was extended by the Operators to allow for the flow of natural drainage along the north-west side of the permit. This drainage-way cuts across the center of the permit, separating the east and west sides, and bends through the western side, separating the north and south portions of the western side (see Map 1**). The main drainage way, as well as a few minor ones (Photos 12, 13, and 15) were dry, with the exception of a small shallow puddle noted in Photo 18. The Operator had placed boulders lining the south side of the drainage way that bisects the western side of the permit (Photos 21 and 22) to ensure that mining and reclamation operations stayed out of the channel. The drainage channels appear stable and no erosion or excess sedimentation was observed in the main channel. The minor drainage way observed in the western side (Photo 15) appeared to be armored with cobbles, and resistant to erosion.

Photo 15: Looking south at evidence of some drainage cutting through the center of the recently reclaimed portion of the site.

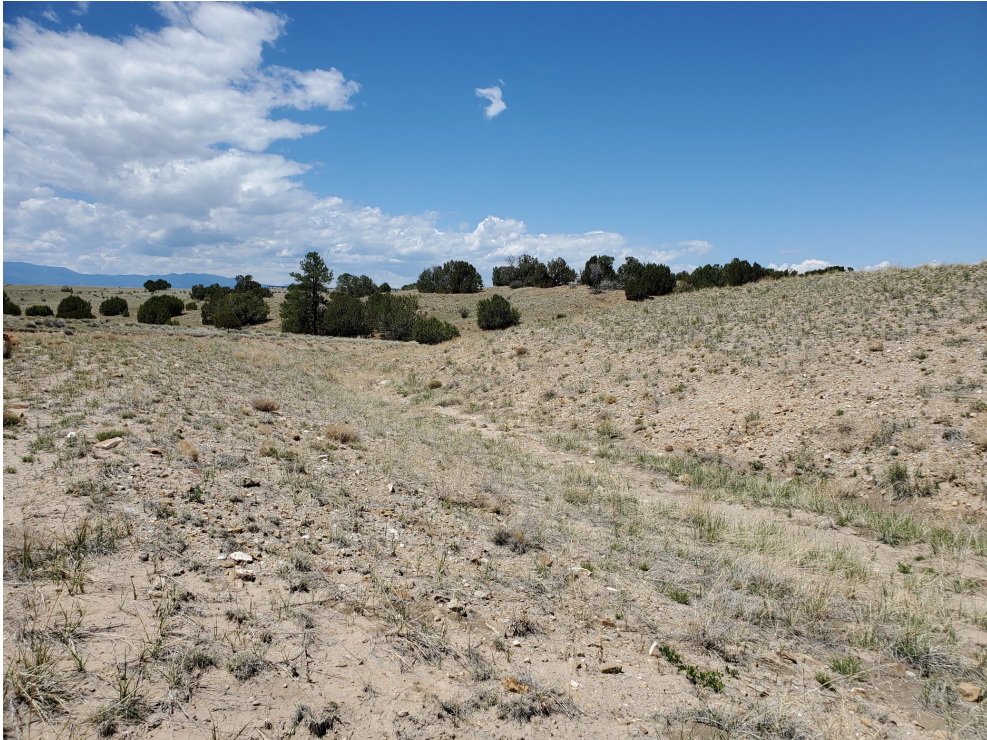
Mining operations have ceased and the site has been in final reclamation since 2020. All mining pits have been backfilled and graded to slopes not steeper than 3H:1V (Photos 22,33, and 35) in compliance with the approved mining plan. The area on the east side of the permit has been in reclamation since 2007. A highwall no bigger than eight feet was approved by the Division in 2006 to remain in this area. Photos of the highwall (Photos 16, 17, 20, 36-38; Map 1) were taken during the inspection, and its length was captured using the Esri Field Maps application (Map 1). The area on the west side of the permit was reclaimed in two major sections. The north half of the west side began undergoing reclamation in 2017, during which the southern portion of the west side was actively being mined. The remainder of the western side underwent reclamation beginning in 2020.

Photo 22: Looking north-west beyond the boulders at the northern drainage channel.

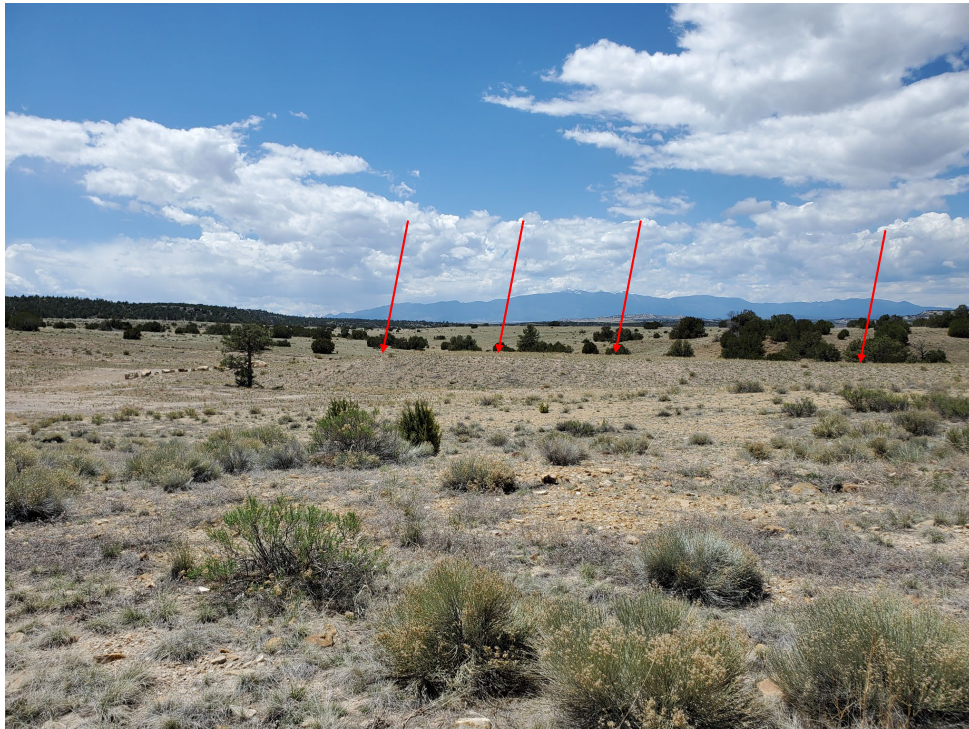
Photo 33: Looking north-west from the extent of the affected land in the north-eastern portion of the permit. The arrows indicate reclaimed slopes angled at a 3H:1V.

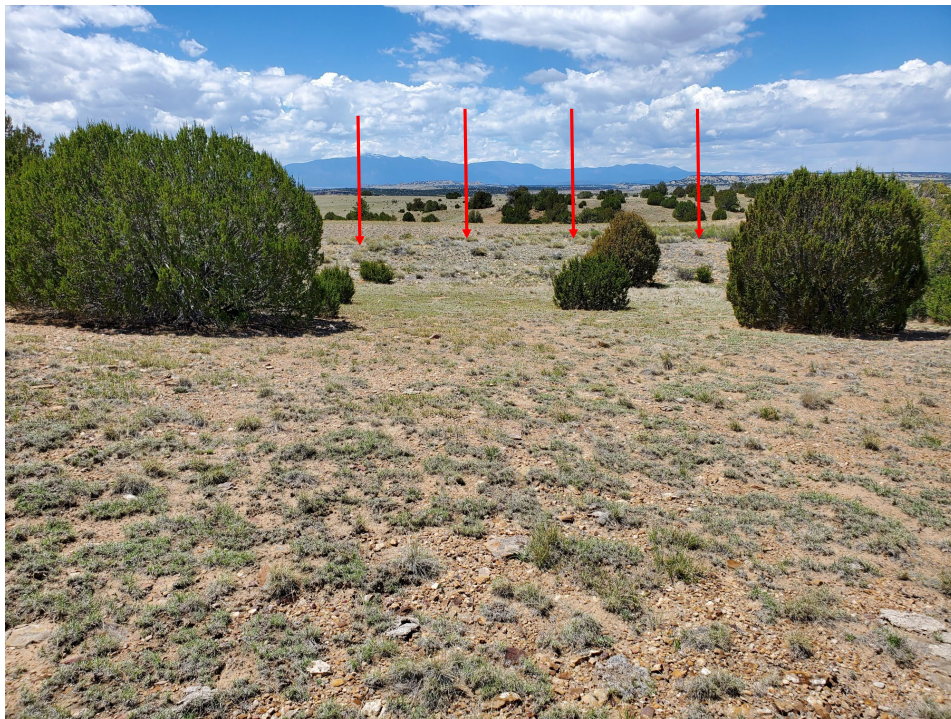
Photo 35: Looking west from the approximate corner of the permit at the reclaimed eastern disturbance boundary (arrows).

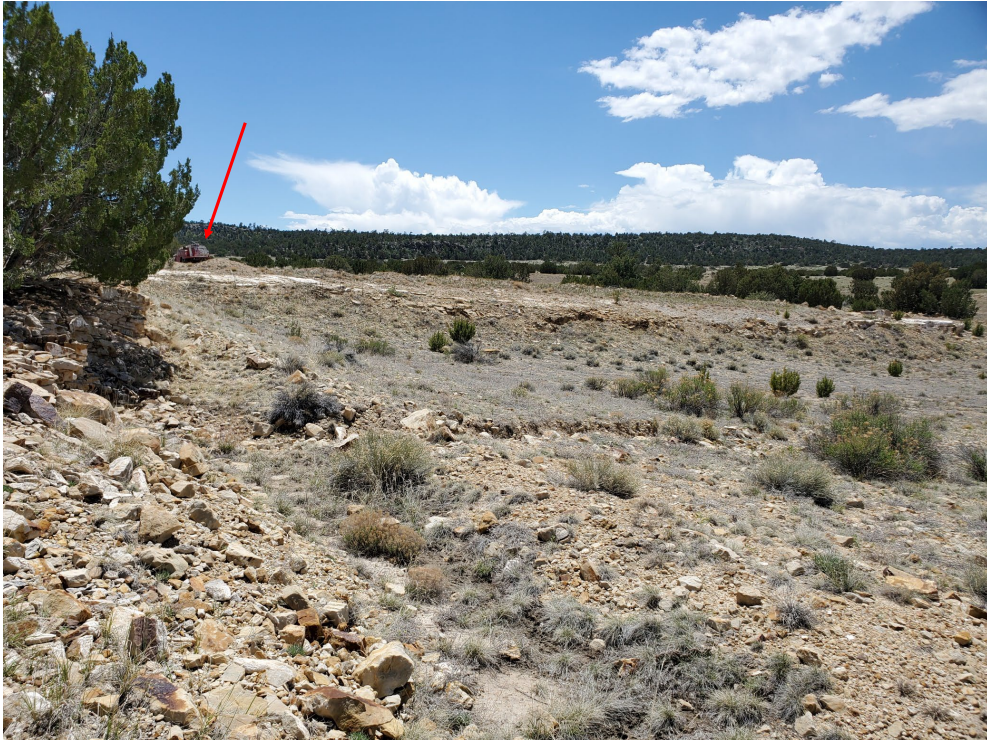
No acid or toxic materials are stored on site. However, an old fuel tanker was observed south of the reclaimed area on the eastern side of the permit (Photos 36 and 40: Map 1). The Operator stated that it would be removed prior to a release request.

Photo 36: Looking at the eastern corner of the highwall. Oil tanker located to the south (arrow).

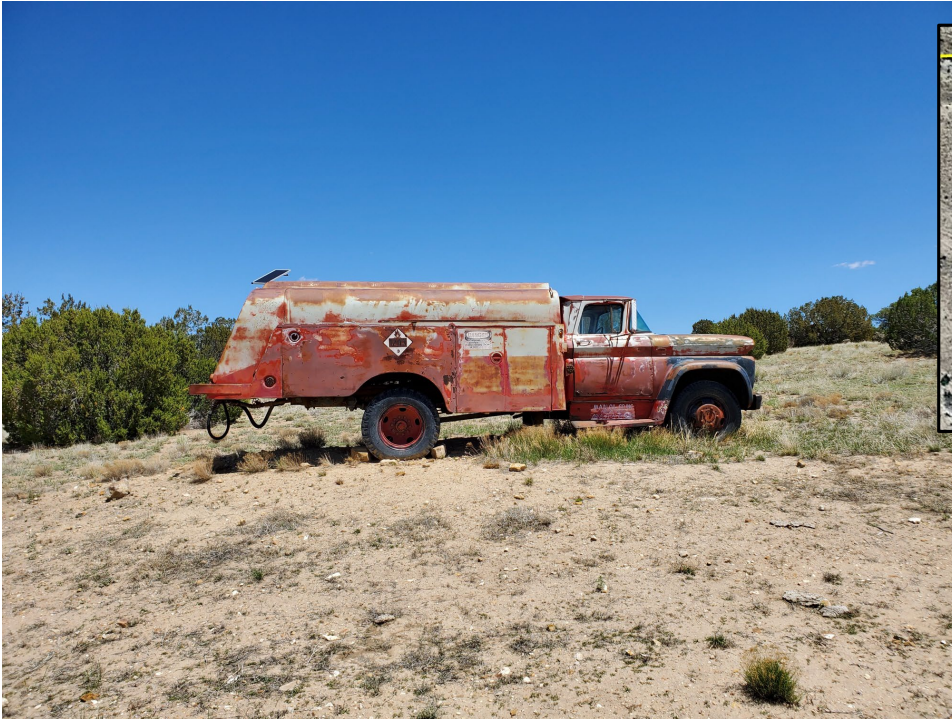
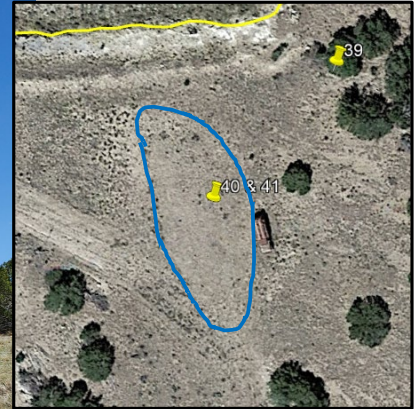
No topsoil piles currently remain on the site. The topsoil pile that was located south of the reclaimed eastern pit has been used to reclaim the western side of the permit (Photo 40).

Photo 40: Looking east at an old fuel tanker located on site east of where the topsoil pile was located prior to reclamation. Old topsoil pile location encircled in blue on the excerpt from Map 1)

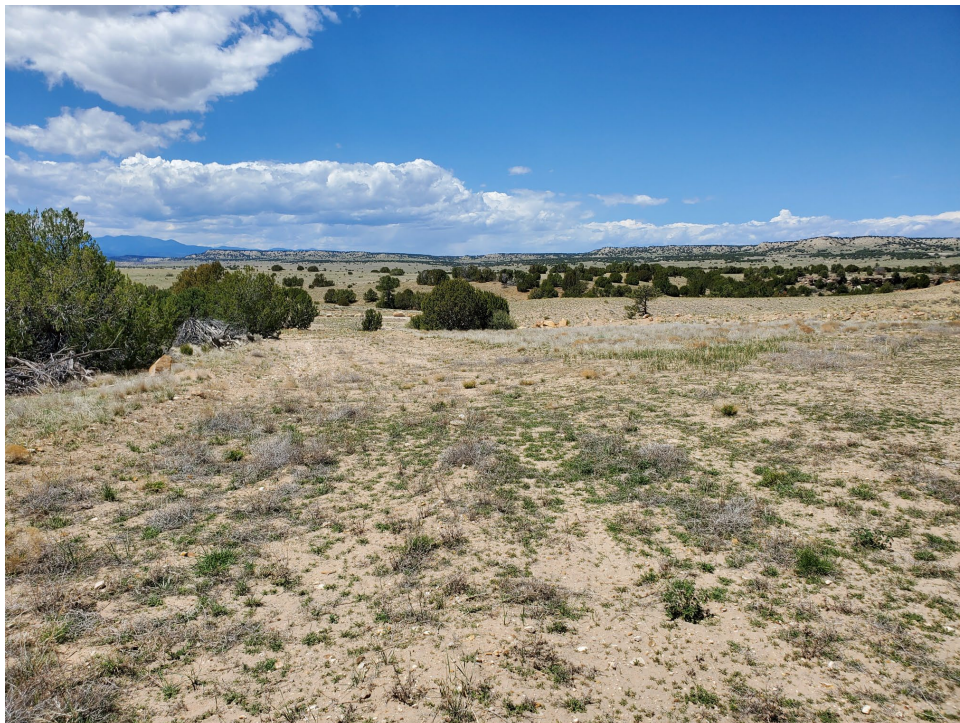
Photo 41: Looking south along the portion of reclaimed road within the permit area south of the topsoil pile location.

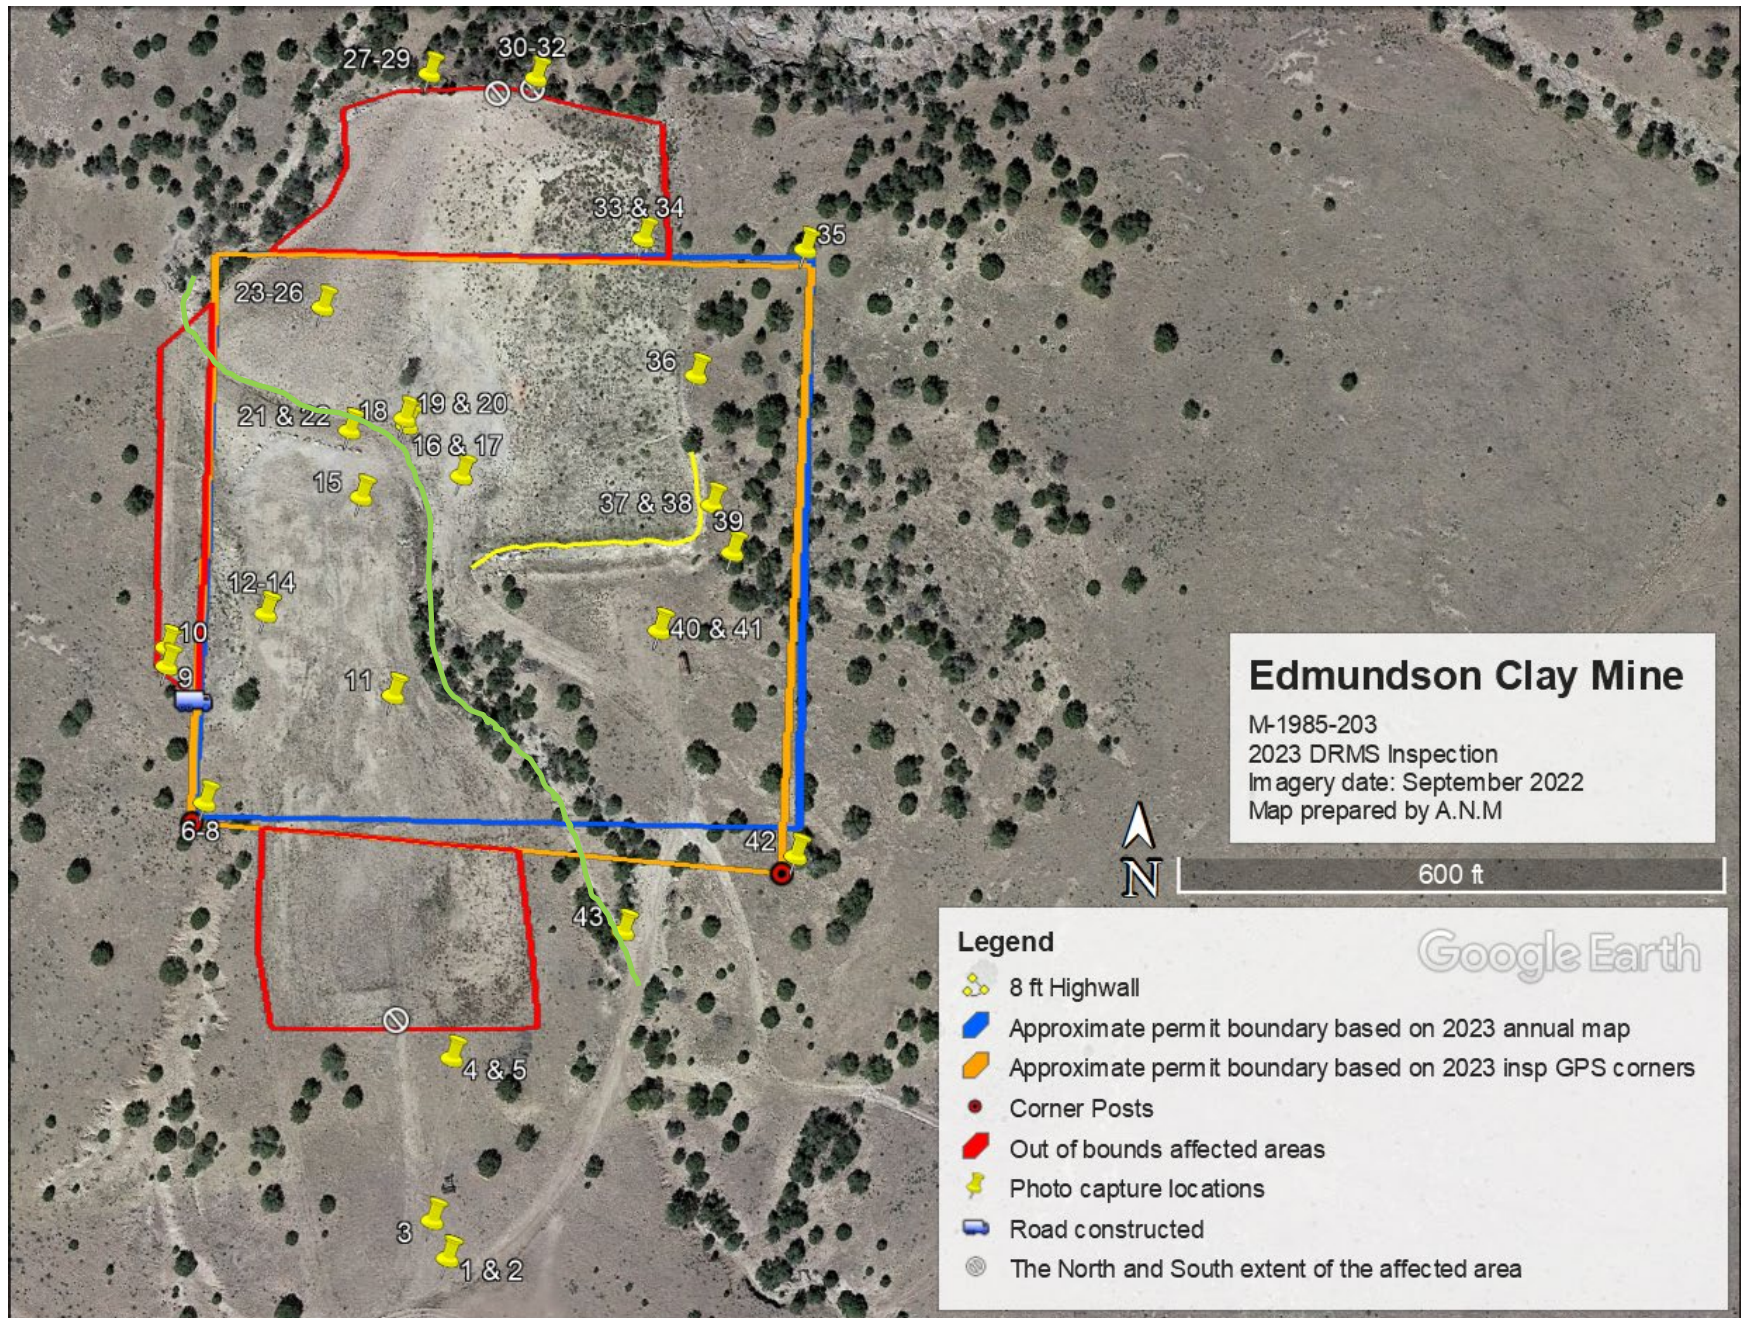
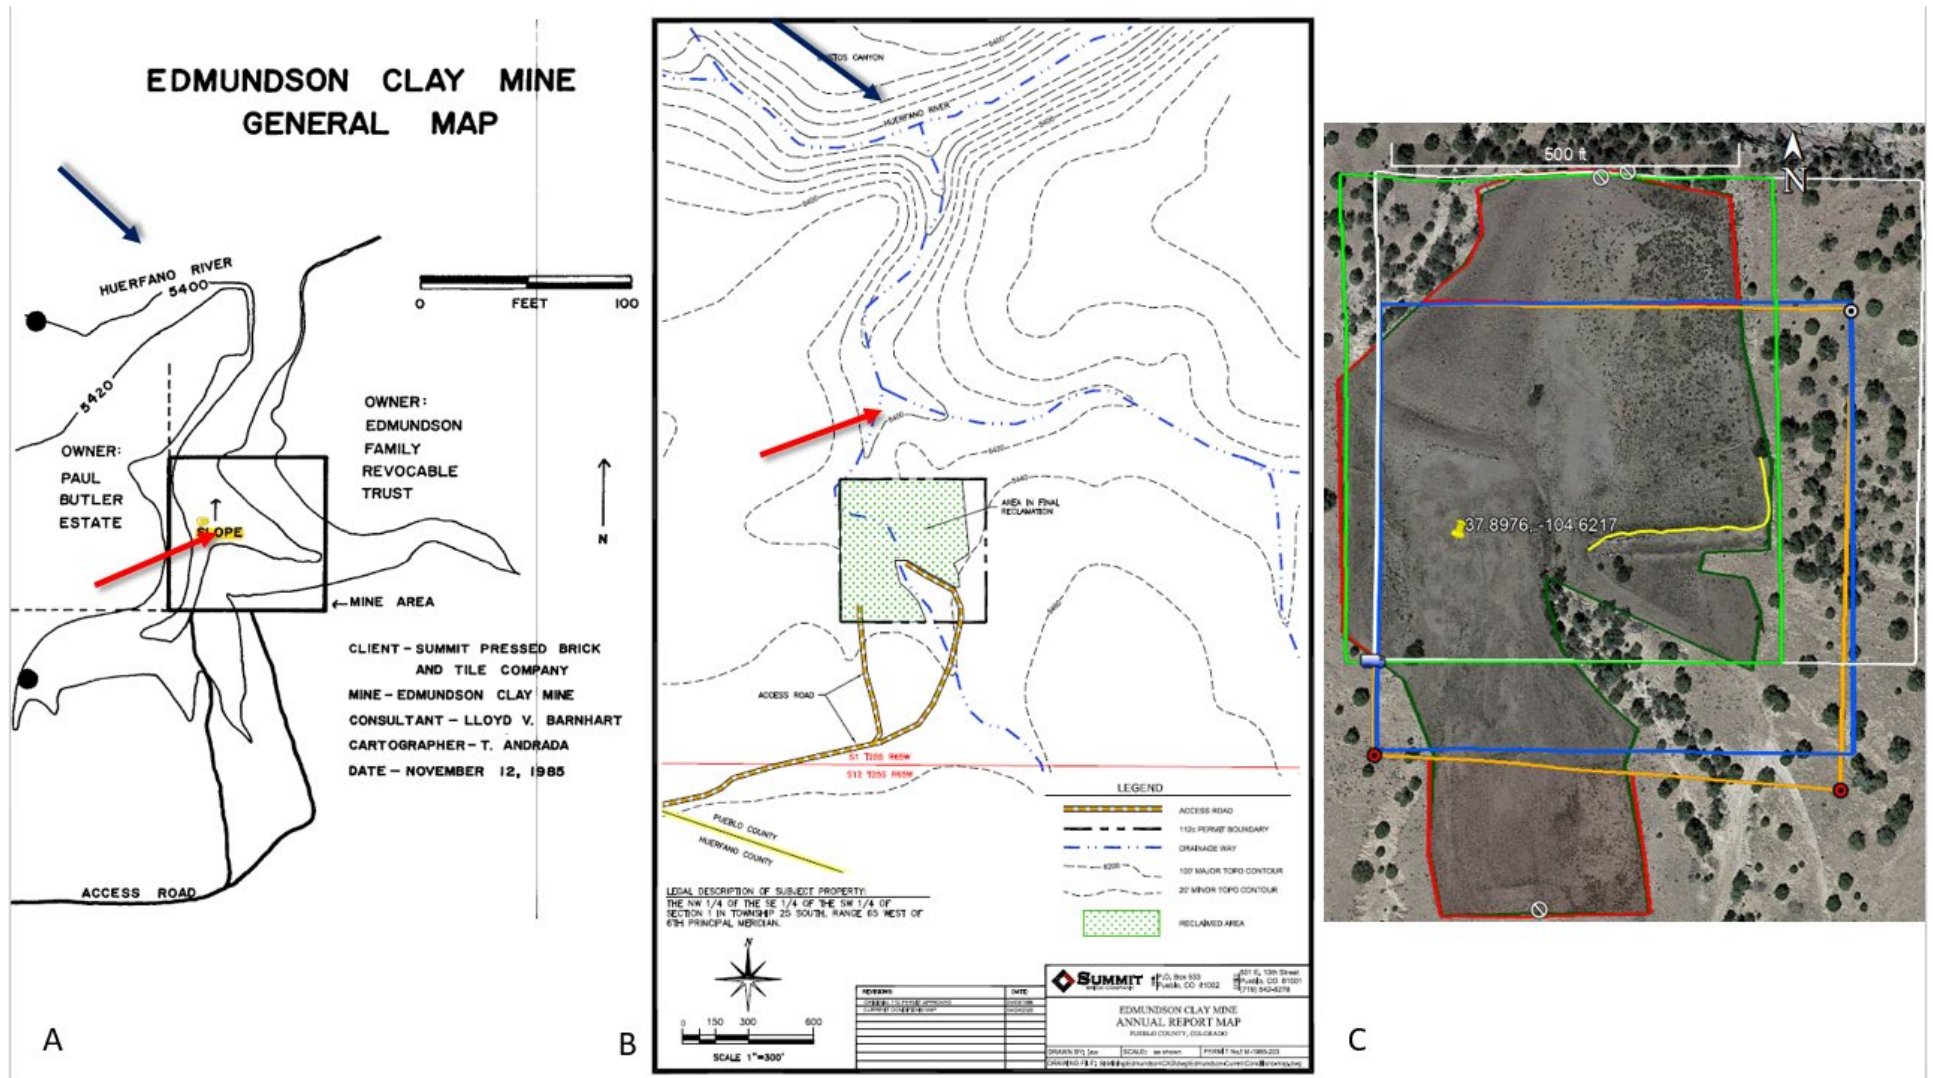
POSSIBLE VIOLATION: Land has been affected outside of the approved permit boundary and the affected land boundary markers are incorrectly placed. This is a possible violation at this time pursuant to: 1.) C.R.S. 34-32.5-109(1) for failure to first obtain from the board or office a reclamation permit prior to engaging in a new operation, 2.) C.R.S. 34-32.5-116(4)(i) for failure to protect areas outside of the affected land from slides or damages occurring during the mining operation, AND Rule 3.1.12(2) for failure to adequately delineate the affected area with monuments or markers.

A possible violation has been cited above due to the Division's observation of affected land outside the permit boundary (Map 1; Figures 1 and 2). The permit history has contained discrepancies of where the permit boundary lies and where mining and reclamation activities have been conducted (Figure 1). Regardless of which of the possible boundaries outlined in Figure 1 is representative of the actual approved permit boundary, land is affected outside of each variation, with land affected outside of the boundary to the south of the permit in each case. When using the permit boundary derived from the currently marked southern corners (orange boundary on Map 1 and Figures 1 and 2), the total acreage affected off-site is approximately 3.42 acres (indicated by the red polygons on Figure 2). Figure 2 depicts the Operator's mining and reclamation activities that caused off-site disturbance in each of these areas. The Division will set the Operators up for a hearing in front of the Mined Land Reclamation Board pursuant to Rules 3.3.1 and/or Rule 3.3.2.

The Division has found discrepancies in the approved permit boundary, the boundary shown on annual reports maps and the boundaries marked in the field. However, it is clear land has been affected outside of the approved and marked boundaries (See Figure 1). The north-south extent of the affected land exceeds possible north-south dimensions of the affected land boundary. Two boundary markers, marking the south-west (Photo 6) and the south-east (Photo 42) corners of the site were observed and their GPS locations were acquired using the Esri Field Maps application. Two t-posts were also observed at the northern-most extent of the affected land (Photo 30). It appears the south-west and south-east corners are incorrectly placed, and are located further south than the approved boundary. Part of the corrective actions that the Division will recommend for the violation noted above will include clearly defining the permit and affected land boundaries.

Figure 1: A) The approved mining plan map. **B)** The 2023 annual report, this is the first report map that deviated from editing the approved map. **C)** Figure generated in Google Earth to show four approximate permit boundaries based on variations of the approved map and annual reports. The white polygon is the approximate location of the approved boundary. According to the scale, the approved boundary encompasses more land than the permit was approved for. The green polygon represents a boundary more consistent with the reported disturbance and the 9.8 acre approved area. The blue boundary represents the approximate location of the boundary reported in the 2023 annual report. The orange boundary represents the approximate boundary in relation to the

southern corner posts located onsite that were observed during the 2023 inspection. *The gray-shaded polygon represents the entire affected area during the life of the permit. **The red polygons represent the area affected outside of the permit based on the 2023 boundary corner locations. The southern-most red polygon specifically represents the area affected outside of all four permit boundary variations. ***The Red and Black arrows added to Figure 1 A and B indicate the location of topographic features consistent on both maps that indicate the permit boundaries shifted south on the 2023 annual report map in comparison to the approved boundaries located in Figure 1 Map A.

CORRECTIVE ACTIONS: This possible violation will require a hearing before the Mined Land Reclamation Board ("MLRB" or "Board"). The hearing will be scheduled during the August 16 and 17, 2023 MLRB meeting. The schedule and other details for the MLRB hearing will be provided under a separate document to be sent via certified mail to the operator.

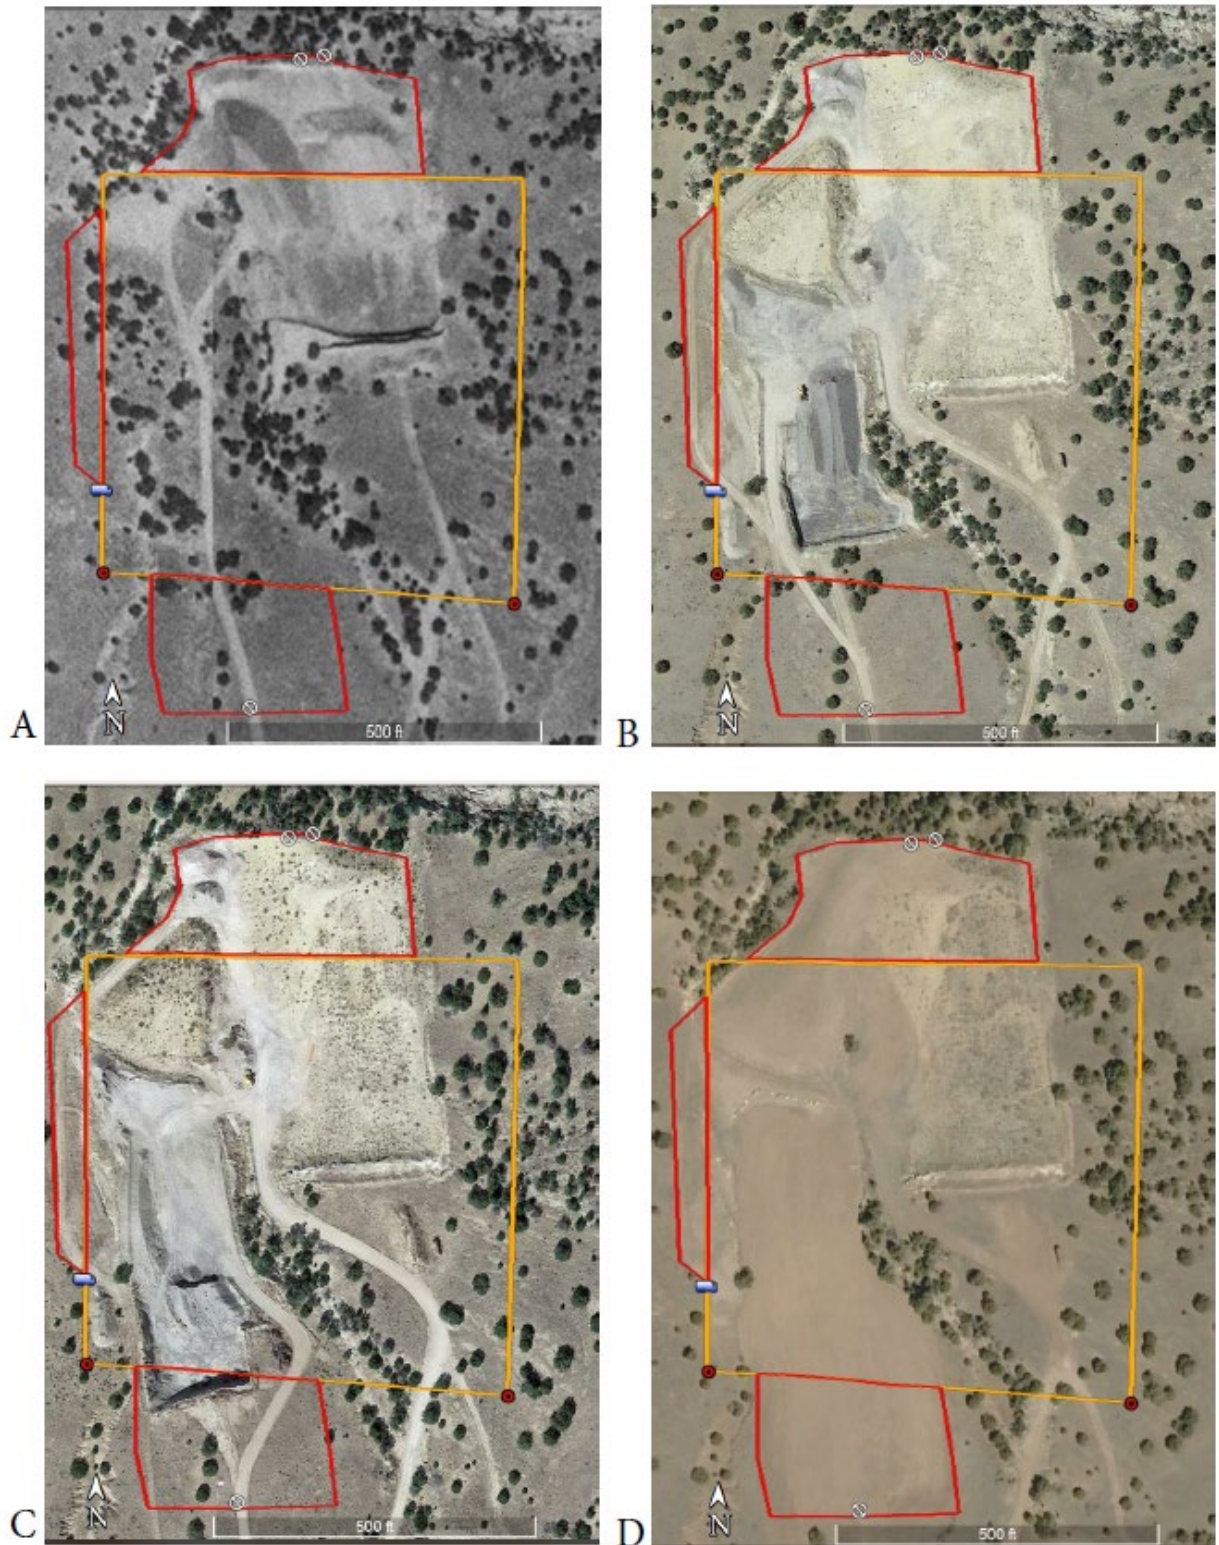
Figure 2: Images A-D were captured in Google Earth Pro. Each image illustrates mining activities over the years that highlight areas where land has been affected outside of the currently partially marked permit boundary. The red polygons indicate the land affected off-site and the orange polygon depicts the currently marked permit boundary. **A)** Image taken September 1999. This is the first clear image on Google Earth and it depicts mining occurring north of the orange boundary. **B)** Image taken in April 2013 depicting a road constructed to the west of the permit boundary. This road first appears in a blurry Google Earth Image in 2011. **C)** Image taken in October 2015, showing the first evidence of off-site mining activity south of the permit boundary. **D)** Image taken March 2022 that shows reclamation activities further extending the affected area south of the permit boundary.

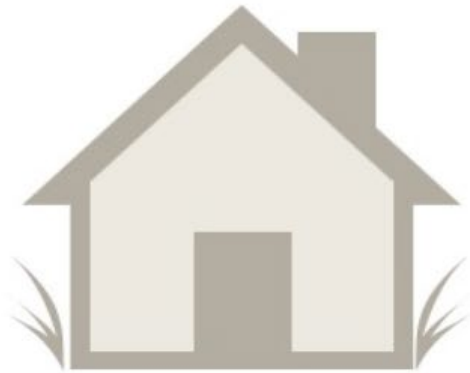
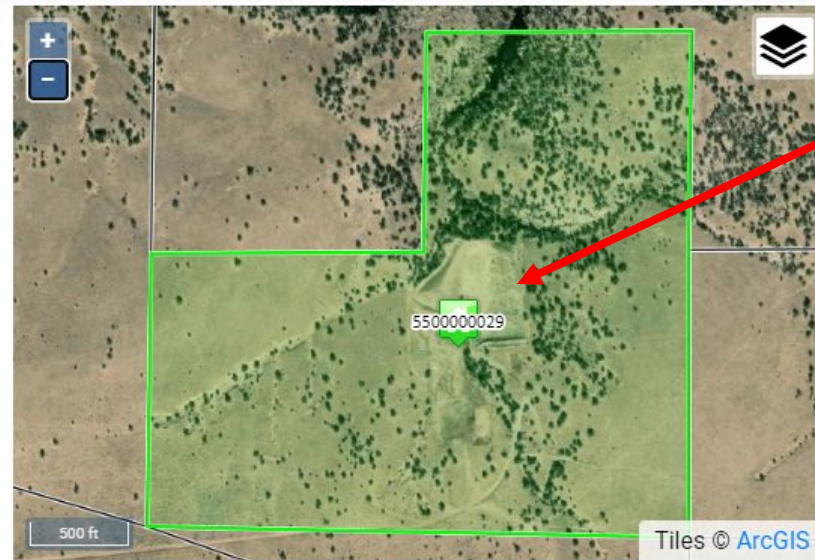
During the inspection, the Operator asked whether the land owners were still the original landowners at the time the permit was approved and whether the Operator still had legal right of entry, to which the Operator stated that they believed this was the case. However, post-inspection, the Division discovered that according to the Pueblo County Assessor's site, the land is under new ownership (Figure 3). Pending enforcement actions, the Operator will be required to provide a valid source of legal right to enter to conduct reclamation pursuant to Rule 6.3.7 or Rule 6.4.14.

Figure 3: The legal right to enter may be invalid according to the Pueblo County Assessor site's ownership information for parcel number 5500000029, which encompasses the entirety of the Edmundson Clay Mine (red arrow). According to the site, this parcel is now owned by Beaver Creek Ranches LLC, and not split by the Edmundson Family Revocable Trust and the Paul Butler Estate (see Figure 1 (A)).

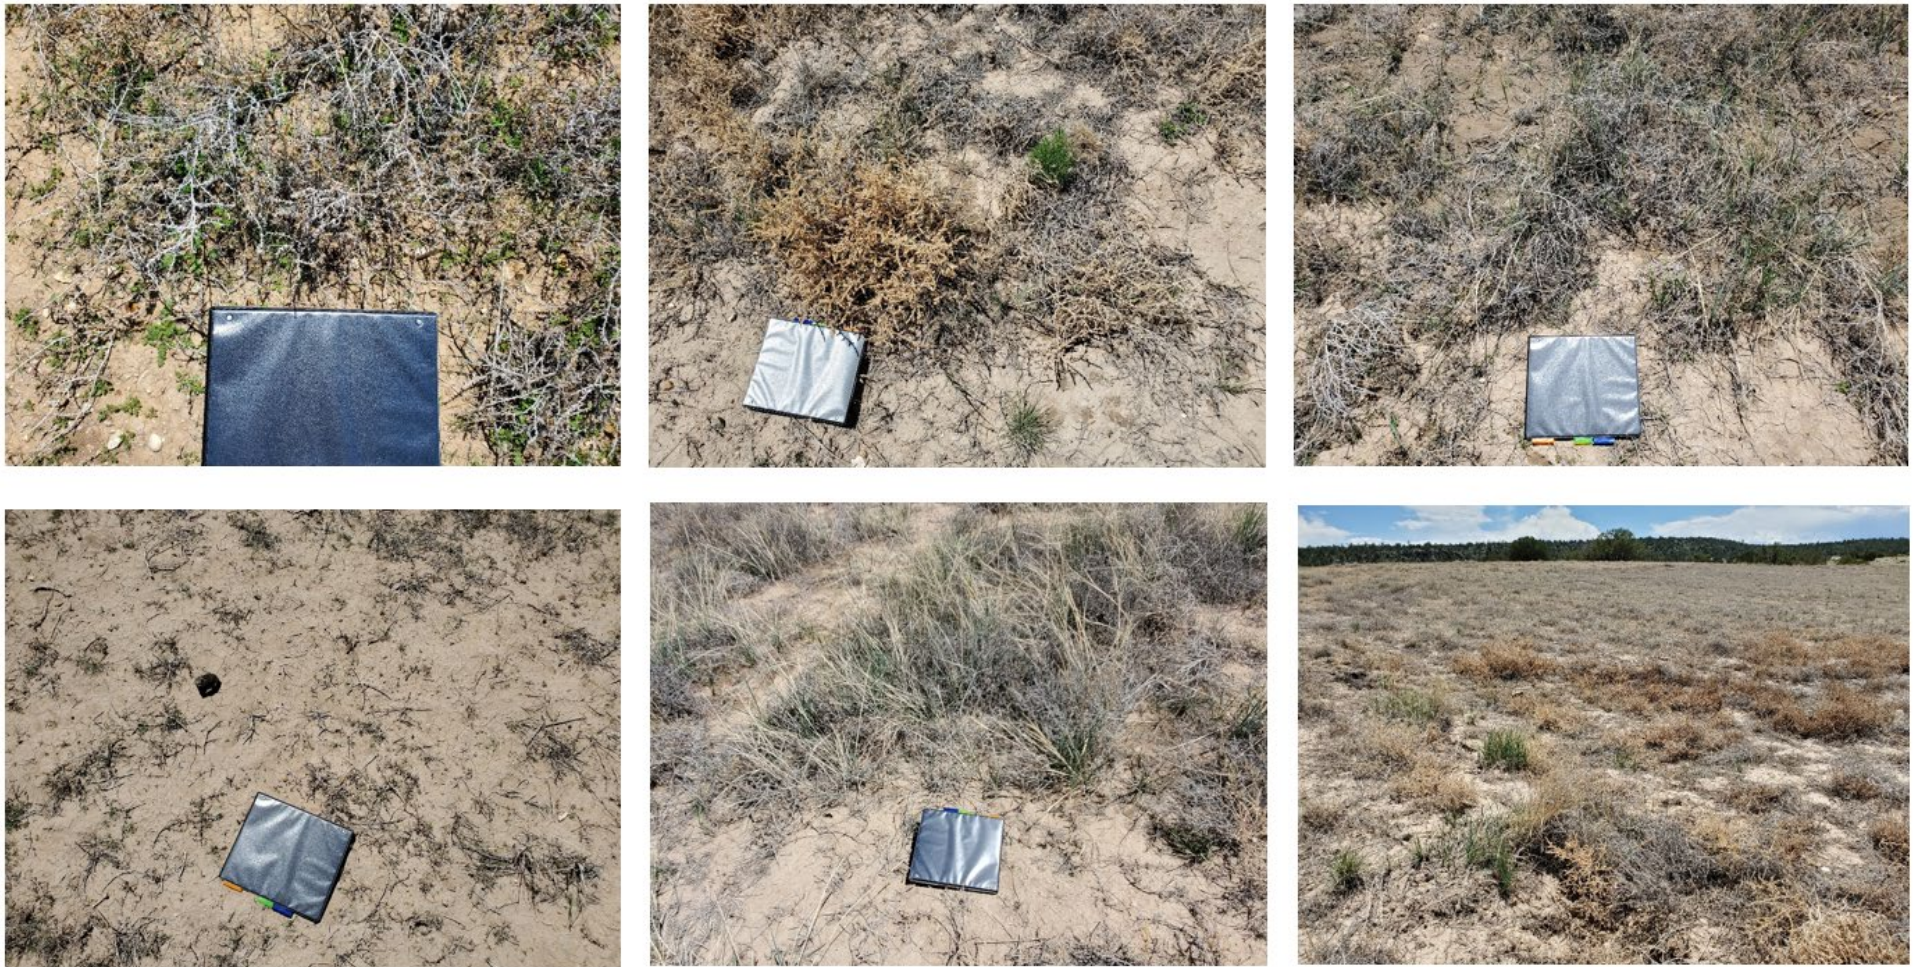
The entire site has been seeded, with the most recent acres (the portion south of the main drainage in the west side of the permit) having been seeded in 2020. The most recently reclaimed area does not have adequate vegetative cover and is mostly comprised of annual weeds primarily Russian Thistle (see Figure 4; Photos 7, 11, 14, 15, and 24). At this time, the reclamation in this portion of the permit is not eligible for release. Also, starting north of photo location 11 down to photo location 15, the vegetation is sparse. The Operator will be required to re-seed the south-western recently reclaimed area -- once it has established vegetative cover representative of the adjacent unaffected land it will then be eligible for release. The vegetative cover on the other reclaimed portions of the site is adequate and no noxious weeds were observed onsite. (16, 17, 19, 20, 23, 29 and portions of others).

Figure 4: Various examples of vegetative cover throughout the most recently seeded area (the south-western portion of the permit). An 11.5 x 9.5" binder is used for scale. Much of the established vegetation in this area consists of the annual weed Russian Thistle.
