MINERALS PROGRAM INSPECTION REPORT
PHONE: (303) 866-3567

MINE NAME: Pikeview Quarry	MINE/PROSPECTING ID#: M-1977-211	MINERAL: Limestone (general), granite gneiss and do	COUNTY: El Paso
INSPECTION TYPE: Monitoring	WEATHER: Clear	INSP. DATE: June 22, 2023	INSP. TIME: 10:00
OPERATOR: Riverbend Industries Inc.	OPERATOR REPRESENTATIVE: Jerry Schnabel	TYPE OF OPERATION: 112c - Construction Regular Operation	
REASON FOR INSPECTION: Normal I&E Program	BOND CALCULATION TYPE: None	BOND AMOUNT: \$13,389,784.00	
DATE OF COMPLAINT: NA	POST INSP. CONTACTS: None	JOINT INSP. AGENCY: None	
INSPECTOR(S): Zach Trujillo	INSPECTOR'S SIGNATURE:

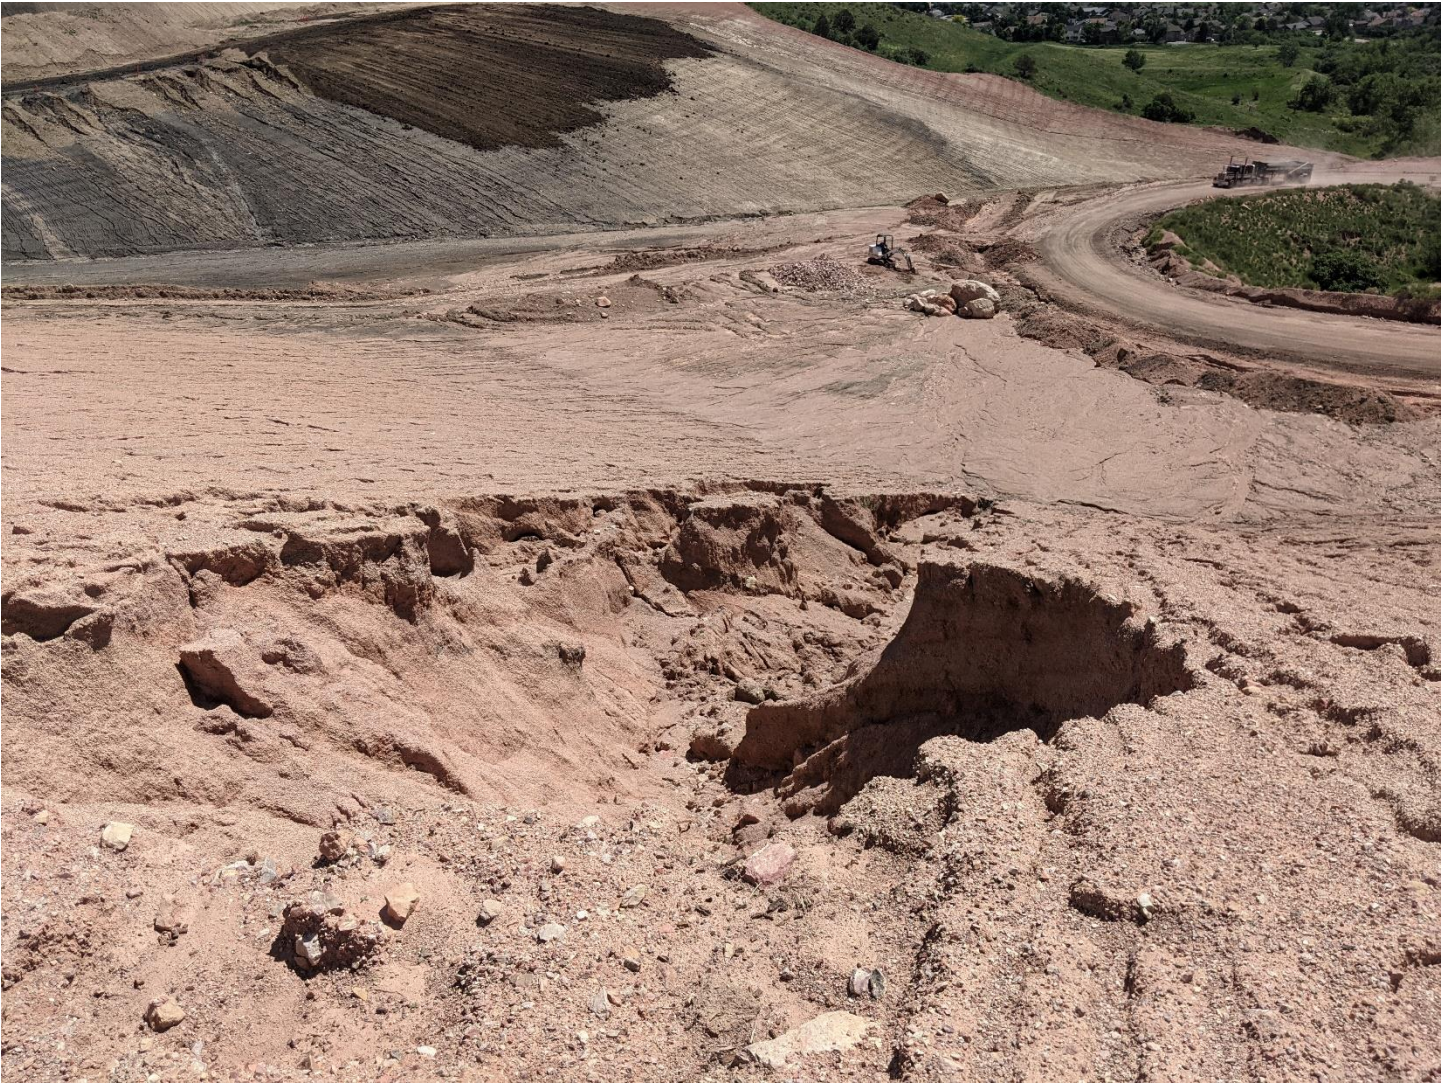
Backfill and compaction efforts were not occurring during the inspection. A temporary cease on backfill placement has occurred for a change in contractors. Due to strong precipitation events, gullying has occurred along the face of the constructed buttress. Maintenance is planned to backfill and recompact the areas once operations recommence. Overall, the backfill remains stable.

Gully along buttress slope.

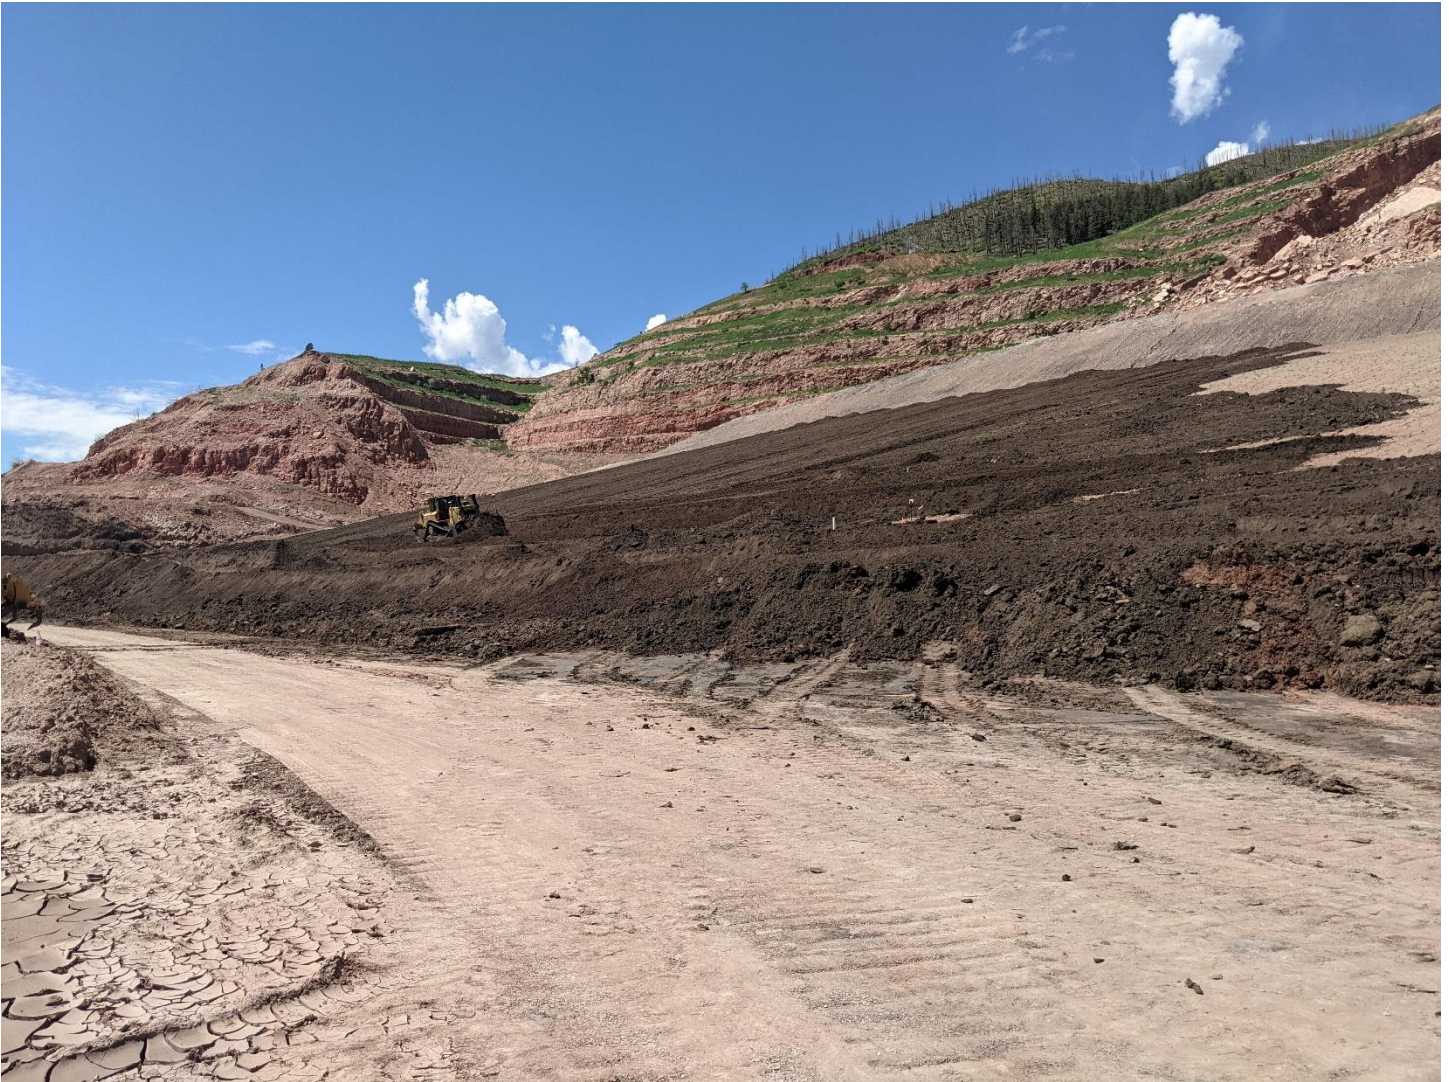
Topsoil placement along the buttress.

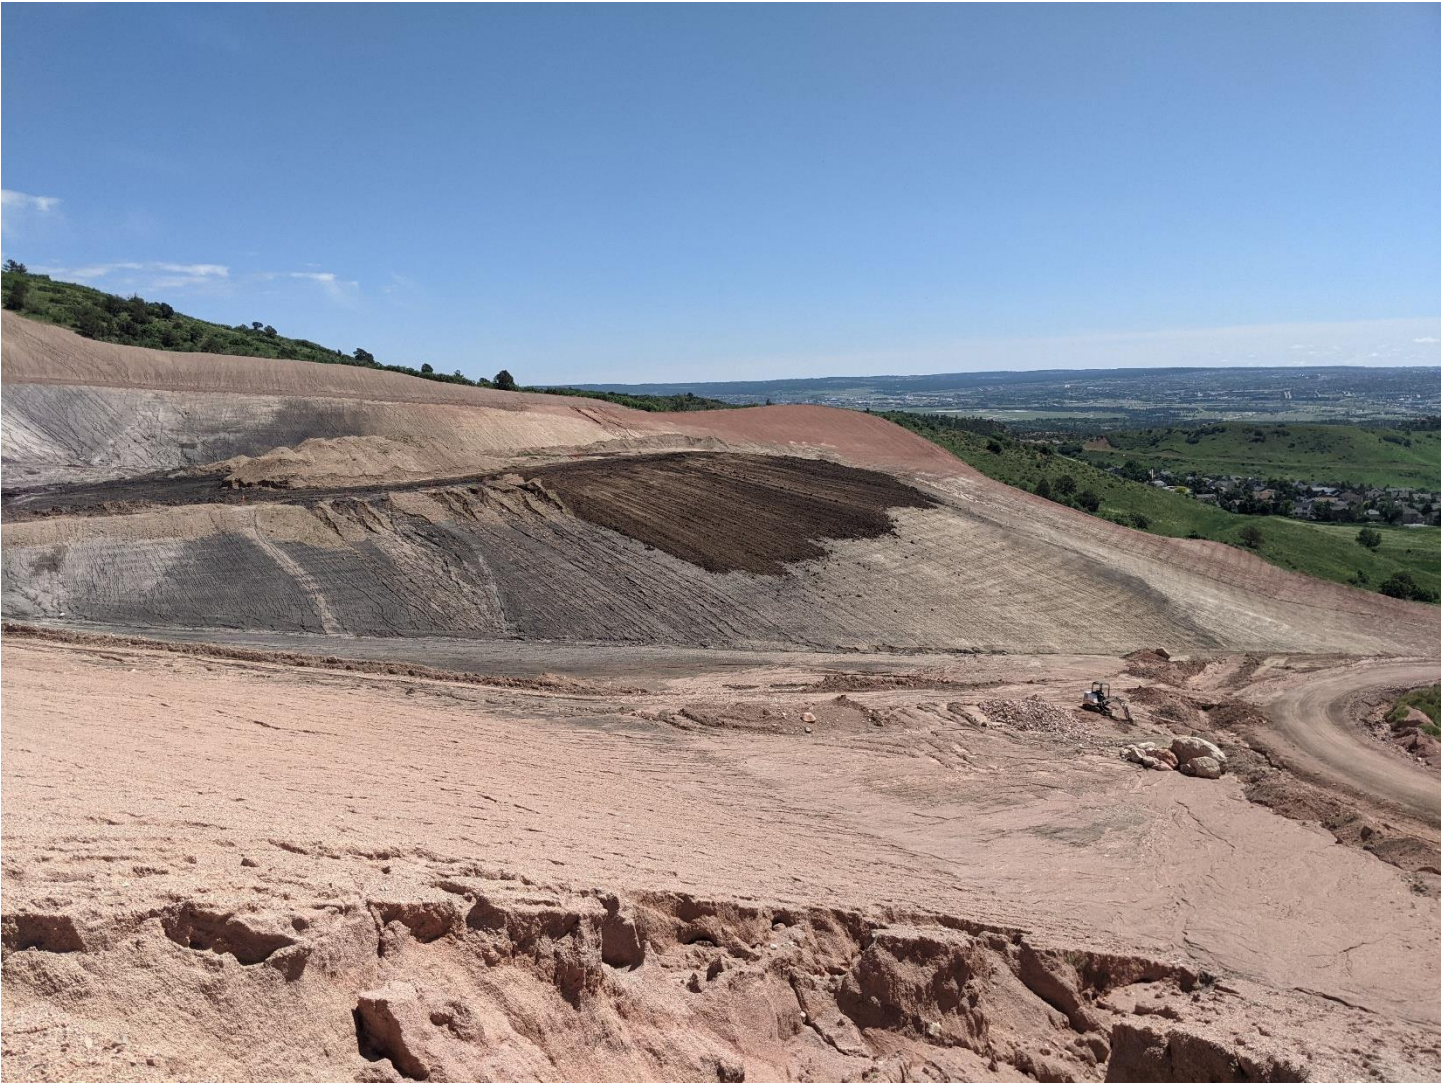
Topsoil placement along north-eastern regraded slope.

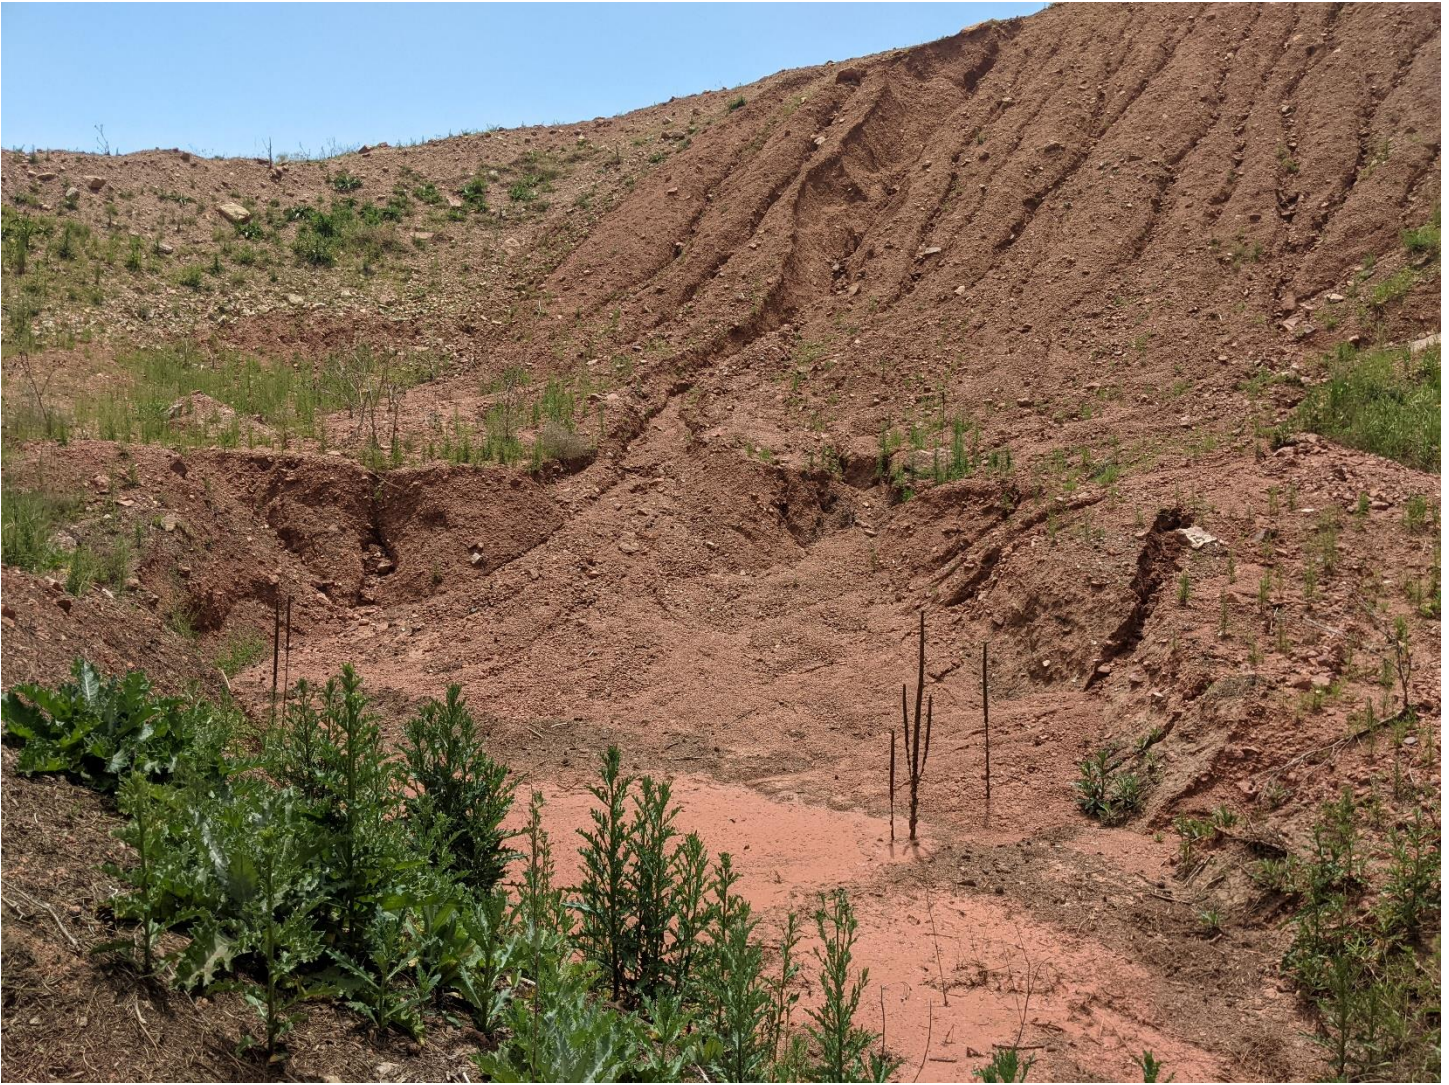
The culvert located beneath the access road along the north-western portion of the site was clogged during the inspection. Cleaning and maintenance for the culvert is planned.

Location of clogged culvert.
