MINERALS PROGRAM INSPECTION REPORT
PHONE: (303) 866-3567

MINE NAME: Phoenix Mine	MINE/PROSPECTING ID#: M-1982-075	MINERAL: Gold and silver	COUNTY: Clear Creek
INSPECTION TYPE: Monitoring	WEATHER: Clear	INSP. DATE: June 15, 2023	INSP. TIME: 10:00
OPERATOR: Mosch Exploration & Mining, LLC	OPERATOR REPRESENTATIVE: David Mosch	TYPE OF OPERATION: 110(2) - Hard Rock Limited Impact	
REASON FOR INSPECTION: Normal I&E Program	BOND CALCULATION TYPE: Partial Bond	BOND AMOUNT: \$8,750.00	
DATE OF COMPLAINT: NA	POST INSP. CONTACTS: None	JOINT INSP. AGENCY: None	
INSPECTOR(S): Peter Hays	INSPECTOR'S SIGNATURE:

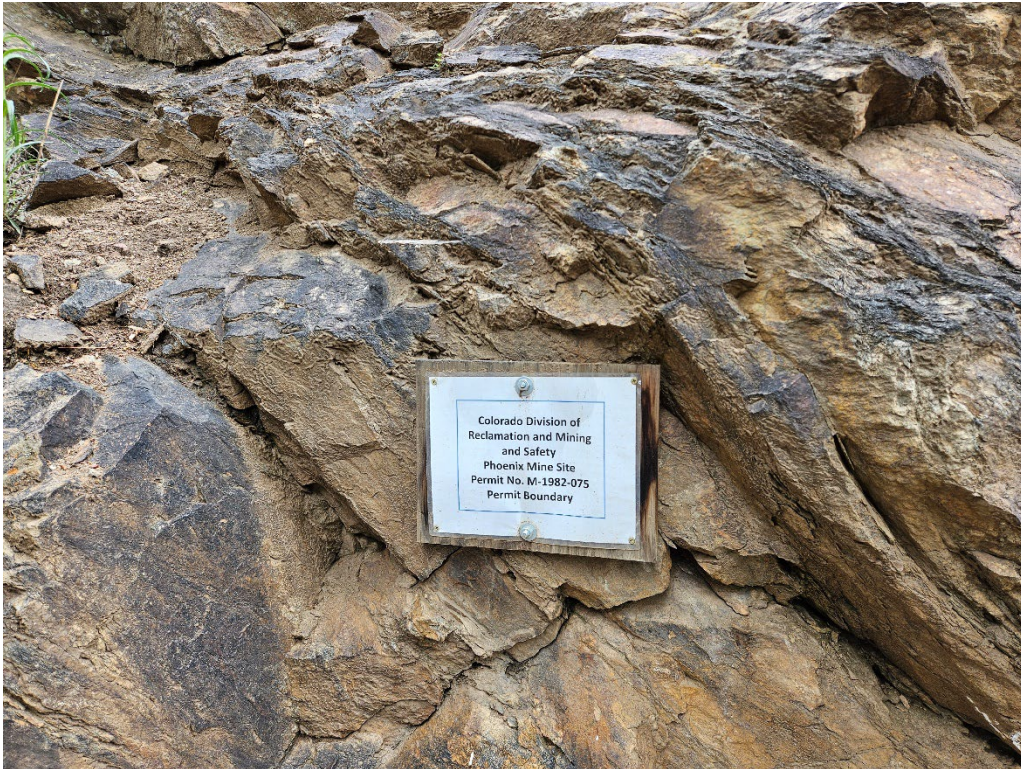
The Division holds a financial warranty in the amount of \$4,475.00. The financial warranty amount will be evaluated during the permitting process to convert the site to a DMO operation. The mine sign and boundary markers were observed as required by Rule 3.1.12.

Phoenix Mine sign

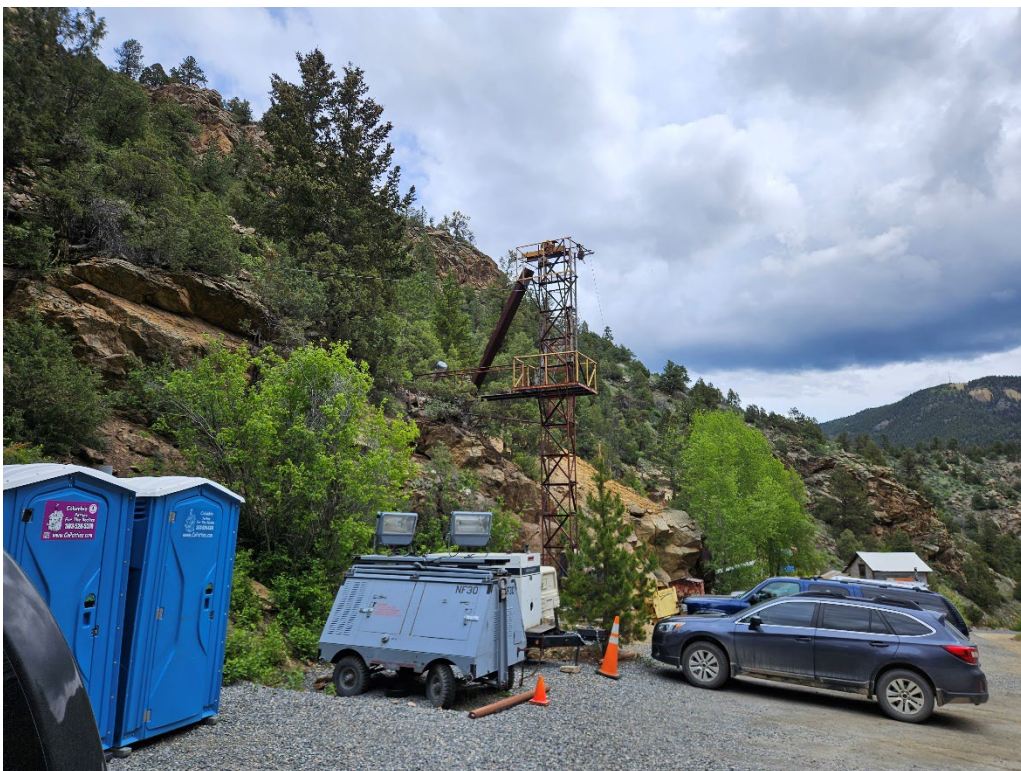
View from the southeast corner of the southern permit polygon looking northwest

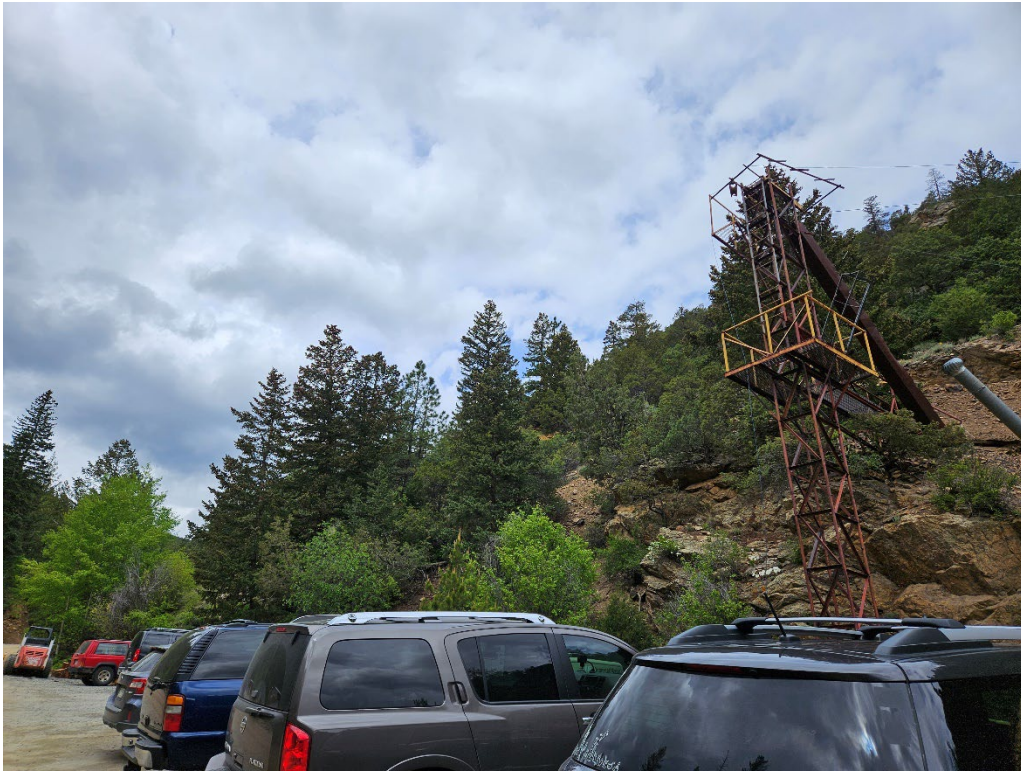
View from the northeast corner of the southern permit polygon looking southwest

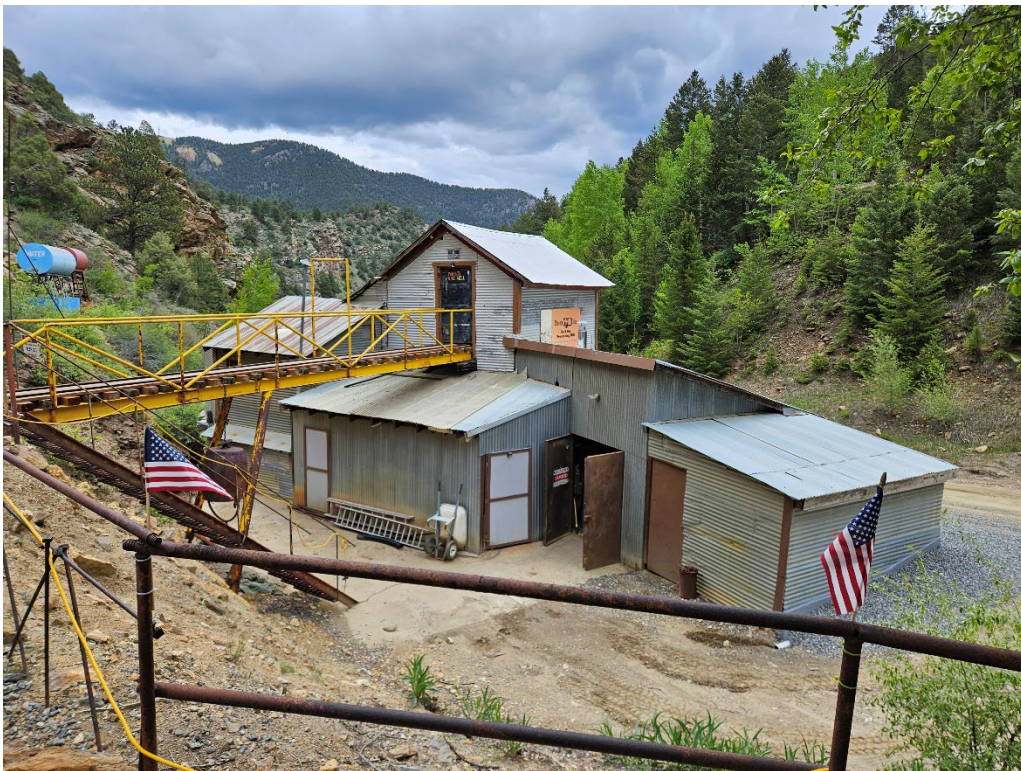
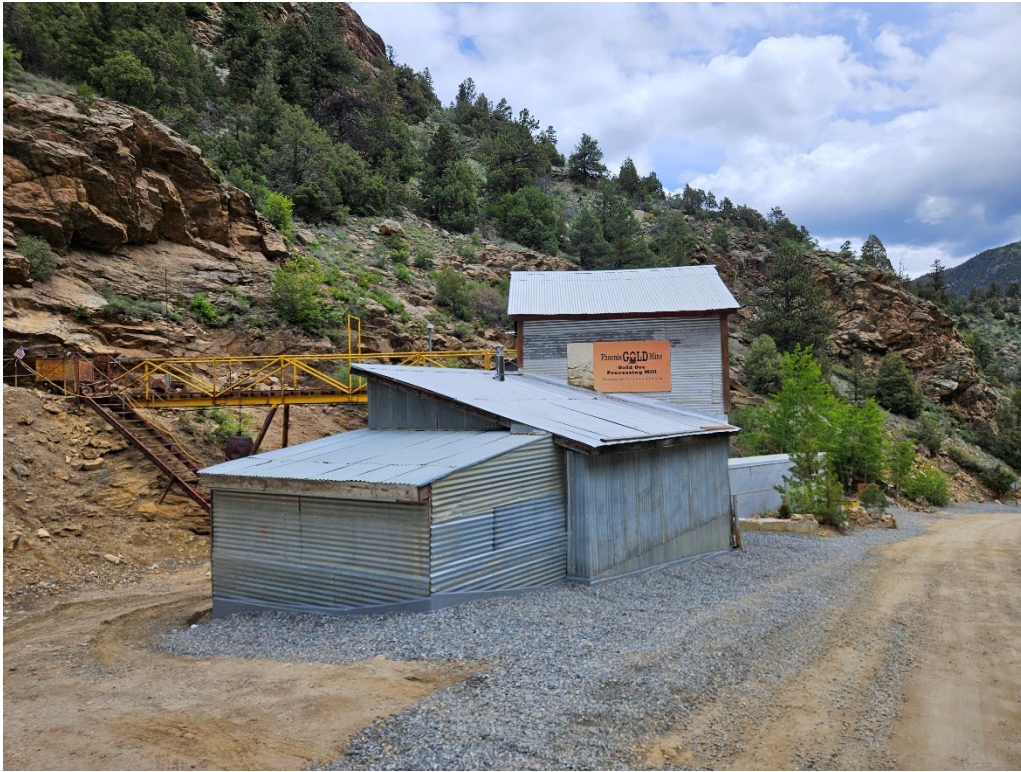
The inspection focused on the surface facilities at the site. The underground portions of the mine were not inspected by the Division. All mine entrances are secured with steel doors with locks. The mill building houses a jaw crusher, a ball mill, a bank of float cells and a shaker table. According to the Operator, the mill building has not been operational for decades. The bank of float cells were not hooked up to the milling circuit. The mill would require some additional work to be fully functional, which the Operator intends to perform to operate the mill. The milling process currently does not use chemicals in metal recovery and relies on gravity concentration. The Division found no evidence of chemicals being stored or used in the mill. A variety of spare parts and tools are stored in the mill building. The Operator stated they intend to clean up the mill building as time allows. The upper level of the mill is accessed by way of a cat-walk which connects to the hillside above the mill building. The upper level of the mill building contains an office area and the jaw crusher. The current Mining Plan does not contain any details about how the mill will be operated. The pending conversion to a DMO operation must include a complete explanation of all processing facilities, including the mill, as part of an updated Mining Plan.

View of the mill building in the northern permit polygon
