**MINERALS PROGRAM INSPECTION REPORT**  
**PHONE: (303) 866-3567**

<b>MINE NAME:</b> Poorman Mine	<b>MINE/PROSPECTING ID#:</b> M-1982-058	<b>MINERAL:</b> Gold and silver	<b>COUNTY:</b> Clear Creek
<b>INSPECTION TYPE:</b> Monitoring	<b>WEATHER:</b> Clear	<b>INSP. DATE:</b> June 15, 2023	<b>INSP. TIME:</b> 09:00
<b>OPERATOR:</b> Mosch Exploration & Mining, LLC	<b>OPERATOR REPRESENTATIVE:</b> David Mosch	<b>TYPE OF OPERATION:</b> 110(2) - Hard Rock Limited Impact	
<b>REASON FOR INSPECTION:</b> Normal I&E Program	<b>BOND CALCULATION TYPE:</b> Partial Bond	<b>BOND AMOUNT:</b> \$4,803.00	
<b>DATE OF COMPLAINT:</b> NA	<b>POST INSP. CONTACTS:</b> None	<b>JOINT INSP. AGENCY:</b> None	
<b>INSPECTOR(S):</b> Peter Hays	<b>INSPECTOR'S SIGNATURE:</b>

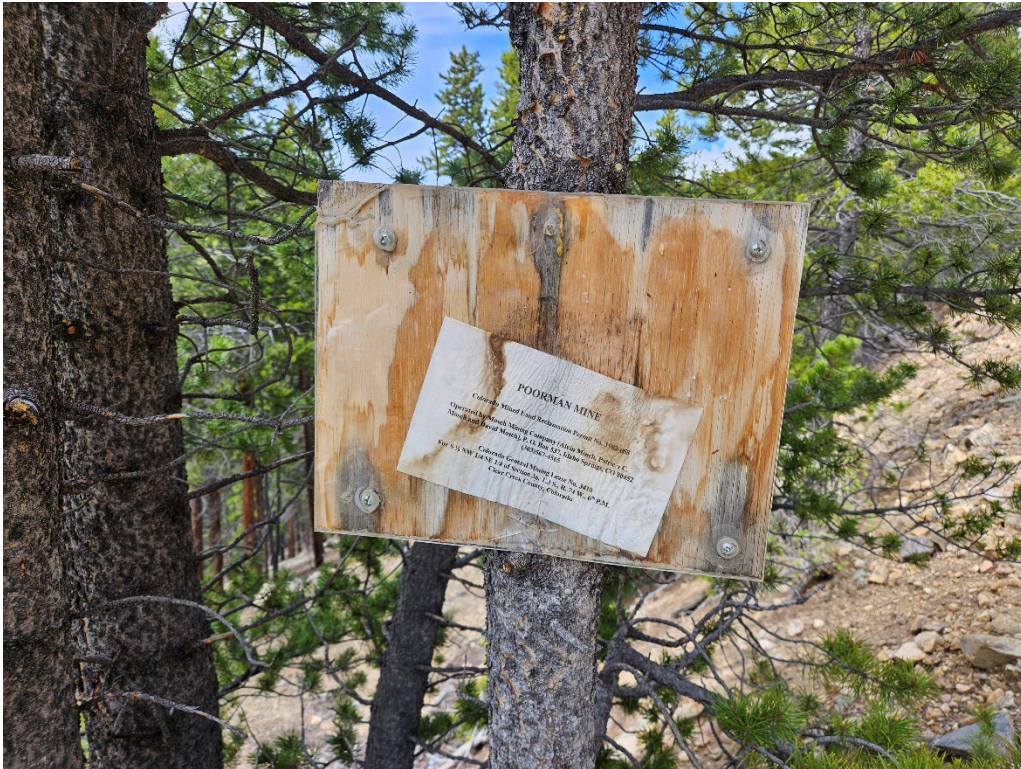
The Division holds a financial warranty in the amount of \$4,803.00, which is adequate to perform the remaining reclamation at the site based on the observations from this inspection. The mine sign and boundary markers were observed as required by Rule 3.1.12.

Poorman Mine sign

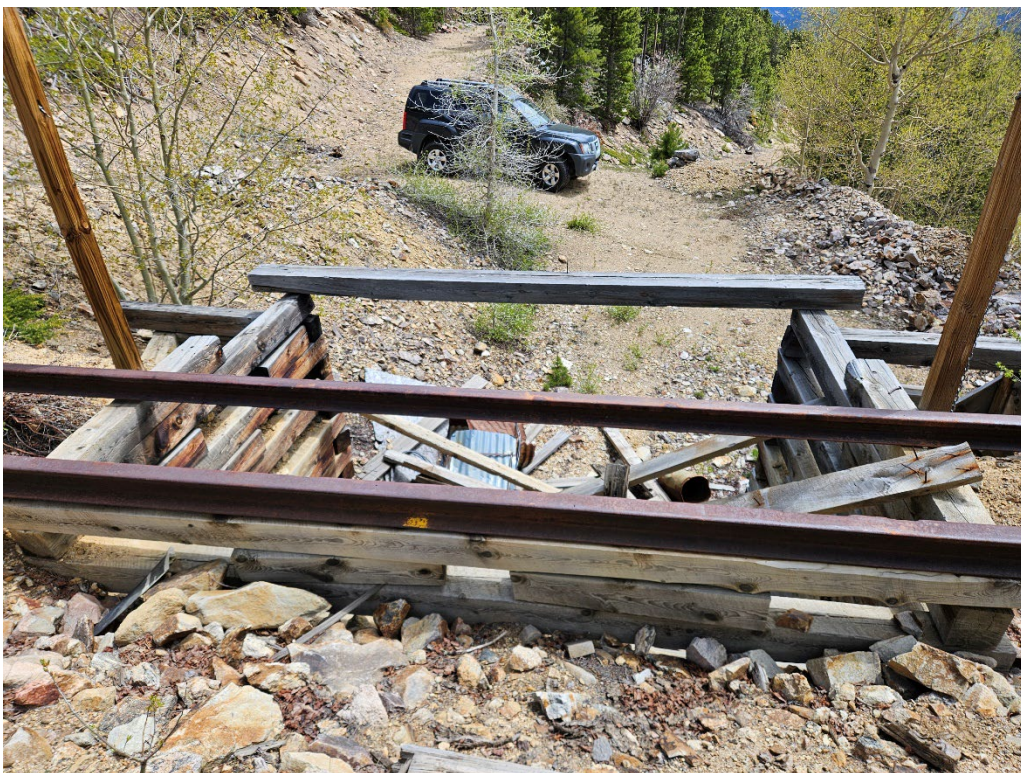
View of the trestle pocket from the top

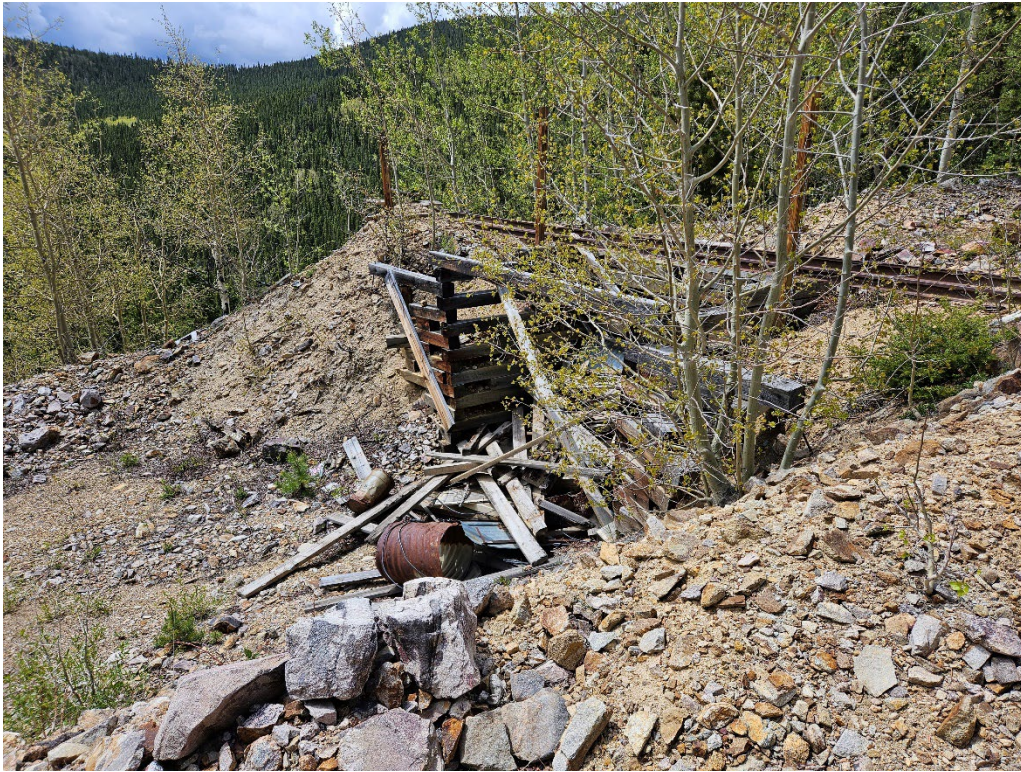
View of the trestle pocket from the bottom

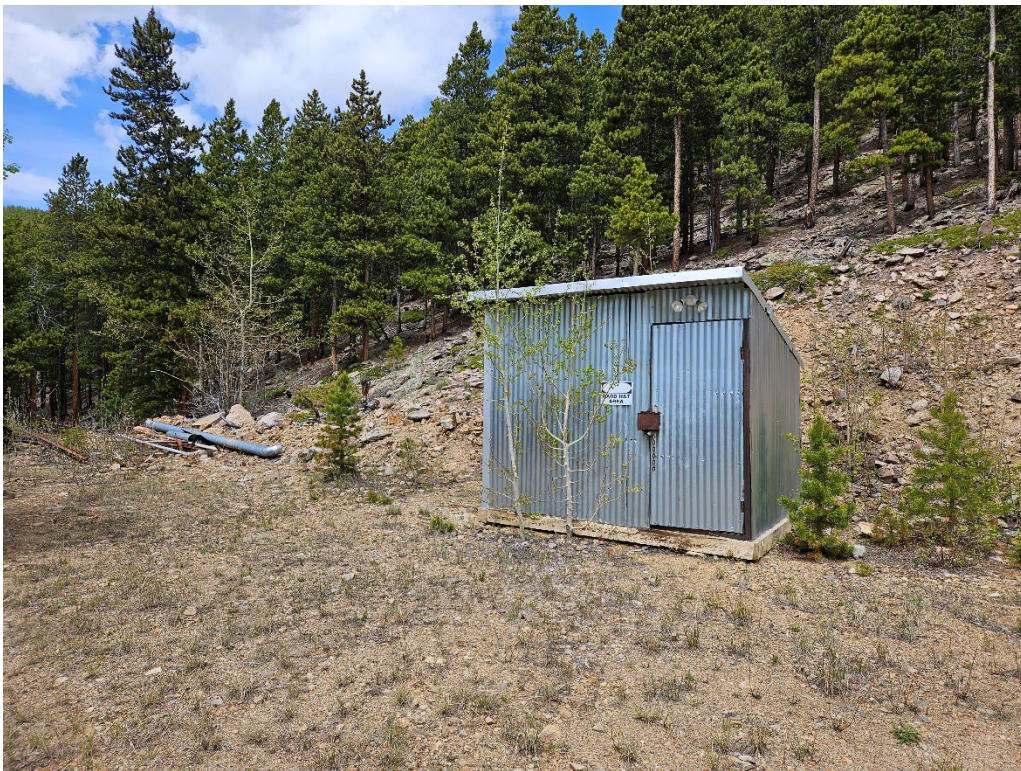
The approved Reclamation Plan states the mine structures will be removed from the site and the area will be graded to a 2.22H:1V slope to match the existing topography. Final reclamation activities were initiated by the Operator. The antique school bus was relocated to the Phoenix Mine. The metal storage shed is in the process of being clean out to allow for removal from the site. The shed, timbers and the rail are scheduled to be removed from the site this year. The school bus, generator, air compressor and mine fan were removed since the last inspection. A pile of metal debris was observed west of the shed. Metal and wood debris, including filing cabinets, were observed at the former school bus location and in the trestle pocket. The debris will need to be removed as part of the site reclamation. The waste dump appeared stable and vegetated with aspen trees and raspberry plants. The possibility of leaving the trestle dumping pocket timber structure in place was discussed during the inspection. No erosion features were noted during the inspection.

View of the storage shed

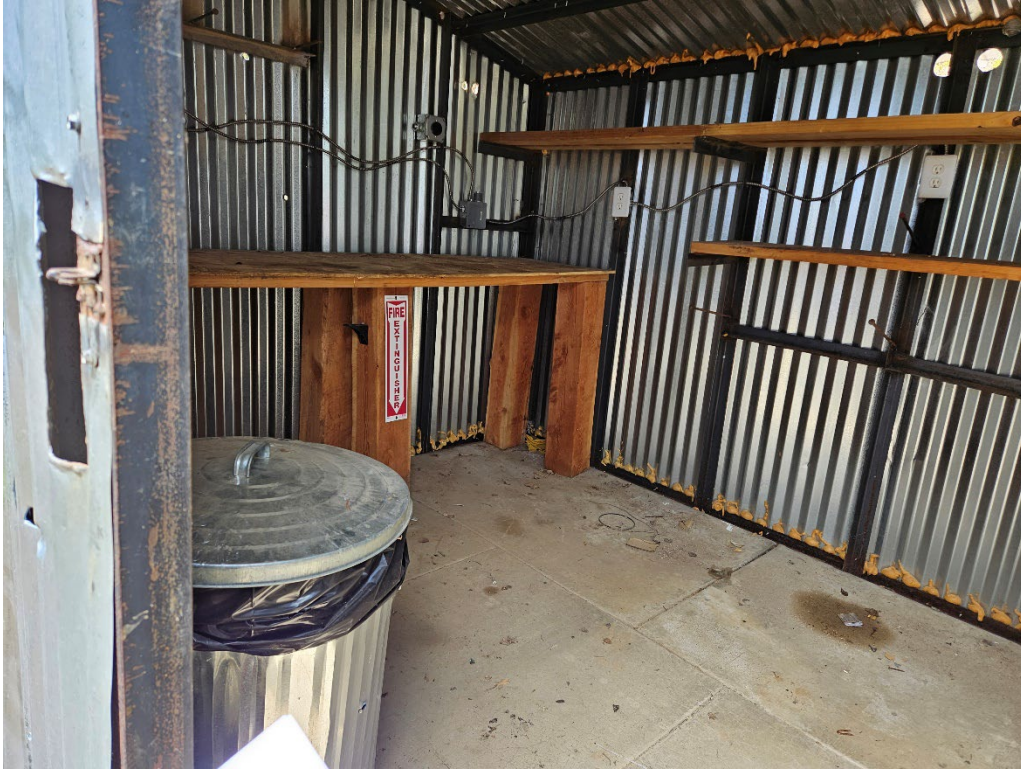
View inside the storage shed

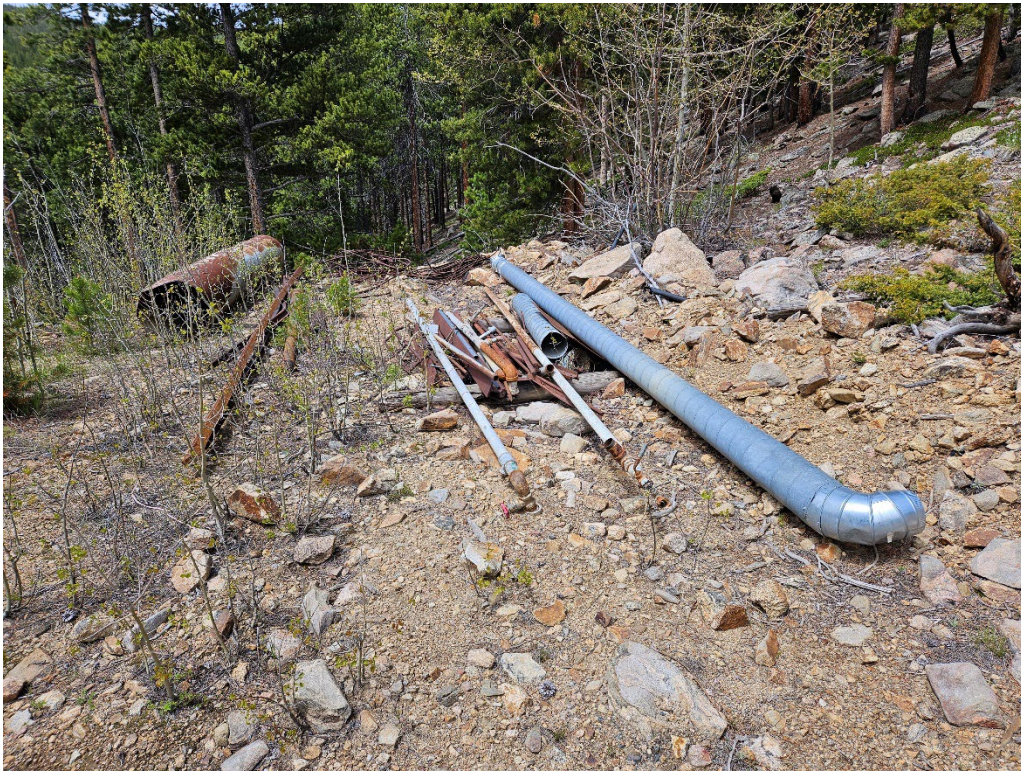
View of the debris west of the storage shed

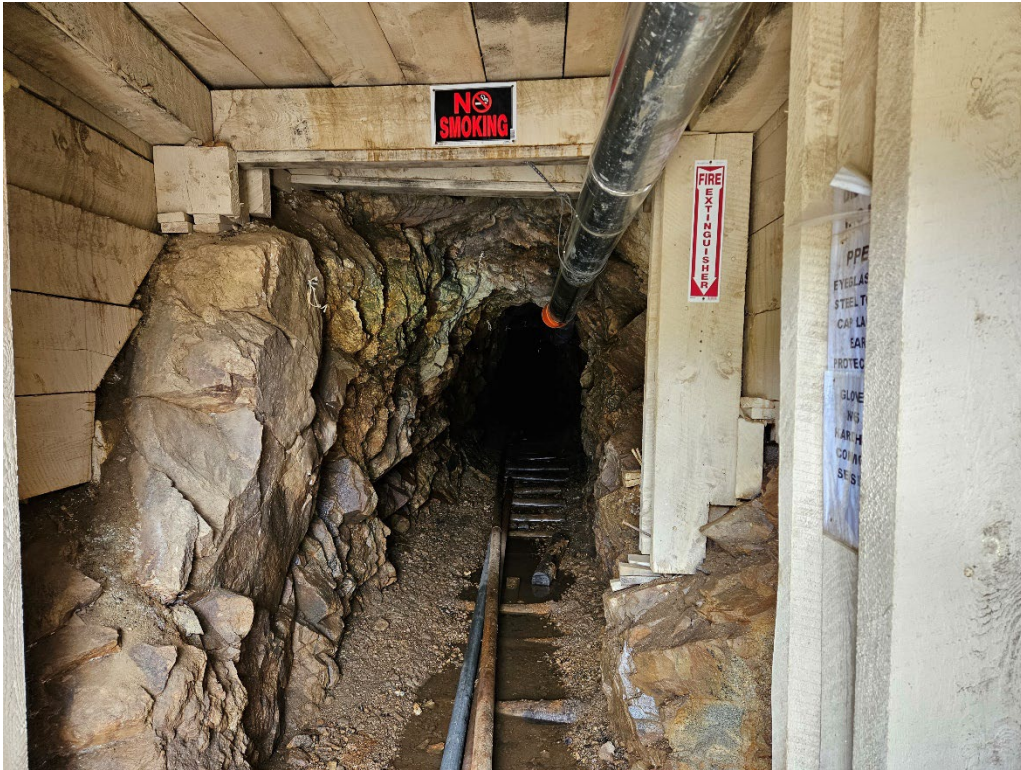
View inside the portal

The Operator intends to use material from the top of the waste dump and MSHA safety berm to contour the site for stability and to match the existing topography. The Operator intends to leave the locked portal doors exposed during final reclamation. The Operator will contact the SLB regarding leaving the portal exposed or backfilling the portal area and leaving the trestle structure on-site as part of the final reclamation plan.

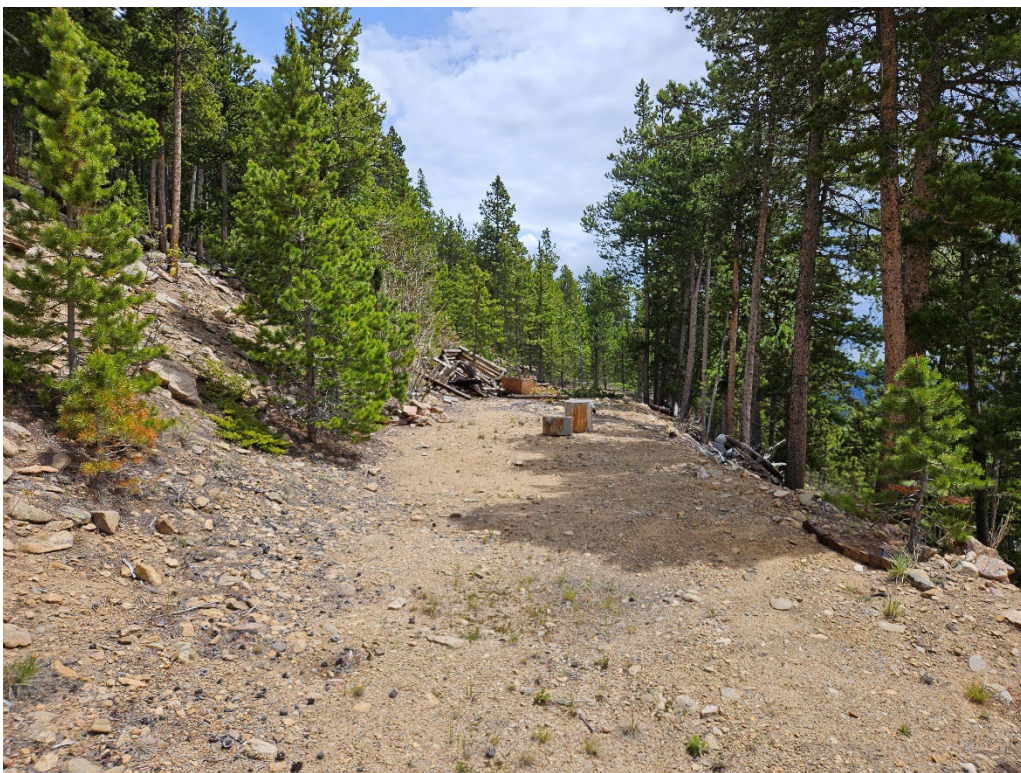
View of the former school bus location and debris
