**MINERALS PROGRAM INSPECTION REPORT**  
**PHONE: (303) 866-3567**

<b>MINE NAME:</b> Bear Hug	<b>MINE/PROSPECTING ID#:</b> P-2011-028	<b>MINERAL:</b> Gold and silver	<b>COUNTY:</b> Clear Creek
<b>INSPECTION TYPE:</b> Monitoring	<b>WEATHER:</b> Clear	<b>INSP. DATE:</b> June 16, 2023	<b>INSP. TIME:</b> 11:00
<b>OPERATOR:</b> Terry Winters	<b>OPERATOR REPRESENTATIVE:</b> Terry Winters	<b>TYPE OF OPERATION:</b> MP - Mineral Prospecting	
<b>REASON FOR INSPECTION:</b> Normal I&E Program	<b>BOND CALCULATION TYPE:</b> Partial Bond	<b>BOND AMOUNT:</b> \$2,268.23	
<b>DATE OF COMPLAINT:</b> NA	<b>POST INSP. CONTACTS:</b> None	<b>JOINT INSP. AGENCY:</b> None	
<b>INSPECTOR(S):</b> Peter Hays	<b>INSPECTOR'S SIGNATURE:</b>

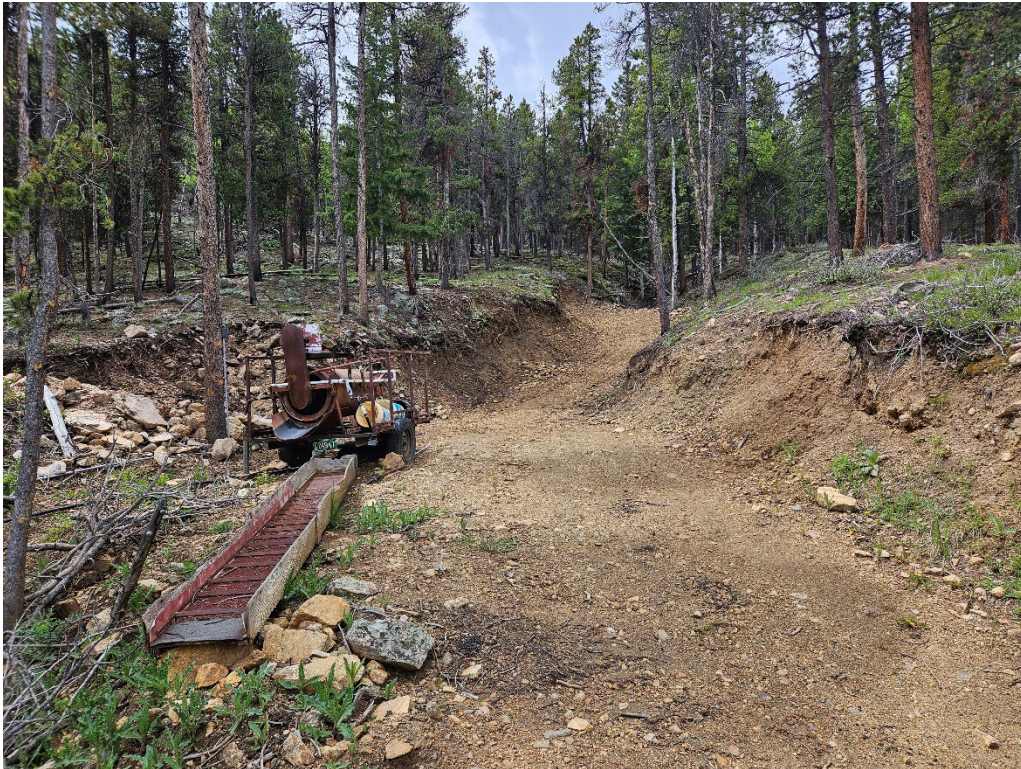
The small excavation located at the top of the access road observed during the last inspection was expanded into a trench by the Prospector. The trench was estimated at 50 feet in length, 2 to 5 feet in height and 6 feet wide. Mr. Winters stated the clay seam located along the southern base of the trench contained mineral deposits. The trench was being excavated from east to west along the clay seam.

View of the trommel and prospecting trench looking west

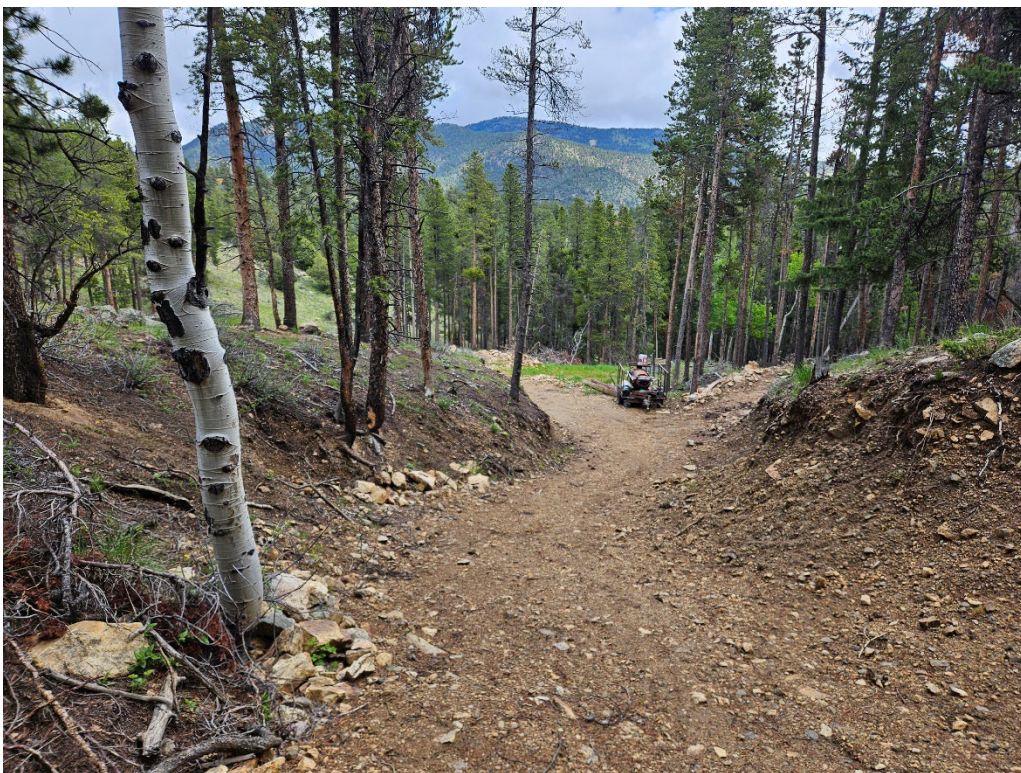
View of the prospecting trench looking east

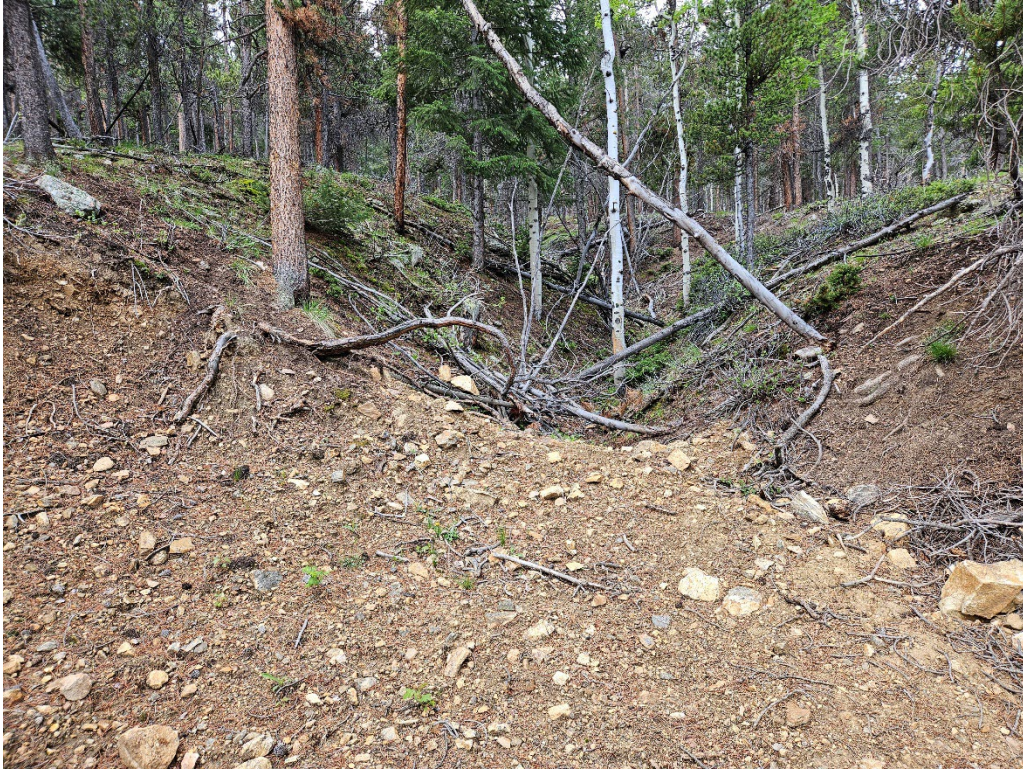
View of the western end of the trench looking uphill

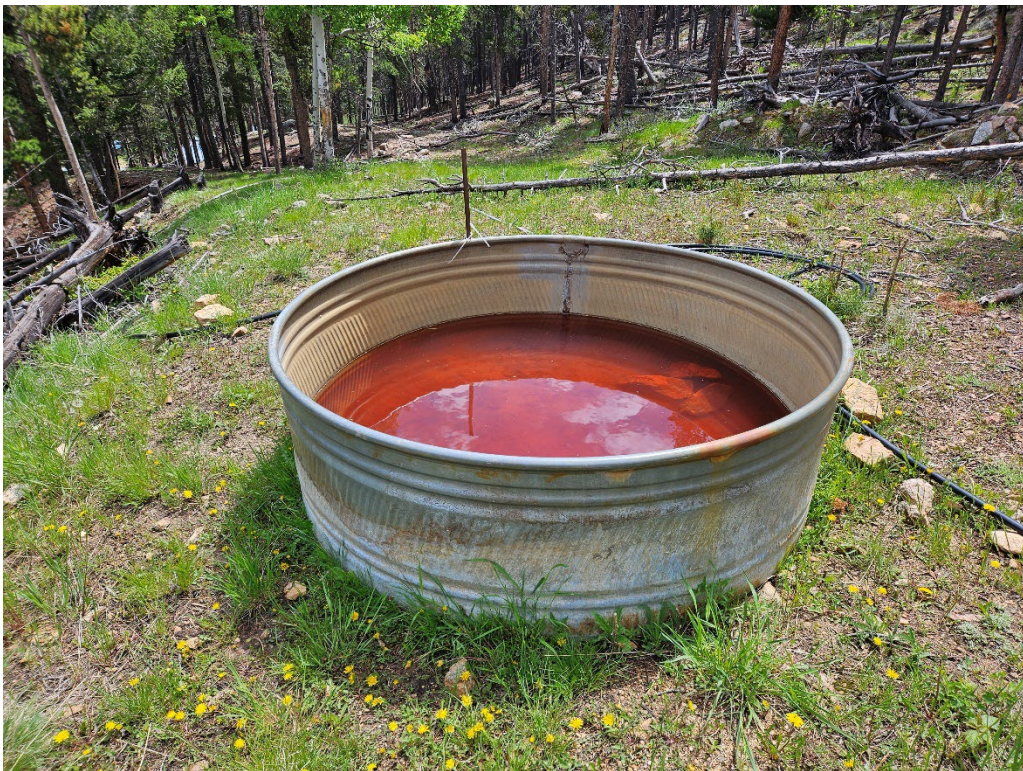
View of the cattle tank
