## Bowie #2 inspection report

<b>Permit Number:</b> C-1996-083 <b>Mine Name:</b> Bowie No. 2 Mine <b>Operator:</b> Bowie Resources, LLC <b>Operator Address:</b> Mr. Basil Bear P.O. Box 1488 Paonia, CO 81428	<b>County:</b> Delta <b>Operation Type:</b> Underground <b>Permit Status:</b> Active <b>Ownership:</b> Private
	<b>Operator Representative Present:</b>  None
<b>Operator Representative Signature: (Field Issuance Only)</b>

<b>Inspection Start Date:</b> June 22, 2023 <b>Inspection Start Time:</b> 09:35 <b>Inspection End Date:</b> June 22, 2023 <b>Inspection End Time:</b> 12:00	<b>Inspection Type:</b> Coal Partial Inspection <b>Inspection Reason:</b> Normal I&E Program <b>Weather:</b> Clear
<b>Joint Inspection Agency:</b>  None	<b>Joint Inspection Contacts:</b>  
<b>Post Inspection Agency:</b>  None	<b>Post Inspection Contacts:</b>  
<b>Inspector(s):</b>  Robert Zuber, P.E.	<b>Inspector's Signature:</b>

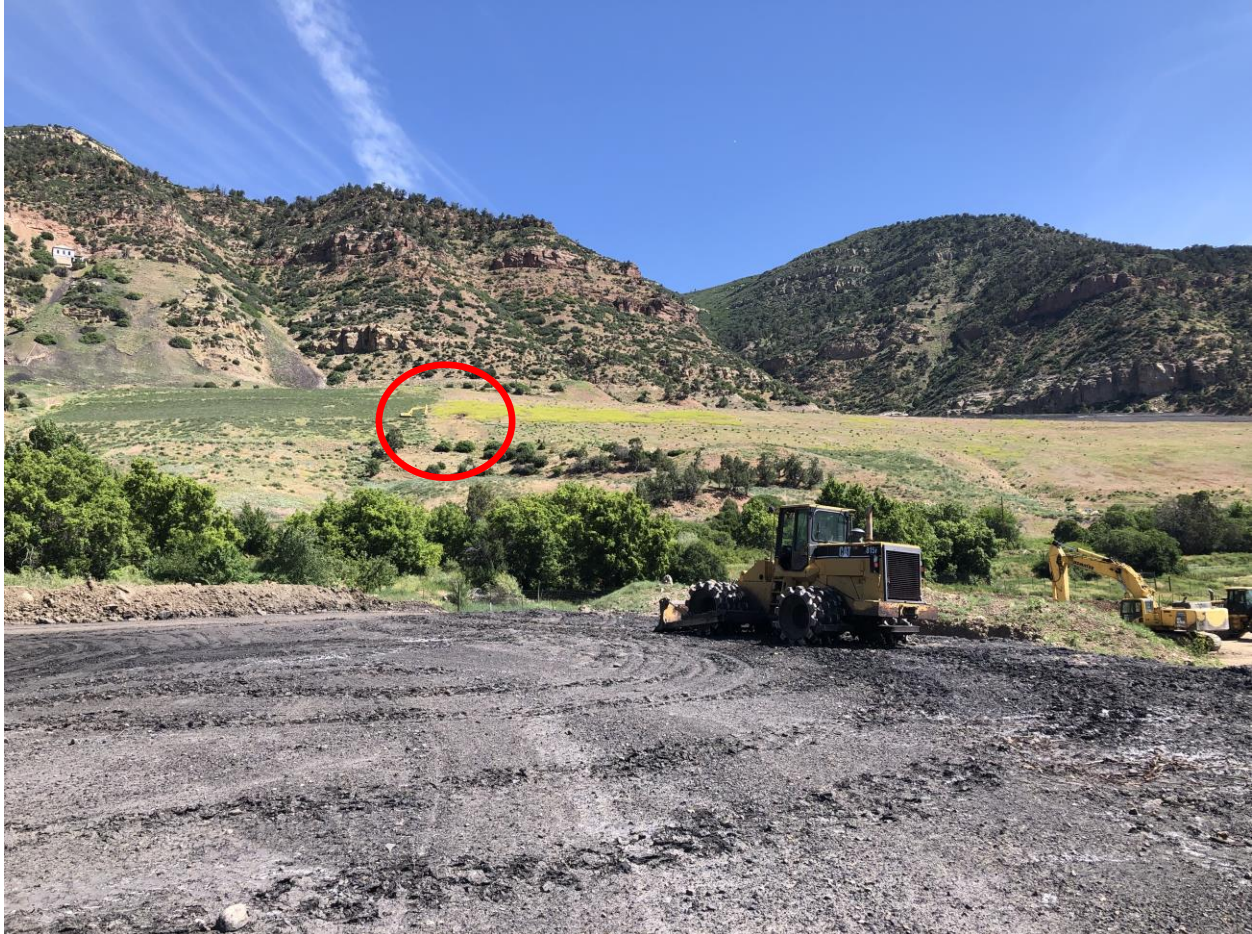
Gob Piles 1, 2, and 3 appeared stable. The ditches and BMPs on the upper part of Gob Pile 2 appeared to be functioning. Rills on the upper face of Gob Pile #2 have not significantly increased in size in recent months.

**Gob Piles - Gob Pile #2 in foreground and blow out on Gob Pile #4 is in the red circle.**

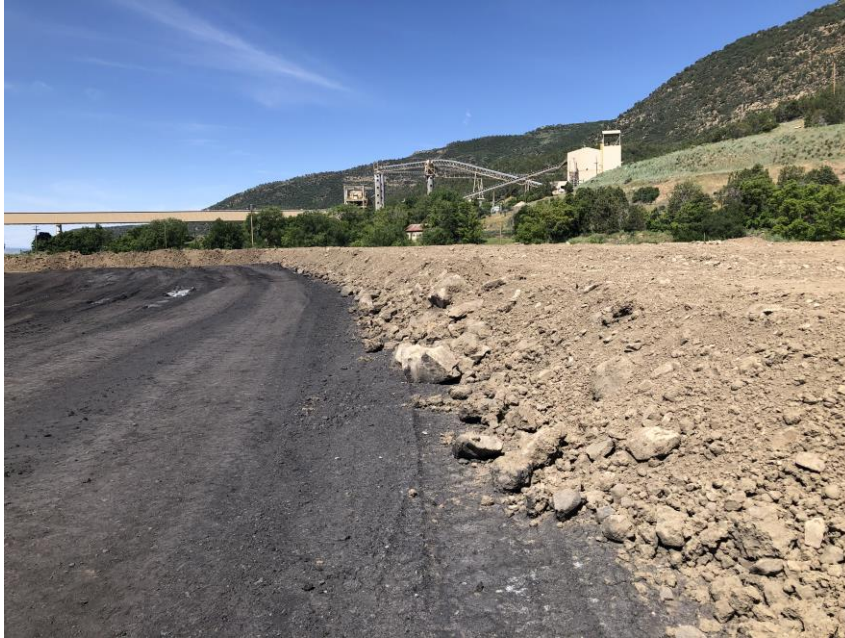
Work on Gob Pile #3 (placement of coverfill) continues, although no operations were seen during the inspection. A surveyor, Steve Craig, was onsite checking coverfill depths. The coverfill pile east of Gob Pile #3 is considerably smaller than in past months, but it appears there is enough material to cover the pile at least 2.5 feet deep (per the reclamation plan).

Coverfill on Gob Pile #3, looking west

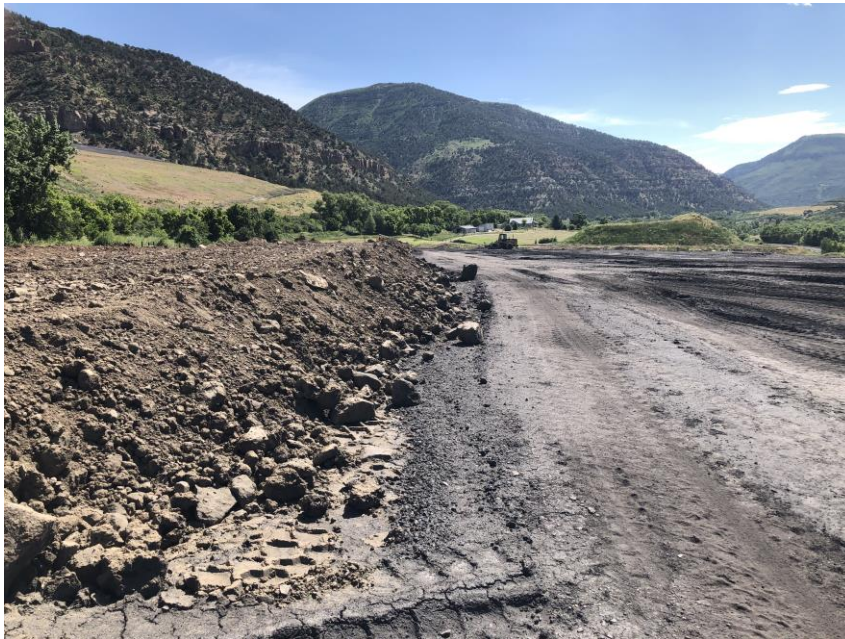
Coverfill on Gob Pile #3, looking east

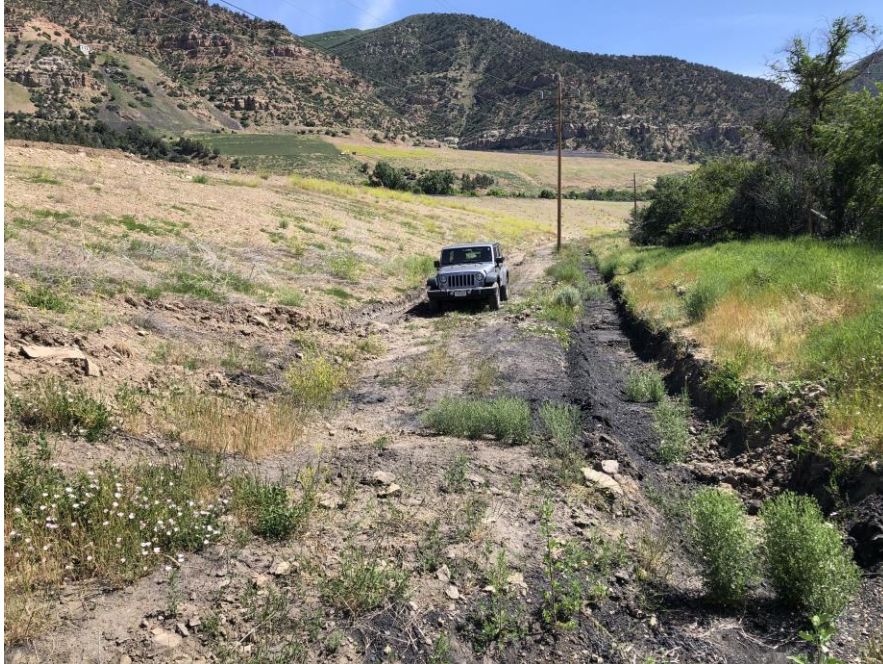
No problems with ditches were identified, including the temporary ditch below Curve Number 8 and the large ditch below Gob Pile #3 (Ditch J3).

**Ditch J3 below Gob Pile #3**

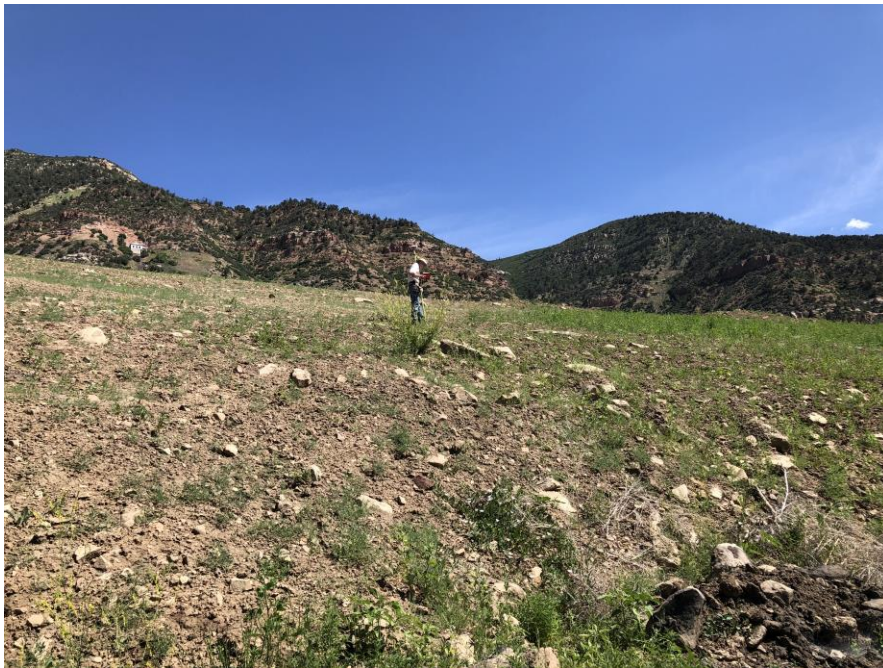
**Surveyor on Gob Pile #3**

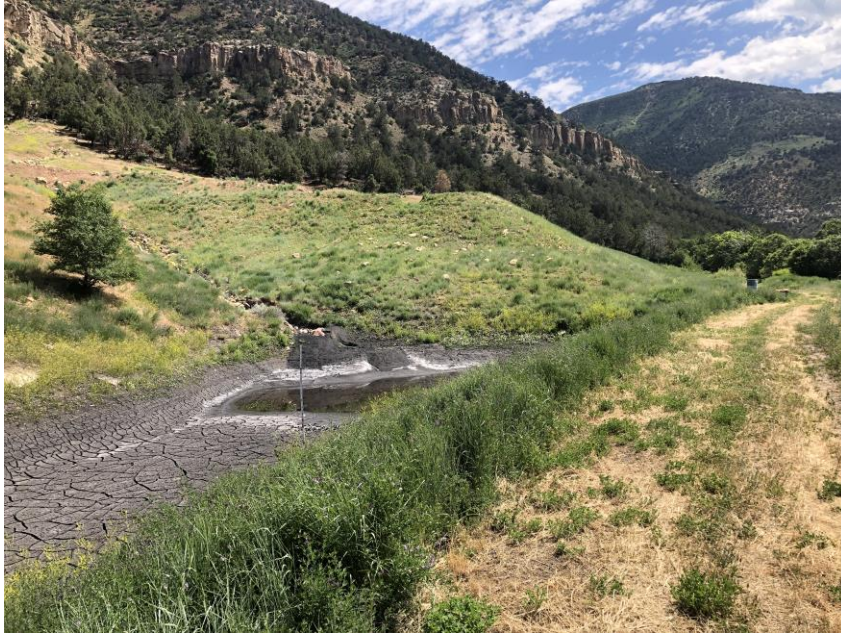
**Pond F**

Two sediment ponds were inspected: F and J. Neither of the ponds was discharging, and both were nearly dry. No significant problems were identified with embankments, spillways, inlet channels, or other features of the ponds.

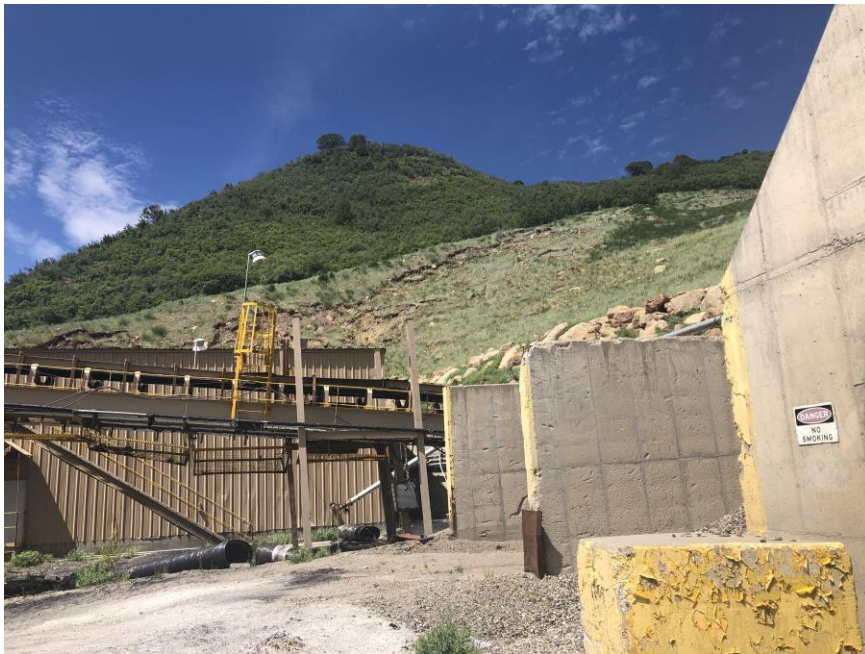
It appears that slumps above Curve Number 6 along the Haul Road, above the B Portal bench, and above Curve Number 11 have not moved significantly in the recent past.

**Slide above B Portal bench**

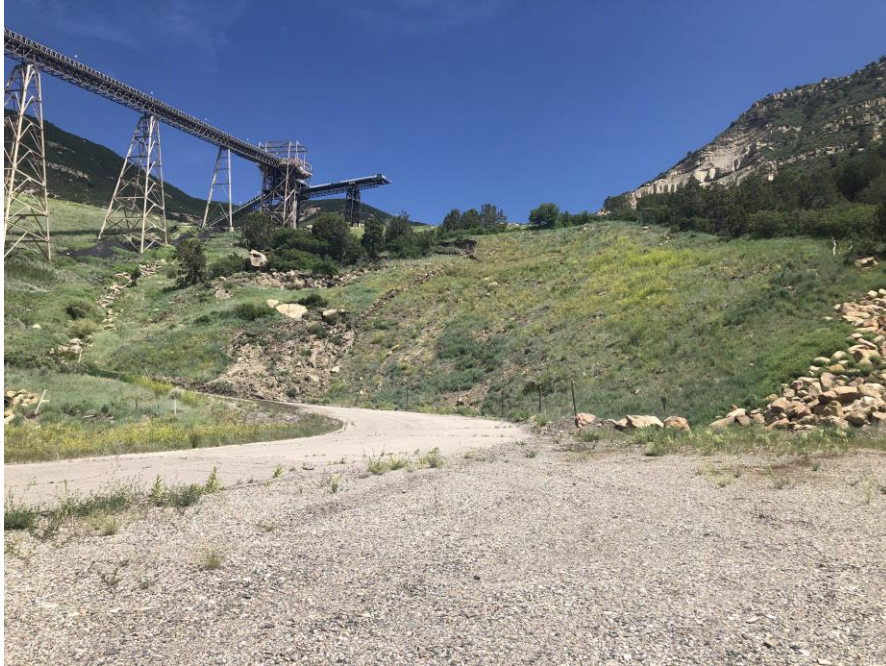
The slide above Curve Number 10 is an ongoing problem, but does not appear to have worsened in June 2023. Ditch C8 continues to be blocked. Water was seeping out of this area and onto the road during the inspection, and BRL is waiting for it to dry out before performing any work on the slope.

**Slide at Curve 10**

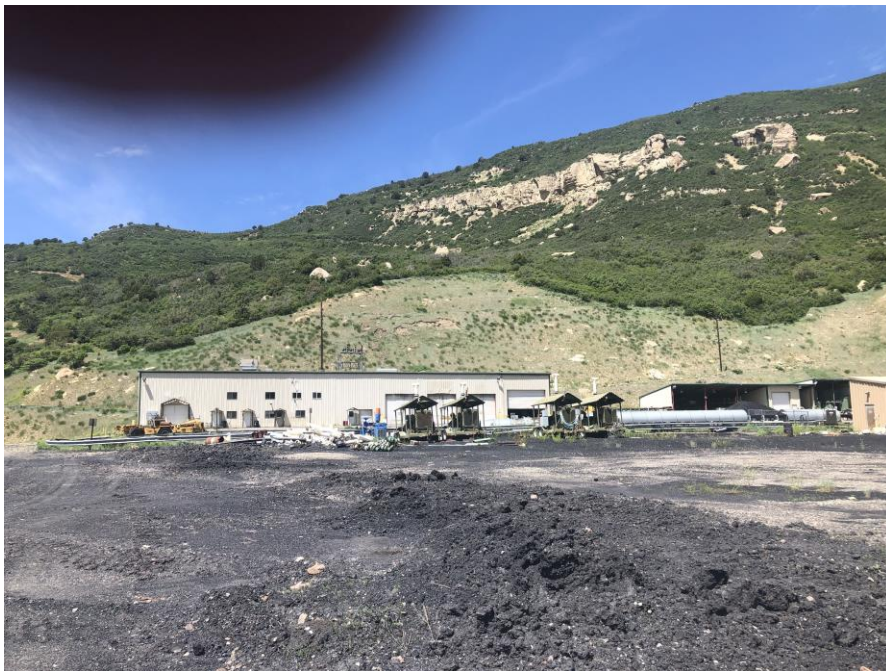
The slide above the road to the Utility Bench was observed and will be closely monitored in the future.

**Slide above the road to the Utility Bench**
