QUARTERLY SEDIMENTATION POND INSPECTION REPORT

Mine: New Elk

Inspection Period: Second Quarter 2023

Inspection Date: 6/22/2023

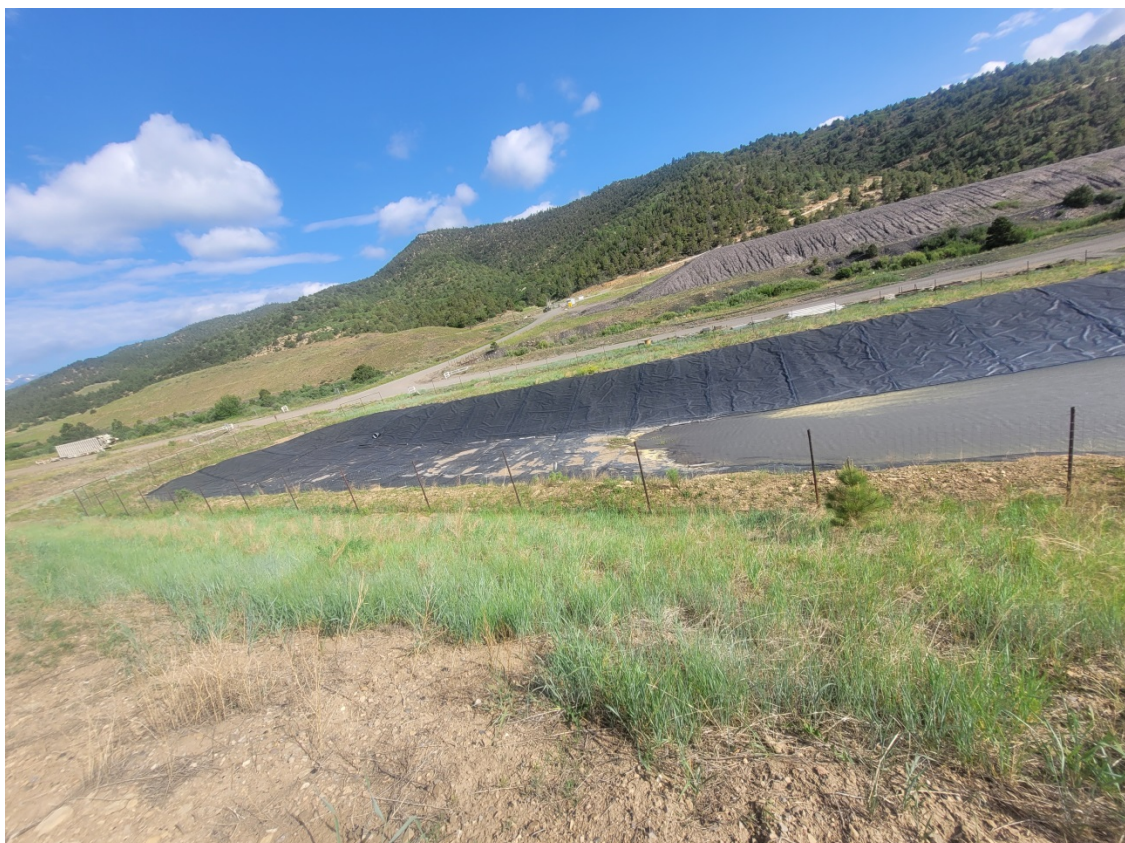
Pond 1 looking West

Pond liner is in good working condition at time of inspection. Pond was holding water at time of
inspection. The mine is putting water into the pond. No issues observed.

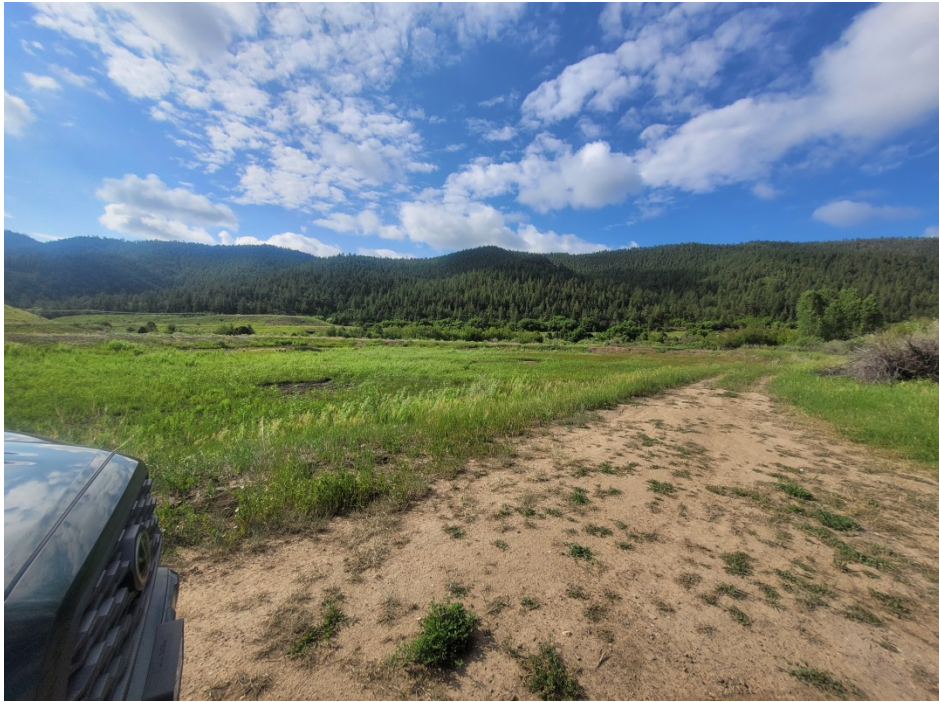
Pond 4

Pond was holding a small amount of water at the time of inspection. No Issues observed,

A little water has been pumped into the pond recently, but not occurring during the inspection.

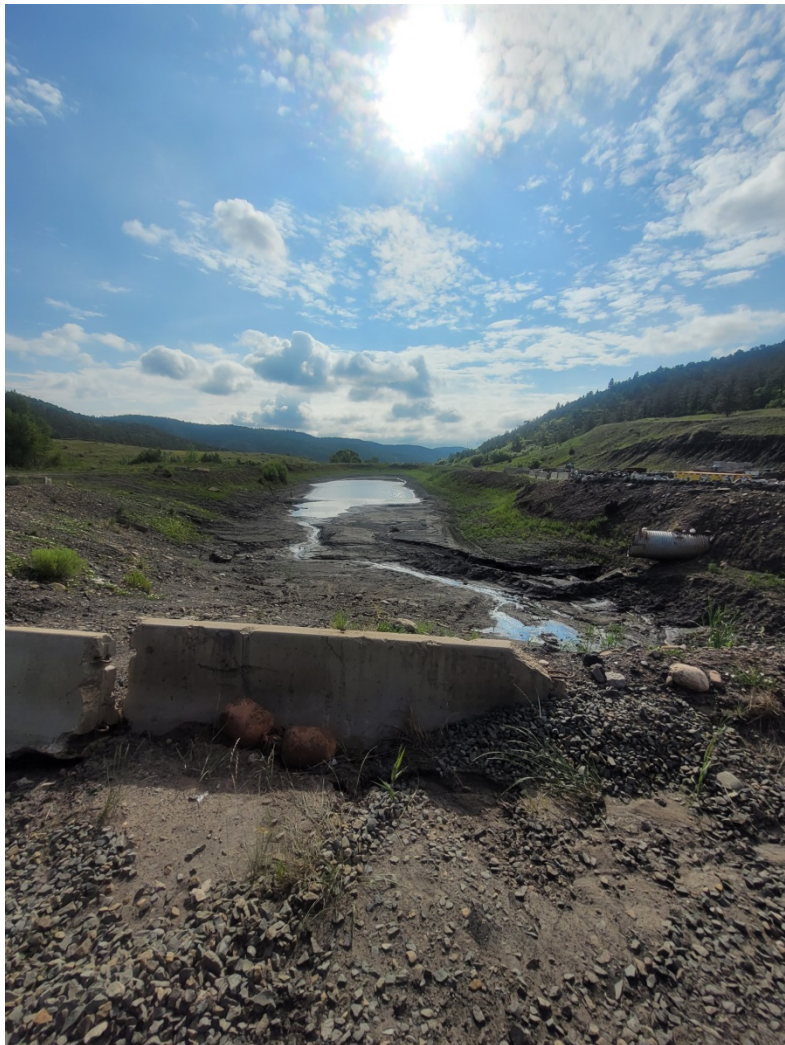
Pond 7

Pond is holding a minimal amount of water, not near the decant level. No issues observed.

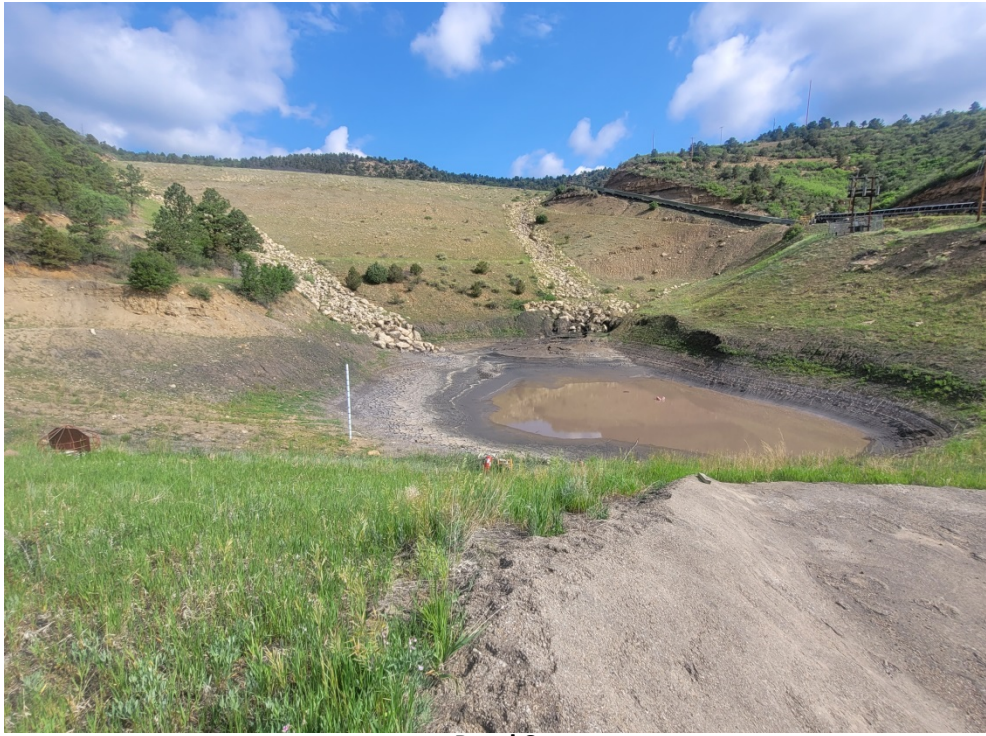
Pond 8

Pond was holding about six inches to a foot of water, not close to the decant level. No issues

found during the inspection.

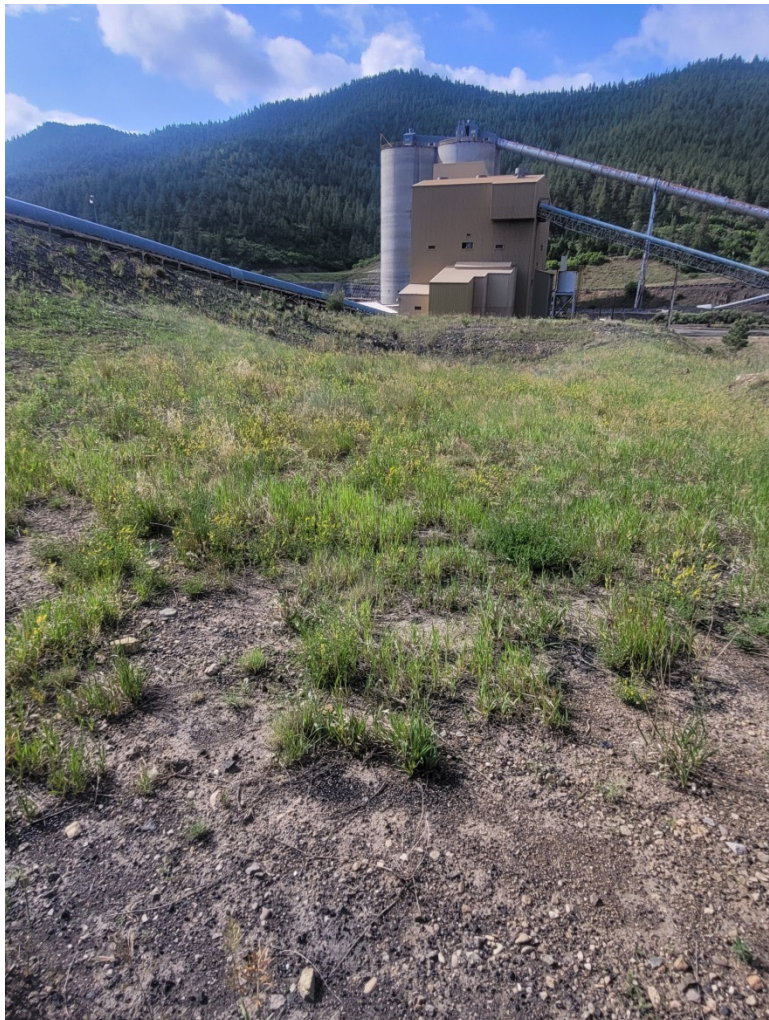
Containment Area #3

Containment Area was dry at time of inspection.

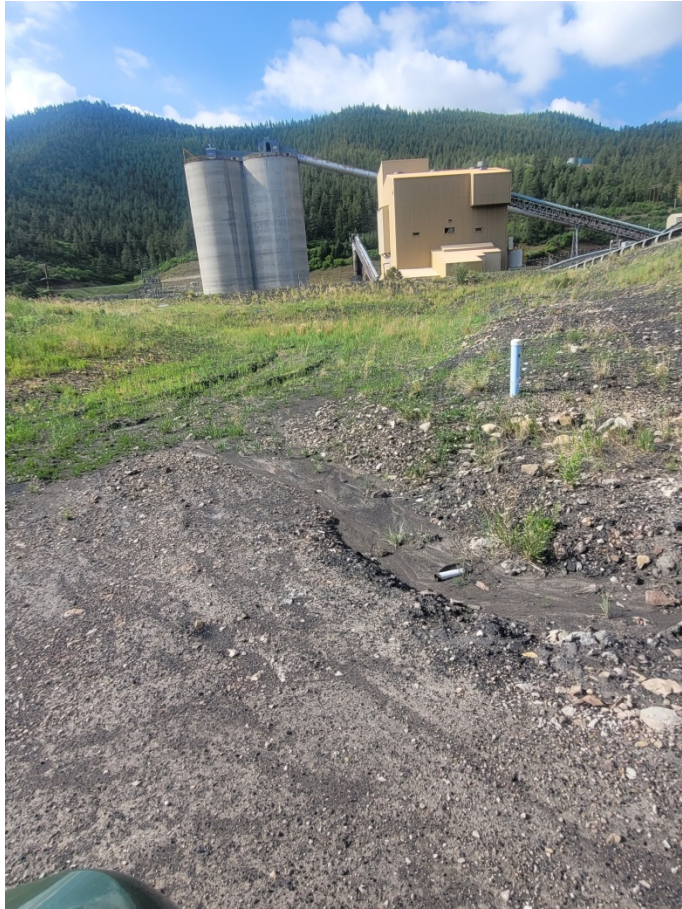
Containment Area #4

Containment Area was dry at time of inspection.

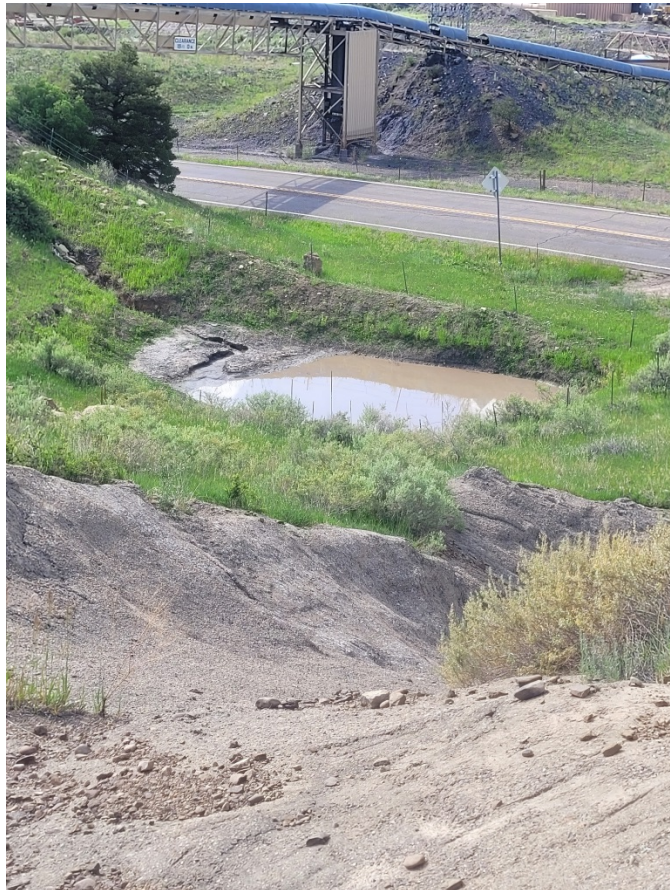
Containment Area #5

Containment Area was holding a small amount of water. It was cleaned in 20.22.
