QUARTERLY SEDIMENTATION POND INSPECTION REPORT

Mine: Lorencito

Inspection Period: Second Quarter 2023

QUARTERLY SEDIMENTATION POND INSPECTION REPORT
Lorencito Canyon Mine- June 22, 2023

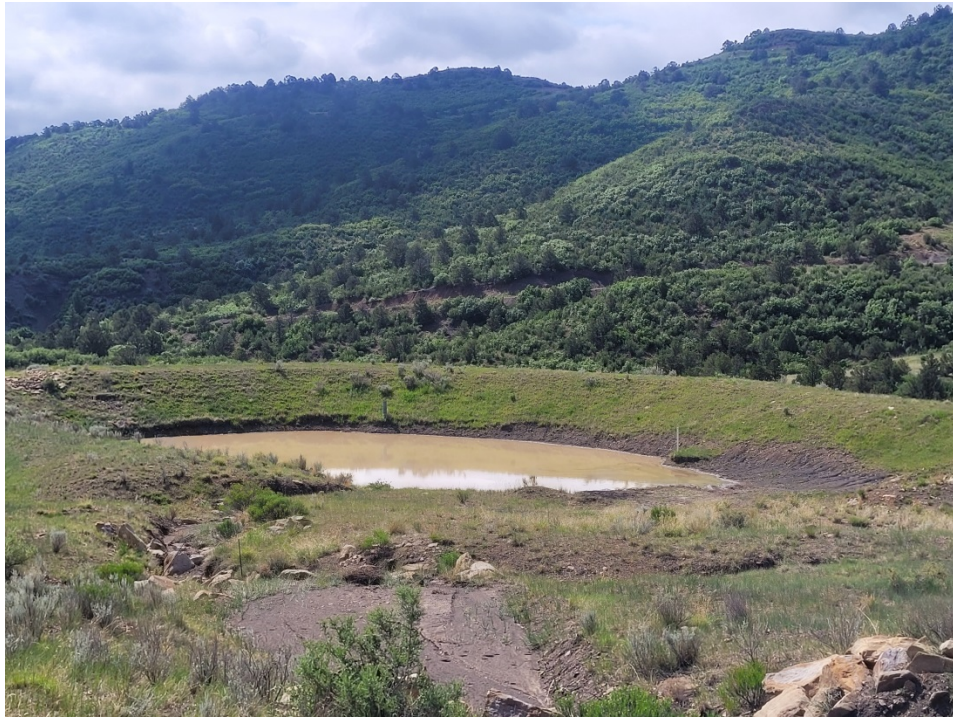
Pond 6

Pond was holding water at time of inspection, not near the bottom of the decant.

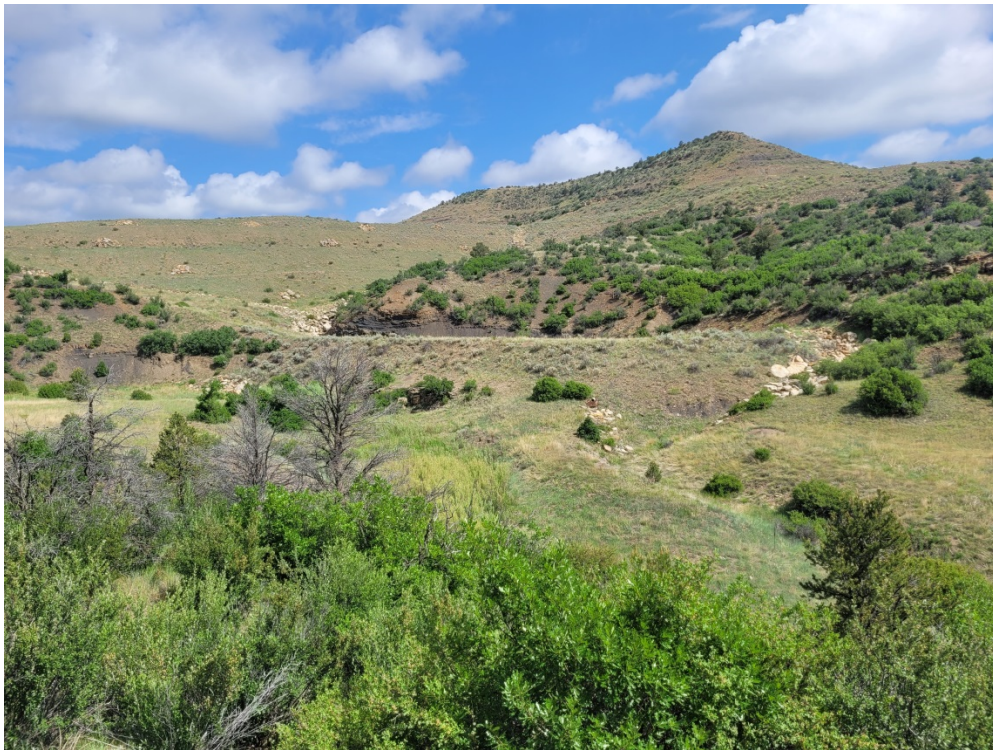
Pond 7

Pond was holding a small amount of water at time of inspection. Not discharging.

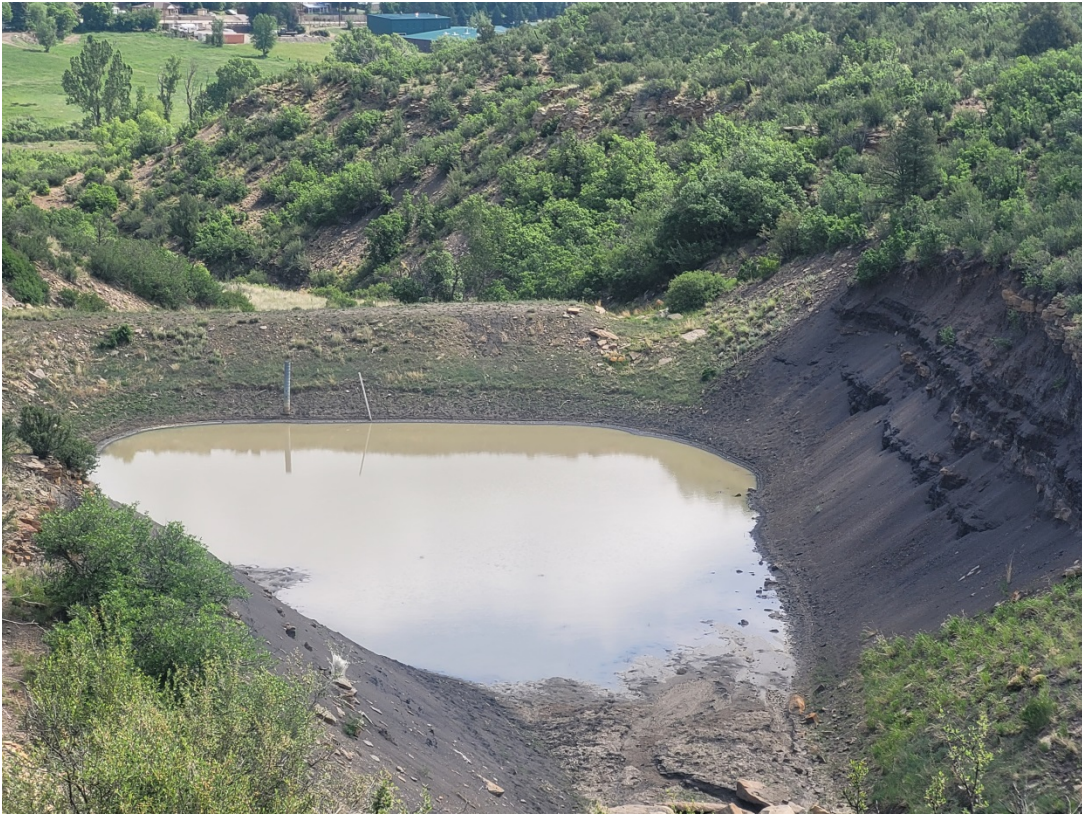
Pond 8

Pond was holding water at the time of inspection. Not near the level of the decant.

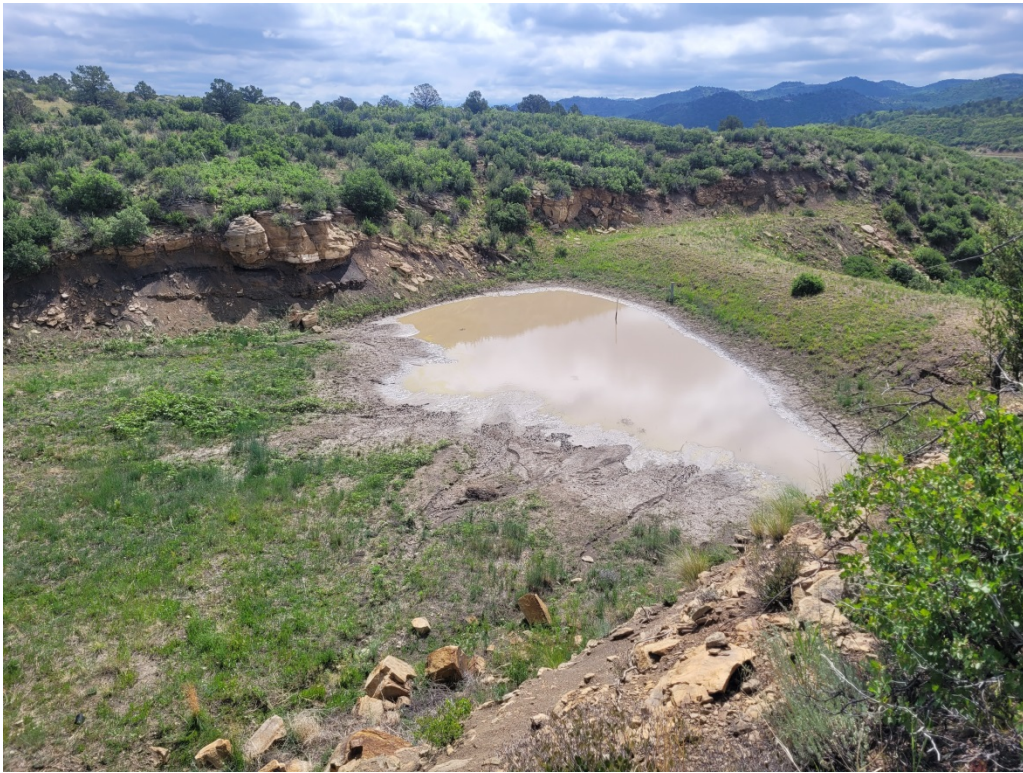
Pond 9A

Pond was holding water at time of inspection.

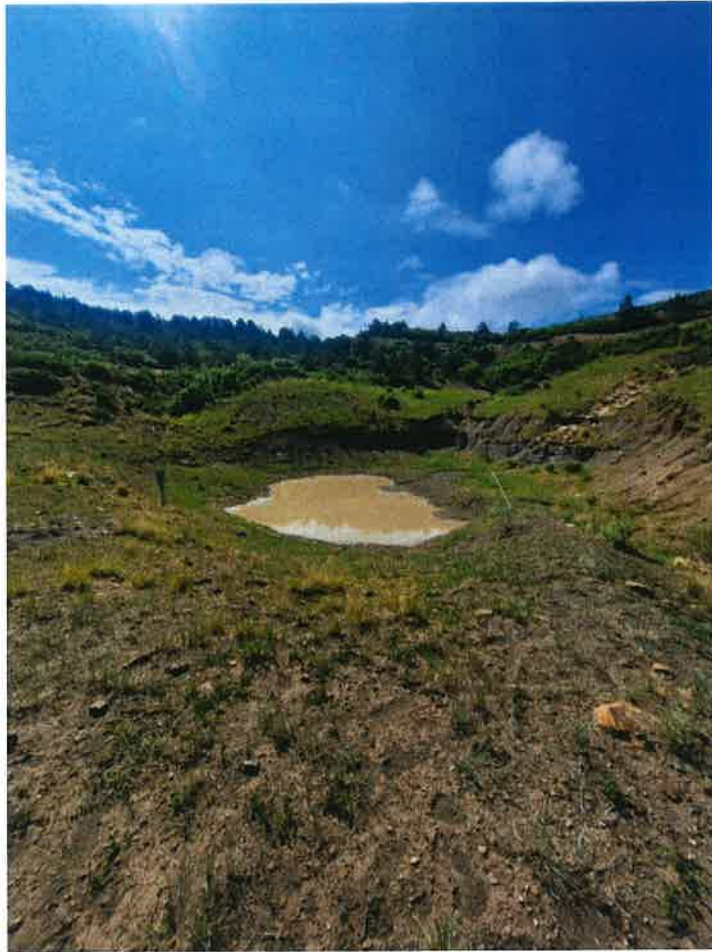
Pond 9

Pond was holding some water at time of inspection. Not near the level of the decant.
