Re: GCC Energy, LLC, King II Mine
CDRMS Permit # C-1981-035
Stoner Engineering: Quarterly Inspection: Refuse
Pile 2nd Quarter 2023

Date: June 20, 2023

Re: King Coal I – Quarterly Waste Pile/Embankment Inspection

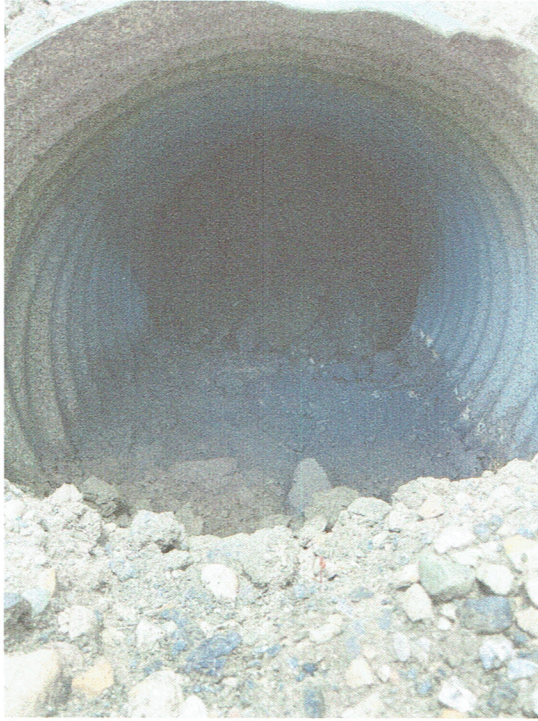
The south treated water ditch (Reach 10) as well as the north clear water ditch (Reach 1) were found to be in generally good condition. The north clear water ditch has experienced some sedimentation/localized erosion as a result of the spring snow melt. The culverts located under the haul road at both the north and south switchbacks (along the face of the main waste pile) were clogged with sediment and need to be cleaned (see Pic. 1 and 2). It is unclear if the culvert along the north side of the pile has been repaired as noted in the previous inspection report.

Pic. 1 –Culvert, North switchback, main waste pile haul road.

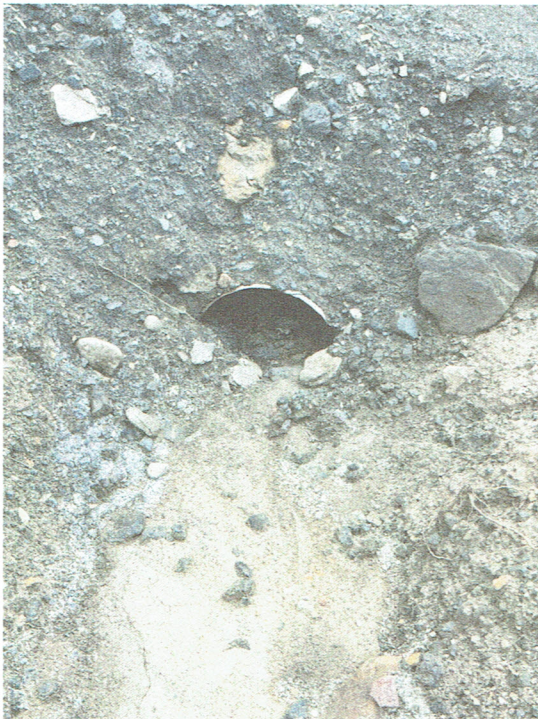
Pic. 2 –Culvert South switchback, main waste pile haul road.

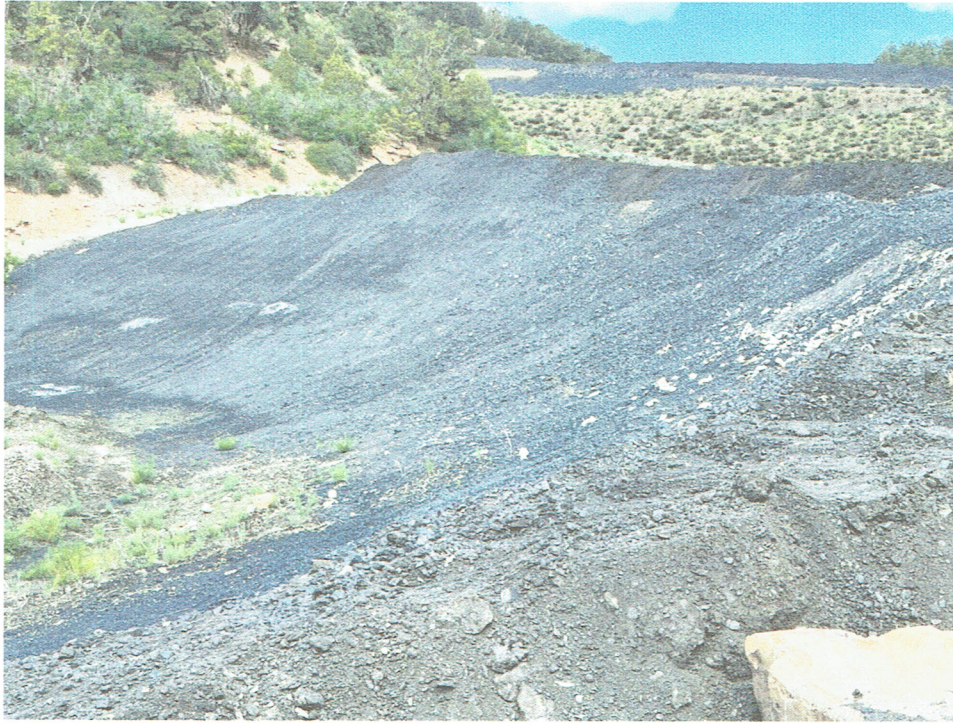
There has been additional waste material placed at the top of both the main waste embankment pile and the lower waste embankment pile since the previous inspection (see Pic. 3 & 4). The treated water ditch needs to be extended along the south side of the interface between the main waste embankment pile/existing hillside. The surface runoff is directed to this area and without the armored channel, significant erosion may occur during storm events (see Pic. 5). The surface grading of the waste embankment piles appears to direct surface runoff away from the face of the piles and the required berming is in place. The slope of the top of the existing pile is close to that defined in the Waste Bank Design produced by Don May, 1997.

Pic. 3 – Lower waste pile stockpile.

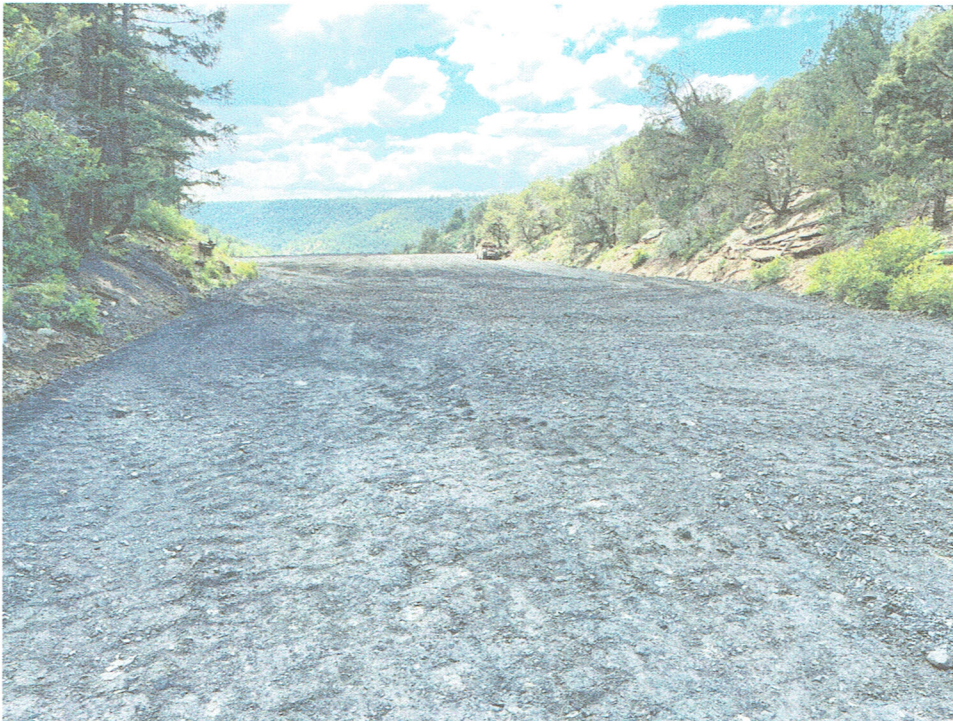
Pic. 4 – Upper waste pile stockpile.

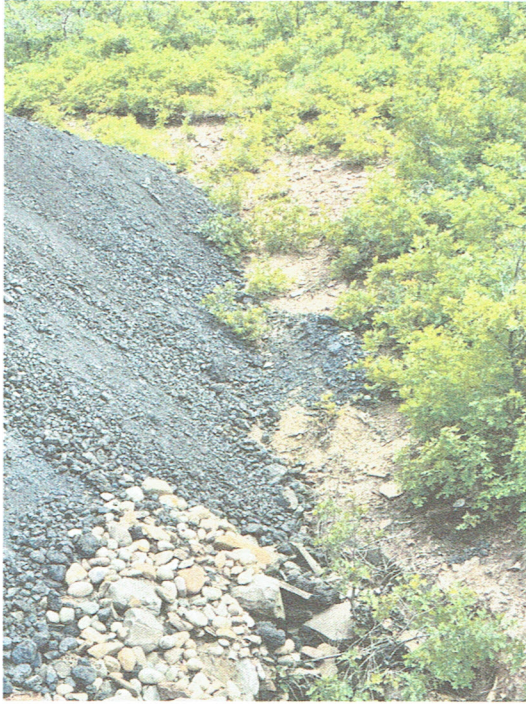
Pic. 5-South side of main waste pile surface runoff point, no erosion protection.

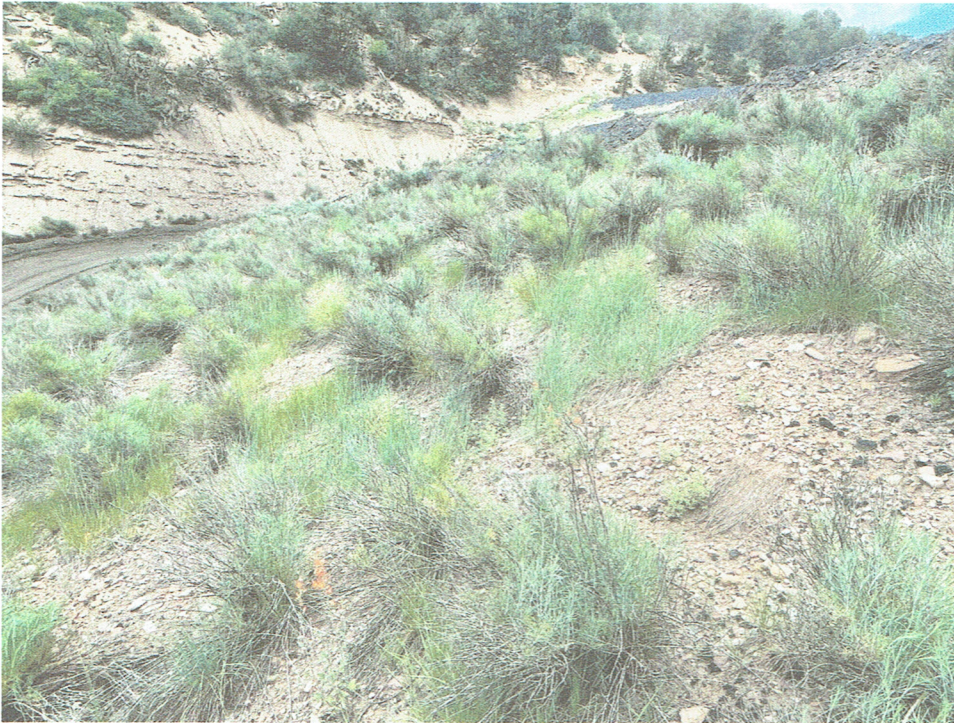
The face of the upper and lower waste embankments appeared to be in generally good condition. There were no signs of excessive erosion, instability, sloughing or weakness observed on the face of either of the waste embankment piles at the time of the inspection (see Pic. 6).

Pic. 6-Face of main waste pile.
