MINERALS PROGRAM INSPECTION REPORT
PHONE: (303) 866-3567

MINE NAME: 6S Pit No.1	MINE/PROSPECTING ID#: M-1986-101	MINERAL: Sand and gravel	COUNTY: Pueblo
INSPECTION TYPE: Monitoring	WEATHER: Clear	INSP. DATE: May 17, 2023	INSP. TIME: 08:30
OPERATOR: 6S Land & Cattle co.	OPERATOR REPRESENTATIVE: Austin Clennin	TYPE OF OPERATION: 110c - Construction Limited Impact

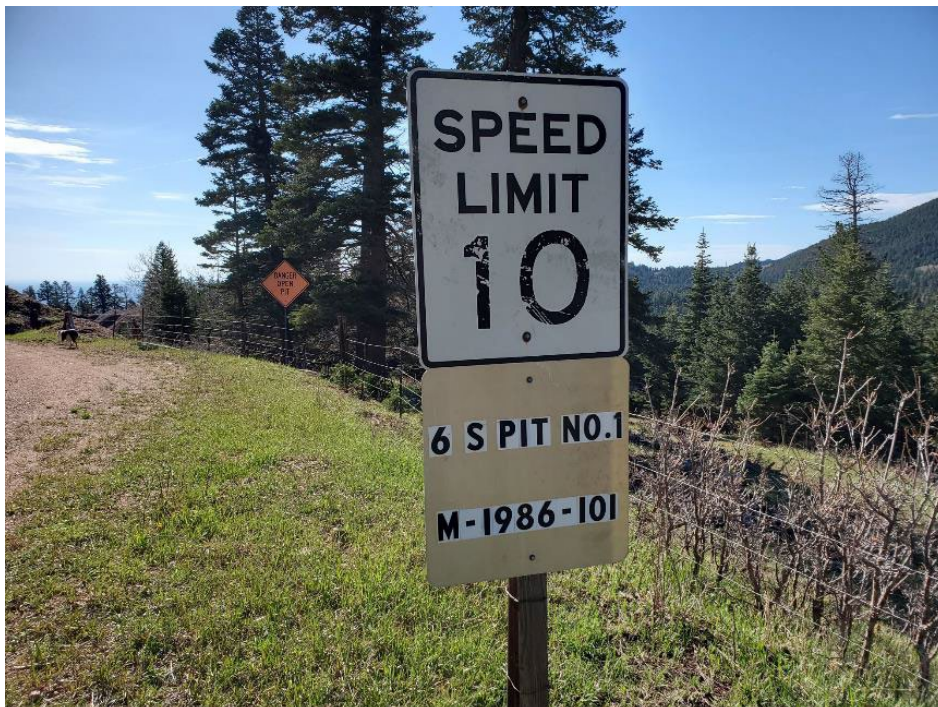
A permit sign posted in compliance with Rule 3.1.12(1) was observed at the entrance of the site (Photo 2).

Photo 2: Permit sign posted just north of the entrance gate.

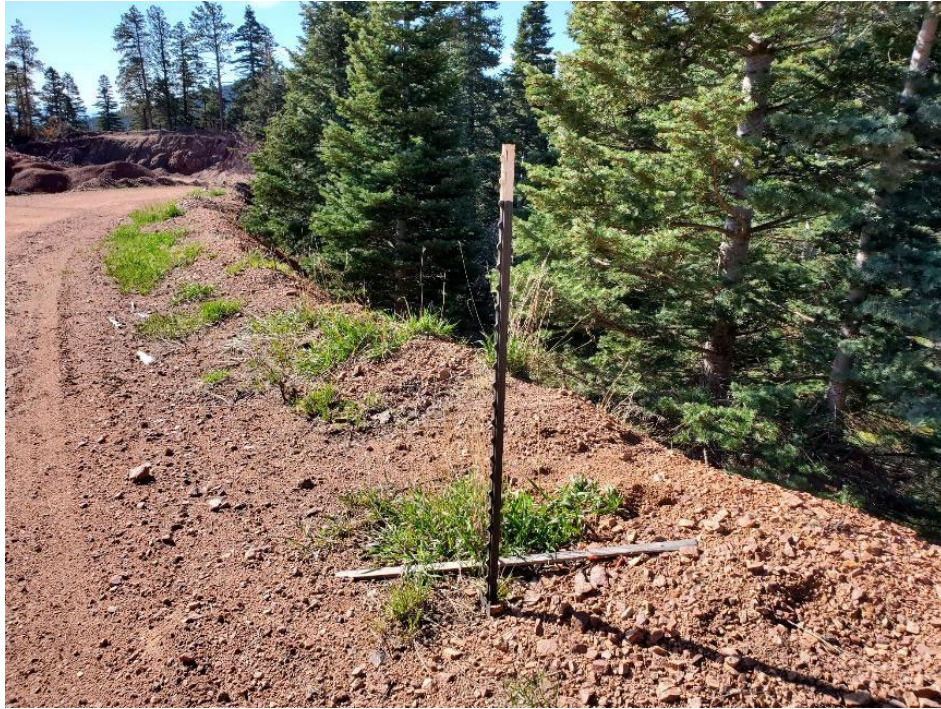
T-posts were observed onsite. The Operator identified the corners, and photos were taken at each location (Photos 3, 20, 23, and 30; Maps 1 and 2). In 2019, the Division cited a problem for the boundary markers being misplaced. In response, the Operator had a land survey conducted, and provided an updated and accurate depiction of the permit boundaries. This updated map also included coordinates for the boundary markers. However, during the 2023 inspection, it appears that the boundary markers are placed around the affected area, rather than the permit boundary (see Maps 1 and 2 and Figure 1). It also appears that the corner markers observed during the 2023 inspection are the same observed during the 2019 inspection (Map 2).

Photo 3: T-post delineating a portion of the south-west boundary.

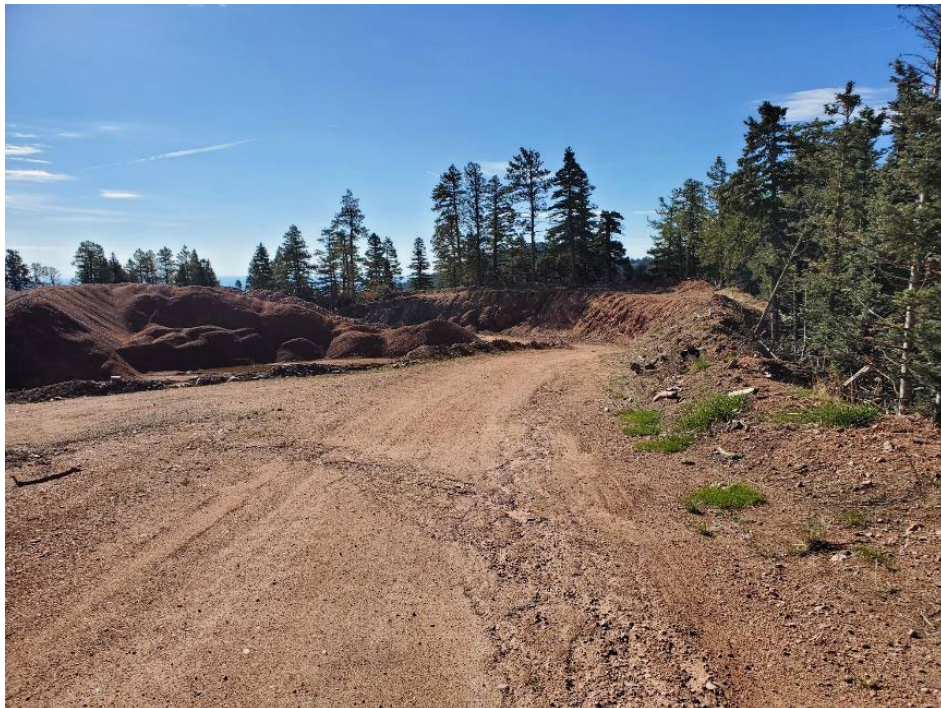
The roads are well maintained and have safety berms lining the southern border (Photo 4 and 14). To the south of the southern perimeter, the Division could hear the Little Saint Charles Creek flowing. No sedimentation or erosion was observed on the southern side of the road's perimeter berm.

Photo 4: Looking south-east along the southern boundary of the pit. A safety berm lines the interior road to the south.

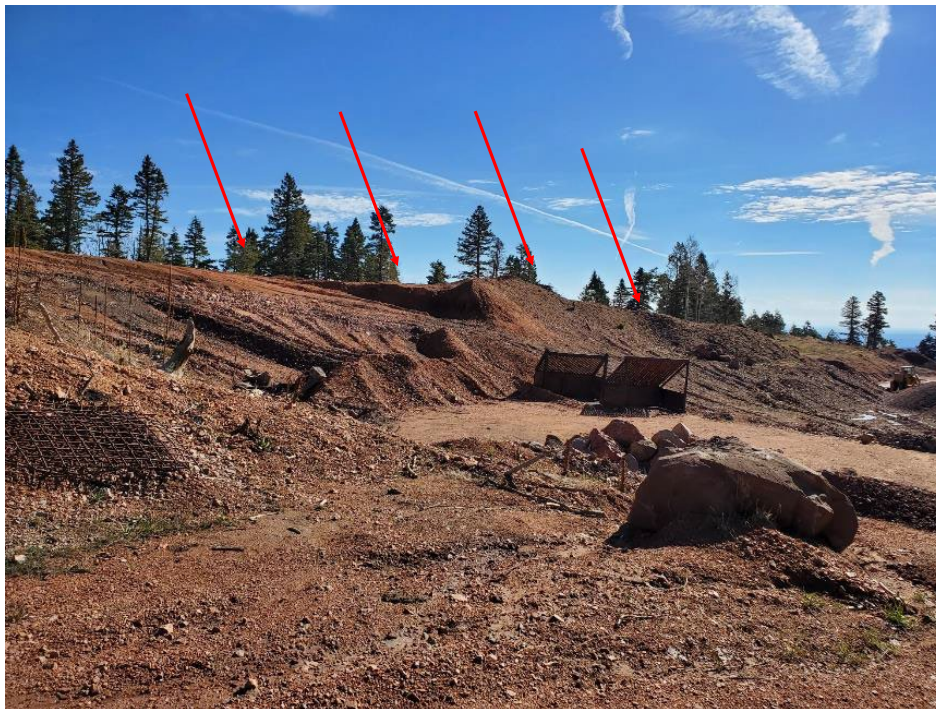
During the previous 2019 DRMS inspection, a high-wall averaging 25 feet was observed in the north-western pit area. Within the past two years, the north and north-western border of the pit area has been back-sloped and graded to a 3H:1V slope (Photos 6 and 28: Map 1). The Operator stated that they plan to keep all slopes on site at a 3H:1V slope. There is a highwall located along the southern border of the active mining pit that is planned to be sloped this summer. During the inspection, photos were taken along the length of the highwall (approximately 221.5' long), and the maximum height was estimated to be around 12' using a 11.5" x 9.5" binder and ImageJ software (Photo 10). This summer, the Operator plans to slope down the majority of the southern highwall from above (blue lines on Map 1), except for the portion that is close to the permit boundary which he plans to backfill by pushing material up (white line on Map 1).

Photo 6: Looking north-east from the entrance to the main pit area at the northern pit boundary at the recently back-sloped area (arrows). Also pictured are a few grizzly screeners used as back up to the portable screener.

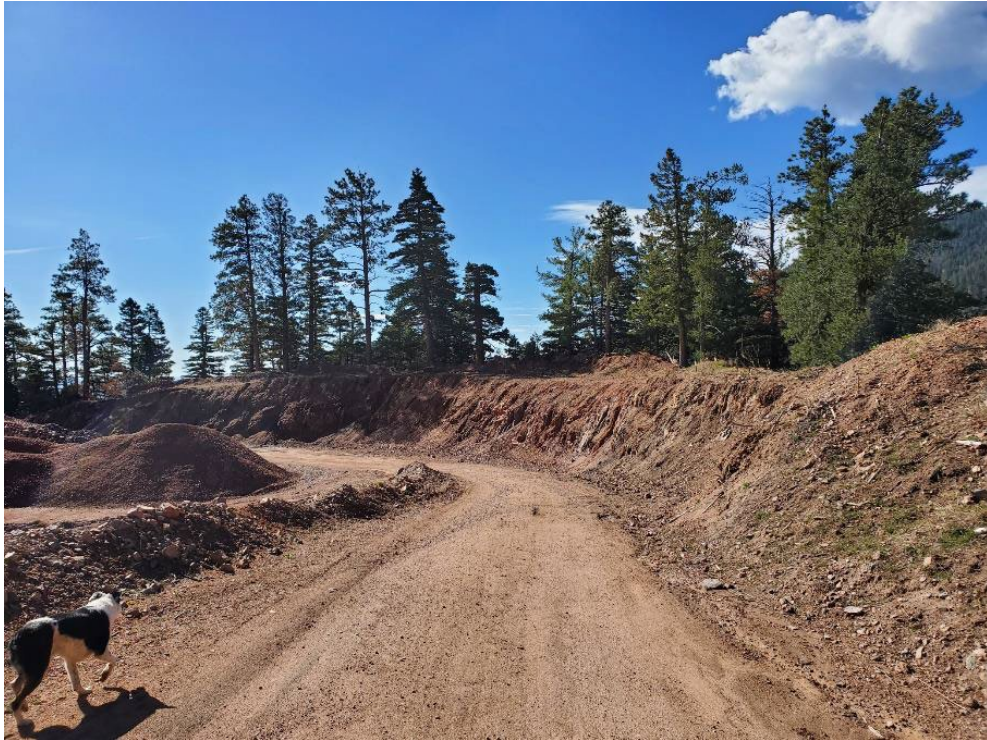
Photo 7: Looking south-east at the tallest portion of the highwall along the southern pit boundary.

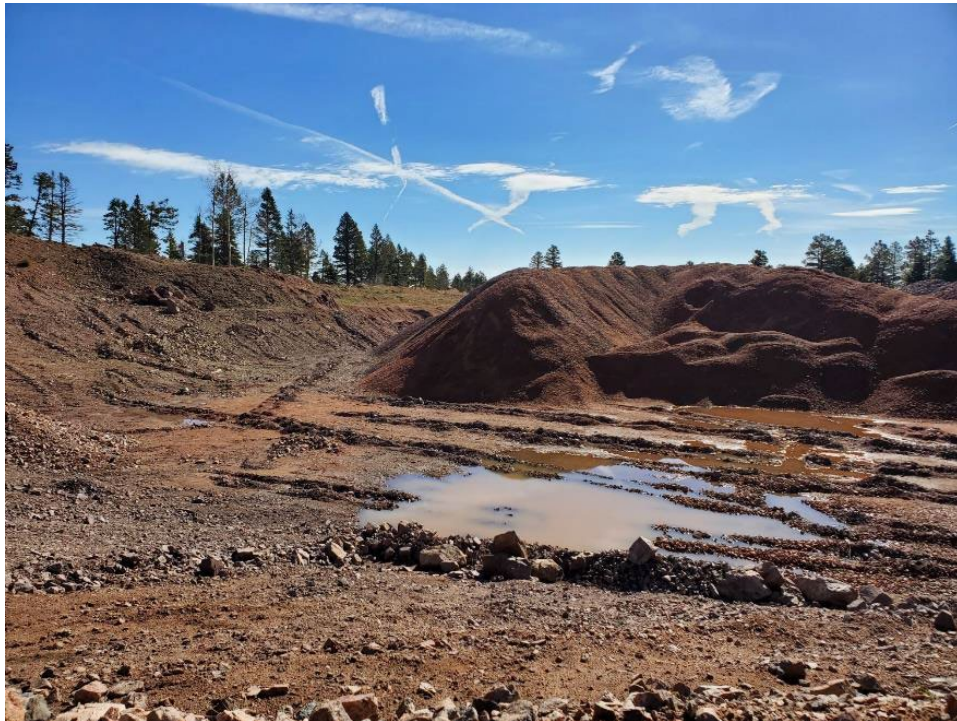
Due to recent storms within the area, standing water has accumulated onsite. Evidence of strong winds was also observed to the north-east of the active pit area (Photos 22 and 23: Map 1). Shallow ponds along the western side of the stockpiles in the main pit (Photo 8: Map 1) and a shallow puddles throughout the pit (Photos 14 and 16) were observed. Additionally, the site slopes to the east, and a small sediment containment area held storm-water run-off (see sediment control section below). The Operator stated that entire area is generally very dry. However, they make sure to rip the pit floor and the floor of the containment area to facilitate infiltration of storm water. If stormwater remains onsite longer than 72 hours, the Operator has a vacuum truck that they can use to pump the water out of containment basin.

Photo 8: Looking east from the eastern side of the pit. Standing water observed on pit floor east of a large stockpile.

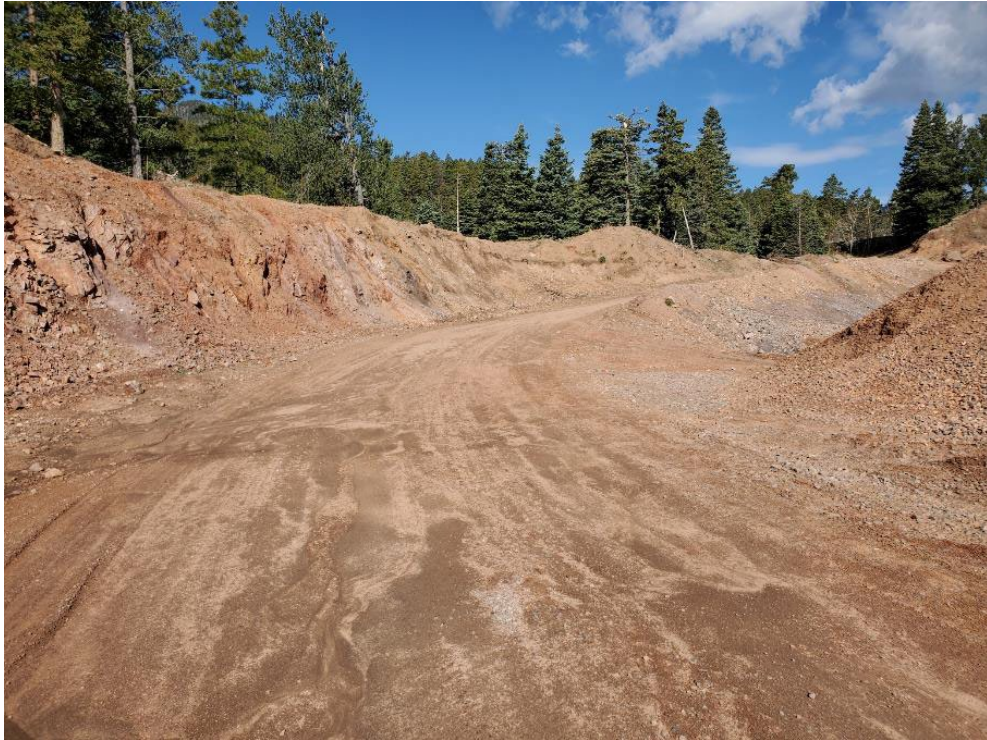
Photo 9: Looking west along the internal road along the southern border. Internal roads are well maintained.

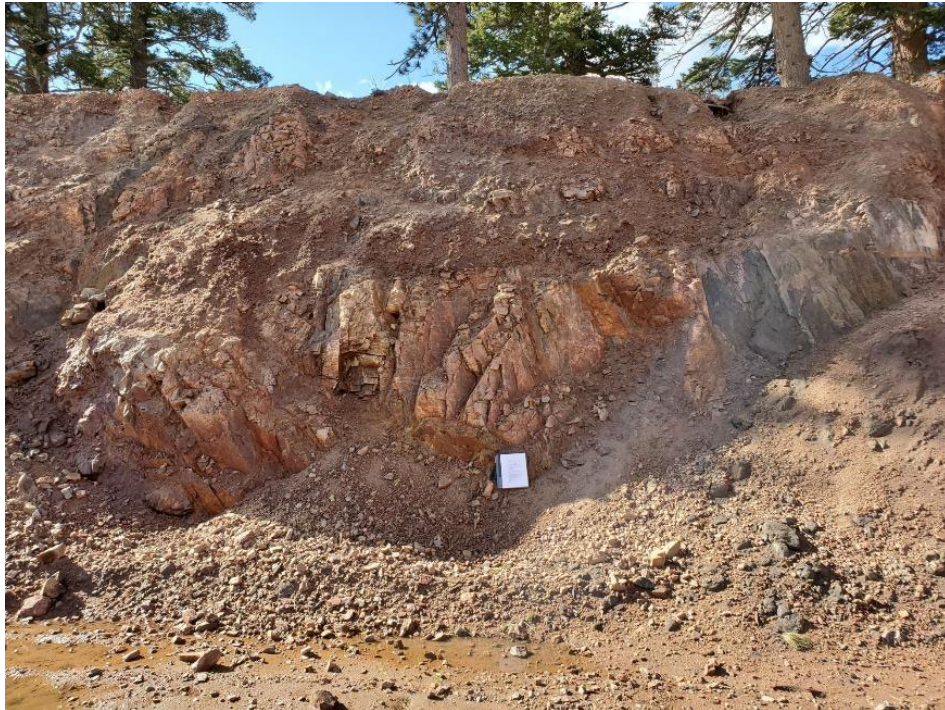
Photo 10: Looking south at the tallest portion of the highwall. A 11.5" x 9.5" binder was used for scale. The tallest portion is estimated around 14' tall, with the extent of the highwall averaging around 12'.

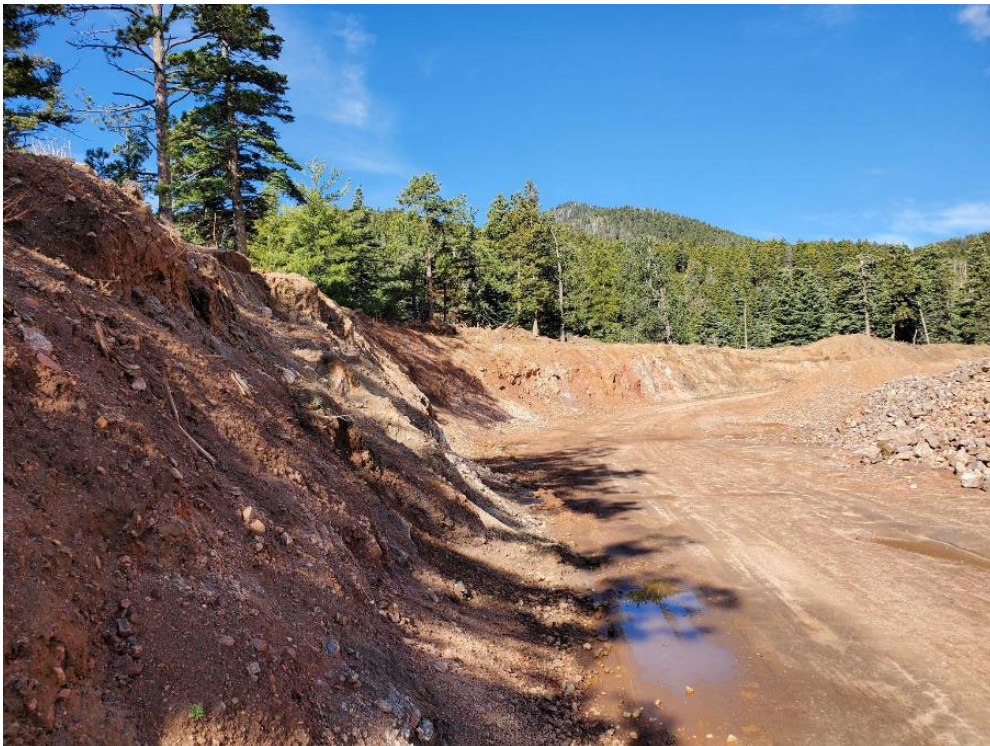
Photo 14: Looking west at the safety berm along the southern border of the pit area, lining the internal road.

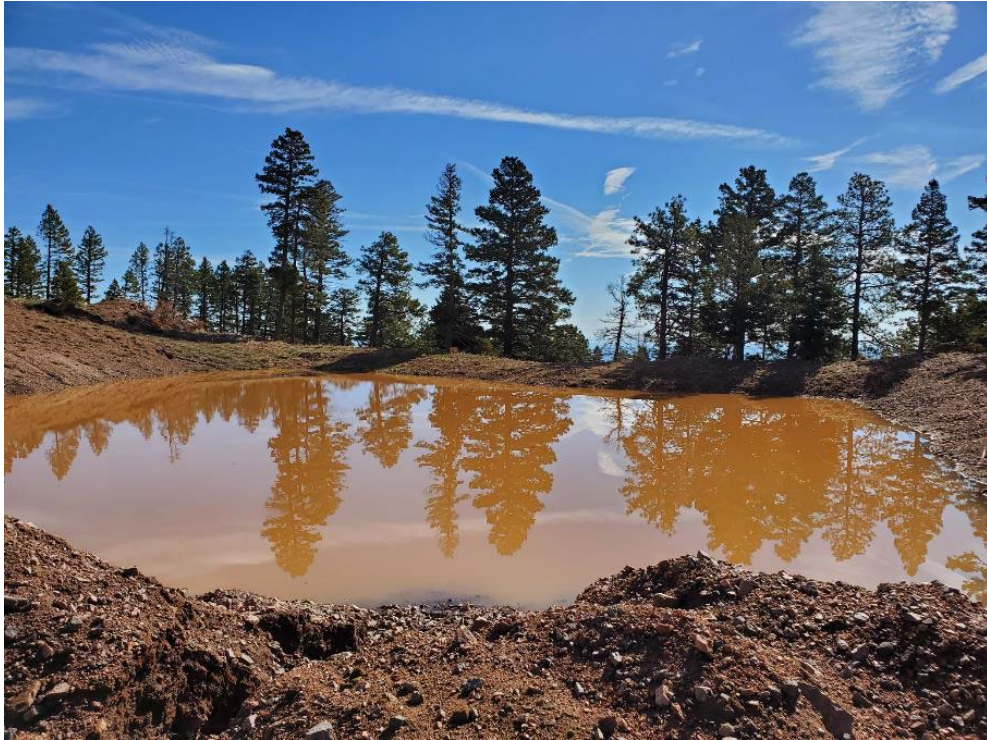
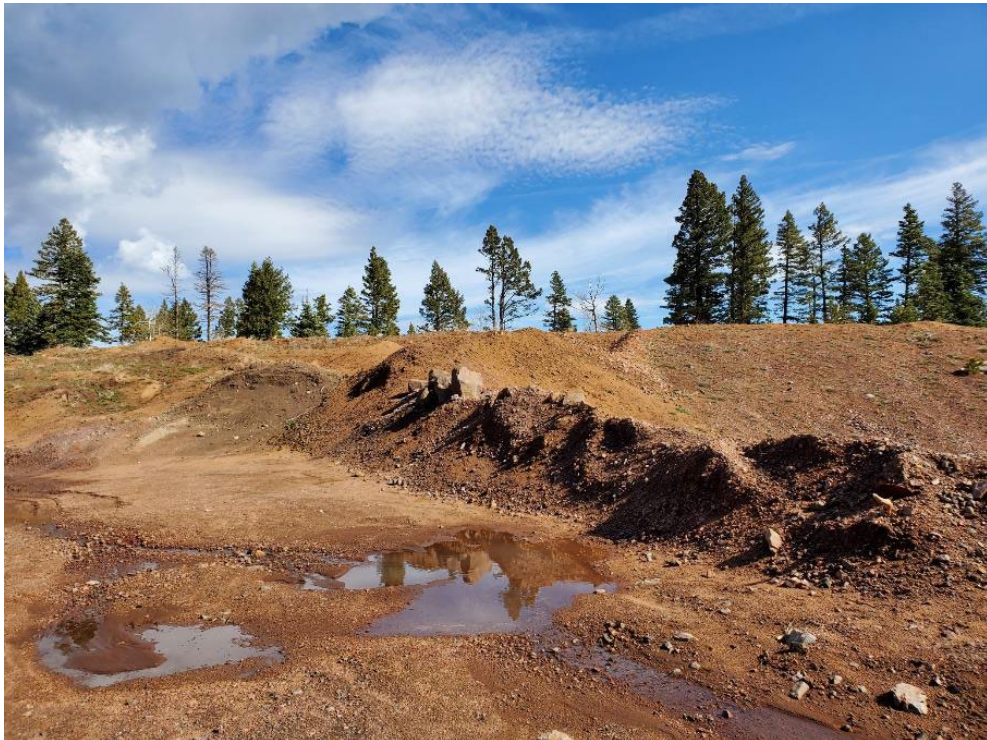
Run-off from high precipitation storm events is temporarily captured in a small sediment containment area along the western boundary of the pit. A small berm separates the main pit floor from the containment area (Photos 17 and 18). This berm was mostly in-tact, but there is an area about a foot wide that has eroded due to the increased precipitation in the area (Photo 21). The Operator stated that usually this containment is dry and any precipitation infiltrates into the ground before reaching this area. The slopes around the pit all appeared to be stable, with no signs of excessive erosion or sedimentation. All sediment is contained onsite within the ~4.5 acre active pit.

Photo 17: Looking east from the western berm surrounding the sediment containment area.

Photo 18: Looking north from the western berm surrounding the sediment containment area.

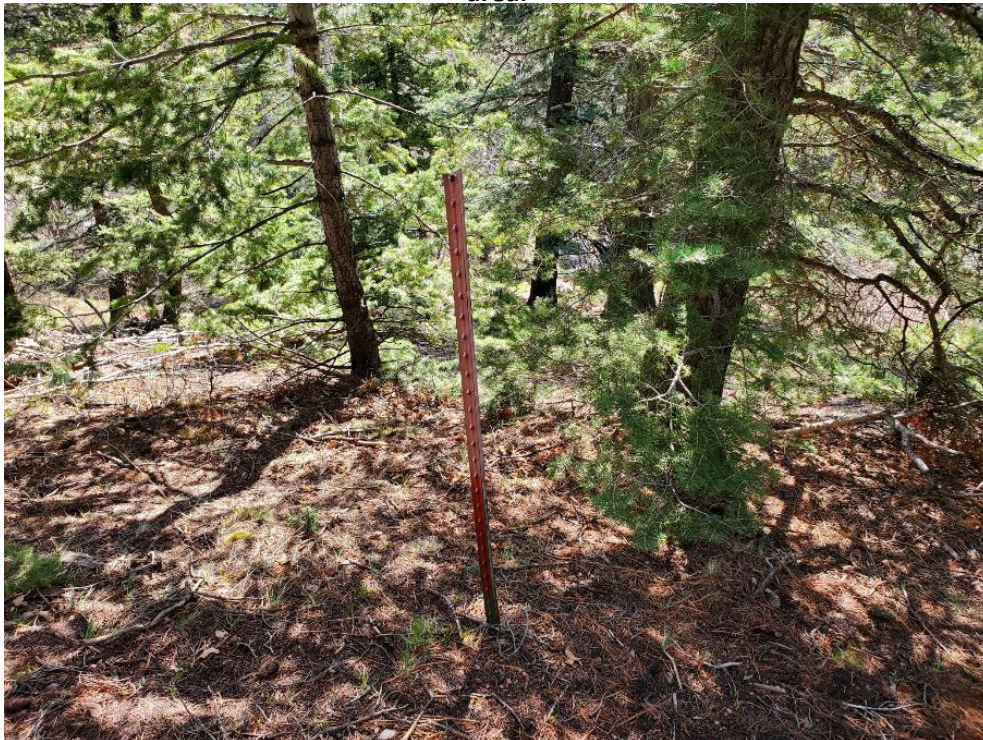
PROBLEM: The affected area boundary markers are missing or incorrectly placed. This is a problem for failure to maintain boundary markers around the affected area as required by Section 3.1.12(2)(a) of the rule.

Photo 20: Affected boundary marker located to the east of the sediment collection pond.

CORRECTIVE ACTIONS: The Operator shall provide photo evidence of the permit boundary markers in the correct location(s). The Operator shall provide proof to the Division that this has been done by the corrective action date.

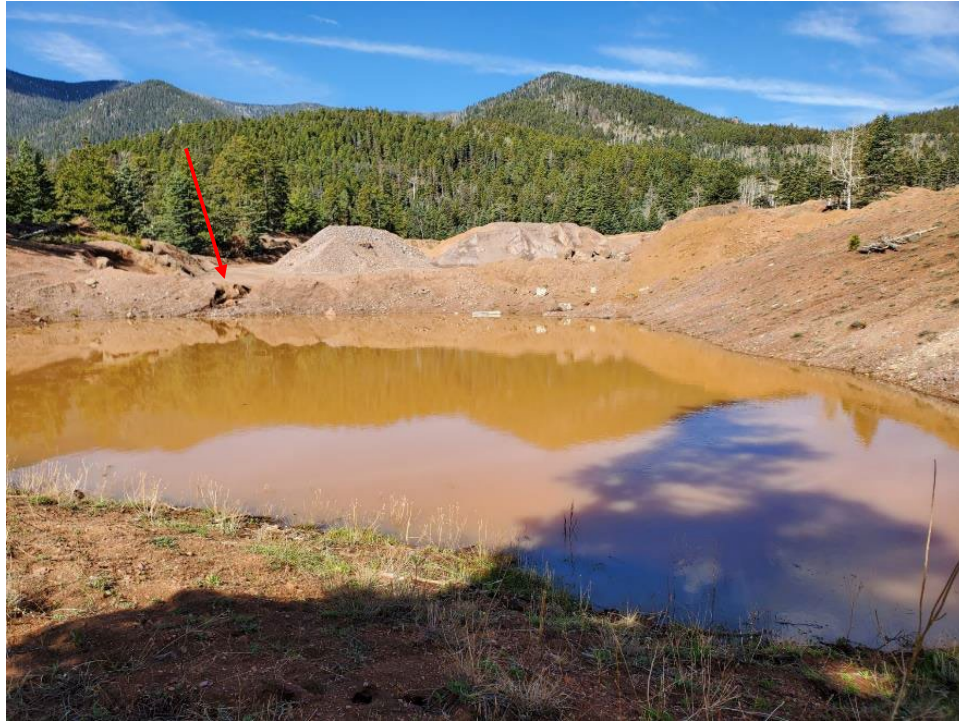
Photo 21: Looking west from the eastern berm surrounding the sediment containment area. The arrow indicates where the increased run-off has cut into the perimeter berm.

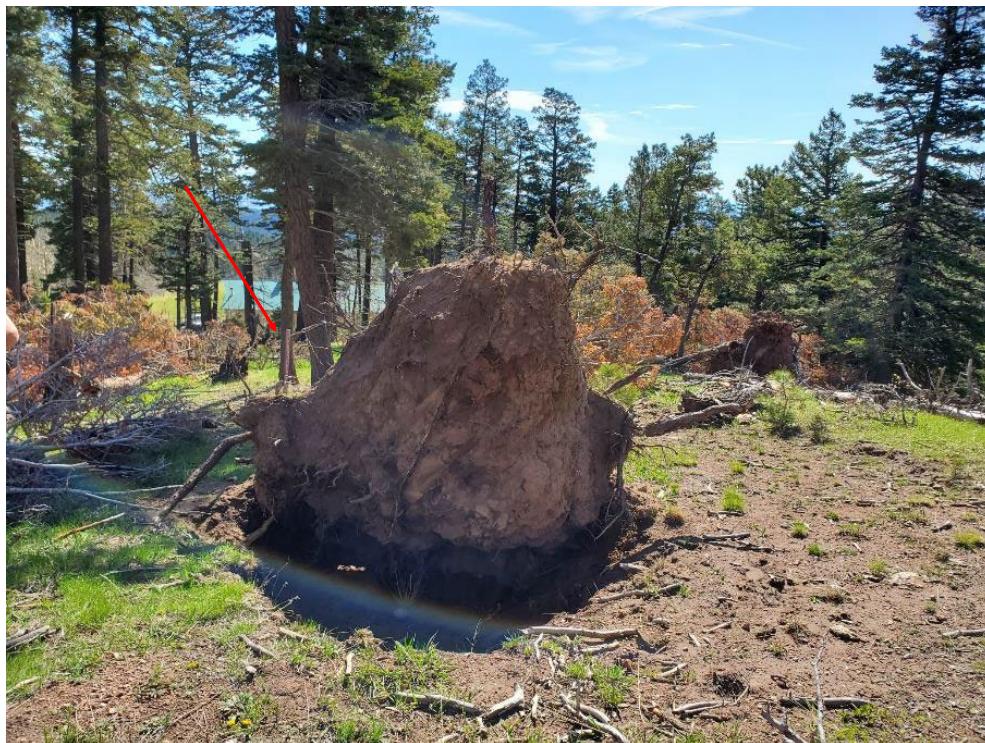
Photo 22: Blown over tree next to the north-eastern affected boundary marker (arrow).

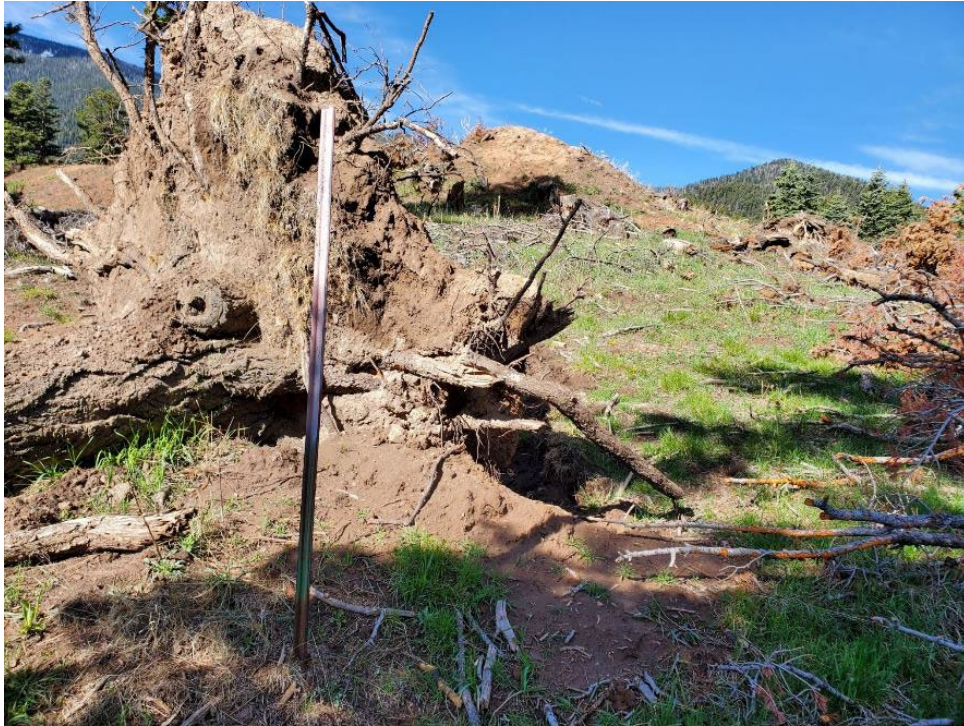
Photo 23: Looking west at the north-east affected area boundary marker. Recent storms and strong winds have blown over many trees in the area.

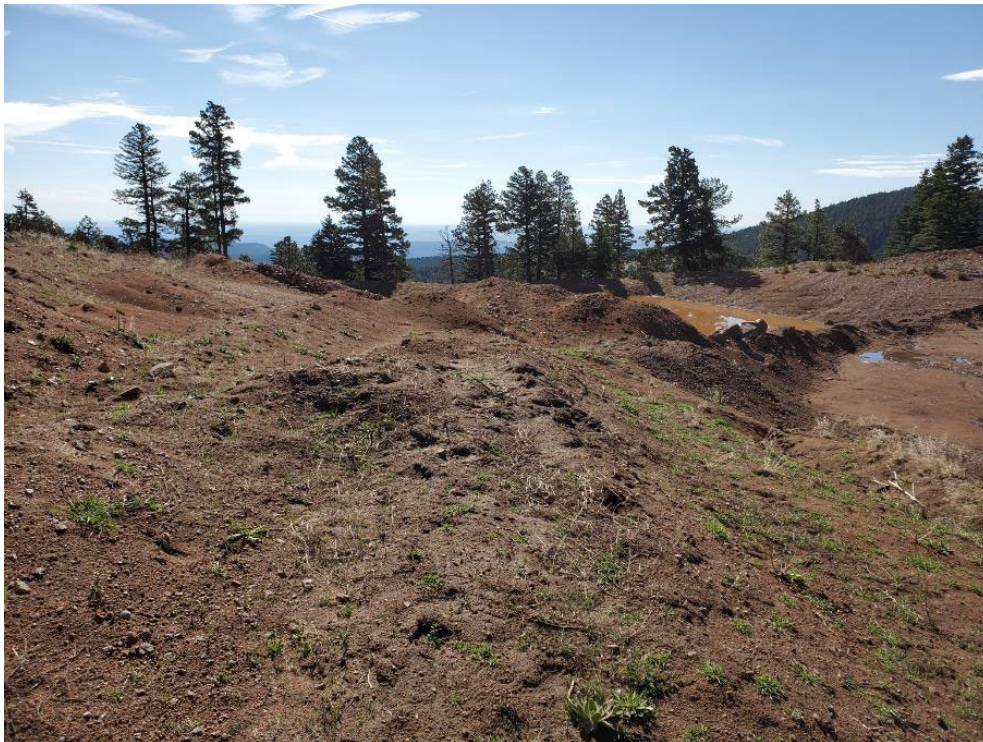
Topsoil was stored along the northern boundary of the pit. The Operator stated that much of the topsoil is virgin material, but some has been piled on top by using a dozer (Photo 24, 27, and 28). The current topsoil pile appears to be stable and in an adequate quantity for use in reclamation. Also, due to the strong storm winds causing tree-fall around the active pit area (see Photos 22, 23, and 29) the Operators are incorporating the burned stumps in compost which will be used as an addition to the topsoil on site.

Photo 24: Looking east across the virgin topsoil.

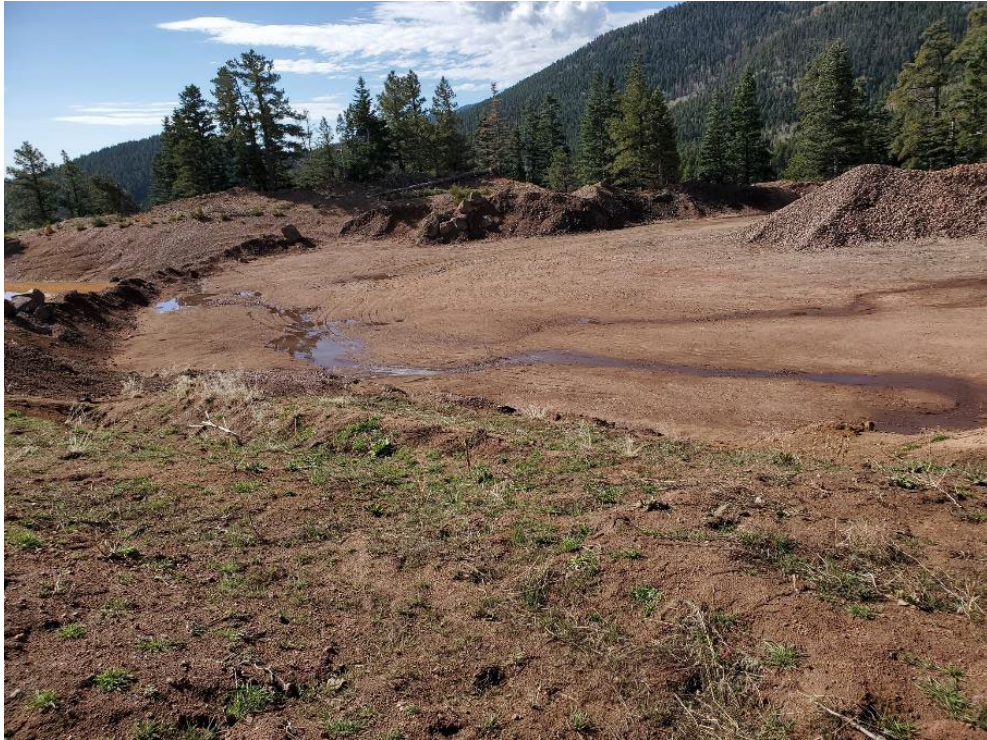
Photo 25: Looking south at material along the road that can be used to slope the highwall.

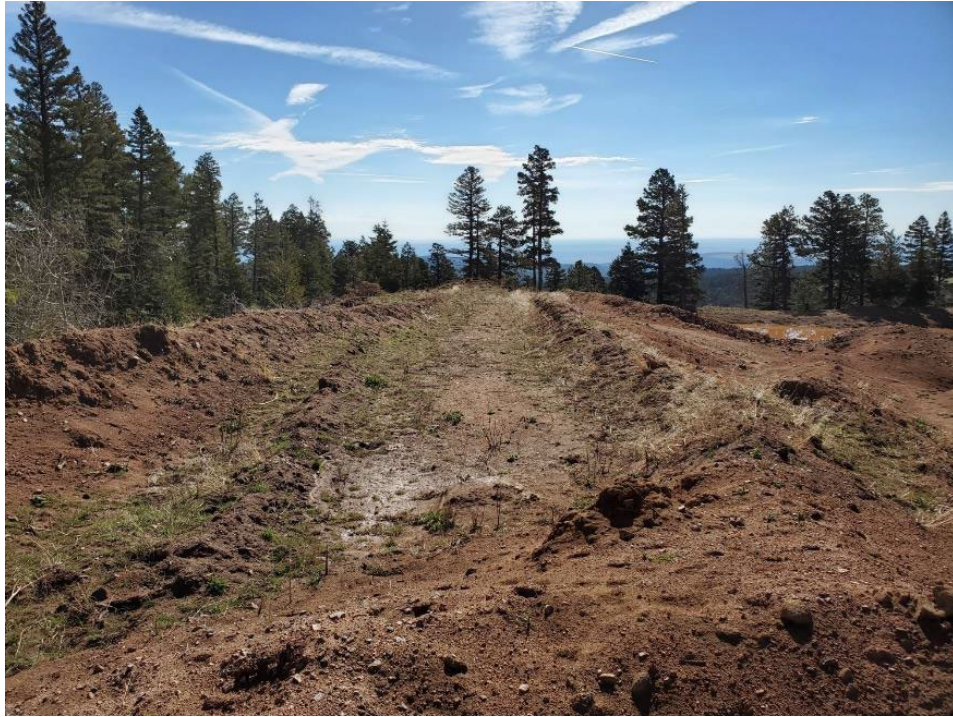
Photo 27: Looking west again across topsoil. To the south is the recently back-sloped area along the north side of the pit.

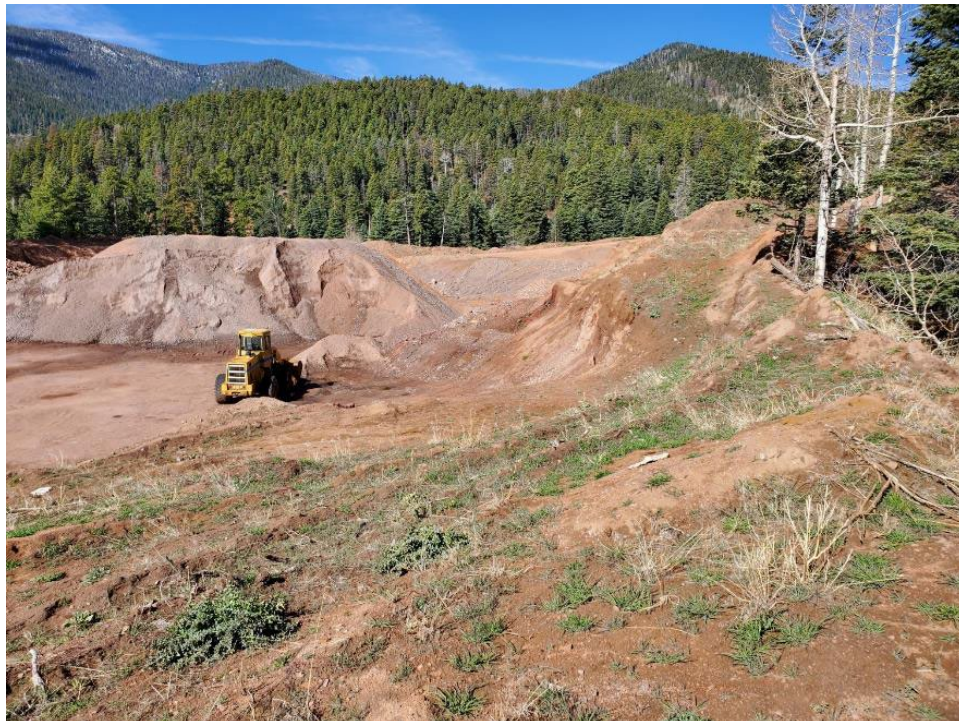
Photo 28: Looking west at more topsoil along the northern ridge and a small portion of the north pit that has yet to be fully graded.

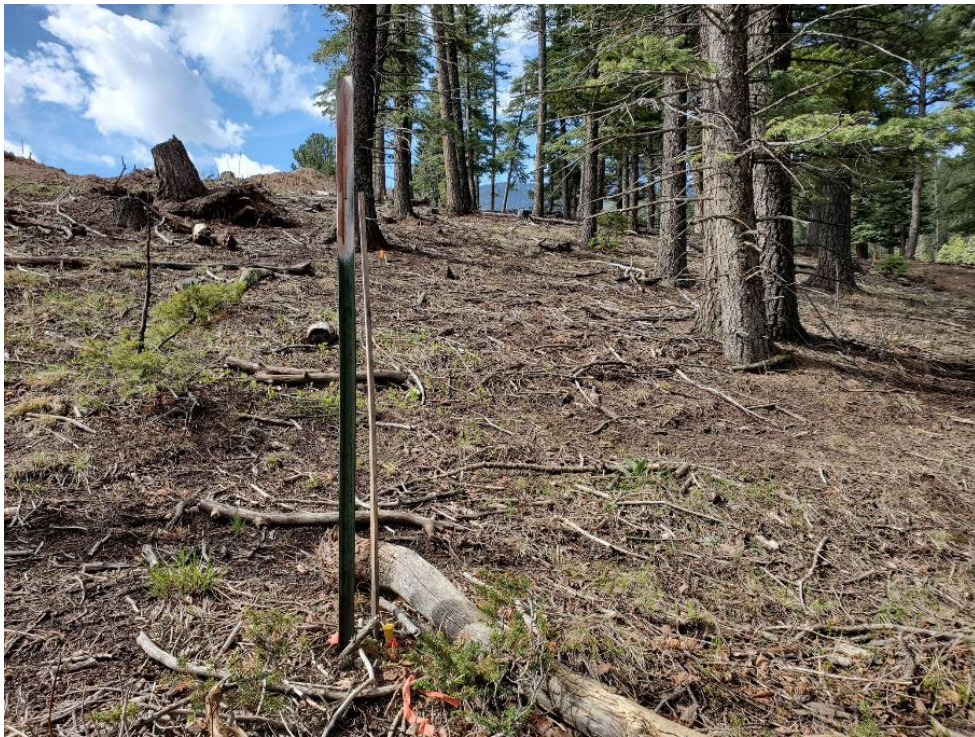
Photo 30: Looking south at the north-west corner post.

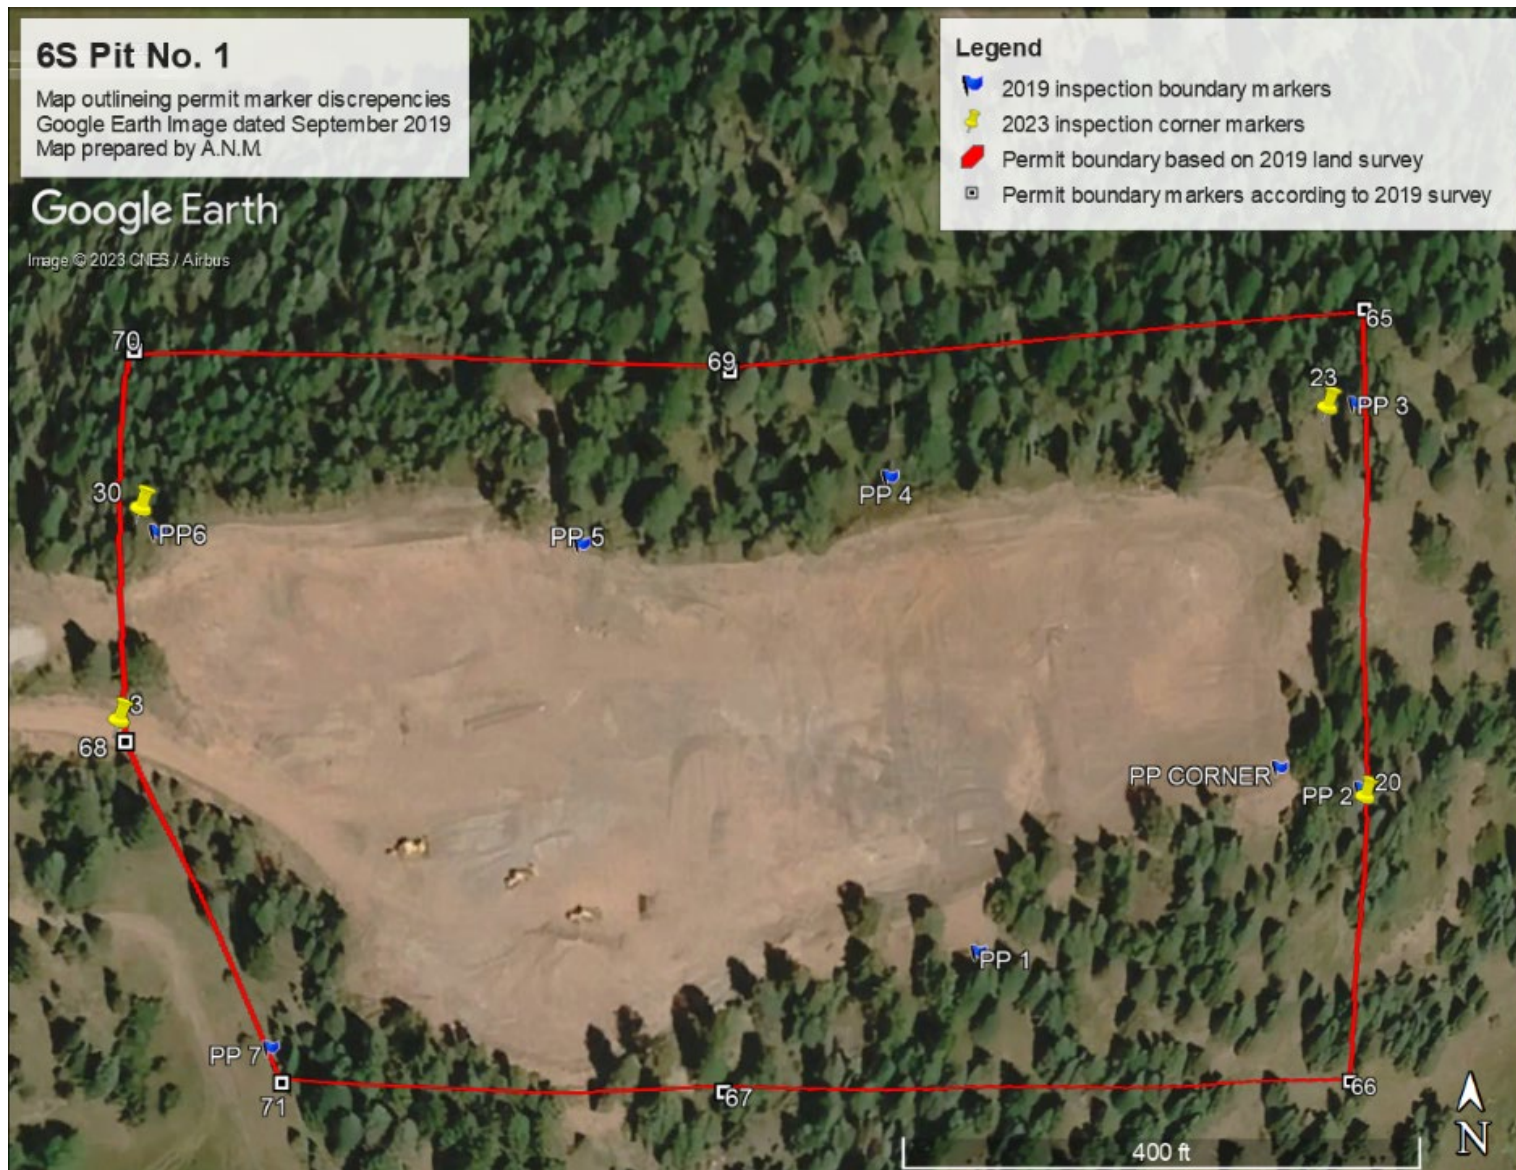
A problem was cited for the boundary marker discrepancy. In accordance with Rule 3.1.12(2)(a), the boundary of the affected area is synonymous with the permit boundary for Limited Impact 110 Operations. Upon

correspondence with the Permittee (Ashley Byers), it seems that there may be two sets of markers (one indicting the active pit area and one indicating the permit boundary). Ashley stated that she will correspond with the Operator on-site (Austin) to clarify this discrepancy. To abate this issue, and to clarify the permit file, please provide photo evidence of the location of the permit boundary markers in place in addition to the active pit boundary markers observed during the inspections. The active pit markers may remain in place to ensure that mining remains contained within the active pit area per the Operator's preference.

Map 2: Map generated in Google Earth Pro to highlight the discrepancies of the permit boundary markers. The blue flags with numbers PP1-7 were taken at boundary markers during the 2019 DRMS inspection. The yellow pins are photo capture locations of the corner markers taken during the 2023 DRMS inspection. The square icons with numbers 65-71 indicate the GPS points submitted with the 2019 land survey (see Figure 1), indicating the permit boundary markers. The red boundary indicates the permit boundary according to the 2019 land survey.
