MINERALS PROGRAM INSPECTION REPORT
PHONE: (303) 866-3567

MINE NAME: Bonser Pit	MINE/PROSPECTING ID#: M-2000-156	MINERAL: Gravel	COUNTY: Larimer
INSPECTION TYPE: Monitoring	INSPECTOR(S): Brock Bowles	INSP. DATE: February 15, 2022	INSP. TIME: 10:00
OPERATOR: Coulson Excavating Company, Inc.	OPERATOR REPRESENTATIVE: Ken Coulson	TYPE OF OPERATION: 112c - Construction Regular Operation	
REASON FOR INSPECTION: Normal I&E Program		BOND CALCULATION TYPE: None	
DATE OF COMPLAINT: NA		BOND AMOUNT: \$659,234.94	
WEATHER: Cloudy		JOINT INSP. AGENCY: None	
INSPECTOR'S SIGNATURE:

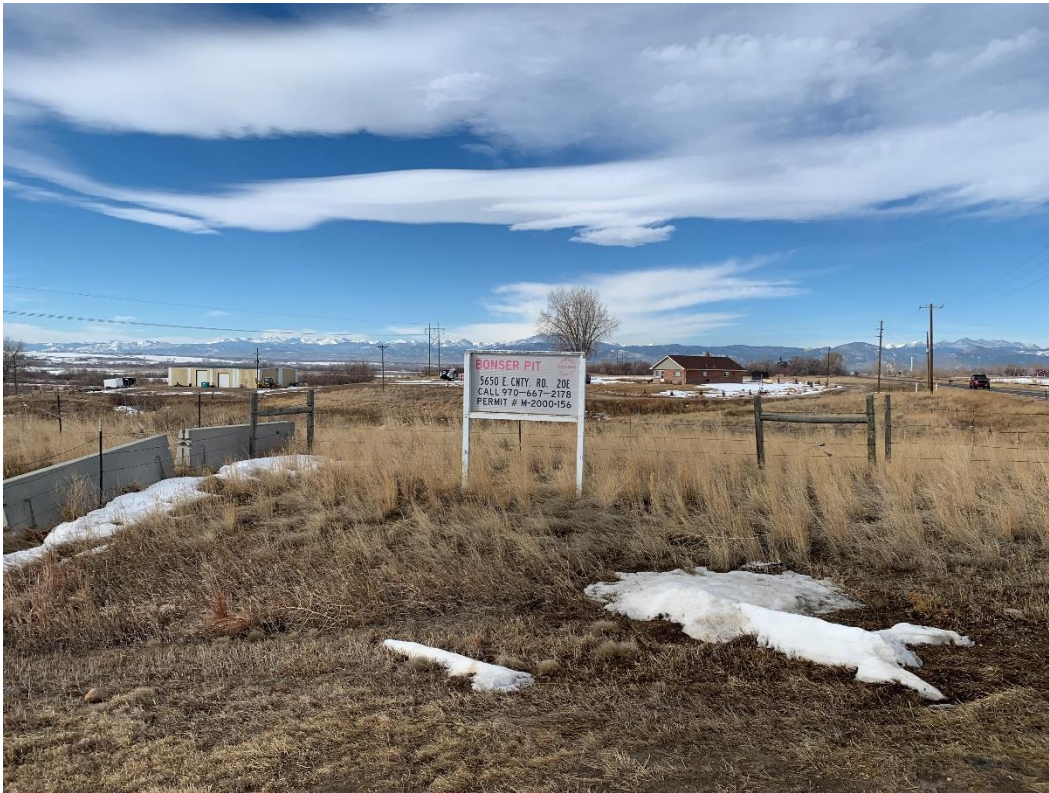
The mine entrance sign was in place facing CR 20E (photo 1).

Photo 1 – Mine entrance sign facing ECR 20

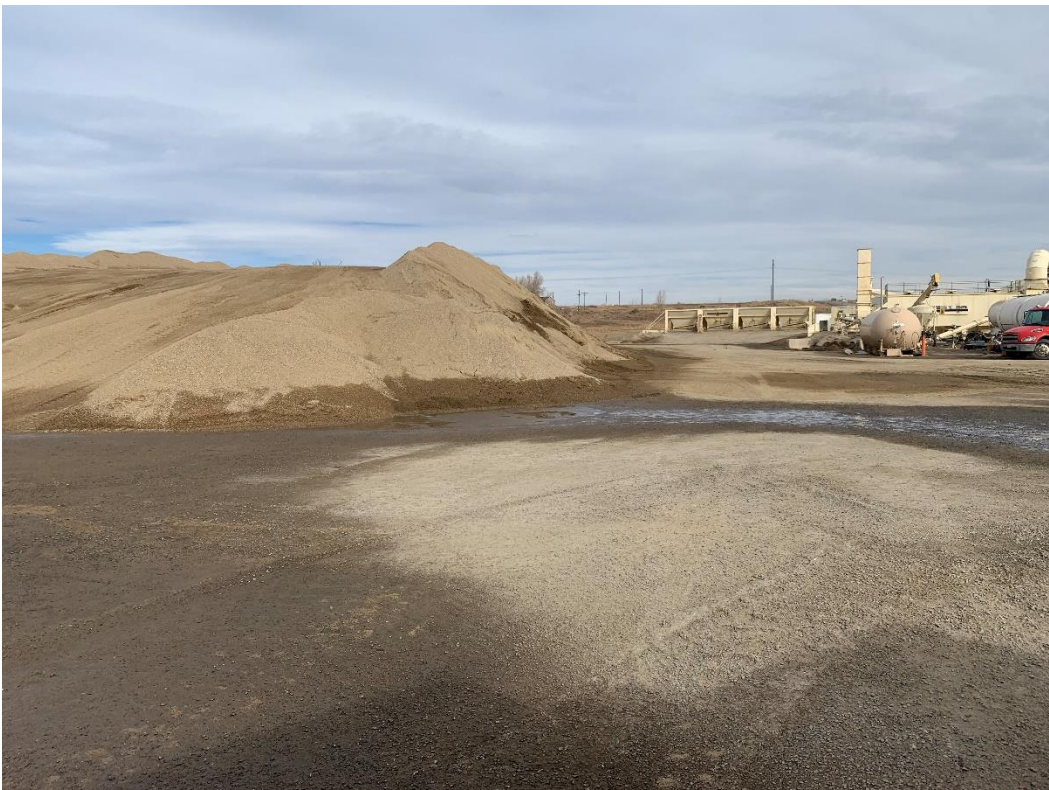
The main facilities area is in an area known as cell 4, which has not yet been mined. It is on the west side of the permit area and contains the scale house, asphalt plant and some product stockpiles (photo 2).

Photo 2 – Facilities area (future cell 4 area)

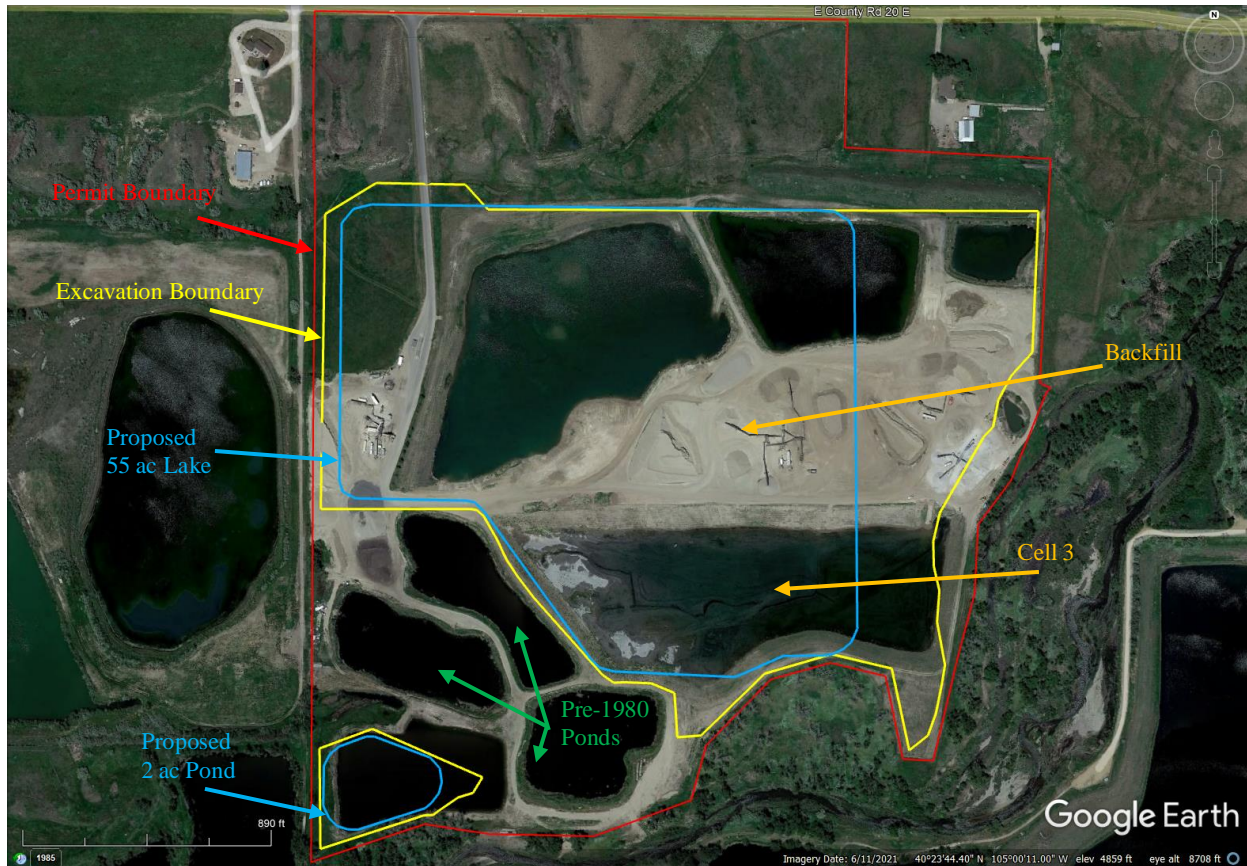
A comparison of the approved reclamation plan and the current site conditions are illustrated on photo 3 below. A 2021 Google Earth Image was used to illustrate the current conditions because it is consistent with the conditions that were noted during the inspection. The current site conditions are significantly different than the approved reclamation plan as noted in the following 3 bullet points.

The backfill in the middle of the 55 acre lake, the creation of Cell 3 and the over excavation of Cell 2 are all significant deviations from the proposed reclamation plan. The operator needs to submit a technical revision within the next 60 days to update the reclamation plan to reflect the current conditions. See the first page of this report for additional information about corrective actions and corrective action due dates.

Photo 3 – Boundaries approved in TR2 (2021 Google Earth, imagery date 2021)

CORRECTIVE ACTIONS: The operator shall submit a Technical Revision, with the required \$216 revision fee, to update and clarify the current approved reclamation plan to reflect existing and proposed activities by the corrective action date.

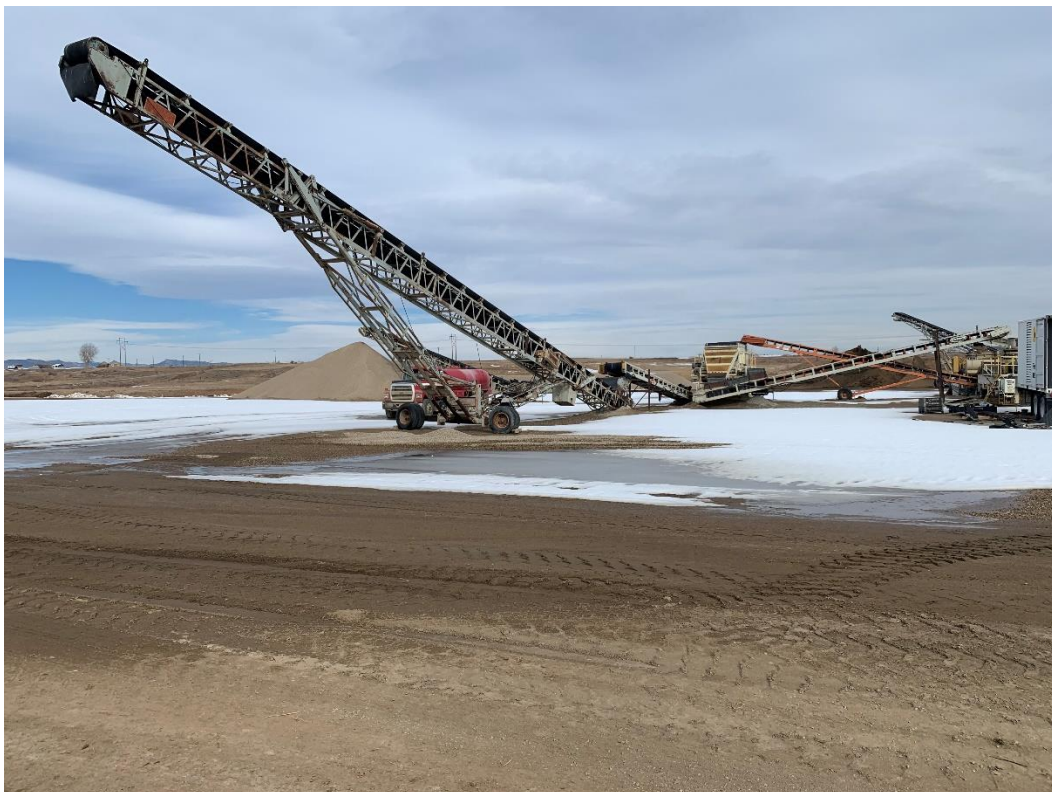
- A single 55 acre lake, approved in TR2, is supposed to be in the northern part of the permit area. The lake was to have a clay liner constructed in a clockwise fashion around the lake. Currently, the center portion of the 55 acre lake has been backfilled creating 4 separate ponds: Cell 3 to the south and 3 individual ponds to the north. The center backfilled area contains processing equipment and product stockpiles (photo 4).

Photo 4 – Processing facilities located on backfilled area, north of Cell 3

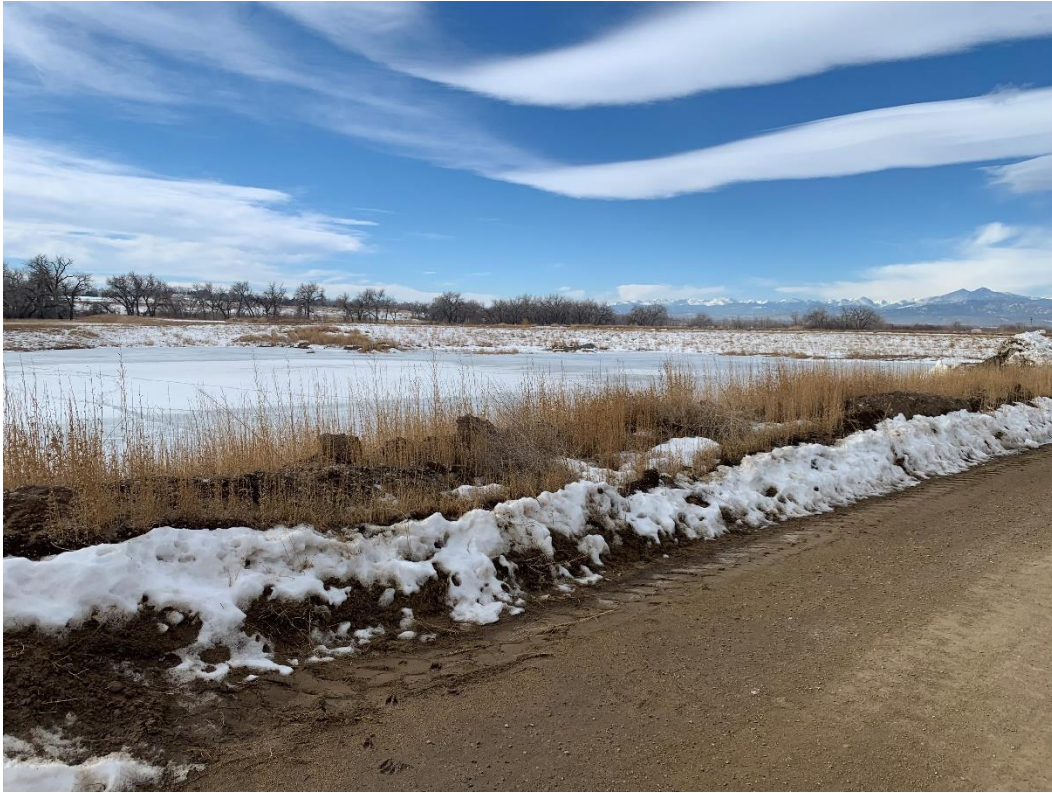
- Cell 3 is the southern portion of the proposed 55 acre lake. It has been separated from the rest of the lake by the backfilled material. It is about 15 acres in size and contains water (photo 5). The slopes were graded to 3h:1v and were vegetated. The operator claims the pond is lined and SEO approved. DWR was contacted to confirm this point and they are not aware of any clay-lined ponds.

Photo 5 – Cell 3, looking southwest
