MINERALS PROGRAM INSPECTION REPORT

MINE NAME: Dixie Mine	MINE/PROSPECTING ID#: M-2015-028	MINERAL: Silver and gold	COUNTY: Clear Creek
INSPECTION TYPE: Monitoring	WEATHER: Raining	INSP. DATE: June 16, 2023	INSP. TIME: 12:00
OPERATOR: Teton Drilling Inc.	OPERATOR REPRESENTATIVE: Mike Jones	TYPE OF OPERATION: 110(1) - Hard Rock Limited Impact	
REASON FOR INSPECTION: Normal I&E Program	BOND CALCULATION TYPE: Partial Bond	BOND AMOUNT: \$14,500.00	
DATE OF COMPLAINT: NA	POST INSP. CONTACTS: None	JOINT INSP. AGENCY: None	
INSPECTOR(S): Peter Hays	INSPECTOR'S SIGNATURE:

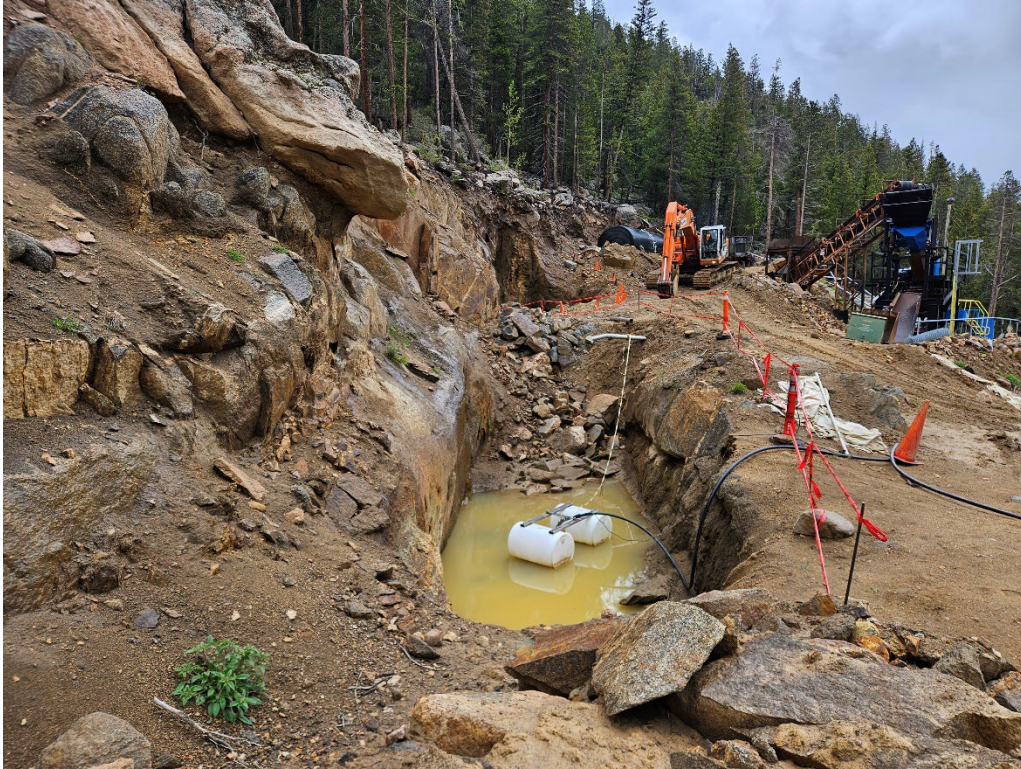
View of the trench excavation from the south end looking north

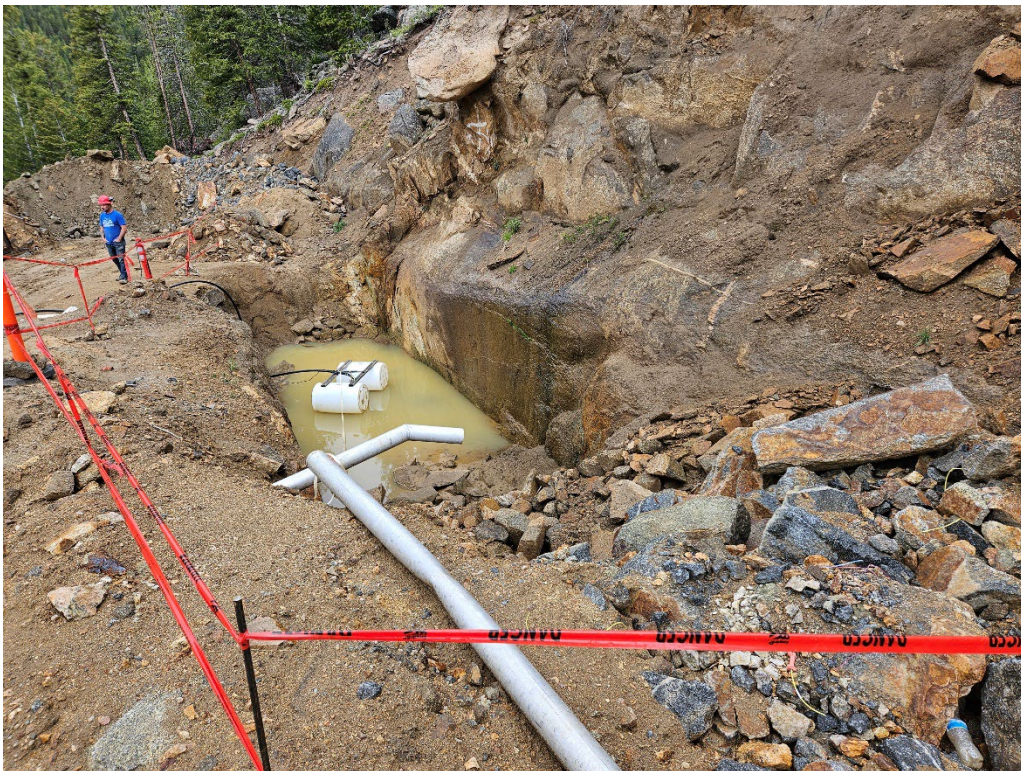
View of the south cell of the trench (water source and backfill area)

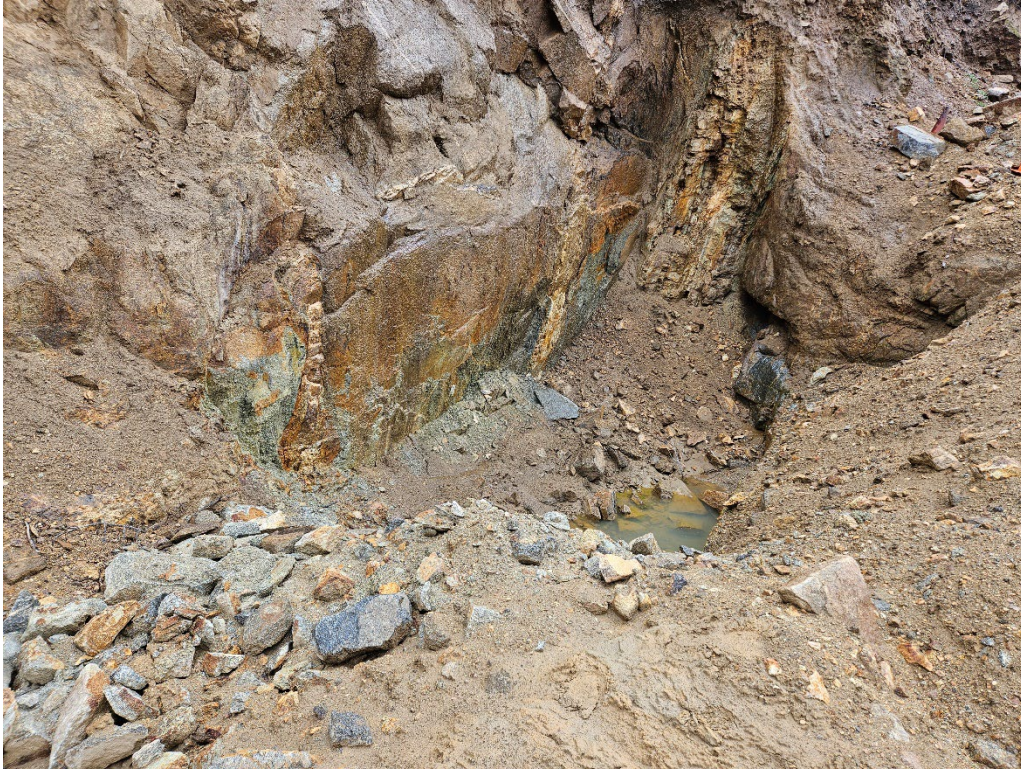
View of the north cell of the trench (excavation area)

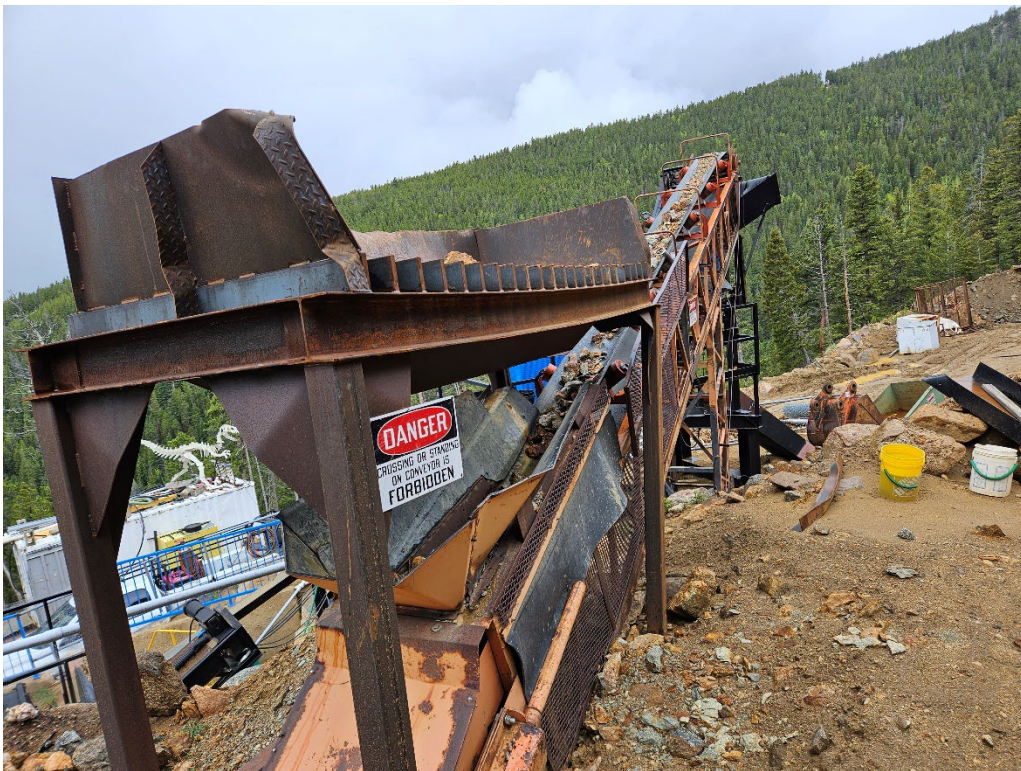
View of grizzly and conveyor

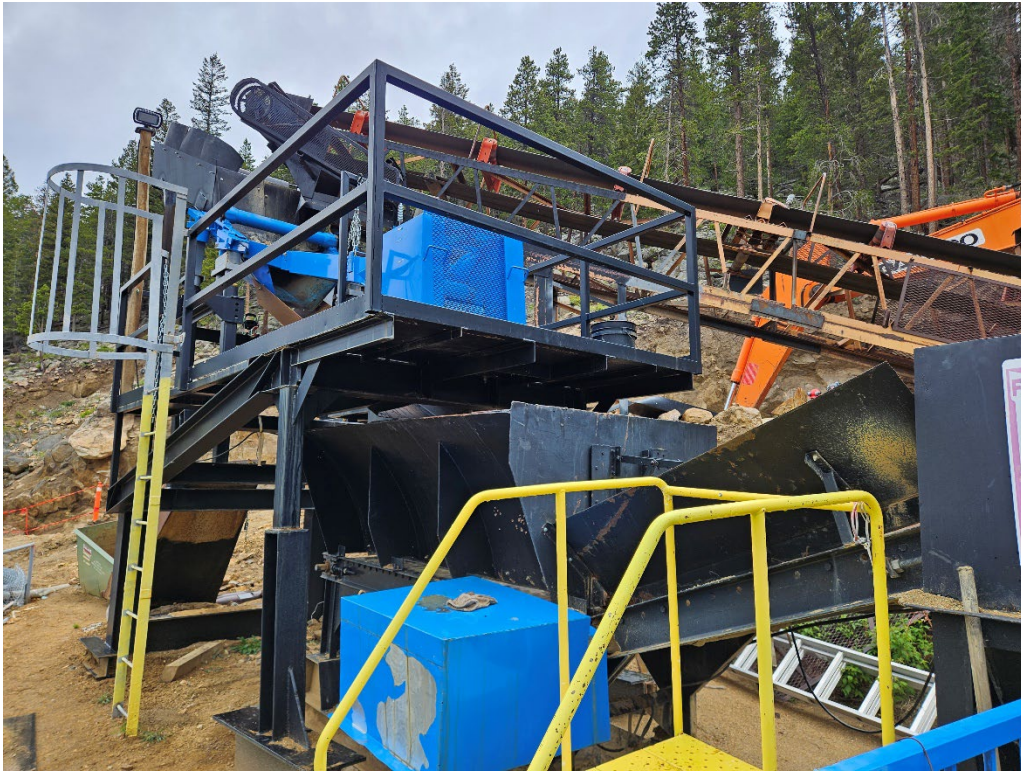
View of the jaw crusher

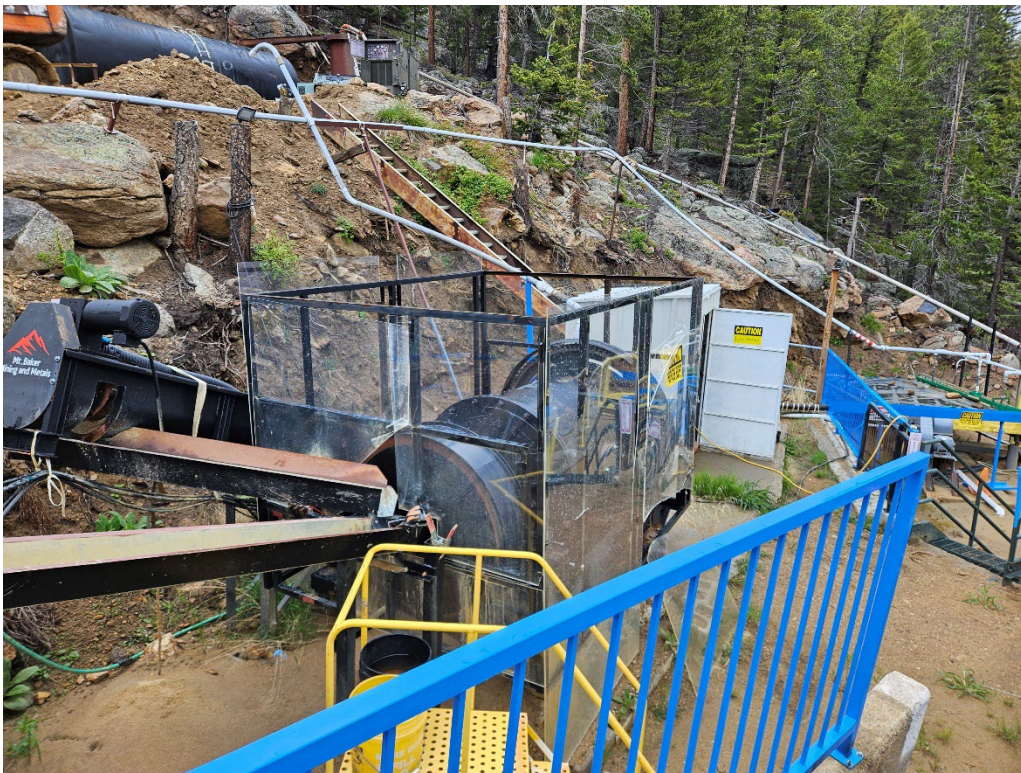
View of the ball mill

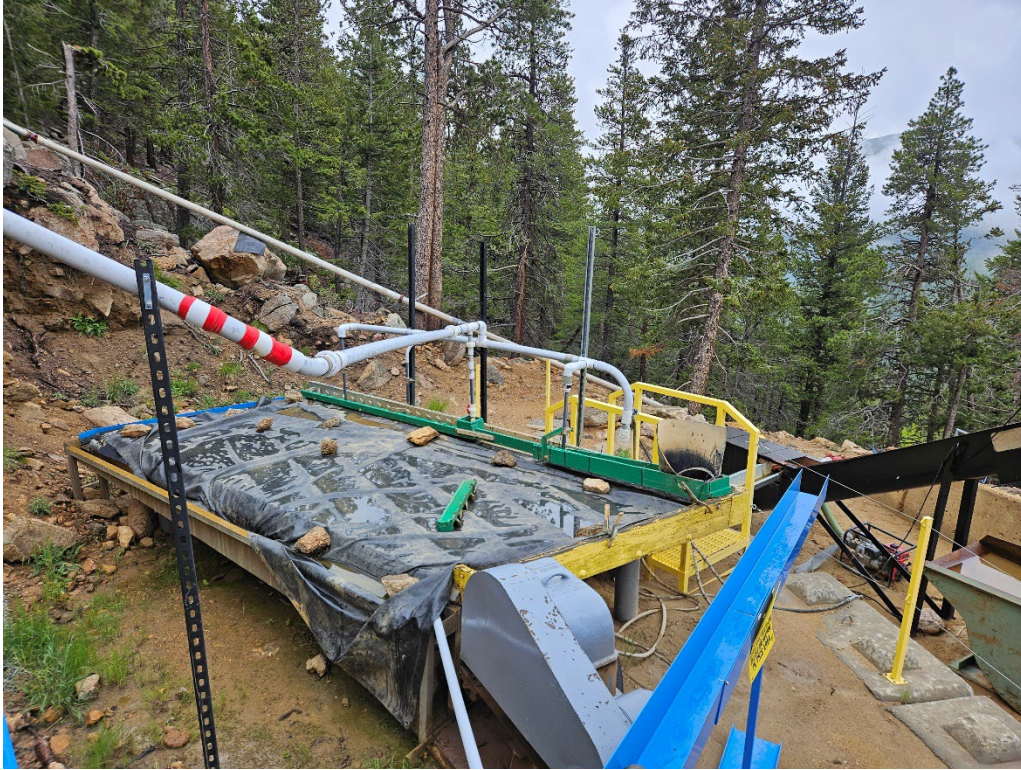
View of the jig table

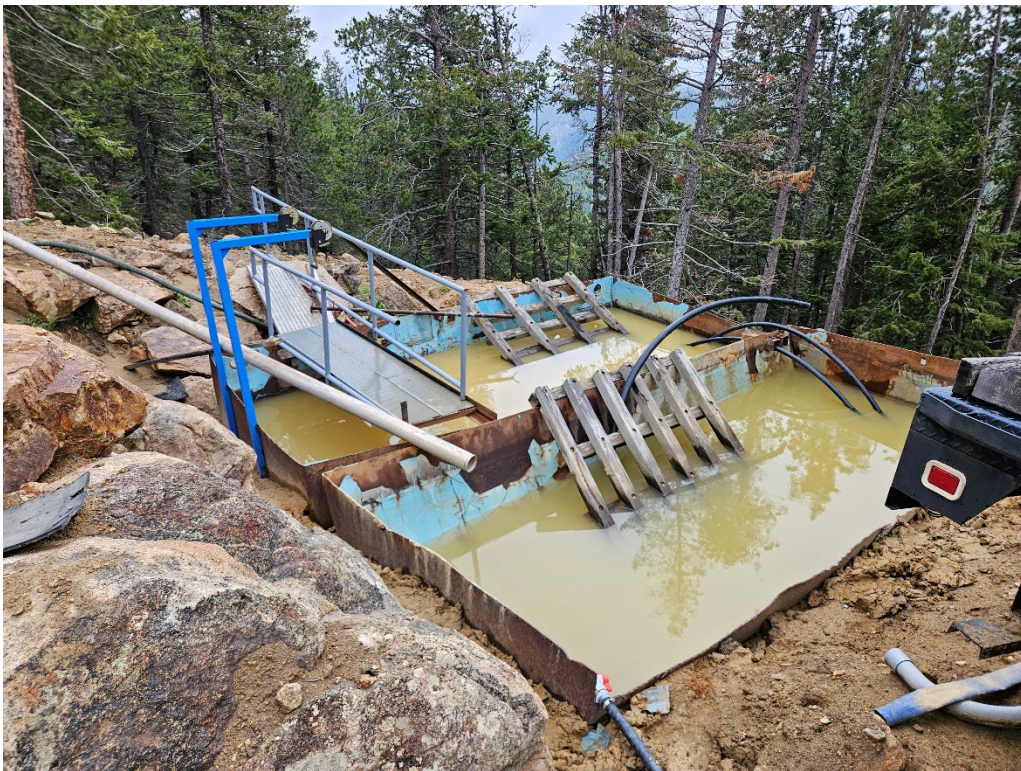
View of the water troughs
