MINERALS PROGRAM INSPECTION REPORT

MINE NAME: Stanley Pit	MINE/PROSPECTING ID#: M-2018-032	MINERAL: Gravel	COUNTY: Dolores
INSPECTION TYPE: Monitoring	WEATHER: Clear	INSP. DATE: June 14, 2023	INSP. TIME: 11:30
OPERATOR: Dolores County	OPERATOR REPRESENTATIVE: John Neilson	TYPE OF OPERATION: 112c - Construction Regular Operation	
REASON FOR INSPECTION: Normal I&E Program	BOND CALCULATION TYPE: None	BOND AMOUNT: \$0.00	
DATE OF COMPLAINT: NA	POST INSP. CONTACTS: None	JOINT INSP. AGENCY: None	
INSPECTOR(S): Todd Jesse Travis Marshall	INSPECTOR'S SIGNATURE:

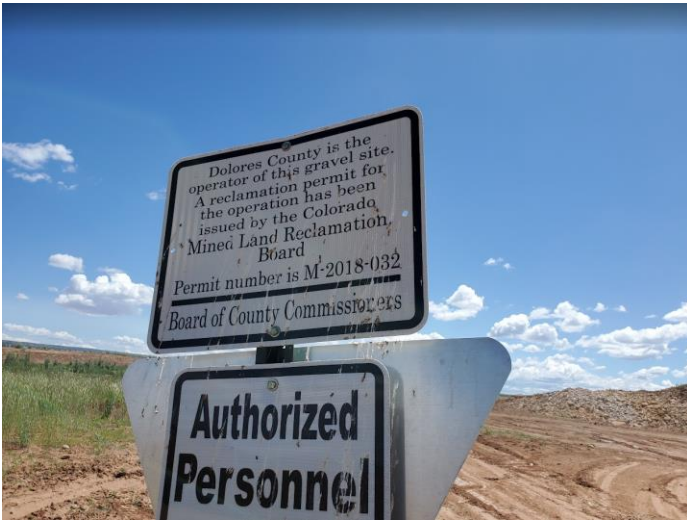
The proper mine identification signage was posted at the entrance to the site off Rd 3.7. The permit boundary is marked by t-posts along the northern boundary and fence along the other boundary lines. The Division recommends that as the pit extends to the north, more t-posts are placed along the northern boundary to better mark the permit boundary and prevent off site damage. The site was not active at time of the inspection, but some equipment was present. There was a conveyor and dozer stored on site but they were not active. The only on-site support facility is a portable bathroom.

View to the east showing proper Mine ID signage posted at the entrance to the site

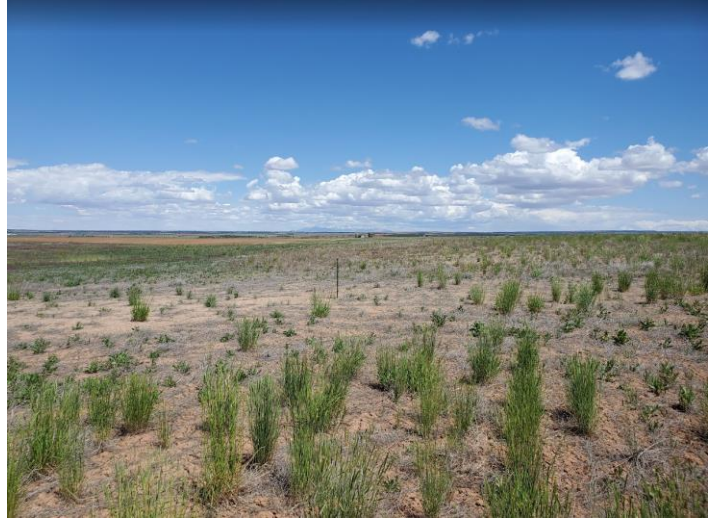
View to the north showing t-post that marks northern permit boundary.

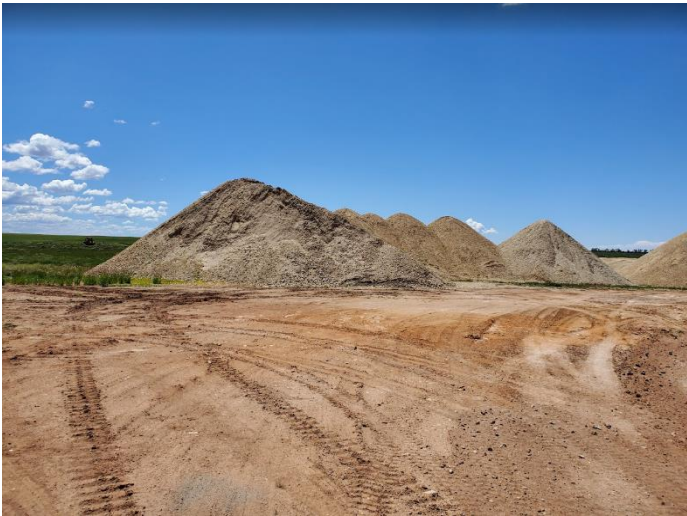
When new material needs to be generated in the pit, bedrock is blasted by a contractor as per the Mining Plan. A portable crushing and screening unit is then moved onto site to process material. Currently there are two products being stockpiled on site – a road base product and a 4" minus product. There is also an overburden stock pile near the northern boundary of the permit. The overburden stockpile is protected by vegetative cover. There is no significant amount of topsoil within the permit boundary to stockpile. The pit is holding a small amount of meteoric water in low lying area. This is expected given the above average amount of precipitation that has been received so far this year.

View to the south showing proper product stockpiles on site.

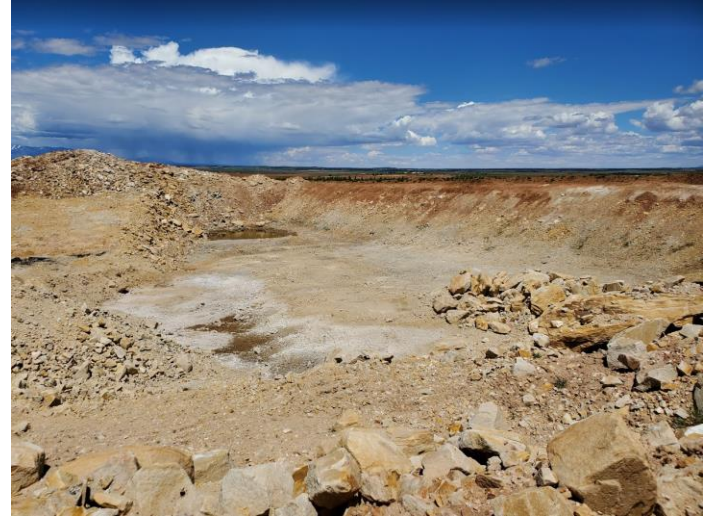
View to the northwest showing meteoric water on the west end of the pit floor.

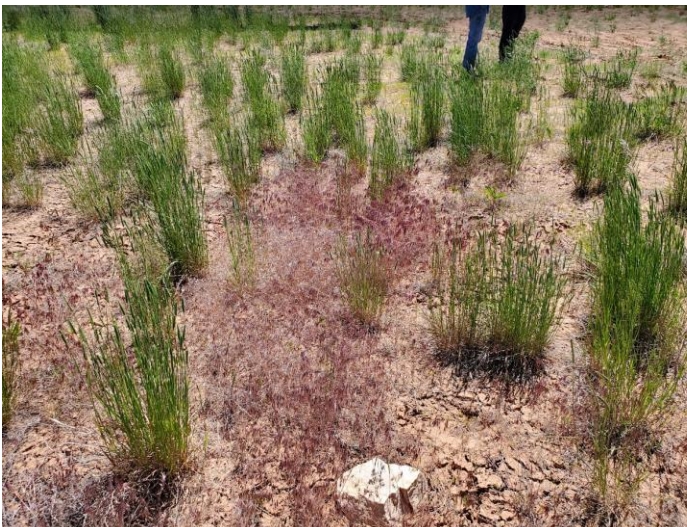
An infestation of Downy brome, also known as cheat grass (*Bromus tectorum*) was discovered on site. This species is categorized as a List C noxious weed by the State of Colorado's Department of Agriculture. No other state listed noxious weeds were observed. The Division recommends that the operator eliminate the brome infestation and contact the Dolores County Noxious Weed Program to develop a Weed Management Plan.

View to the southeast showing Downy brome infestation.

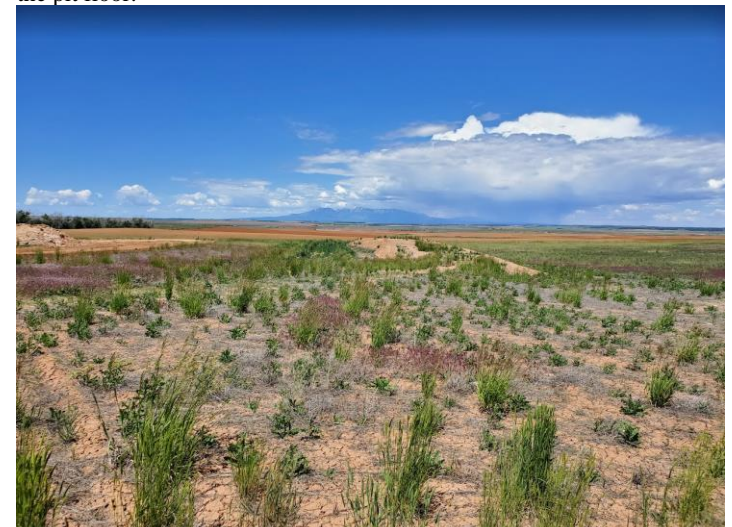
View to the west showing overburden stockpile protected by vegetation with Downy brome in the foreground.
