June 21, 2023

Re: Follow Up on Mayflower Return Pipeline Leak – Climax Mine Permit No. M-1977-493

Attachment 1
Photos of Investigation

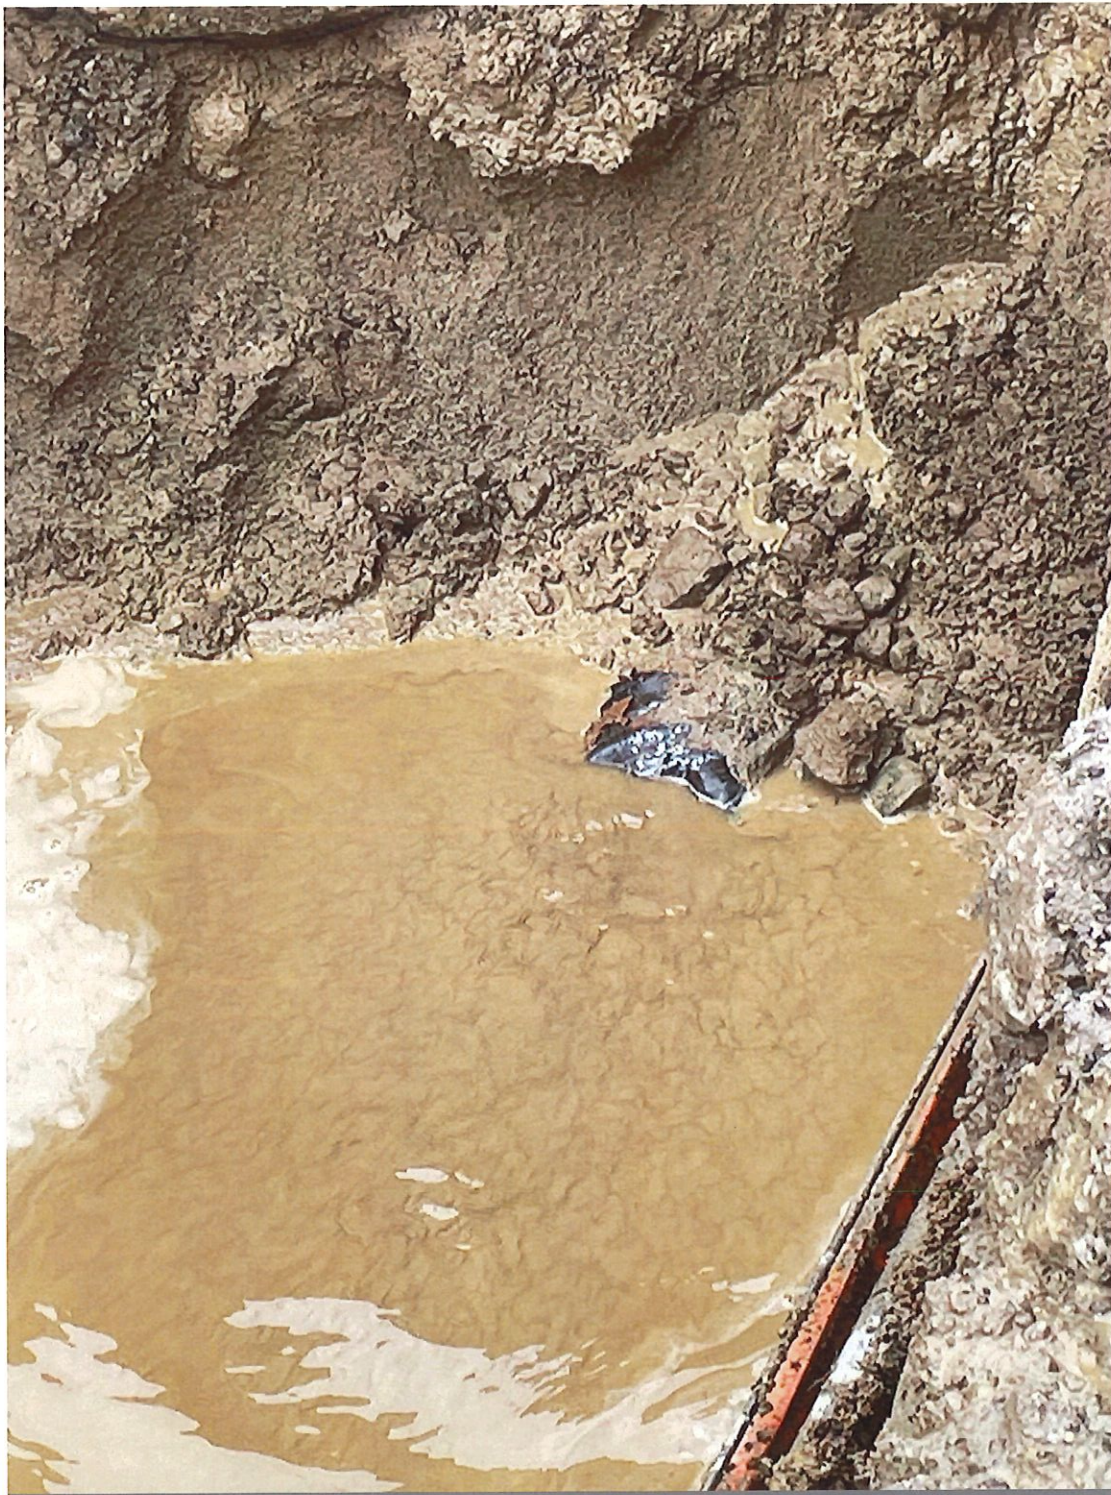
Climax conducted additional investigations subsequent to the May 6, 2023, report, to determine the source of the water. It was determined the water source is a historic French drain which had water daylighting through backfill around the Mayflower Return Pipeline. The French drain was a historic non-contact water (i.e., natural seep) conveyance under the pavement of the old highway (Highway 91) that historically ran through this area, approximately 5 feet deep. Climax was able to locate the historic French drain system along the existing road ditch and connect additional perforated pipe to re-route the French drain and discharge this natural seepage near the existing culvert that runs under the existing road (see Photos in Attachment 1).

[Photo 1 – Old iron French drainpipe, discovered by following the water that was surfacing by excavating approximately 5 feet down]

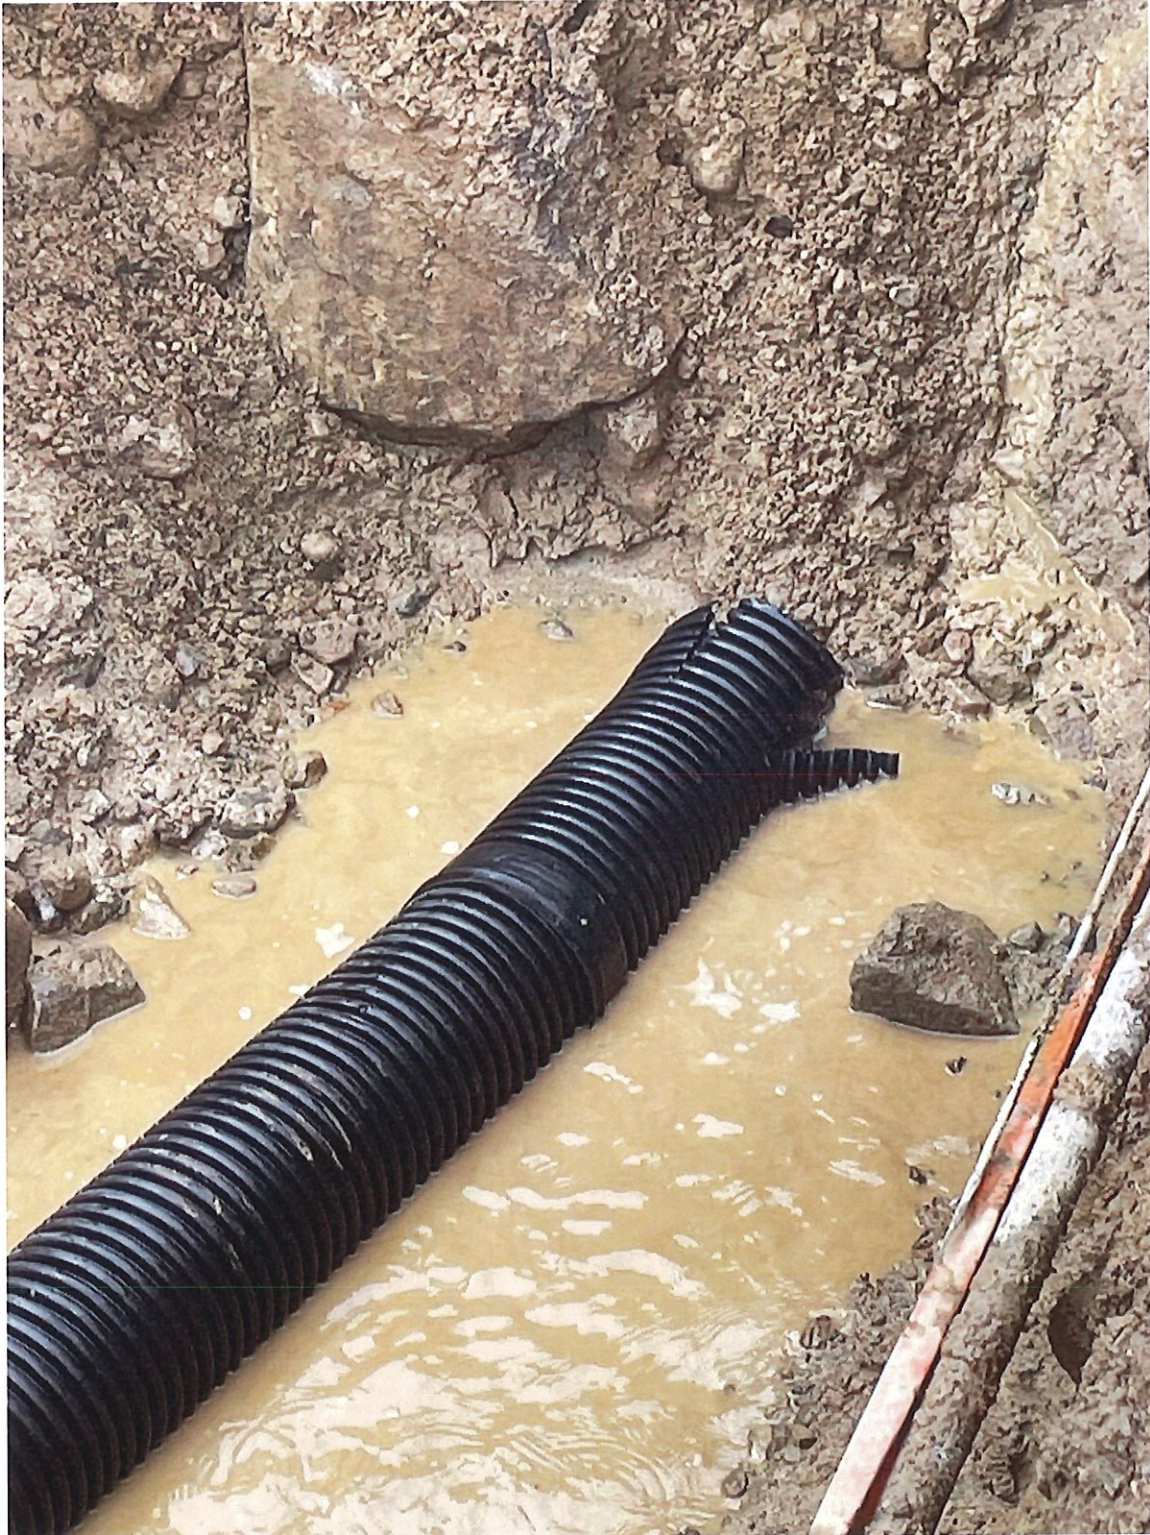
[Photo 2 – New corrugated pipe attached to old French drainpipe]

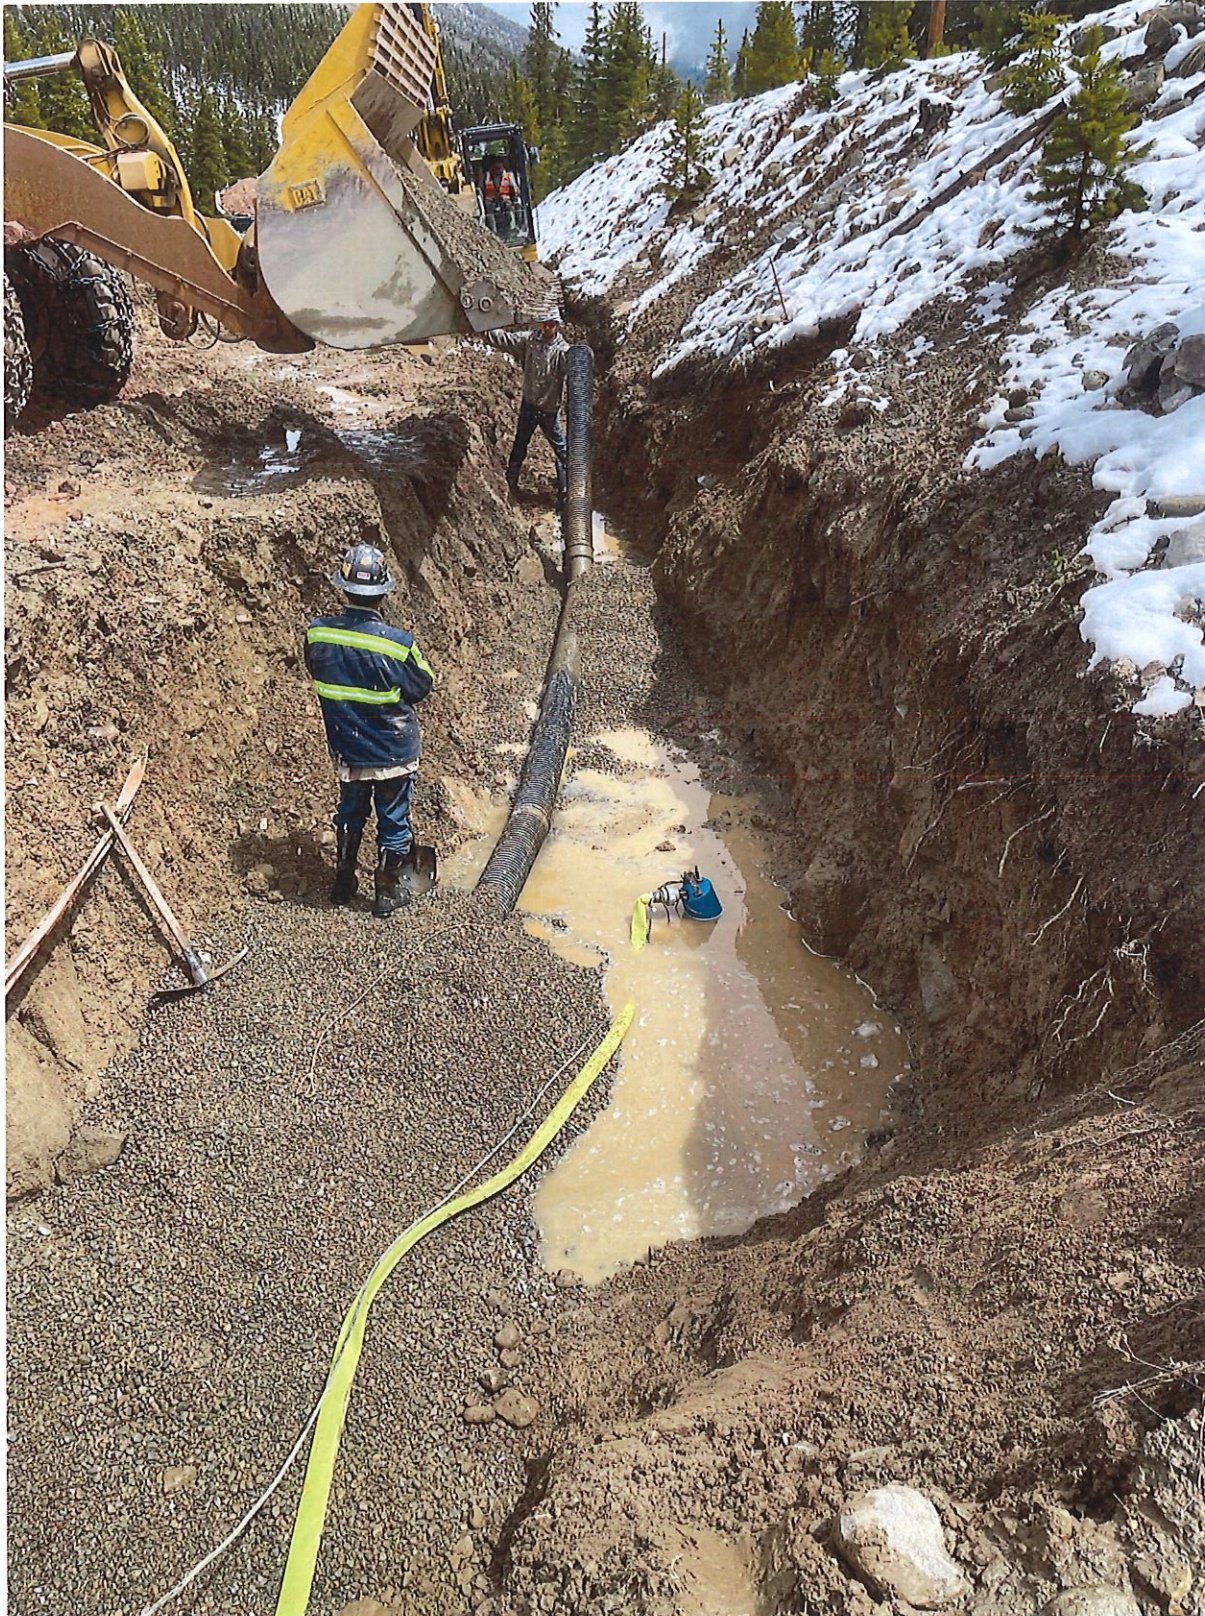
[Photo 3 – New corrugated pipe stretch installed to convey water into existing ditch alongside road]

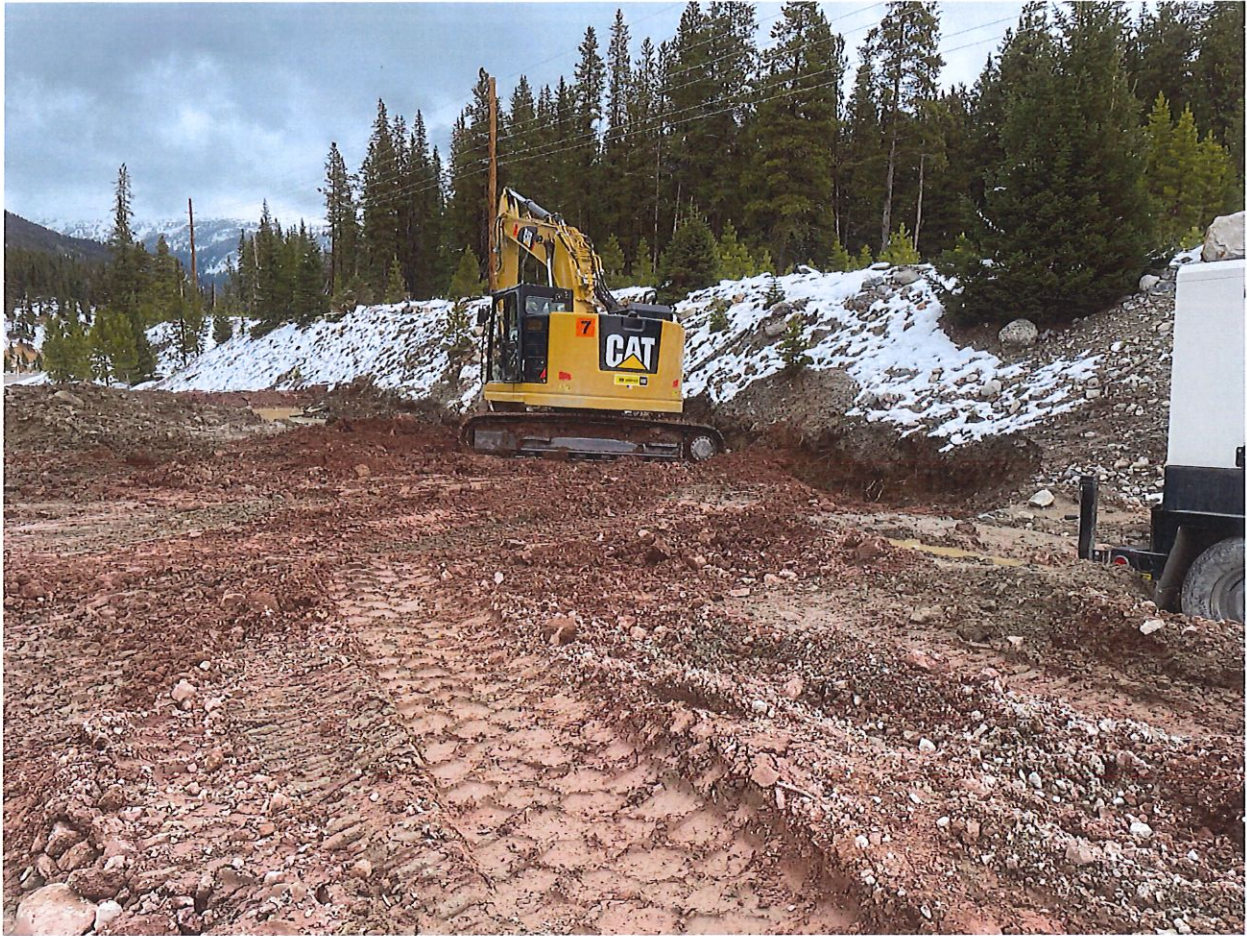
[Photo 4 – Gravel was used to bed pipe and surround the new French drainpipe, then excavation was backfilled]
