TRAPPER MINING INC.  
CRAIG, COLORADO

HORSE GULCH FILL  
QUARTERLY FILL CERTIFICATION

# **Horse Gulch Fill Quarterly Inspection Report**

**Second Quarter 2023**

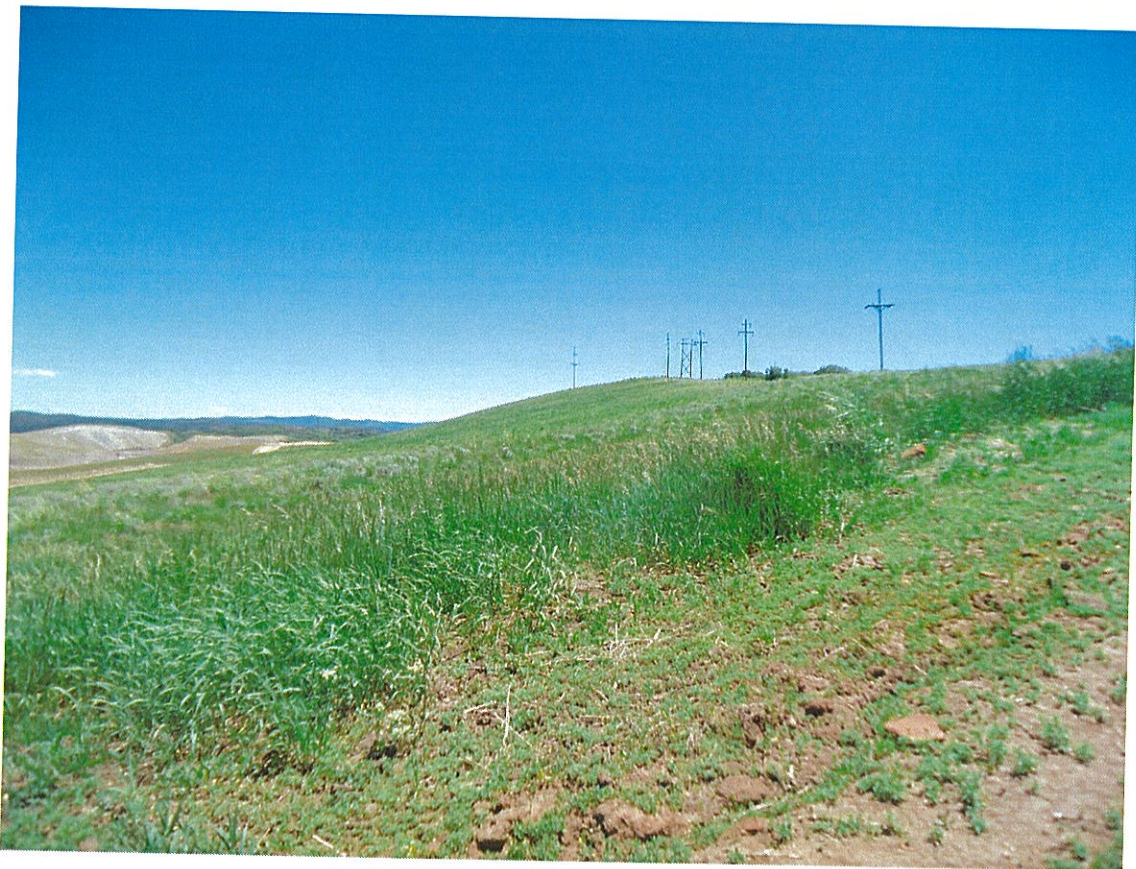
No appearances of instability, structural weakness, or other hazardous conditions were observed. Both the southeast side of the fill and the northeast side of the fill were inspected this quarter (Photographs 1 and 2). The area where cracks were detected on the top south portion of the dump during the first quarter of 2013 inspection was checked. There was no additional cracking found.

Photograph 1: East Side Looking South (6/26/2023)

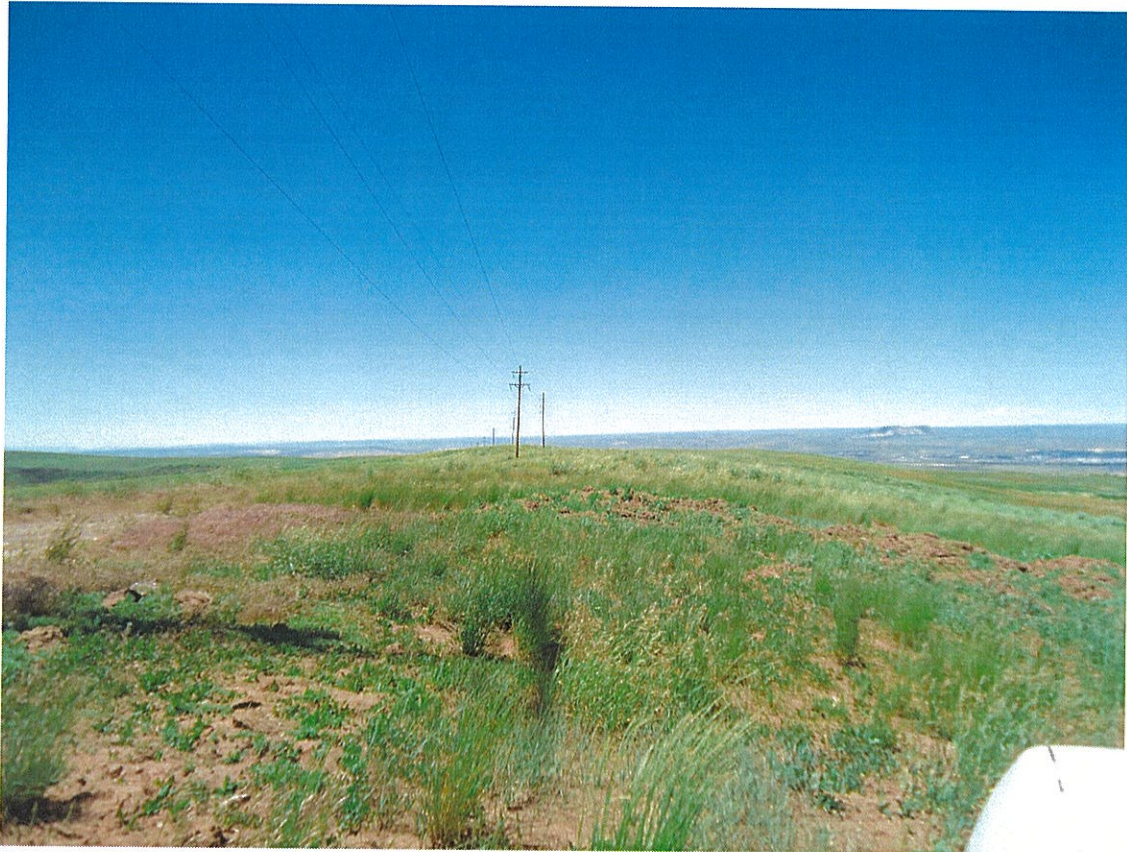
*Photograph 2: South Side Looking North (6/26/2023)*

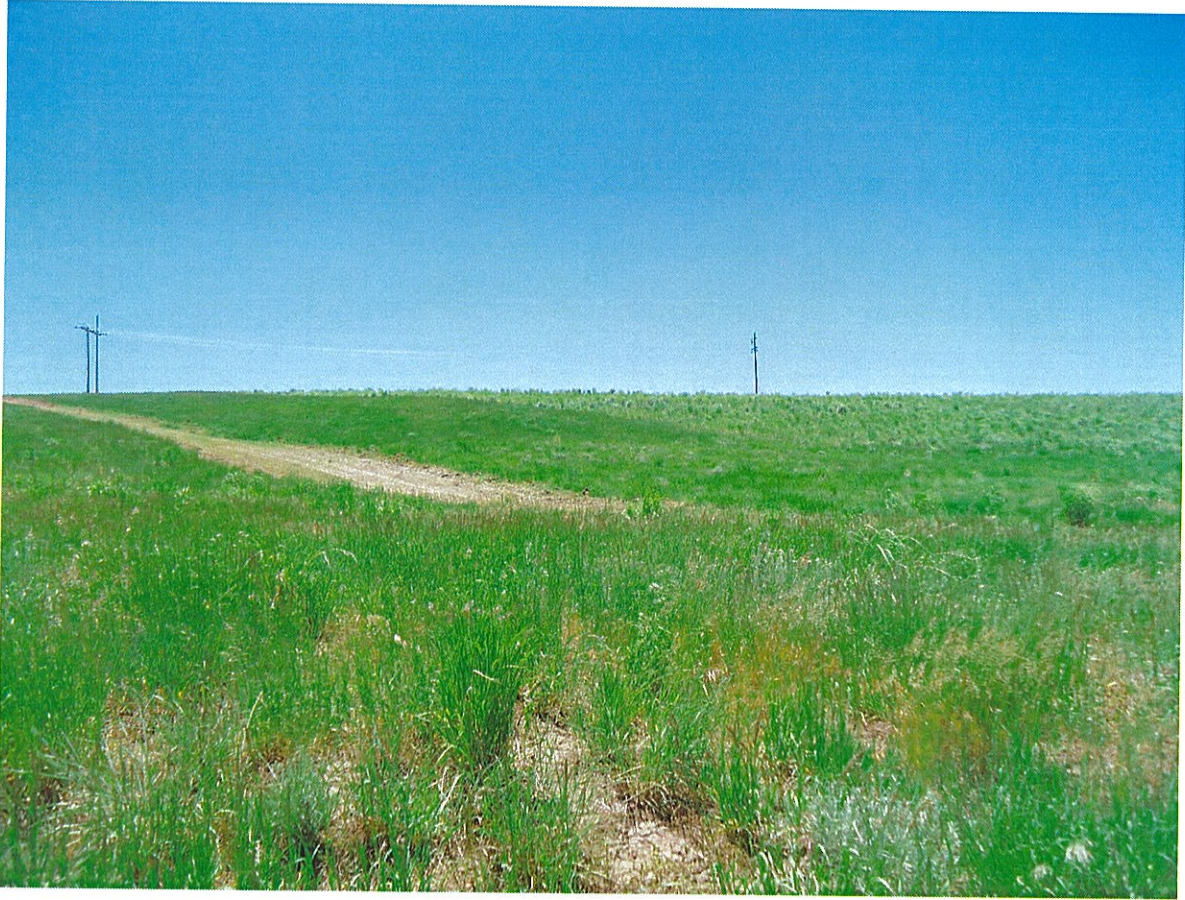
There was no placement of material or contour work done on the fill this quarter. All the required material for the fill has been placed and compacted. It is anticipated there will be no more additional fill material placed on the fill.

Photograph 3 depicts the east facing slope of the fill.

*Photograph 3: East Side of the Fill Looking North-west (6/26/2023)*
