**MINERALS PROGRAM INSPECTION REPORT**  
**PHONE: (303) 866-3567**

<b>MINE NAME:</b> Farm Road Source	<b>MINE/PROSPECTING ID#:</b> M-2019-033	<b>MINERAL:</b> Gravel	<b>COUNTY:</b> Montrose
<b>INSPECTION TYPE:</b> Monitoring	<b>WEATHER:</b> Clear	<b>INSP. DATE:</b> June 6, 2023	<b>INSP. TIME:</b> 11:30
<b>OPERATOR:</b> Cornerstone Materials LLC	<b>OPERATOR REPRESENTATIVE:</b> None	<b>TYPE OF OPERATION:</b> 110c - Construction Limited Impact	
<b>REASON FOR INSPECTION:</b> Citizen Complaint	<b>BOND CALCULATION TYPE:</b>	<b>BOND AMOUNT:</b> \$19,366.00	
<b>DATE OF COMPLAINT:</b> NA	<b>POST INSP. CONTACTS:</b> None	<b>JOINT INSP. AGENCY:</b> None	
<b>INSPECTOR(S):</b> Dustin Czapla	<b>INSPECTOR'S SIGNATURE:</b>

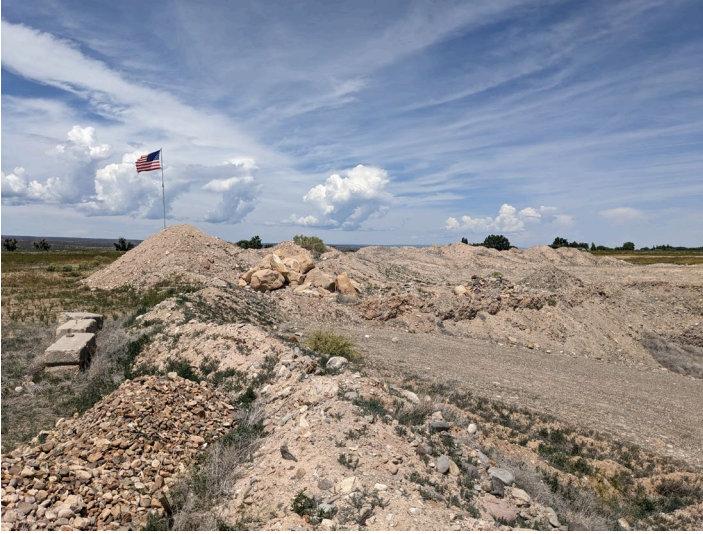
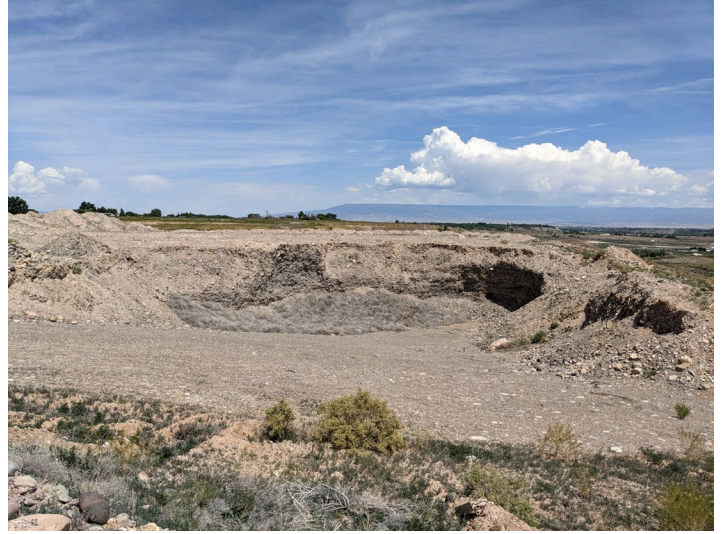
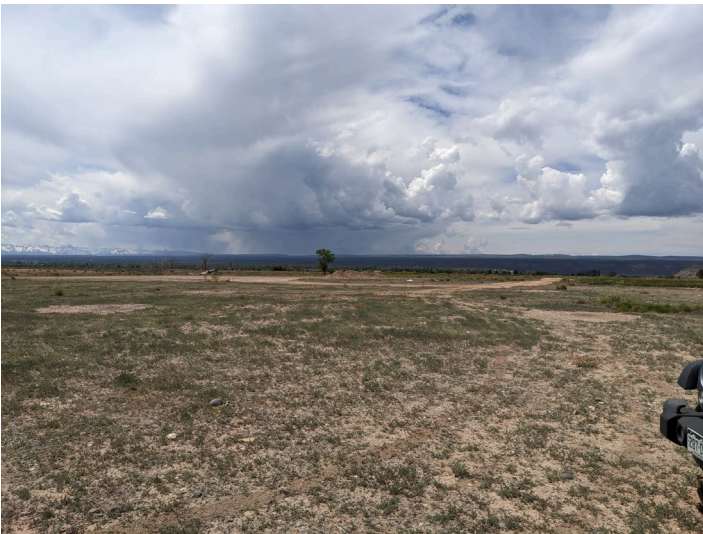
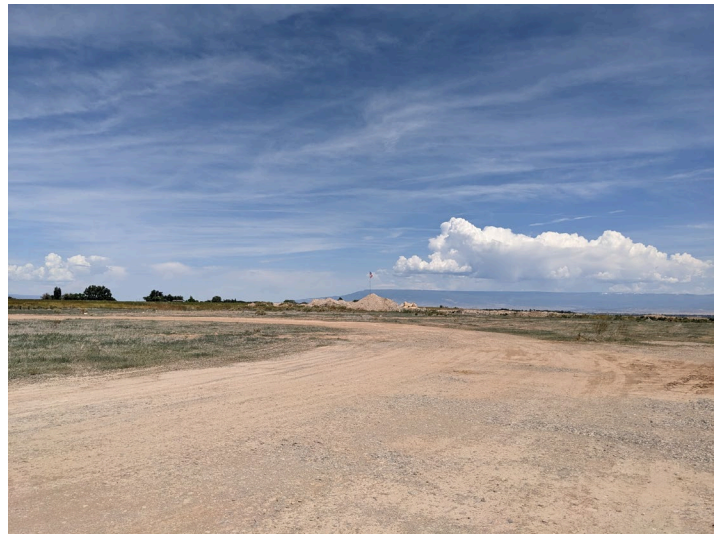
During this inspection it was found that the 12,000 cubic yard gravel stockpile that was produced prior to the issuance of the 110c Reclamation Permit had been removed from the site. Evidence of further mining was not observed.

Stockpile area on south side of pit where stockpile has been removed
