MINERALS PROGRAM INSPECTION REPORT
PHONE: (303) 866-3567

MINE NAME: Dakota Clay Pit	MINE/PROSPECTING ID#: M-1989-052	MINERAL: Clay (general)	COUNTY: Jefferson
INSPECTION TYPE: Monitoring	WEATHER: Clear	INSP. DATE: June 28, 2023	INSP. TIME: 09:00
OPERATOR: The Denver Brick Company	OPERATOR REPRESENTATIVE: Richard Murphy	TYPE OF OPERATION: 110c - Construction Limited Impact	
REASON FOR INSPECTION: Normal I&E Program	BOND CALCULATION TYPE:	BOND AMOUNT: \$43,926.00	
DATE OF COMPLAINT: NA	POST INSP. CONTACTS: None	JOINT INSP. AGENCY: None	
INSPECTOR(S): Eric Scott	INSPECTOR'S SIGNATURE:

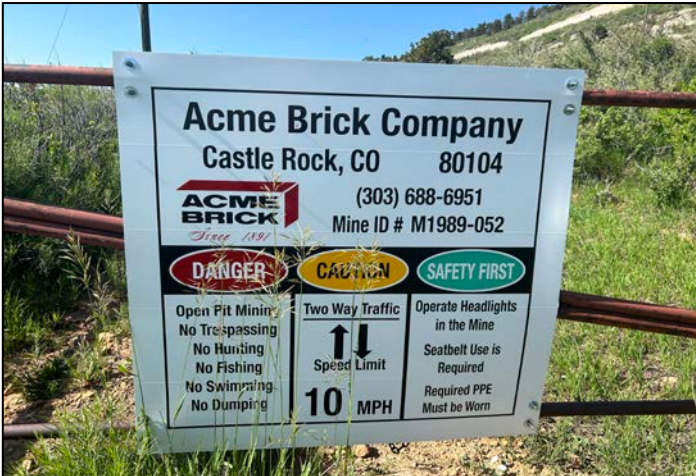
It was noted that the site identification sign was present at the site entrance (Photo 1) and the permit boundary markers (white PVC pipe) were present. The last date of active mining at the site was in 2018 and the site has been in reclamation since that time. Mr. Murphy requested this inspection of the site to identify any remaining items that would require attention prior to requesting the final release of the permit.

Photo 1 – site identification sign at gated entrance to the site on south side of county road 56.

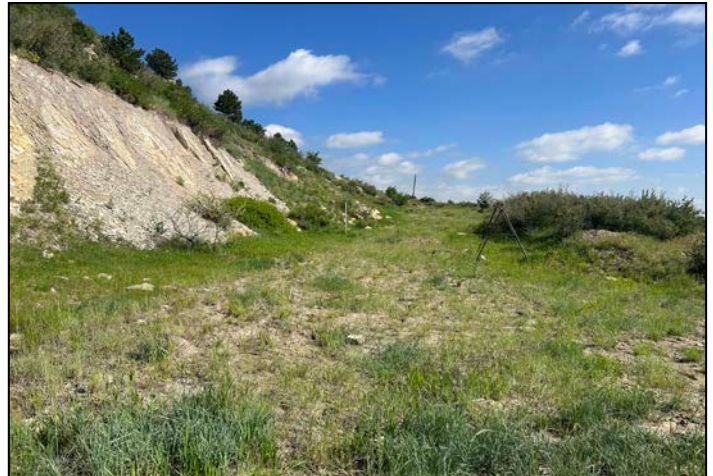
Photo 2 – Reclamation of access road at base of former working face.

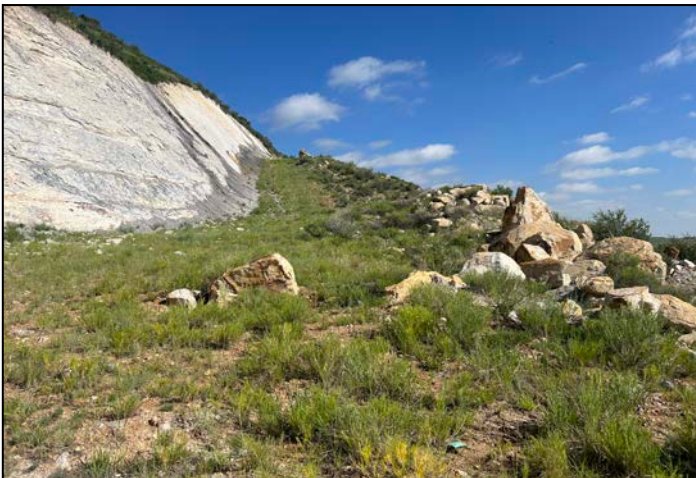
Photo 3 – Reclamation of access road at base of former working face.

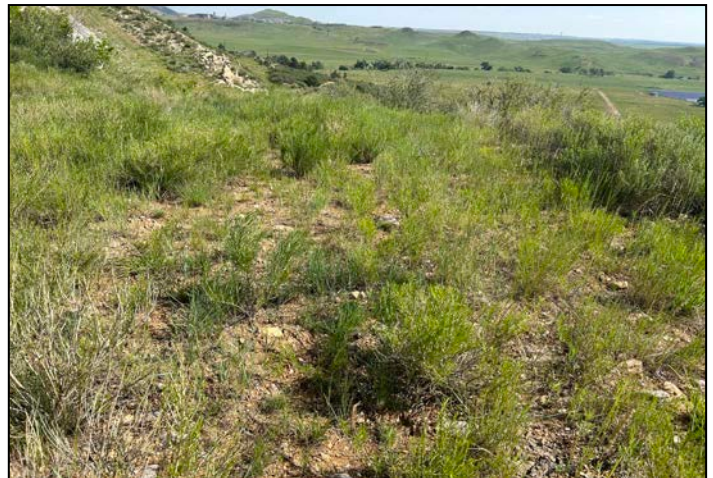
Photo 4 – Reclamation vegetation on site blends very well with native vegetation in the area.

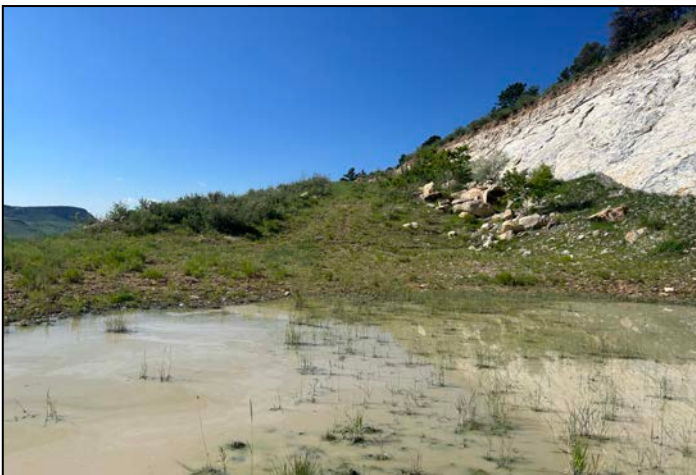
Photo 5 – Reclamation of access road at base of former working face. Standing water due to recent heavy rains.

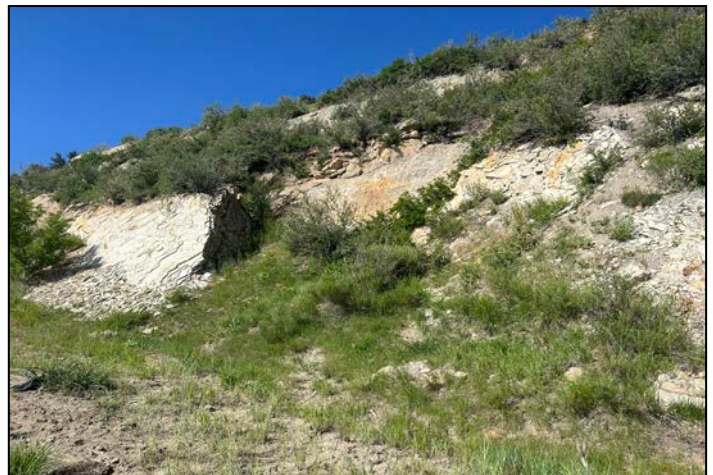
Photo 6 – Site reclamation blends well with native surrounding areas.
