**MINERALS PROGRAM INSPECTION REPORT**  
**PHONE: (303) 866-3567**

<b>MINE NAME:</b> Henderson Mine	<b>MINE/PROSPECTING ID#:</b> M-1977-342	<b>MINERAL:</b> Molybdenum	<b>COUNTY:</b> Clear Creek, Grand
<b>INSPECTION TYPE:</b> Monitoring	<b>WEATHER:</b> Clear	<b>INSP. DATE:</b> June 14, 2023	<b>INSP. TIME:</b> 10:00
<b>OPERATOR:</b> Climax Molybdenum Company	<b>OPERATOR REPRESENTATIVE:</b> Jolyn Bryant	<b>TYPE OF OPERATION:</b> 112d-3 - Designated Mining Operation	
<b>REASON FOR INSPECTION:</b> Normal I&E Program	<b>BOND CALCULATION TYPE:</b> Partial Bond	<b>BOND AMOUNT:</b> \$135,204,778.00	
<b>DATE OF COMPLAINT:</b> NA	<b>POST INSP. CONTACTS:</b> None	<b>JOINT INSP. AGENCY:</b> None	
<b>INSPECTOR(S):</b> Peter Hays Brock Bowles Joel Renfro	<b>INSPECTOR'S SIGNATURE:</b>

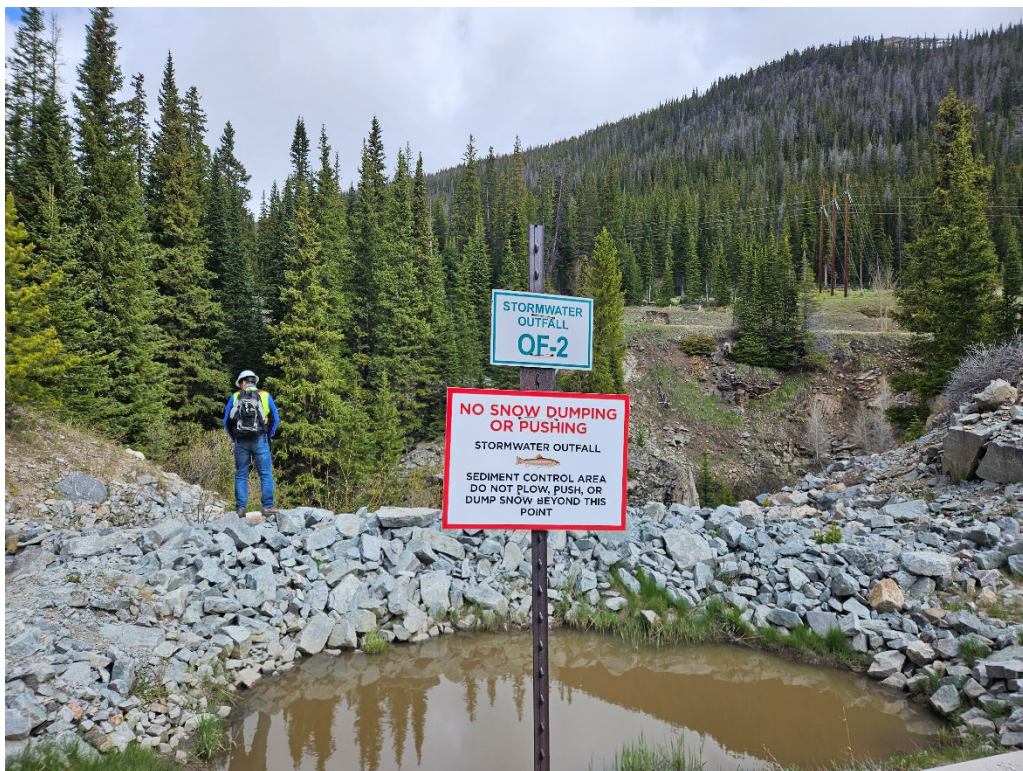
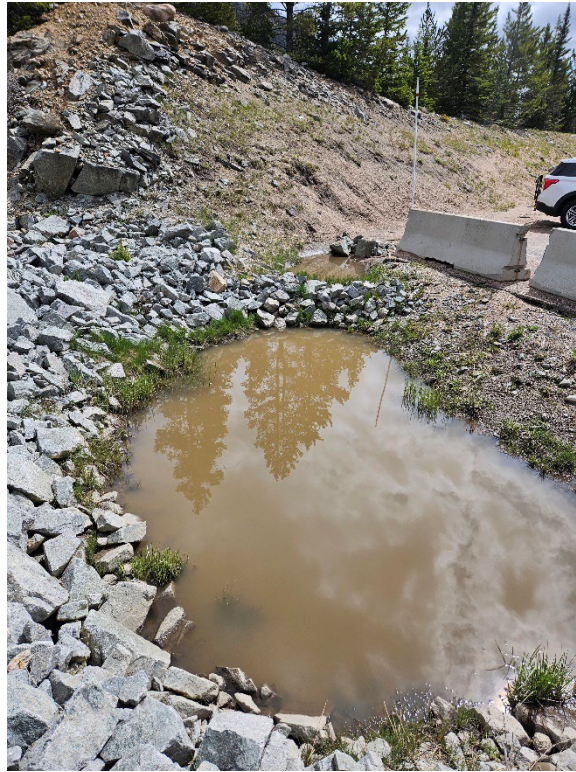
OF-2

OF-2: BMP's at this outfall location consist of a series of rock check dams leading to a sedimentation pond above the rip-rap outfall. The sediment pond contained standing water at the time of the inspection.

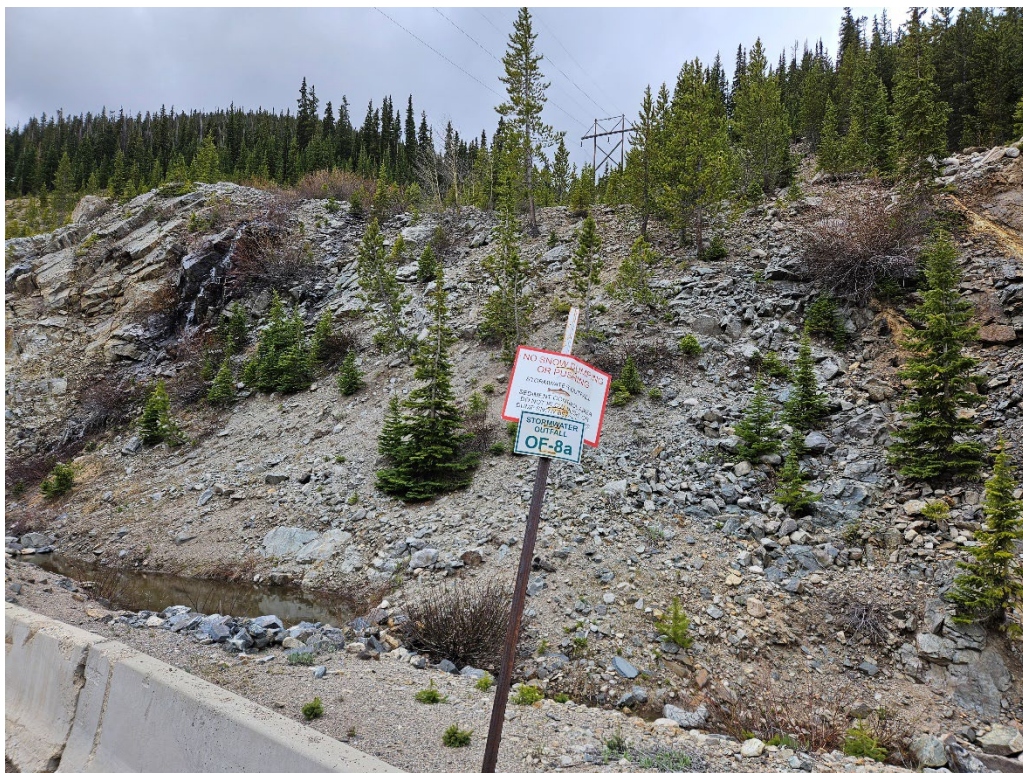
OF-08a

OF-8a: BMP's at this outfall location consist of a ditch with a series of rock check dams leading to a sedimentation pond. The ditch and sedimentation pond contained water and the rock check dams appeared to be working properly.

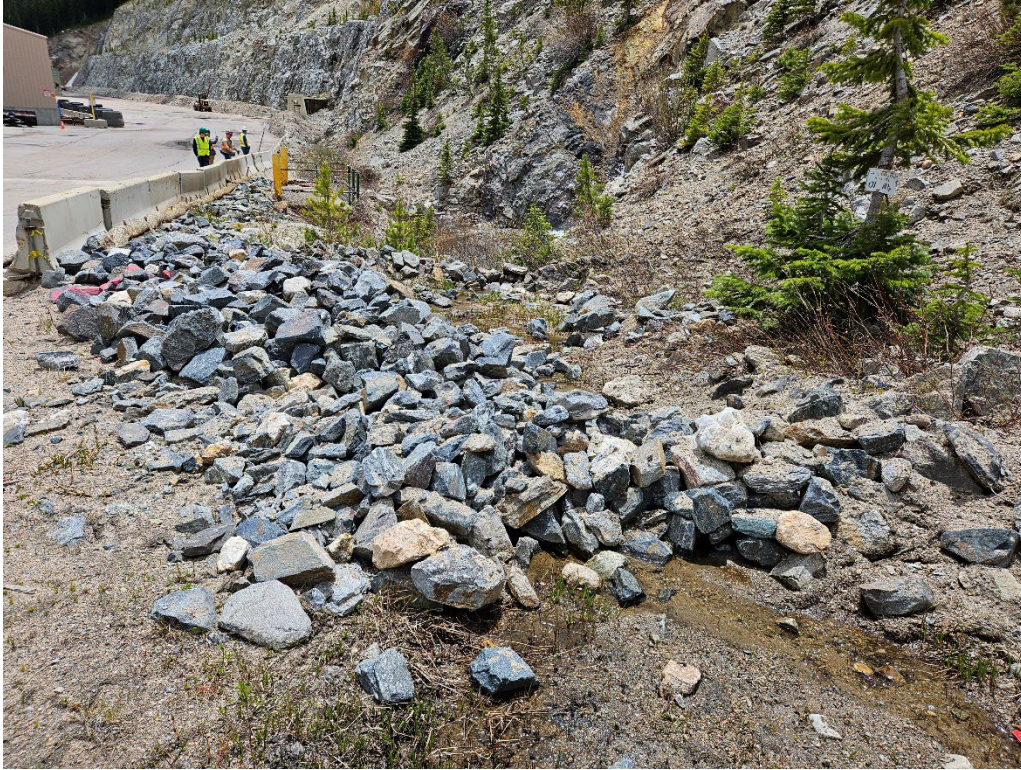
OF-8b: BMP's at this outfall location consist of a series of ditches and rock check dams leading to a rip-rap outfall. The ditches contained water and the rock check dams appeared to be working properly.

OF-08b (no sign)

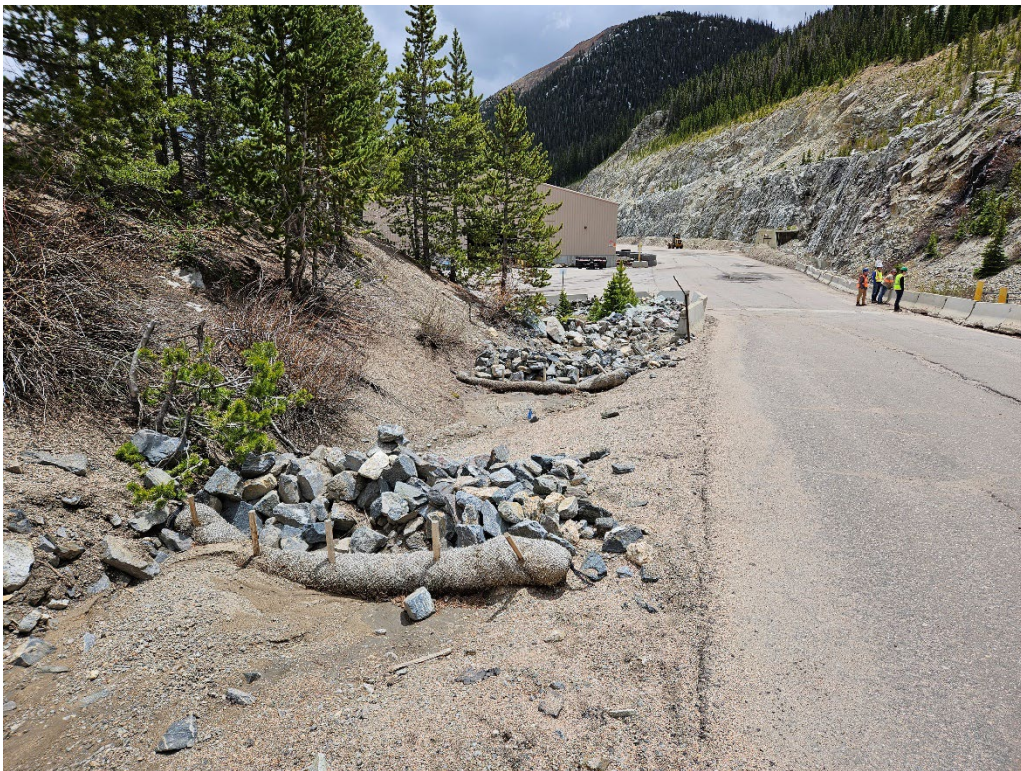
OF-8c: BMP's at this outfall location consist of a ditch with a series of rock check dams and straw waddles leading to a rip-rap outfall. The ditch and sedimentation pond contained water and the rock check dams and waddles appeared to be working properly.

OF-08c (damaged sign)

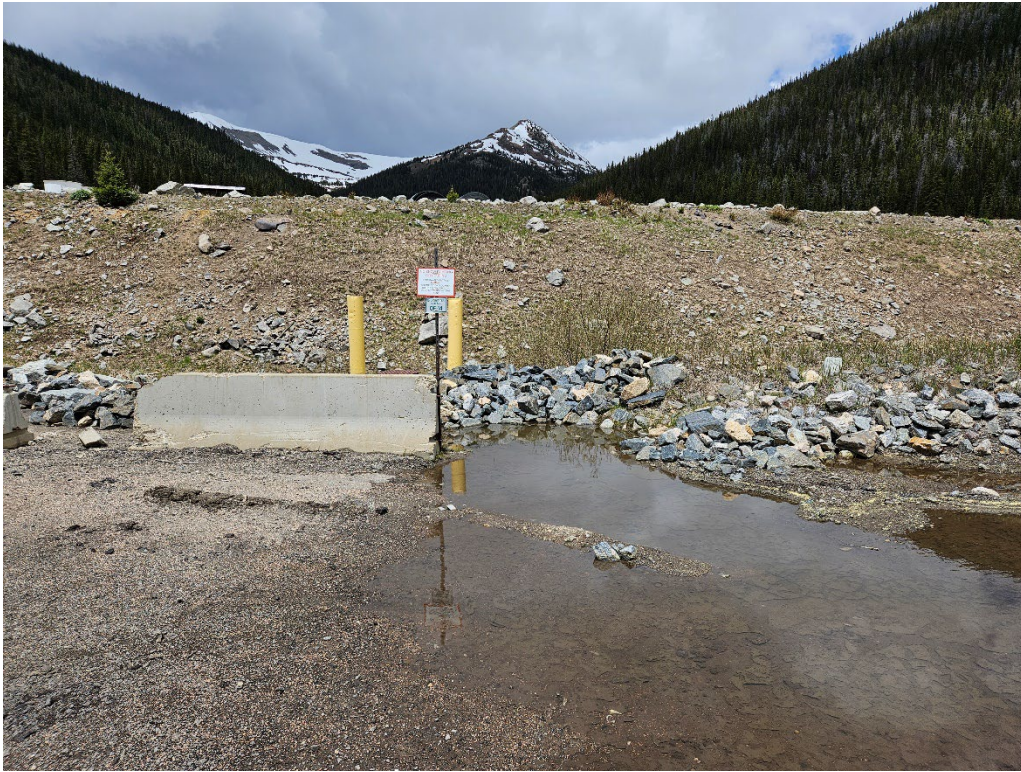
OF-14

OF-14: BMP's at this outfall location consist of a ditch with a series of rock check dams leading to a rip-rap outfall. The sediment pond contained standing water at the time of the inspection.

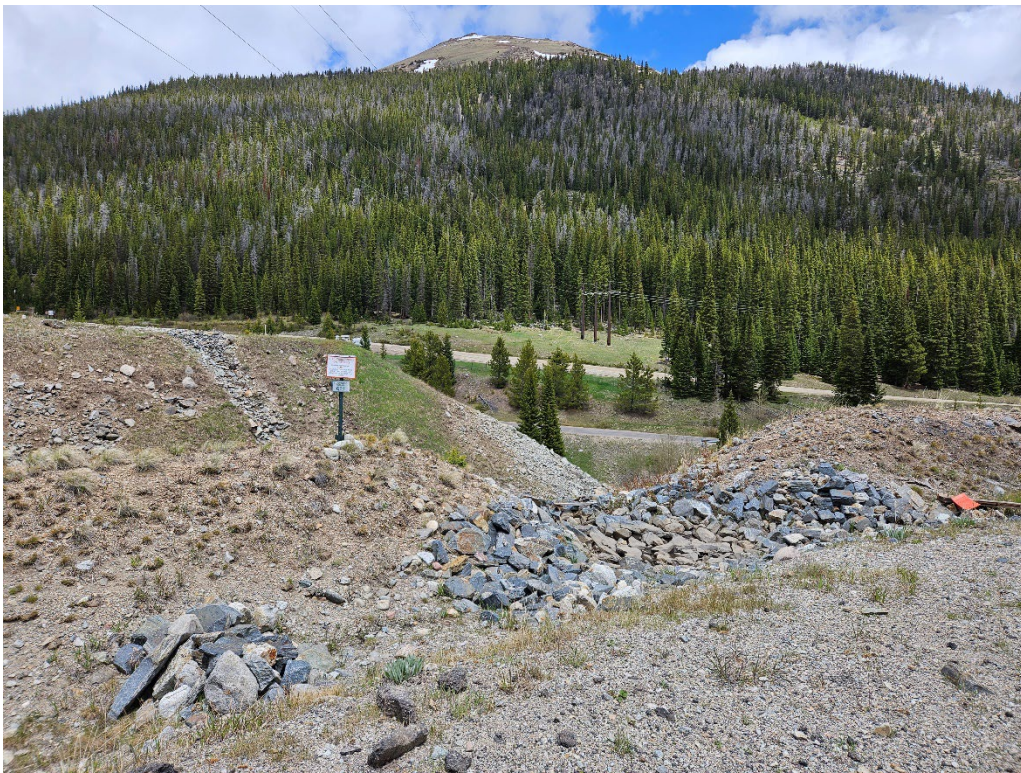
OF-7

OF-7: BMP's at this outfall location consist of rip-rap and rock check dams. The outfall contained a small pool of water and appeared to be functional and properly constructed.

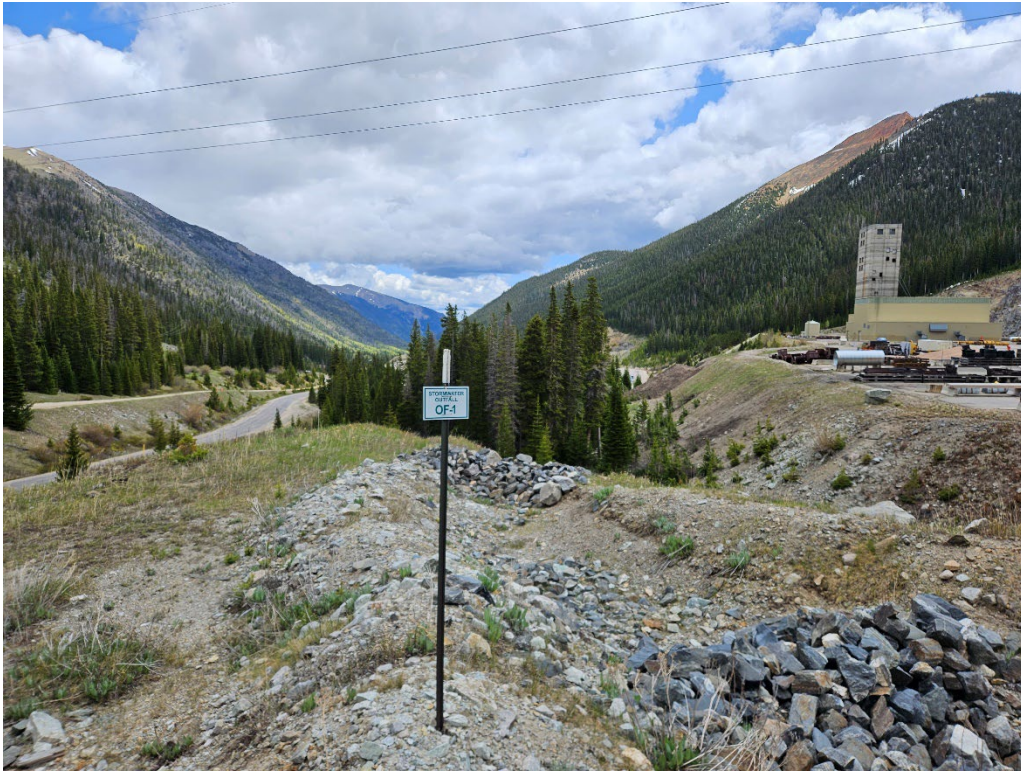
OF-1

OF-1: BMP's at this outfall location consist of a series of rock check dams leading to a rip-rap outfall. The outfall was dry, but appeared to be functional and properly constructed.

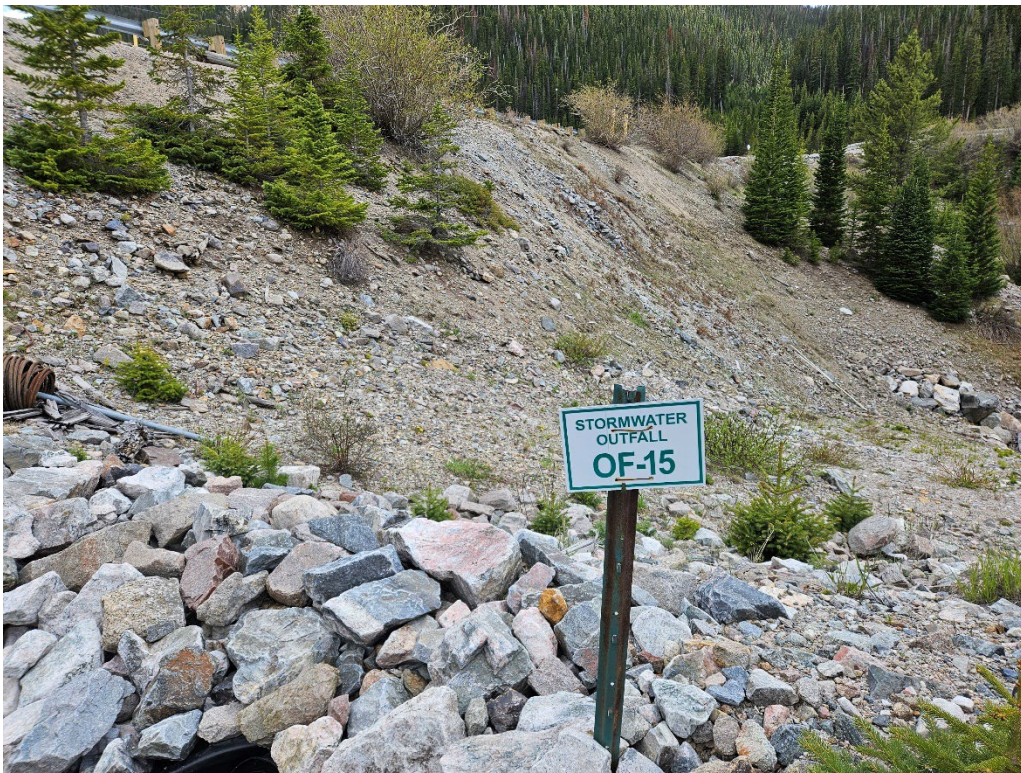
OF-15

OF-15: BMP's at this outfall location consist of a series of rock check dams leading to a sedimentation pond above a culvert. The sediment pond contained standing water. The outfall was dry and appeared to be functional and properly constructed.

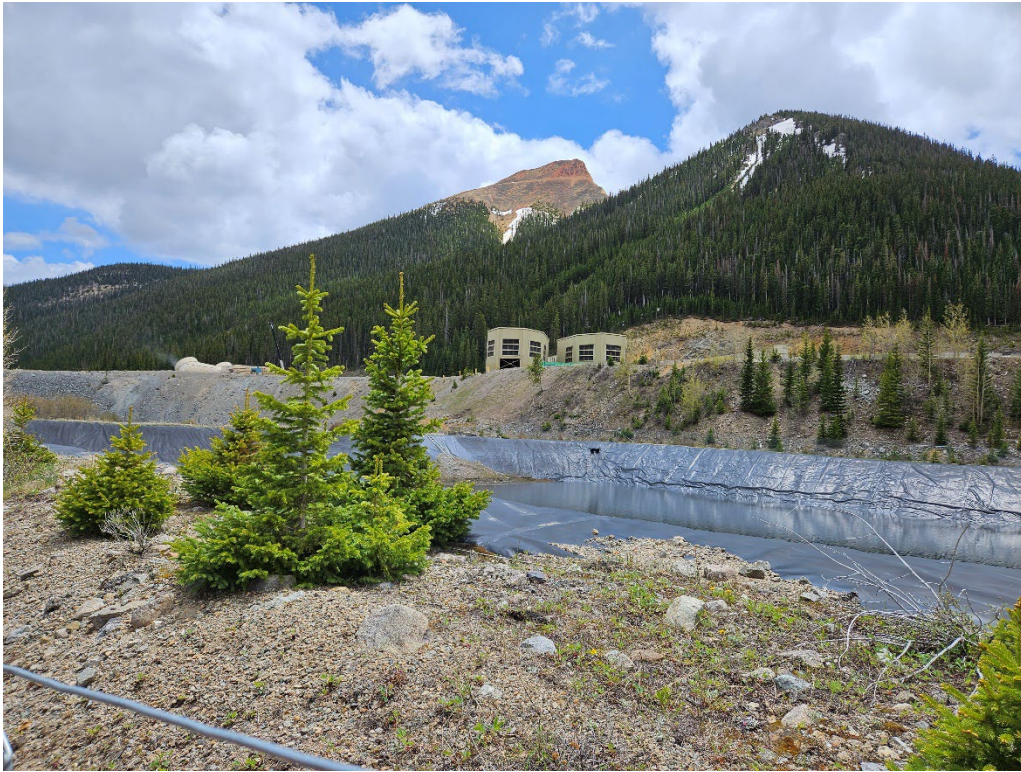
Pond 1.2 is a 26 acres-foot, subgrade lined pond located southeast of the Mine entrance gate. The pond was originally designed as a mine water sediment pond. The pond was repurposed in TR-08 for the storage of HDS generated at the URAD water treatment plant. The pond has been maintained in an inactive state since 1999. The Pond 1.2 liner contain stormwater at the time of the inspection. The liner and the inlet and outlet structures appeared to be working as designed and in accordance with the approved as-built drawings. The chain-link fence surrounding the pond was repaired in 2019. Sections of the fence were observed to be damaged by the snow load over the past winters. The Division recommends the damaged sections of fence are repaired by the Operator.

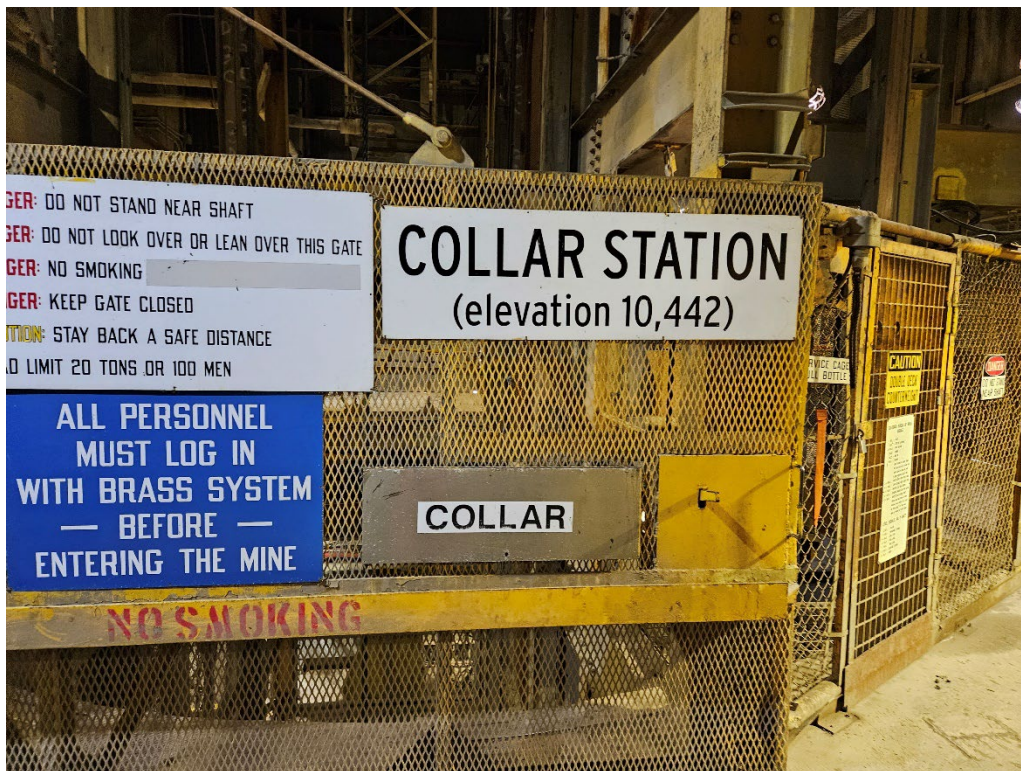
#2 Shaft Collar

The #2 Shaft is the main shaft for access to the underground mine workings. The service and man cages are located in the shaft and are controlled by the hoist house operator. The shaft also serves as the main air inlet for the mine. The #1 and #3 shafts were previously used as air outlet shafts, but are now passive air inlets. The #5 shaft is the current air outlet shaft of the underground mine operations.

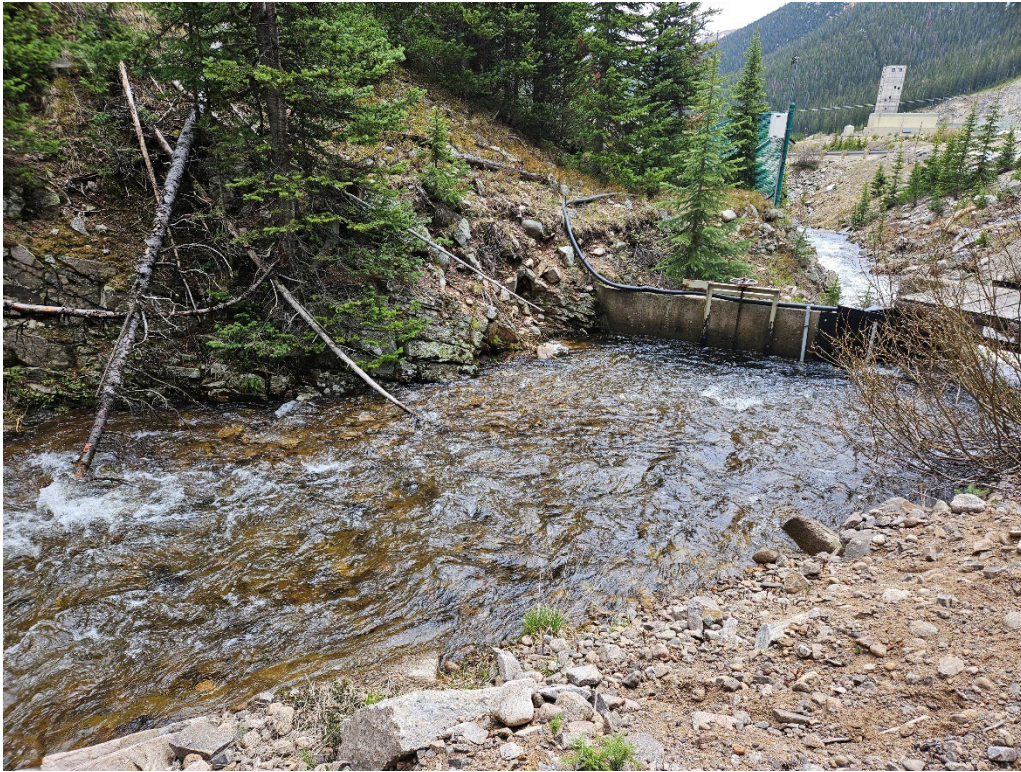
CC-10

Surface water compliance points; CC-10, CC-30 and BG-20 were observed. No problems were noted at the compliance points.

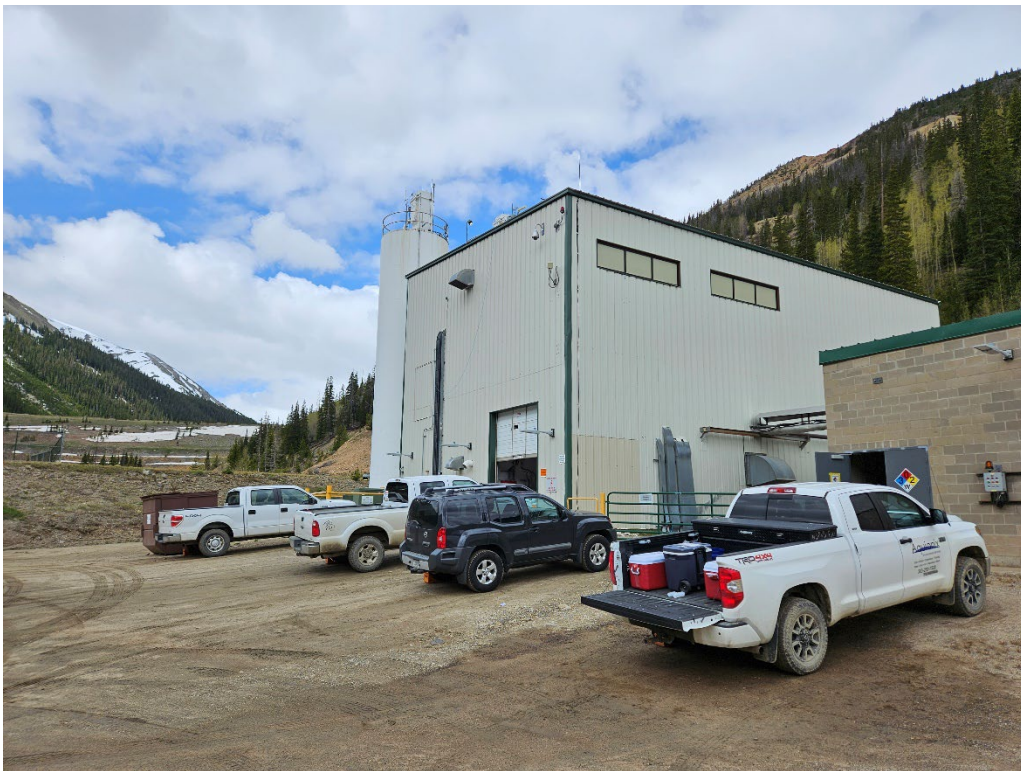
Mine water is collected underground and pumped to settlers to remove solids. The mine water is pumped to the surface through the #2 Shaft. Once on the surface, the water is pumped to a holding tank which is conveyed to the URAD water treatment plant (WTP) via 12" and 14" HDPE pipelines. The pipelines are cleaned weekly, alternating lines, with "pigs" which are pushed through the lines with pressure from a surge tank to scour and reduce scaling in the pipes. The water sent to the URAD WTP is delivered to the Buffer Pond (Pond 1) where it is held until pumped into the treatment system. The treated water is discharged under CDPS permit #CO-0041467. The resulting solids from the treatment system are piped to sludge cells east of the WTP. The dry solids are disposed of in an approved solid waste landfill. The URAD WTP and associated facilities and the entire length of the mine water pipelines were incorporated into the permit boundary under AM-07 in 2020.
