MINERALS PROGRAM INSPECTION REPORT
PHONE: (303) 866-3567

MINE NAME: Young Ranch Resource Quarry	MINE/PROSPECTING ID#: M-2021-009	MINERAL: Granite, granite gneiss gold	COUNTY: Gilpin
INSPECTION TYPE: Monitoring	WEATHER: Clear	INSP. DATE: June 28, 2023	INSP. TIME: 09:00
OPERATOR: Young Ranch Resource LLC	OPERATOR REPRESENTATIVE: Bob Young	TYPE OF OPERATION: 112c - Construction Regular Operation	
REASON FOR INSPECTION: Normal I&E Program	BOND CALCULATION TYPE: None	BOND AMOUNT: \$330,461.00	
DATE OF COMPLAINT: NA	POST INSP. CONTACTS: None	JOINT INSP. AGENCY: None	
INSPECTOR(S): Brock Bowles	INSPECTOR'S SIGNATURE:

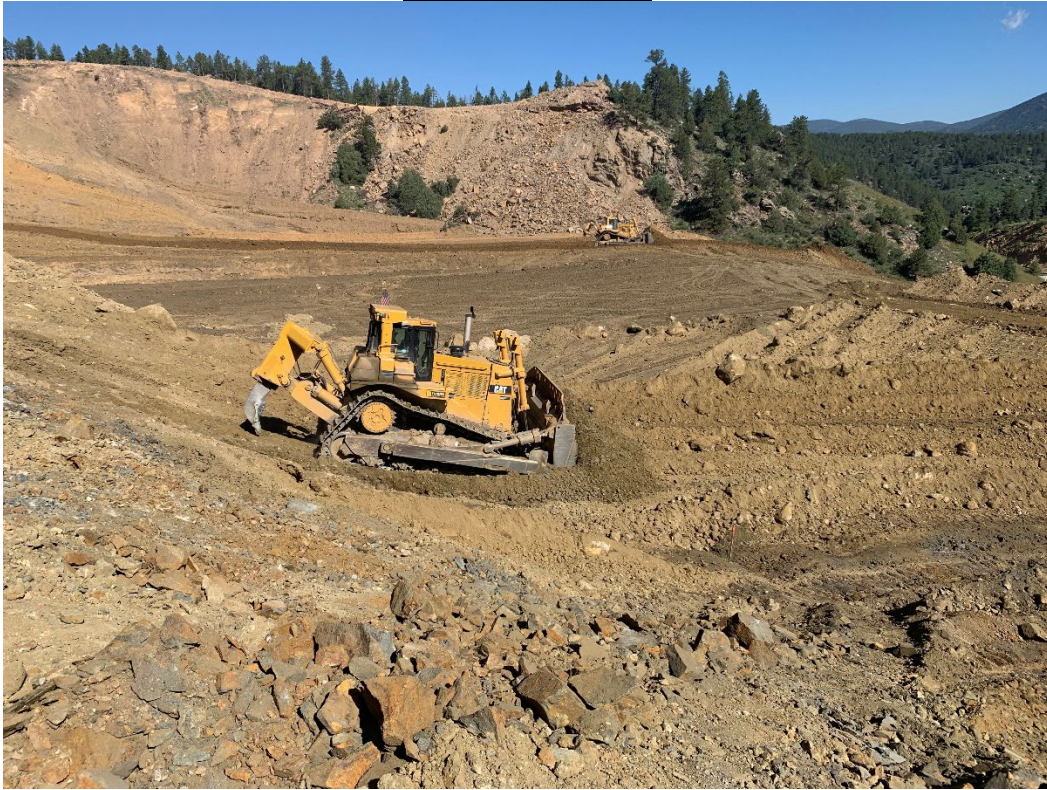
The main facilities pad area was being constructed in a drainage on the south side of the Central City Parkway at about mile marker 2.7. The south side of the pad area is being cut into the hillside. An excavator is removing the loose material from the hillside exposing a rock substrate. The rock will be blasted to expand the utilities pad to the south. The material cut from the hillside is pushed north by two dozers (photo 1) to fill in the area adjacent to the CCP. A ditch and collection basin were in place along the CCP to control storm water runoff.

Photo 1 – Dozers pushing material south to north to create facilities pad

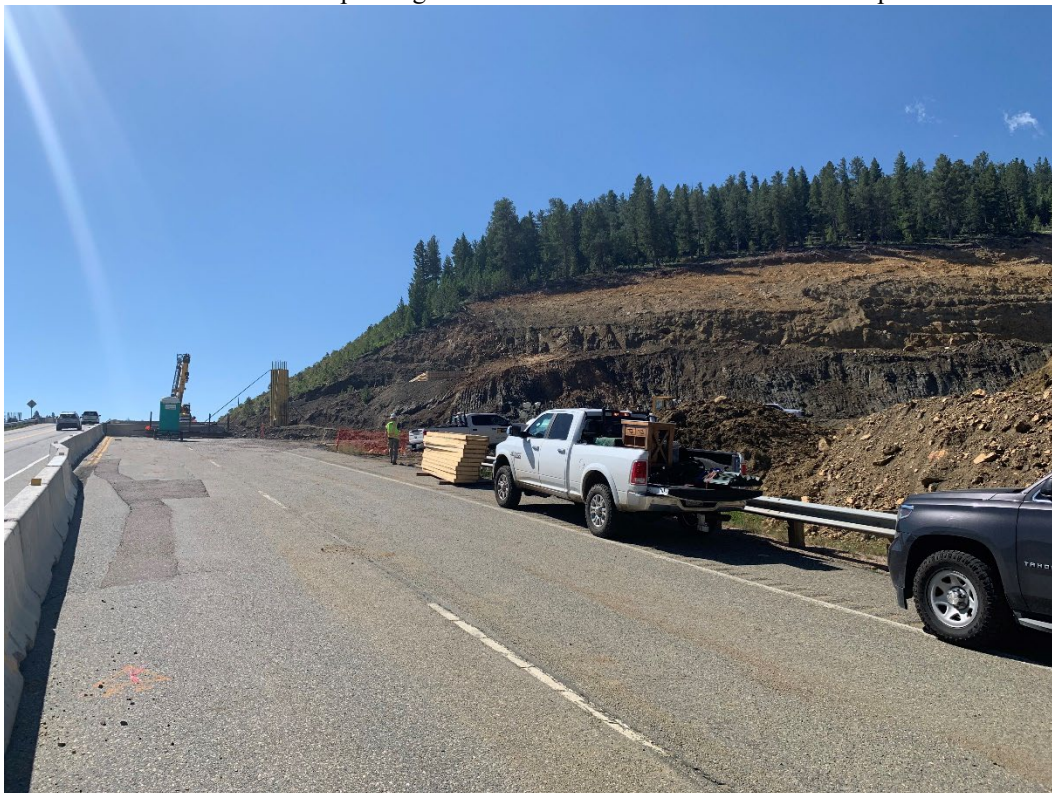
The two southbound lanes of the Central City Parkway were blocked off and marked as a construction zone (photo 2). The lanes were being used for staging material and parking for the mine development.

Photo 2 – Southbound lanes of CCP closed for staging and parking during mine development

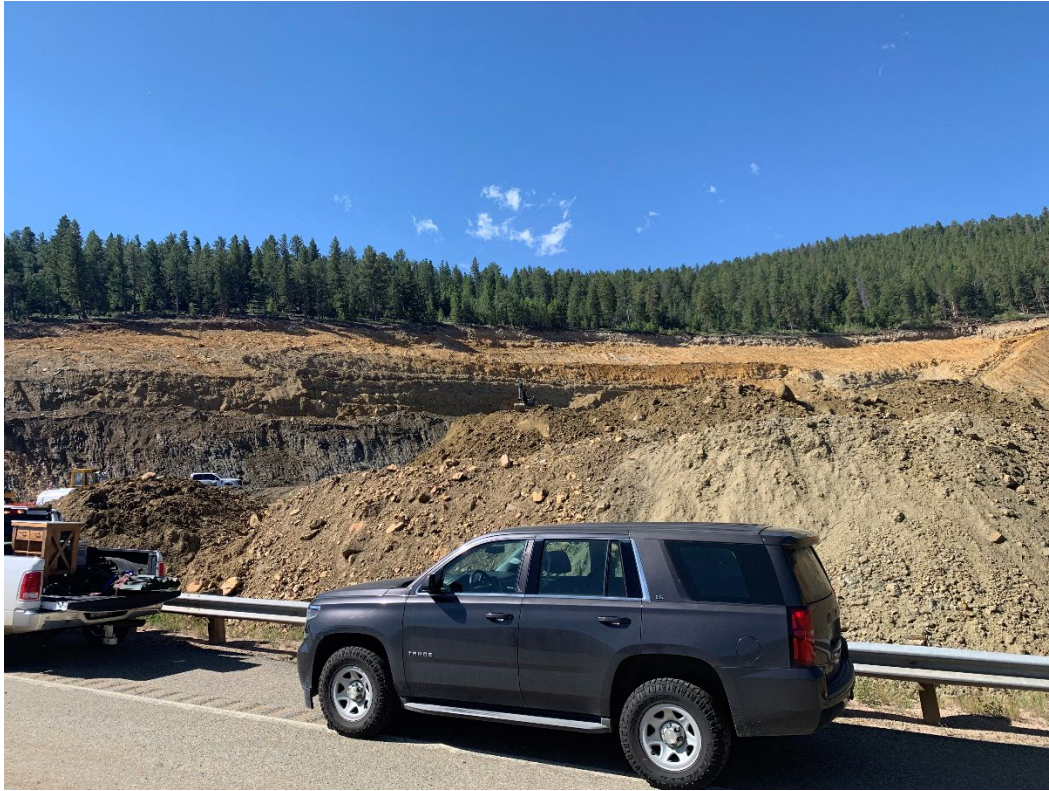
Photo 3 – Overview of eastern side of development area

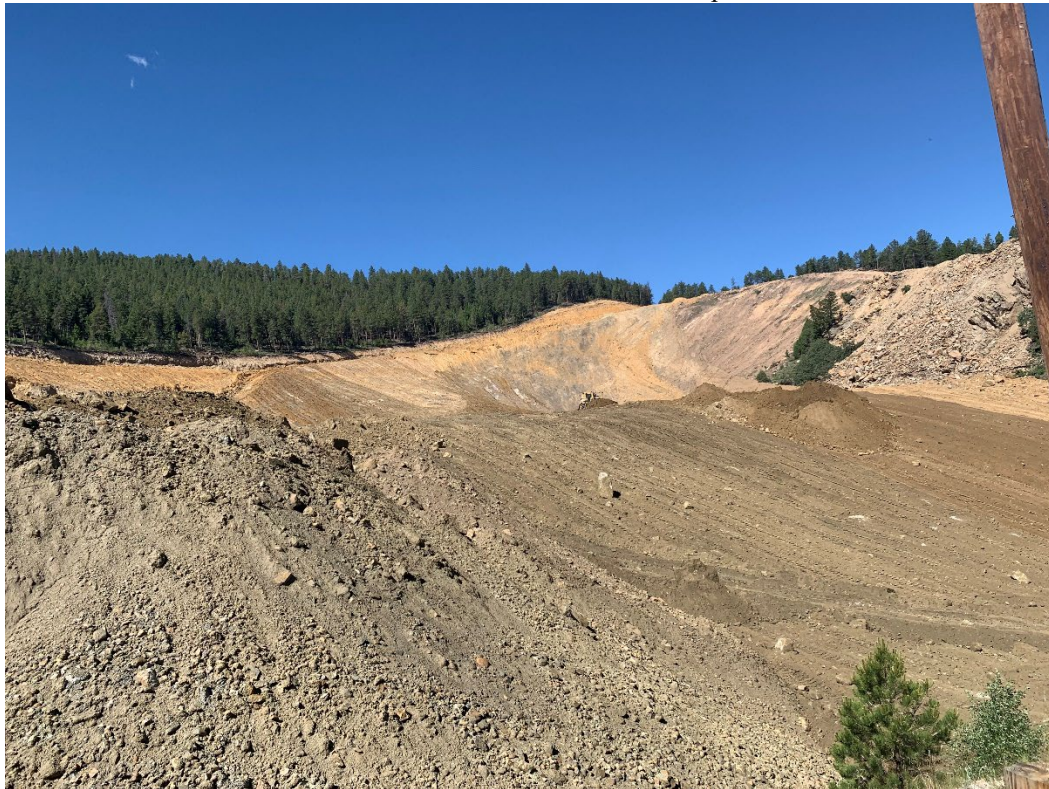
Photo 4 – Overview of western side of development area
