File: May 2023 Monitoring Summary

Date: June 30, 2023

**Reference: May 2023 Geotechnical Monitoring Summary Pikeview Quarry**

PIKEVIEW QUARRY SLOPE  
MONITORING

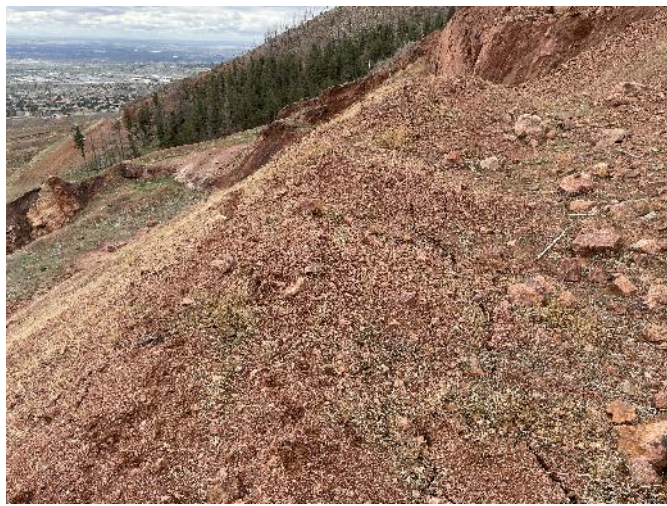
6. Cracking along upper haul road following rain.

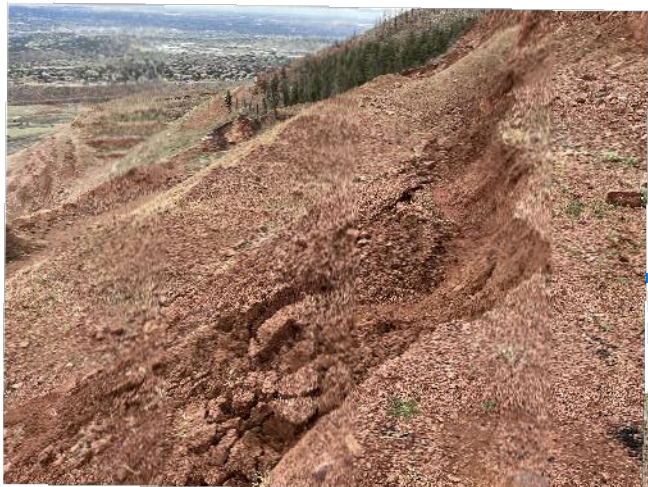
- Surficial slumping and cracking were identified on the loose fill on the upper sections in the previously disturbed areas. These features were located near (within 3 feet of) the surface and are limited to loosely placed angle of repose slopes. Slumping of this nature is expected to occur on these types of slopes following the heavy rains that recently occurred at the site.

5. Sloughing along upper haul road following rain.

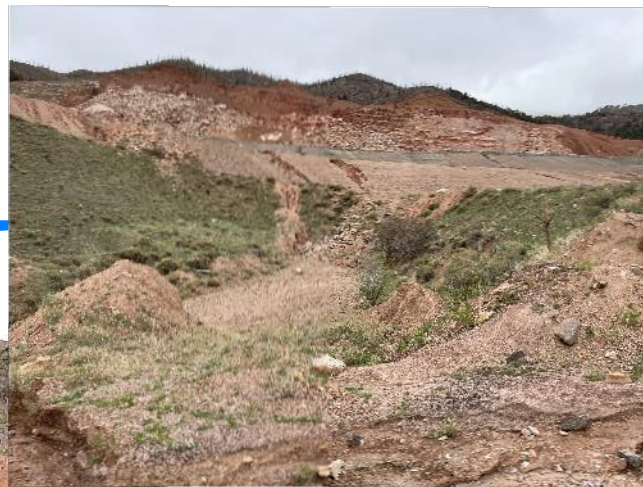
- The slope below the first bench has been placed to the final grade, and this slope was traversed on foot and examined for cracks or signs of instability by Stantec engineers. No cracks or signs of instability were identified.

4. First bench on May 15, following rain event.

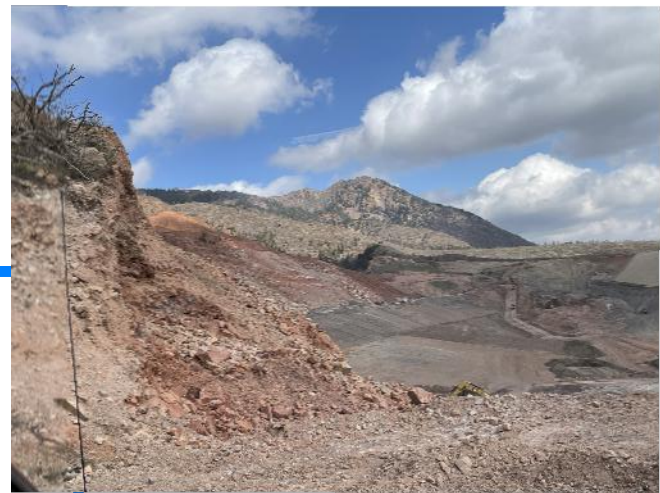
3. First bench on May 10, before rain event.

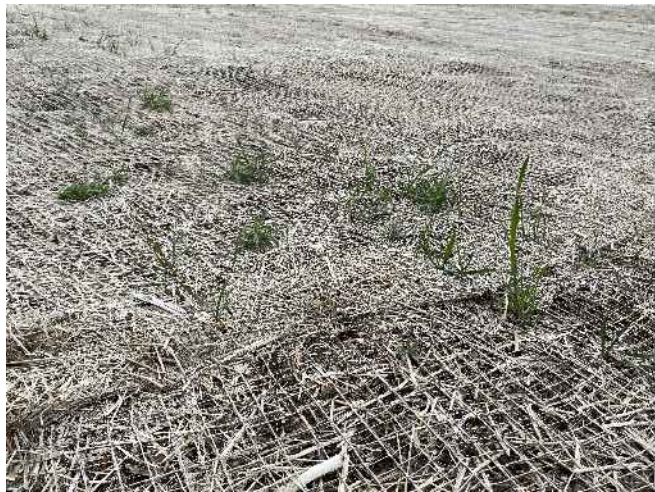
7. Vegetation growing within erosion blanket.

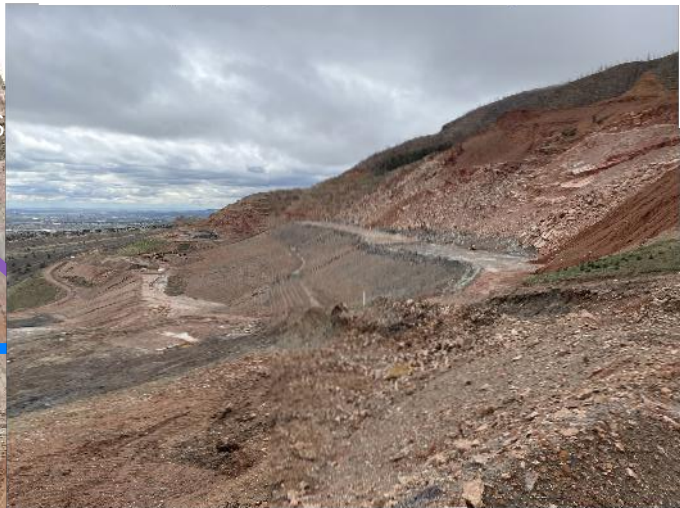
- Rock was being screened, sorted, and stockpiled as riprap for use as erosion protection in the channels.
- The culvert inlet was blocked by debris during the May 10-12 rain event. Water appears to have temporarily pooled before draining. Riverbend has partially cleared the debris, but access limitations and supports within the culvert inhibit clearing all the debris. Riverbend has procured a pump and will begin pumping operations if any water collects behind the culvert. Riverbend inspects the culvert for ponded water following rain events, and should any water be observed, it will be removed using pumps. Following the May 10-12 rain event, an insufficient amount of water remained after the rain event to warrant draining the basin using pumps.

2. Pit floor on May 15, following rain event.

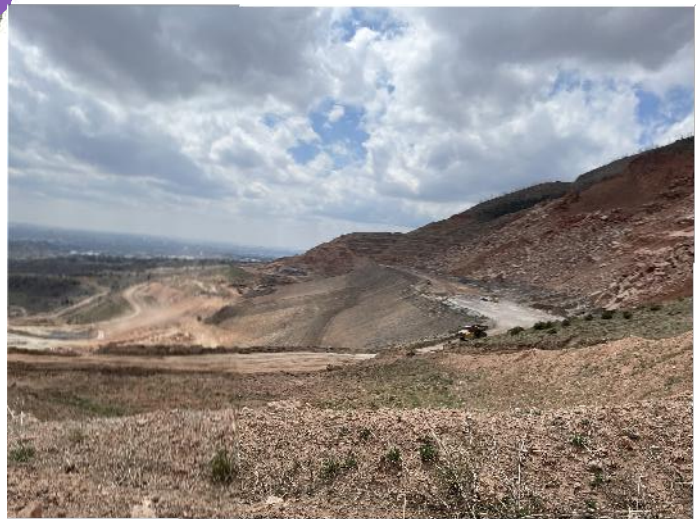
1. Pit floor on May 10, before rain event.

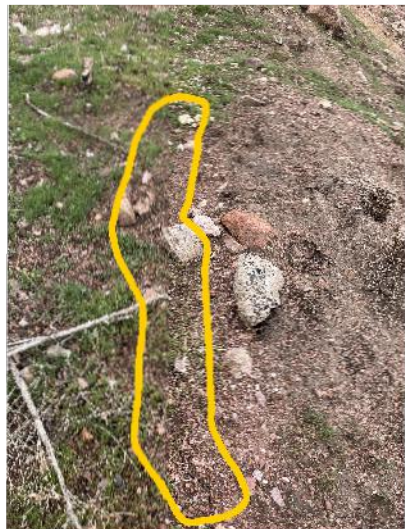
- Known cracks were monitored for changes. The hummocky field in the area immediately above the southern extent of the slide shows evidence of previous cracking. A fresh hairline crack was found immediately (approximately 20 feet south) next to the slide area, and the crack ran parallel to the slide area. Cracking of this kind and in this area was expected from the May 10-12 rain event and is addressed in the buttress design which specifically stabilizes these movements. The slide has not been reactivated, these cracks are alongside and like the older cracks in this area.

8. Hairline crack on the south end.

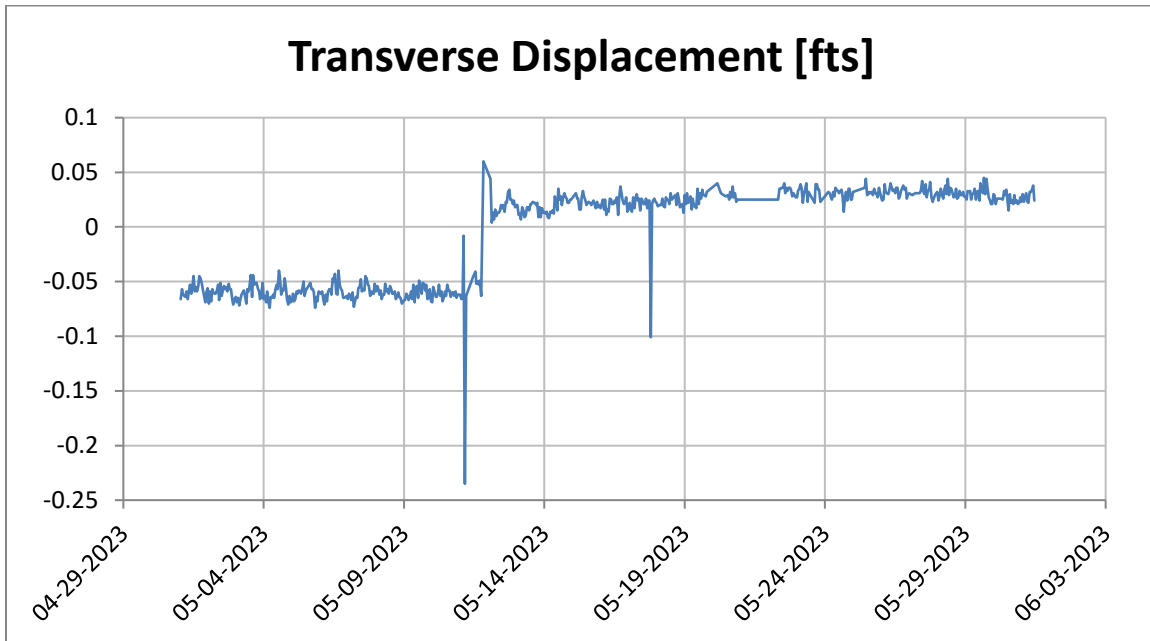
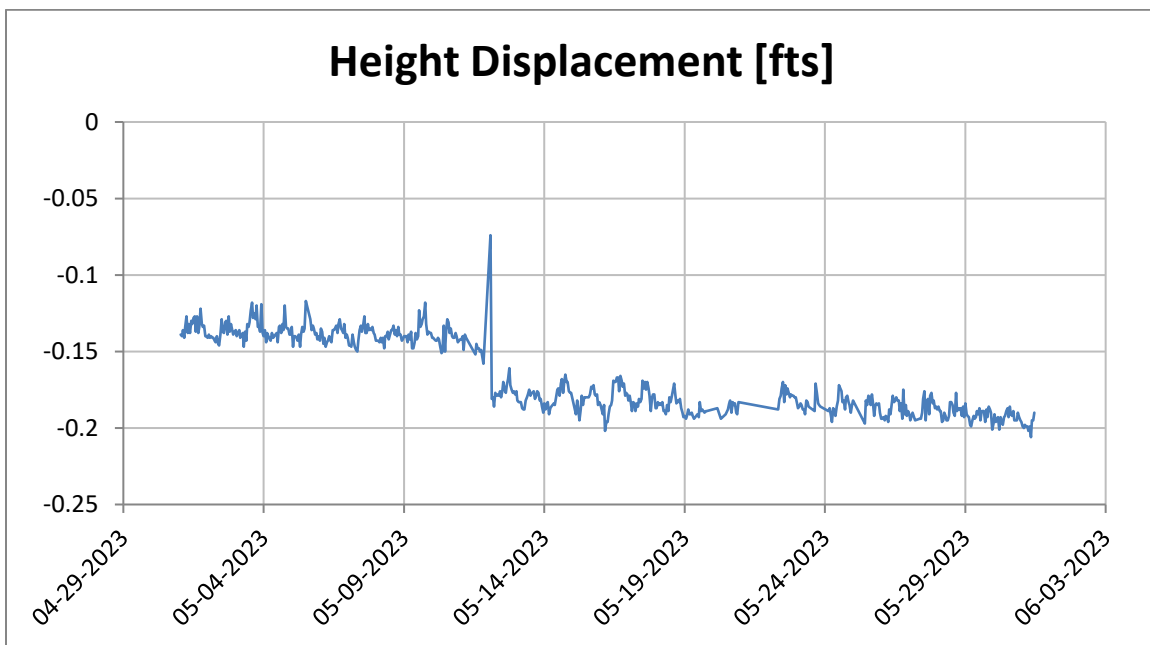
## Prism BR1

1. Survey accuracy is +/-0.016 feet.
2. Alert threshold is +/-0.35 feet.
3. Transverse displacement is in the horizontal direction. Positive direction means closer to the robotic station.
4. Height displacement is in the vertical direction. Positive direction means higher in elevation.
5. Prism records slope creep movements with slow velocity.

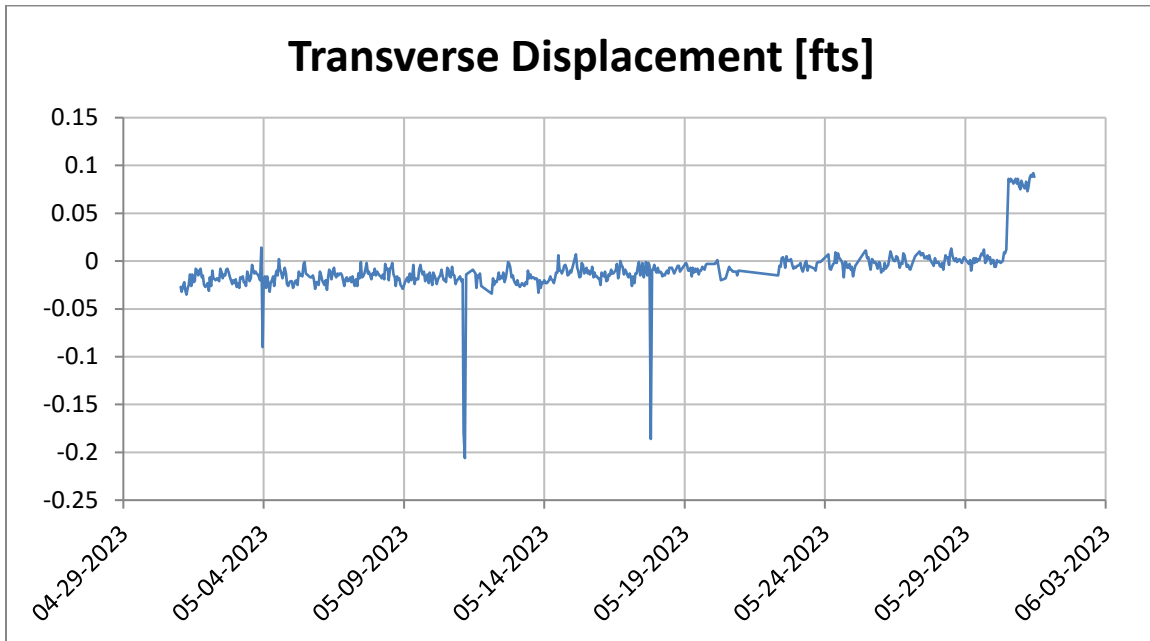
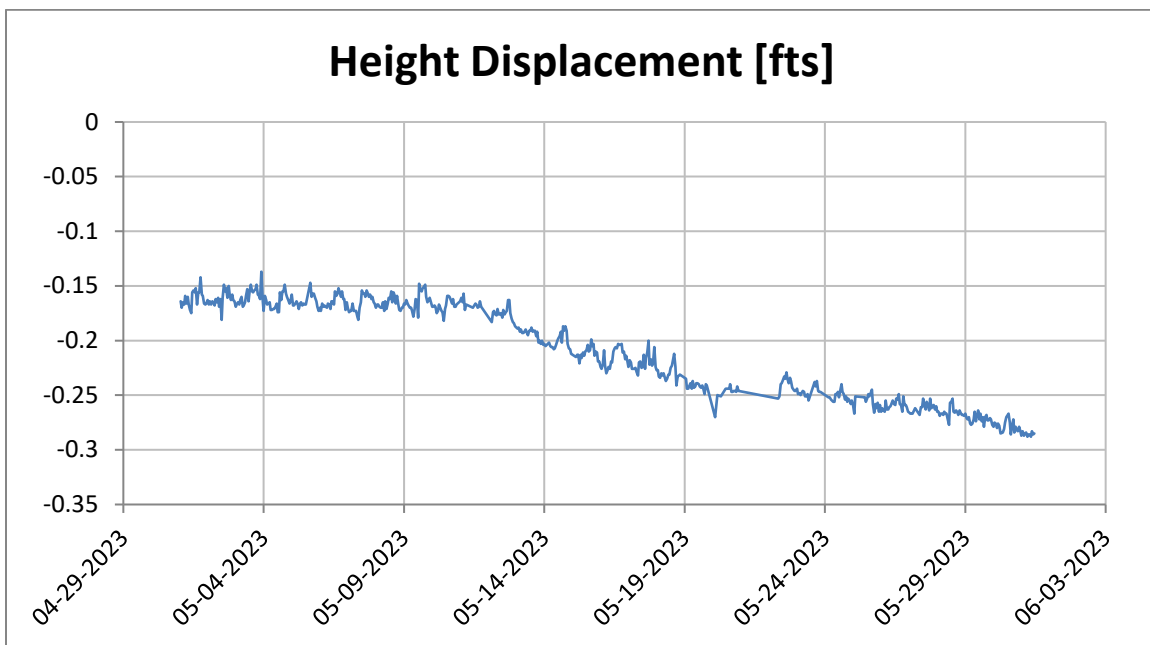
## Prism BR2

1. Survey accuracy is  $\pm 0.016$  feet.
2. Alert threshold is  $\pm 0.35$  feet.
3. Transverse displacement is in the horizontal direction. Positive direction means closer to the robotic station.
4. Height displacement is in the vertical direction. Positive direction means higher in elevation.
5. Prism previously records slope creep movements with slow velocity.

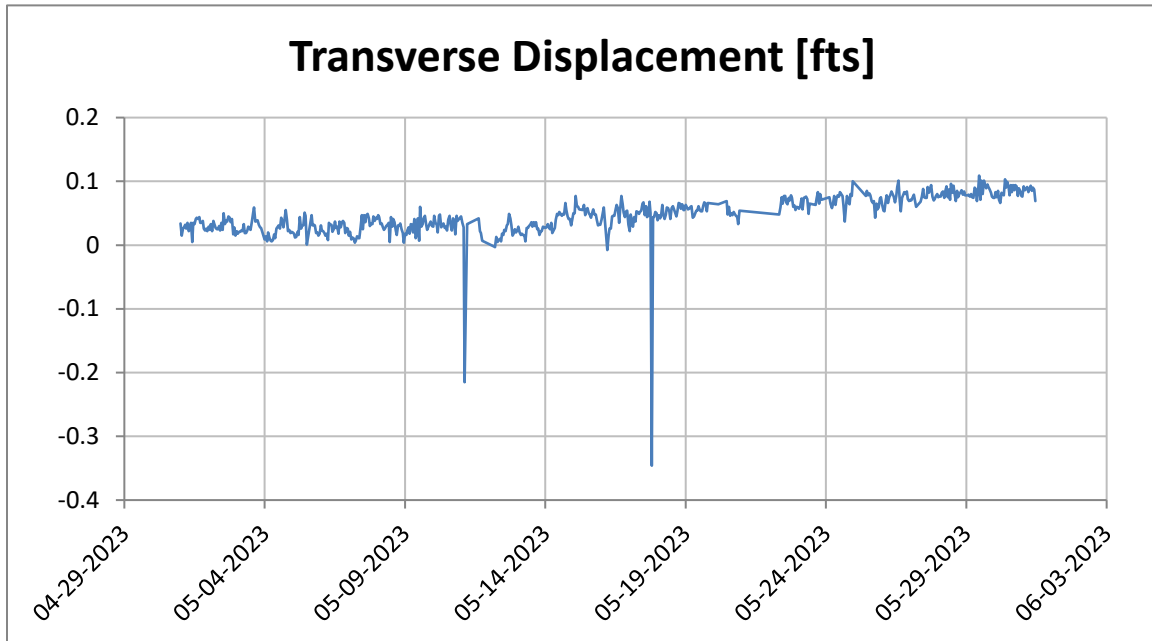
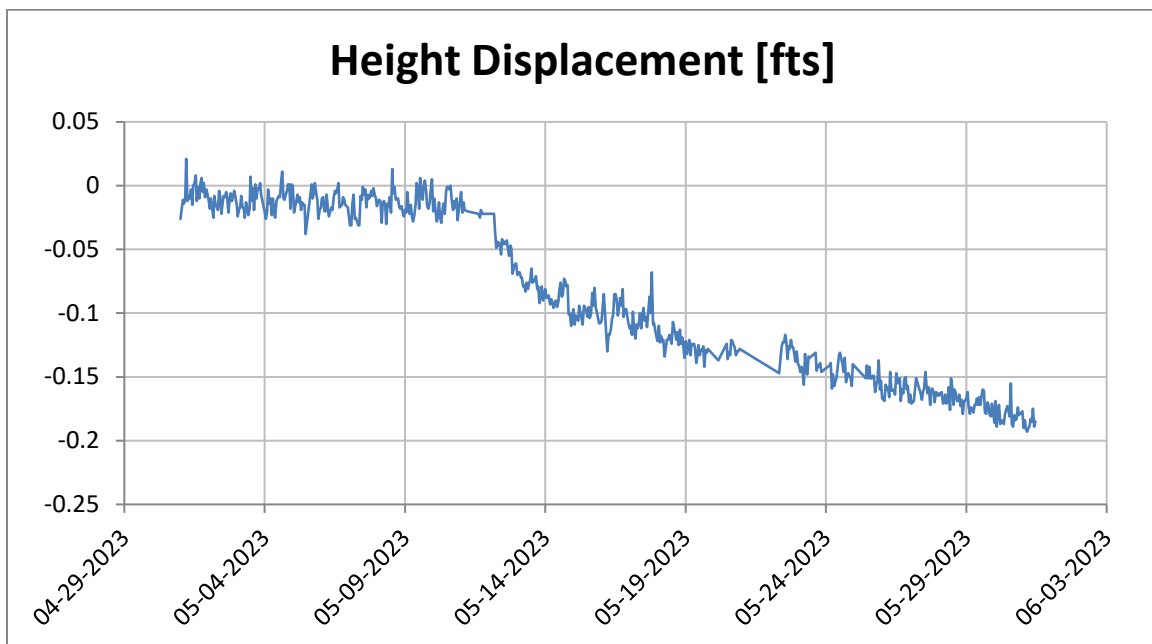
## Prism NP3

1. Survey accuracy is +/-0.016 feet.
2. Alert threshold is +/-0.35 feet.
3. Transverse displacement is in the horizontal direction. Positive direction means closer to the robotic station.
4. Height displacement is in the vertical direction. Positive direction means higher in elevation.
5. Prism records slope creep movements with slow velocity.

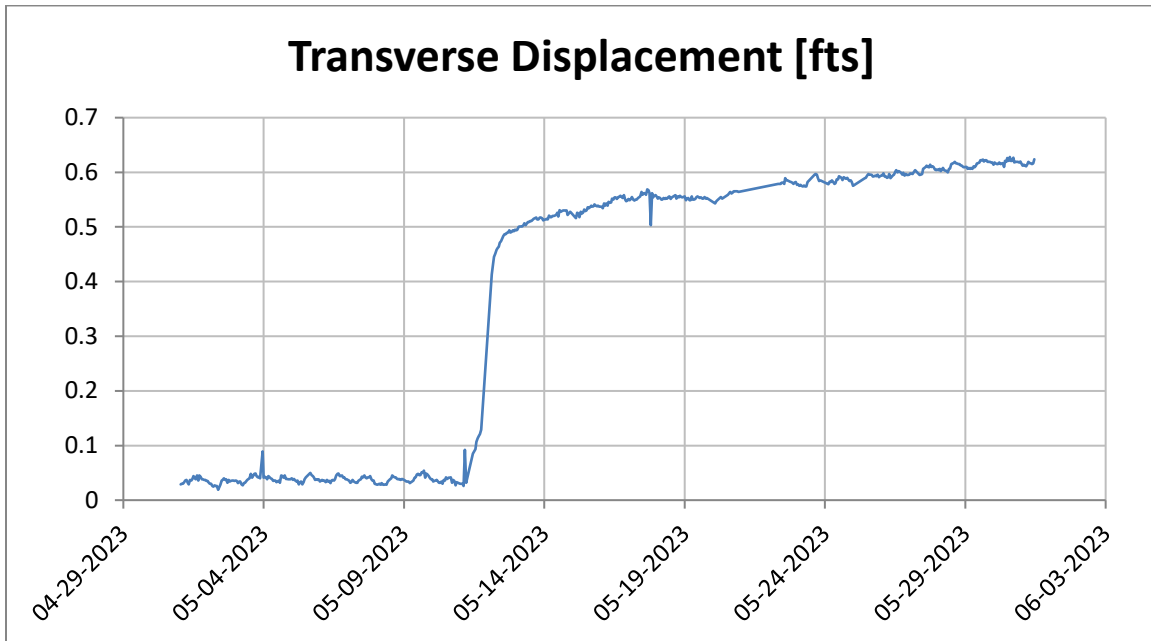
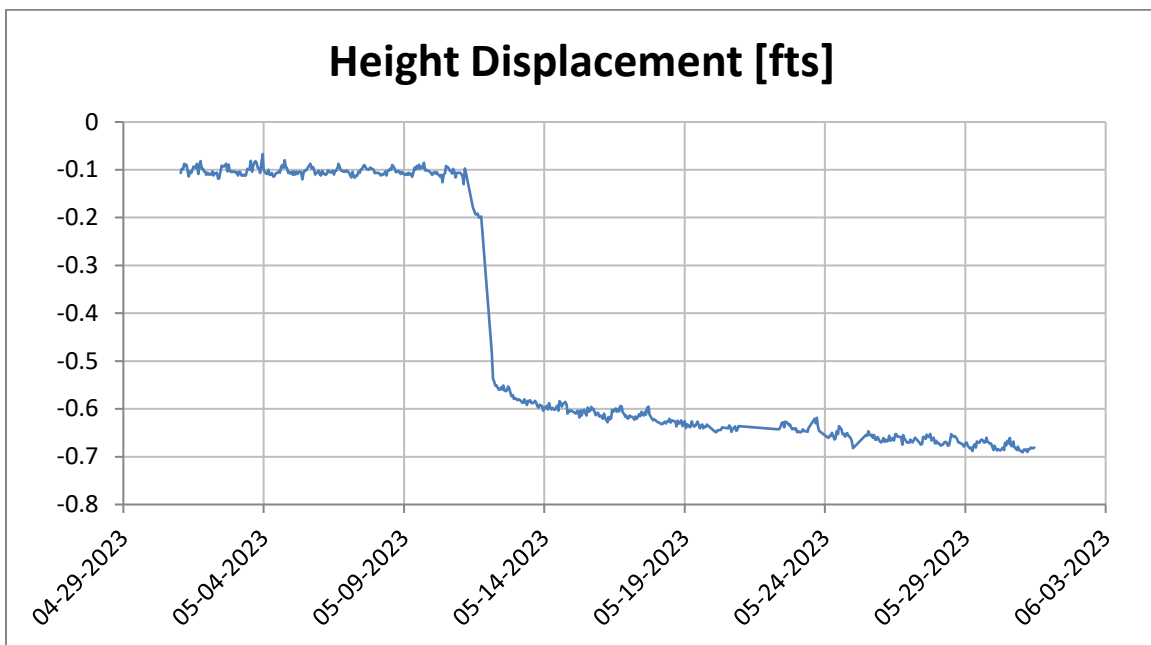
## Prism NP66

1. Survey accuracy is +/-0.016 feet.
2. Alert threshold is +/-0.35 feet.
3. Transverse displacement is in the horizontal direction. Positive direction means closer to the robotic station.
4. Height displacement is in the vertical direction. Positive direction means higher in elevation.
5. Prism records slope creep movements with slow velocity.

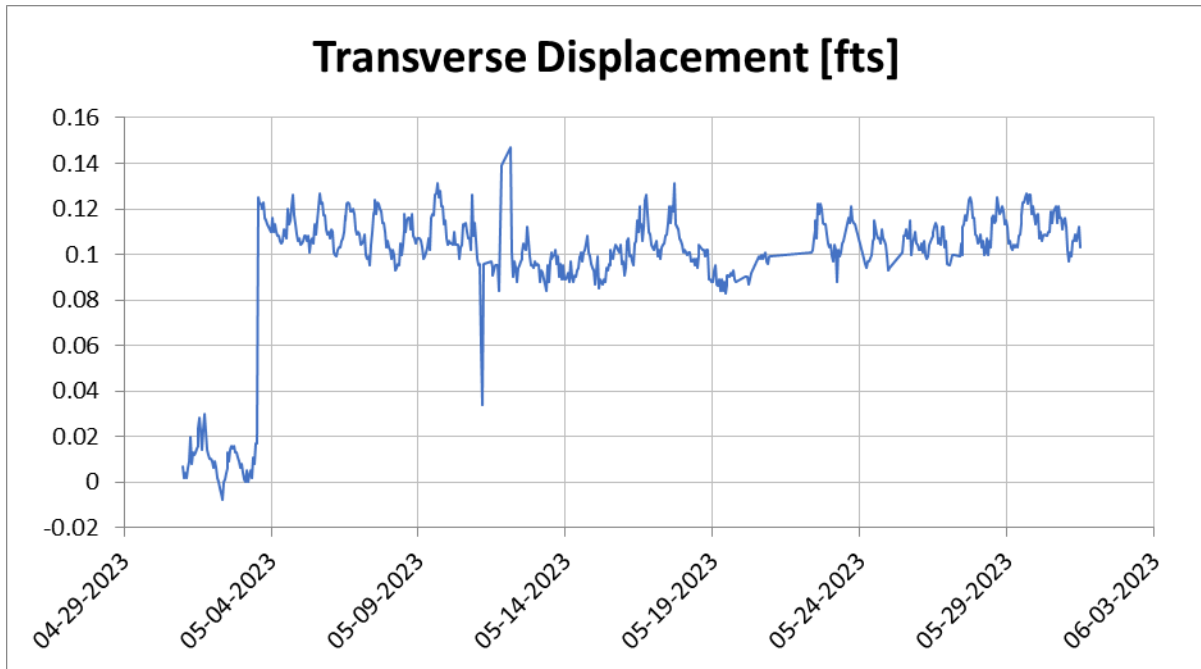
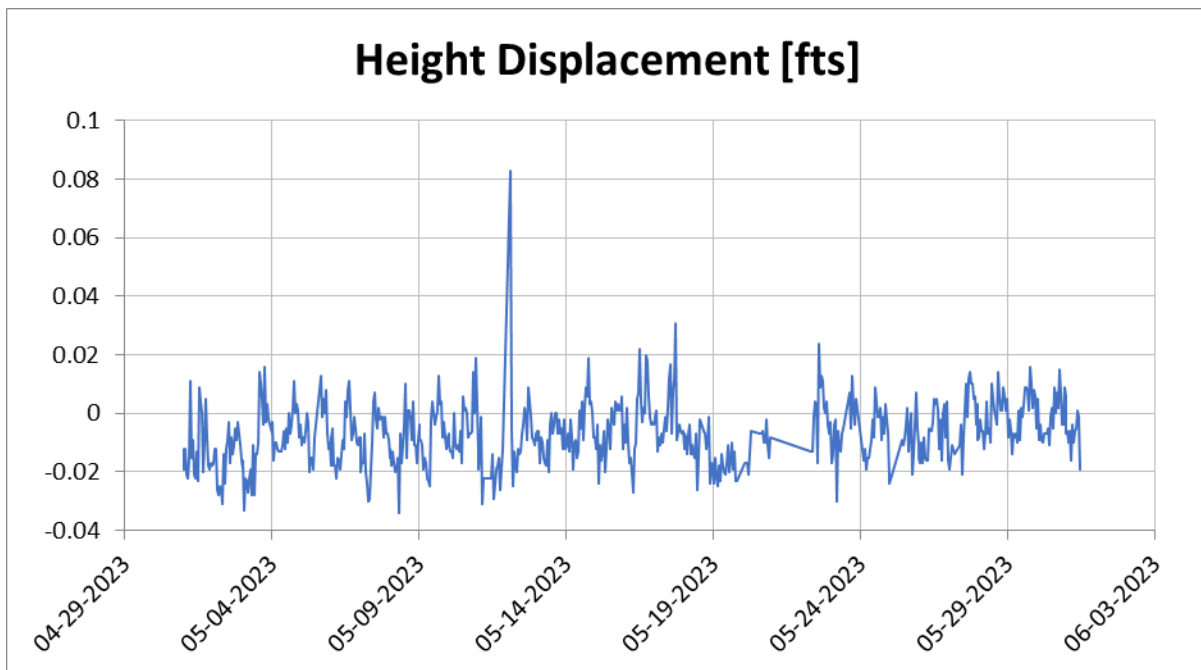
## Prism P33

1. Survey accuracy is +/-0.016 feet.
2. Alert threshold is +/-0.35 feet.
3. Transverse displacement is in the horizontal direction. Positive direction means closer to the robotic station.
4. Height displacement is in the vertical direction. Positive direction means higher in elevation.
5. Movement on P33 believed to have been caused by a shift of the prism support pole.

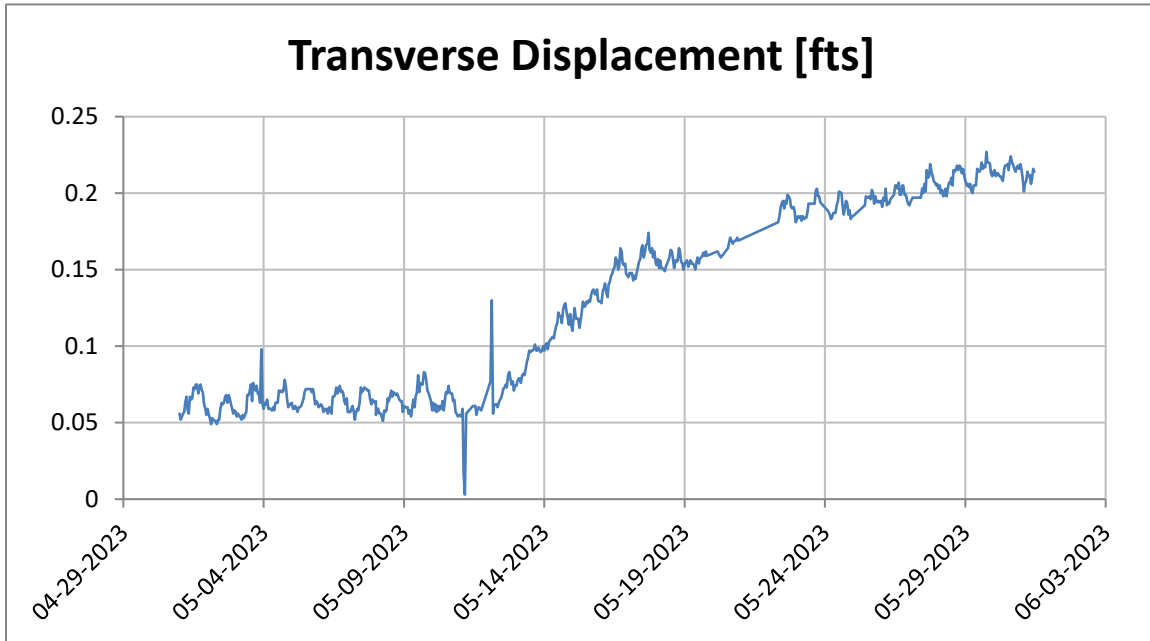
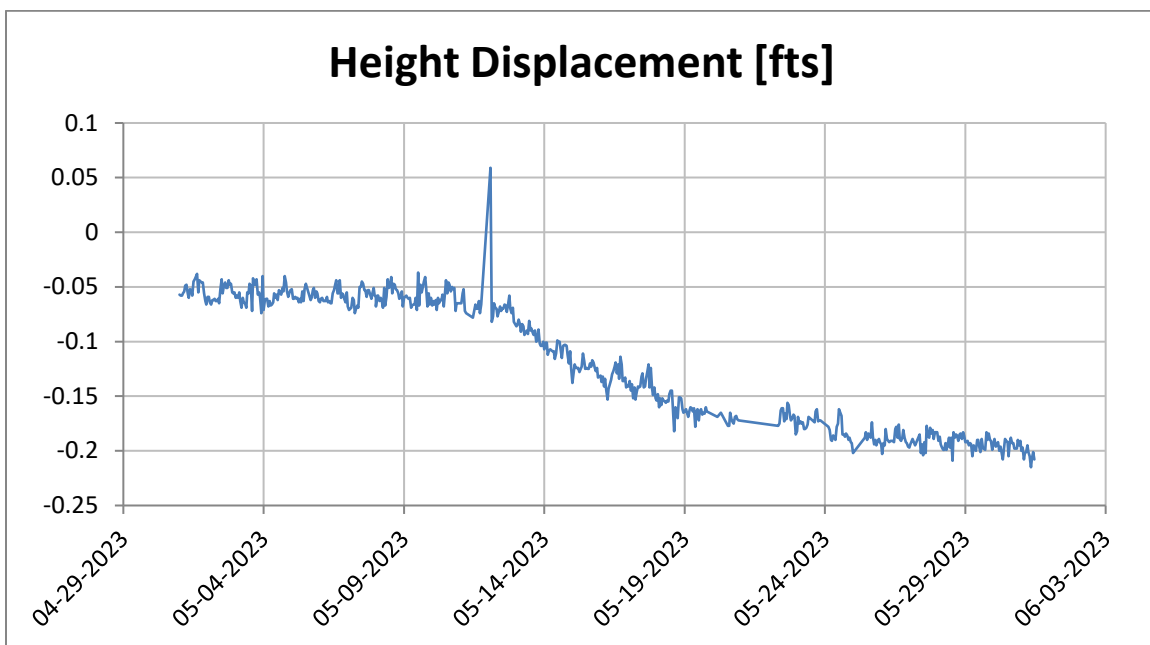
## Prism P69A

1. Survey accuracy is  $\pm 0.016$  feet.
2. Alert threshold is  $\pm 0.35$  feet.
3. Transverse displacement is in the horizontal direction. Positive direction means closer to the robotic station.
4. Height displacement is in the vertical direction. Positive direction means higher in elevation.
5. Prism records slope creep movements at slow velocity.

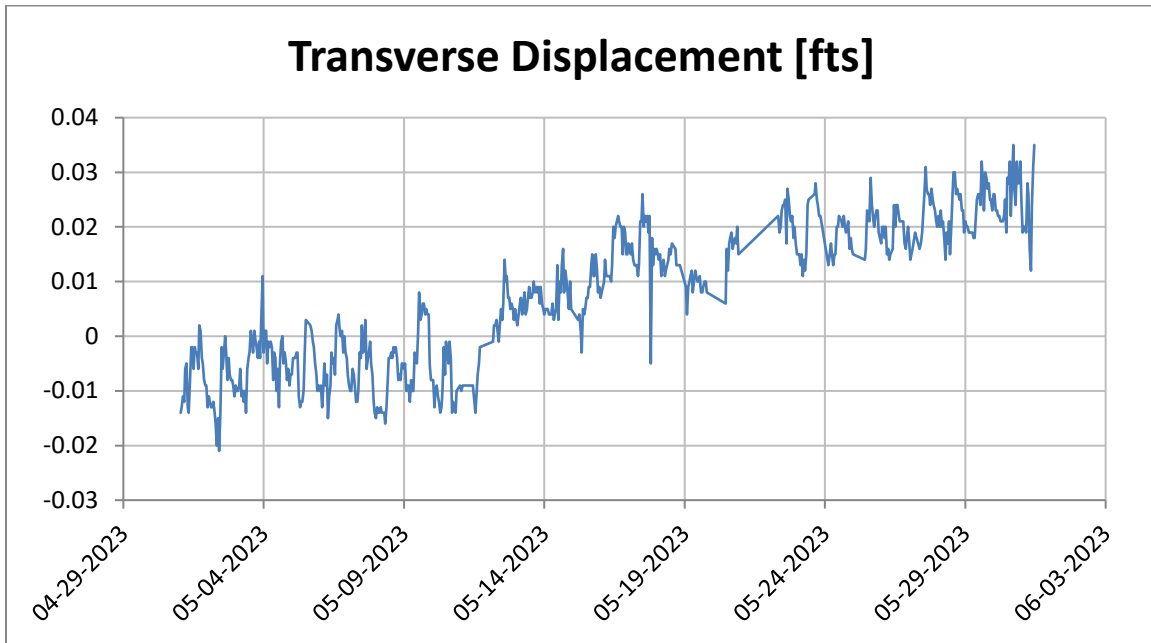
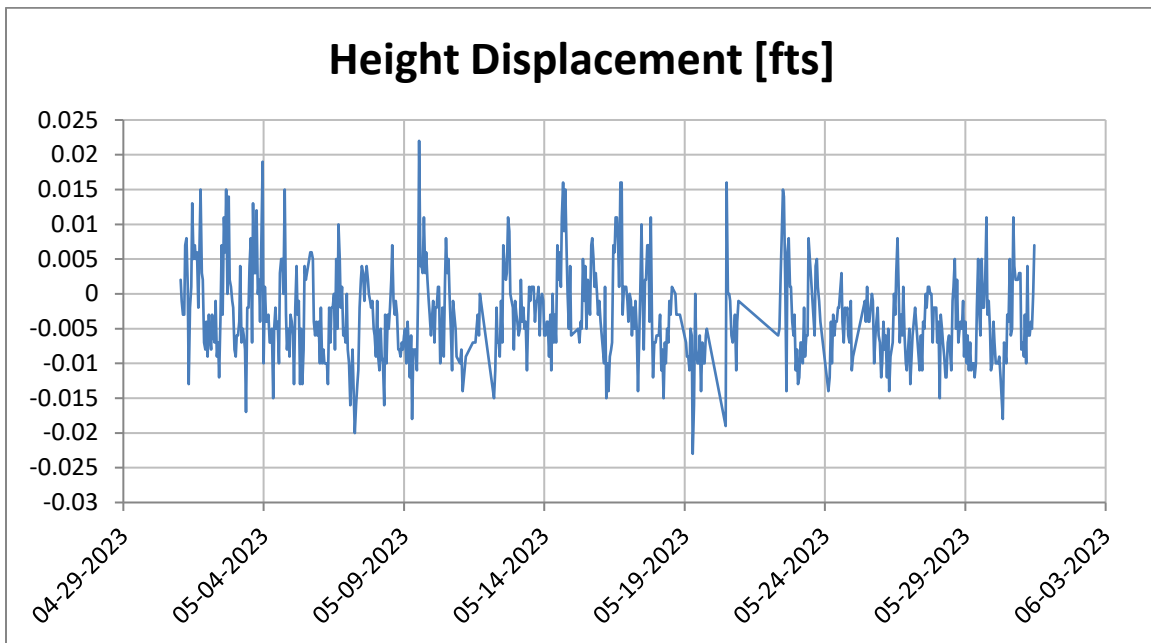
## Prism P70

1. Survey accuracy is +/-0.016 feet.
2. Alert threshold is +/-0.35 feet.
3. Transverse displacement is in the horizontal direction. Positive direction means closer to the robotic station.
4. Height displacement is in the vertical direction. Positive direction means higher in elevation.
5. Prism records slope creep movements at slow velocity.

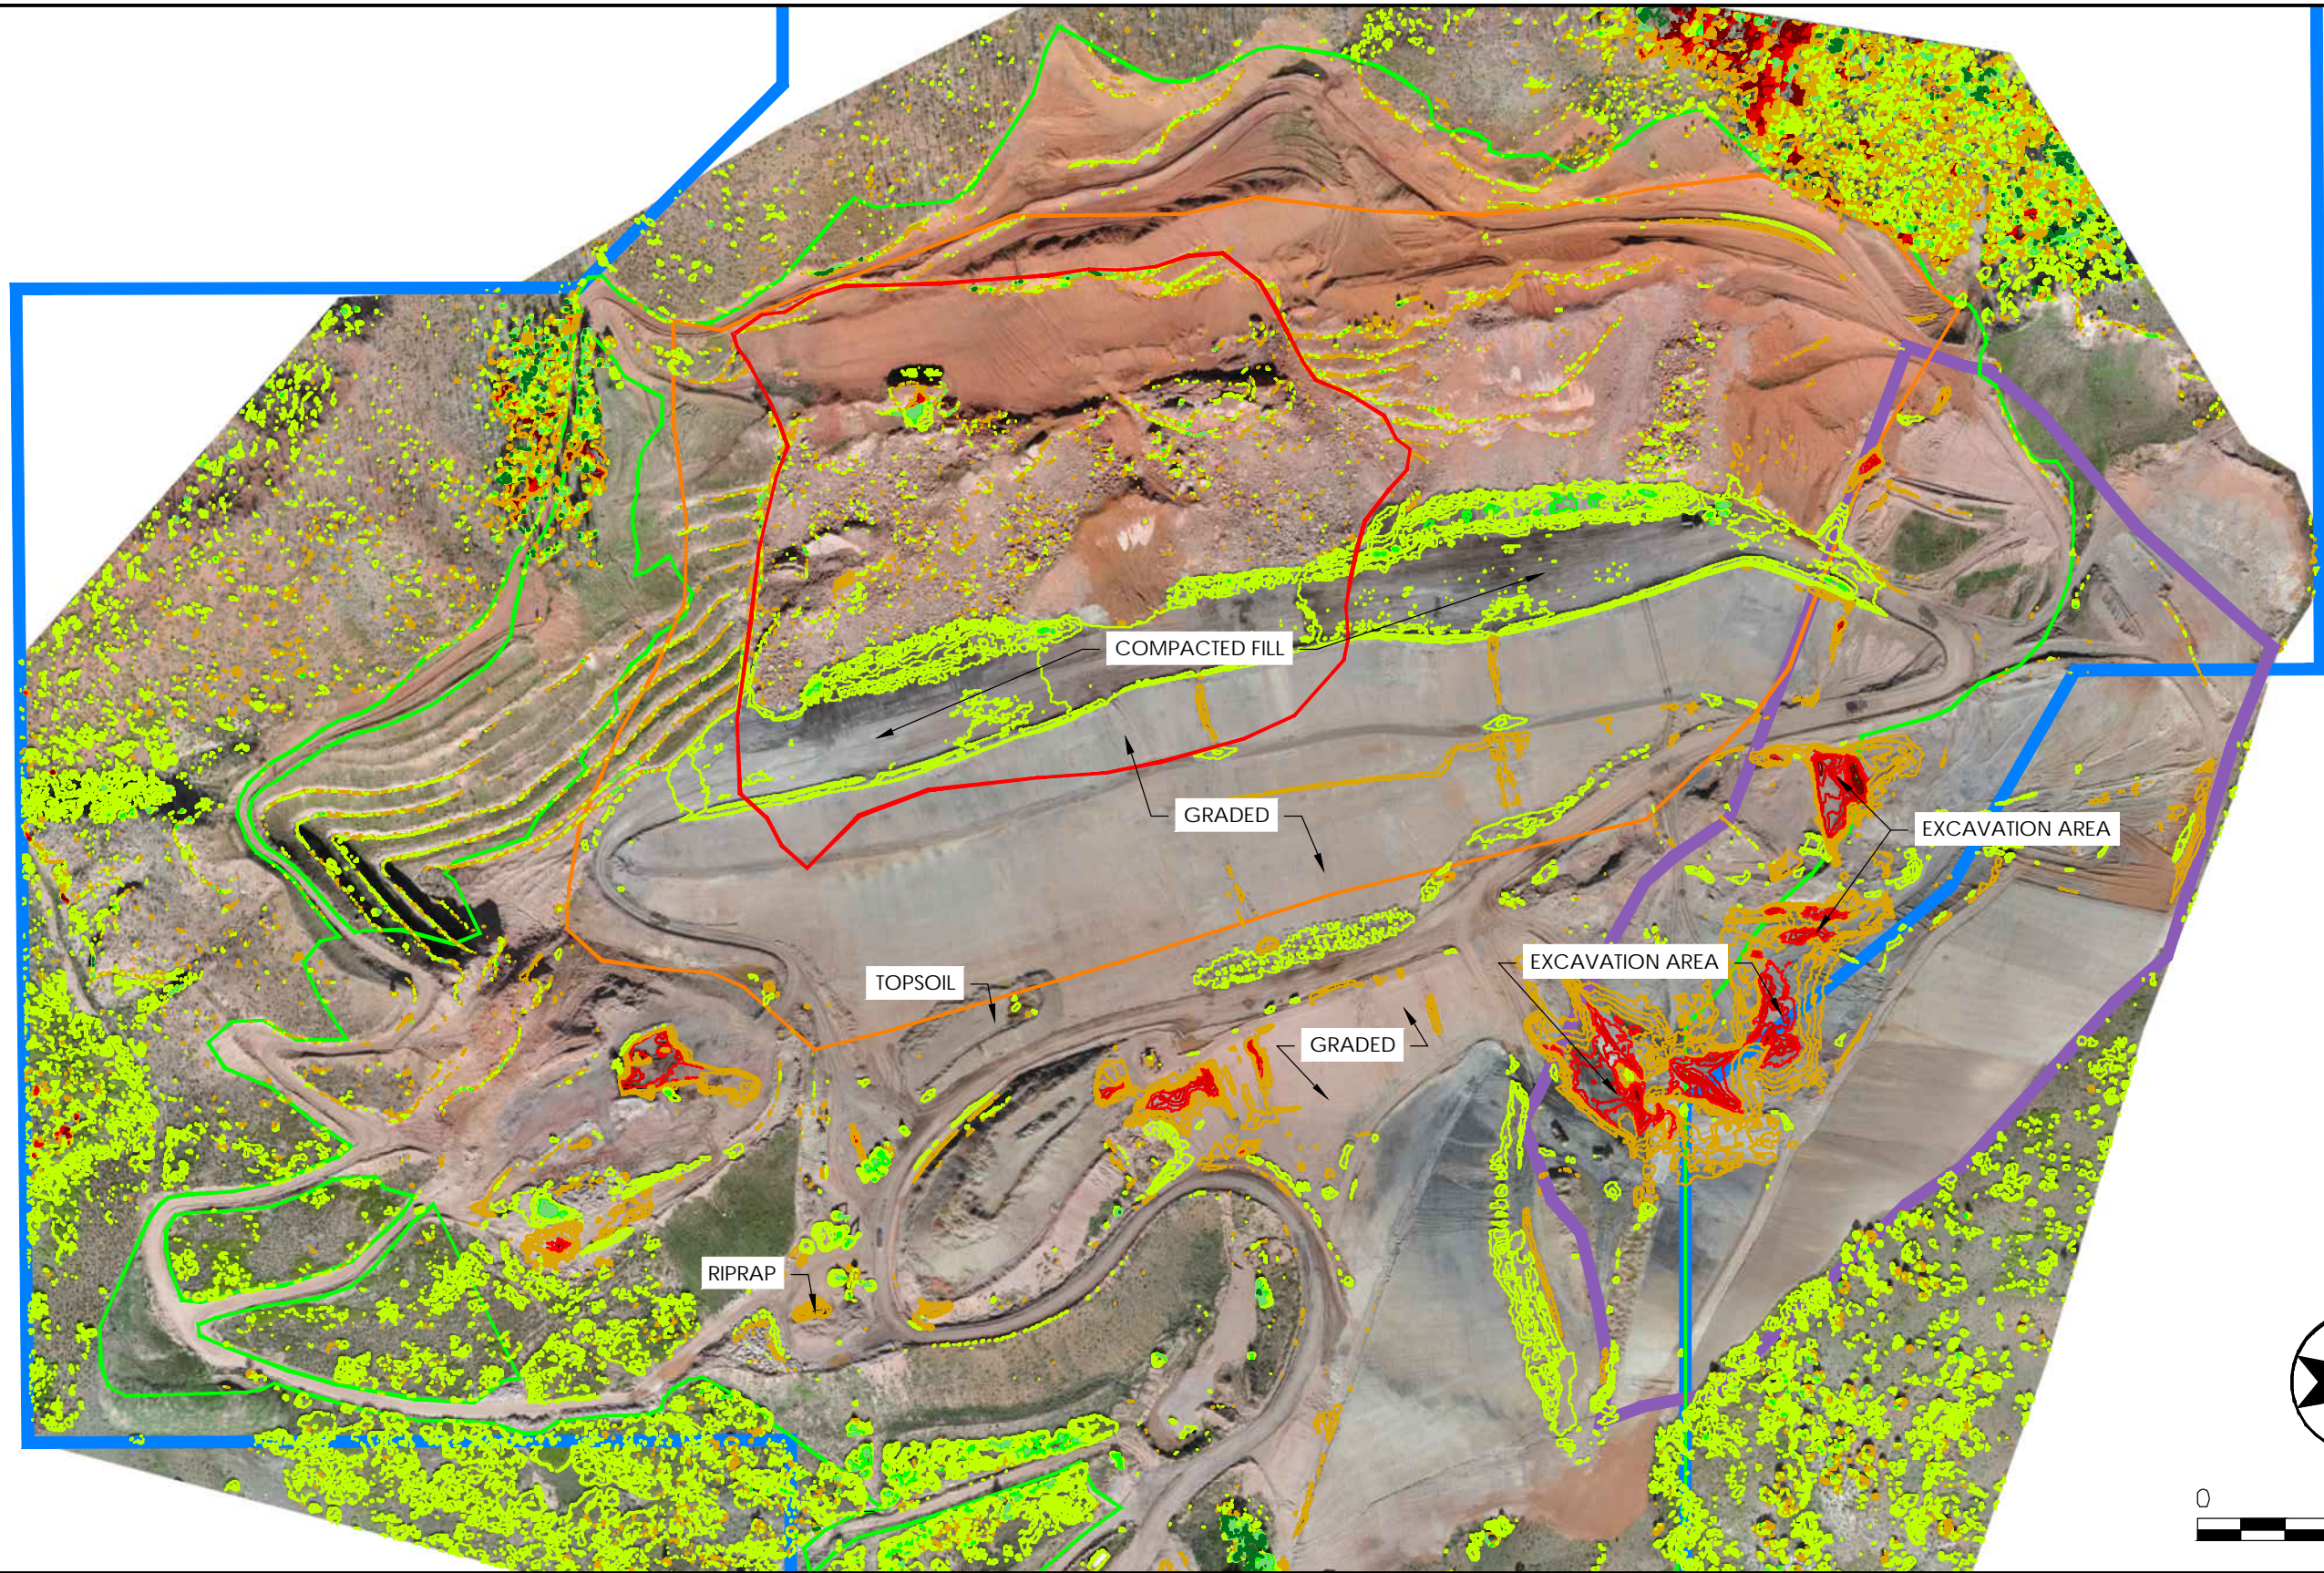
Revision #	Date
1	2023.06.30
Drawn By PK	Figure No. 5

material is excavated from the Shop Borrow Area or imported from offsite projects, including the North Borrow Area. No slope movements or other changes in topography were identified. The current imagery and topography are included in Figures 1 and 3, and the comparison surface is included as Figure 5 in Appendix C.

As previously reported in the September 2020 monitoring report, there are limitations with the method of comparing drone surveys from different months. The drone data indicate changes in the slopes along each of the reclamation benches, buildings, and areas with trees or shrubs. These areas are stable, and the changes are the result of survey limitations on or near vertical slopes.
