MINERALS PROGRAM INSPECTION REPORT
PHONE: (303) 866-3567

| MINE NAME: Snyder Quarry | MINE/PROSPECTING ID#: M-1977-210 | MINERAL: Limestone (general) | COUNTY: El Paso |
| INSPECTION TYPE: Monitoring | WEATHER: Cloudy | INSP. DATE: November 3, 2022 | INSP. TIME: 11:30 |

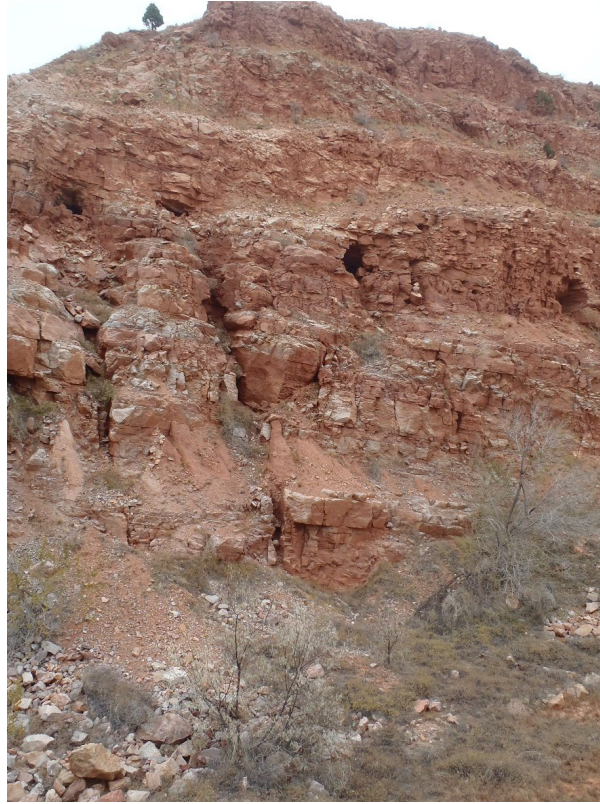
Backfilling and Grading: The unreclaimed highwalls (see **Photo 1**) will require scaling to reduce rockfall and increase safety; primarily for bench reclamation activity, but also for the post-mine land use. It should also be noted both pits (see **Photos 2** and **3**) are required to be backfilled per the approved AM-4 reclamation plan (**Attachment A – emailed only**). The approved plan covers multiple highwall configurations. Sufficient backfill material may be available onsite for the pits after grading the southeast area for positive drainage as depicted in Figure RP-4 of the reclamation plan.

Photo 1. Typical unreclaimed highwall needing scaling, at a minimum (North Phase WP pit, looking NW).

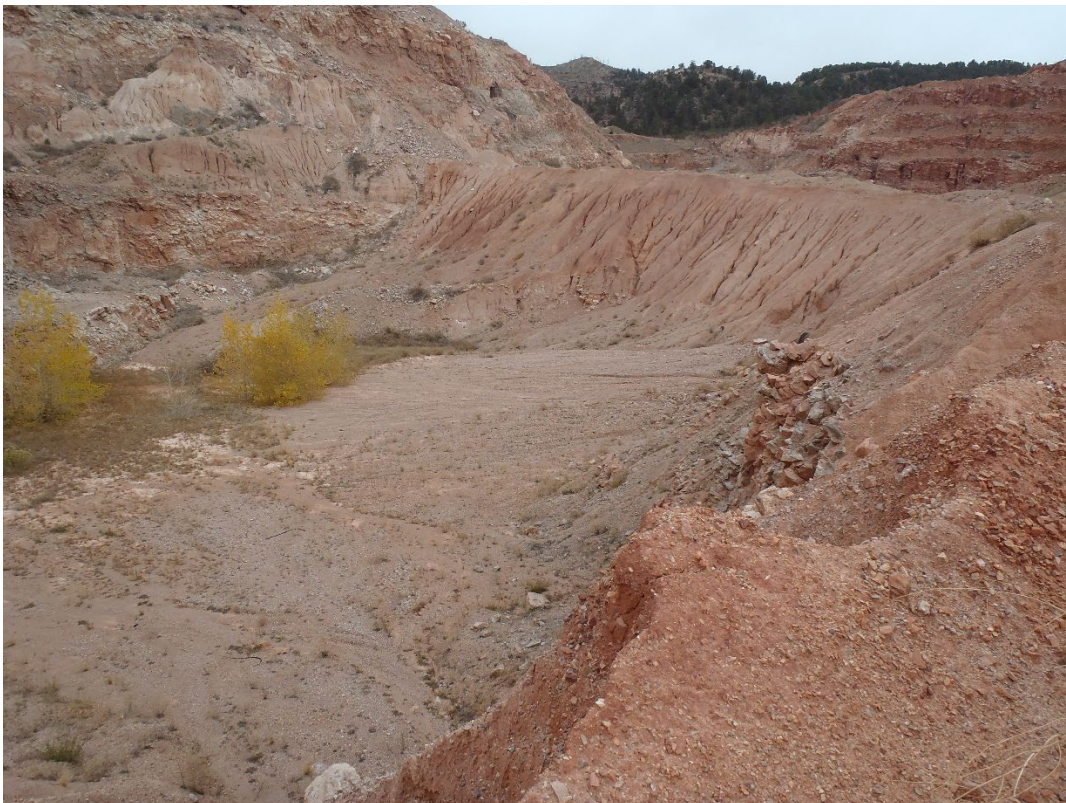
Photo 2. Southern pit needing backfill (looking north).

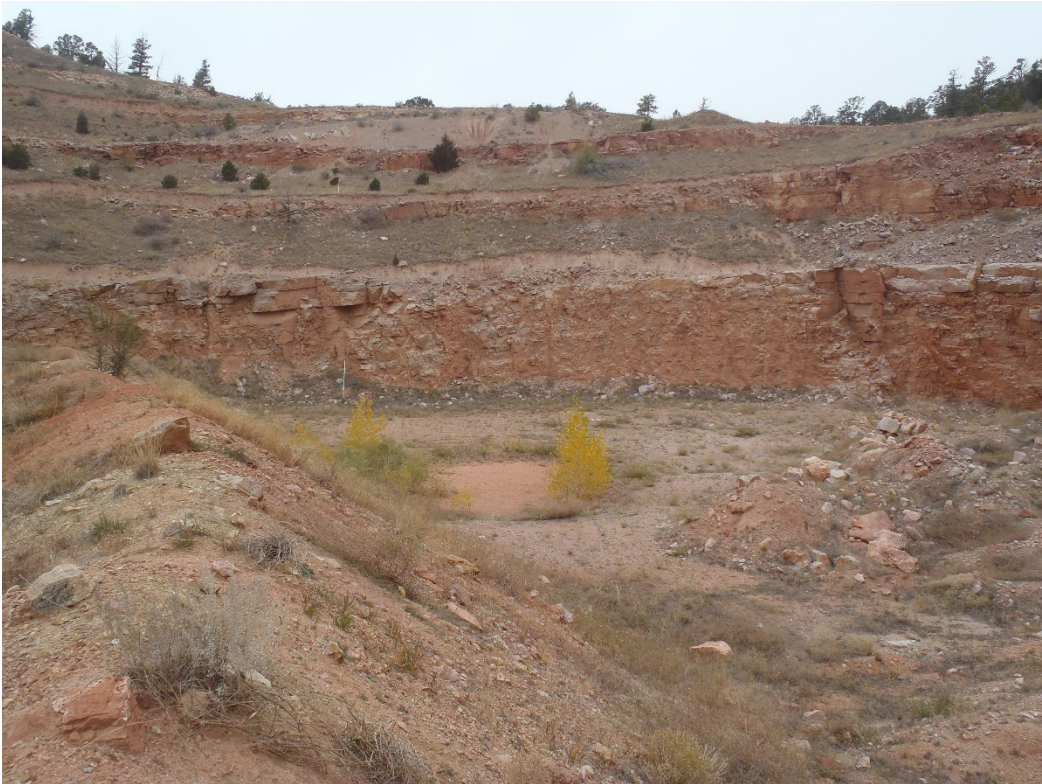
Photo 3. Northern pit needing backfill (looking NW).

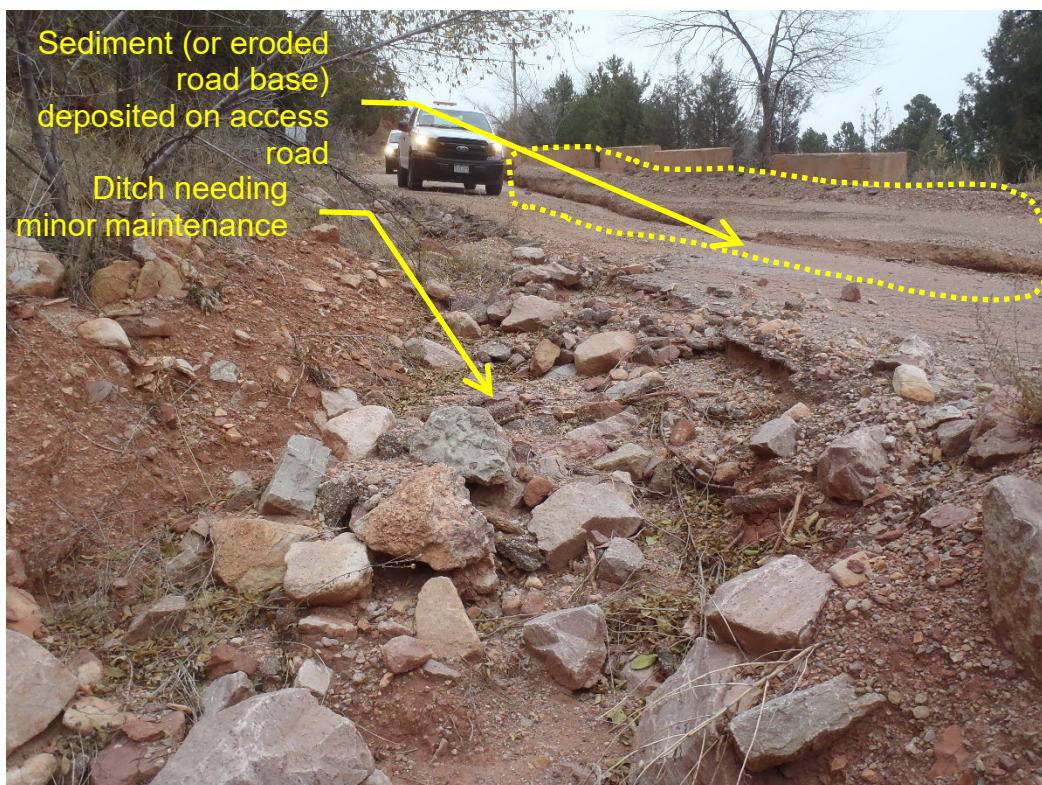
Roads: The main access road was observed to have an approximately 6-inch layer of sediment deposited on the road (or possibly 6 inches of roadbase that has eroded on the west side; see **Photo 4**) and the roadside ditch could benefit from some maintenance to remove rock and sediment (see **Photos 4** and **5**).

Photo 4. Access road and ditch needing maintenance (looking NW).

- Potential erosion of the sediment layer on the access road and the recommendation to perform maintenance in the access road side ditches;
- Continued treatment of the observed knapweed;
- Potential need to update the approved blasting plan as additional residences have been constructed since the blasting plan approval in 2001.

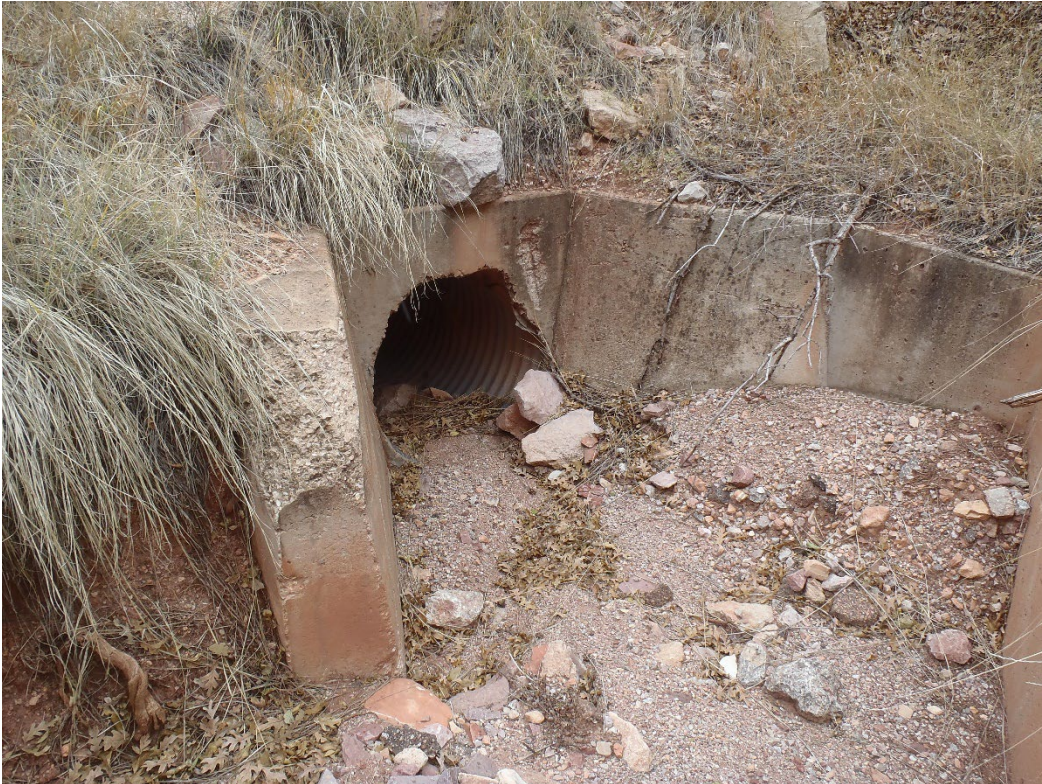
Photo 5. Access road culvert beginning to accumulate sediment (west/inlet side).

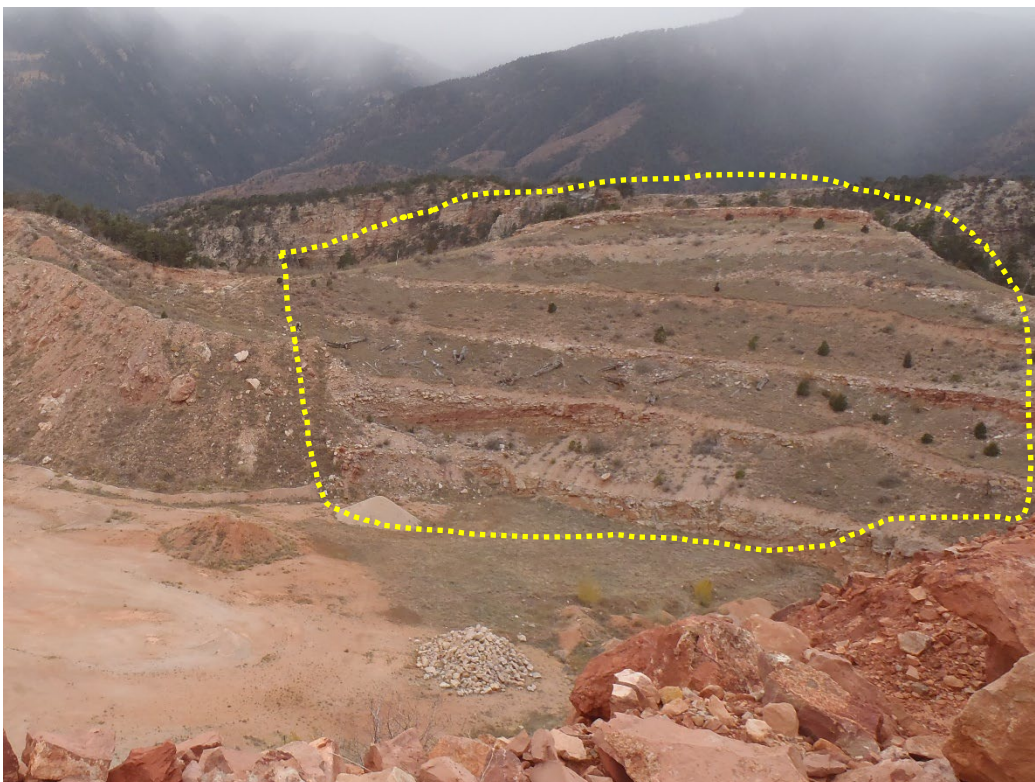
Reclamation Success: The City had not initiated any new reclamation since the permit was transferred from the previous Permittee in 2021. The highwalls west and north of the north pit (see **Photo 6**) appeared to have been adequately reclaimed.

Photo 6. Reclaimed highwalls on NW side of Phase WP (looking west).

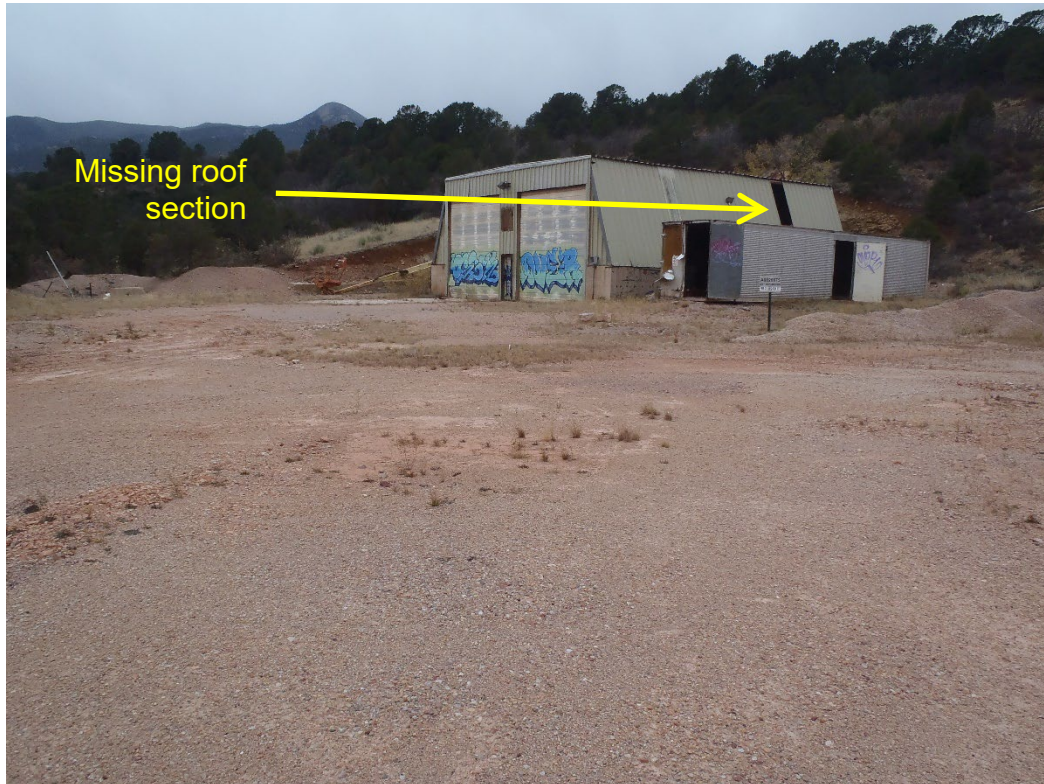
Support Facilities On-site: The shop building (see **Photo 7**) is allowed to remain per the approved reclamation plan, but it has been damaged by weather and vandalism. No other equipment or facilities were observed on site.

Photo 7. Shop building subjected to vandalism and weather damage.

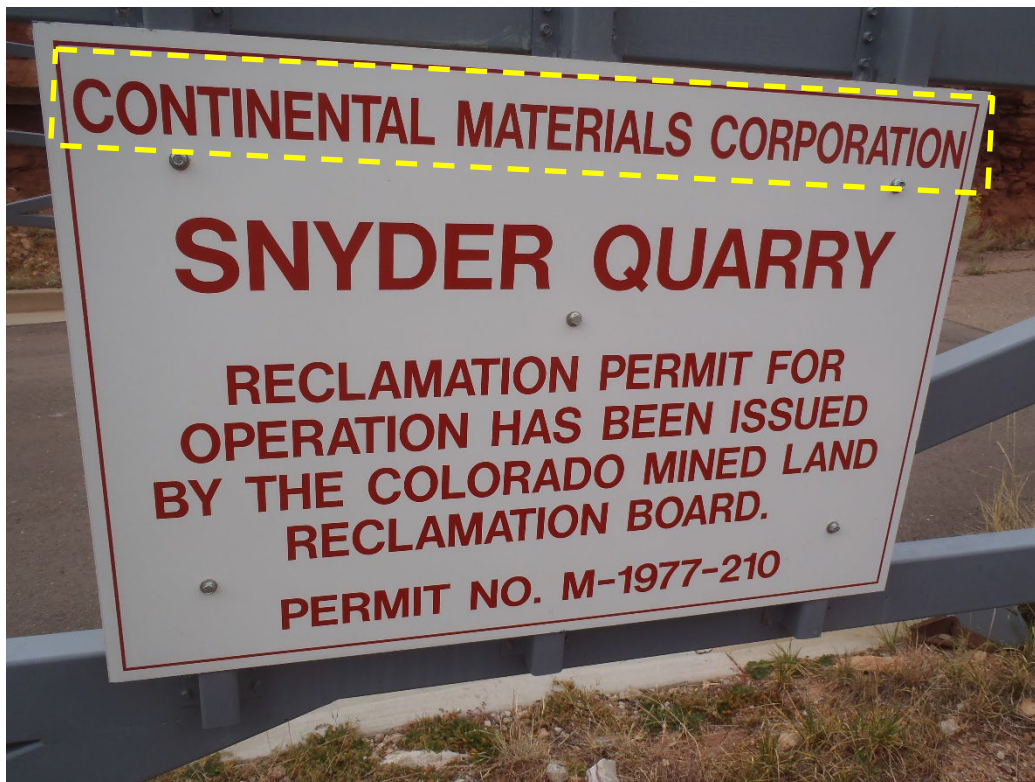
Signs and Markers: The permit sign was properly posted (see **Photo 8**), but the Permittee name needs to be changed from Continental Materials Corporation to Colorado Springs. Boundary markers were still visible.

Photo 8. Permit Sign at entrance (Permittee name needs to be changed).
