Permit Number: C-1981-015 Mine Name: Fruita No 1 & 2 Operator: Dorchester Coal Company Operator Address: Greg Lewicki 9054 South Forrest Drive Highlands Ranch, CO 80126	County: Mesa Operation Type: Underground Permit Status: Revoked Ownership: Private
	Operator Representative Present: NA
Operator Representative Signature: (Field Issuance Only)

Inspection Start Date: June 22, 2023 Inspection Start Time: 11:00 Inspection End Date: June 22, 2023 Inspection End Time: 11:40		Inspection Type: Coal Complete Inspection Inspection Reason: Normal I&E Program Weather: Clear	
Joint Inspection Agency: None		Joint Inspection Contacts: None	
Post Inspection Agency: None		Post Inspection Contacts: None	
Inspector(s): Clayton Wein	Inspector's Signature: <i>Clayton Wein</i>		Signature Date: 7/6/2023

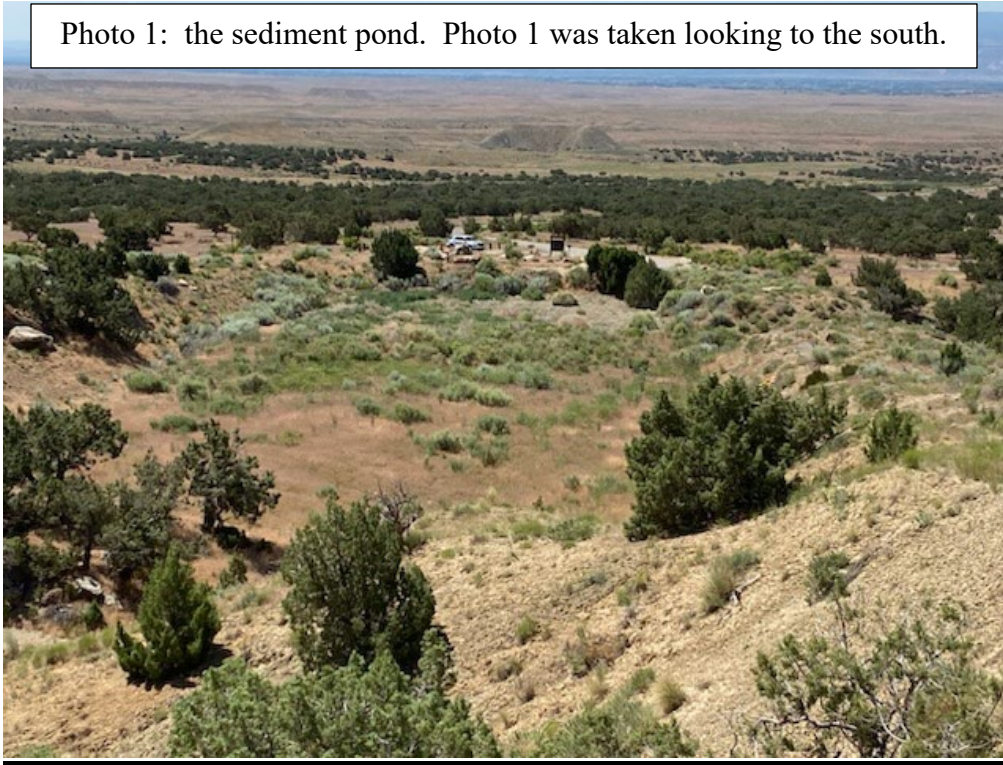
The sediment pond is located at the southern portion of the permit area. The pond will remain as a permanent feature after the permit is released. The pond was dry at the time of the inspection. The embankments for the pond were stable with vegetative cover (Photo 1). There were no indications of erosional features identified. The outlet for the pond was clear of obstructions and the riprap lining was in good condition.

Photo 1: the sediment pond. Photo 1 was taken looking to the south.

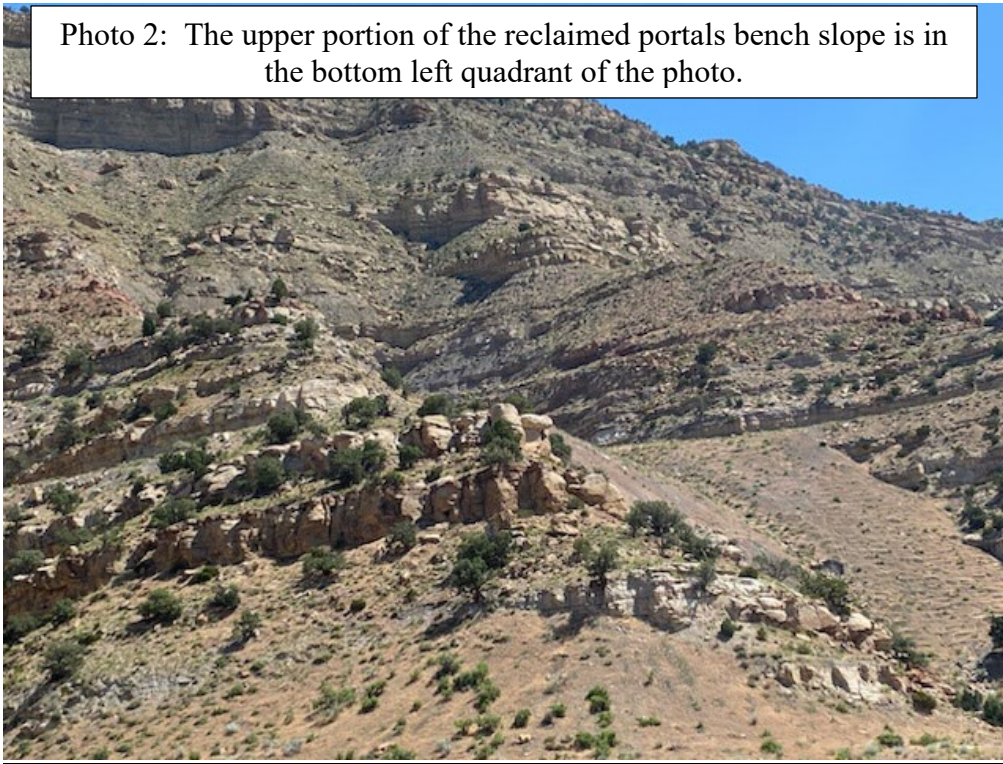
The reclaimed portals bench was stable. The pad was covered with mature vegetation. A combination of grasses, forbs and brush covered the area. The backfilled portals were stable with no erosional features. The gully identified on the reclaimed pad has been documented in previous Division inspection reports. The gully has been self-stabilized. The gully had not enlarged in size or depth since previous inspections. Water that may be captured and transported in the gully flow to the edge of the reclaimed bench and into the riprap lined channel on the slope of the bench. The slope of the bench is south facing and covered with sparse amounts of vegetation. The slope was stable with only minor rills on the face. These rills have been documented in previous Division inspection reports. The rills had not increased in size or depth. The riprap lined channel on the face of the slope was in good condition. There were no erosional concerns identified. The slope was stable (photo 2 and 3).

Photo 2: The upper portion of the reclaimed portals bench slope is in the bottom left quadrant of the photo.

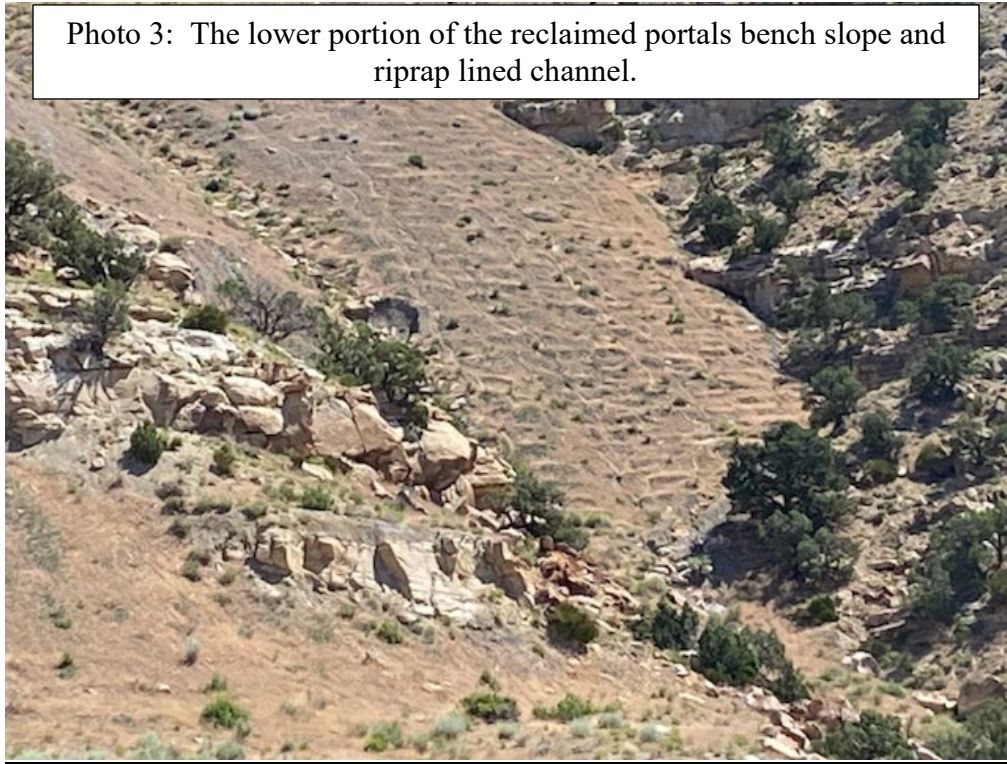
Photo 3: The lower portion of the reclaimed portals bench slope and riprap lined channel.

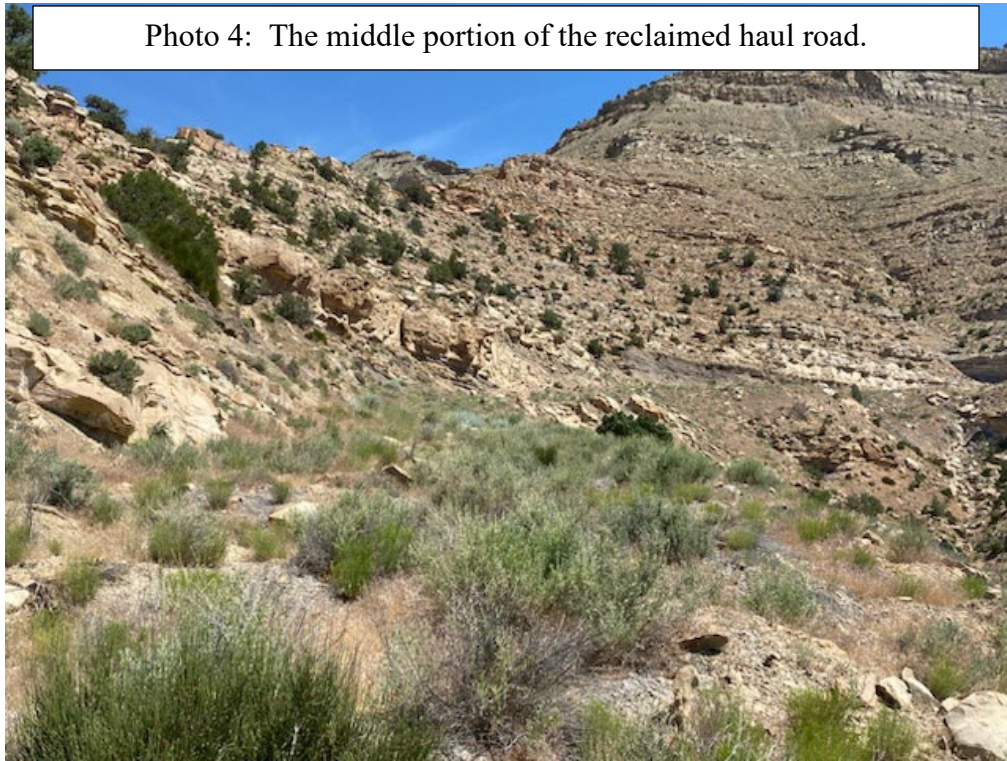
The reclaimed haul road was stable with vegetative cover (Photos 4 and 5). There were no indications of erosion. A rill/small gully has been documented in previous Division inspection reports on the reclaimed haul road. The

rill has become stabilized and there was no indication of the rill increasing in size or depth. Runoff that is captured in the rill is transported into the gulch above the sediment pond. Any runoff from this rill will end up in the sediment pond. No off-site impacts have occurred. The cut and fill slopes of the reclaimed haul road were stable. There were no indications of sloughing or erosional features identified.

Photo 4: The middle portion of the reclaimed haul road.

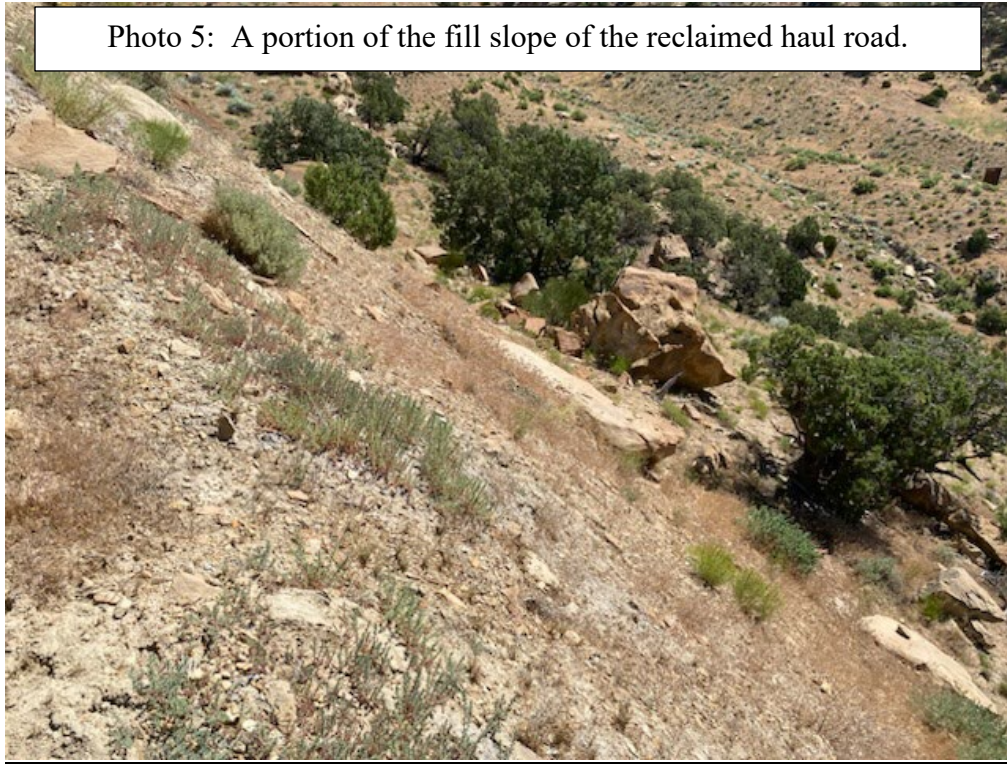
Photo 5: A portion of the fill slope of the reclaimed haul road.
