**MINERALS PROGRAM INSPECTION REPORT**  
**PHONE: (303) 866-3567**

<b>MINE NAME:</b> Journey Ventures Pit	<b>MINE/PROSPECTING ID#:</b> M-2008-080	<b>MINERAL:</b> Aggregate, gravel and sand	<b>COUNTY:</b> Weld
<b>INSPECTION TYPE:</b> Monitoring	<b>WEATHER:</b> Raining	<b>INSP. DATE:</b> June 30, 2023	<b>INSP. TIME:</b> 10:00
<b>OPERATOR:</b> Journey Ventures, LLC	<b>OPERATOR REPRESENTATIVE:</b> Chris Leone, JC York	<b>TYPE OF OPERATION:</b> 112c - Construction Regular Operation	
<b>REASON FOR INSPECTION:</b> Normal I&E Program	<b>BOND CALCULATION TYPE:</b> Partial Bond	<b>BOND AMOUNT:</b> \$487,550.00	
<b>DATE OF COMPLAINT:</b> NA	<b>POST INSP. CONTACTS:</b> None	<b>JOINT INSP. AGENCY:</b> None	
<b>INSPECTOR(S):</b> Peter Hays	<b>INSPECTOR'S SIGNATURE:</b>

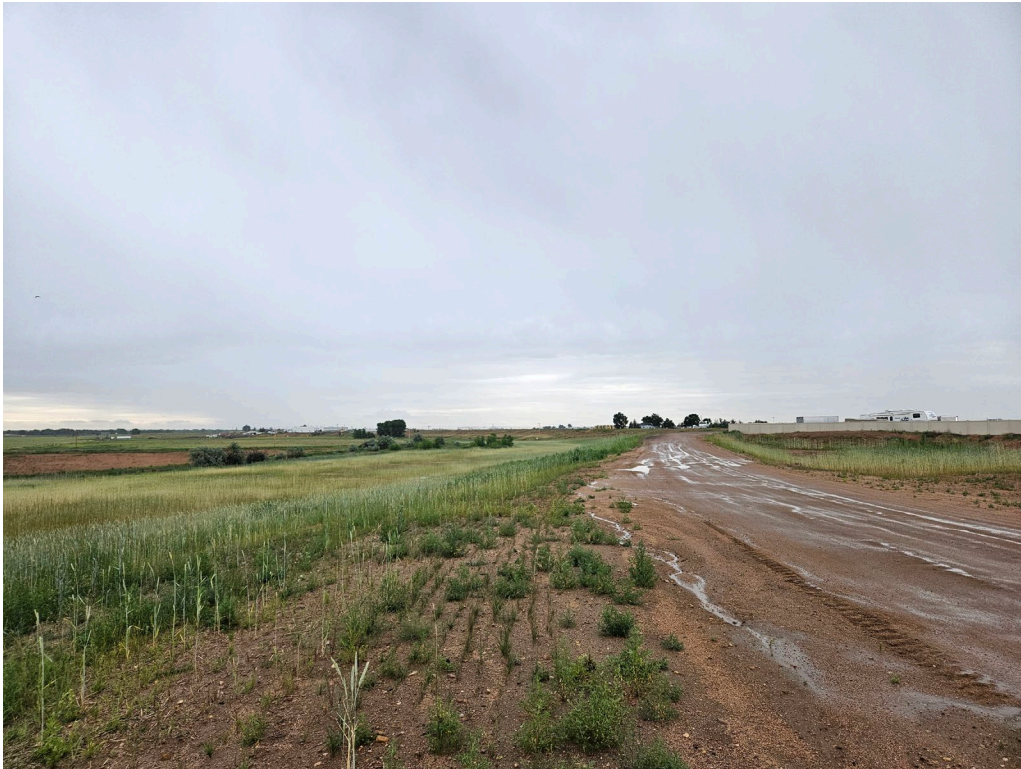
View of the site from the oil and gas facilities looking southeast

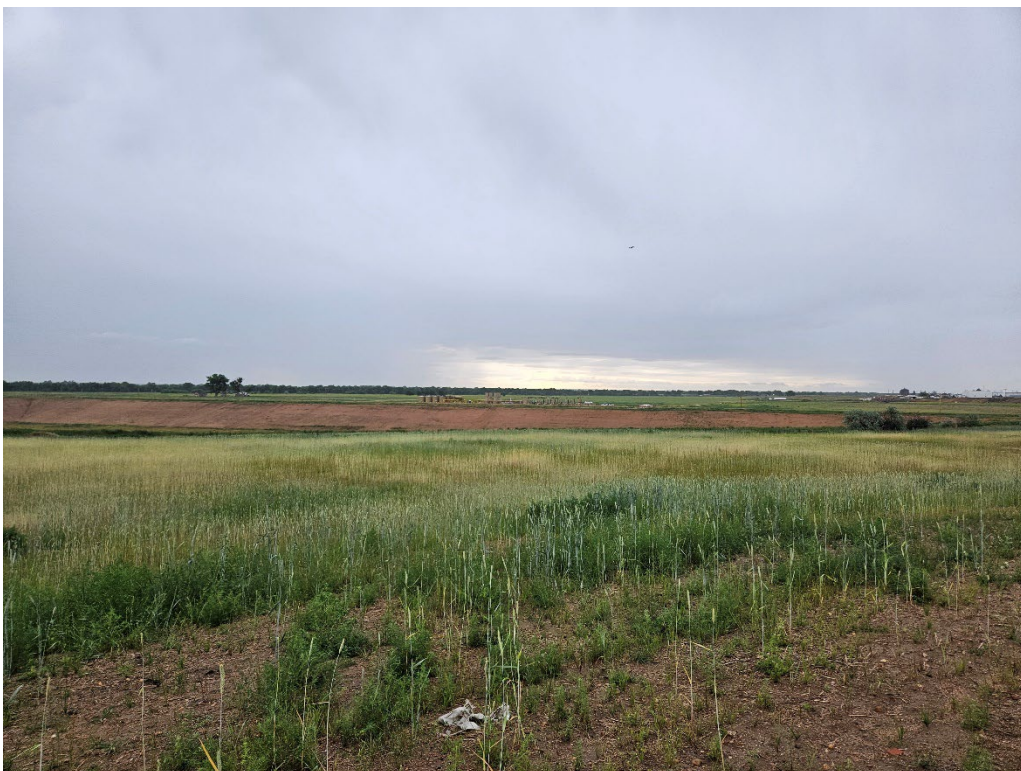
View of the site from the oil and gas facilities looking east

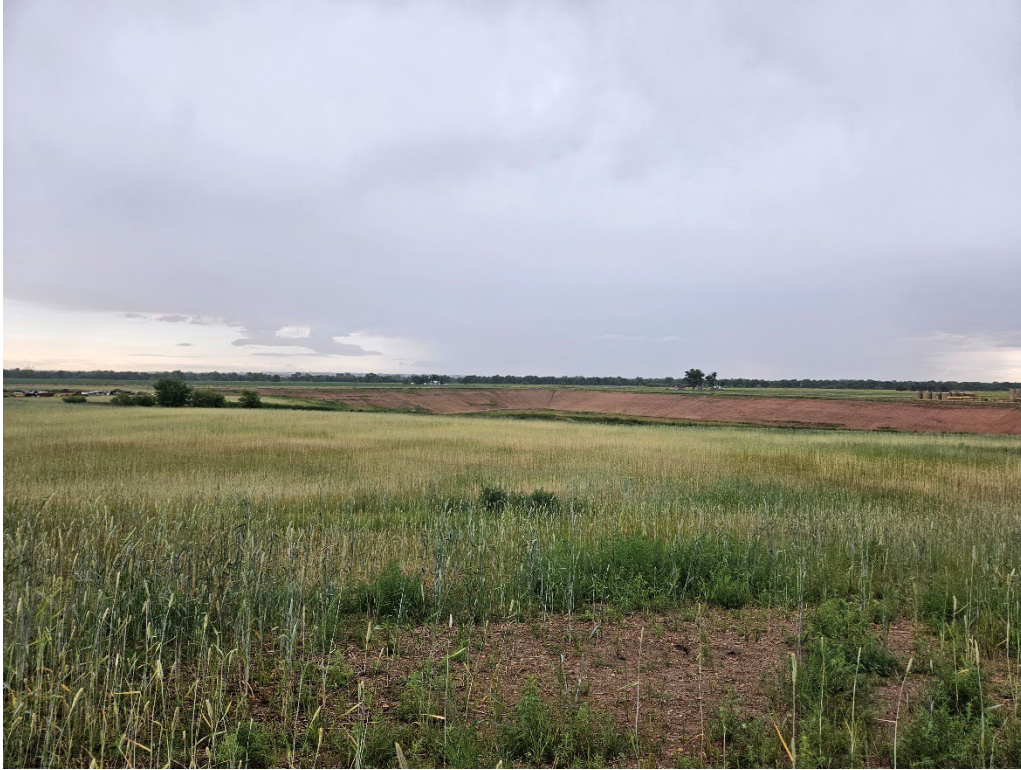
View of the site from the oil and gas facilities looking northeast

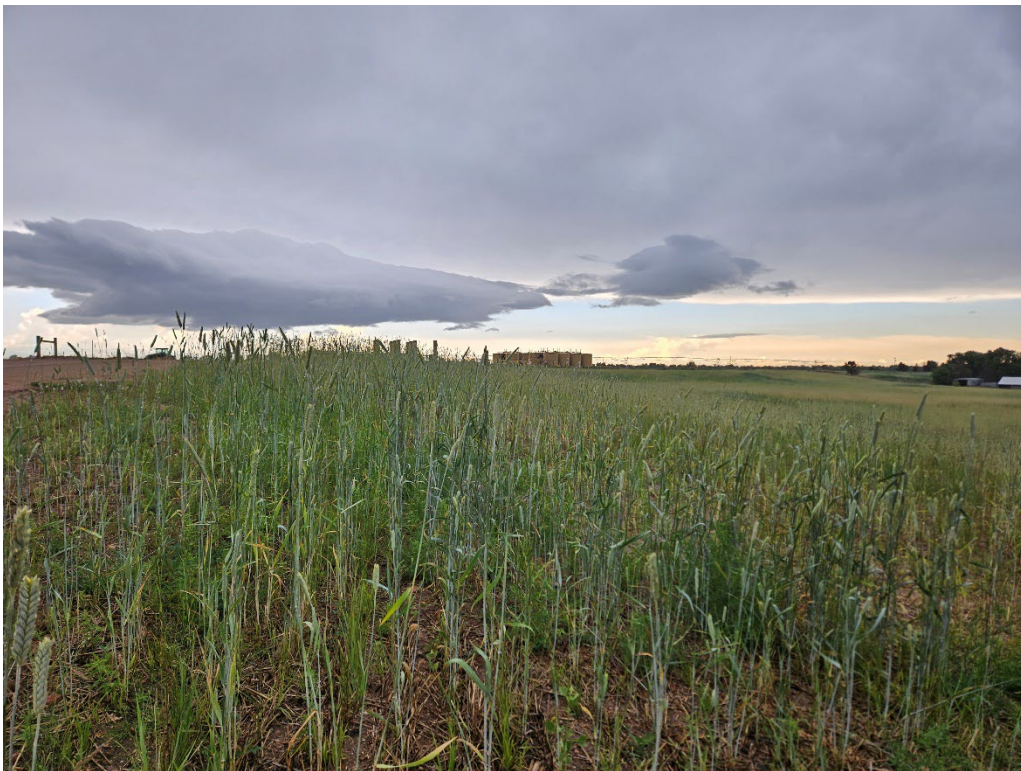
The approved post-mining land use for the site is developed water resources. A slurry wall was constructed around the perimeter of Phase 2 creating a reservoir. The approved Reclamation Plan states the Operator will replace 12 inches of topsoil during reclamation. The upland areas of the site, excluding the storage yard area and the reservoir slopes were seeded in the fall of 2022. The vegetation was establishing well with several varieties of grasses observed during the inspection.

View of typical reclamation vegetation

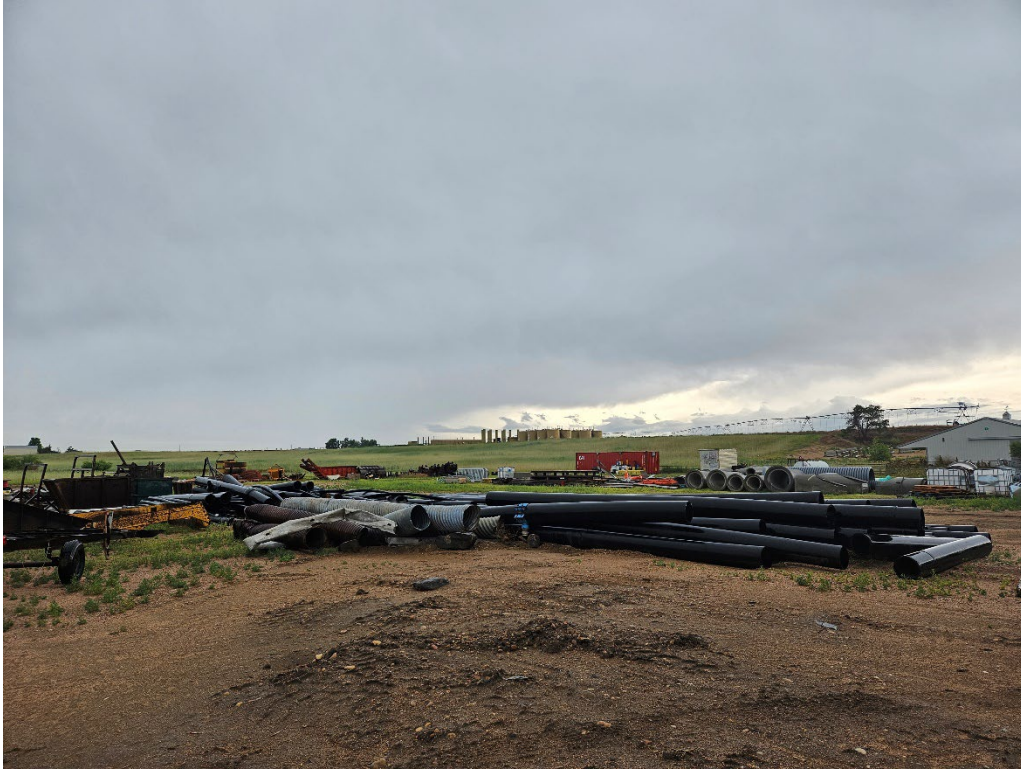
View of the construction yard from the northeast corner looking southwest

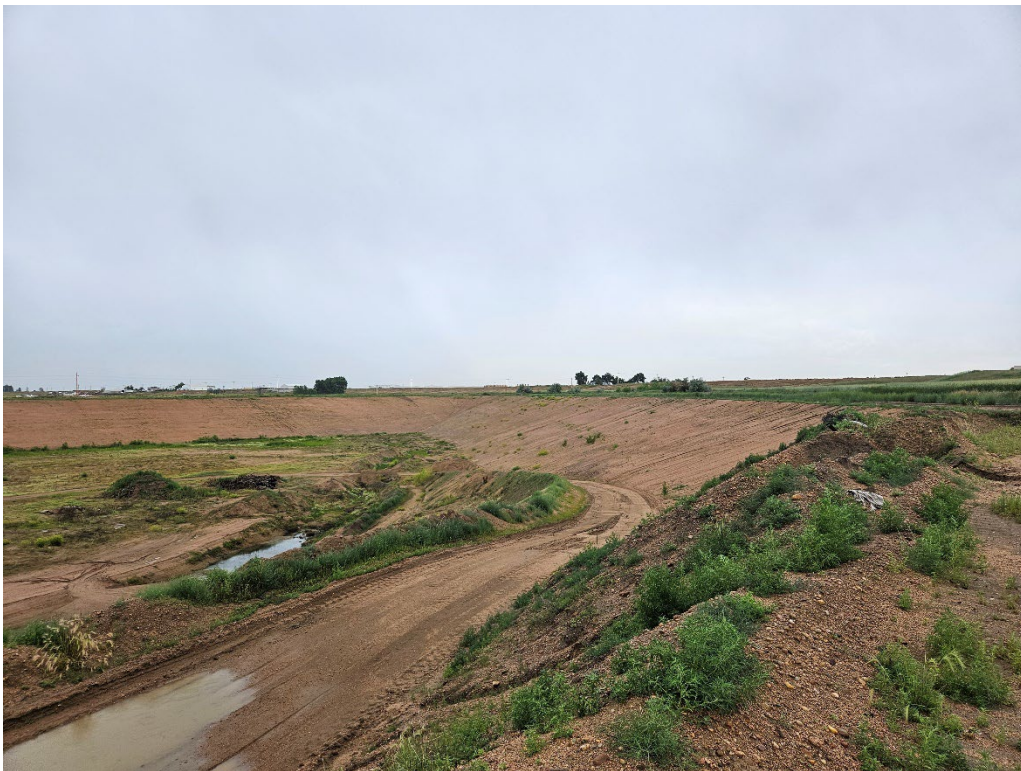
View of the reservoir from the west side looking southeast

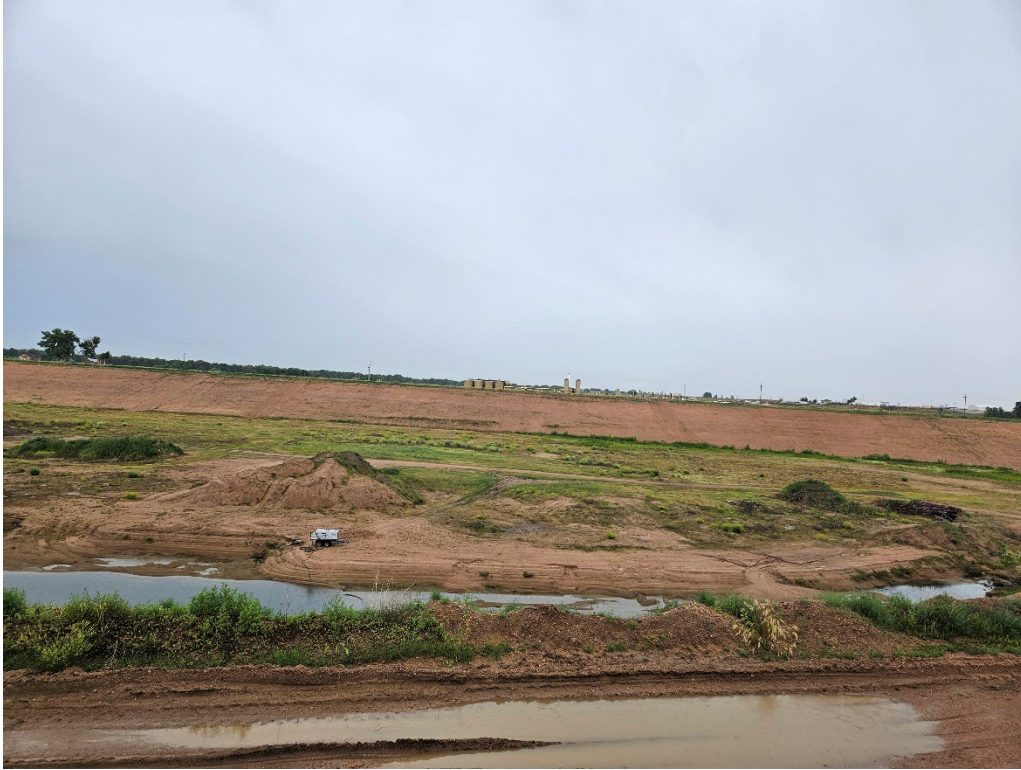
View of the reservoir from the west side looking east

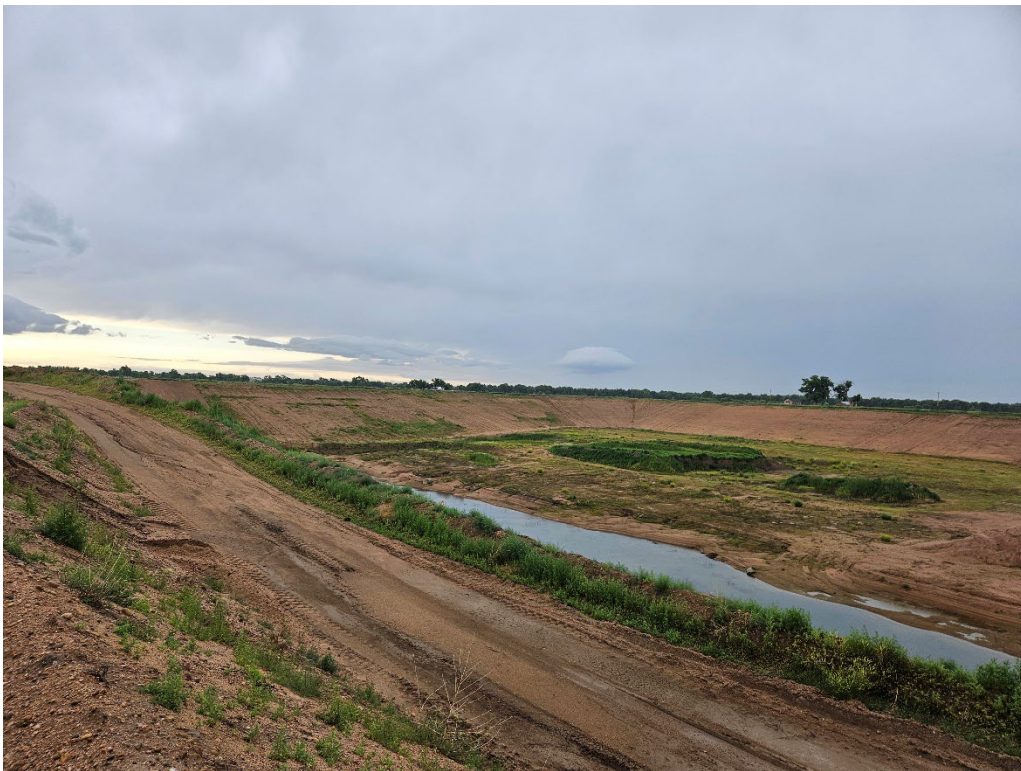
View of the reservoir from the west side looking northeast

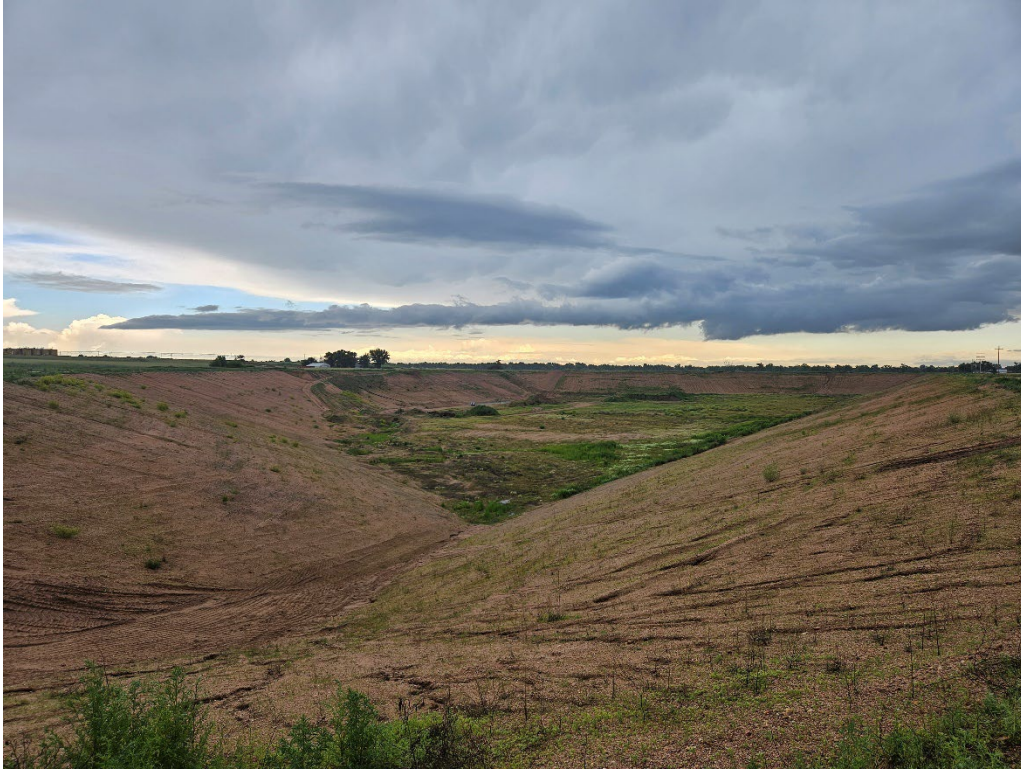
View of the reservoir from the southeast corner looking northwest

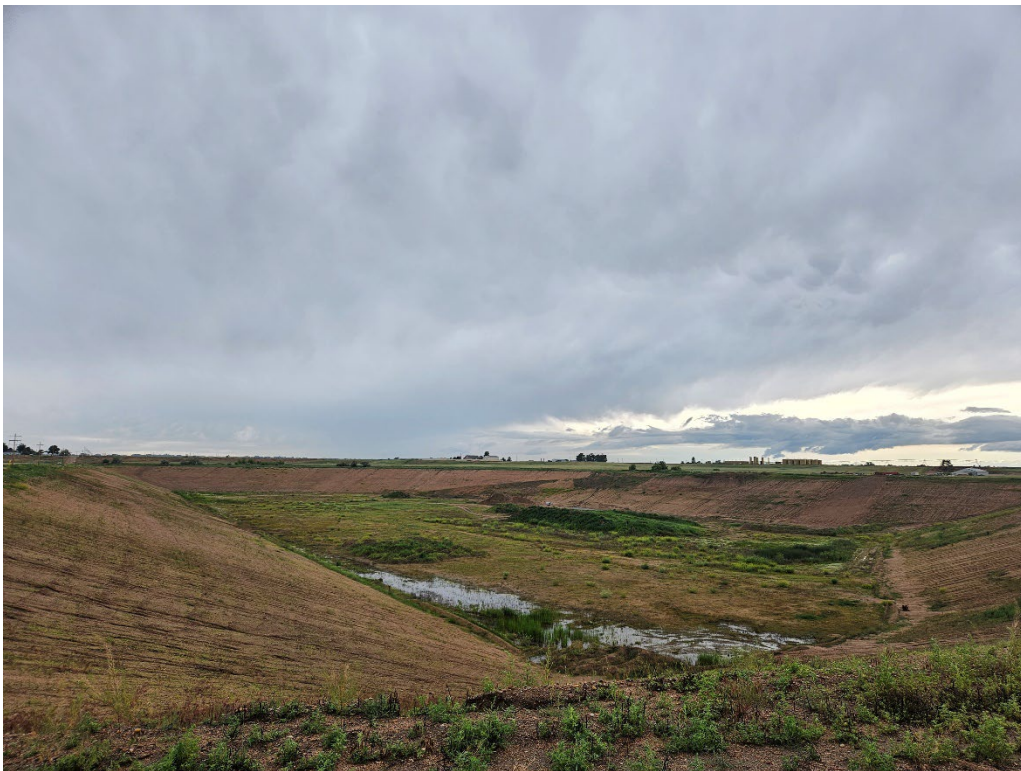
View of the reservoir from the northeast corner looking southwest
