## McClane Canyon Mine, C-1980-004, June Partial Inspection Report

**PERMIT INFORMATION**

<b>Inspection Start Date:</b> June 22, 2023 <b>Inspection Start Time:</b> 09:05 <b>Inspection End Date:</b> June 22, 2023 <b>Inspection End Time:</b> 10:20		<b>Inspection Type:</b> Coal Partial Inspection <b>Inspection Reason:</b> Normal I&E Program <b>Weather:</b> Clear	
<b>Joint Inspection Agency:</b>  None		<b>Joint Inspection Contacts:</b>  None	
<b>Post Inspection Agency:</b>  None		<b>Post Inspection Contacts:</b>  None	
<b>Inspector(s):</b>  Clayton Wein	<b>Inspector's Signature:</b>  <i>Clayton Wein</i>		<b>Signature Date:</b>  7/6/2023

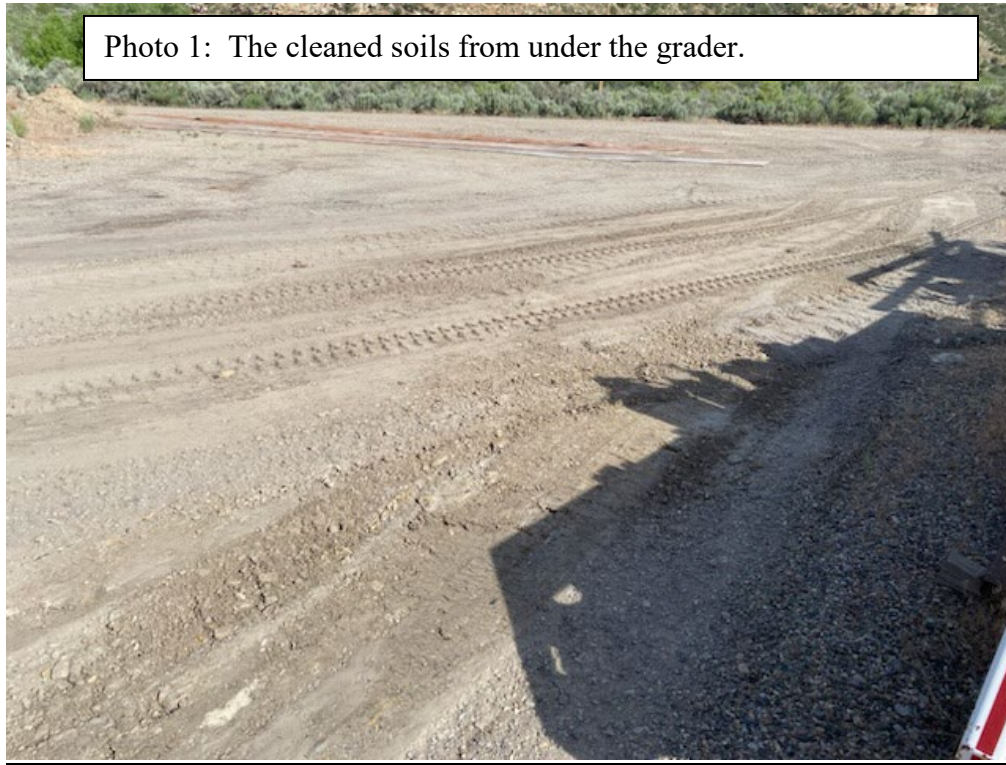
2. *Clean up the contaminated soils beneath the grader parked on the west side of the mine office and dispose of the contaminated material in accordance with the SPCC.* The contaminated soil located underneath the grader had been removed and placed in a spill proof container. The material was awaiting transportation to a disposal facility scheduled for June 27, 2023. (Photo 1)

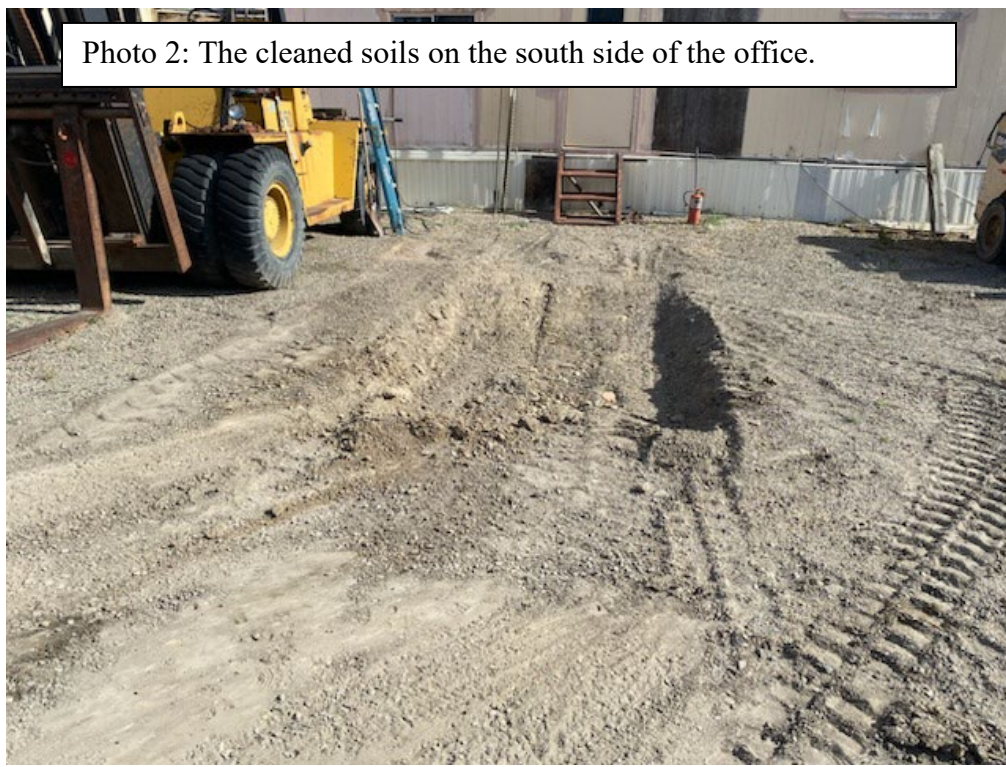
3. *Clean up the contaminated soils located at the back/south side of the mine office and dispose of the contaminated soils in accordance with the SPCC.* The contaminated soils located on the south side of the mine office had been scooped up and placed in a spill proof container. The contaminated soils were scheduled to be taken to a disposal facility on June 27, 2023. (Photo 2)

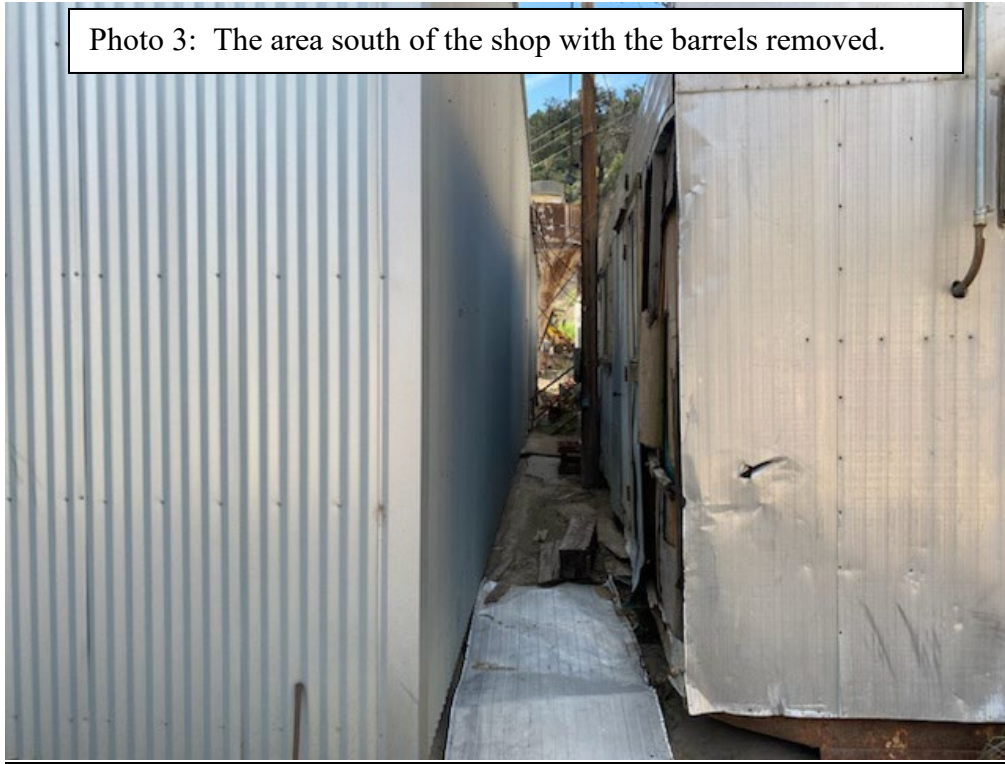
5. *Remove old barrels located behind the shop and dispose of in accordance with the approved SPCC.* The barrels from behind the shop were removed from the mine site and disposed of in accordance with the approved SPCC. (Photo 3)

Photo 3: The area south of the shop with the barrels removed.

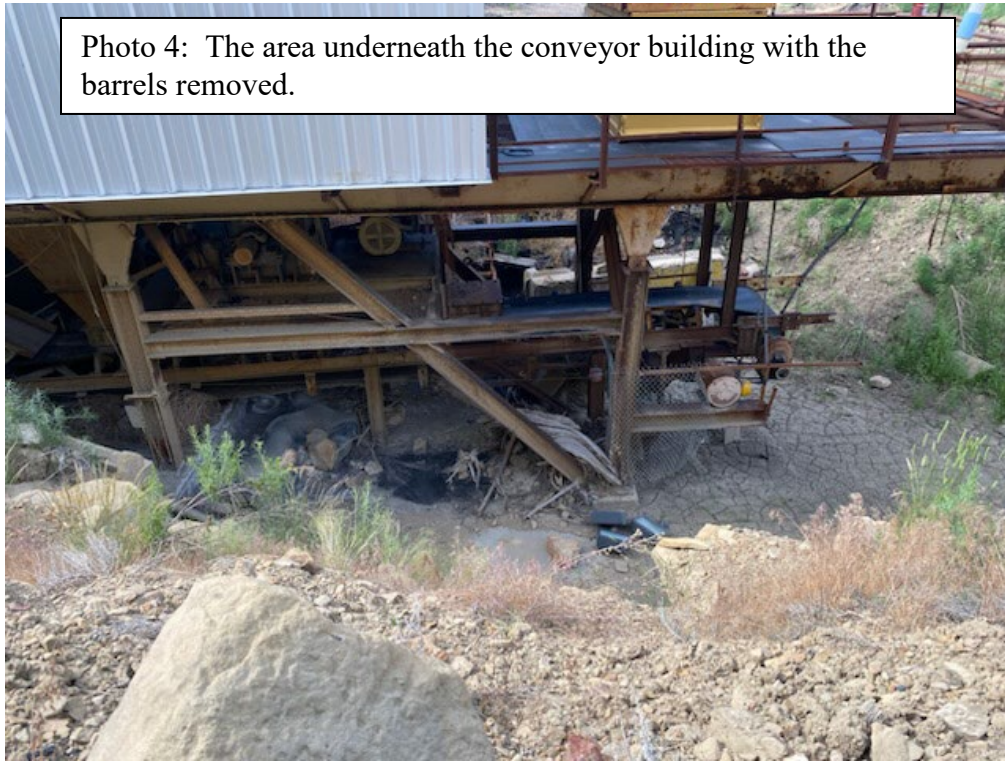
8. *Remove the barrels from beneath the conveyor building and dispose of in accordance with the approved SPCC.* All barrels that were located beneath the conveyor building were removed and disposed of in accordance with the approved SPCC. (Photo 4)

Photo 4: The area underneath the conveyor building with the barrels removed.

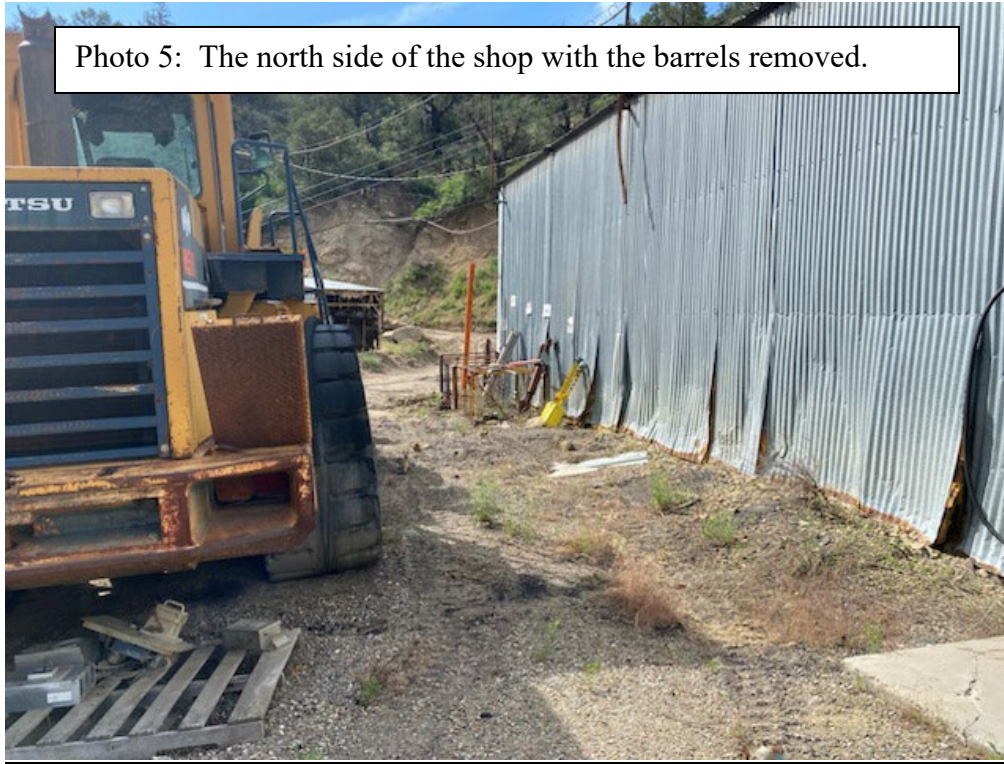
9. *Remove all barrels containing fluids located on the north side of the shop and dispose of in accordance with the approved SPCC.* All barrels located on the north side of the shop had been removed from the site and disposed of in accordance with the SPCC. (Photo 5)

Photo 5: The north side of the shop with the barrels removed.

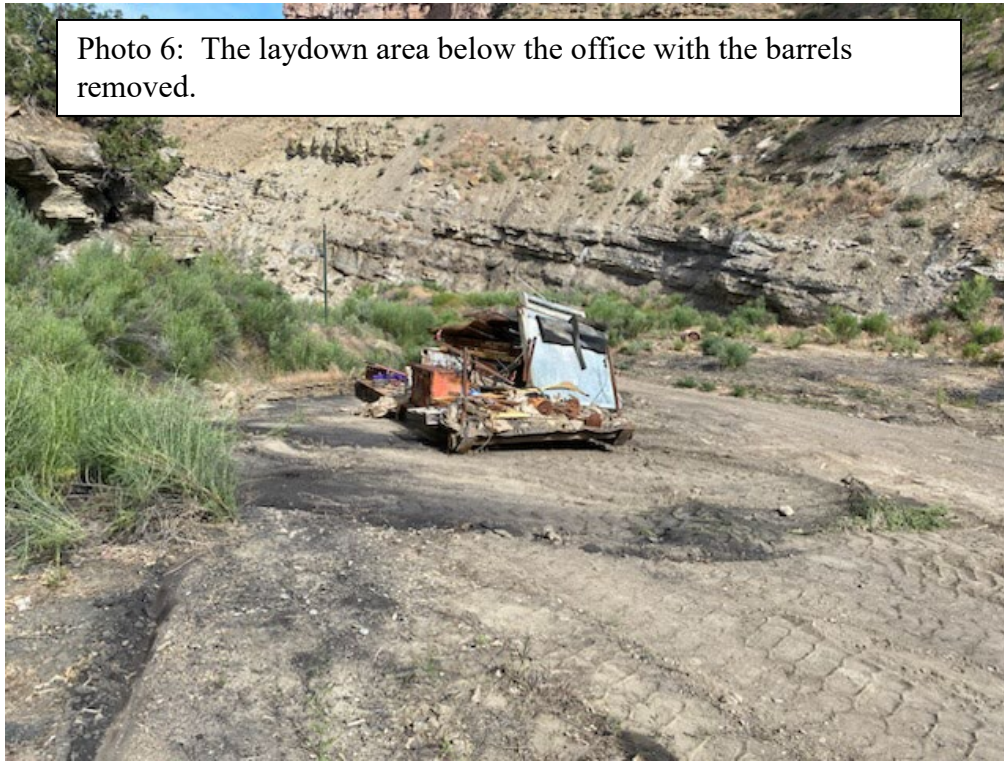
10. *Remove all barrels of liquids from the laydown area located on the bench below and to the north of the shop. Dispose of the liquids in accordance with the approved SPCC.* Barrels that were located in the laydown area on the bench below the north side of the shop had been removed and disposed of in accordance with the approved SPCC. (Photo 6)

Photo 6: The laydown area below the office with the barrels removed.

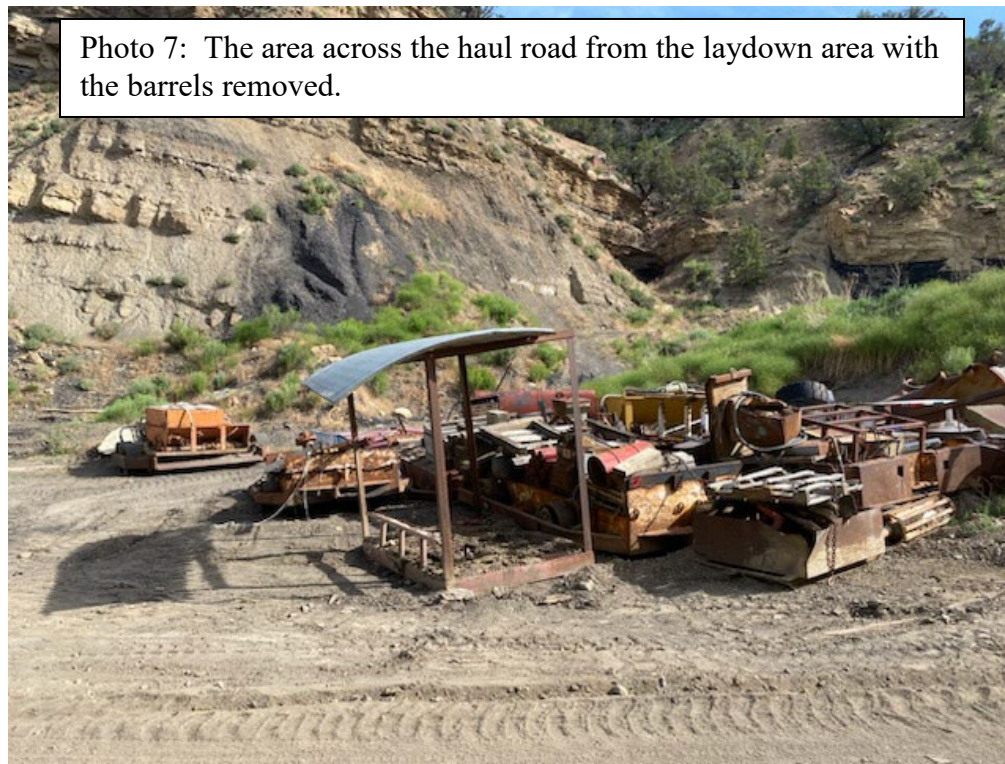
11. *Please remove the barrels located across the haul road from Item # 10. Dispose of the barrels in accordance with the SPCC.* All barrels that were located across the haul road from Item #10 were removed and disposed of in accordance with the SPCC. (Photo 7)

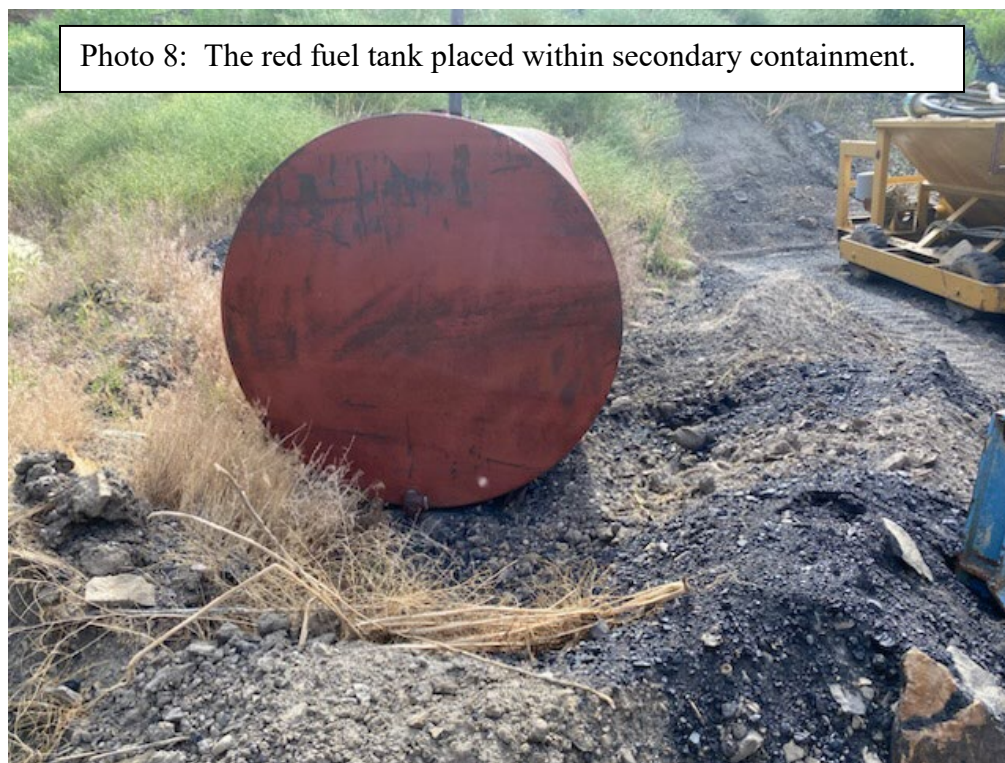
12. *Please relocate the large red fuel tank located just east of Sump I to a location with a containment berm as outlined in the approved SPCC.* The large red fuel tank had been moved to a laydown area and placed in a location with a secondary containment berm. (Photo 8)

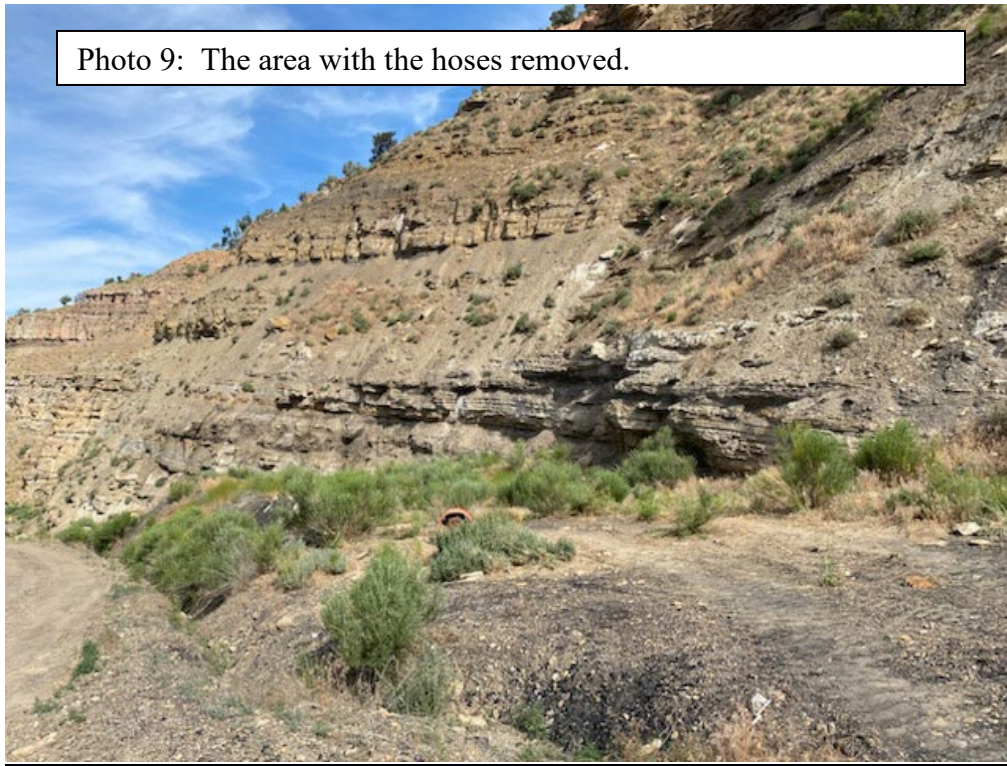
13. *Please pick up the hoses located near the fuel tank described in Task no. 12 and store in an approved location such as the shop or dispose of in accordance with the approved SPCC.* The hoses located near task #12 had been picked up and placed in the shop, in the area with secondary containment. (Photo 9)

Photo 9: The area with the hoses removed.

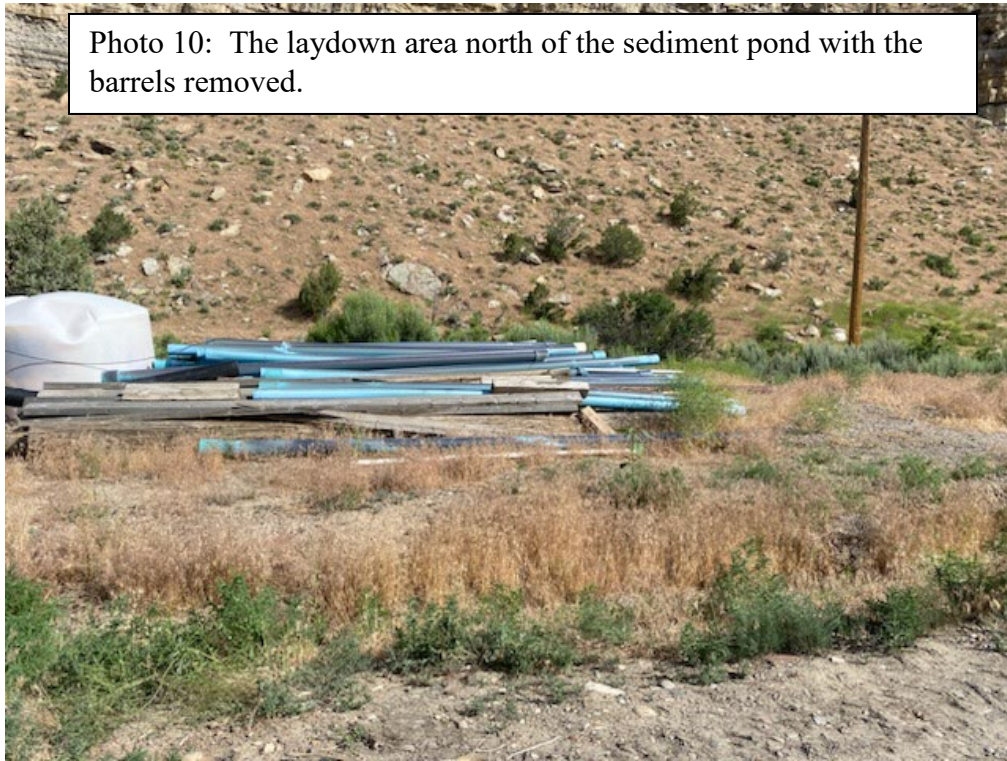
14. *Remove all barrels and any containers with liquids from the equipment laydown area north across the haul road from the sediment pond. Dispose of the barrels and containers with liquids in accordance with the approved SPCC.* All barrels located in the laydown area north of the sediment pond had been removed and were disposed of in accordance with the SPCC. (Photo 10)

Photo 10: The laydown area north of the sediment pond with the barrels removed.

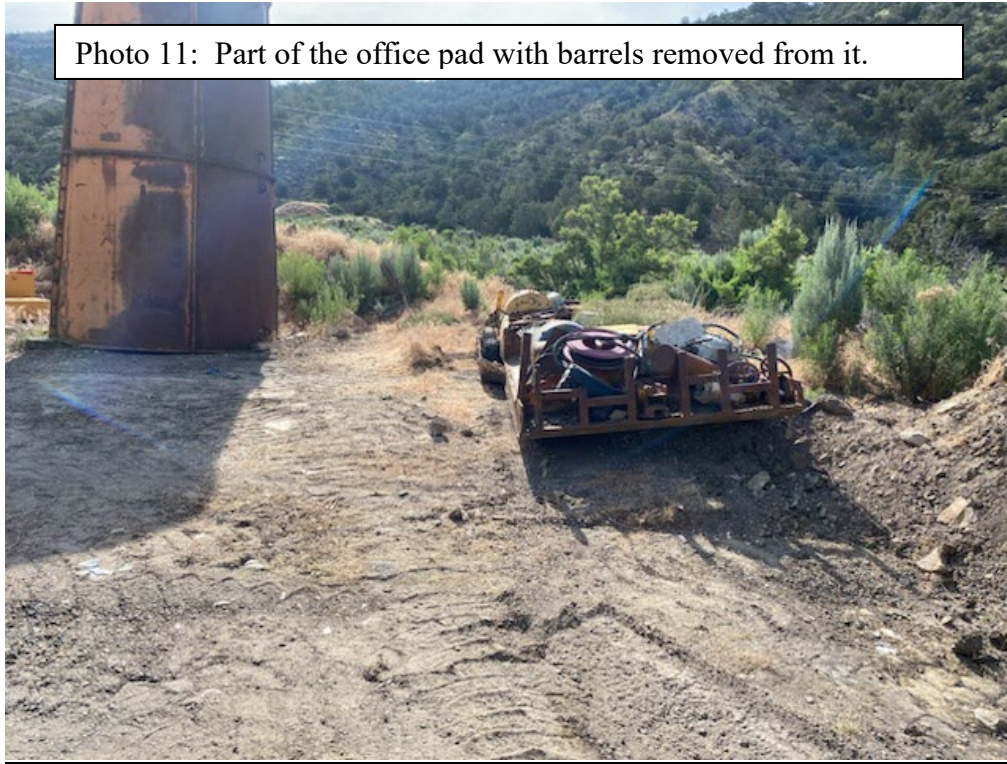
15. *Remove all barrels and containers with liquids from the mine office pad. Dispose of the barrels and any containers with liquids in accordance with the approved SPCC.* All barrels and containers with liquids had been removed from the mine office pad. A couple of containers currently being used were located within a secondary containment structure. No off-site impacts were observed. (Photo 11 and 12)

Photo 11: Part of the office pad with barrels removed from it.

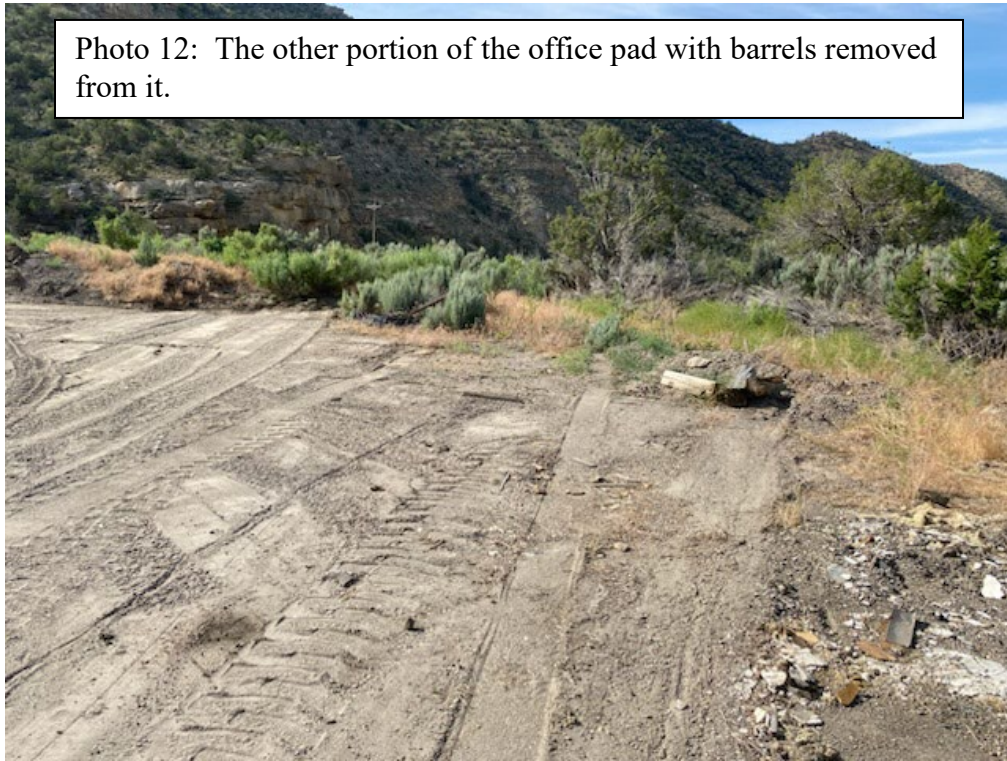
Photo 12: The other portion of the office pad with barrels removed from it.

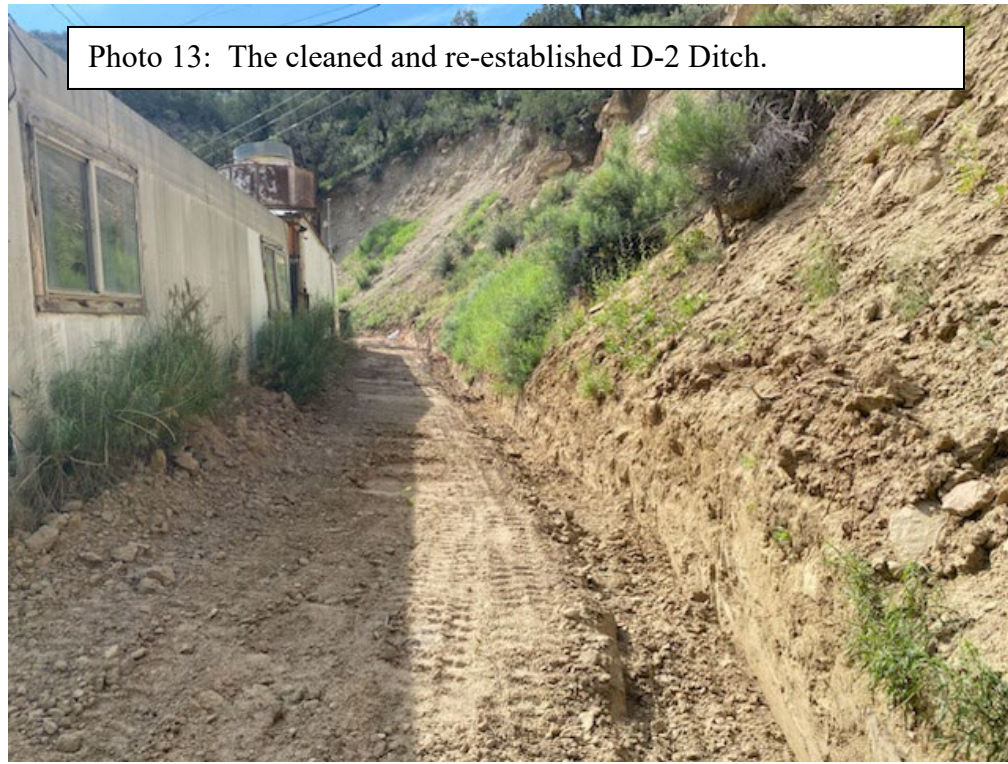
16. *The clearwater diversion ditch, D-2, located behind the south side of the shop needs to be cleaned out and reestablished to ensure proper conveyance of water from undisturbed areas around the disturbed areas of the Portals Bench.* Ditch D-2 had been cleared of any debris and the channel was re-established. (Photo 13)

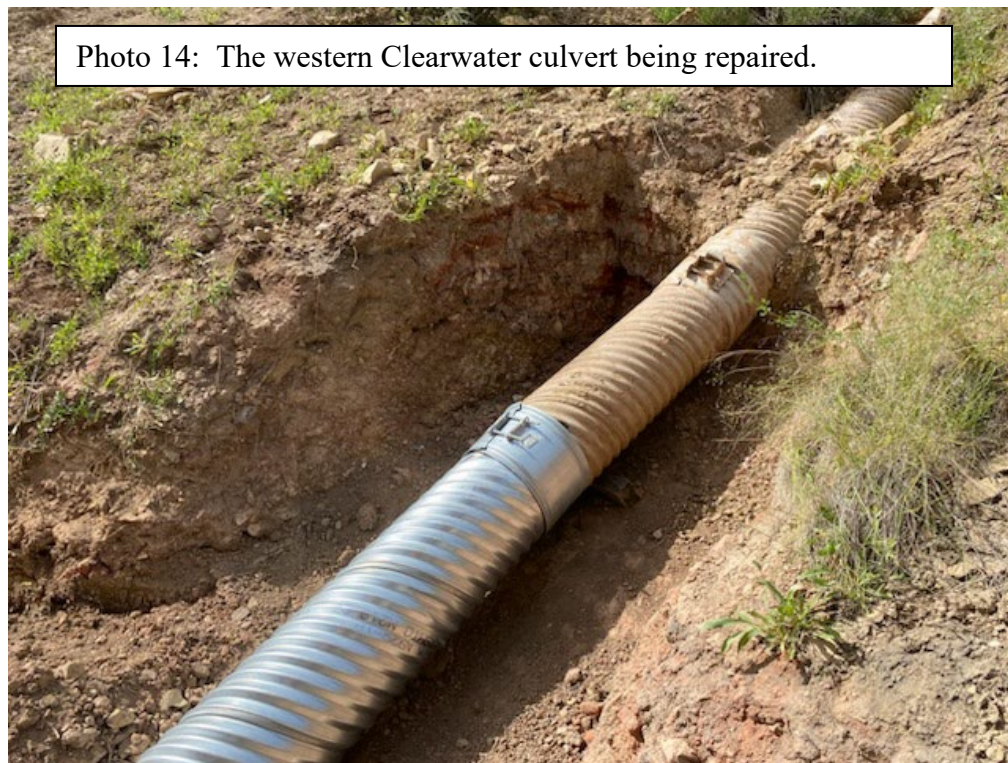
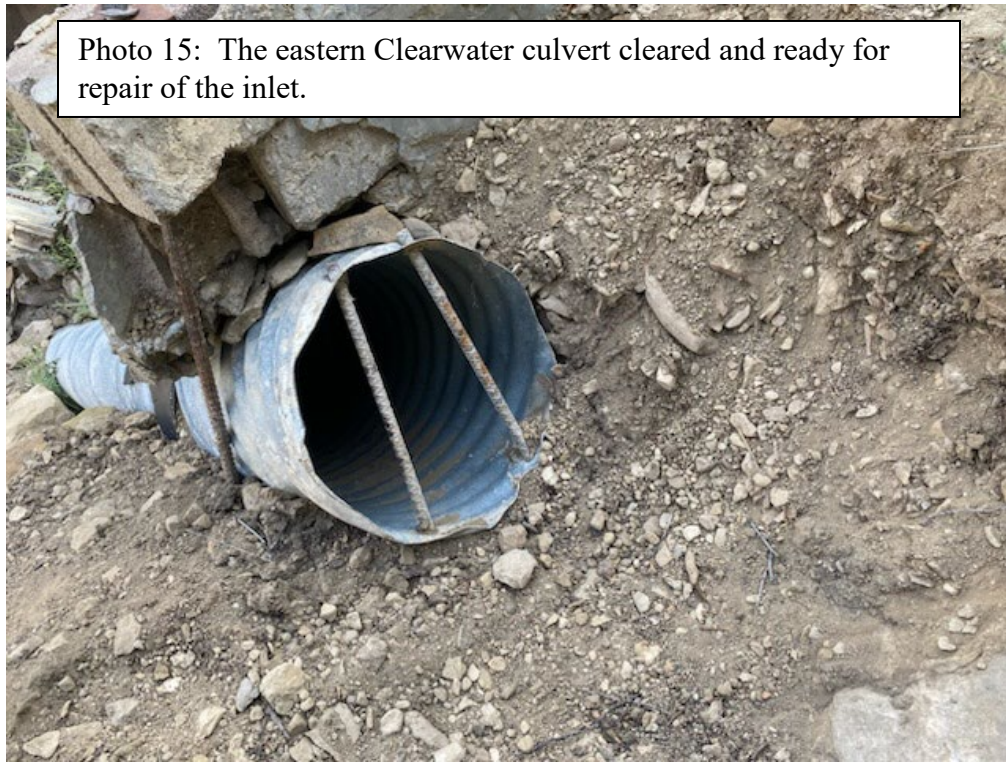
17. *A revision needs to be submitted to the Division to repair the functionality of surface water features for clearwater drainages D-5. Both Clearwater culvers are completely plugged. The revision could alter these features to surface ditches that would connect to Ditch D-2. During the inspection both Clearwater culverts had been unplugged and were being repaired to restore the designed functionality. Since both culverts can be restored, no revision is necessary to restore the functionality of the drainage design. (Photos 14 and 15)*

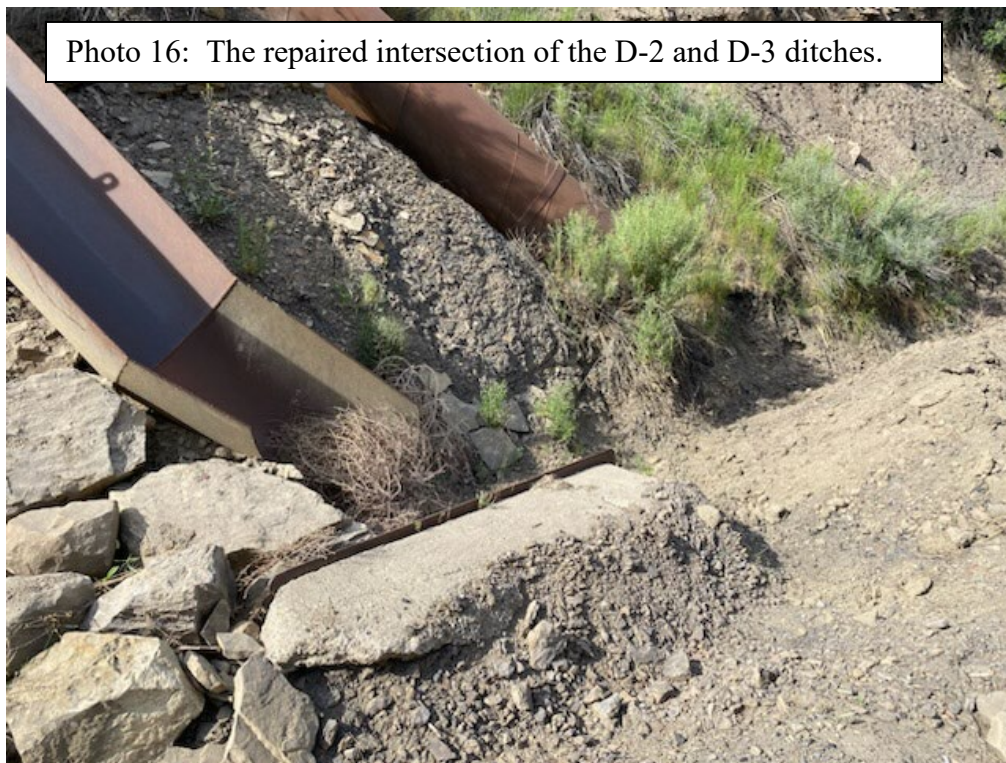
18. *The connection between Clearwater ditches D-2 and D-3 has become filled with sediment and breached the berm onto the haul road. Repair this connection between the D-2 half culvert into the D-3 ditch. This section needs to be cleaned and returned to its original design to prevent Clearwater from entering the disturbed area. The connection between Ditches D-2 and D-3 was repaired. The connection between the ditches had been cleaned and the berm had been restored to original design specifications. (Photo 16)*

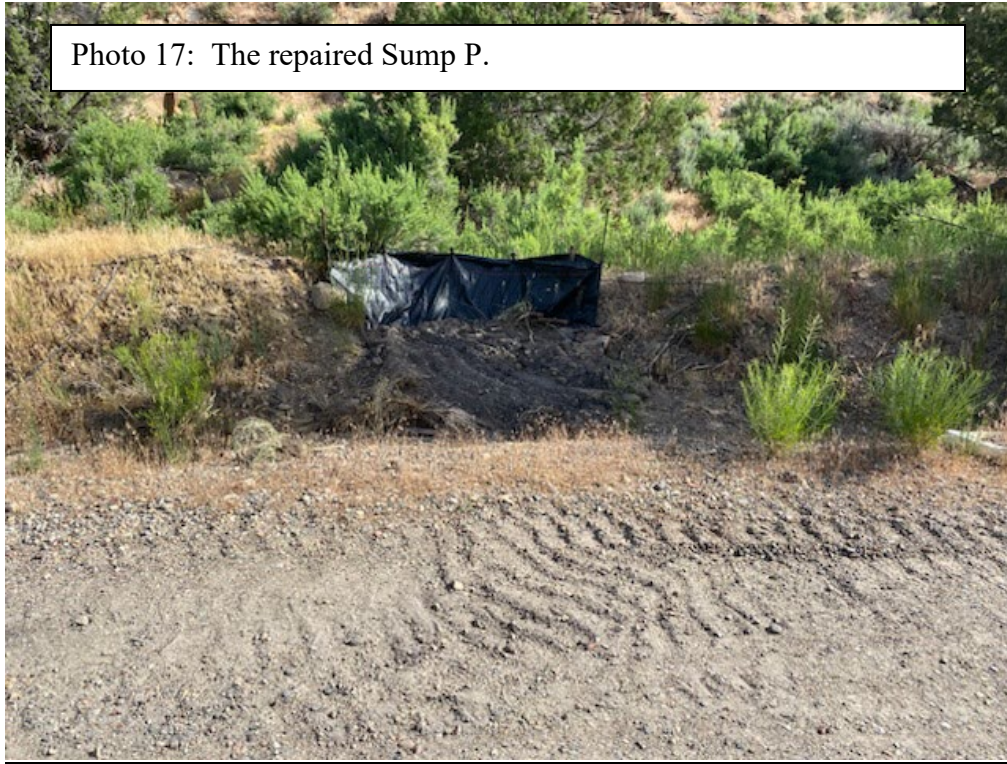
21. *Sump P along the north side of the haul road to the east of the sediment pond has filled with sediment and the silt fence on the outlet has fallen down. Clean out Sump P and repair the silt fence. Sump P had been cleaned out and the silt fence had been replaced. (Photo 17)*

Photo 17: The repaired Sump P.

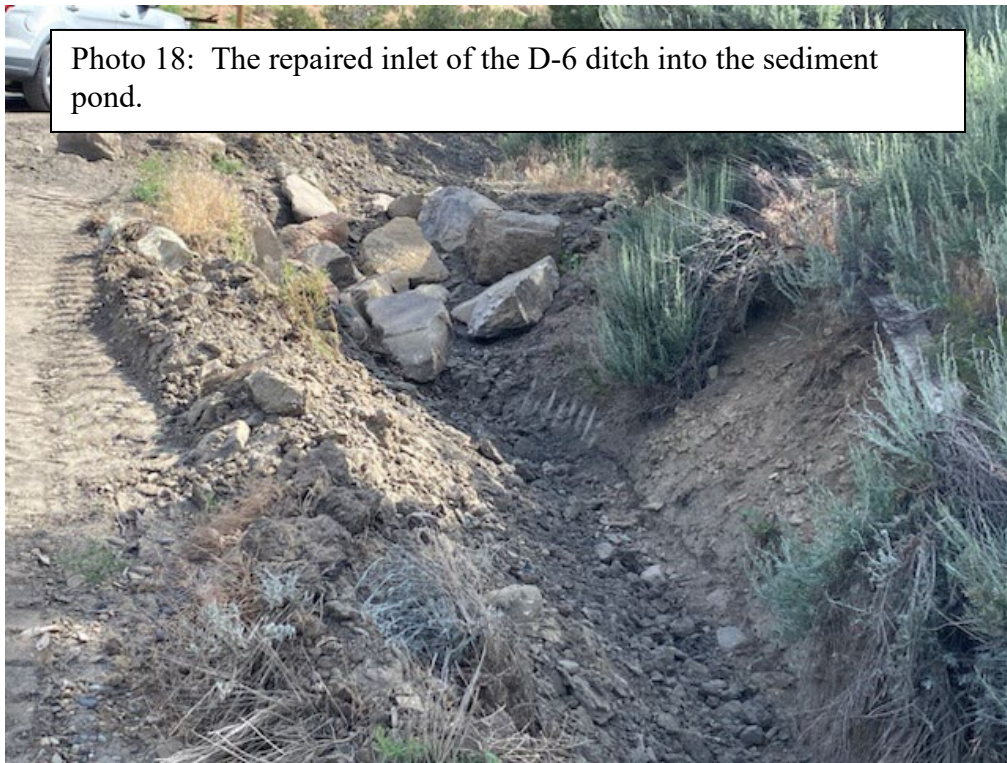
22. *Repair the inlet of ditch D-6 into the sediment pond. The inlet has partially filled with sediment and then significantly down cut before entering the sediment pond. The inlet to the sediment pond from Ditch D-6 had been repaired and armored with rocks. (Photo 18)*

Photo 18: The repaired inlet of the D-6 ditch into the sediment pond.

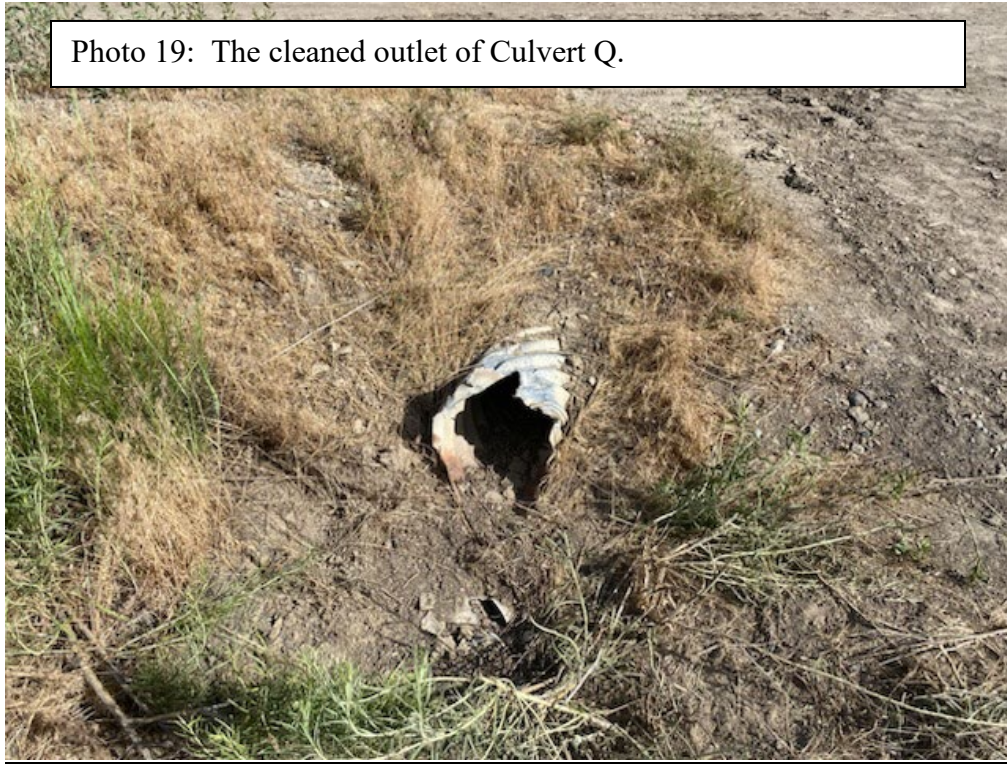
23. *Clean out the outlet of culvert Q that leads into the sediment pond on the south side of the haul road. The culvert has become partly obstructed by sediment. The outlet to Culvert Q had been cleaned and there were no remaining obstructions. (Photo 19)*

Photo 19: The cleaned outlet of Culvert Q.

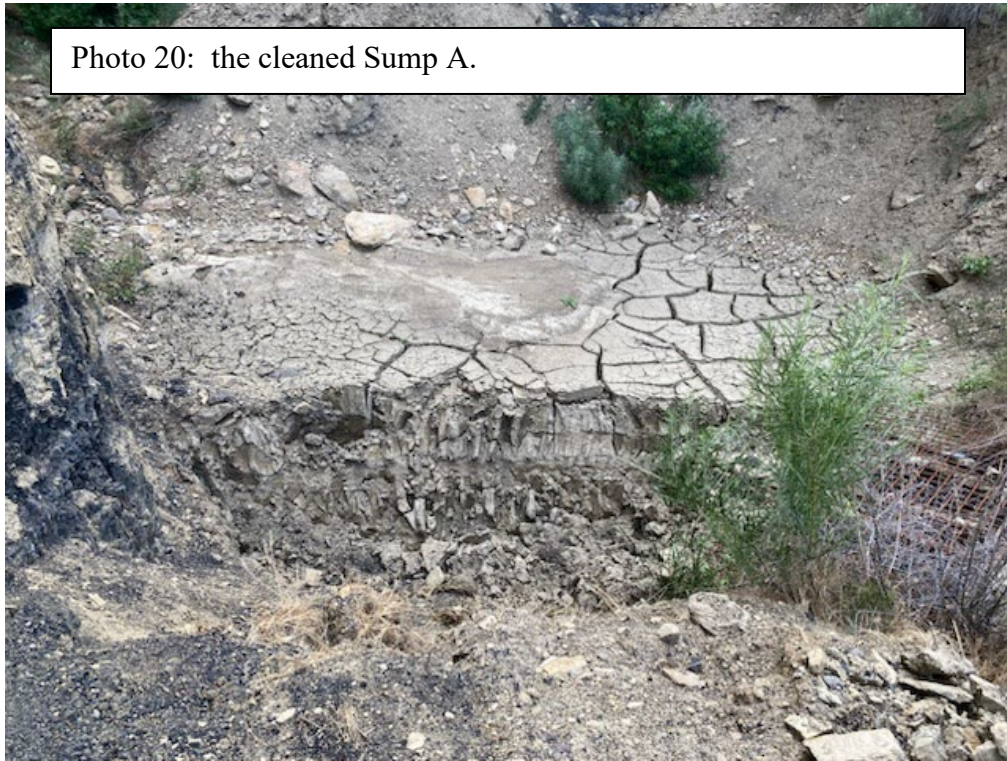
27. *Replace the subsoil pile marker on top of the subsoil stockpile. The subsoil pile marker was observed to be placed on top of the subsoil stockpile.*
28. *Sump A has had material slough off the box canyon walls and deposited into the mouth of the sump. The most amount of material feasible needs to be cleaned out from the sump. The operator had used a mini excavator to clean out Sump A as much as possible. (Photo 20)*
29. *Several rills were identified on the haul road adjacent to the shop. The rills need to be filled.*

Photo 20: the cleaned Sump A.
