## Roadside Mine, C-1981-041, June Complete Inspection Report

**PERMIT INFORMATION**

**INSPECTION INFORMATION**

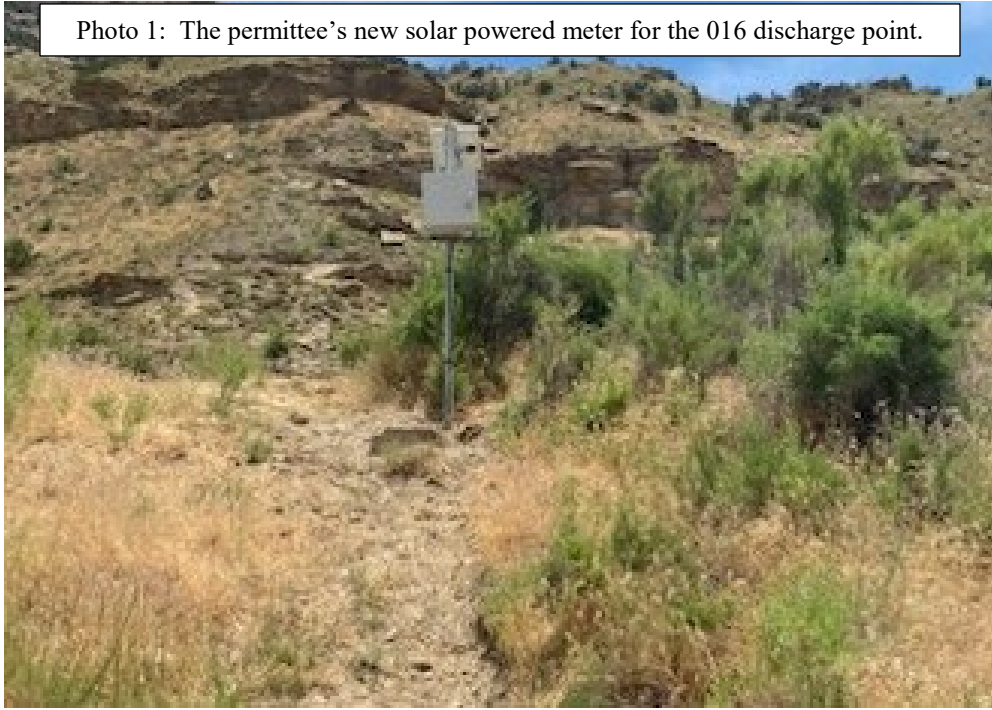
The water monitoring point 016 was visited during the inspection. The operator had recently installed a solar powered meter on the discharge outlet (Photo 1). The outlet was discharging at a rate of 134 gallons per minute. This value is within the historical seasonal range of data collected at this site. The outfall discharge pipe was in good condition and no obstructions were observed.

Photo 1: The permittee's new solar powered meter for the 016 discharge point.

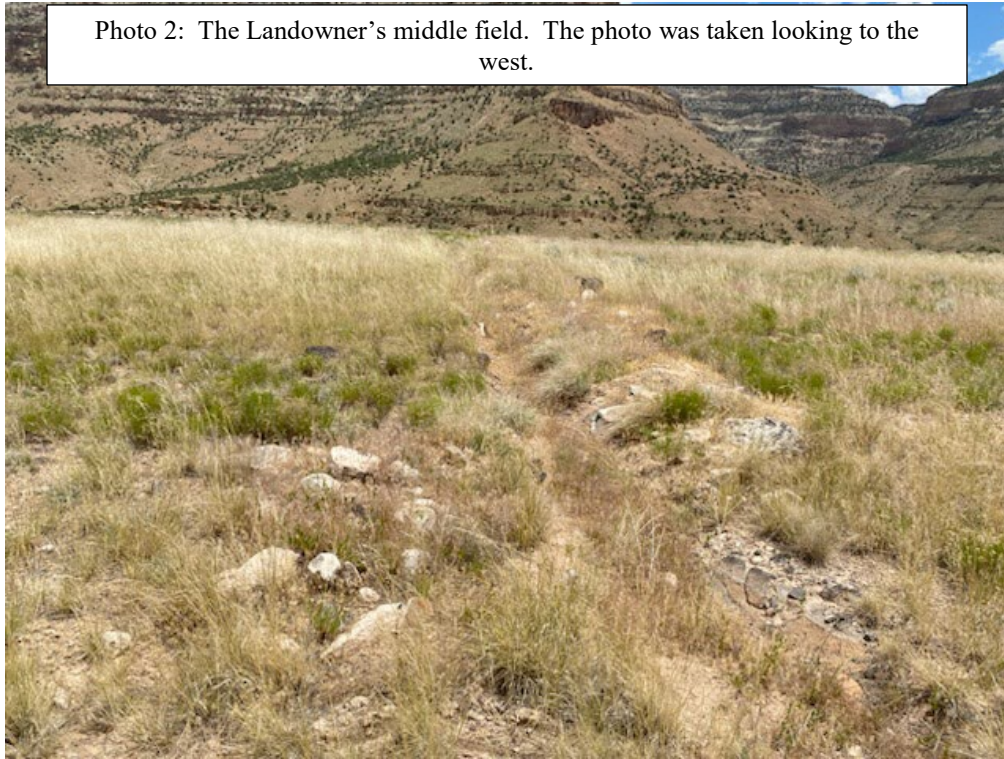
No water was observed flowing in the landowner's trenches on the southern part of the Tract 70 Mesa. The trenches were dry indicating that there has been no recent water application to the area. The landowner's middle

field was also dry (Photo 2). The water conveyance pipes were not hooked up at the time of the inspection. The landowner's pipe at the head of the Tract 71 trench was not hooked up. The east (Photo 3) and north portions of the trench were dry indicating that there has been no recent water application to the ditch. The Carey pit, located in the southwestern portion of the permit area was also dry (Photo 4). There was no evidence of recent flow from the landowner's buried pipeline into the pit.

Photo 2: The Landowner's middle field. The photo was taken looking to the west.

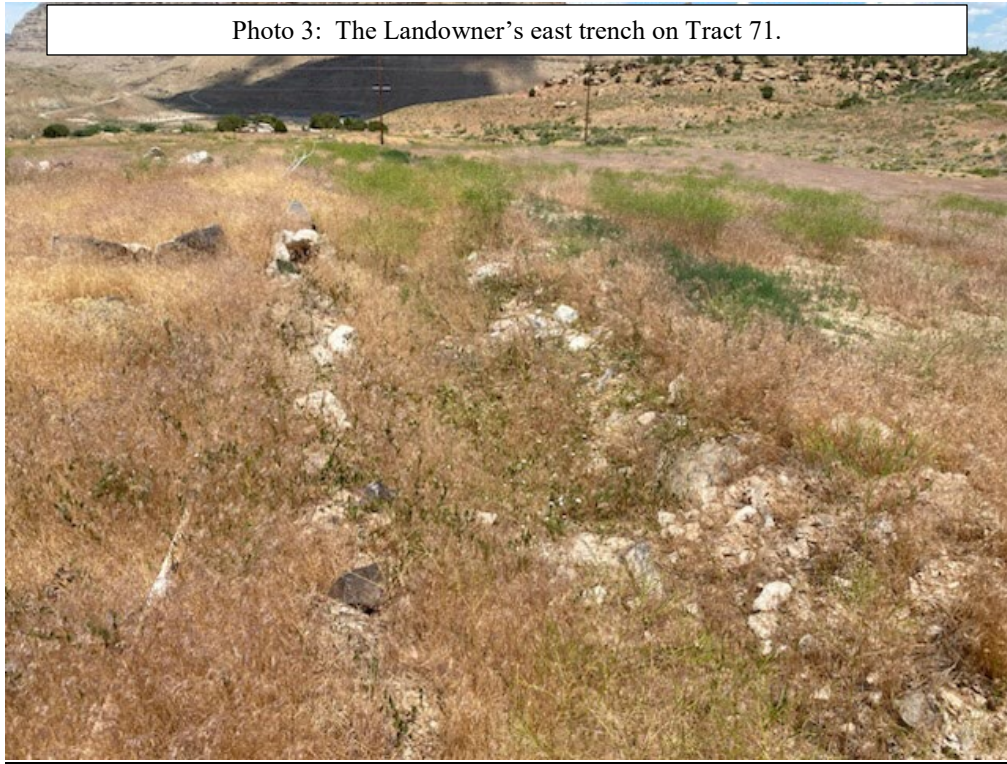
Photo 3: The Landowner's east trench on Tract 71.

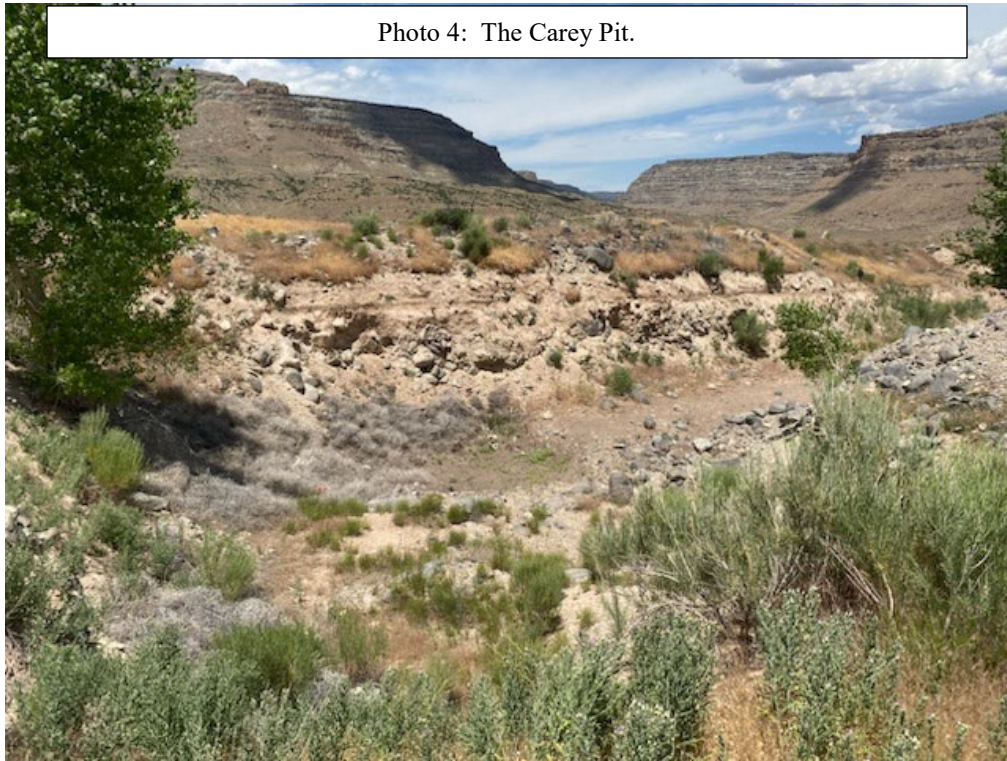
Photo 4: The Carey Pit.

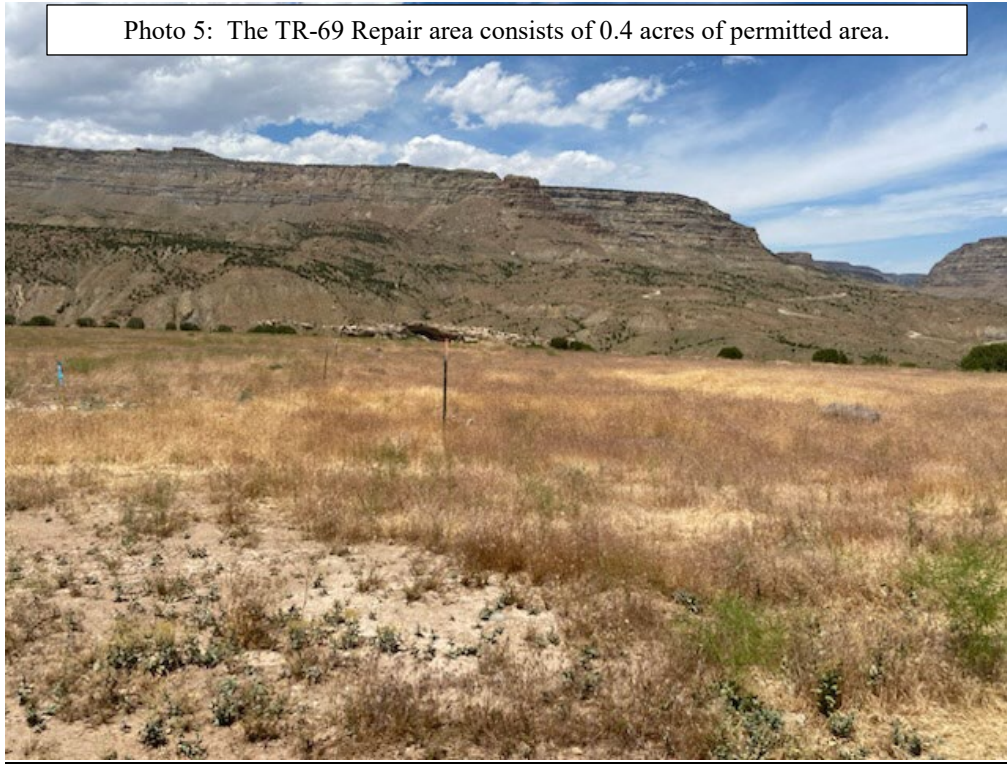
The remaining disturbed area permitted at the Roadside Mine is approximately 0.4 acres located within the northwestern part of what is referred to as Tract 71. The reclamation and seeding of the area was completed in the fall of 2019. The site was stable with vegetative cover (Photo 5). There were no indications of erosional features. The straw waddle placed along the down gradient portion of the site were in good condition. There were no off-site impacts observed. The disturbed boundary is marked by several T-posts. The T-posts were intact and remained in the correct locations.

Photo 5: The TR-69 Repair area consists of 0.4 acres of permitted area.
