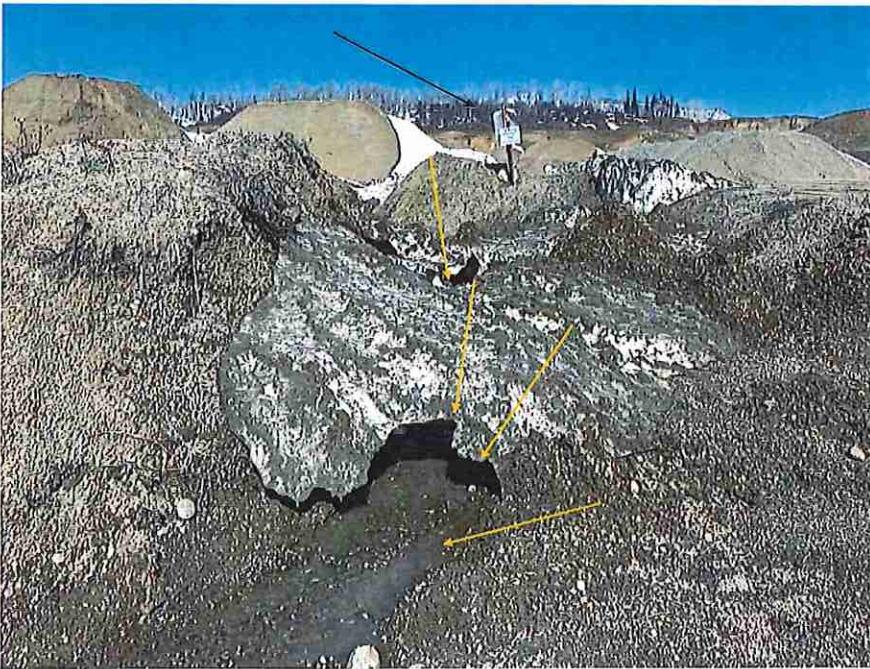
Pit sign

Water flow (run off)

Photo 8: View north of sediment pond and break in the dam which is allowing water to flow into the ditch along CR62. See above problem citation.

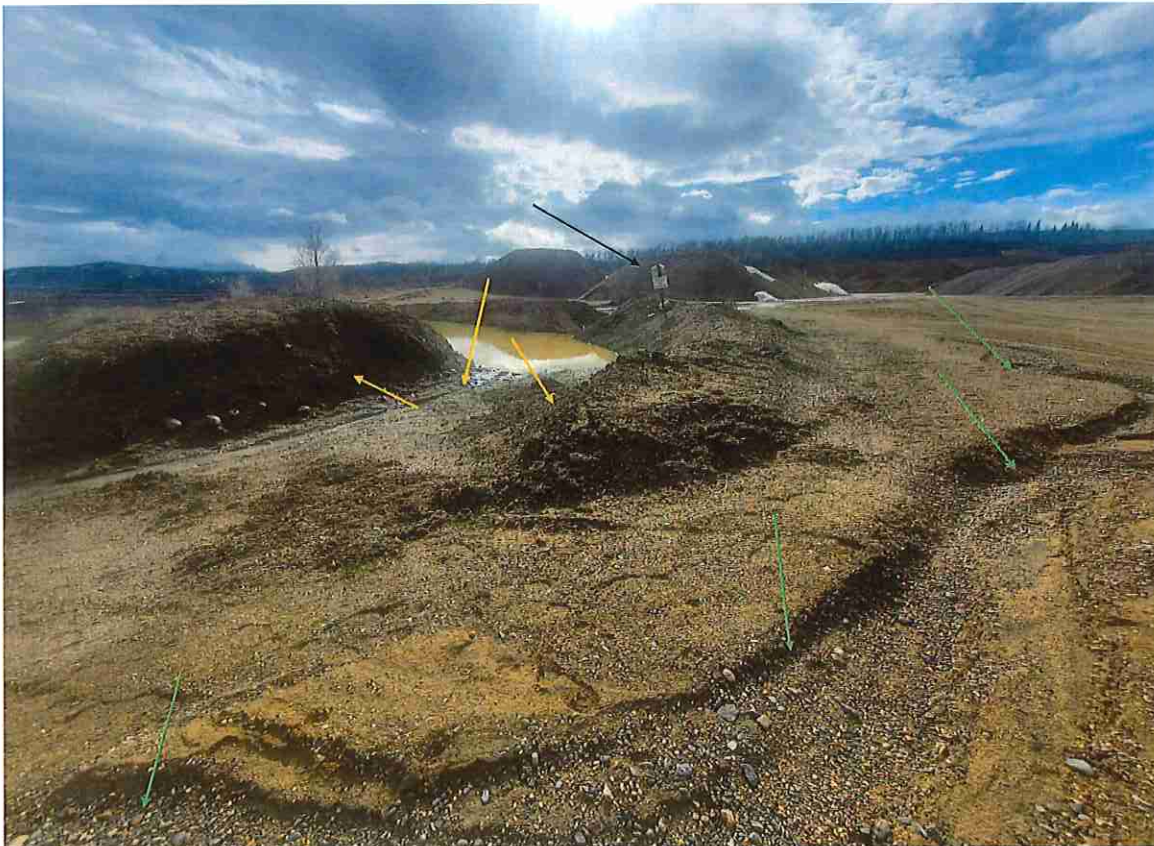
Pit sign

Water flow  
(damaged berm)

Damage caused  
by run off

The damage to the  
road in and the berm  
holding the water in  
the retention pond.

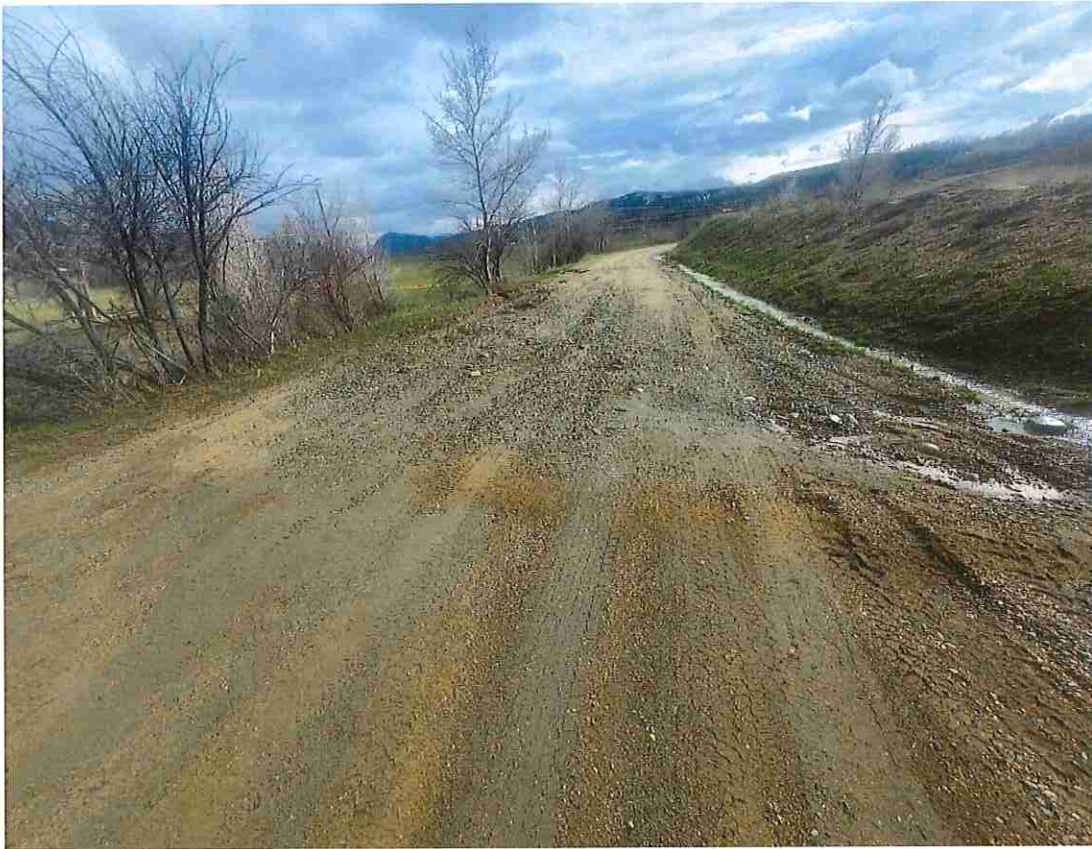
Damage to CR 62

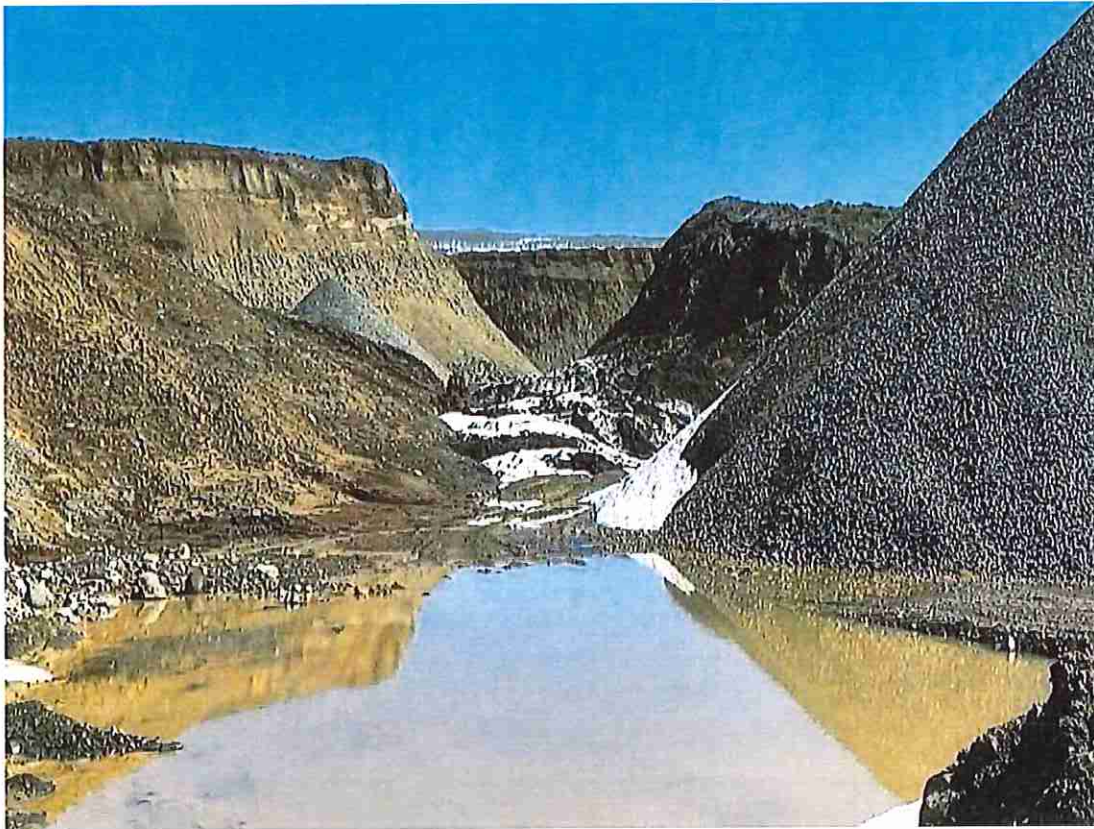
Standing water in Pit

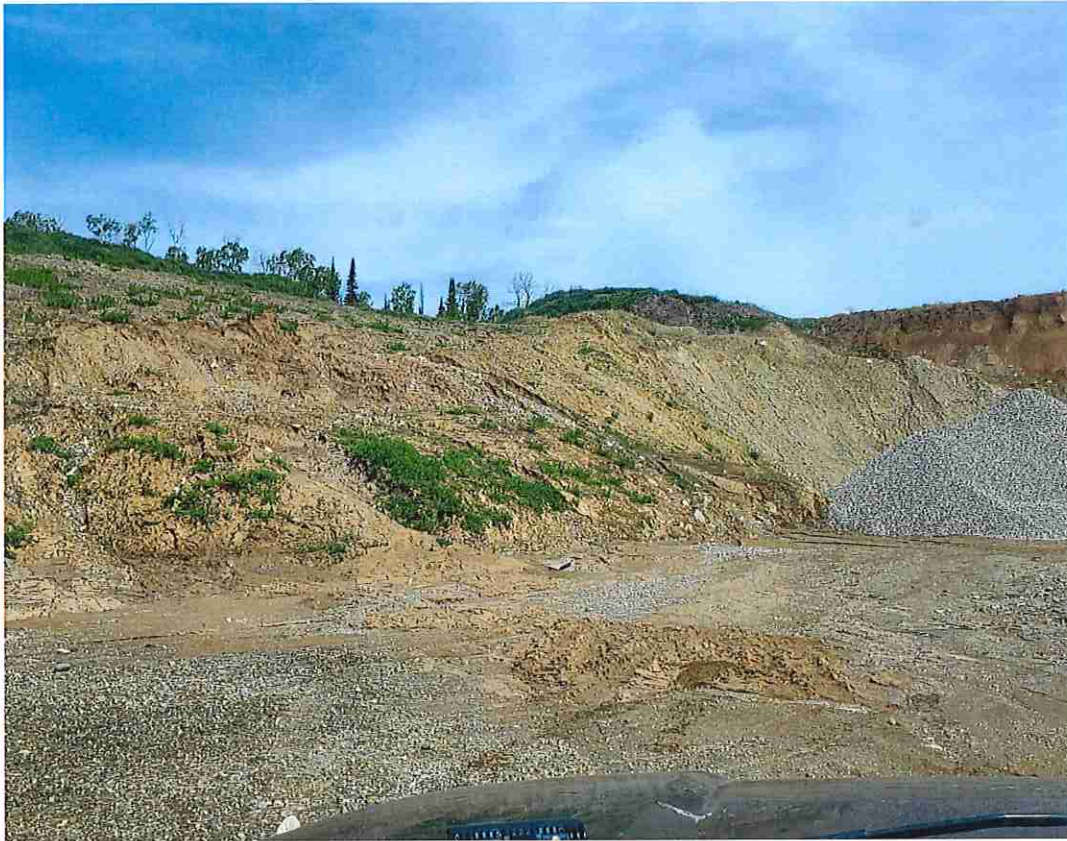
Standing water dissipated

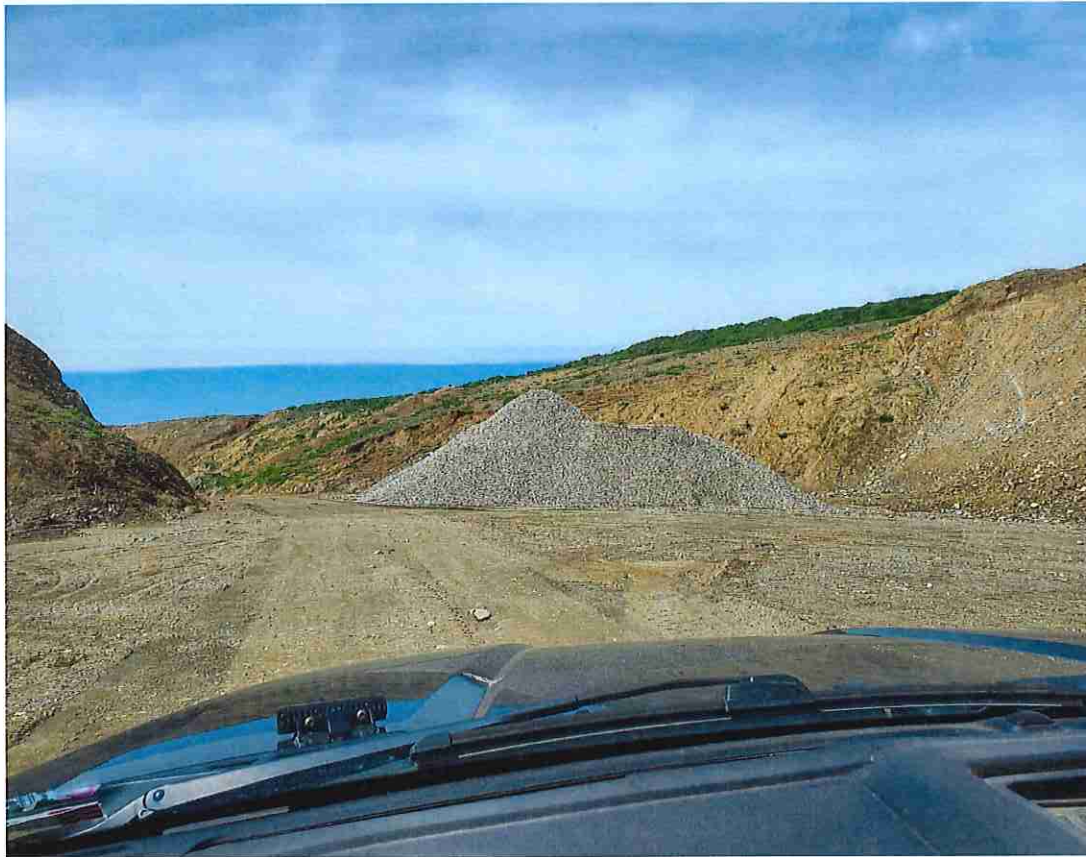
Standing water dissipated  
Both sides of the gravel pile

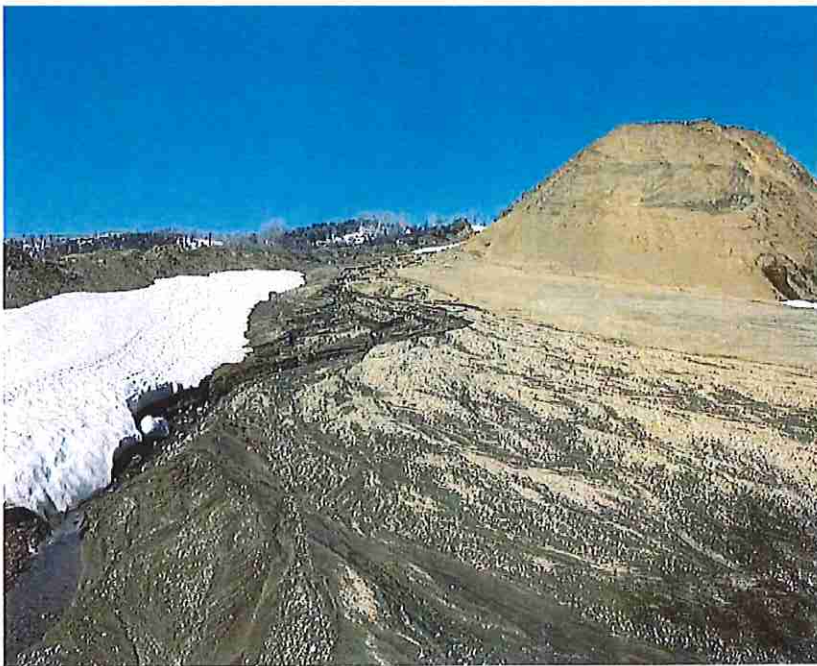
Extremely heavy run off  
Not enough capacity anywhere  
In the area for oncoming water

**Photo 10: View north of the western pit boundary. Deeply incised erosional features are seen coming from uphill where water drains to the sediment pond. Water is flowing outside of the ditch in which it is designed to collect.**

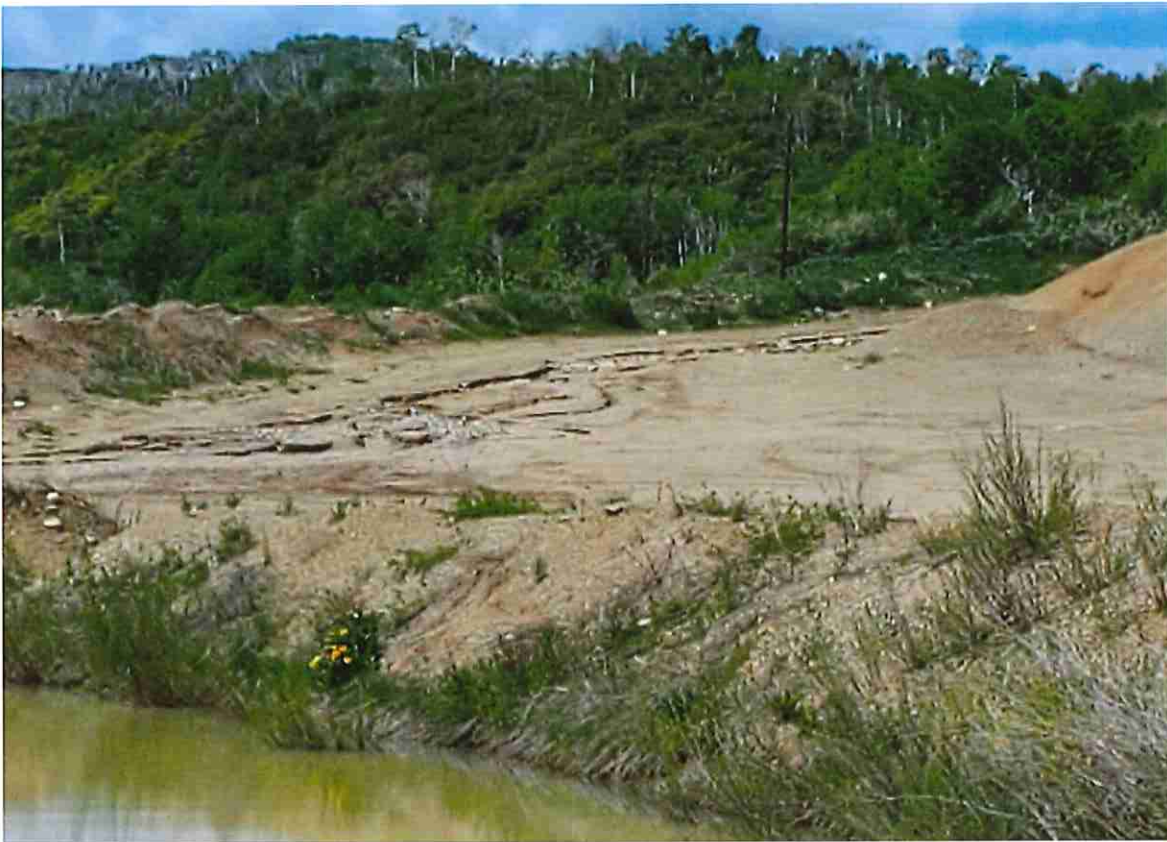
Run off slowed down  
Left deep ruts in the  
Pit floor

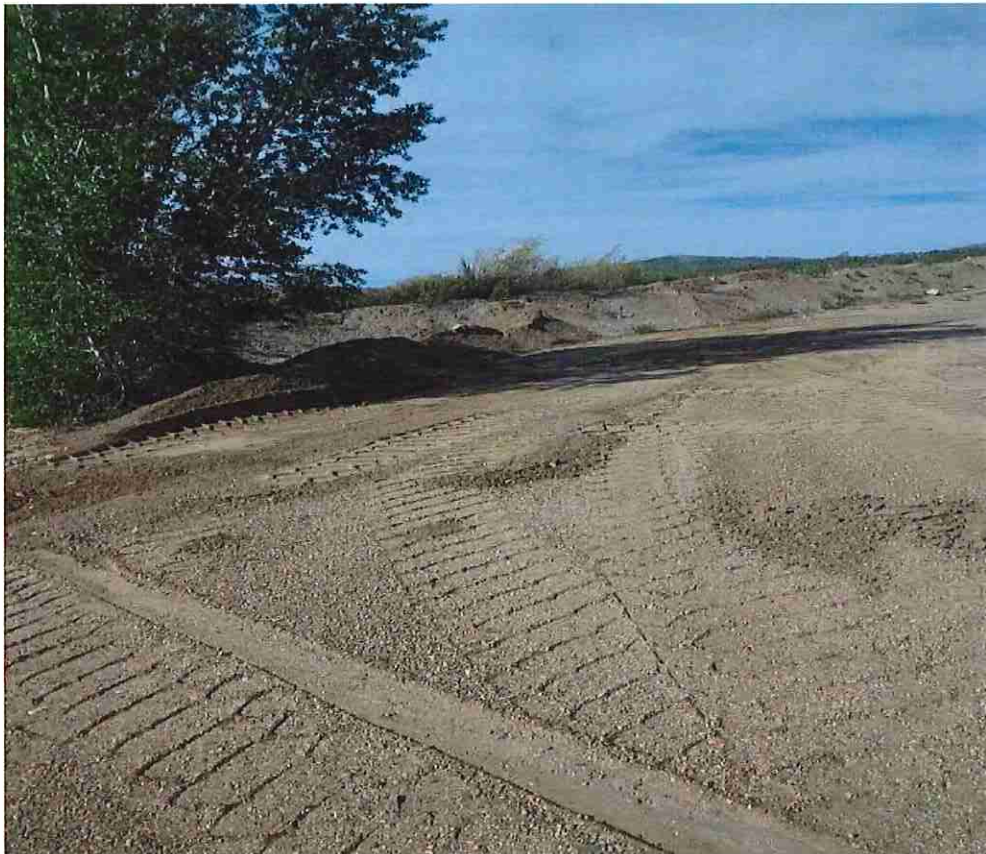
Looking up the hill where the  
snow damage was.
