MINERALS PROGRAM INSPECTION REPORT
PHONE: (303) 866-3567

MINE NAME: Stroh Pit	MINE/PROSPECTING ID#: M-2002-078	MINERAL: Gravel	COUNTY: Larimer
INSPECTION TYPE: Monitoring	WEATHER: Clear	INSP. DATE: June 27, 2023	INSP. TIME: 10:00
OPERATOR: Coulson Excavating Company, Inc.	OPERATOR REPRESENTATIVE: Ken Coulson	TYPE OF OPERATION: 112c - Construction Regular Operation	
REASON FOR INSPECTION: Priority	BOND CALCULATION TYPE: None	BOND AMOUNT: \$1,000.00	
DATE OF COMPLAINT: NA	POST INSP. CONTACTS: None	JOINT INSP. AGENCY: None	
INSPECTOR(S): Patrick Lennberg	INSPECTOR'S SIGNATURE:

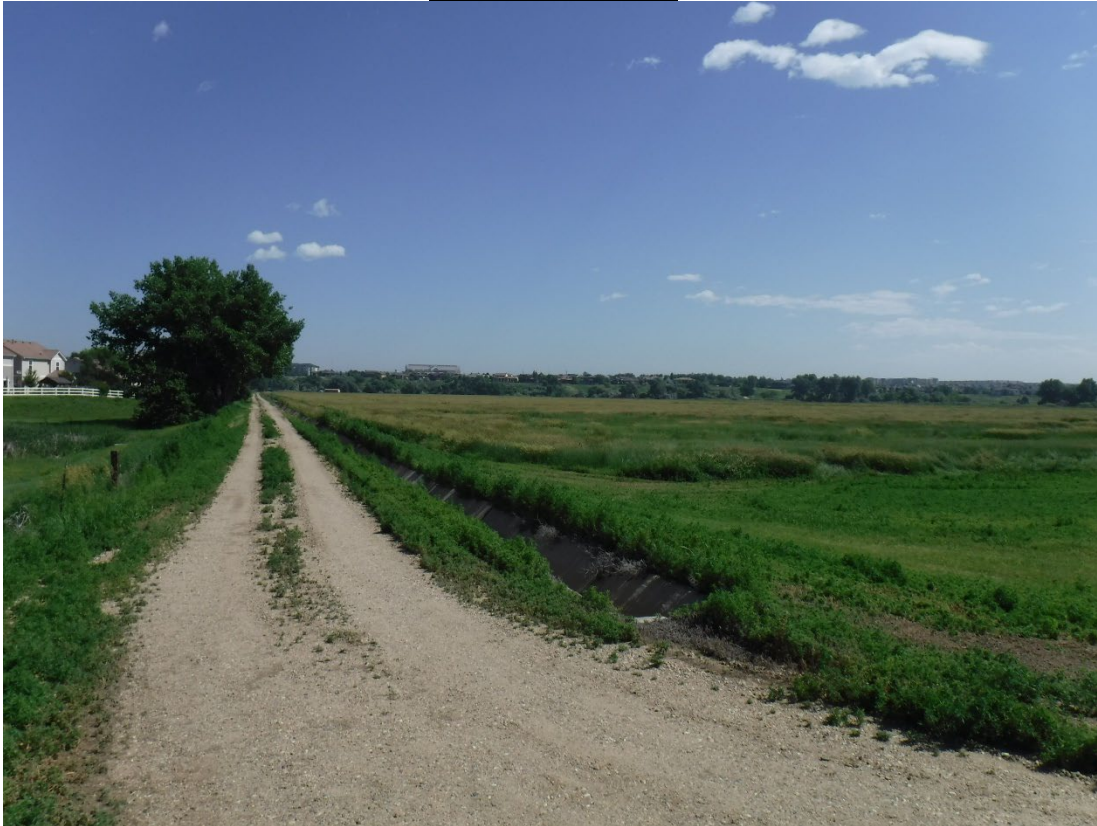
Photo 1: Looking north across the permit area from the SW corner of the permit

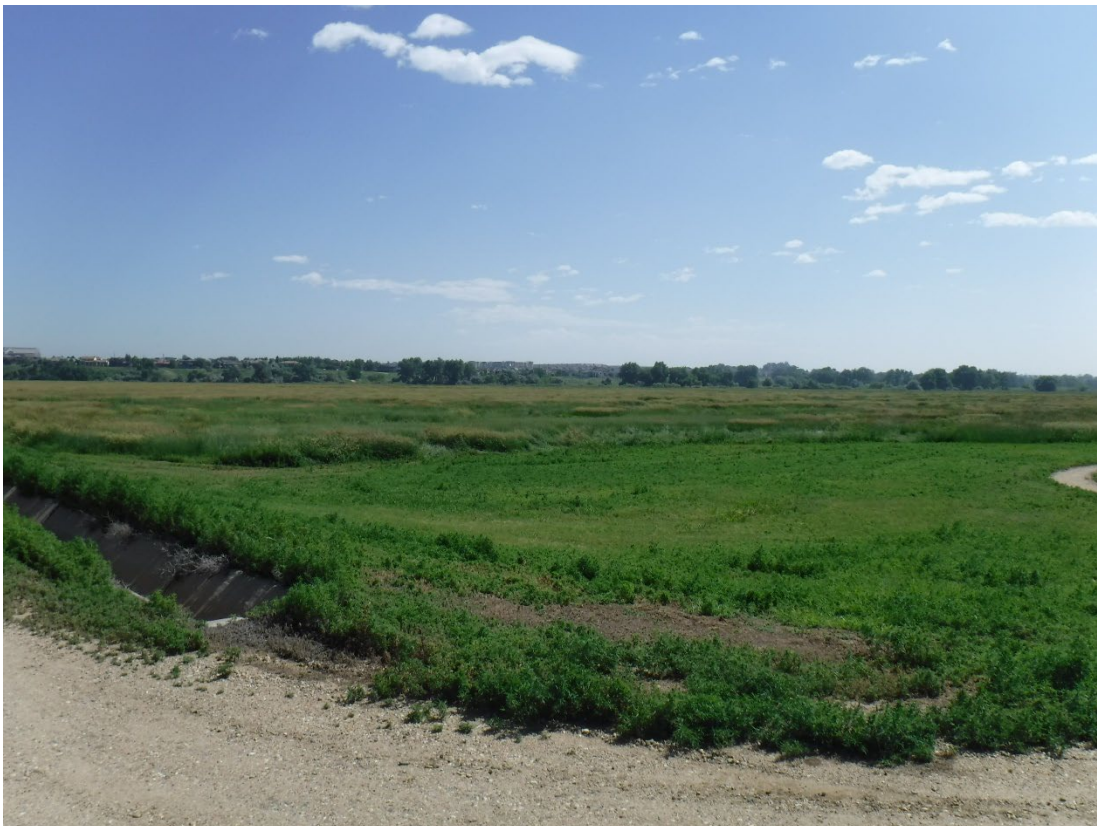
Photo 2: Looking northeast across the permit area from the SW corner of the permit

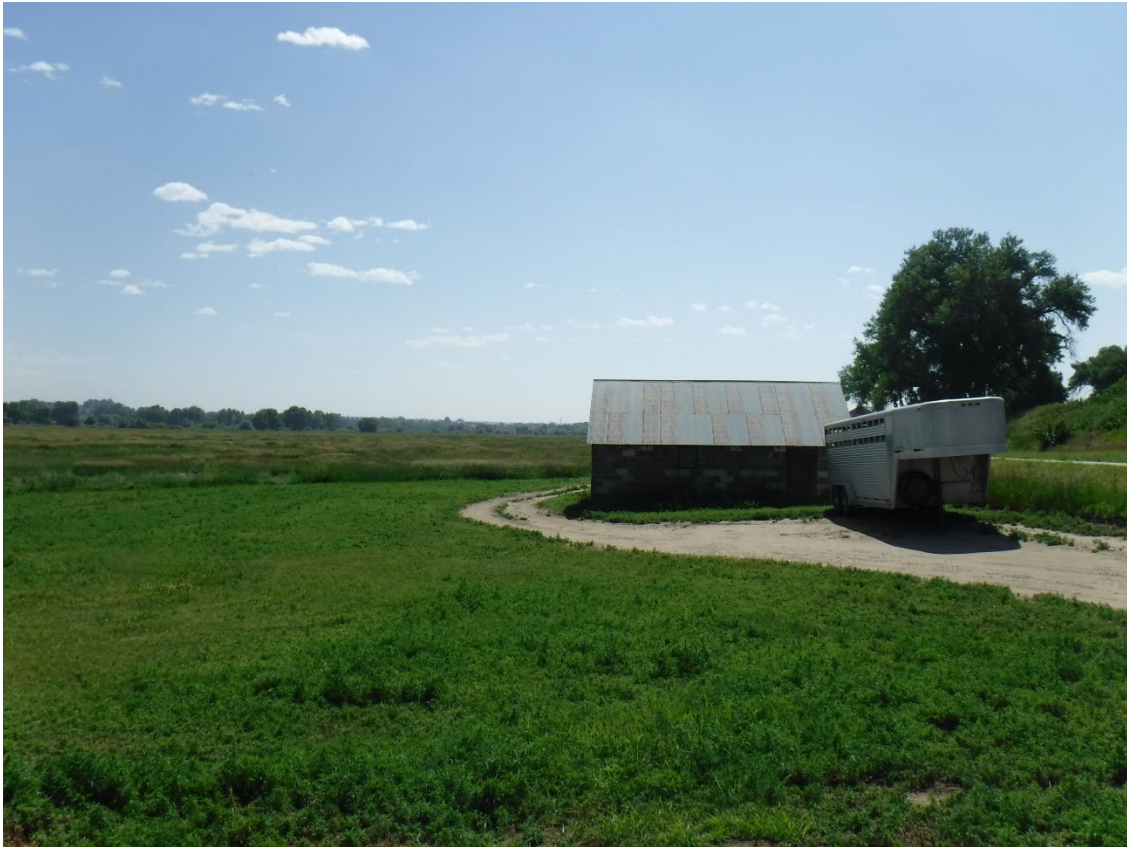
Photo 3: Looking east across the permit area from the SW corner of the permit

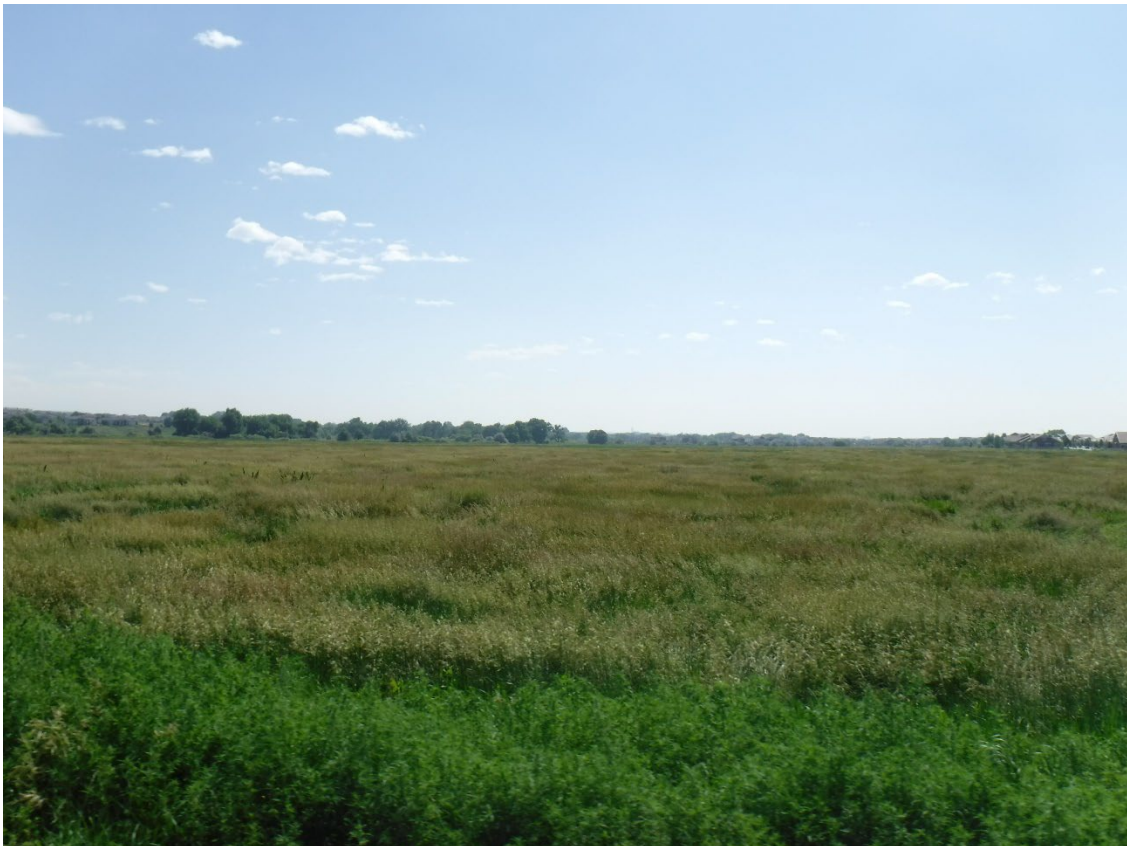
Photo 4: Looking east across the permit area from the midpoint of the western edge of permit
