Inspection Report, Foidel Creek Mine, C-1982-056

Permit Number: C-1982-056 Mine Name: Foidel Creek Mine Operator: Twentymile Coal, LLC Operator Address: Ms Miranda Kawcak 29515 Routt County Road No. 27 Oak Creek, CO 80467	County: Routt Operation Type: Underground Permit Status: Active Ownership: Private
	Operator Representative Present: Miranda Kawcak
Operator Representative Signature: (Field Issuance Only) Miranda Kawcak, Kevin Copeland, Mike Howard

Inspection Start Date: June 28, 2023 Inspection Start Time: 08:45 Inspection End Date: June 28, 2023 Inspection End Time: 13:30		Inspection Type: Coal Complete Inspection Inspection Reason: Normal I&E Program Weather: Clear	
Joint Inspection Agency:		Joint Inspection Contacts:	
Post Inspection Agency: None		Post Inspection Contacts:	
Inspector(s): Hunter Ridley	Inspector's Signature:

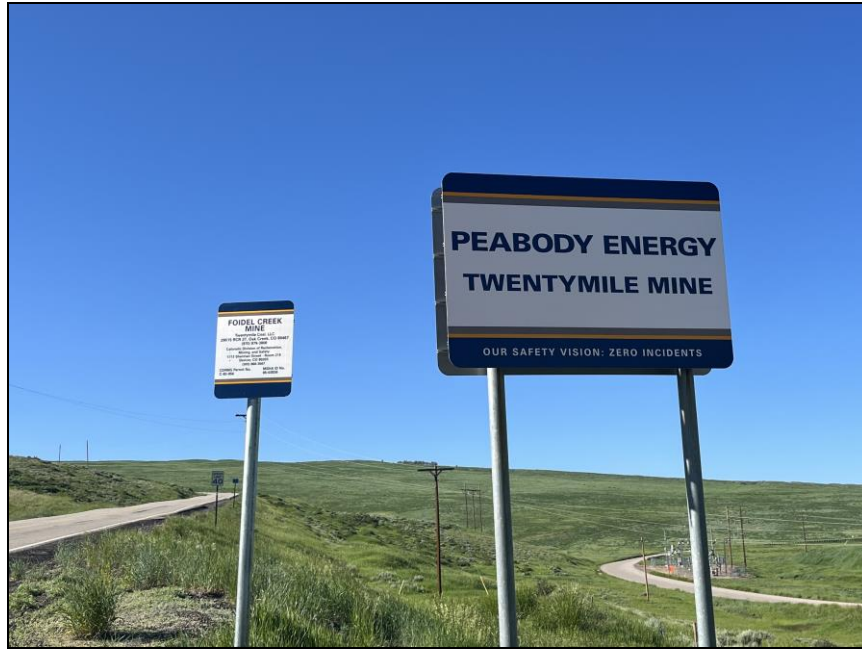
Mine identification markers were observed throughout the site (Photo 1). All information for compliance was present. The missing phone number information on mine signs for HG Loadout (see related inspection reports dated March 30, 2023, April 25, 2023 and May 2, 2023) has been amended.

Photo 1: Mine sign is located at the entrance to the main facilities off Highway 40.

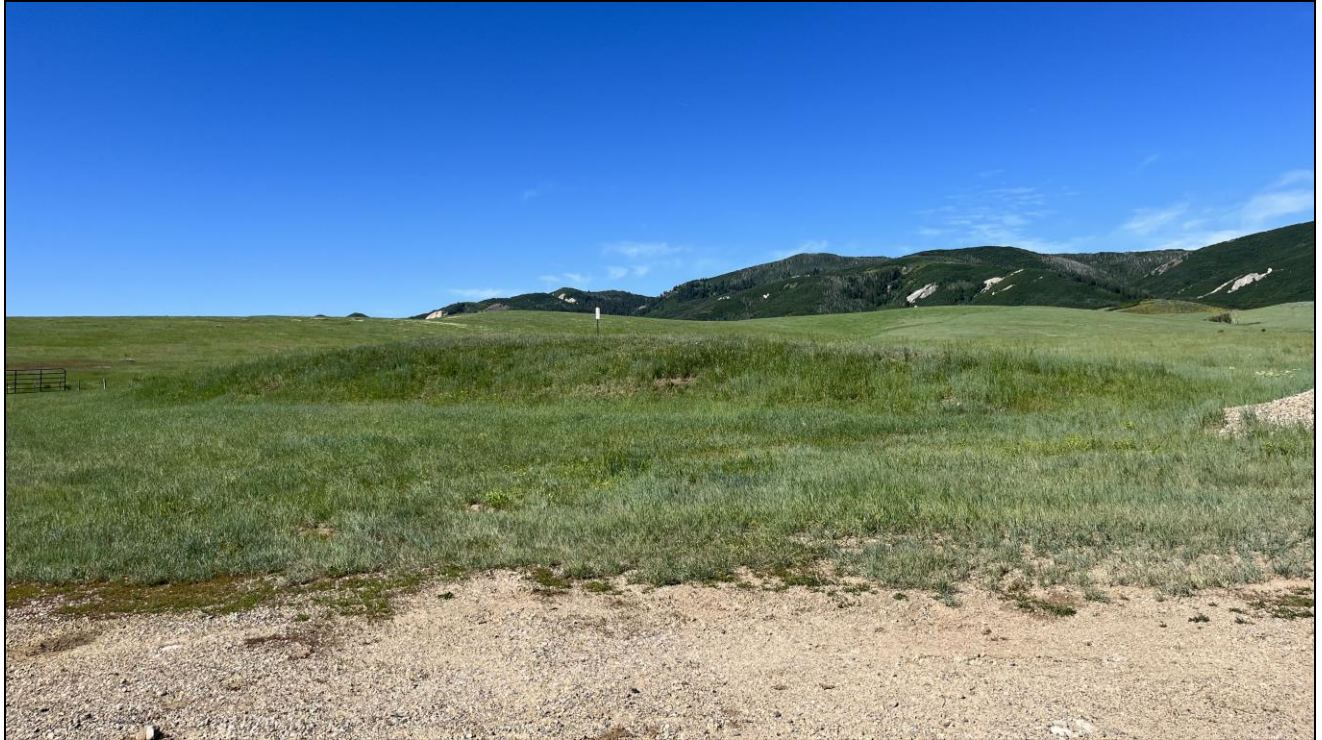
Topsoil piles around the entire site were checked for proper vegetation, stability, and appropriate markers. While all piles are properly vegetated and free of disturbance (Photos 2 and 8), some have missing or broken signs. Please ensure that all piles remain properly marked with signage at all times and broken signage is replaced in a timely manner. Topsoil piles were all appropriately reseeded approximately 1 month ago.

Photo 2: Example of an appropriately marked and vegetated topsoil pile, located at the 17 Left TUF borehole.

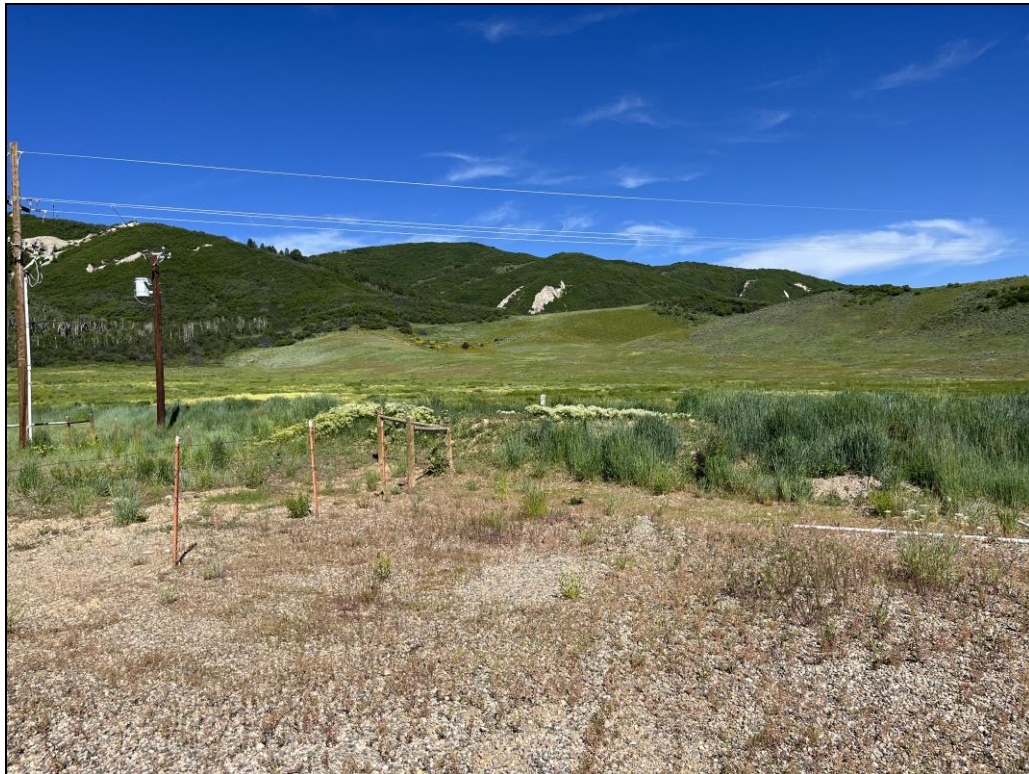
All borehole area sites were in good condition with proper storage of materials, fencing, topsoil piles, and drainage. The 16 L is a utility borehole which is not frequently utilized as the Wadge Seam in this area has been mostly mined out (Photos 3 and 4). 18 LT is a dewatering borehole and is in frequent use (Photo 5).

Photo 3: 16 LT utility borehole fencing and topsoil pile.

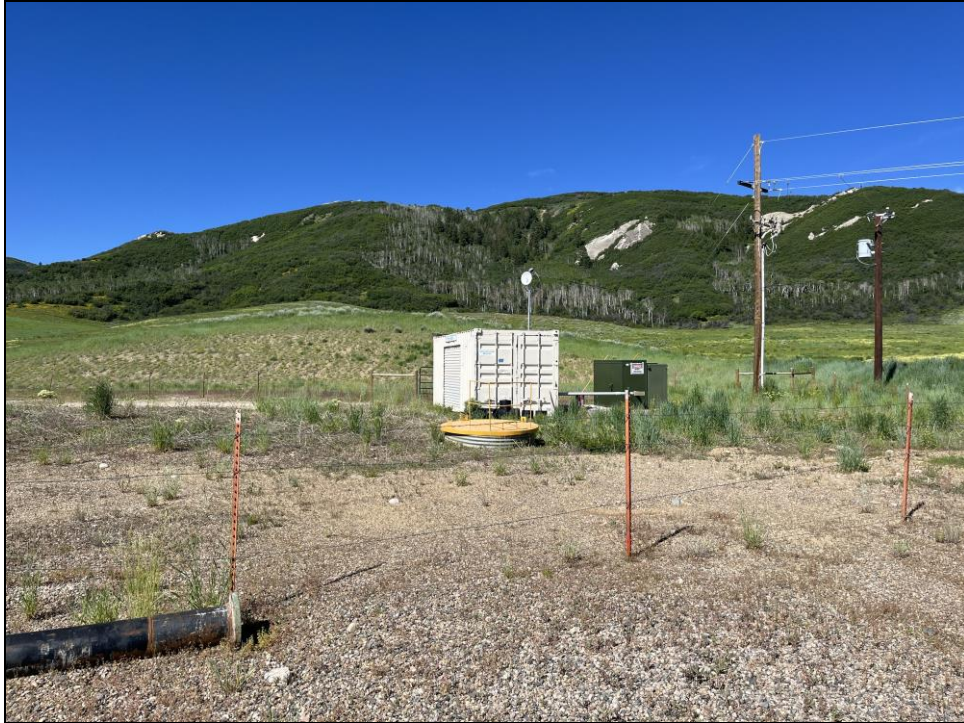
Photo 4: 16 LT utility borehole.

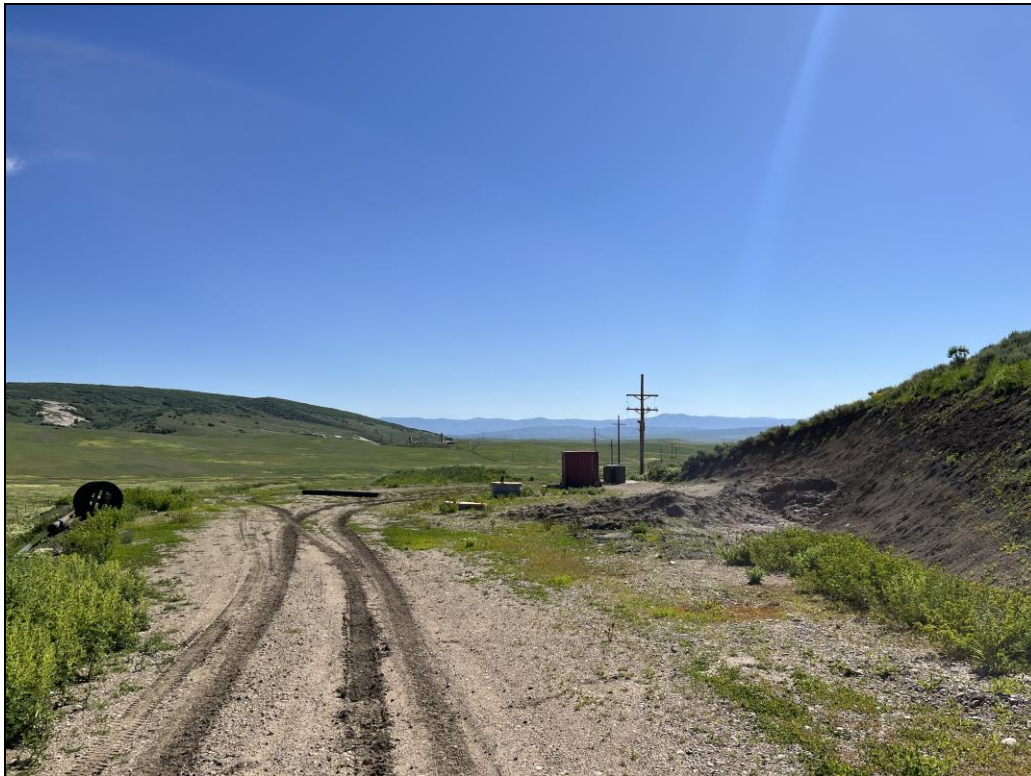
Photo 5: 18 LT Dewatering borehole

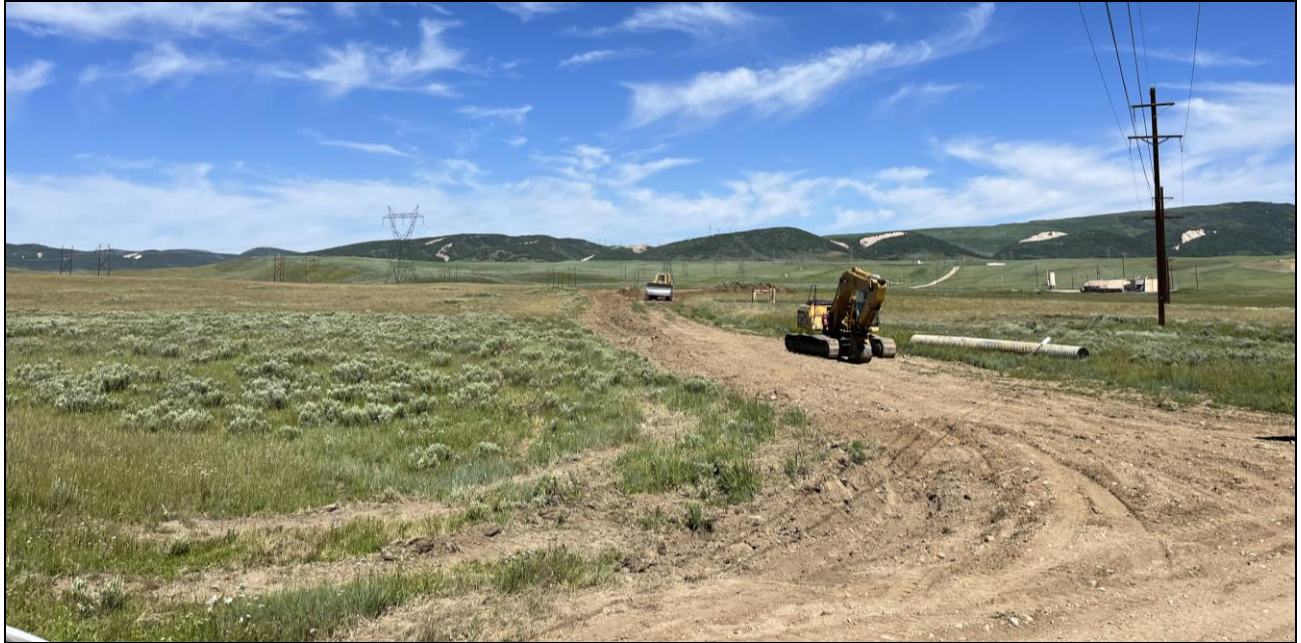
The 13 Left Outby Gate Road Utility Borehole has been nearly fully reclaimed. The end of the access road was being filled in at the time of inspection (Photo 6). This reclaimed area is scheduled to be seeded in the fall of 2023.

Photo 6: 13 Left Outby Gate Road Utility Borehole is nearly fully reclaimed. Photos shows access road being filled in.

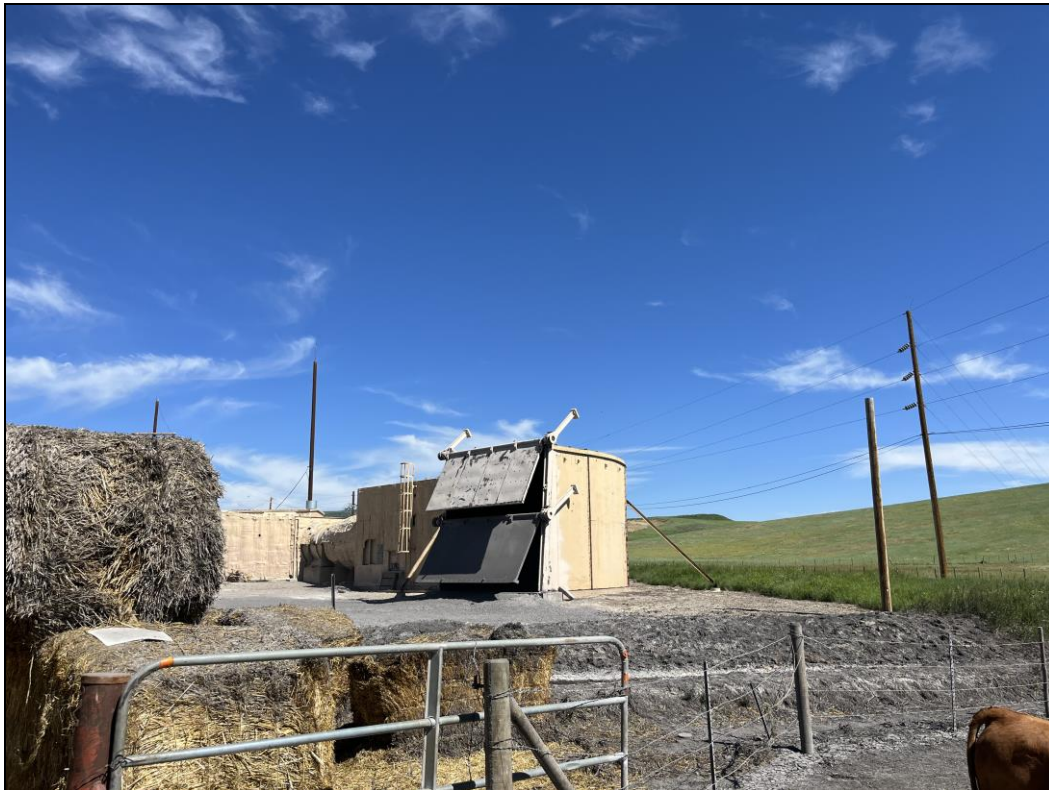
MR322 was issued by the Division on 10/25/2022 and approved the relocation of an internal road. This new road is set to be constructed in 2023 in the 6MN area. Hay bales put in place as a temporary remedy to the winter season fog issues in this area are still in place (Photo 7). RN-08 is currently in progress with the Division and has been extended to a decision date of July 21, 2023.

Photo 7: NW Mains Ventilation Shaft, area will be the site of new haul road construction as per MR322.

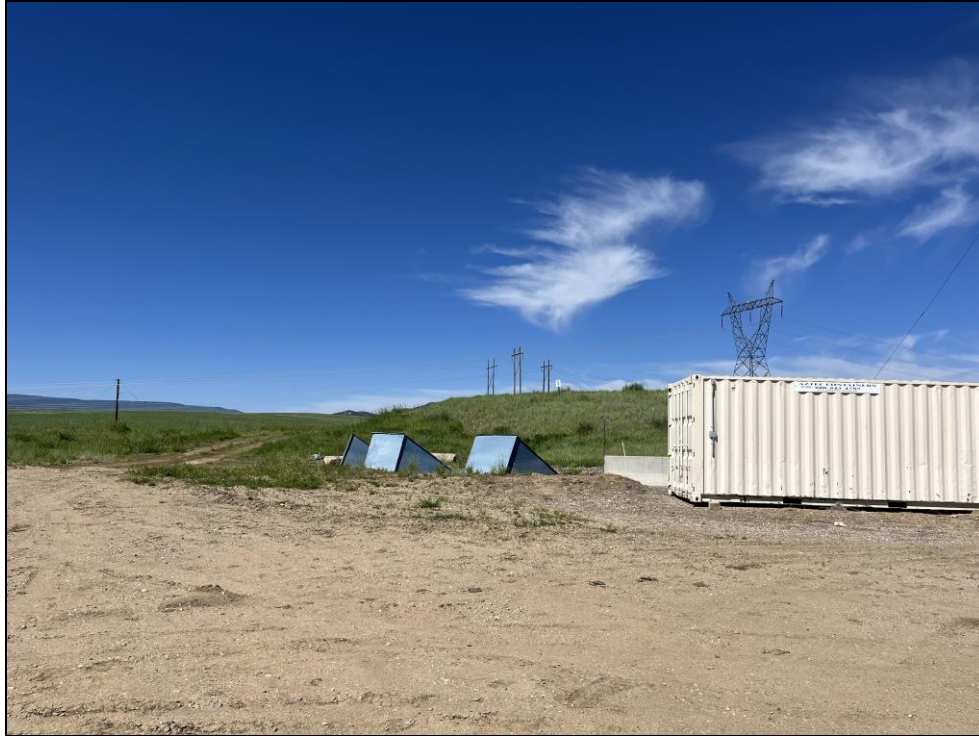
Photo 8: Topsoil pile and storage in the 6 Main North Vent Shaft area.

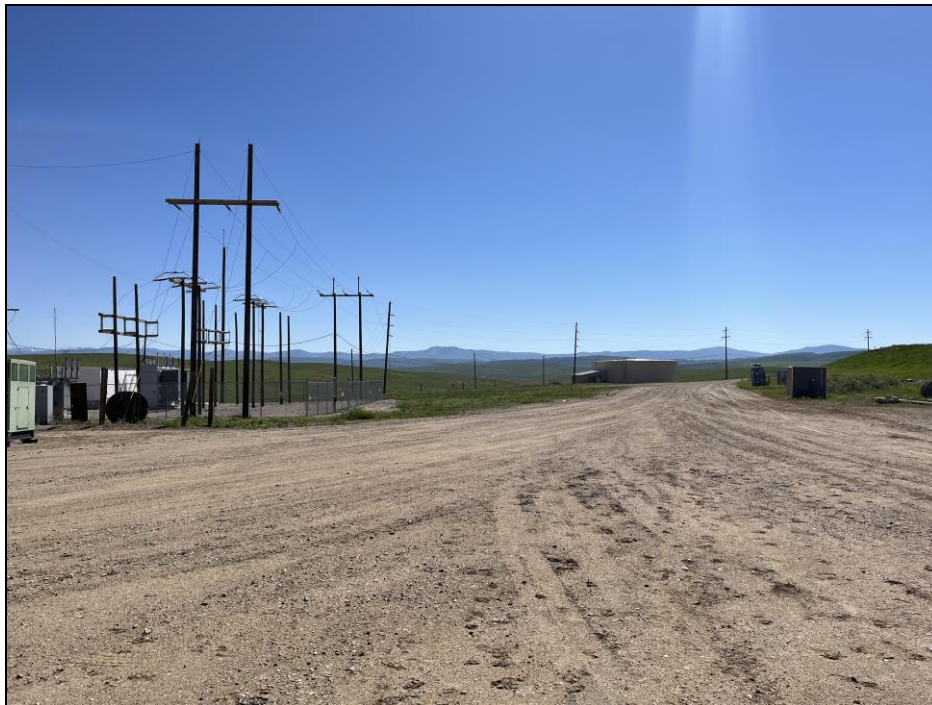
Photo 9: View east of the million gallon tank which holds mine water for used underground in dust supression. Located in the 6MN area.

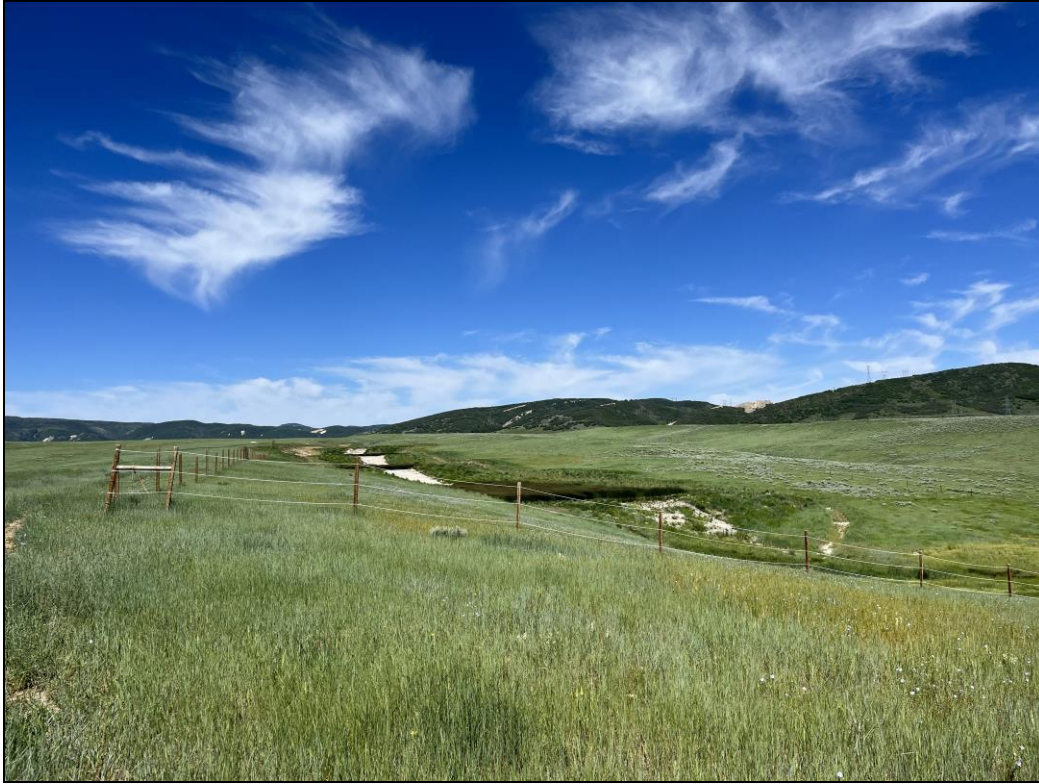
The Passive Treatment System Project Area (PTSPA) was accessible for the first time this year after an unusually wet spring (Photo 10 and 13). Located in the northern portion of the site's permitted acreage and just west of the 6 Main North Ventilation Shaft, the PTSPA is an experimental system which uses a system of rocks and wetland vegetation to filter mine water. While the systems functionality is being tested and adjusted, the system is currently a closed loop. Once functionality is at an approved level, the system will work to remove mine water from underground reservoirs, filter it, and discharge the cleaned water to nearby Foidel Creek. The million gallon tank in the 6MN area (Photo 9) holds a majority of mine water while the system is turned off. The system is completely fenced off to protect from cattle which graze in nearby areas. The system is made up of four ponds, each sitting at a slightly lower elevation than the last. Water is pumped up from underground reservoirs and into the 6MN reservoir (Photos 11 and 14) located to the southwest of the PTSPA. Water is then piped from the 6MN Reservoir up to the PTSPA where it enters the first pond. As water flows downhill, Iron (Fe) and sulfites are captured by thick wetland vegetation while limestone rock in-between each pond reduces oxidation. Each pond is designed with deep ends on both sides and a shallower portion in the middle where vegetation grows (Photo 12). Gates within each pond allow the water level to be adjusted based on the size of flow. The system was turned off at the time of inspection, but was scheduled to be turned on in the next week. A small weather station has been set up near the 6MN reservoir and is utilized by an academic research group to collect climate data (Photo 14).

Photo 10: Passive Treatment System Project Area, located west of the 6MN Vent Shaft area.

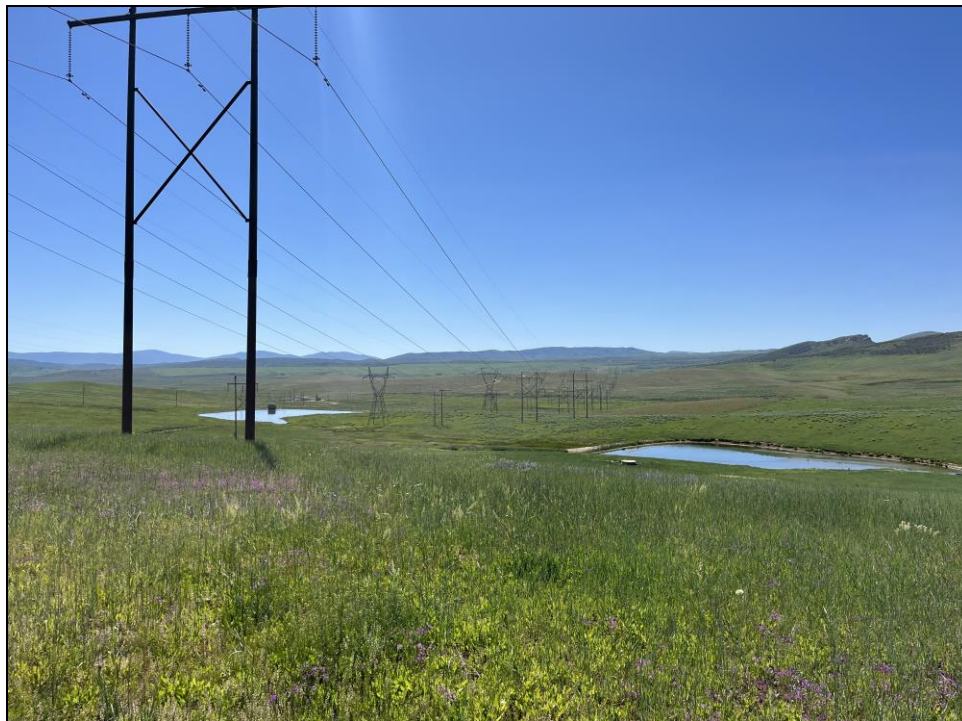
Photo 11: View northeast of the 6 MN Reservoir (background) and livestock pond (foreground) in the 6MN area.

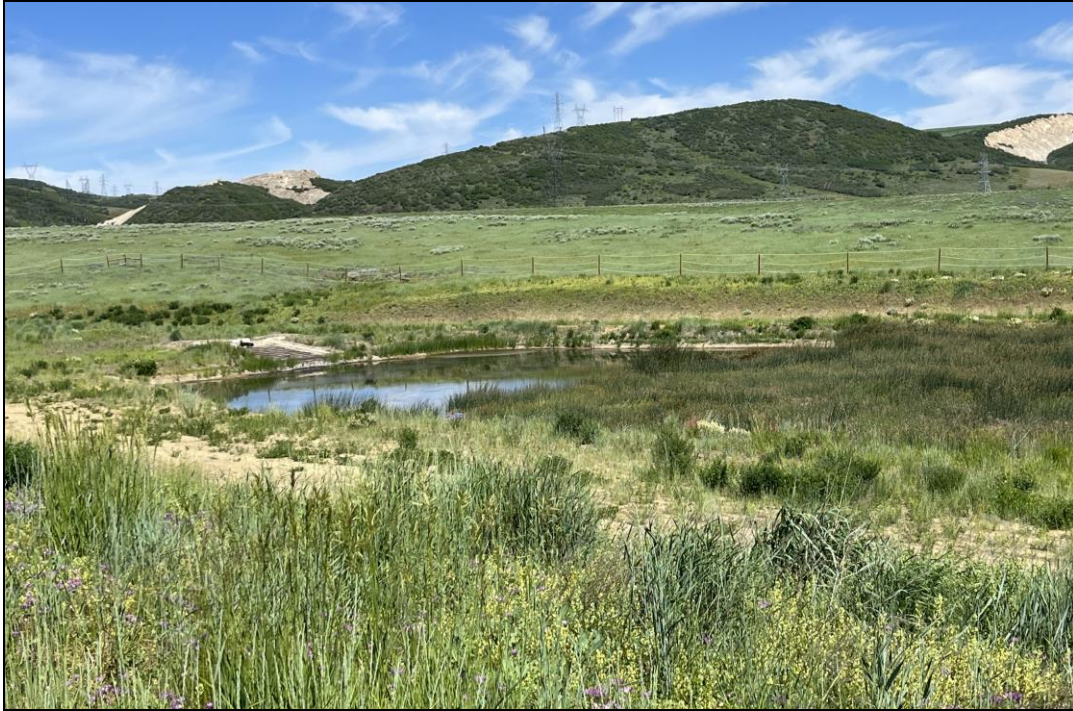
Photo 12: View north of the first pond of the Passive Treatment System Project Area, pond inlet is located to the west.

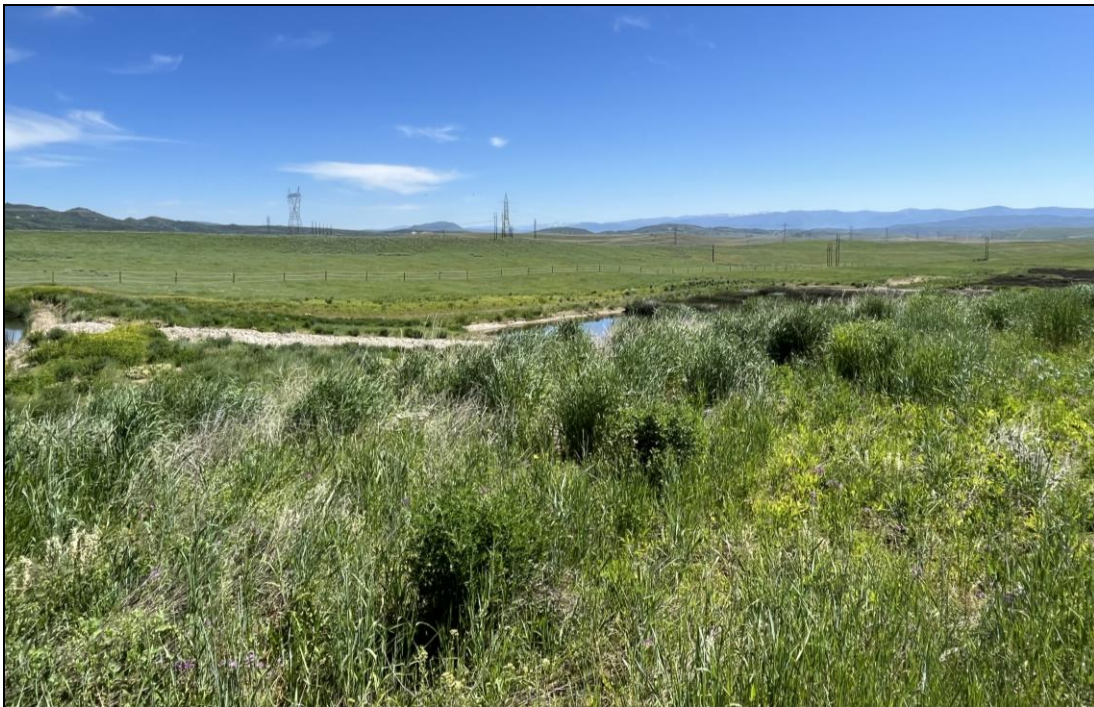
Photo 13: View north of the three other ponds within the Passive Treatment System Project Area.

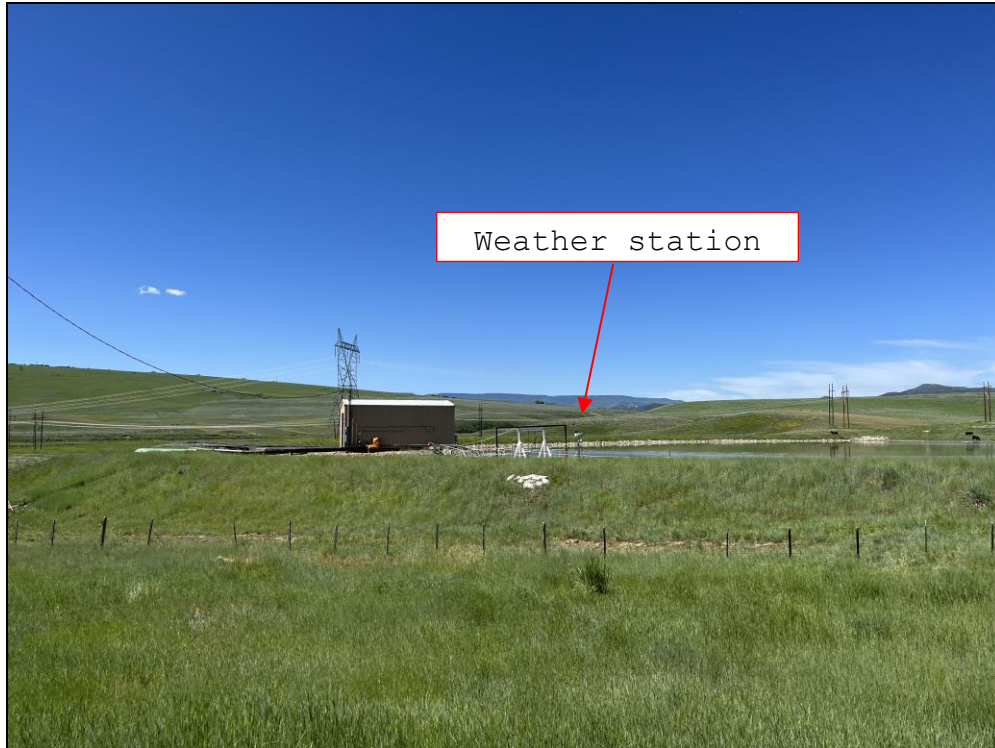
Photo 14: View west of the 6MN Reservoir.

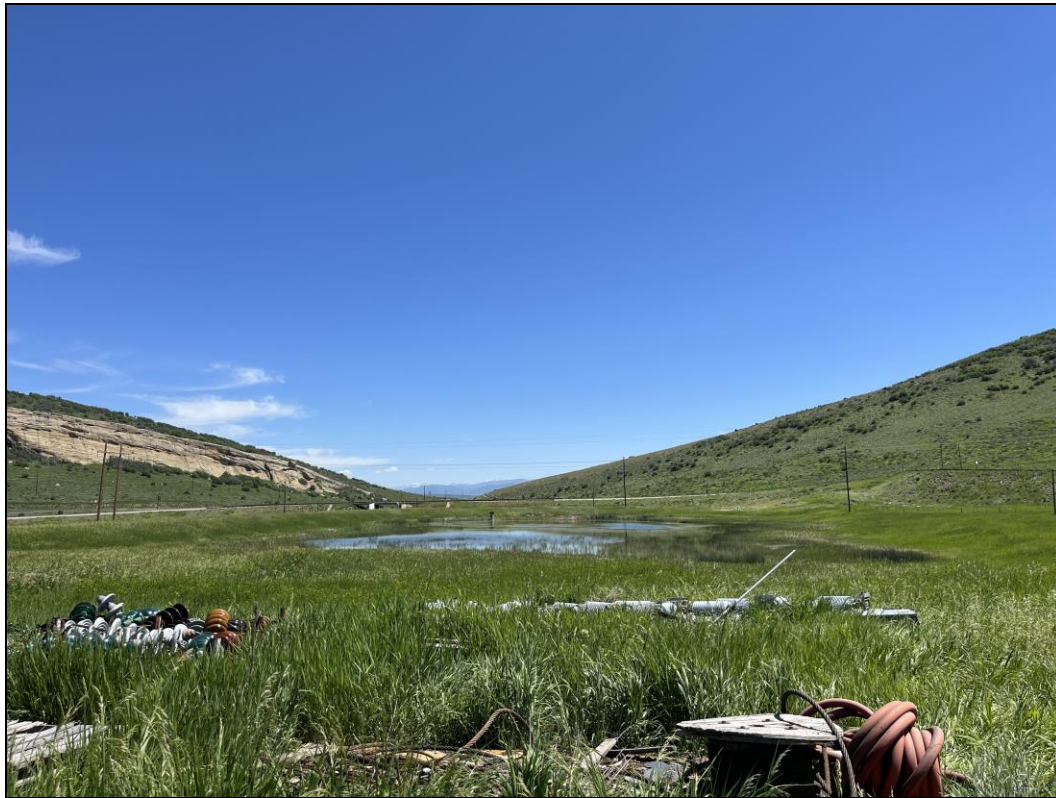
Photo 15: View northeast of Pond G.

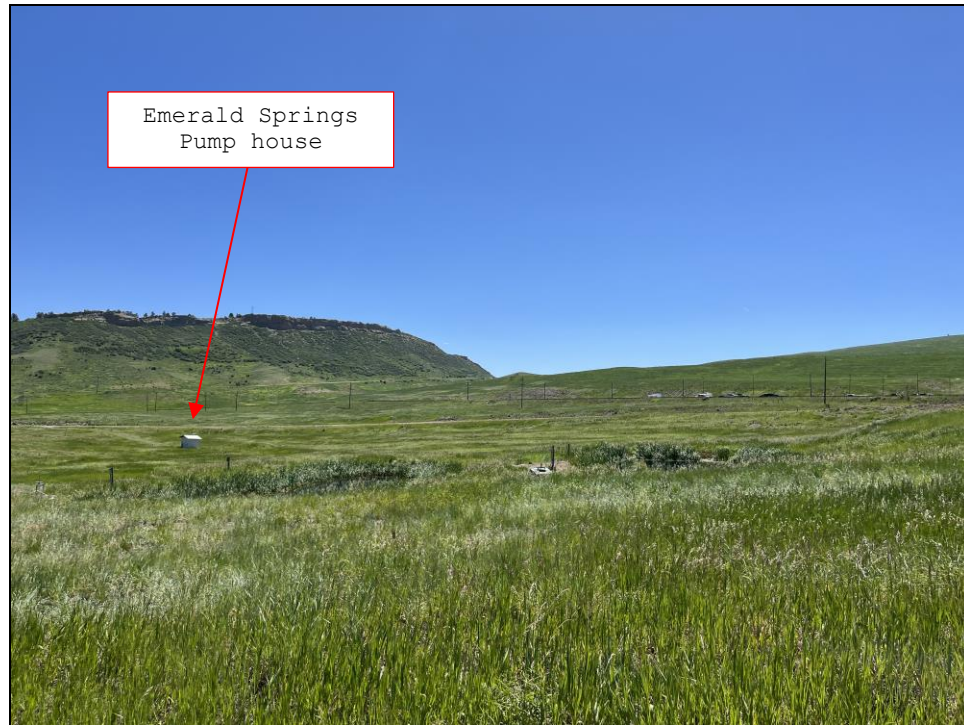
Waste water treatment ponds appear to be functioning properly. These ponds report to groundwater at the pond site itself and report to surface water at the Emerald Springs pump house (Photo 16).

Photo 16: View east of wastewater treatment ponds, report to both surface and groundwater through the Emerald Springs pump house to the east.

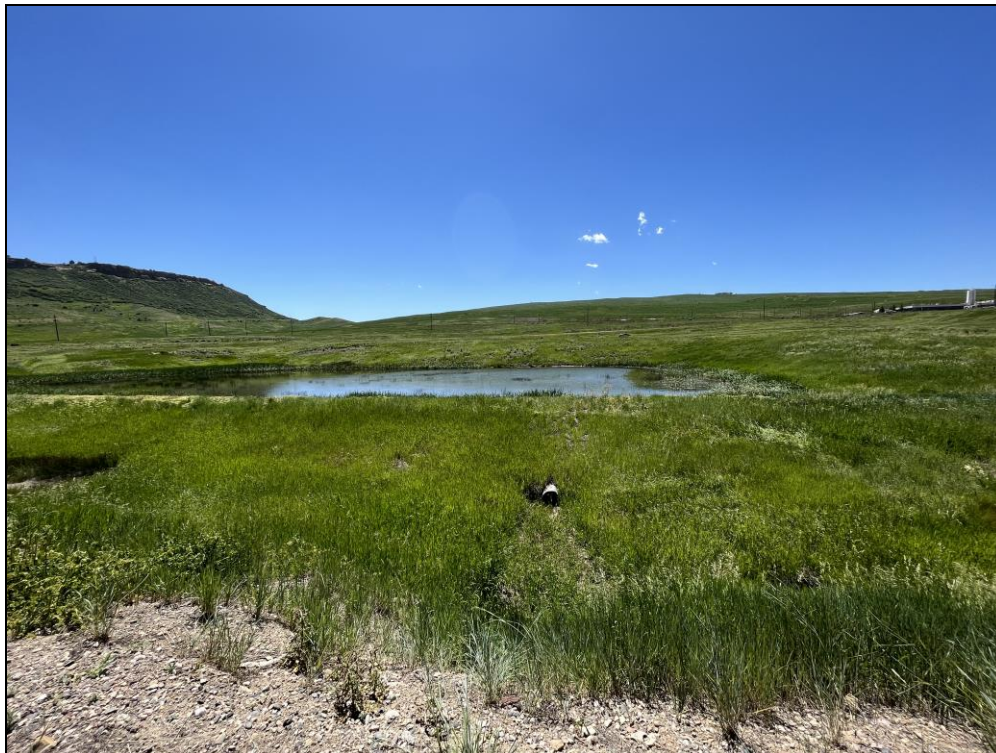
Photo 17: View southeast of Pond F and culvert.

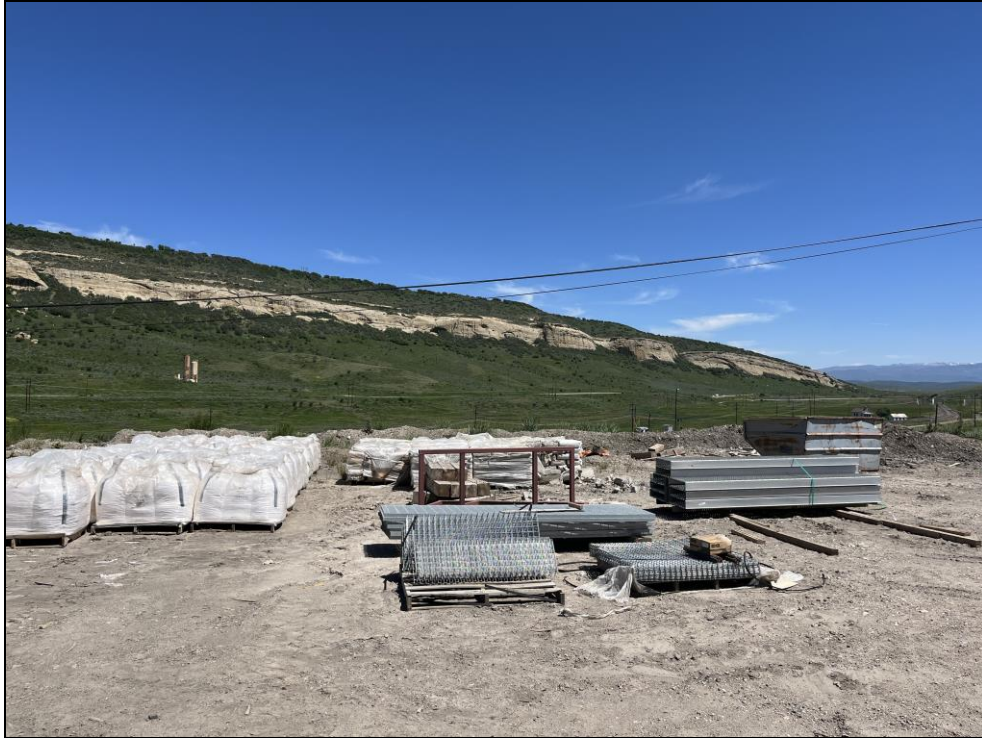
Berms near the main facilities storage area are well maintained to prevent runoff to Ditch E below which runs to Pond E (Photo 18).

Photo 18: View north of a storage area, berms around this area are being maintained to prevent sediment deposit into the ditch below.

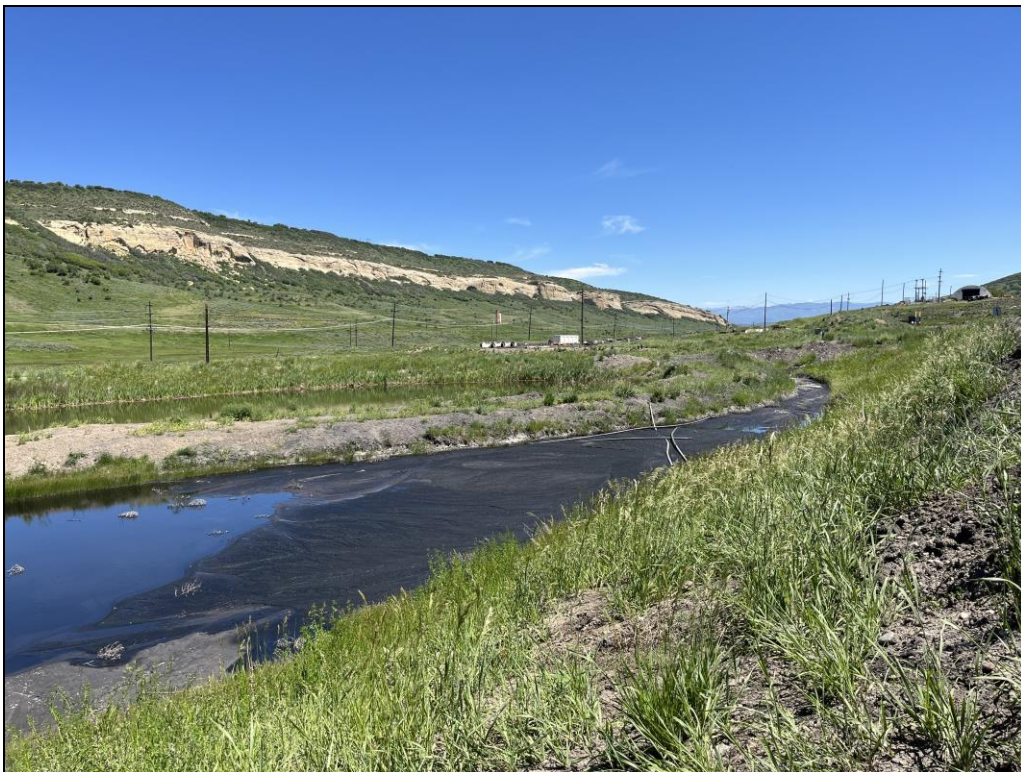
Photo 19: Shows the northern end of Pond E, is scheduled to be cleaned this season.

All ponds across the site are scheduled for cleanup in July of this year. This gives the ground around ponds ample time to dry out from the wet spring conditions so that machinery can move efficiently throughout an area when performing pond cleanout.

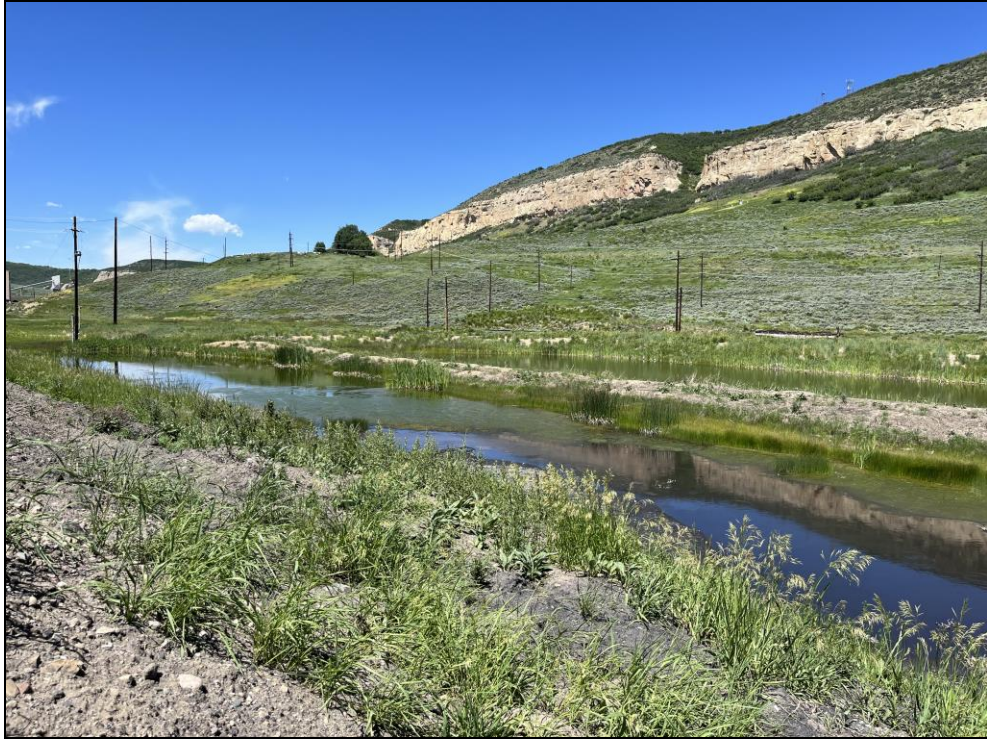
Photo 20: Shows the southern end of Pond E, is scheduled to be cleaned this season.

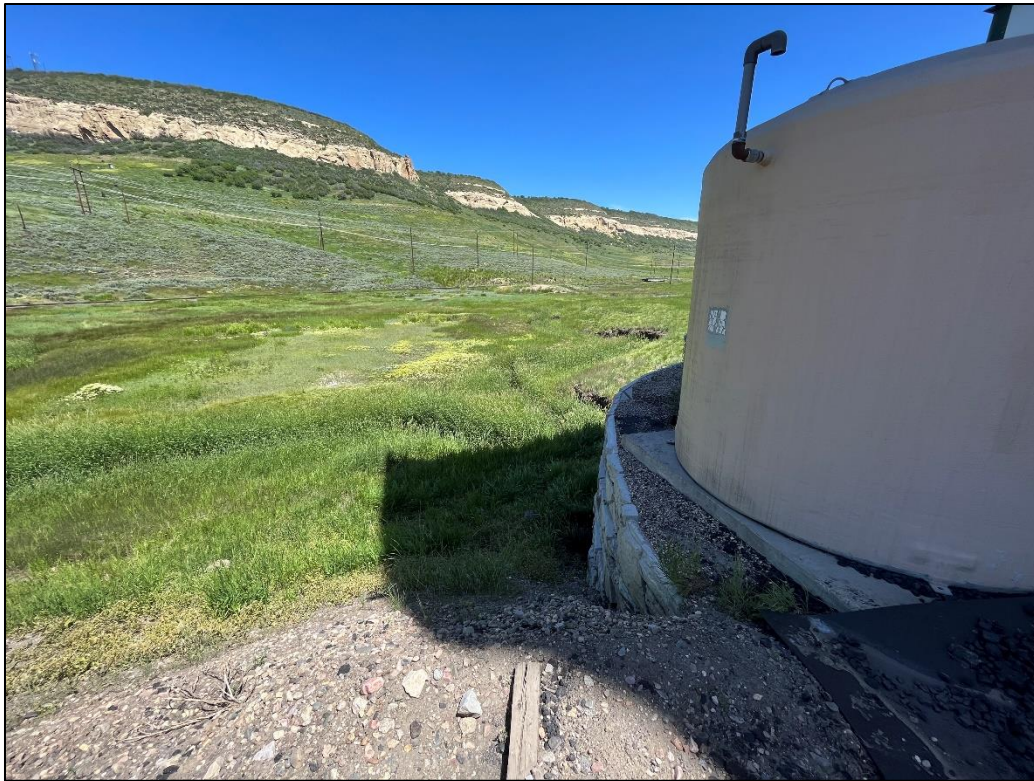
The stoker coal loadout facility has not yet been sealed following a note made in a DRMS inspection report last fall which pointed out that the wash plant facility was leaking water behind the building (Photos 21 - 23). The building was scheduled for sealing in the spring of this year, but difficulty in finding a contractor has pushed back this date. DRMS encouraged the operator to make this task a priority. **Please supply the Division with a firm date of completion when one becomes available.** In the meantime, the Operator has been using straw bales (Photo 23) and a silt fence, which is in need of repair, behind the building to protect Foidel Creek from drainage and sediment from this facility. The filter fabric between the fence's posts has fallen and is now laying on the ground instead of being attached to the poles (Photo 38). **This repair has been listed as an ongoing maintenance item.** After sealing the building, water from the facility will continue to report to Pond E through a pump system to be installed behind the stoker loadout building.

Photo 21: Shows the back of the Stoker Coal Loadout facility, sediment from this side of the building is still eroding down the hill.

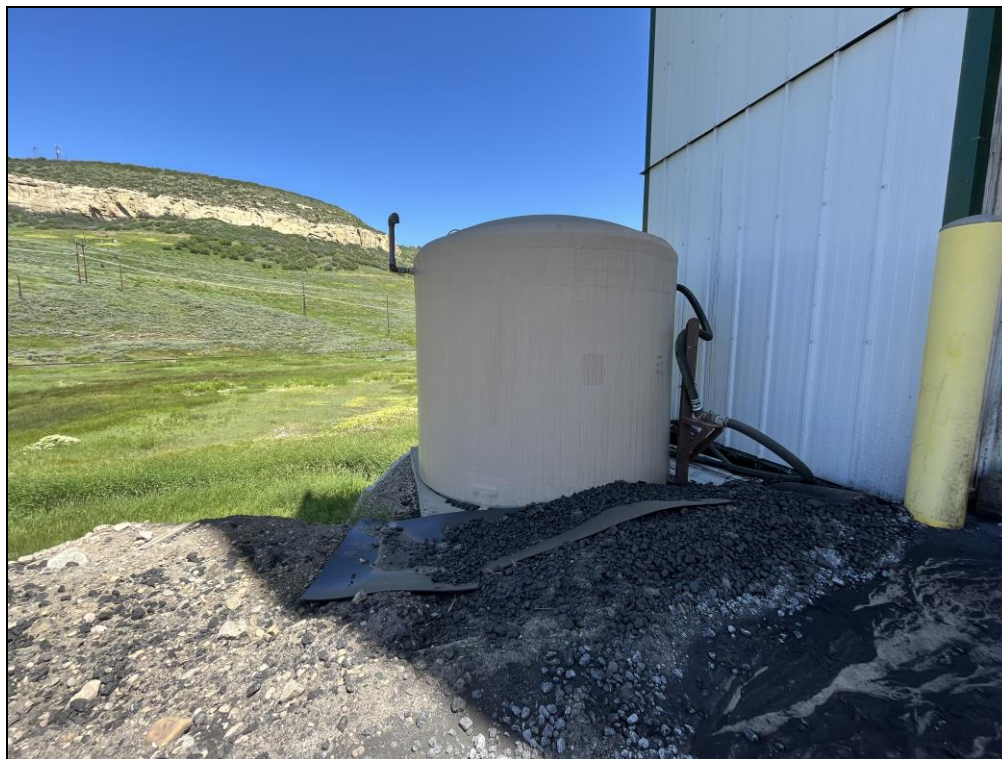
Photo 22: A small spill of coal is noted in front of the stoker building.

A small pile of coal has been spilled at the stoker loadout facility (Photo 22), please clean up the coal that has been spilled and ensure that the berm is adequate height to contain spills.

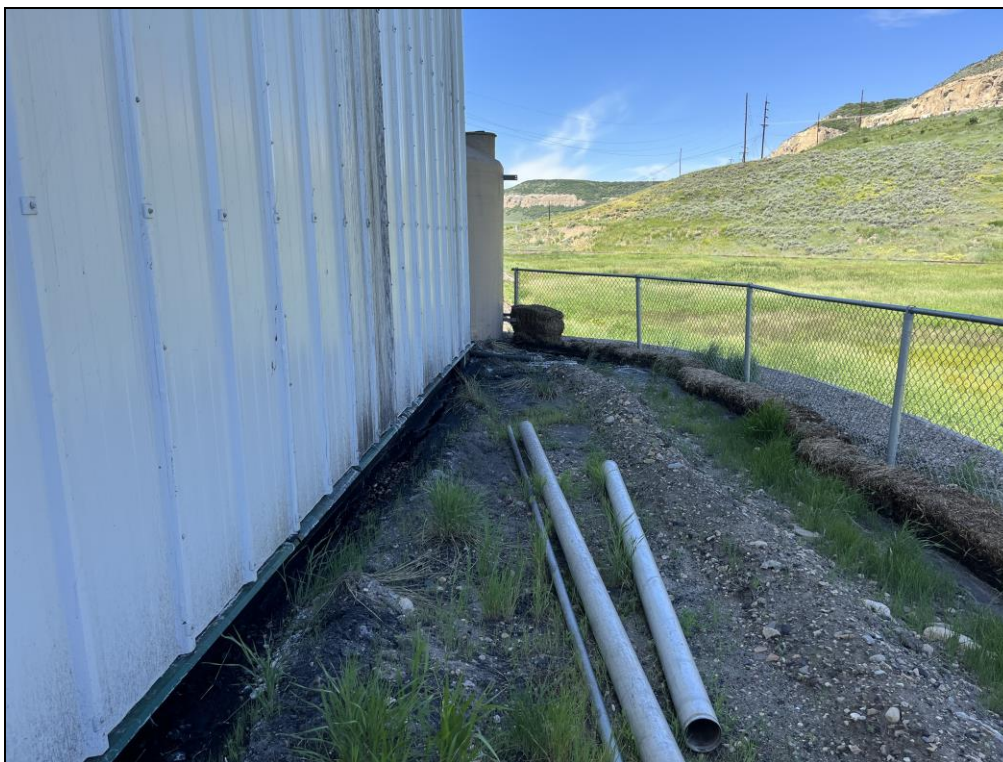
Photo 23: Back of the coal loadout facility, still awaiting construction, straw bales control erosion.

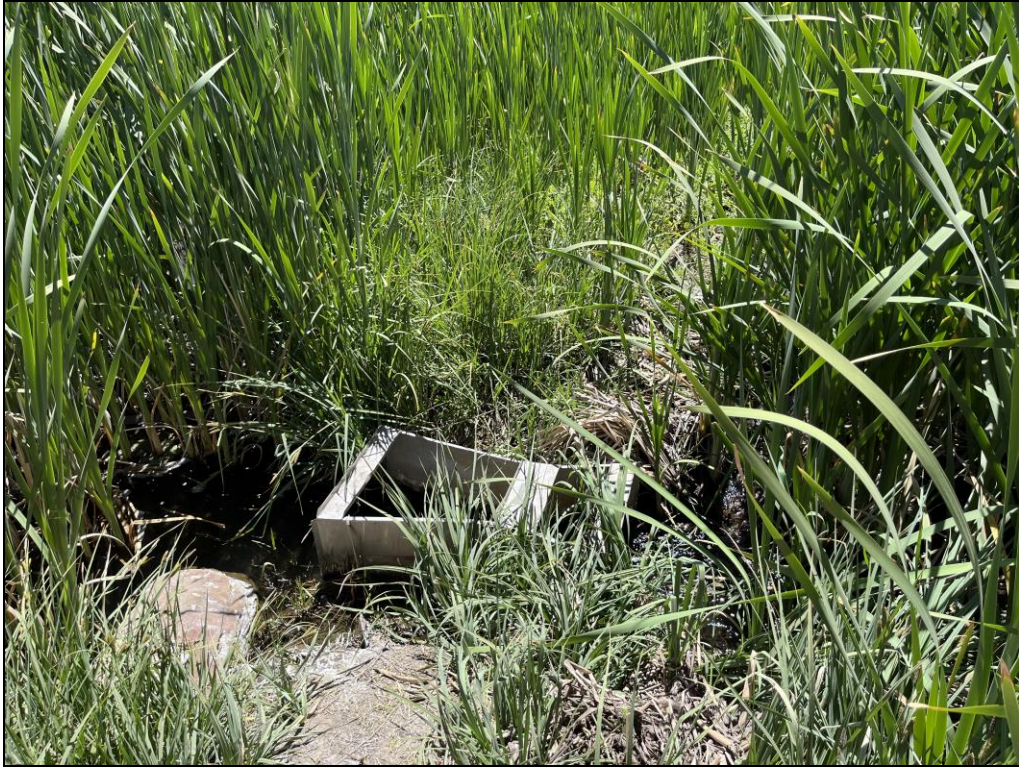
Photo 24: Weir which discharge from Pond D flows through.

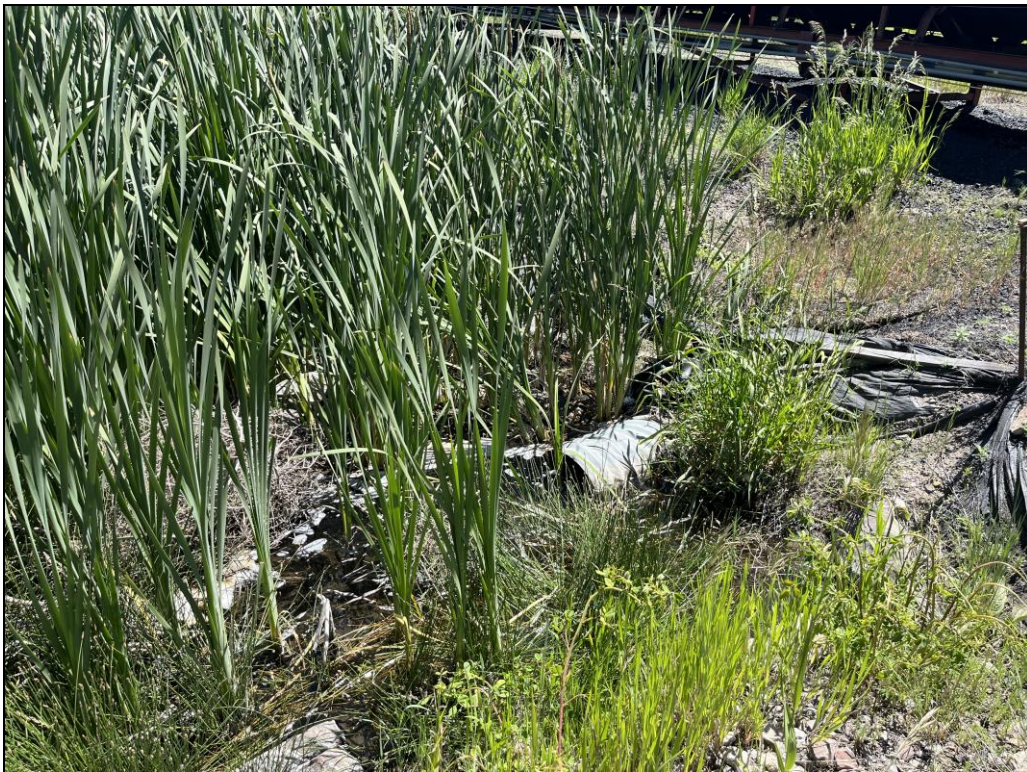
Photo 25: Pond D discharge culvert.

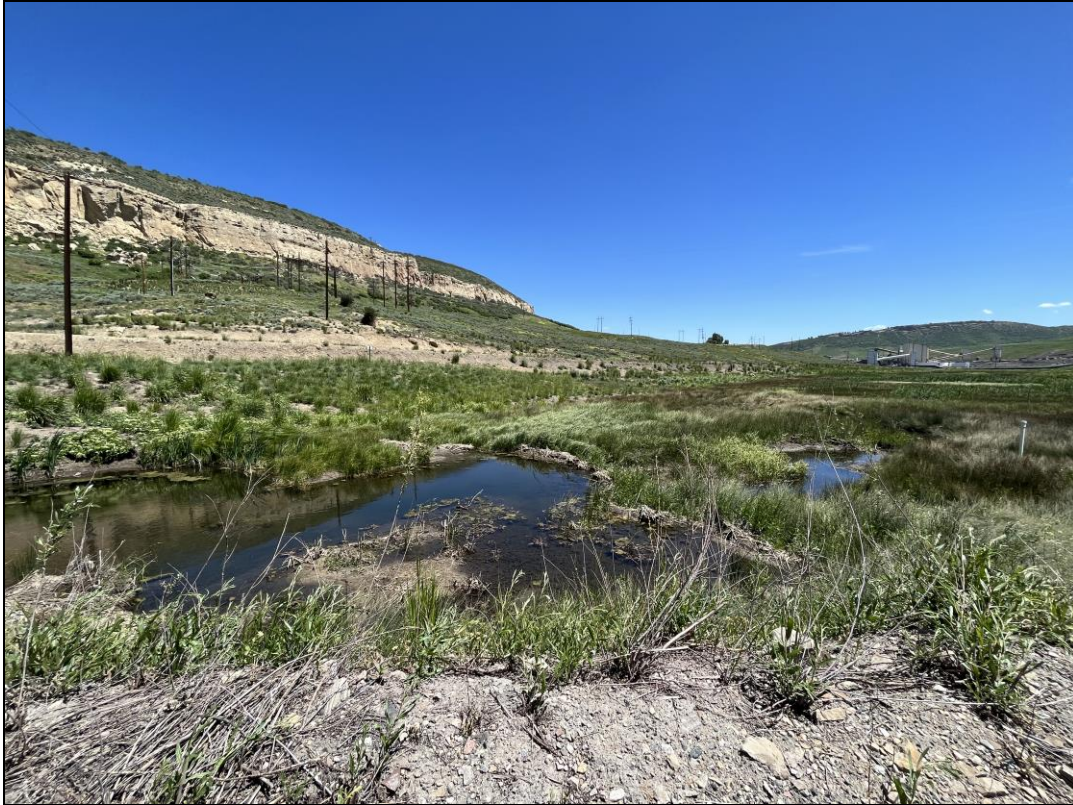
Photo 26: View north of Foidel Creek buffer zone, area is frequently cleared of debris brought in by beavers.

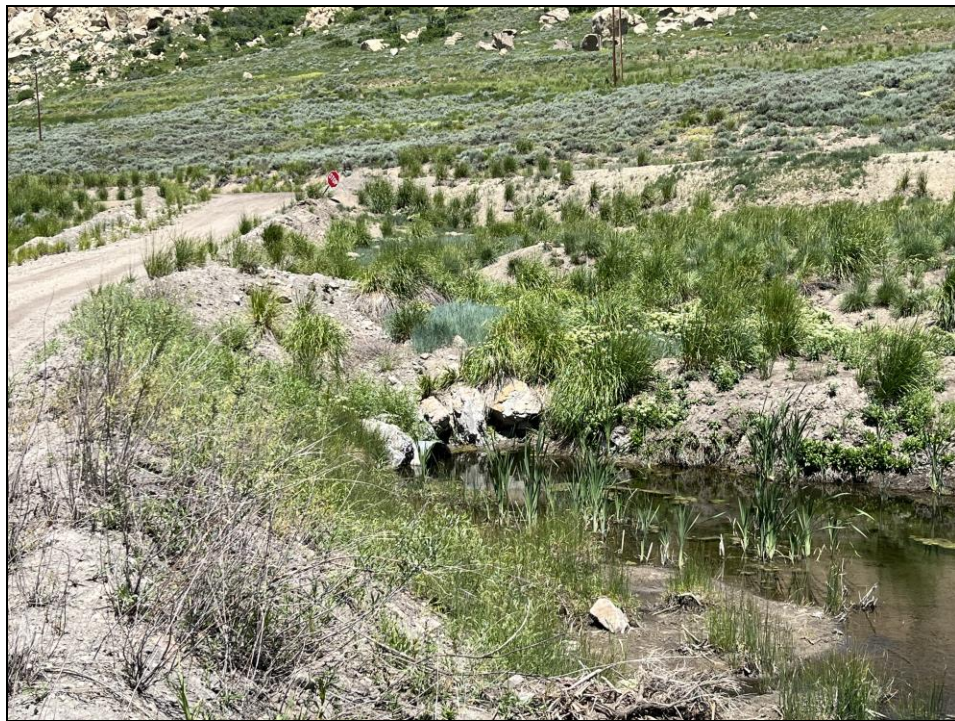
Photo 27: Discharge culvert into Foidel Creek is clear of vegetation.
