Inspection Report, Foidel Creek Mine, C-1982-056

Permit Number: C-1982-056 Mine Name: Foidel Creek Mine Operator: Twentymile Coal, LLC Operator Address: Ms Miranda Kawcak 29515 Routt County Road No. 27 Oak Creek, CO 80467	County: Routt Operation Type: Underground Permit Status: Active Ownership: Private
	Operator Representative Present: Miranda Kawcak
Operator Representative Signature: (Field Issuance Only) Miranda Kawcak, Kevin Copeland, Mike Howard

Inspection Start Date: June 28, 2023 Inspection Start Time: 08:45 Inspection End Date: June 28, 2023 Inspection End Time: 13:30		Inspection Type: Coal Complete Inspection Inspection Reason: Normal I&E Program Weather: Clear	
Joint Inspection Agency:		Joint Inspection Contacts:	
Post Inspection Agency: None		Post Inspection Contacts:	
Inspector(s): Hunter Ridley	Inspector's Signature:

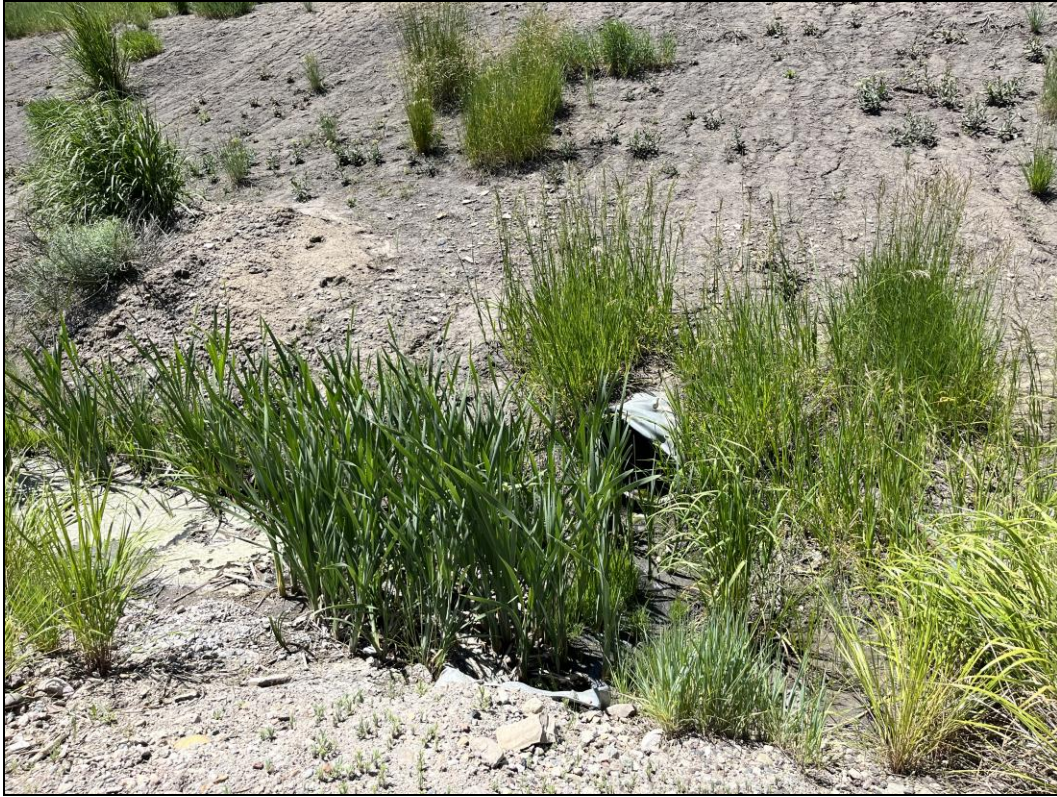
Photo 28: Pond C discharge location.

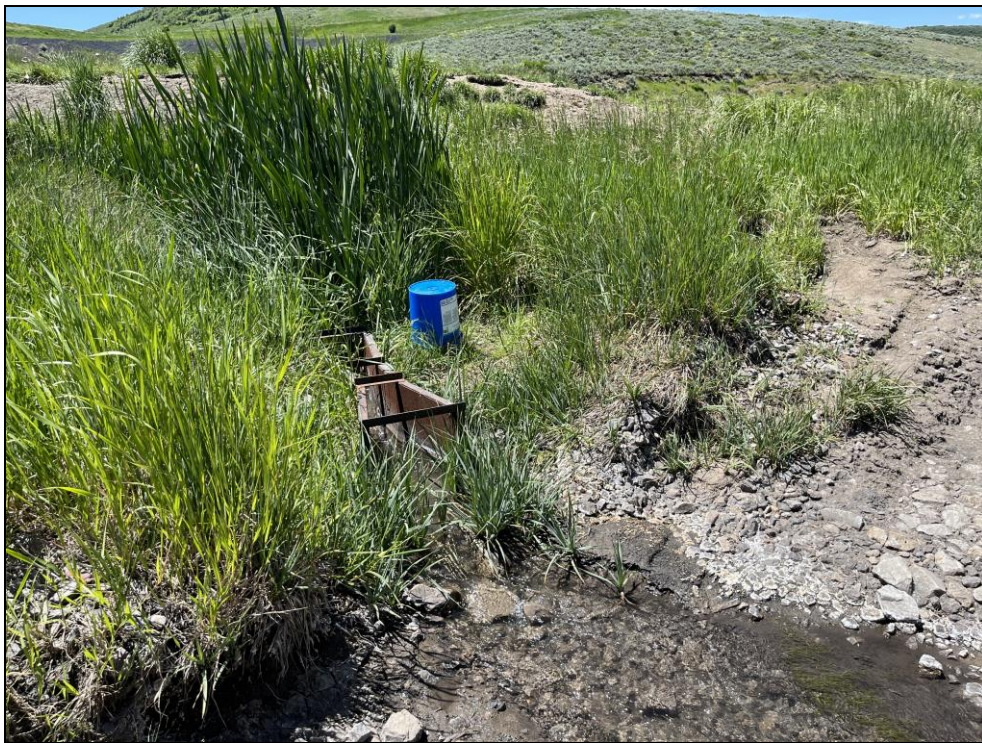
Photo 29: Discharge culvert for Pond B.

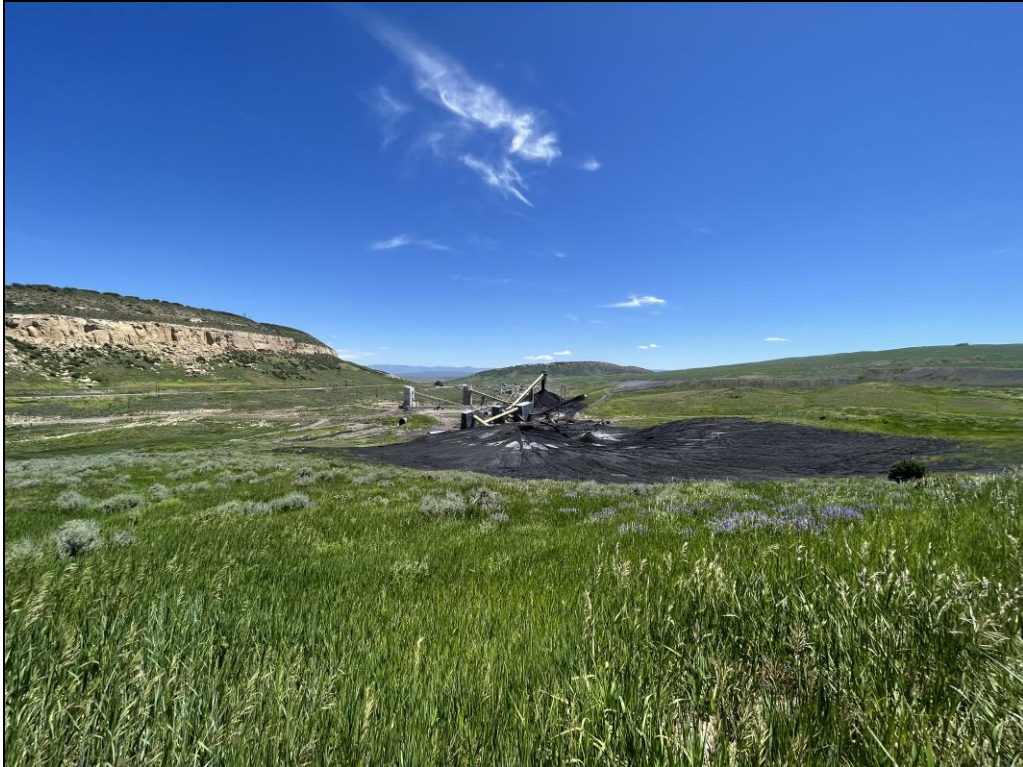
Photo 30: View northeast of ROM coal storage area from above.

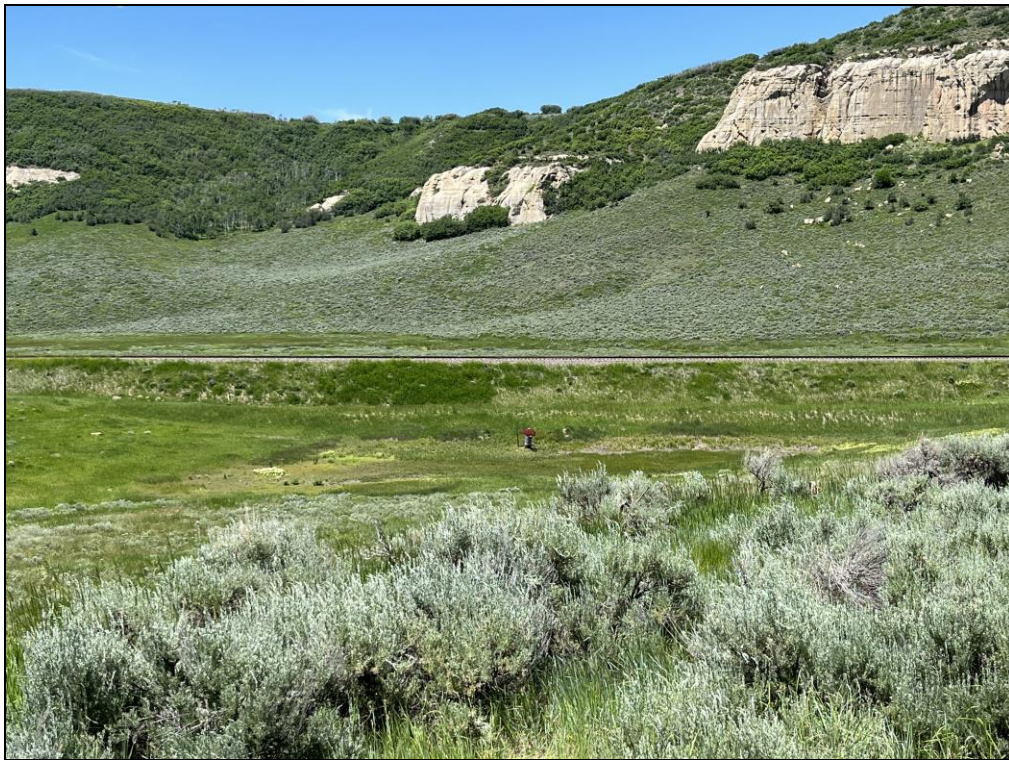
Photo 31: Pond T, has been dry for several years.

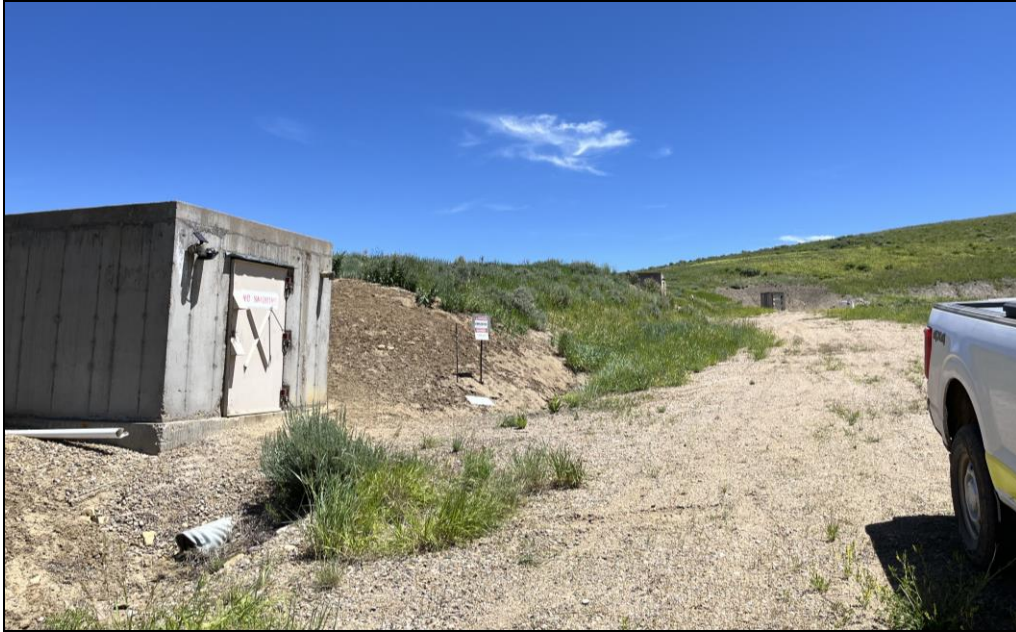
The three bunkers containing explosive materials for the mining operation are being maintained and inventoried on a monthly basis as required (Photo 32).

Photo 32: View east of three explosives storage locations, inventory is taken monthly of each building.

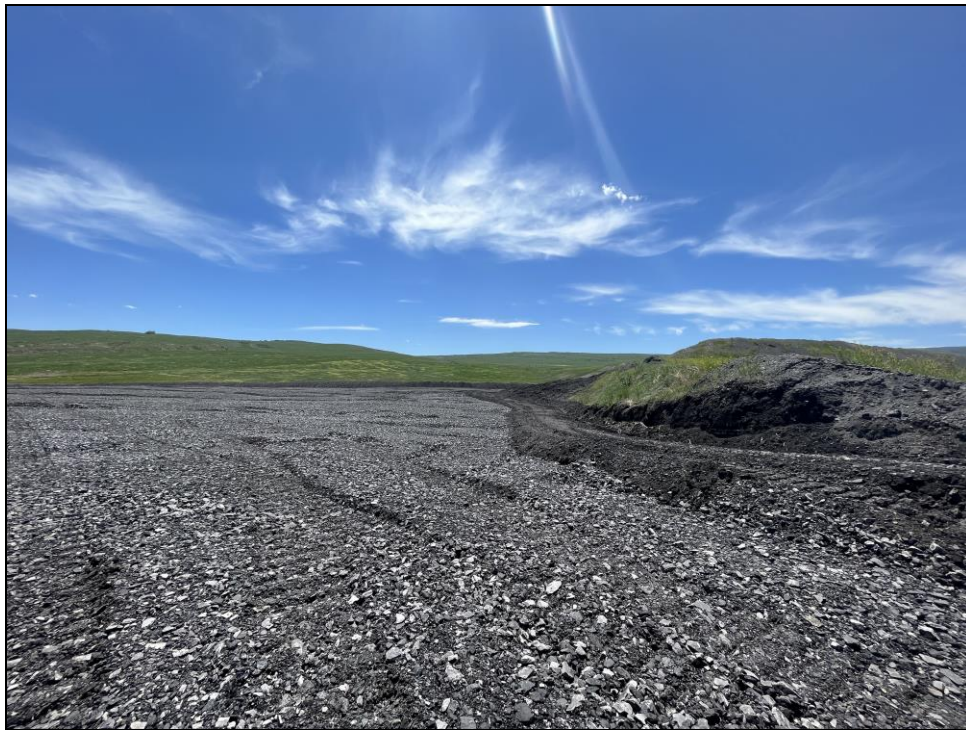
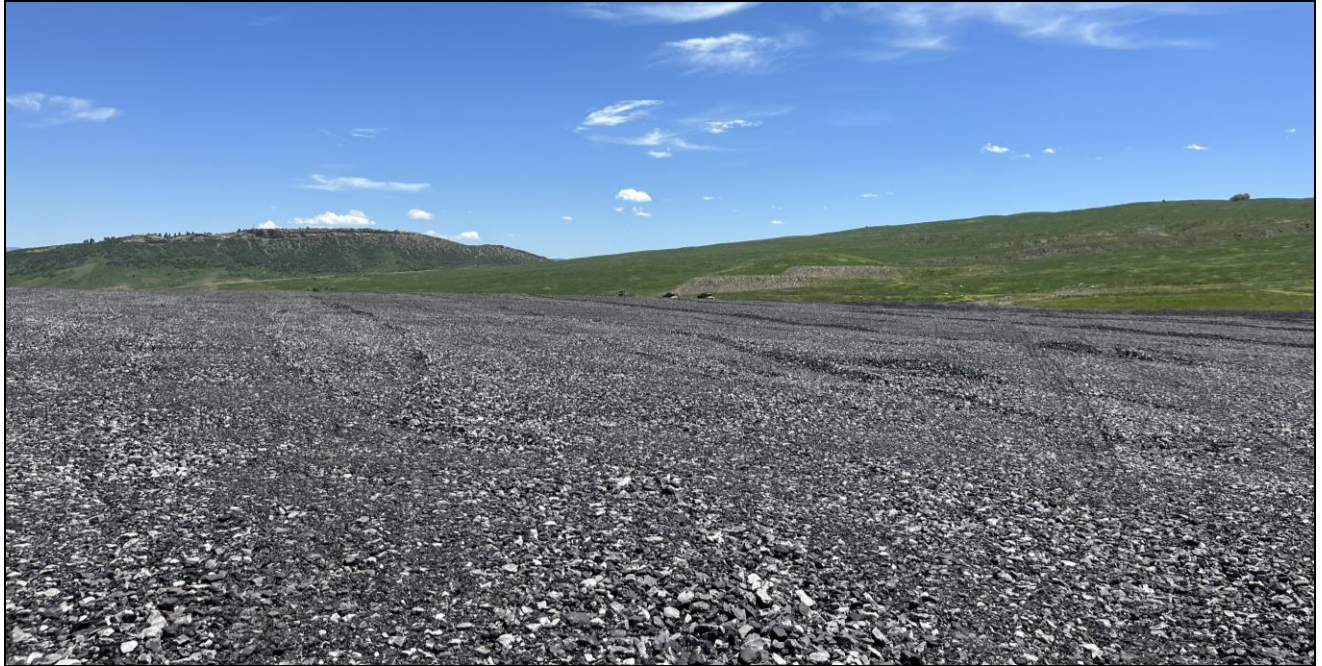
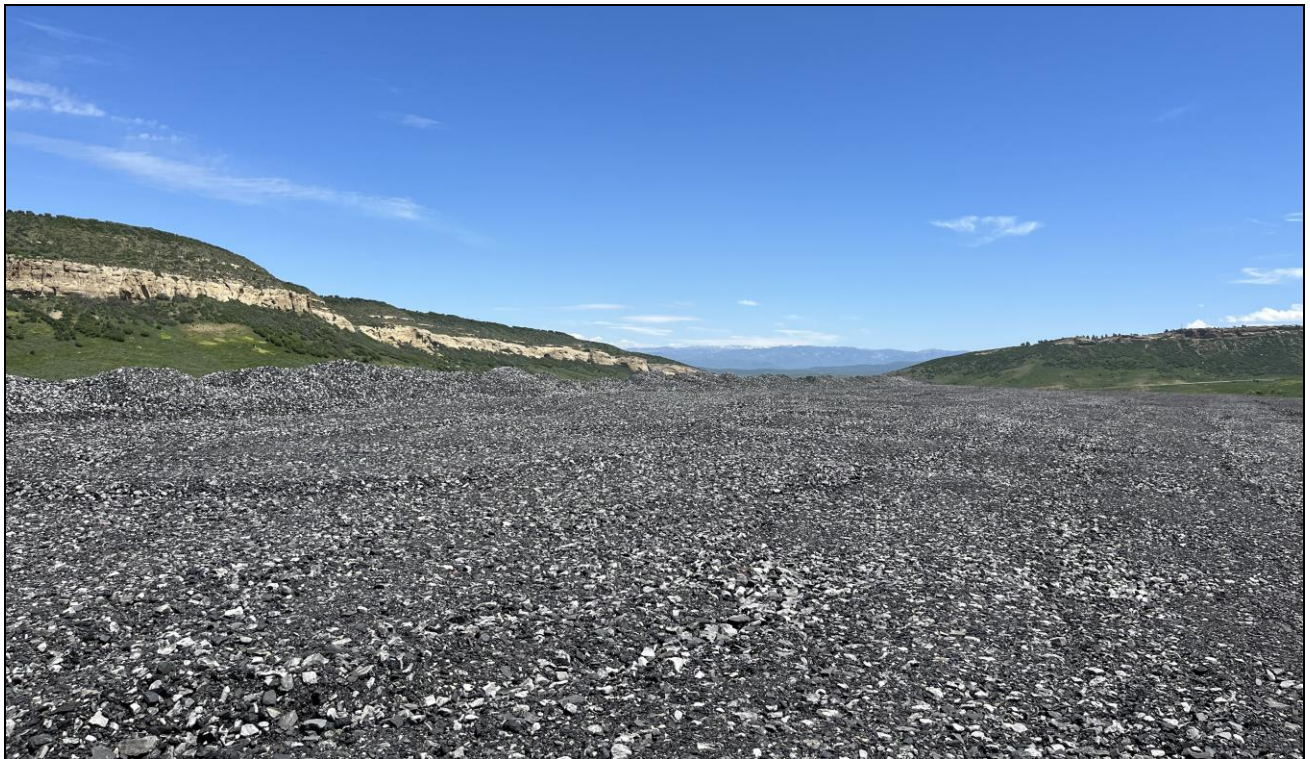
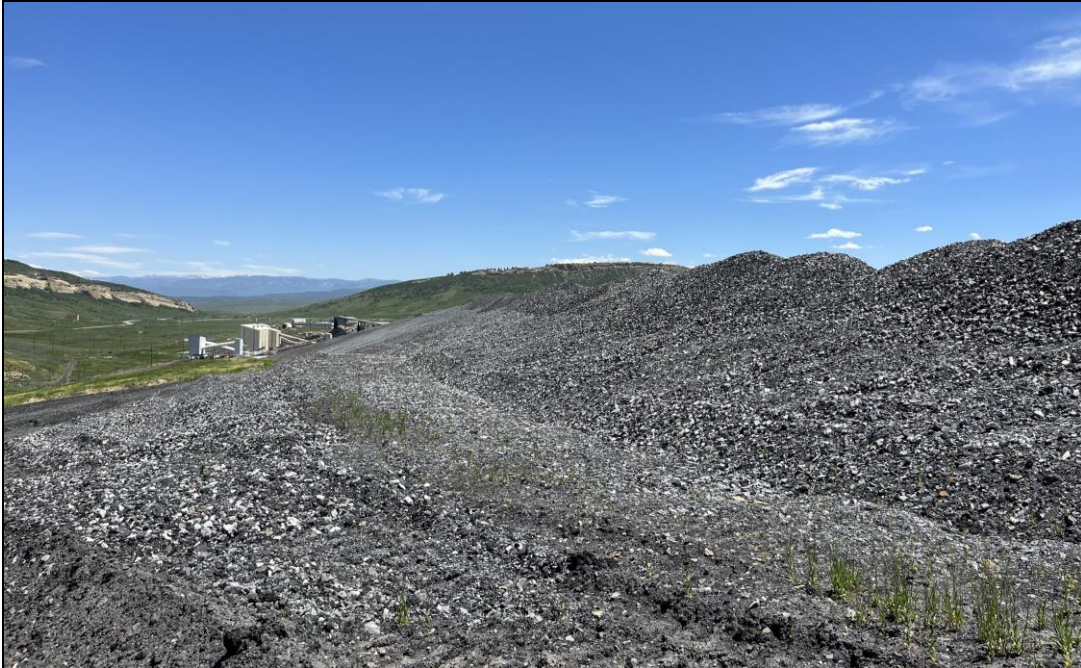
Compaction of refuse material piled throughout the winter has begun (Photos 33 - 36). Drainage is functioning properly in this area with no standing water atop the pit. Lifts three and four are under construction, with plans to face and seed these two lifts in the current season. Lifts are built facing downslope to encourage proper drainage

Photo 33: View south of the recently compacted refuse pile area.

Photo 34: View southeast of compacted refuse pile.

Photo 35: View north of refuse pile, compaction has begun this season.

Photo 36: View north of the dozer path up to the refuse pile.

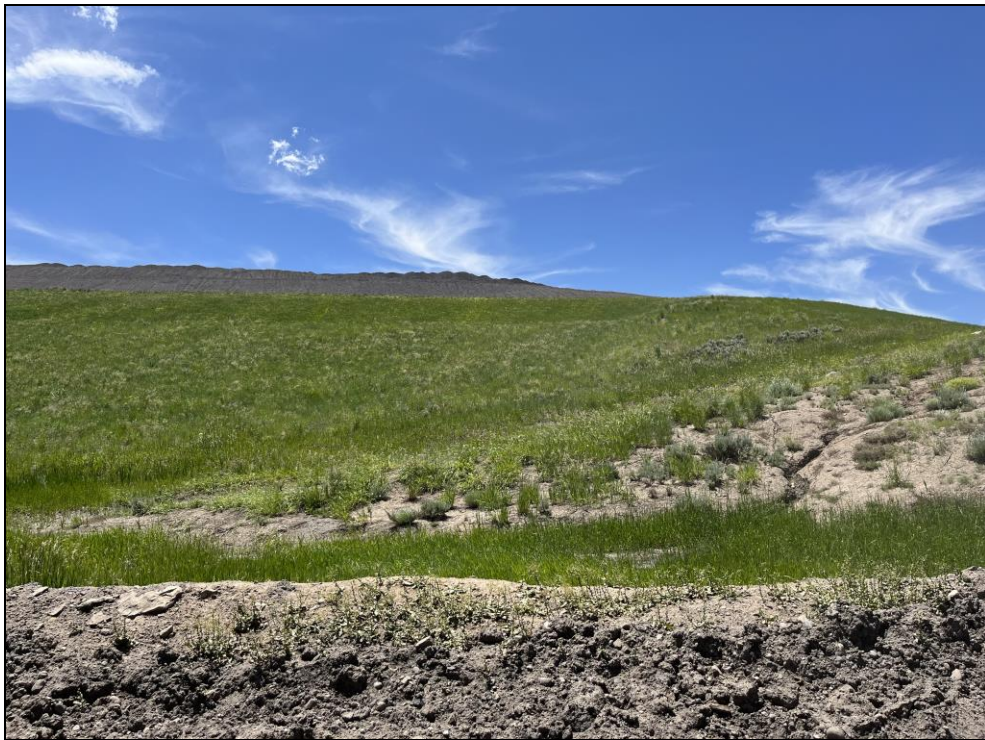
foot of Pond D up to the refuse pile. The new road would connect with the refuse pile haul road currently in place and create a loop. This would ease wear and tear on haul trucks which currently have to make a tight turn near the refuse conveyor to load up on refuse material (Photo 37).

Photo 37: View south of refuse pile from the foot of Pond D, the site of a proposed future MR which will construct a haul road up to the refuse pile.

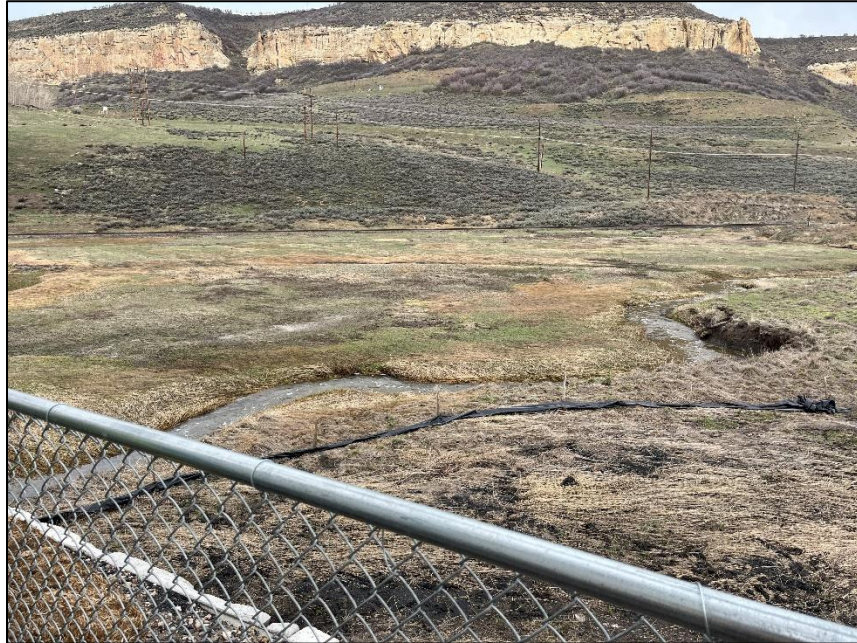
Photo 38: Inspection photo from a previous inspection report dated 5/2/2023 which shows the silt fence behind the stoker loadout building which is in need of repair.

- Repair silt fence located behind the stoker loadout building
- Protect topsoil piles from cattle
- Spray weeds and Reseed the waste pile topsoil pile
- Protect topsoil piles along the 6MN road during maintenance and snow plowing activities during the winter months
- Seal support building near Wash Plant (2023)
