Inspection Report, HG Loadout, C-1992-081

PERMIT INFORMATION

Permit Number: C-1992-081 Mine Name: Hayden Gulch Loadout Operator: Hayden Gulch Terminal, LLC Operator Address: Ms Miranda Kawcak 29515 Routt County Road 27 Oak Creek, CO 80467 County: Routt Operation Type: Loadout Permit Status: Active Ownership: Private

INSPECTION INFORMATION

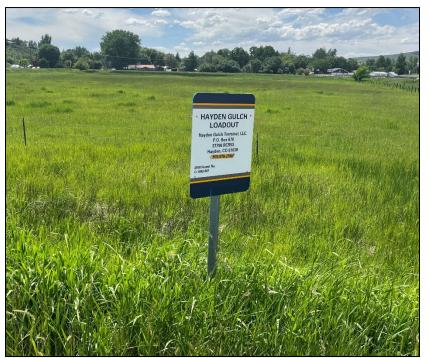
Mine identification markers were observed at the entrance to the unreleased haul road and adjacent to the unreleased agricultural section north and south of Hwy 40. The required phone number information which was missing from signage, as noted in the inspection report dated May 2, 2023, has been added to both mine signs (Photos 1 and 2).

Photo 1: Mine signage located at access road to the site at the intersection of Highway 40 and Hawthorne St.

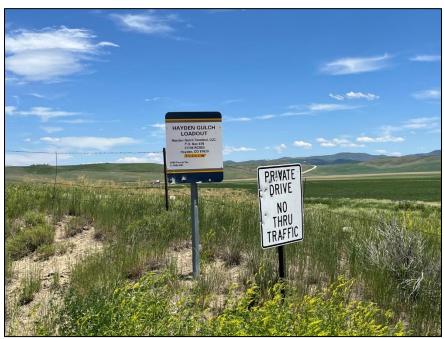
Photo 2: Mine signage posted at the western edge of the site's haul road which intersects with County Road 53.

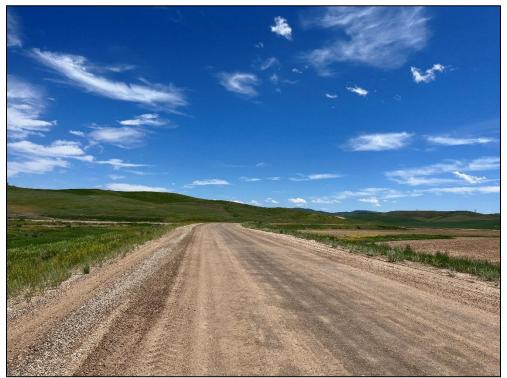
The haul road was well maintained and free of erosional features (Photo 3). The haul road and its associated permanent topsoil pile features to the east will be ready for release this year.

Photo 3: View east of the site's haul road.

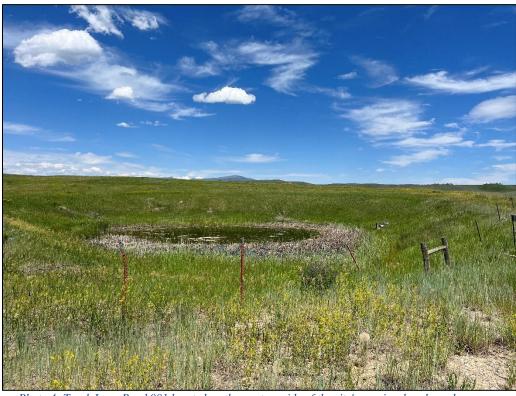
Truck Loop Pond 001 and Rail Loop Pond 002 were full and functioning properly (Photos 4 and 6). Rail Loop Pond 002 is accessed by walking a portion of the Sage Creek Trail located on the site's previously released acreage. This pond is full of both water and thick vegetation. Culverts in the Tracks-to-Trails area were flowing and free of blockages (Photo 5).

Photo 4: Truck Loop Pond 001 located on the western side of the site's previously released acreage.

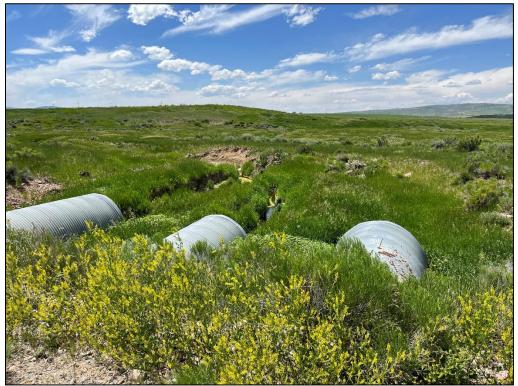
Photo 5: View northwest of culverts which allow Dry Creek to run through the Sage Creek Trail path.

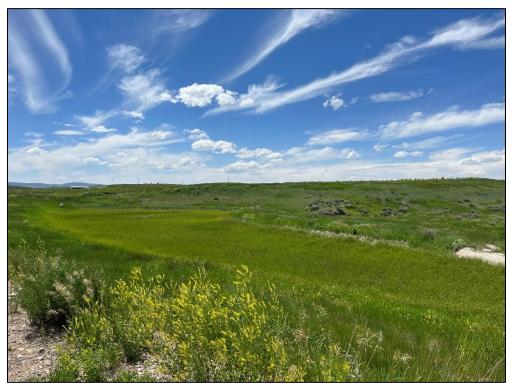
Photo 6: Rail Loop Pond 002 accessed from the Sage Creek Trail located on the site's previously released acreage.
