Deserado Mine, C-1981-018, June 2023 Complete Inspection Report

PERMIT INFORMATION

INSPECTION INFORMATION

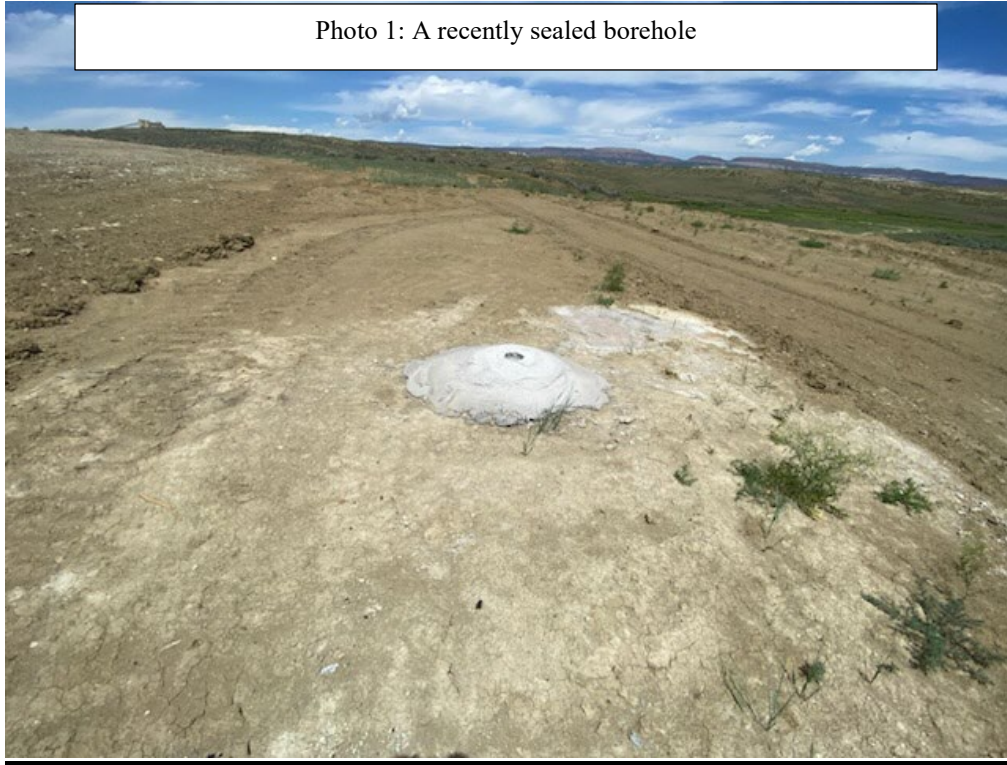
During the inspection a drill pad with recent reclamation work was inspected. The borehole casing had been sealed and capped (Photo 1). The pad had also begun to be backfilled and graded to the approximate original contour (Photo 2). The site was stable and there were no indications of erosional features. No off-site impacts were observed.

Photo 1: A recently sealed borehole

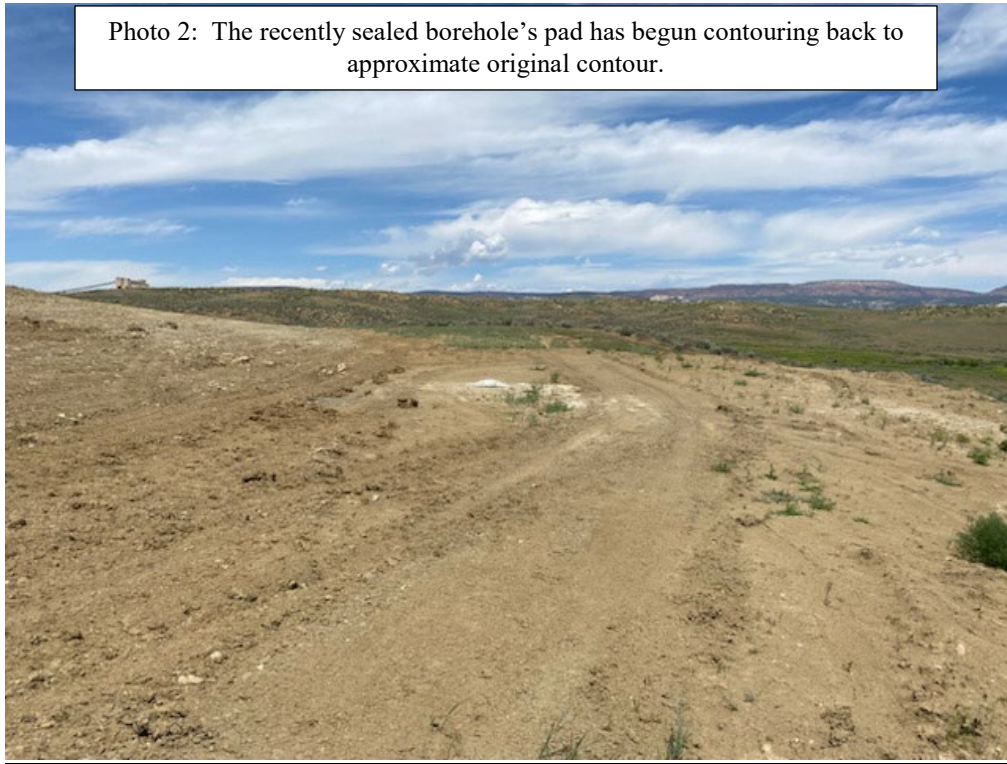
Photo 2: The recently sealed borehole's pad has begun contouring back to approximate original contour.

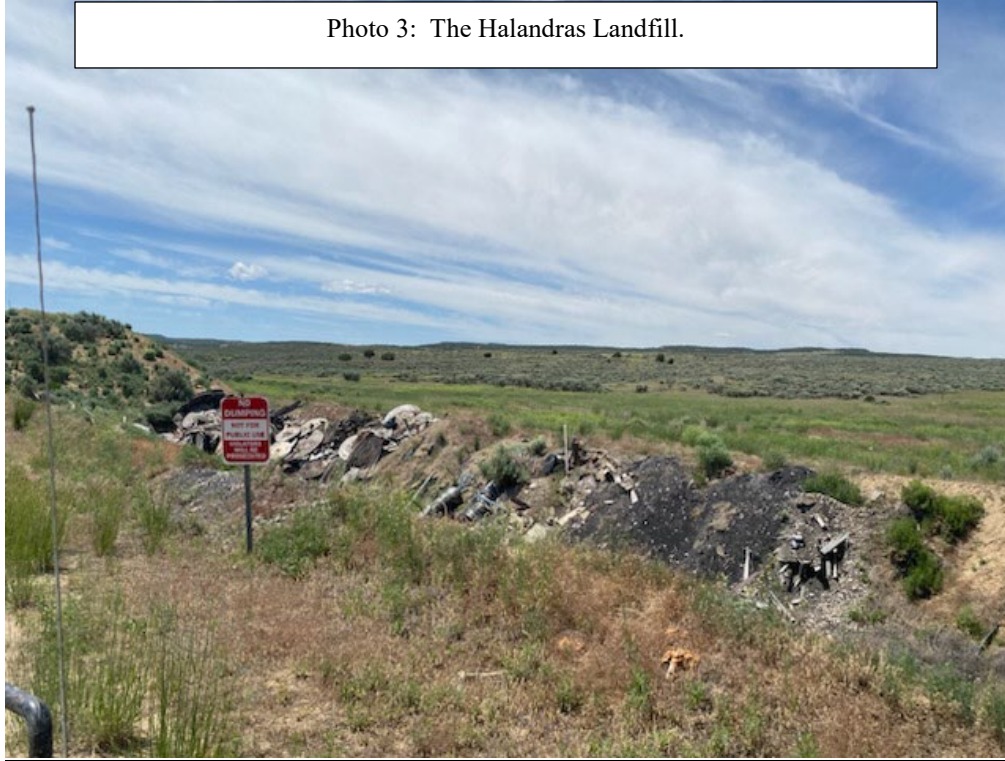
The Halandras Landfill is located to the north of the main facilities area and just west off of County Road 65 (CR65). The landfill consists of two open pits. During the inspection all waste materials were confined to the open pits (Photo 3). The sub soil and topsoil stockpiles were stable with vegetative cover. Topsoil pile markers were visible on top of the resource piles. The sump located at the southern end of the landfill was dry and stable.

Photo 3: The Halandras Landfill.

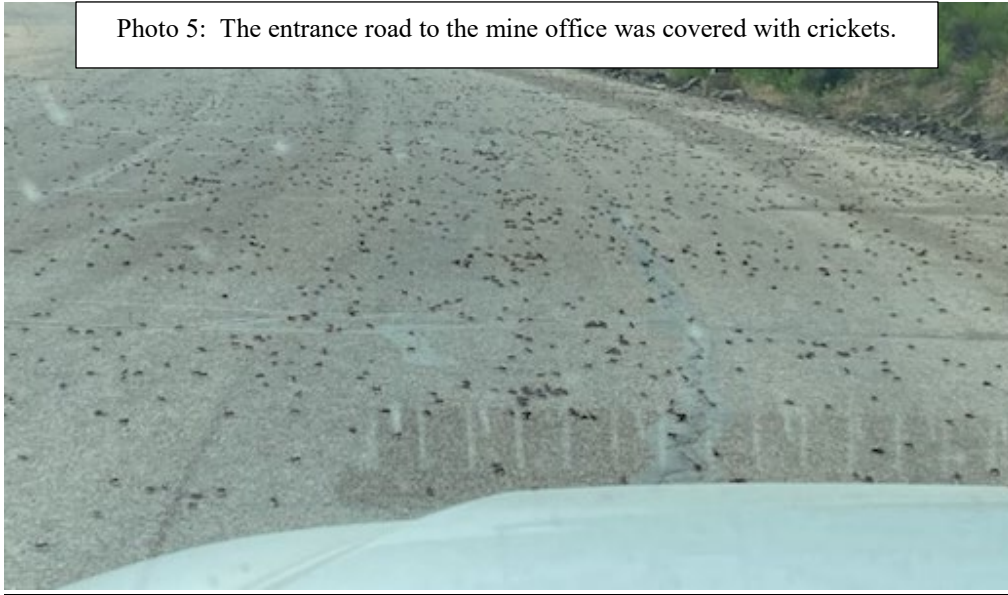
During the inspection of the mine, thousands of large crickets were observed throughout the mine site (Photo 4). The crickets were a part of a somewhat recent hatch. The large volume of crickets may have been due to an above average precipitation amount this spring, a natural hatching cycle or a combination of the two. During

Photo 5: The entrance road to the mine office was covered with crickets.

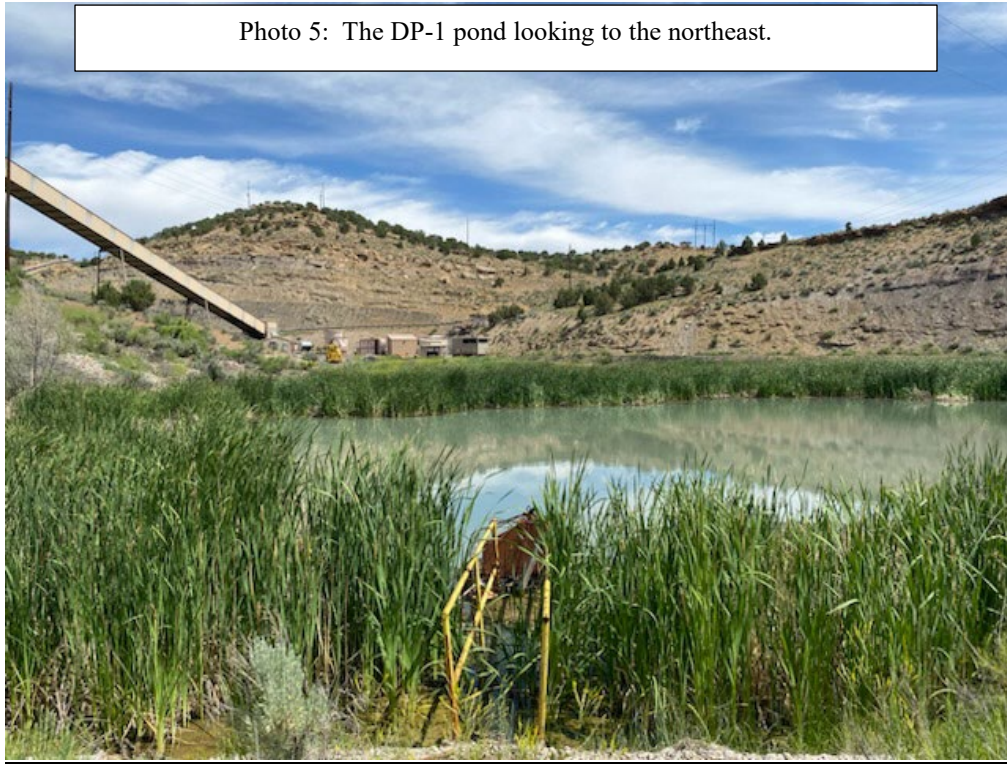
Three ponds are located within the main facilities area; the DP-1 pond, the PP-1 pond and the PP-2 pond. The DP-1 pond is located on the lower facilities bench and treats all runoff from the main facilities area. The DP-1 pond was impounding and discharging water at the time of the inspection (Photo 5). The trash rack on the primary discharge outlet was free of obstructions. The embankment for the pond was stable with vegetation (Photo 6). There were no erosional concerns identified. The PP-1 pond was holding water but was not discharging. The PP-1 pond is located on the middle facilities bench by the prep plant. The pond's embankments were vegetated and stable. No erosional features were observed. The PP-2 pond is located on the upper facilities bench. The pond was holding water during the inspection (Photo 7). No discharge from the pond was occurring. The pond's embankment was stable with vegetative cover. There were no indications of erosion seen.

Photo 5: The DP-1 pond looking to the northeast.

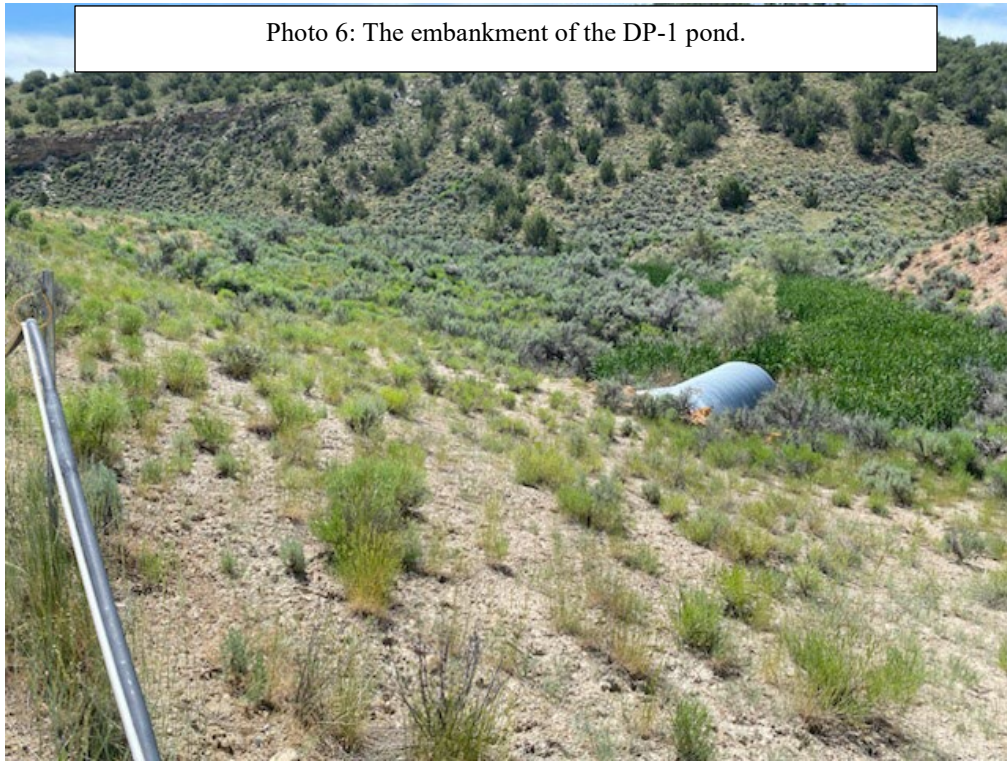
Photo 6: The embankment of the DP-1 pond.

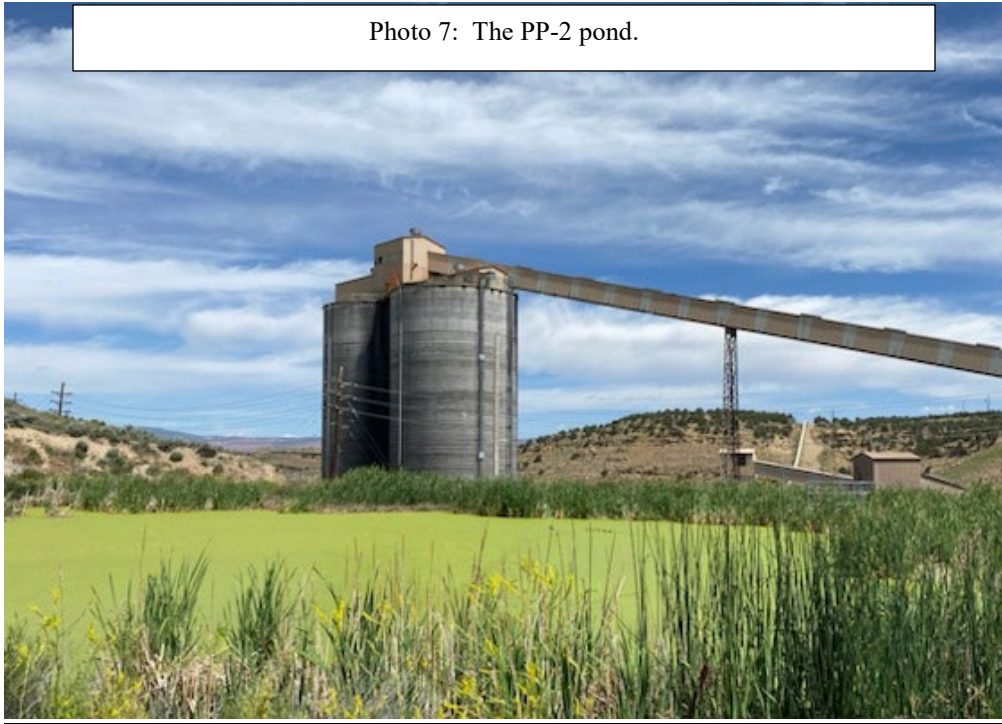
Photo 7: The PP-2 pond.

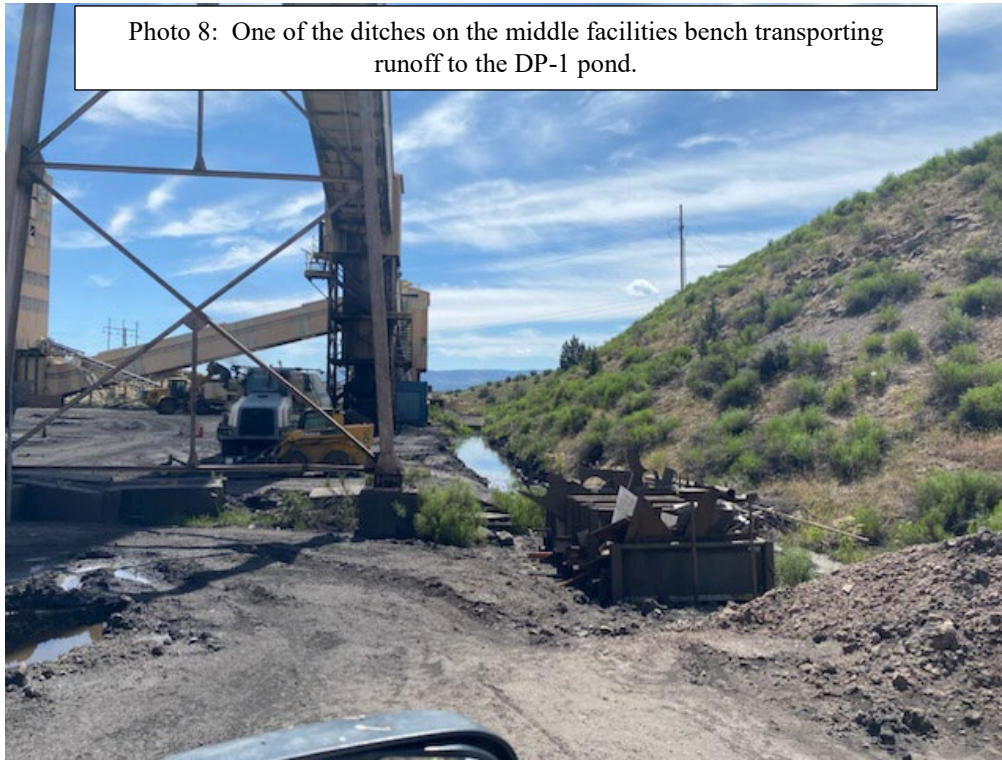
The drainage ditches throughout the main facilities benches were clear from debris and functioning as designed to transport runoff to the DP-1 pond (Photo 8). There are several half CMP culverts on the slopes of the facilities benches that convey water off of the benches and into ditches reporting to the DP-1 pond. The CMP culverts were observed to be in good condition and clear of blockages.

Photo 8: One of the ditches on the middle facilities bench transporting runoff to the DP-1 pond.

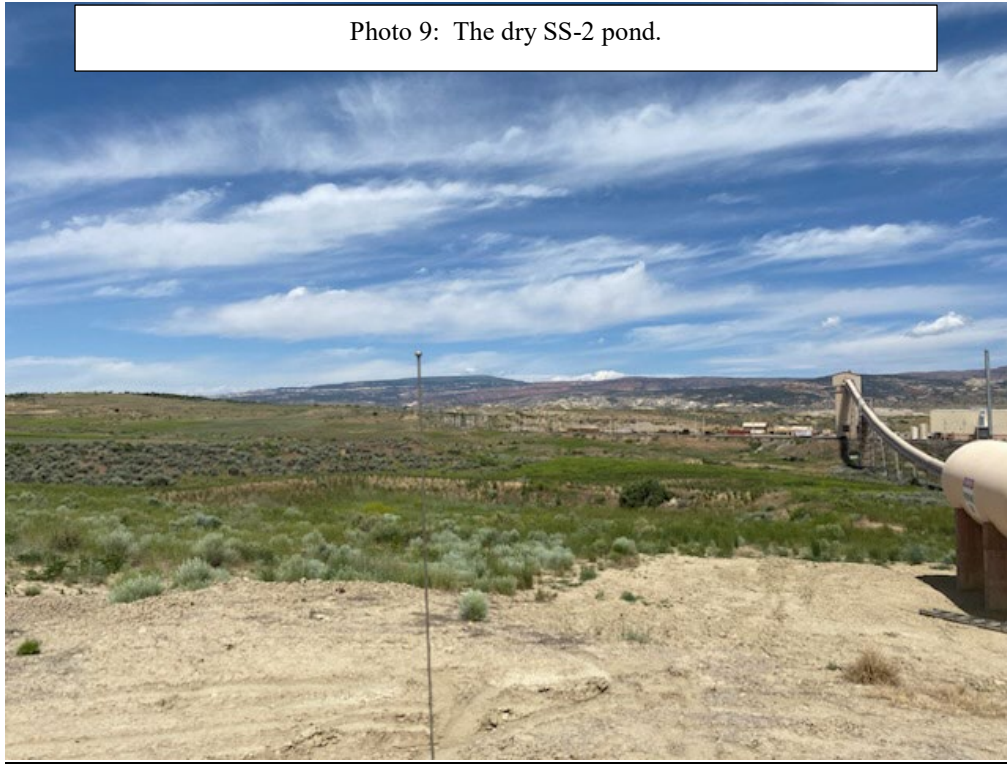
Two ponds, SS-1 and SS-2, are located to the north of the Slot Storage facility. The SS-2 pond was dry (Photo 9). The outlet for the pond was clear of debris. The embankment was vegetated and stable. There were no erosional concerns. The SS-1 pond was mostly muddy in the bottom of the pond. The discharge outlet was observed to be clear. The pond's embankments were stable and vegetated. No erosional features were identified. Culverts and ditches that report to the SS-1 and SS-2 ponds were dry. There were no blockages observed.

Photo 9: The dry SS-2 pond.

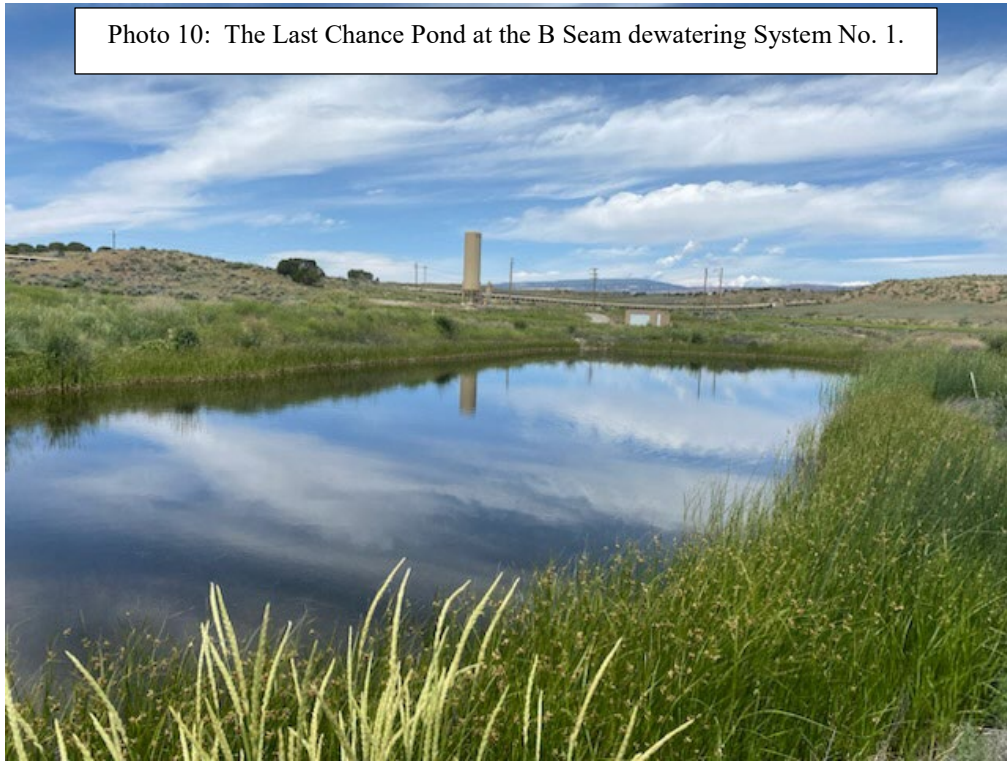
All cells of the B Seam Dewatering System No. 1 were holding water (Photo 10). Water was discharging through the spillway at the Last Chance Pond. The spillway was unobstructed. The embankments were vegetated and stable. No erosional features were observed.

Photo 10: The Last Chance Pond at the B Seam dewatering System No. 1.

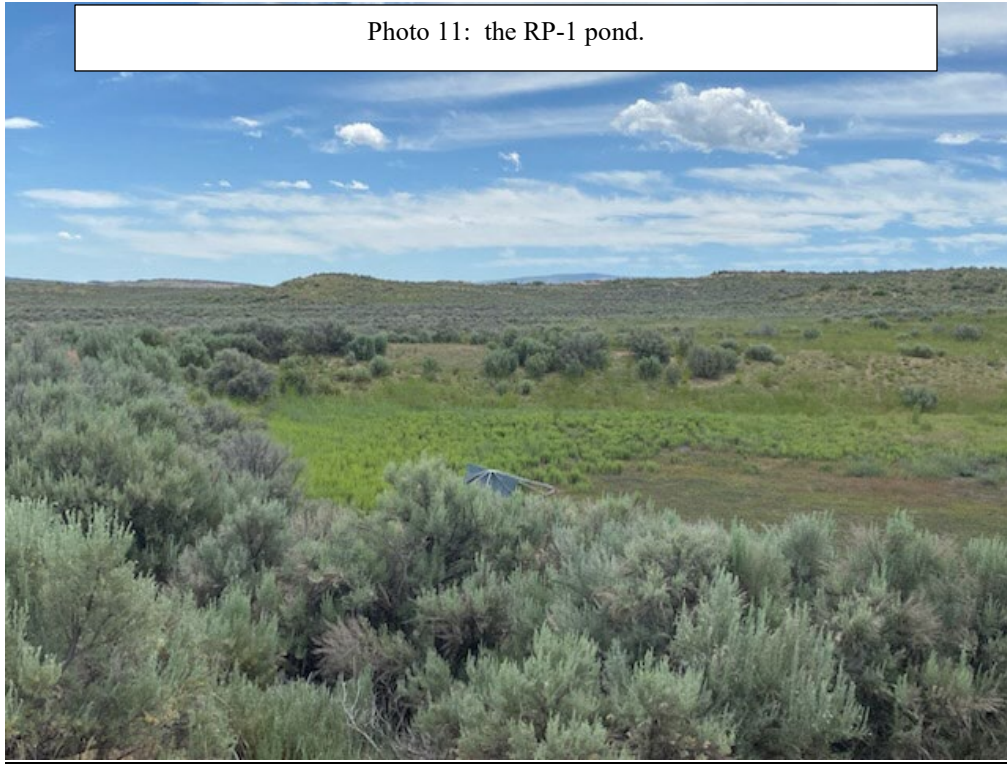
The RP-1 pond is located at the northern base of the reclaimed RP-1 refuse pile. The pond was observed to be dry during the inspection (Photo 11). The trash rack on the spillway was clean. There were no indications of instability or erosion on the embankment. The pond's embankment was covered with vegetation.

Photo 11: the RP-1 pond.

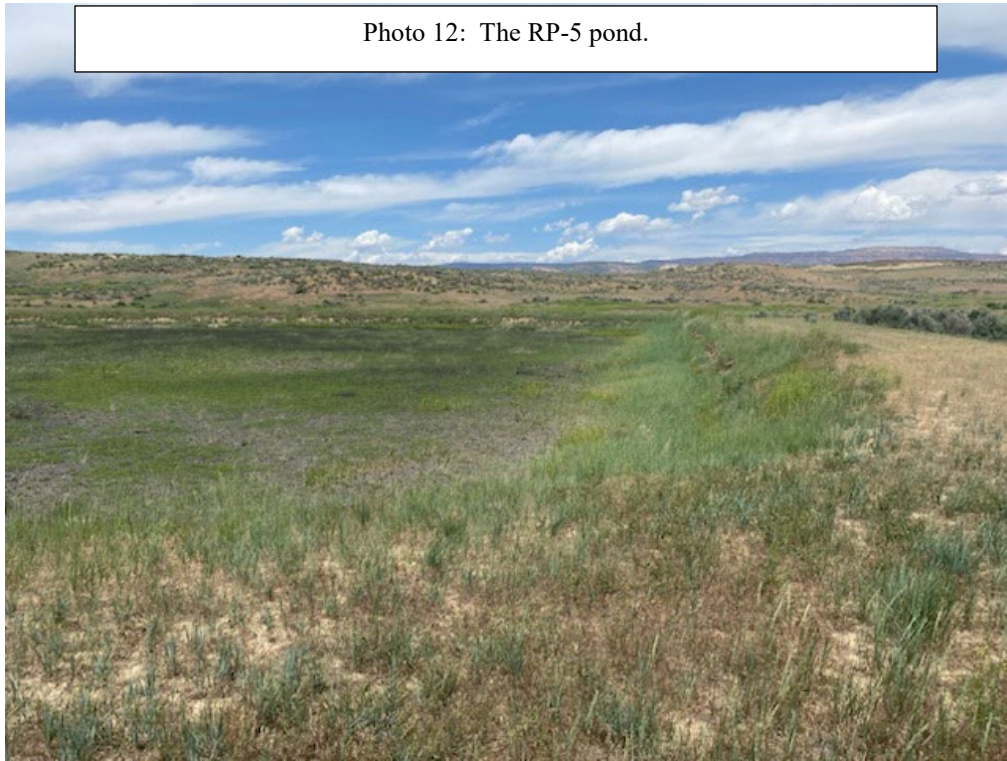
The RP-5 pond is located at the northern base of the RP-5a refuse pile. The pond was also dry during the inspection (Photo 12). The outlet was observed to be clear. The pond's embankment was stable with vegetation. There were no erosional features observed.

Photo 12: The RP-5 pond.

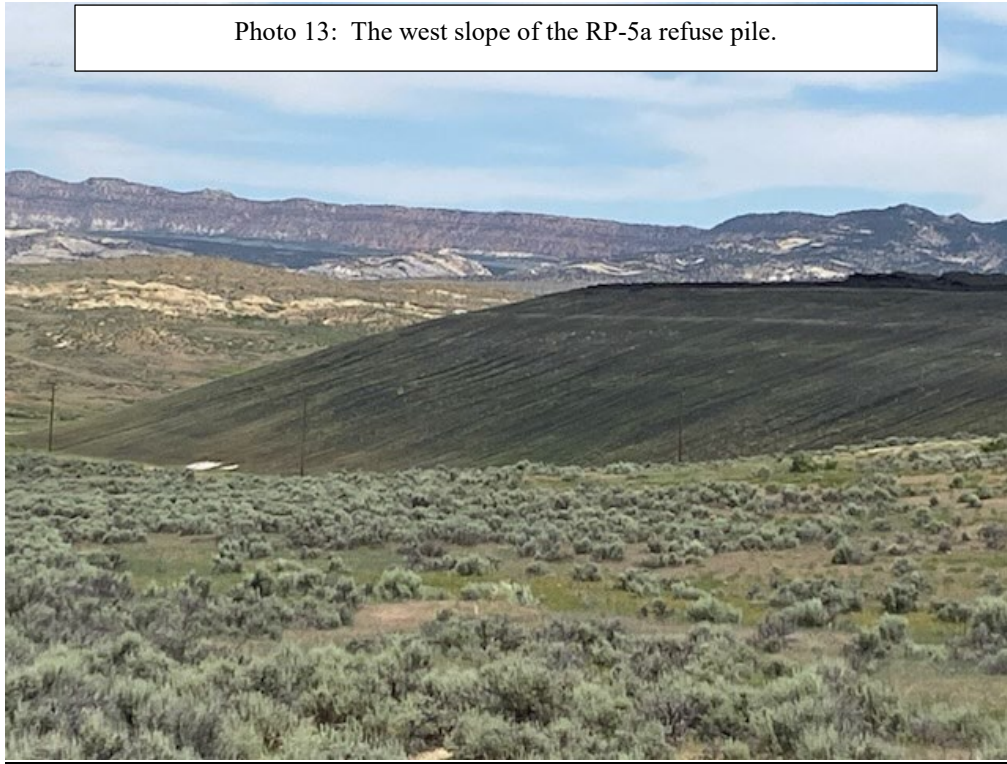
During the inspection Refuse material was being spread out from the windrow stockpiles on top of the RP-5a refuse pile. The slopes of the pile were stable with only minor rilling observed (Photo 13). The rills on the slopes of the pile have been documented in previous Division inspections and are not affecting the stability of the pile. The size of the rills on the slopes have not appeared to have increased in size or depth since the previous inspection.

Photo 13: The west slope of the RP-5a refuse pile.

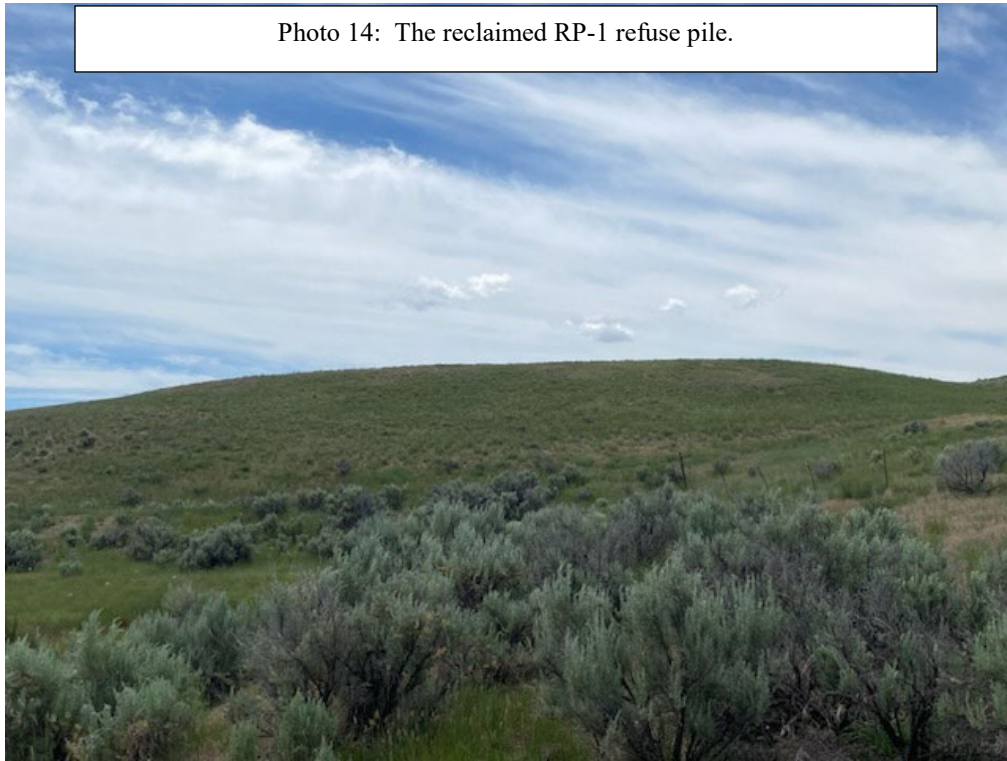
The RP-1 refuse pile has been fully reclaimed. The reclamation work on the pile was completed several years ago. The pile was stable with mature vegetative cover (Photo 14). There were no indications of erosional features. The perimeter ditches were dry and stable. There were no indications of channel breaches or off-site impacts.

Photo 14: The reclaimed RP-1 refuse pile.

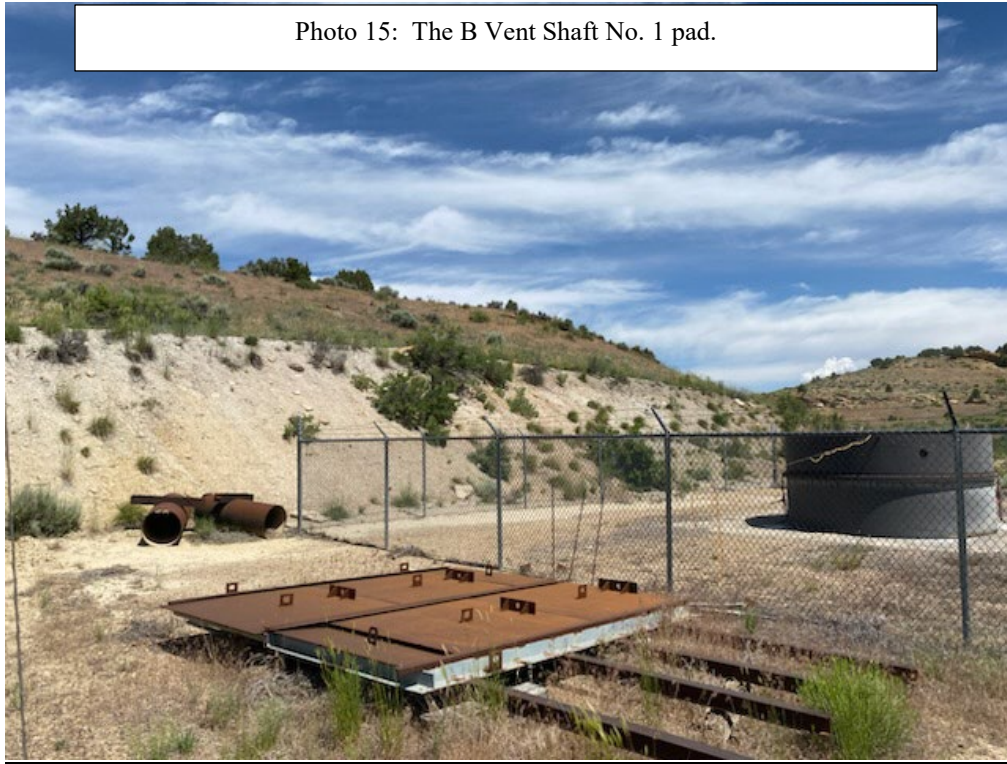
Support facilities inspected included; the main facilities area, the explosives storage pad, the fuel storage tanks, the haul road laydown blisters, the B Vent Shaft No. 1 (Photo 15), RDH-2, RDH-4, the Nitrogen Plant #2, the Slot Storage, the conveyor corridor, transfer buildings, water storage tanks, radio communications tower and the West Mains Vent Shaft. Pads for the facilities inspected were in good condition and stable. Pads with cut and fill slopes were stable with no indications of erosion. Pads with berms were observed to be vegetated and stable. No off-site impacts were identified.

Photo 15: The B Vent Shaft No. 1 pad.
