Inspection Report, Myrin Pit, M-1979-148

MINERALS PROGRAM INSPECTION REPORT
PHONE: (303) 866-3567

MINE NAME: Myrin Pit	MINE/PROSPECTING ID#: M-1979-148	MINERAL: Sand and gravel	COUNTY: Routt
INSPECTION TYPE: Monitoring	WEATHER: Clear	INSP. DATE: June 27, 2023	INSP. TIME: 13:00
OPERATOR: Colorado Department of Transportation	OPERATOR REPRESENTATIVE: Ky Cox	TYPE OF OPERATION: 110c - Construction Limited Impact	
REASON FOR INSPECTION: Normal I&E Program	BOND CALCULATION TYPE: N/A	BOND AMOUNT: \$0.00	
DATE OF COMPLAINT: NA	POST INSP. CONTACTS: None	JOINT INSP. AGENCY: None	
INSPECTOR(S): Hunter Ridley	INSPECTOR'S SIGNATURE:

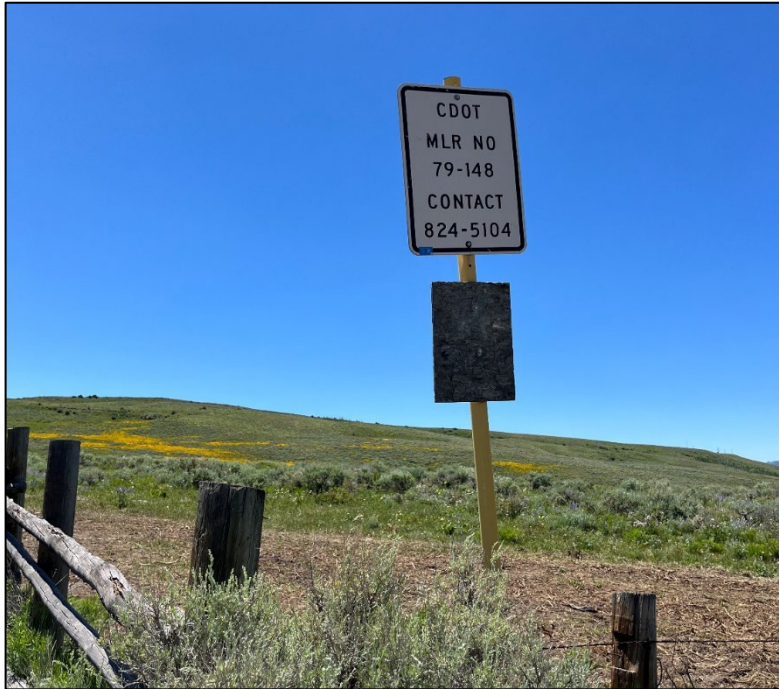
The mine identification sign and affected area boundary markers are in place and in compliance with Rule 3.1.12. The sign is located on the gate as you pull off of Highway 131 onto the access road (Photo 1). T-posts delineate the permit boundary (Photo 2).

Photo 1: Mine signage was located at the entrance to the access road which leads to the pit.

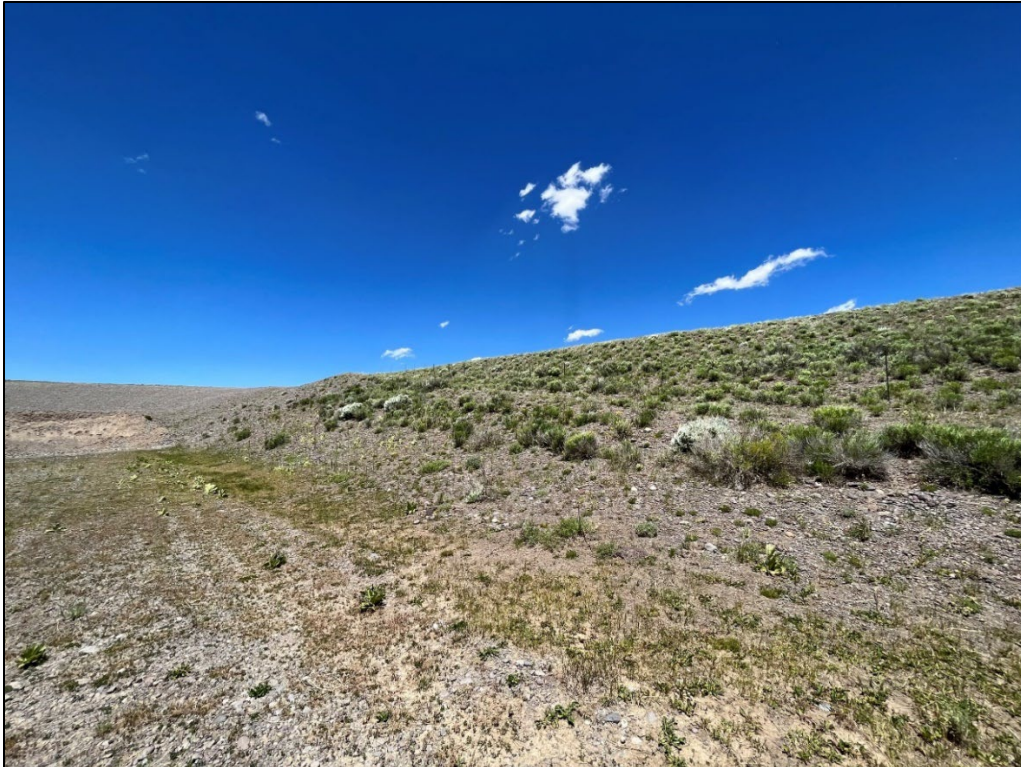
Figure 2: View northwest of partially reclaimed pit slope, t-posts are staked on the hill to delineate permit boundary lines.

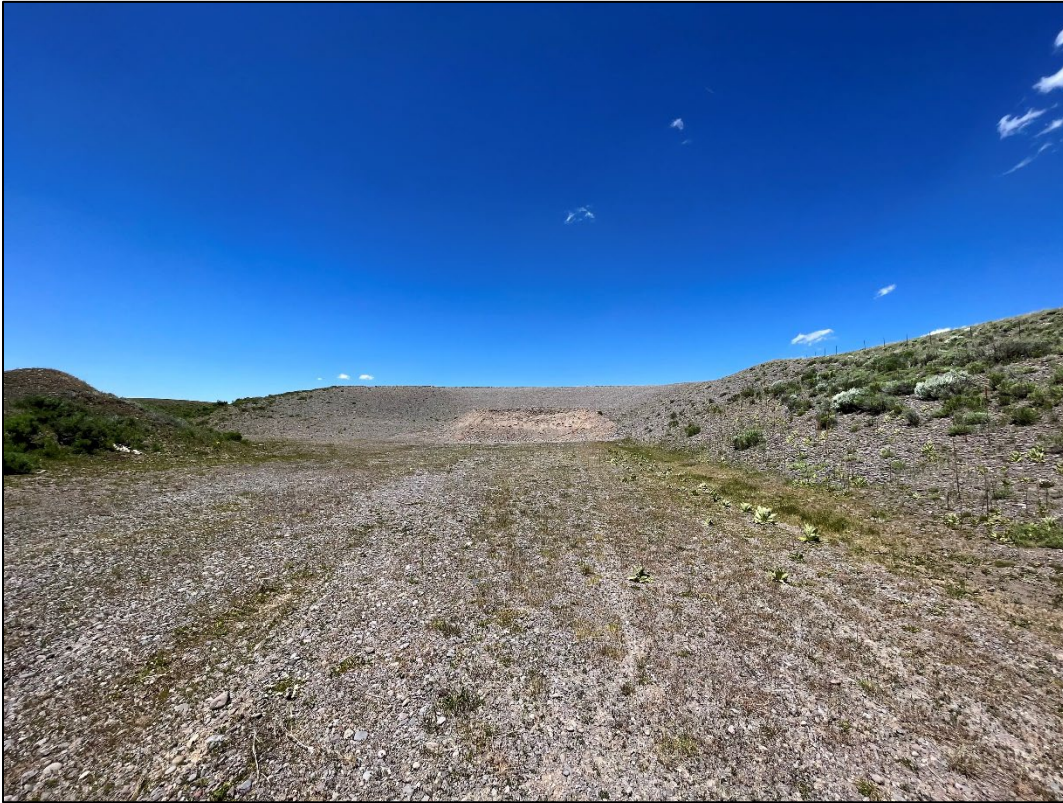
The site is utilized on an as need basis. No activity had occurred at the pit yet as of this year, but the Operator representative stated that the pit was scheduled to be in use this season. The pit has one main highwall that is sloped at approximately 3H:1V (Photo 3). Material is dozed down in to stockpiles and is then crushed. There is one main stockpile located at the foot of the highwall. The stockpile and highwall is partially stabilized with volunteer vegetation (Photo 5). A well vegetated topsoil stockpile is located directly south of the highwall (Photo 4). No erosion problems were observed. No equipment, fuel or structures were observed.

Figure 3: View west directly into the pit, a stockpile sits at the bottom of the mining slope.

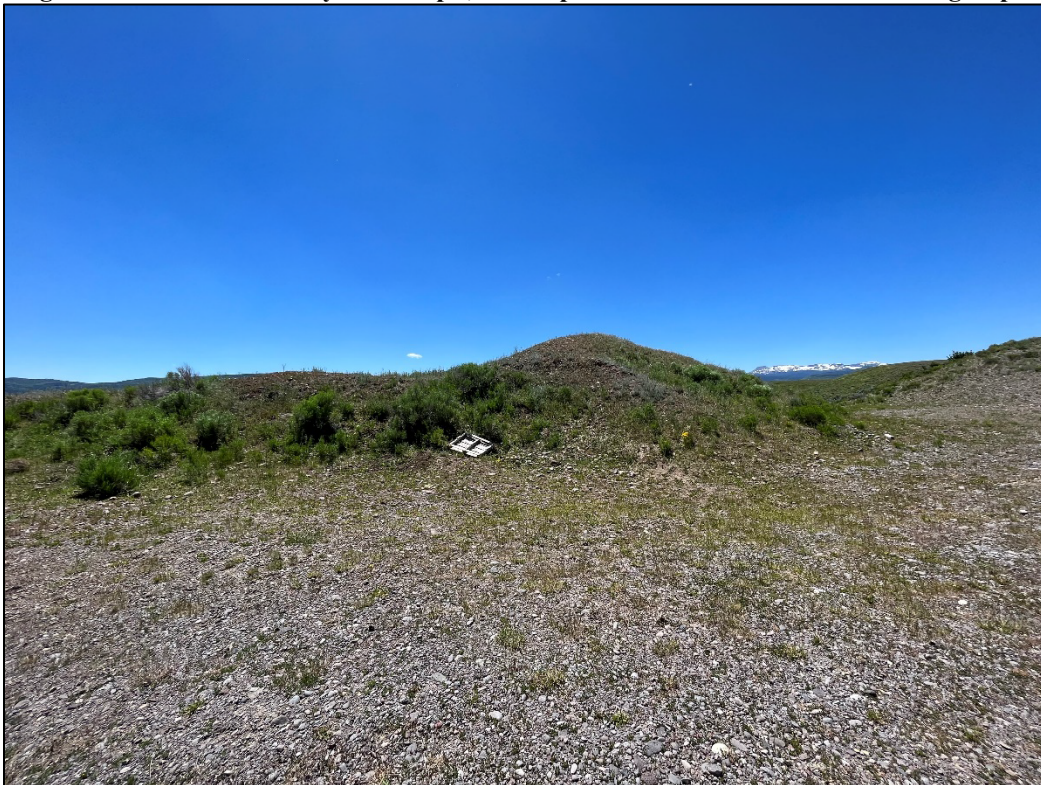
Photo 4: View south of the vegetated topsoil pile.

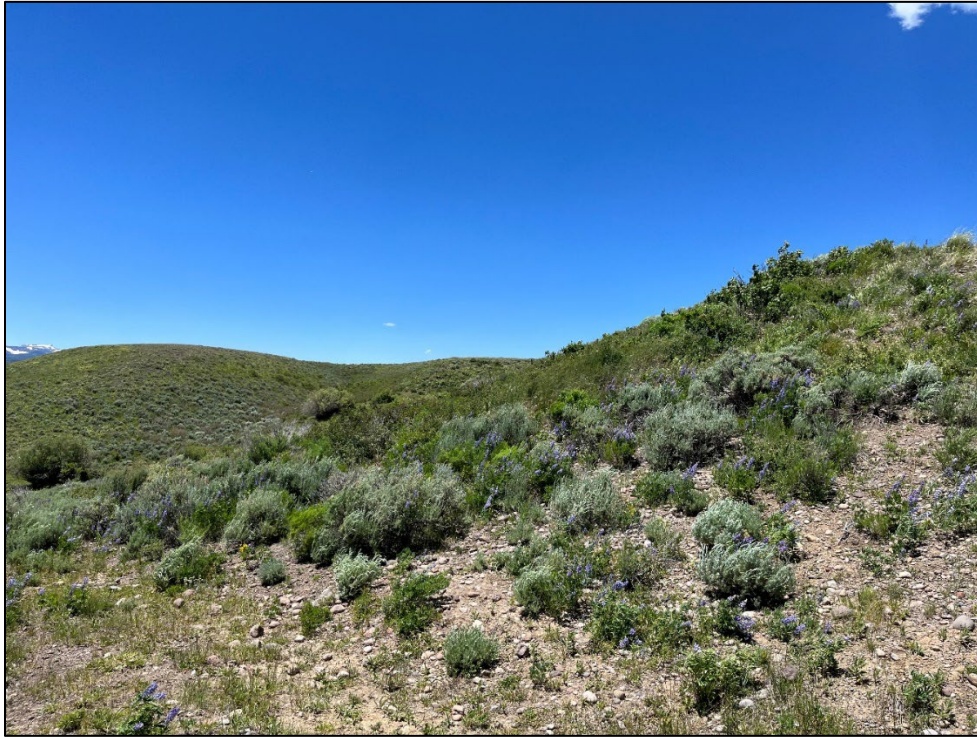
Figure 5: View west of the edge of the permit boundary and the partially vegetated highwall.

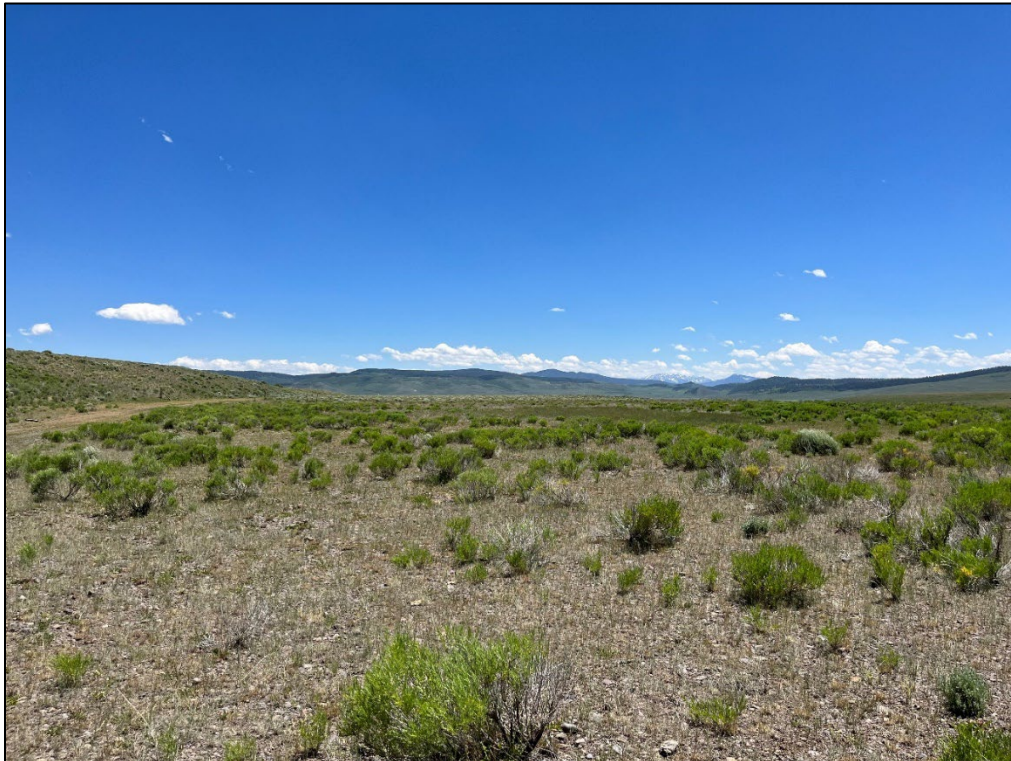
The northern hillside and southeastern half of the pit have been previously reclaimed, but are unreleased. Vegetative cover is good in most of these areas, however a few large patches of bare ground are seen where cattle have overgrazed (Photos 6 and 7). These areas will need to be addressed prior to formal release. The operator representative stated that weeds are sprayed annually by the county.

Figure 6: View southeast of one of the larger bare spots of the reclaimed area, this is due to overgrazing.

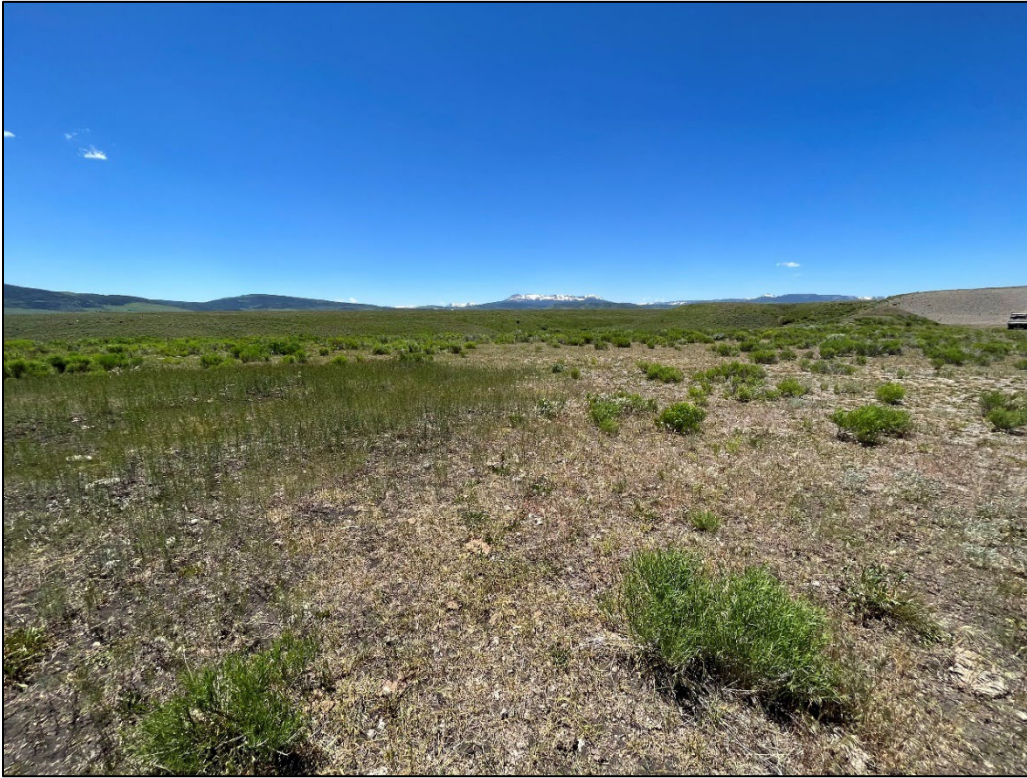
Figure 7: View northwest towards the highwall of the bare spot in the partially reclaimed area, a patch of cheat grass is noted to be growing here.
