COLORADO

Division of Reclamation,
Mining and Safety

MINERALS PROGRAM INSPECTION REPORT

MINE NAME: Schwartzwalder Mine	MINE/PROSPECTING ID#: M-1977-300	MINERAL: Uranium	COUNTY: Jefferson
INSPECTION TYPE: Monitoring	WEATHER: Clear	INSP. DATE: June 8, 2023	INSP. TIME: 08:30
OPERATOR: Colorado Legacy Land, LLC	OPERATOR REPRESENTATIVE: Jim Harrington, Billy Ray	TYPE OF OPERATION: 112d-2 - Designated Mining Operation

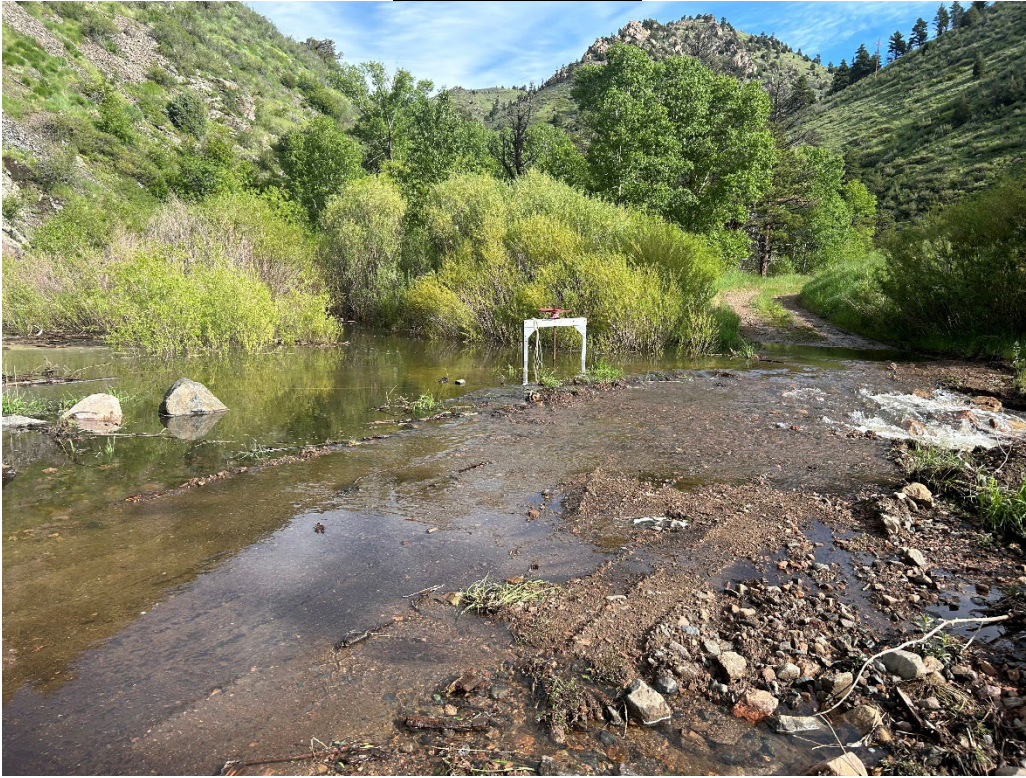
During the inspection, the Division observed that Ralston Creek was overtopping the access road where it crosses the creek on the south side of the north waste rock pile. According to the Operator, the creek flows were contained to the bypass pipeline the day before the inspection. However, there was a spike in flows overnight which caused the water level to quickly rise and overtop the road. The Operator opened the gate at the cutoff wall and the creek flows receded and were routed through the culverts beneath the access road; no

damage was observed on the access road. Both the north and south waste rock piles were inspected and were found to be in good shape. The diversion channel on the north waste rock piles was free of debris and was functioning properly.

1. Ralston Creek overtopping access road.

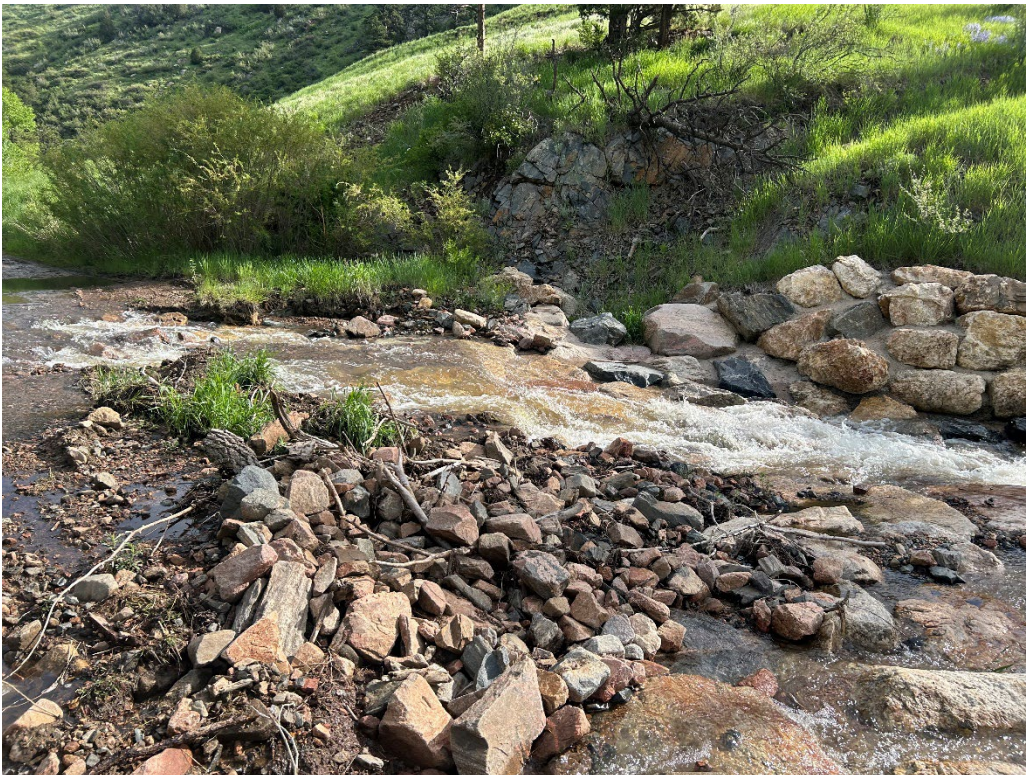
2. Ralston Creek, below north waste rock pile.

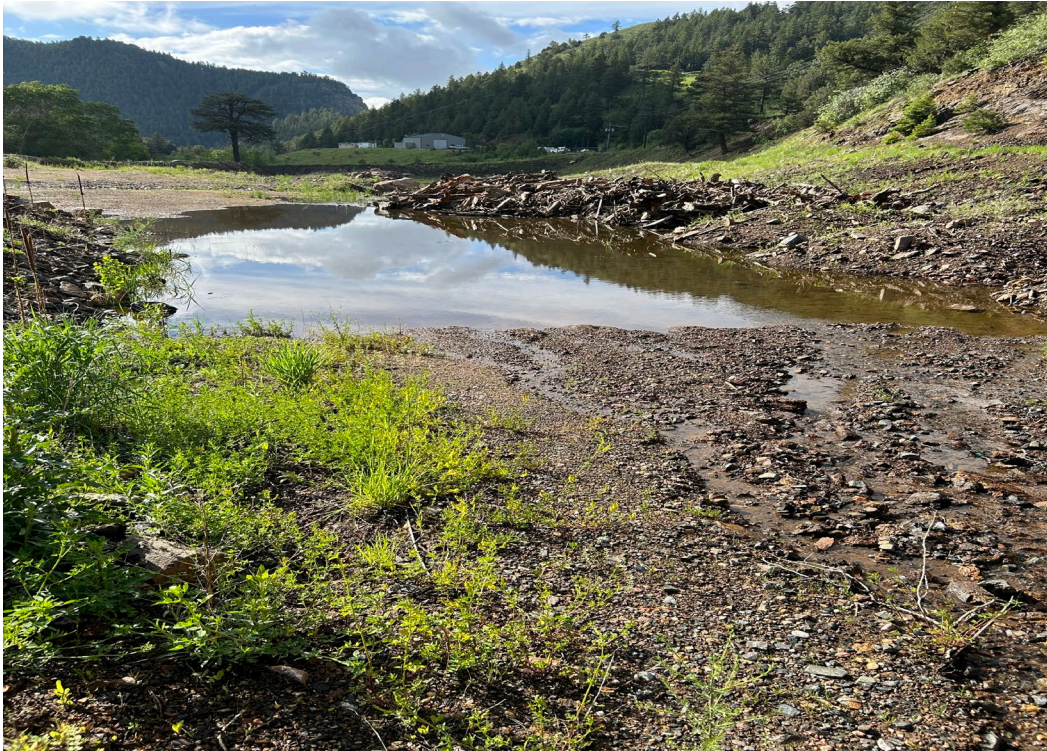
The excavation of waste rock from the valley floor ceased last year and there are several large excavated areas on the south side of Ralston Creek which have not yet been reclaimed. As noted above, if the Operator is able to secure funding, removal of the remaining waste rock will resume. The remaining areas to be excavated are primarily under the existing access road that runs parallel to Ralston Creek and adjacent to the by-pass pipeline. During the inspection, the Division observed that the excavated areas were full of water. However, none of the pits were discharging water to Ralston Creek. The excavated areas had been filled by direct precipitation and runoff from upland areas. In addition, the Division observed that water was expressing outside of the creek channel near the eastern edge of the south waste rock pile. The Division has not previously observed this expression of groundwater outside of the main channel. The Division believes this is due to saturated conditions within the alluvium and an above average amount of water moving through Ralston Creek. It is believed that these flows will dry up later in the season. However, it highlights the need for additional designs for the final configuration of the alluvial valley and the channel of Ralston Creek. The Operator informed the Division that the captured water will be pumped to the water treatment plant before discharging it back to Ralston Creek.

3. Surface and groundwater captured in excavated areas.

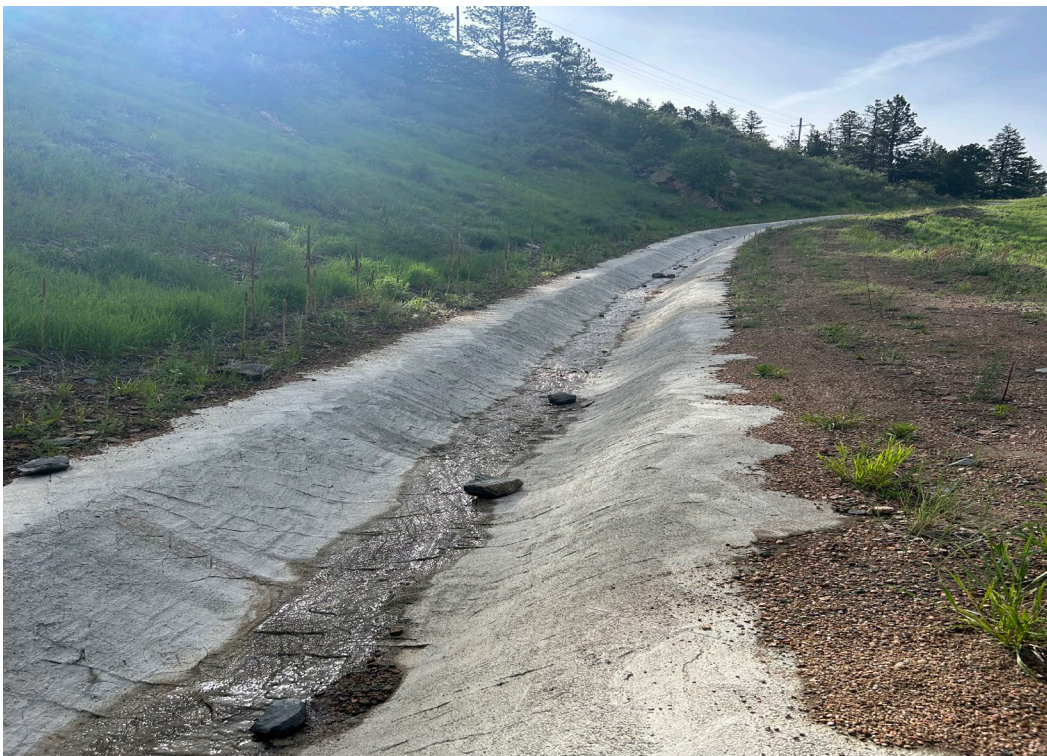
4. Stormwater diversion channel - at north waste rock pile.
