MINERALS PROGRAM INSPECTION REPORT
PHONE: (303) 866-3567

MINE NAME: Humming Bird Mine	MINE/PROSPECTING ID#: M-2017-035	MINERAL: Gemstones, fluorine, copper	COUNTY: Mesa
INSPECTION TYPE: Monitoring	WEATHER: Clear	INSP. DATE: July 5, 2023	INSP. TIME: 10:10
OPERATOR: Miners Mall, LLC	OPERATOR REPRESENTATIVE: Dennis Schneider	TYPE OF OPERATION: 110(1) - Hard Rock Limited Impact	
REASON FOR INSPECTION: Normal I&E Program	BOND CALCULATION TYPE: Complete Bond	BOND AMOUNT: \$4,726.00	
DATE OF COMPLAINT: NA	POST INSP. CONTACTS: None	JOINT INSP. AGENCY: U.S.BLM	
INSPECTOR(S): Amy Yeldell	INSPECTOR'S SIGNATURE:

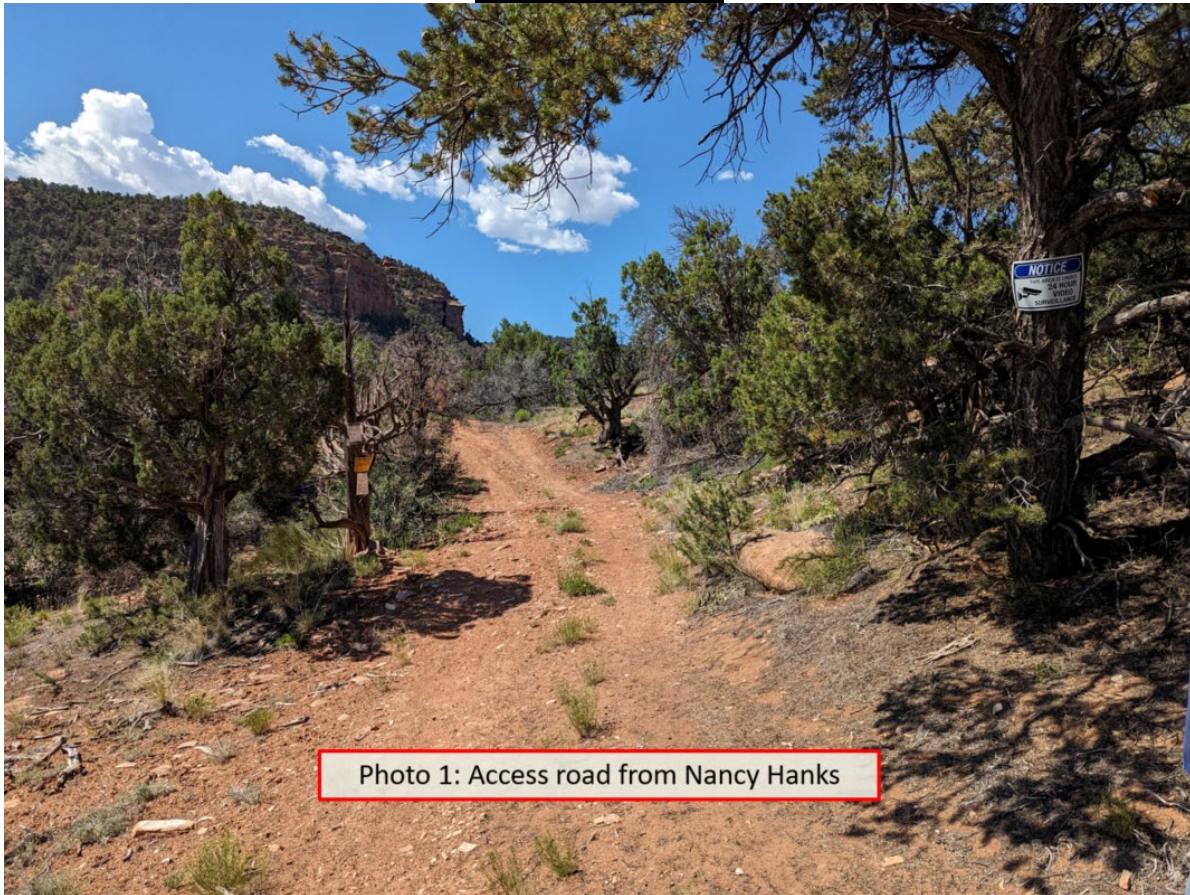
Photo 1: Access road from Nancy Hanks

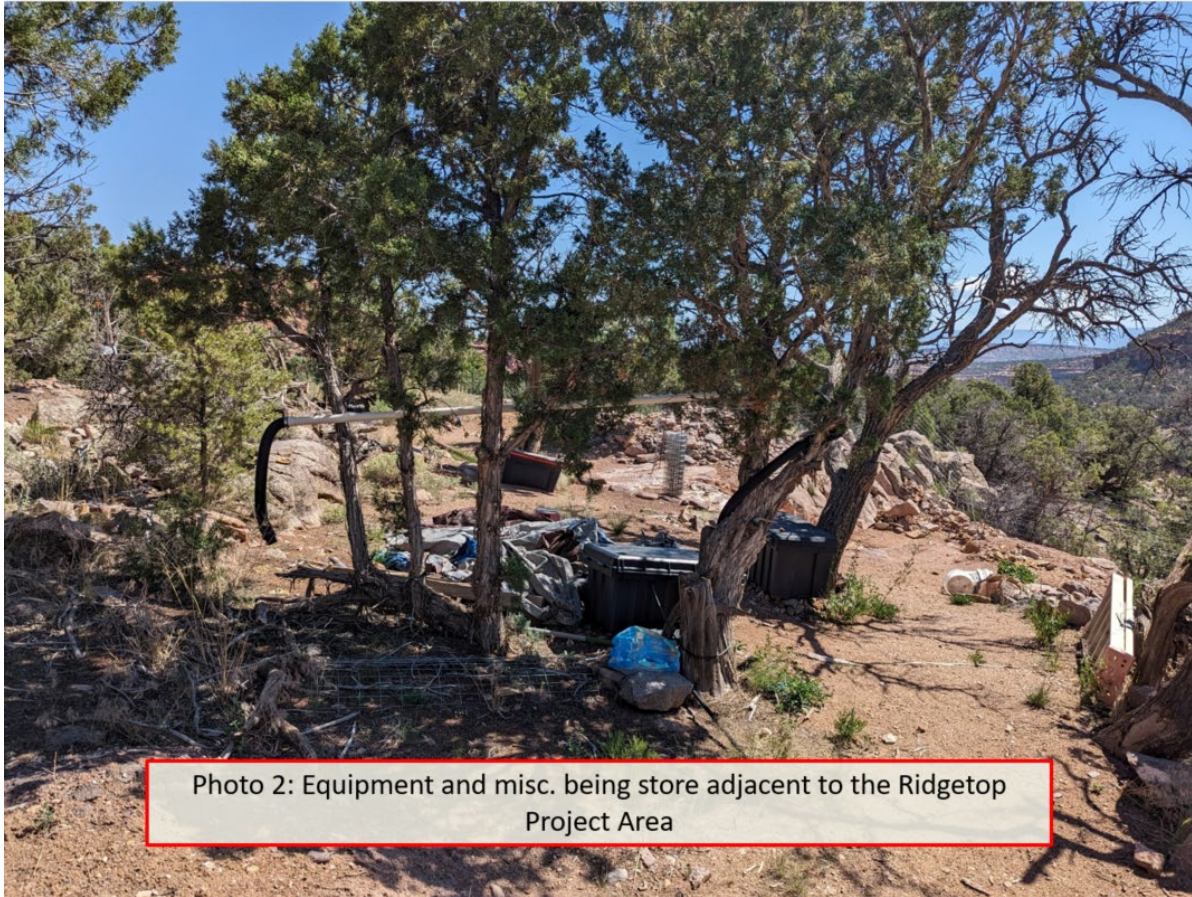
The site was inactive at the time of the inspection. Very few tools or equipment were being stored on site at this time.

Photo 2: Equipment and misc. being store adjacent to the Ridgetop Project Area

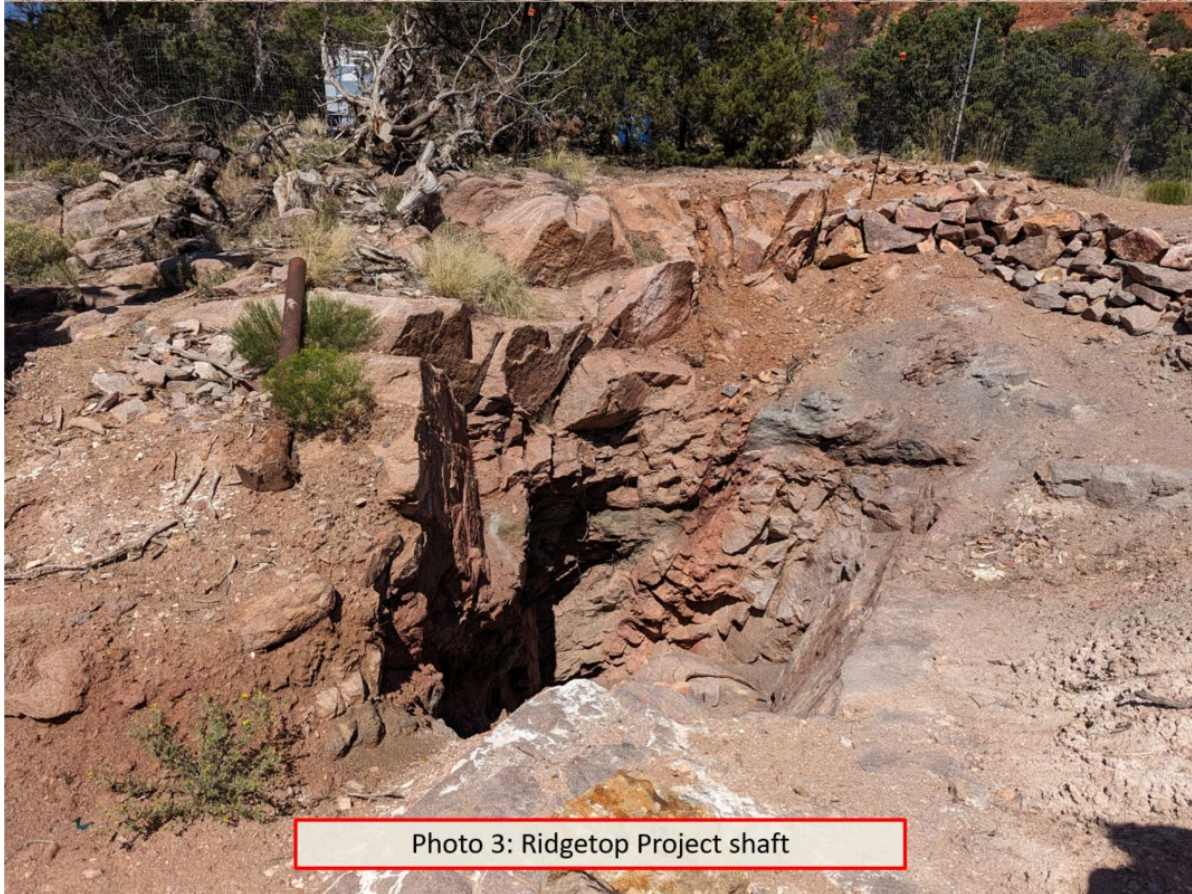
The Ridgetop Project Area remains at phase 2. The Ridgetop portal structure has not been installed so the shaft is neither completely open nor completely closed and secured. The excavated fault area also remains open. No additional work has been done in the Connector Project Area. The portal grate remains in place with a small foot path cleared for access.

Photo 3: Ridgetop Project shaft

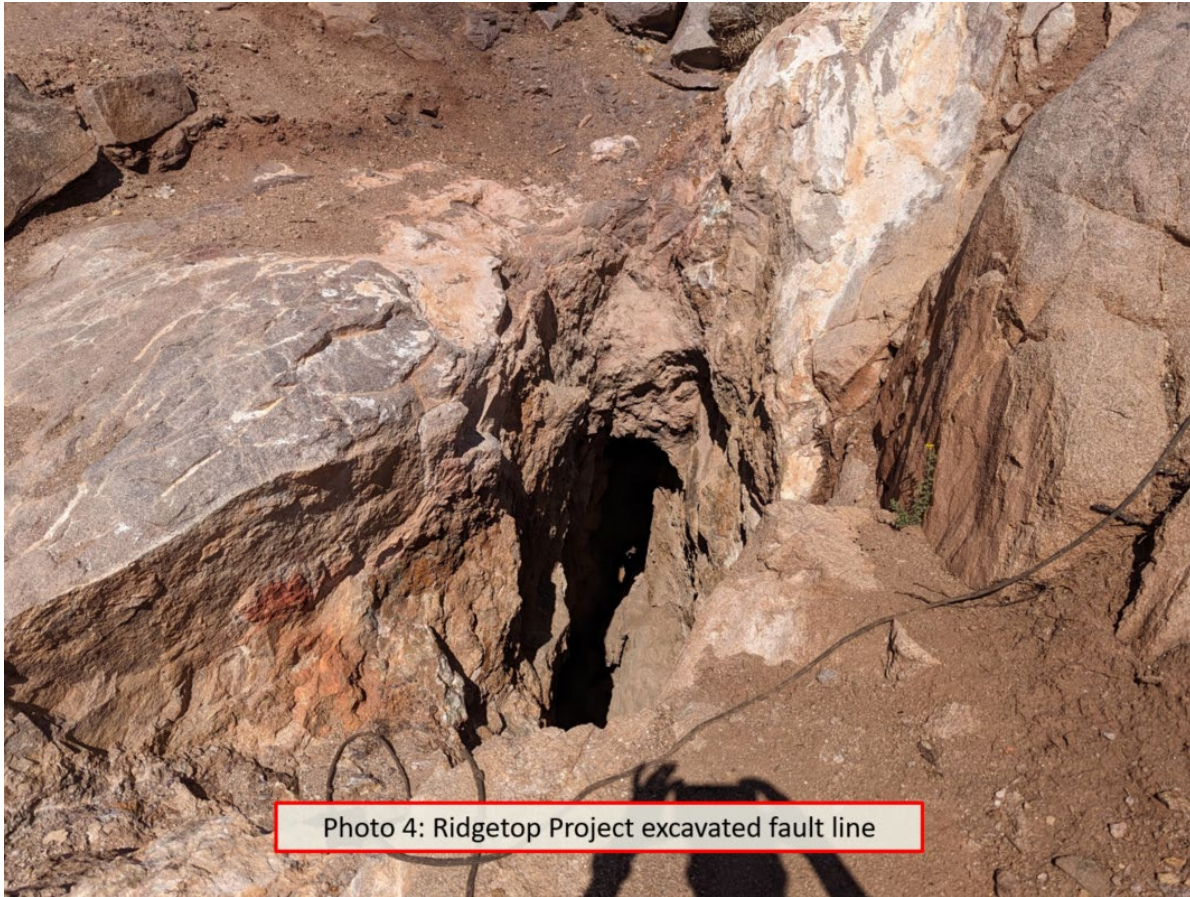
Photo 4: Ridgetop Project excavated fault line

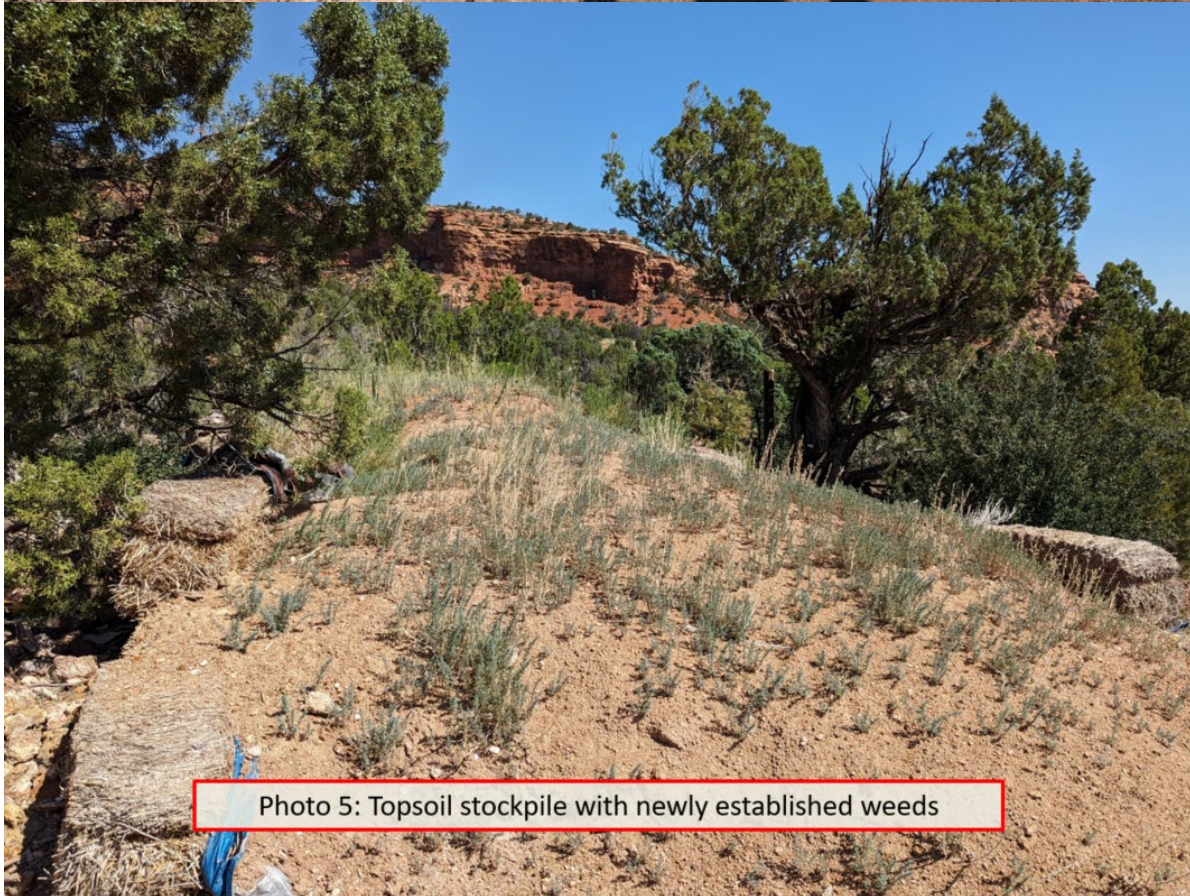
The waste rock and topsoil piles appear to be stable. There is no erosion from the piles. The topsoil has good vegetation establishment. Halogeton and Russian Thistle were observed growing on topsoil pile. Weeds should be treated to preserve topsoil, given the small area, hand pulling may be most effective.

Photo 5: Topsoil stockpile with newly established weeds

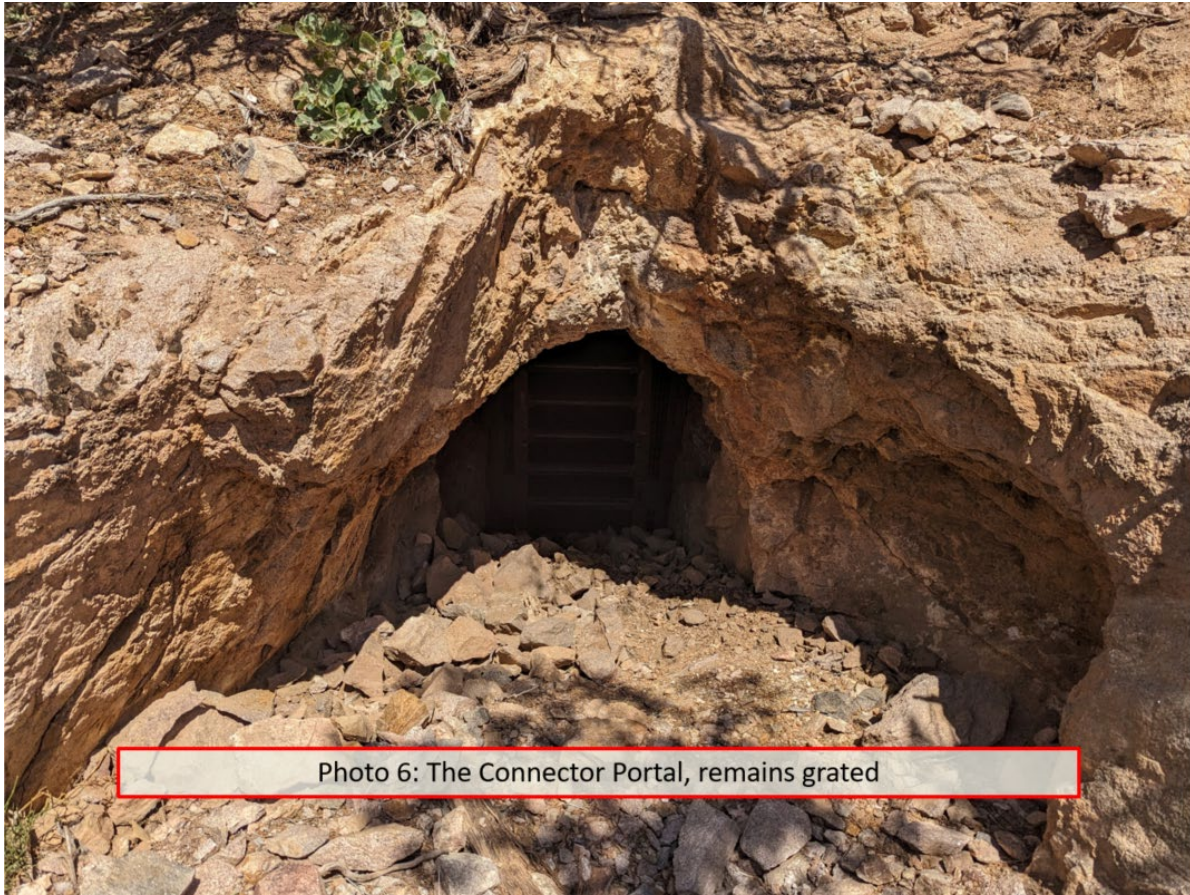
Photo 6: The Connector Portal, remains grated
