PERMIT INFORMATION

Permit Number: C-1980-007 Mine Name: West Elk Mine Operator: Mountain Coal Company, LLC Operator Address: Ms Nicki Poulos 5174 Highway 133 Somerset, CO 81434	County: Delta, Gunnison Operation Type: Underground Permit Status: Active Ownership: Private
	Operator Representative Present: Nicki Poulos, Garren Atchley, Mark Peirce, Cody Rapke, Jessica Wilczek
Operator Representative Signature: (Field Issuance Only)

This was a partial inspection by Leigh Simmons of the Division of Reclamation, Mining and Safety (Division), with a special focus on the reclamation success of sites included in the SL-16 (partial Phase II) and SL-17 (partial Phase III) bond release applications. Tom Medlin (OSMRE), Dan Gray (USFS), and Nicki Poulos, Garren Atchley, Mark Peirce, Cody Rapke and Jessica Wilczek of Mountain Coal Company (MCC) each accompanied the inspection at times. The weather was clear, warm and dry. The mine was active.

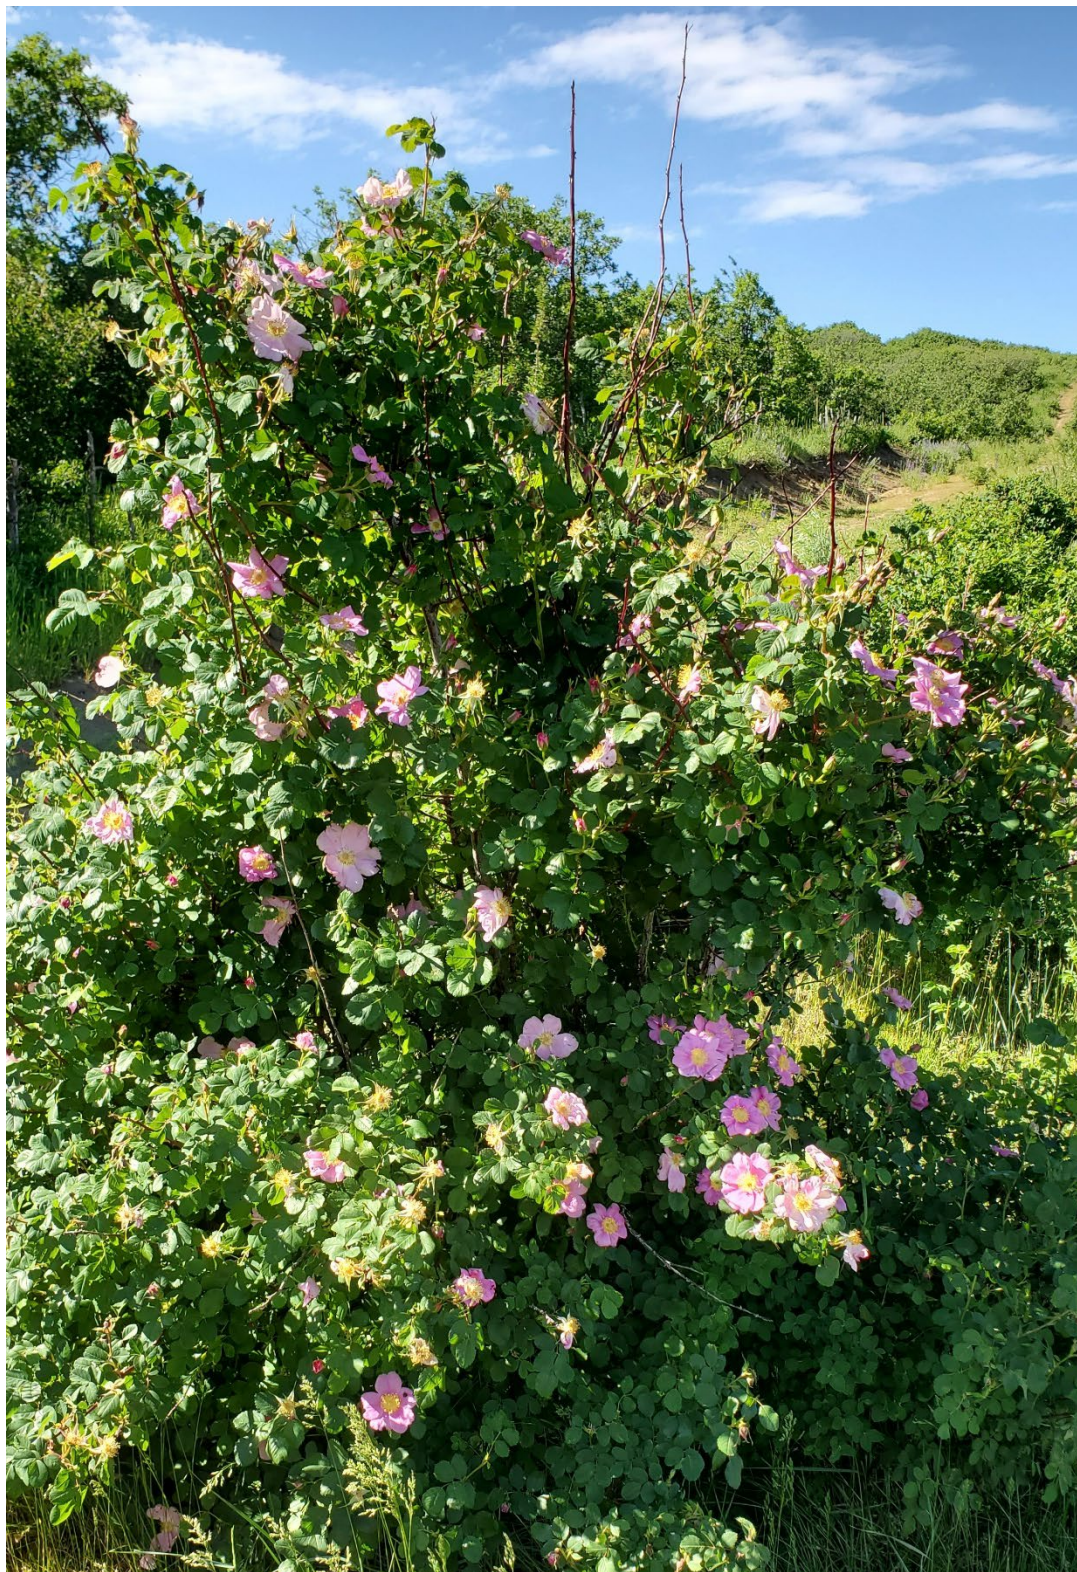
Figure 5: Woods rose on E4-15

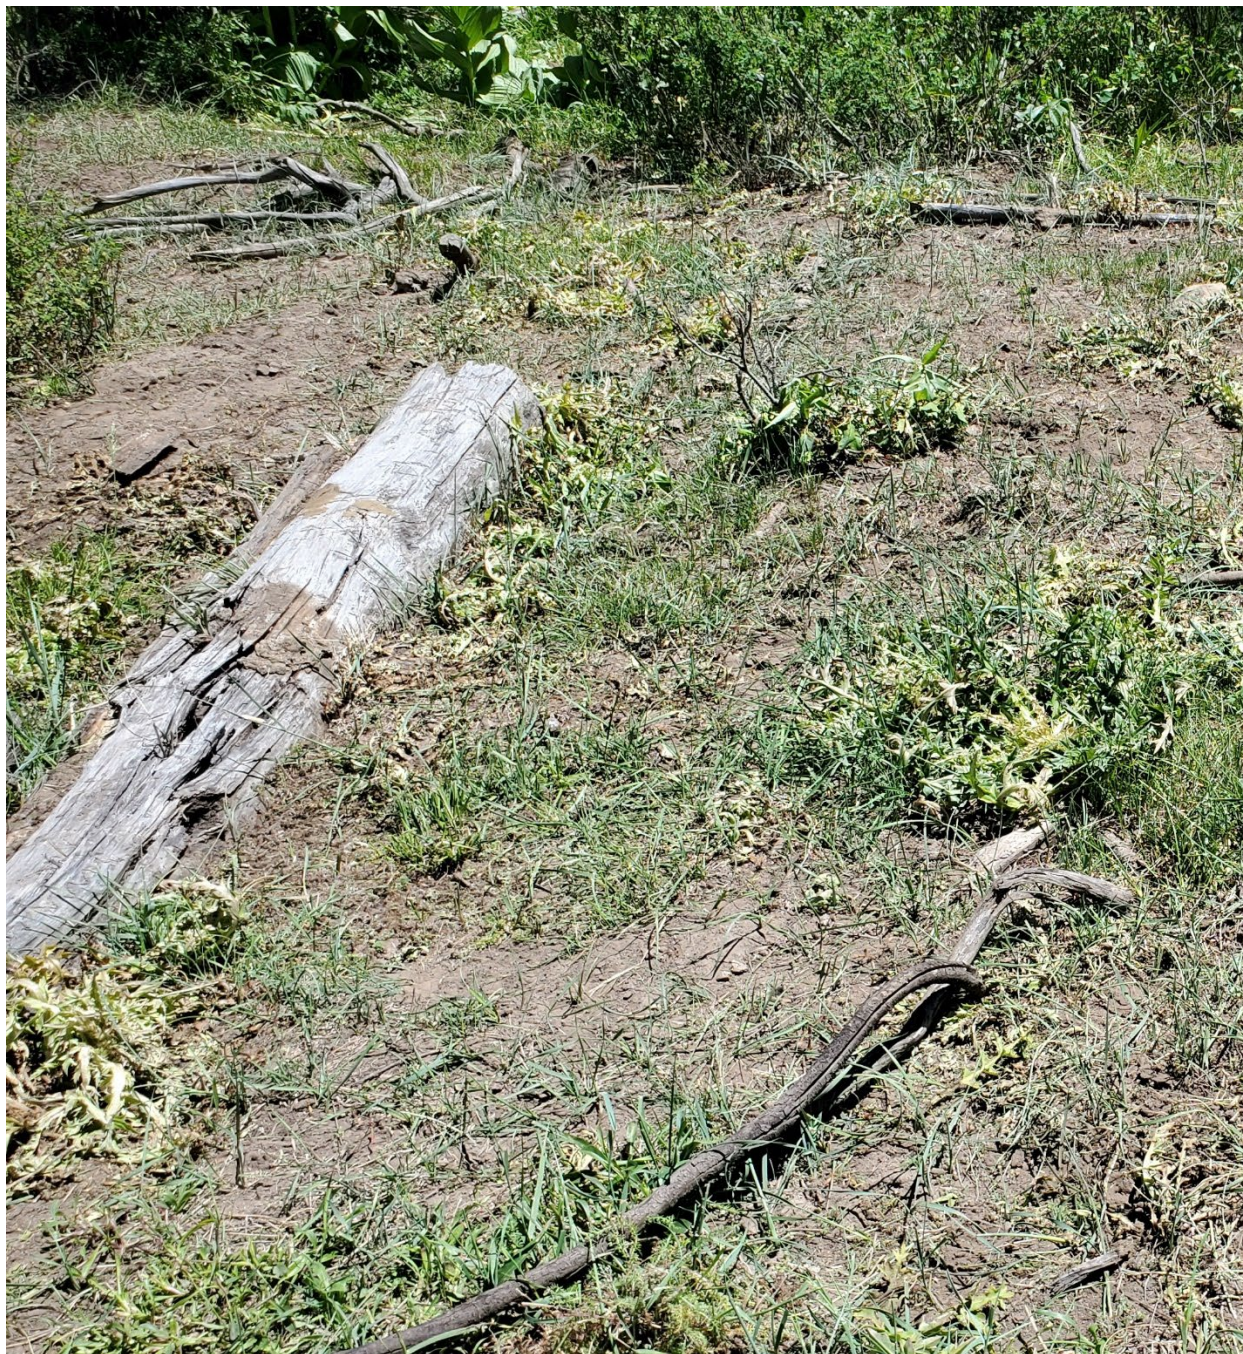
Figure 8: Weeds sprayed on E5-1

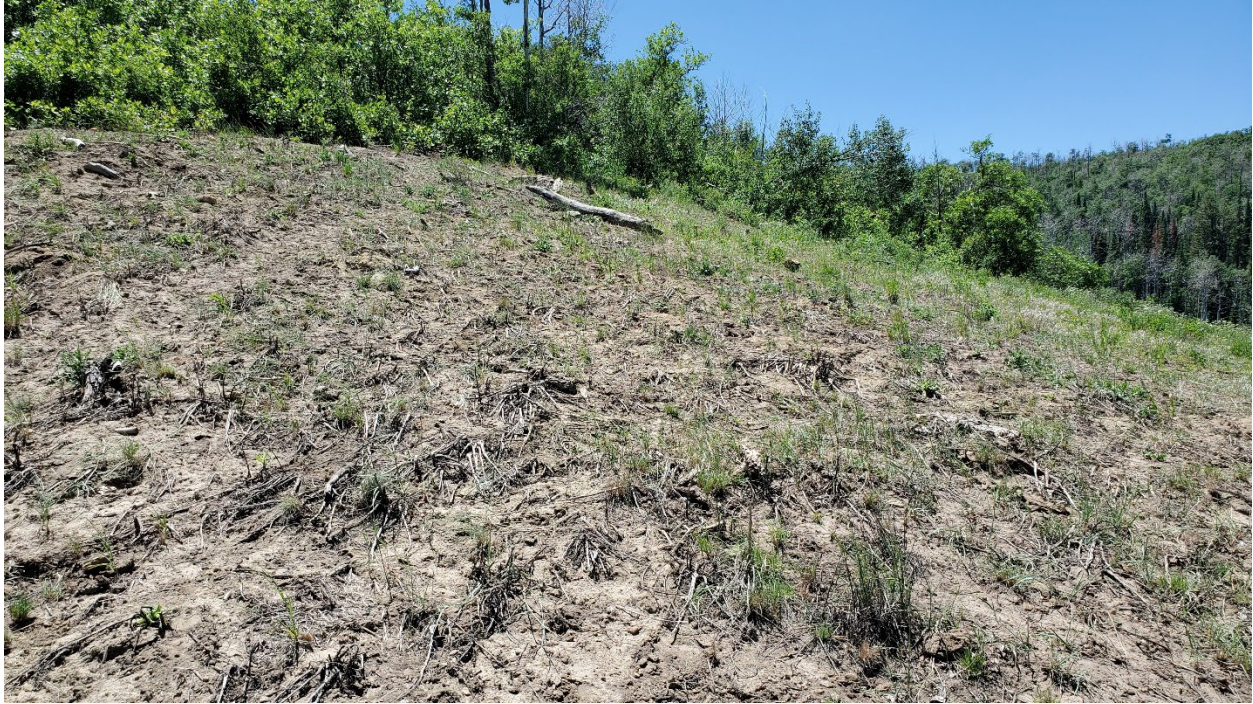
Figure 13: Relatively bare patch on E5-8

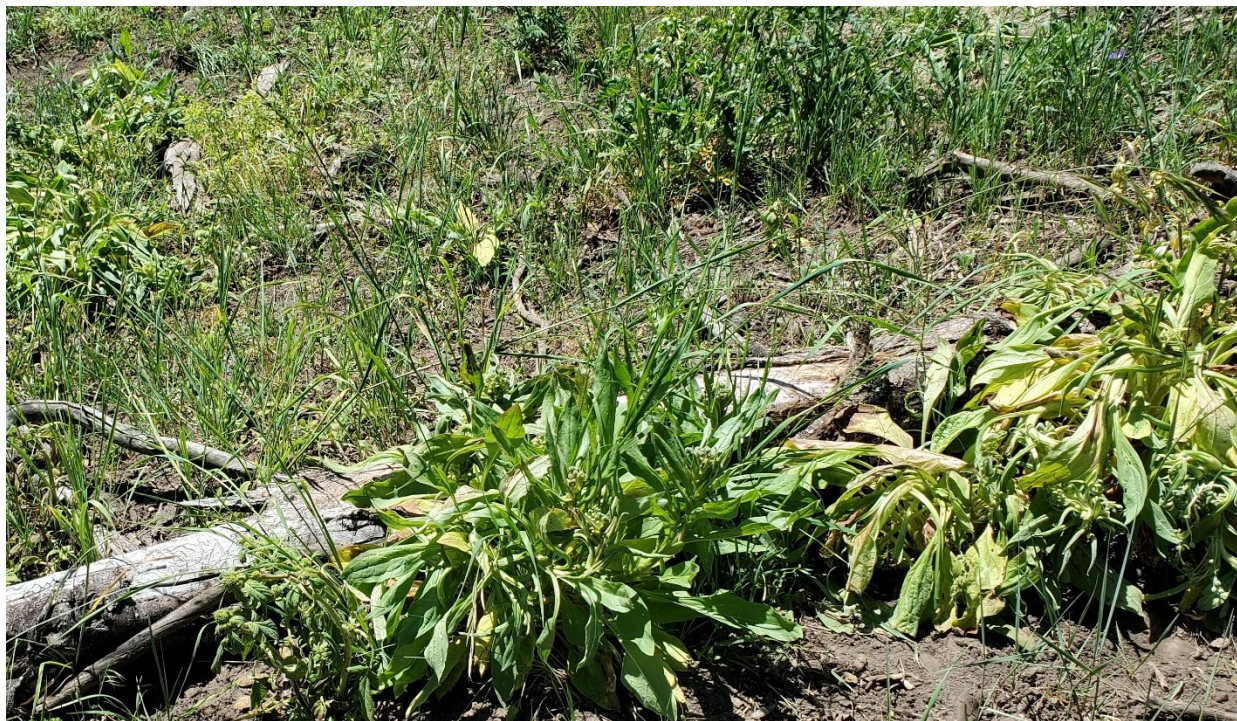
E5-11	N/A	USFS	Not reclaimed	Remove from application
E5-12/13/11LWE5X40 and road	II	USFS	Inspected, no problem	Quite a lot of houndstongue on road, has been sprayed
E5-14 and road	II	USFS	Inspected, no problem	Very few weeds. Has been sprayed.
E5-15 and road	II	USFS	Inspected, no problem	Thistle has obviously been sprayed. Houndstongue too?
E5-16	II	USFS	Inspected, no problem	Thistle, houndstongue and mullein have been sprayed. Some big patches to keep an eye on.
E5-17	II	USFS	Inspected, no problem	Spot treat for thistle
E5-18	II	USFS	Inspected, no problem	
10LWE5X40	II	USFS	Inspected, no problem	
10LWE6X62	II	USFS	Inspected, no problem	
11LWE6X53	II	USFS	Inspected, no problem	Pretty weedy, whole pad needs sprayed
MW 5-11-1	N/A	USFS	Not inspected	Deep creek crossing impassable. Has not been through Phase I. Remove from application
MW 5-12-1	N/A	USFS	Not inspected	Deep creek crossing impassable. Has not been through Phase I. Remove from application

Figure 16: Sprayed houndstongue on road to E5-12

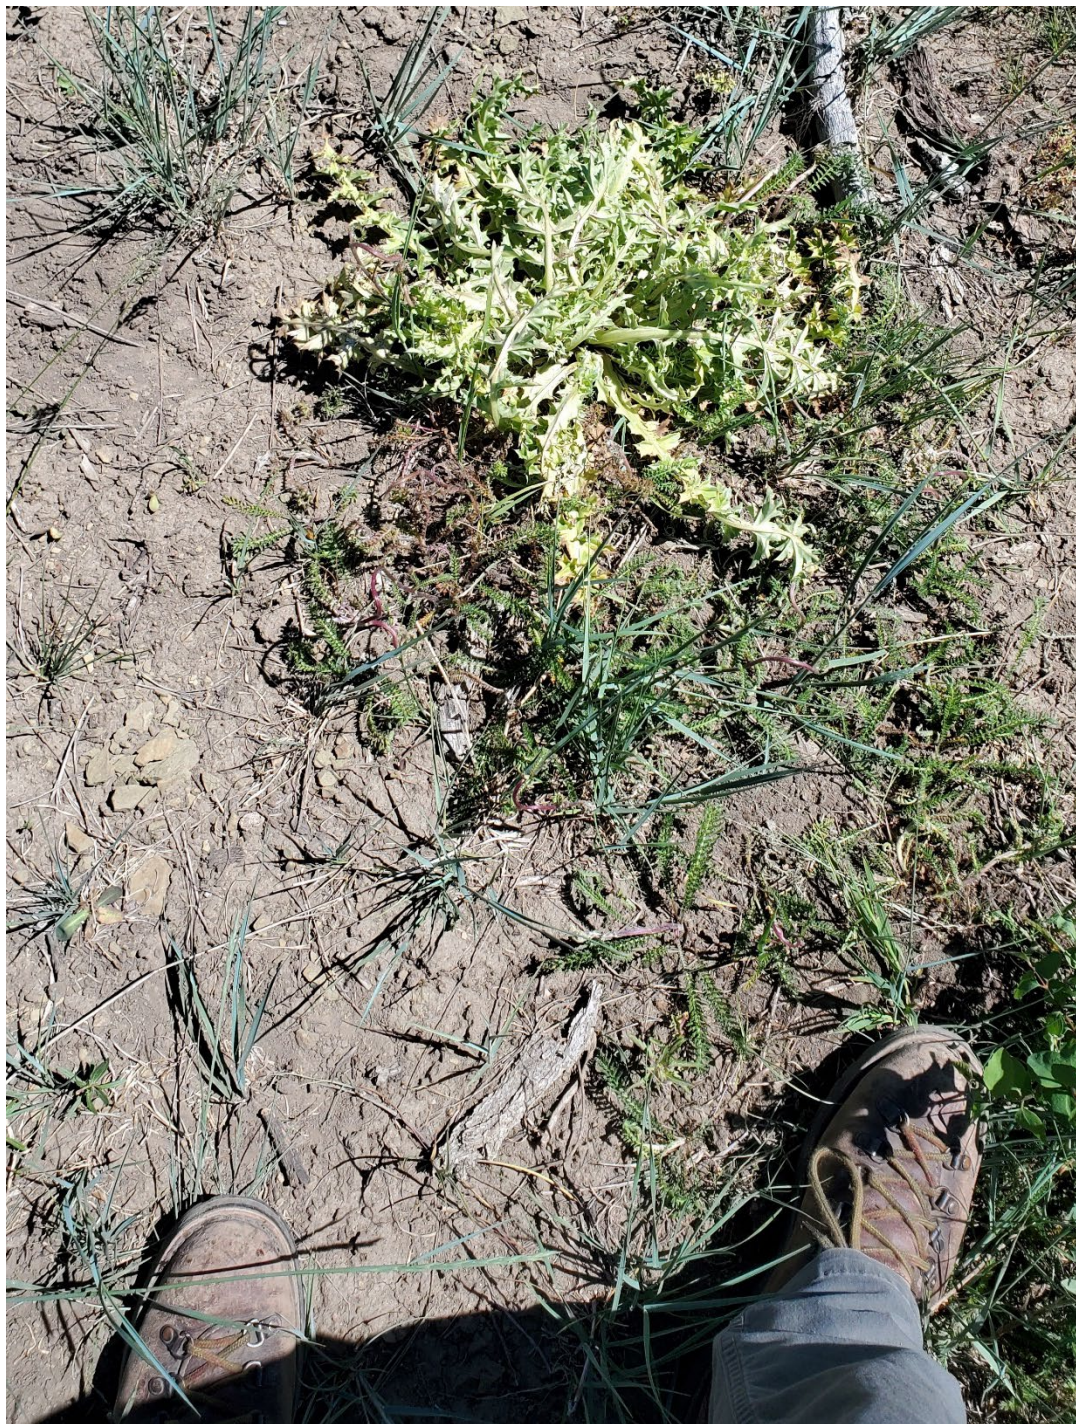
Figure 18: Sprayed thistle on E5-14

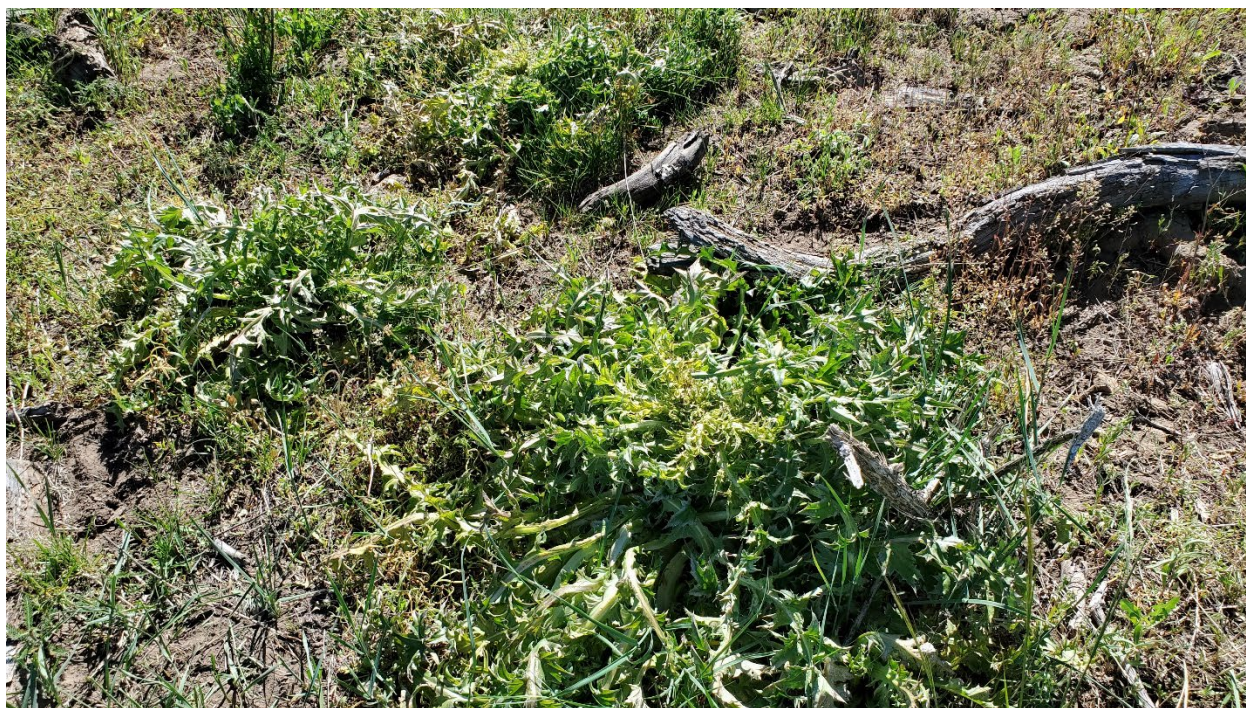
Figure 21: Sprayed thistle on E5-15

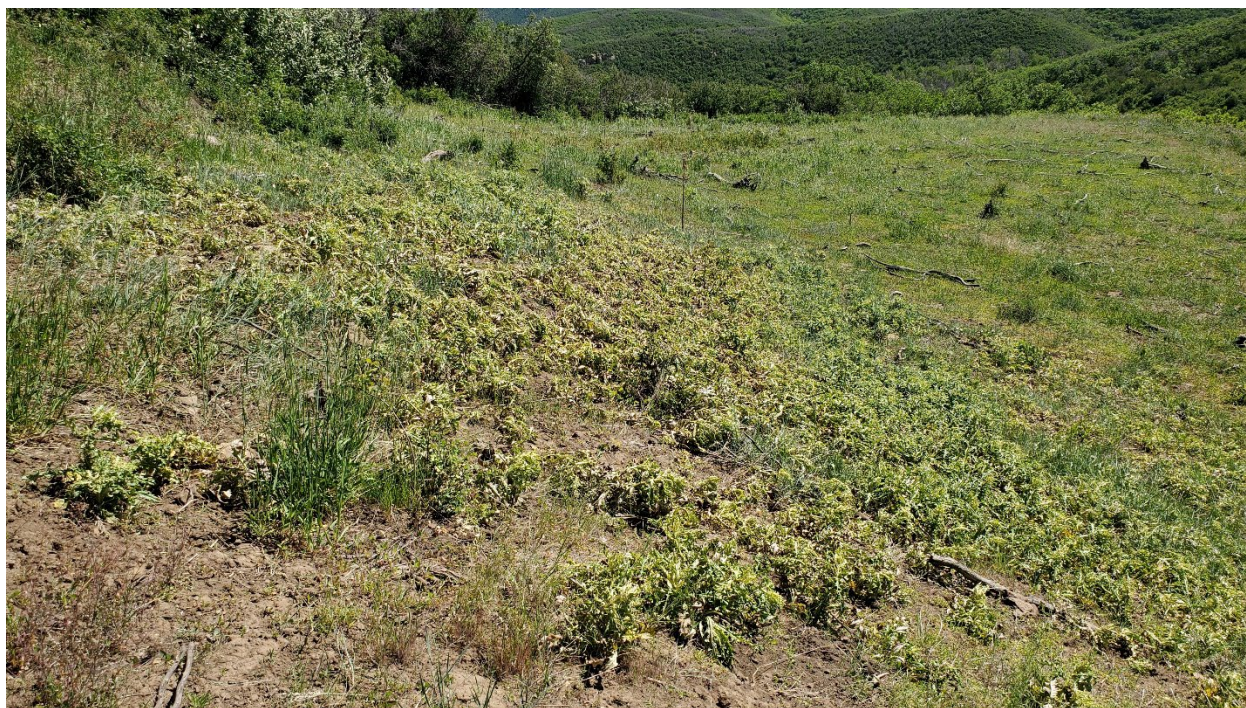
Figure 23: E5-16, with sprayed weeds in foreground

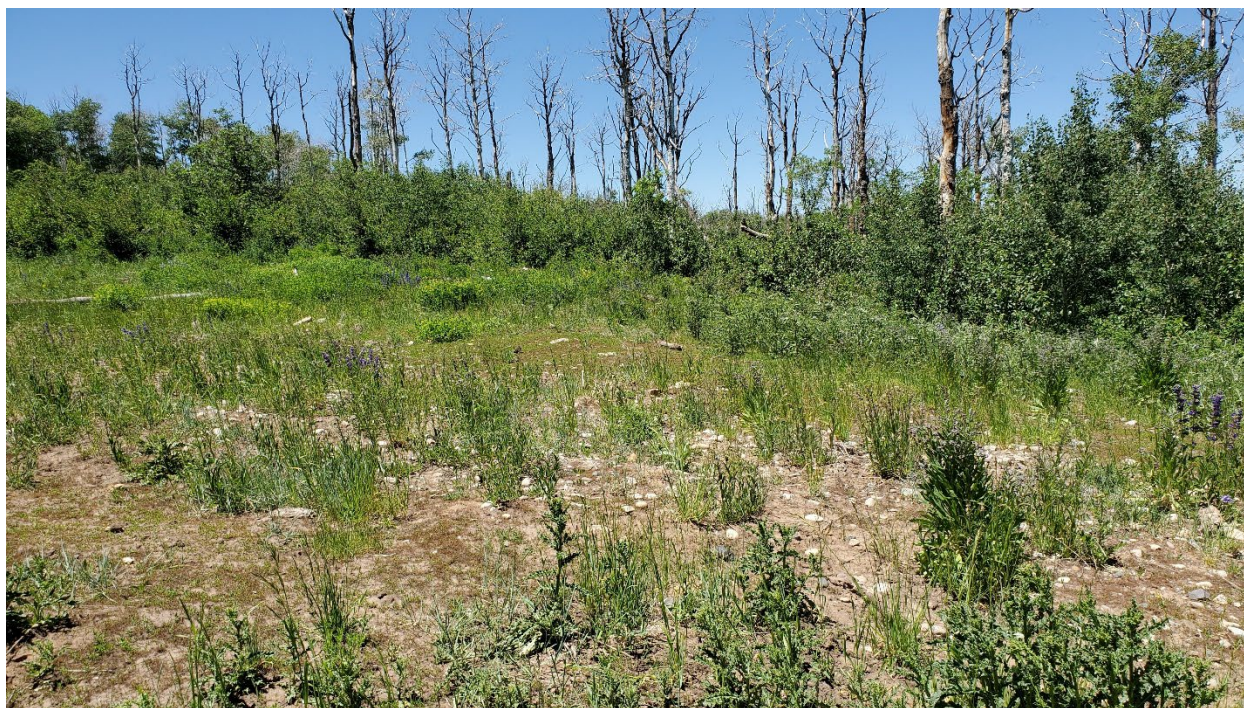
Figure 28: 11LWE6X53, weeds need to be sprayed

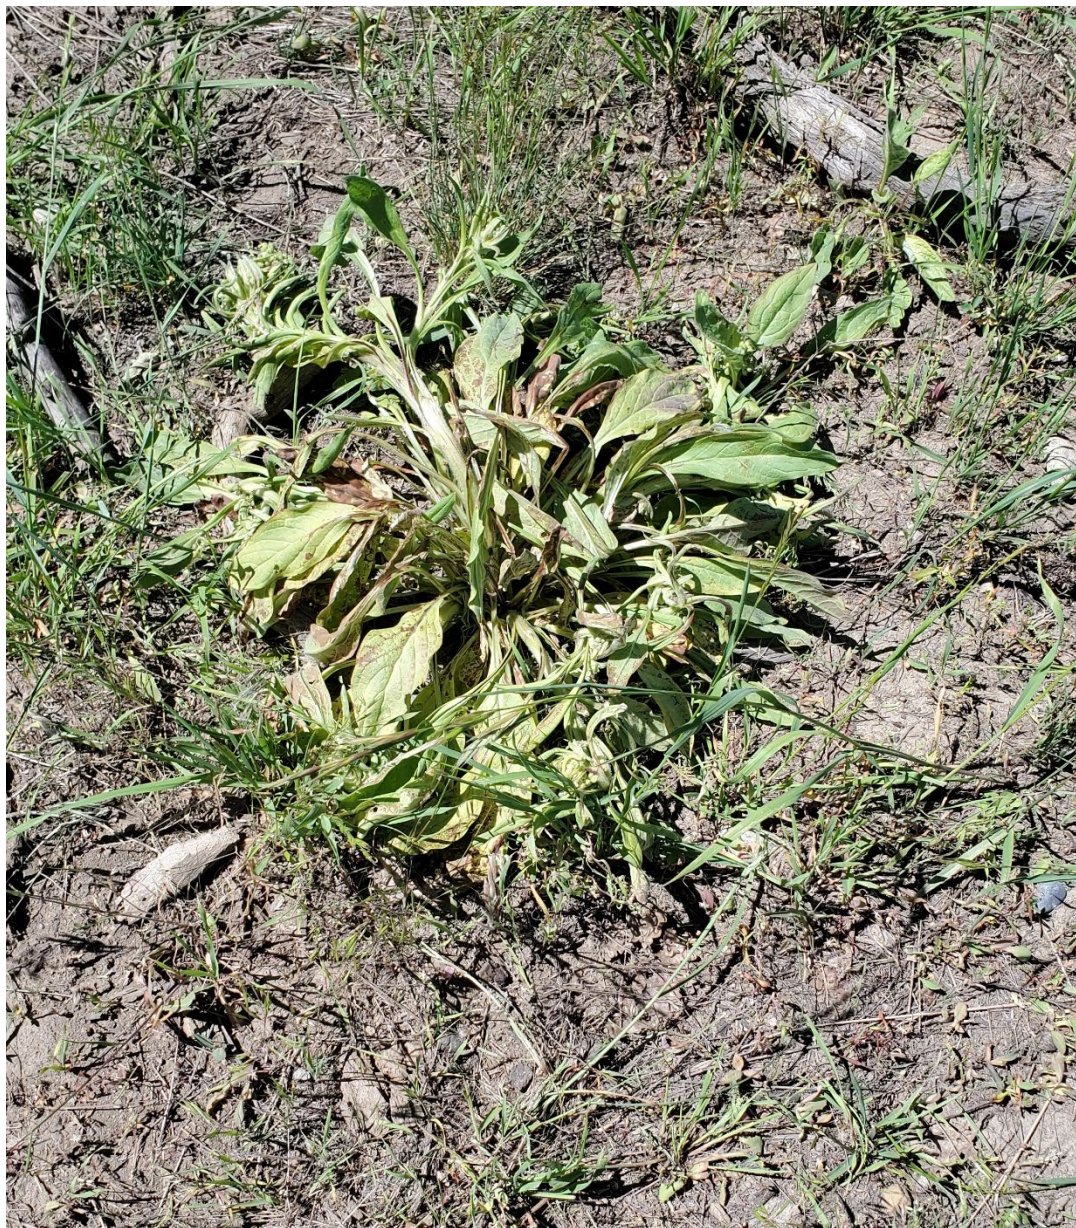
Figure 29: Sprayed houndstongue on 11LWE5X40

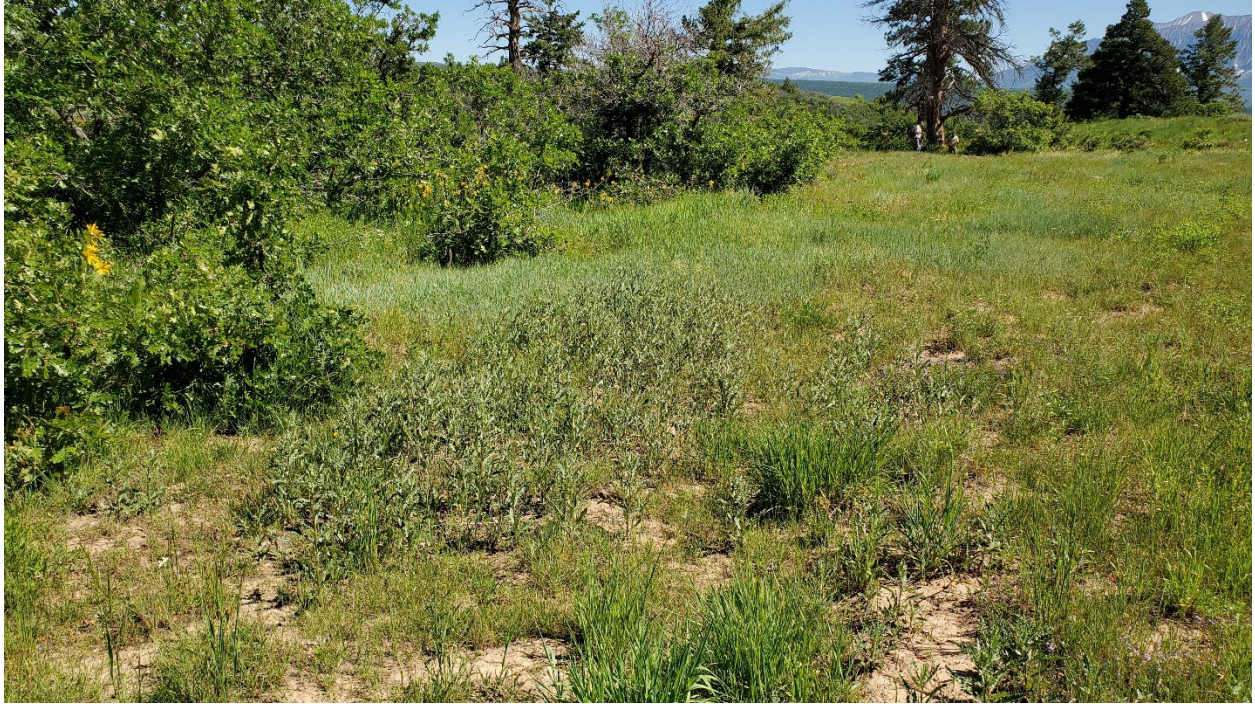
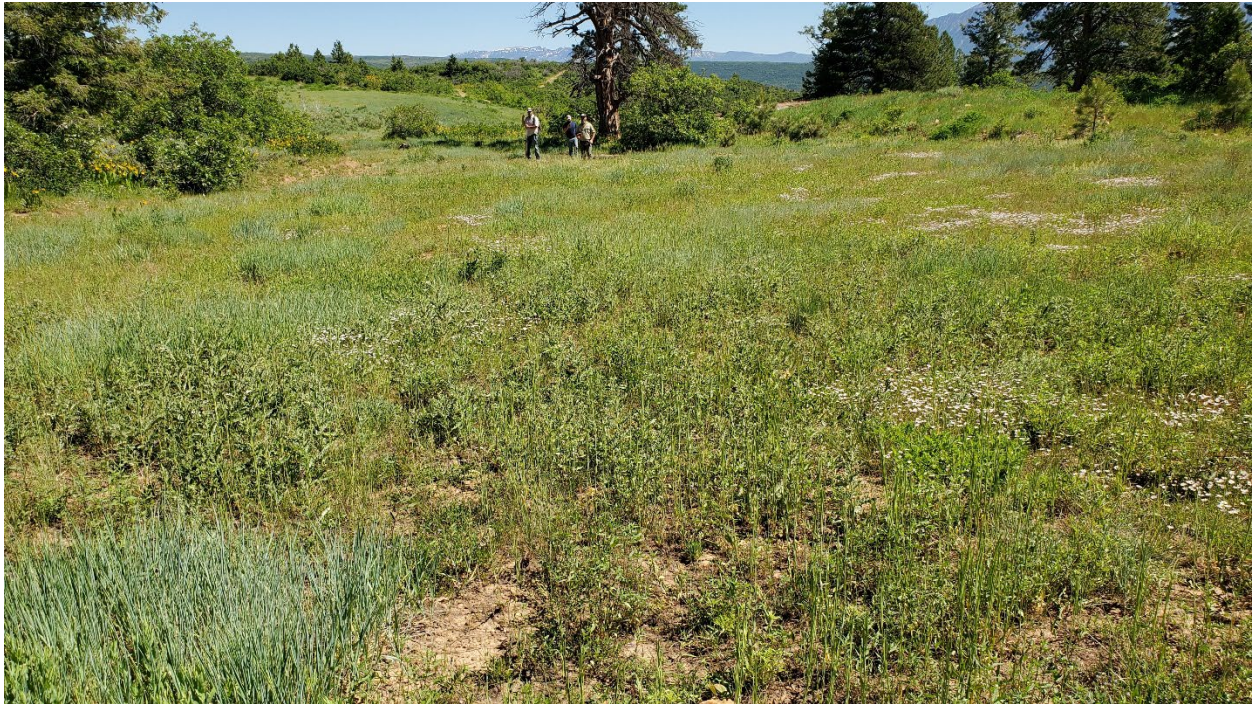
Figure 35: Canada thistle on 20-01A/AAA (1 of 2)

Figure 36: Canada thistle on 20-01A/AAA (2 of 2)

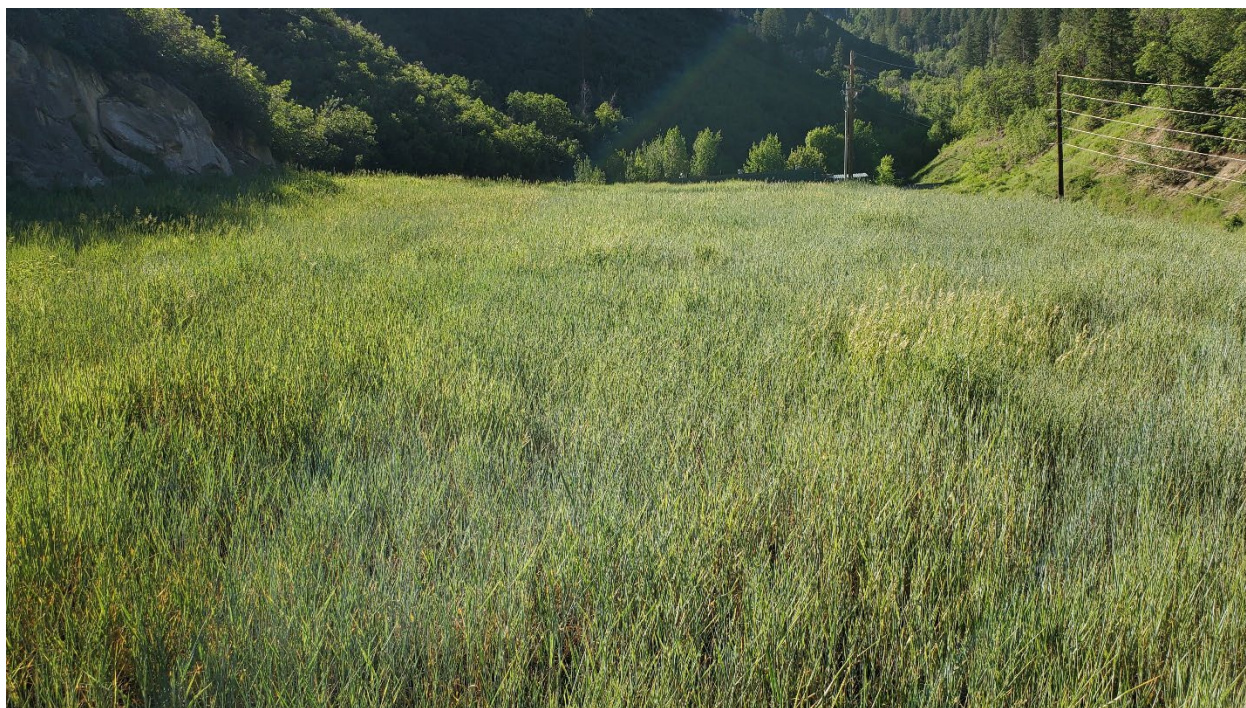
Figure 41: 23HG3E3XC under topsoil pile

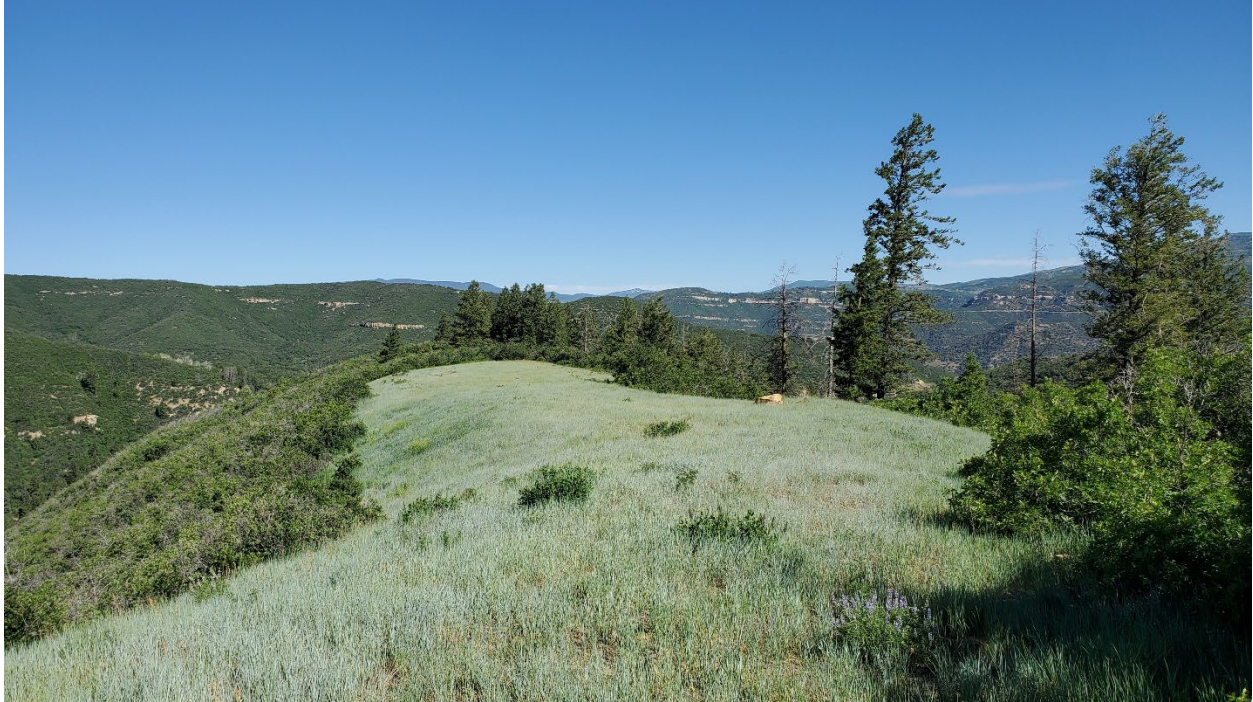
Figure 42: 24HG1E3XC/24HG1E4-5XC/24HG2E5XC

24-09	III	USFS	Inspected, no problem	Road appears to run through location of hole
24HG1E3XC/24HG1E4-5XC/24HG2E5XC	III	USFS	Inspected, no problem	Pad looks great. Incorrect coordinates for 24HG1E4-5XC and 24HG2E5XC were given in Peacock spreadsheet, actually co-located with 24HG1E3XC
Road to 24HG1E3XC/24HG1E4-5XC/24HG2E5XC	III	USFS	Inspected, problem	A few houndstongue in places and some Canada thistle near the top, should be sprayed
