## C1981022, Elk Creek Mine, July Inspection Report

**PERMIT INFORMATION**

**INSPECTION INFORMATION**

<b>Inspection Start Date:</b> July 12, 2023 <b>Inspection Start Time:</b> 10:30 <b>Inspection End Date:</b> <b>Inspection End Time:</b>	<b>Inspection Type:</b> Coal Partial Inspection <b>Inspection Reason:</b> Normal I&E Program <b>Weather:</b> Clear
<b>Joint Inspection Agency:</b>  None	<b>Joint Inspection Contacts:</b>
<b>Post Inspection Agency:</b>  None	<b>Post Inspection Contacts:</b>
<b>Inspector(s):</b>  Leigh Simmons	<b>Inspector's Signature:</b>

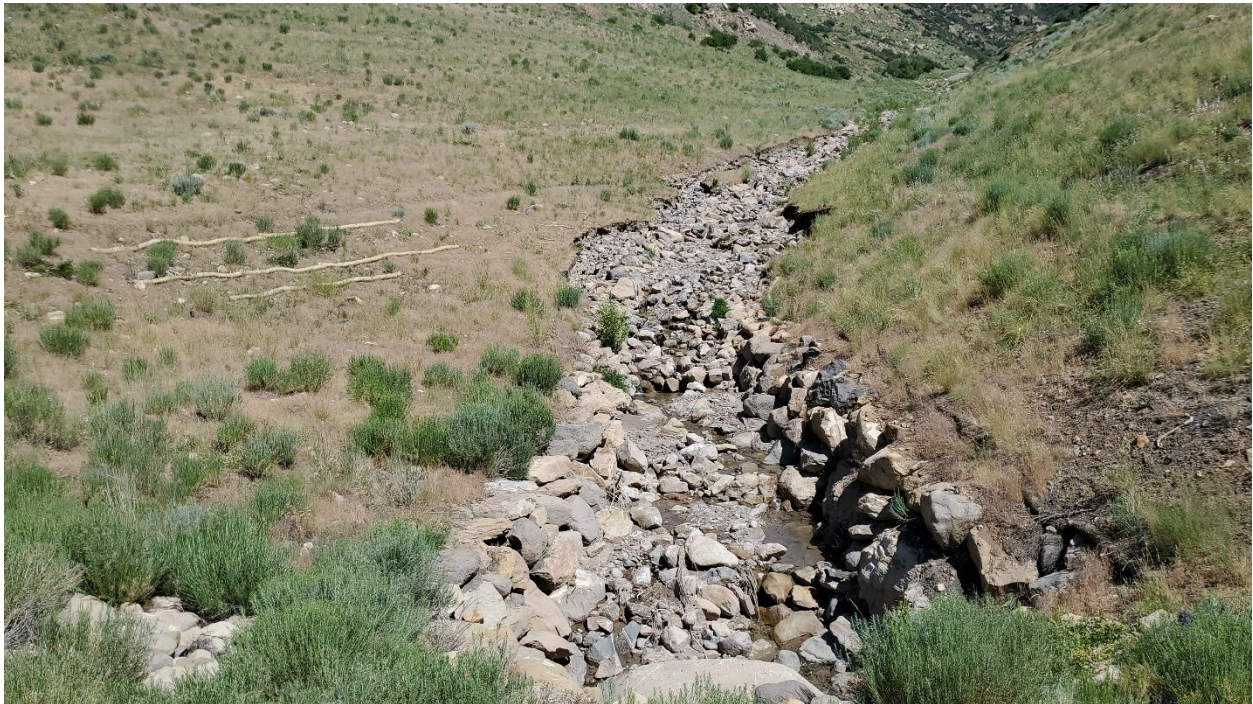
*Figure 1: Elk Creek*

The water level in Elk Creek had dropped lower still since the last inspection, but it continued to flow. No repairs to the stream channel had been attempted yet.

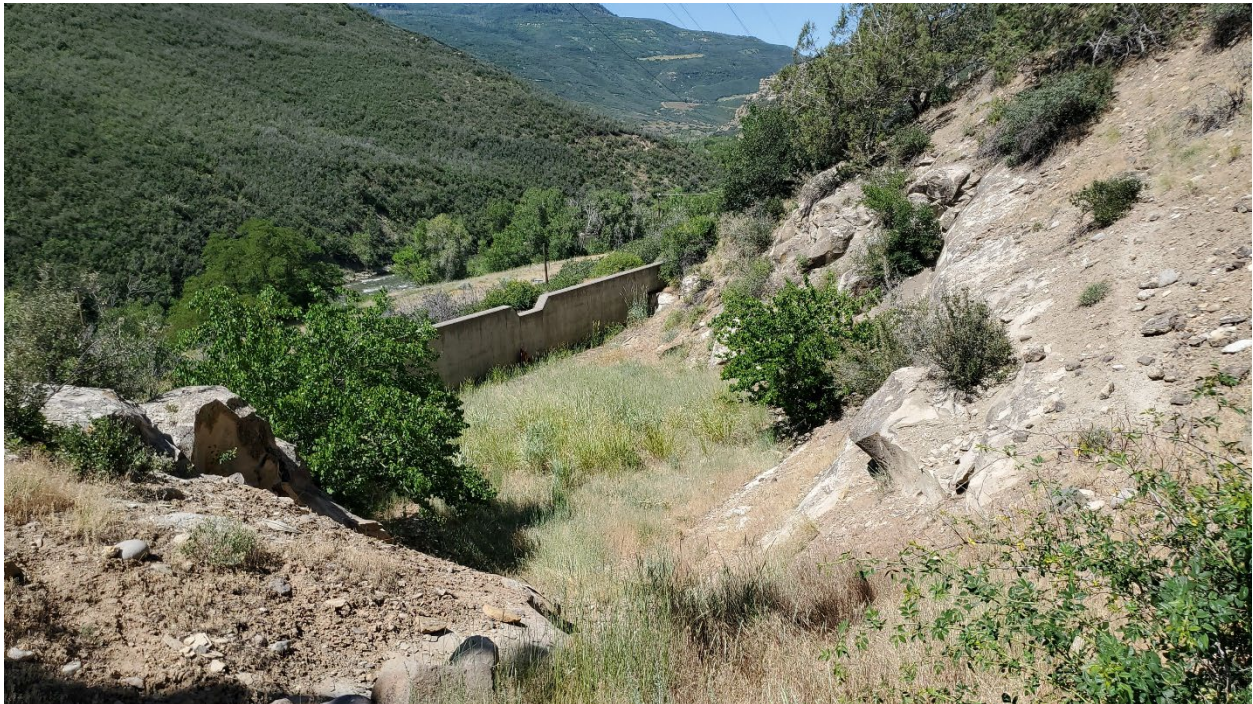
*Figure 2: Pond C*

Ponds C and E were both completely dry. The concrete embankments of each were both stable.

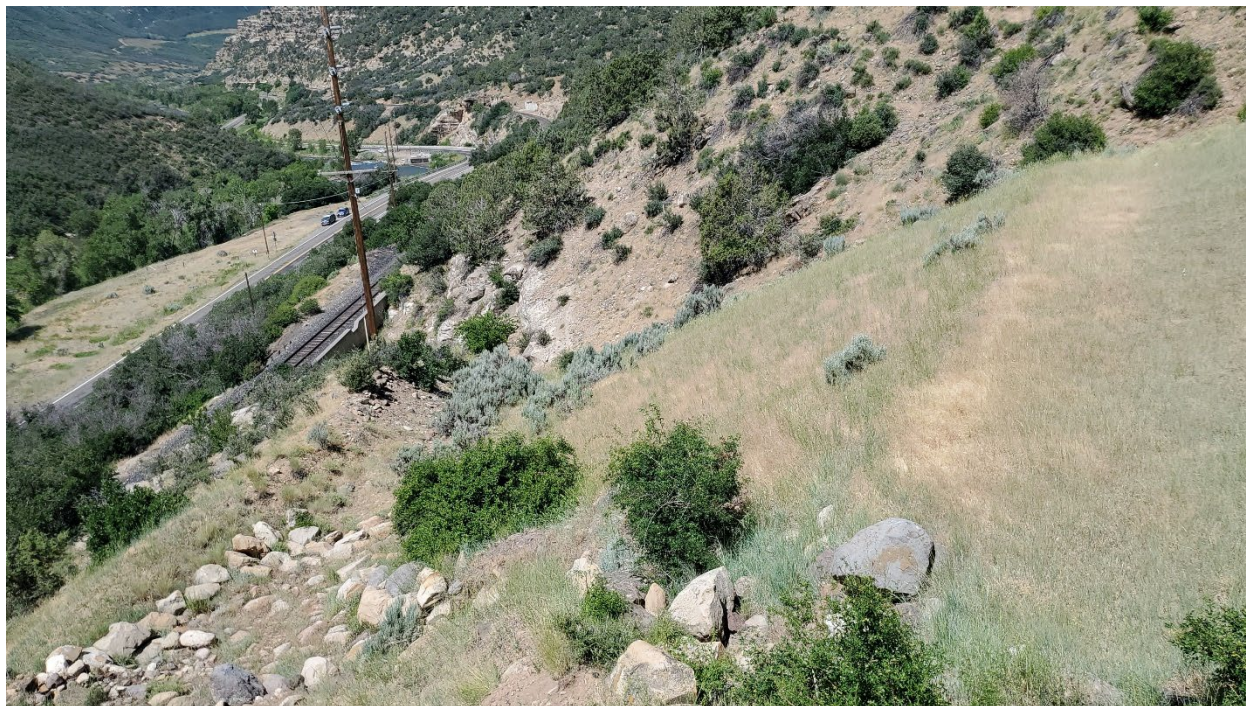
Figure 3: West Valley Fill (1 of 2)

Both the West Valley Fill and the II West Valley Fill were stable and well vegetated.

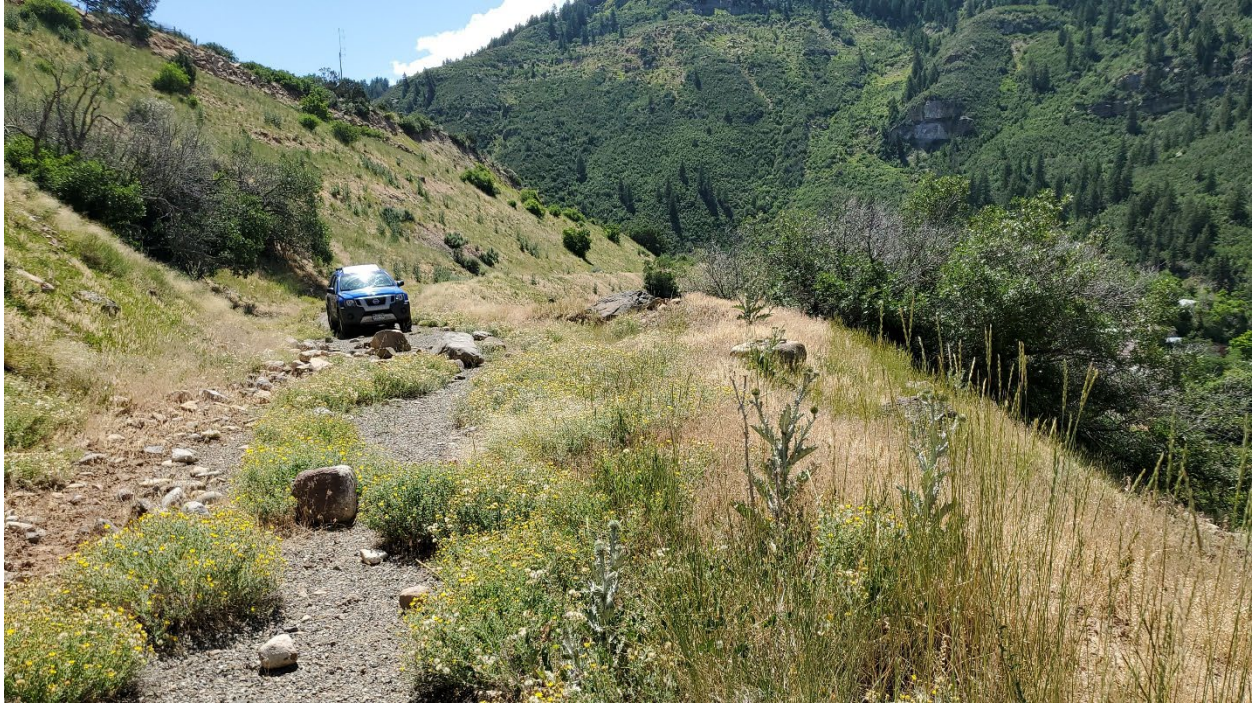
Scotch thistle *Onopordum acanthium* was quite prevalent on the reclaimed Valley Fills and the surrounding areas, and will need to be treated. More details are given in the photograph captions.

*Figure 5: Scotch thistle on lower access road to West Valley Fill (1 of 2)*

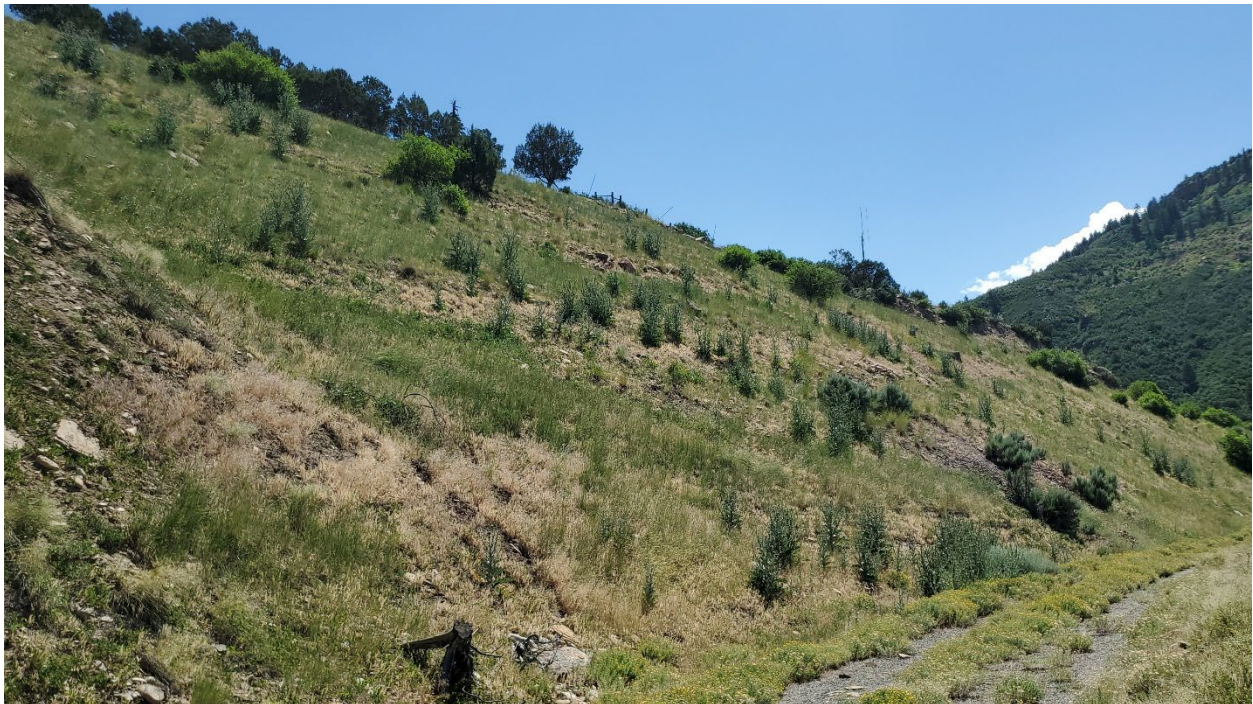
*Figure 6: Scotch thistle on lower access road to West Valley Fill (2 of 2)*

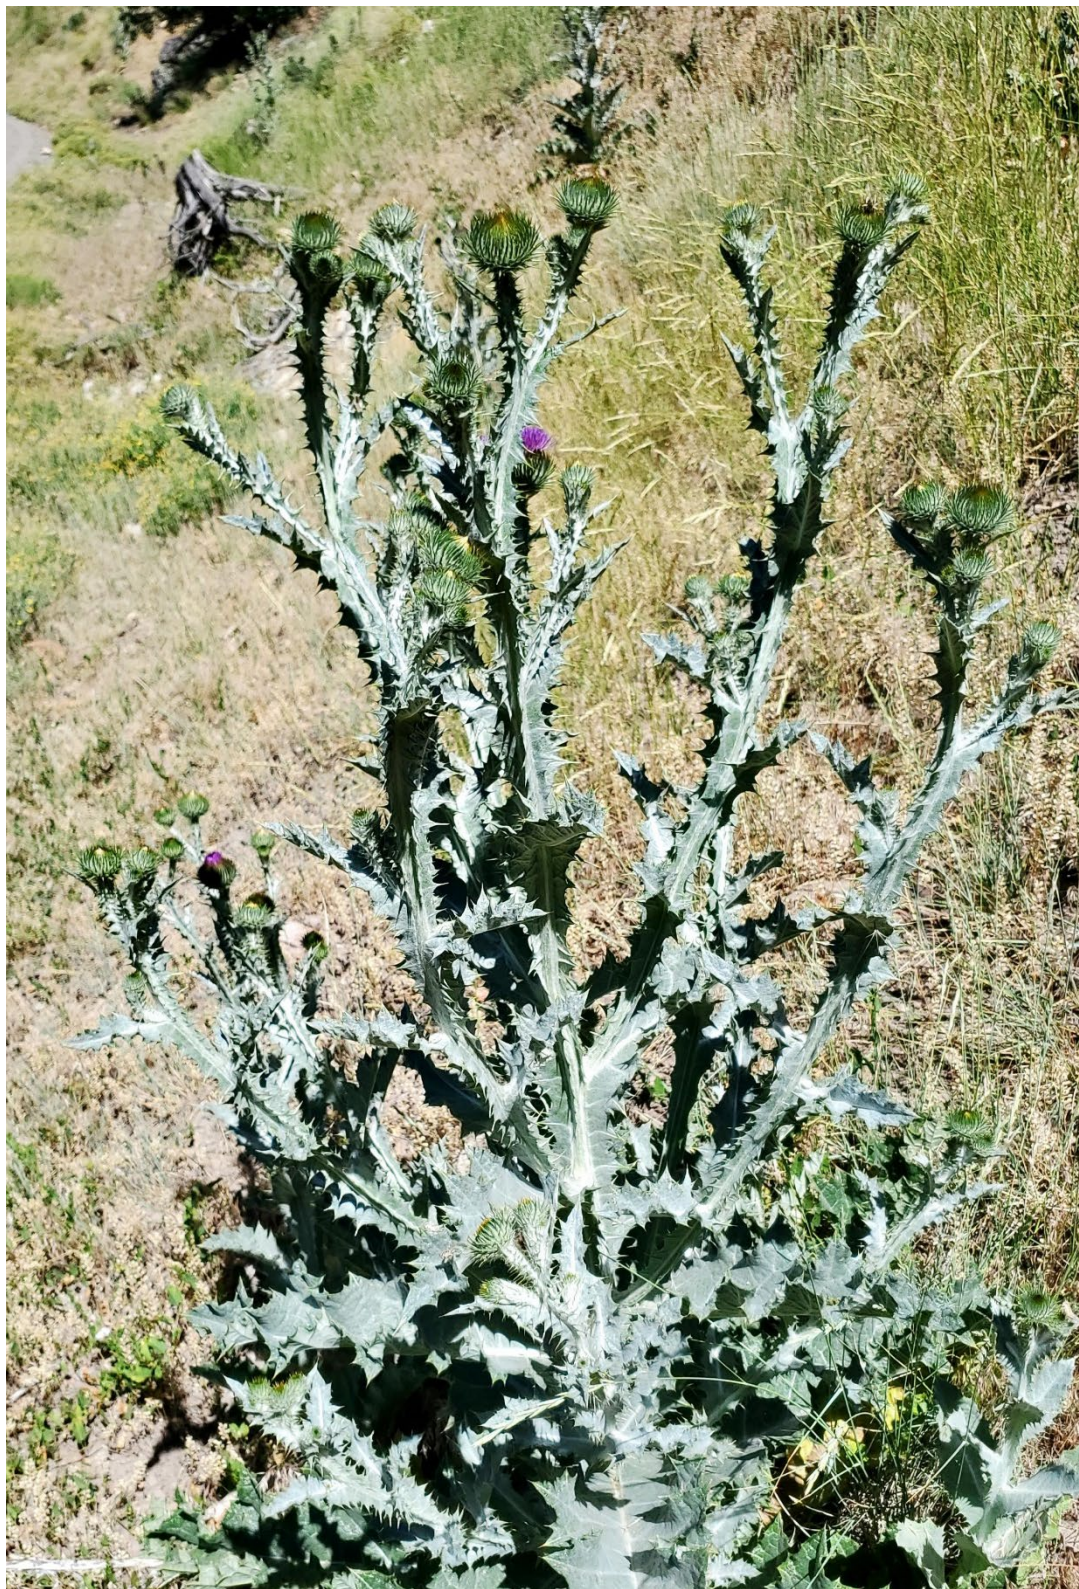
Figure 7: Scotch thistle, *Onopordum acanthium*

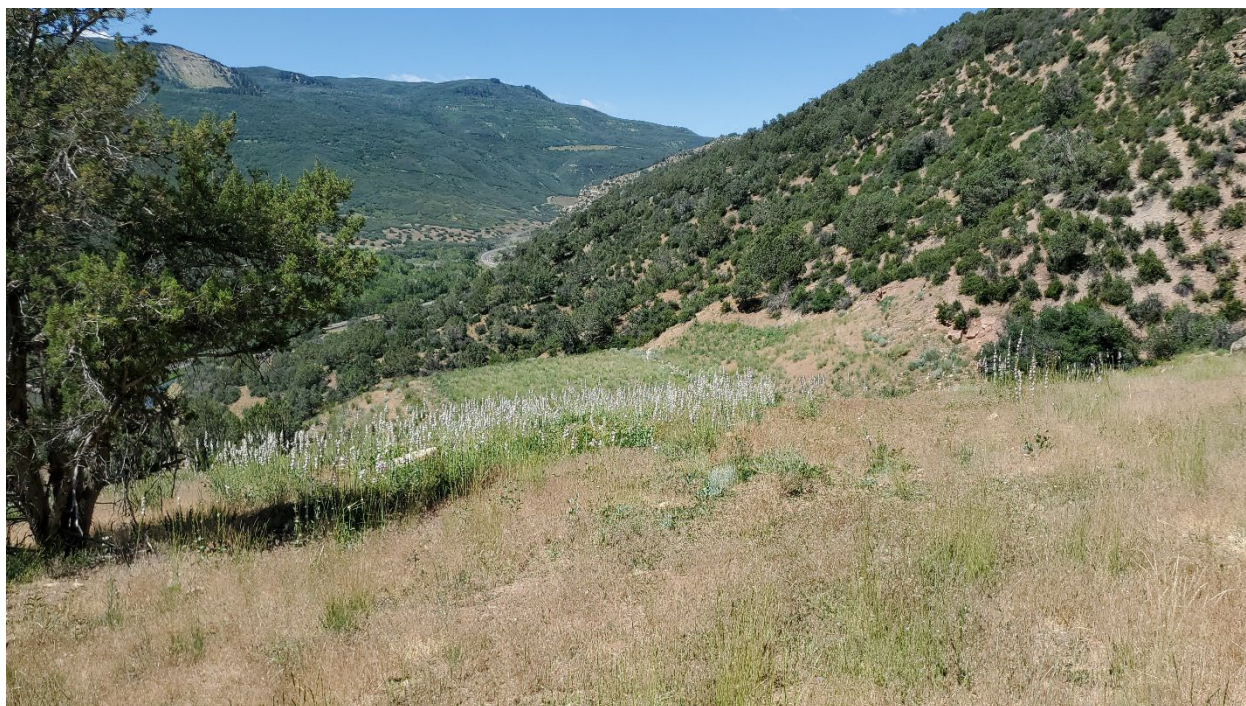
*Figure 9: Reclaimed road to II West Valley Fill. Not too weedy. Lots of penstemon and Cicer Milk Vetch.*

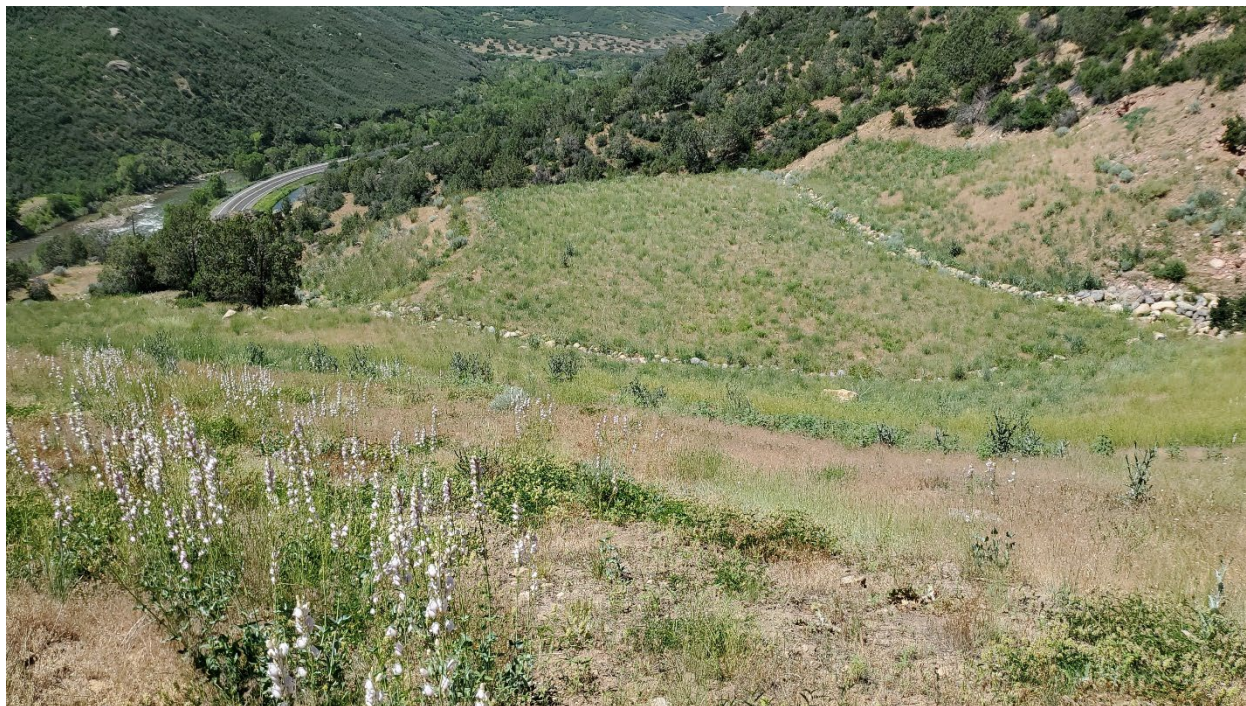
*Figure 10: Top of II West Valley Fill, patch of thistle should be treated*

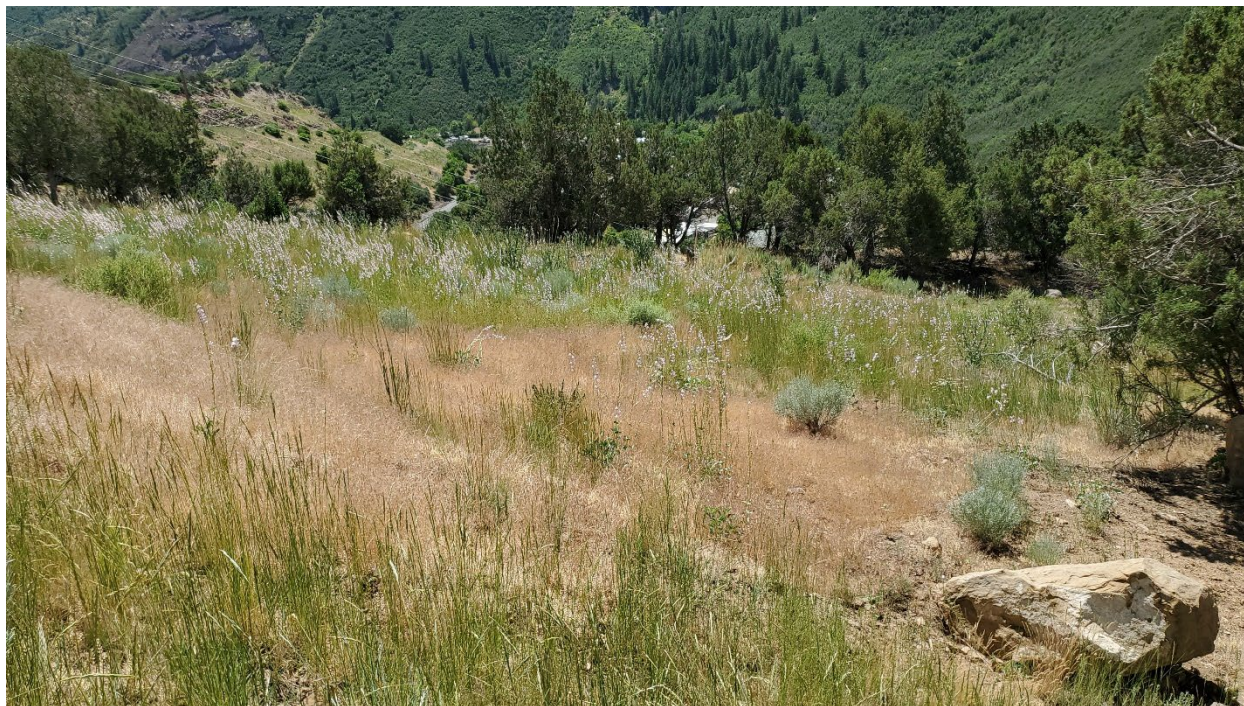
*Figure 12: Isolated thistle along lower access road and at site of topsoil pile should be treated*
