C1980007, West Elk Mine, July Inspection Report

PERMIT INFORMATION

Permit Number: C-1980-007 Mine Name: West Elk Mine Operator: Mountain Coal Company, LLC Operator Address: Ms Nicki Poulos 5174 Highway 133 Somerset, CO 81434	County: Delta, Gunnison Operation Type: Underground Permit Status: Active Ownership: Private
	Operator Representative Present: Nicki Poulos, Ben Godwin, Ed Ogrodny
Operator Representative Signature: (Field Issuance Only)

INSPECTION INFORMATION

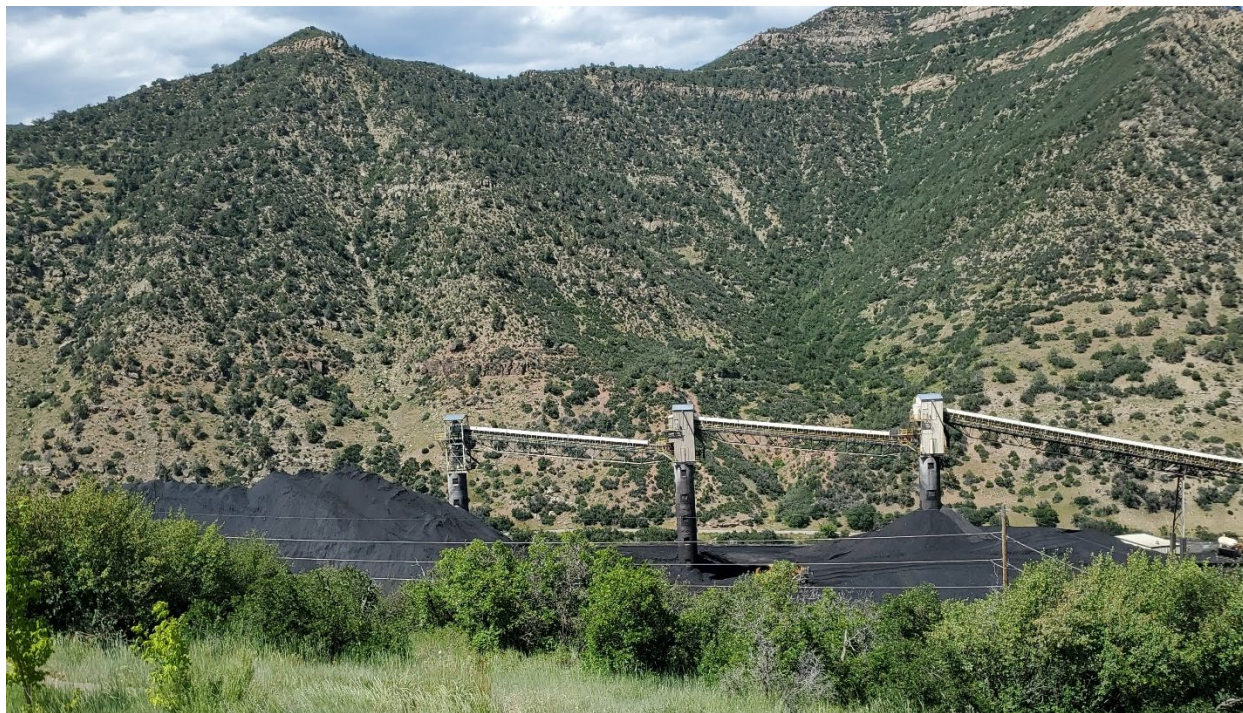
The volume of material in the run-of-mine stockpile, the fines stockpile on the clean coal pad, the temporary fines pile behind the LRP, and the temporary waste pile on the RPE remained very high. Efforts were being made by MCC staff and contractors to transport waste to the RPEE. At the time of the inspection MCC did not have approval from MSHA to place fines on the RPEE, so this material continued to be stored temporarily and blended with clean coal to be shipped when possible.

Figure 2: Run-of-mine stockpile

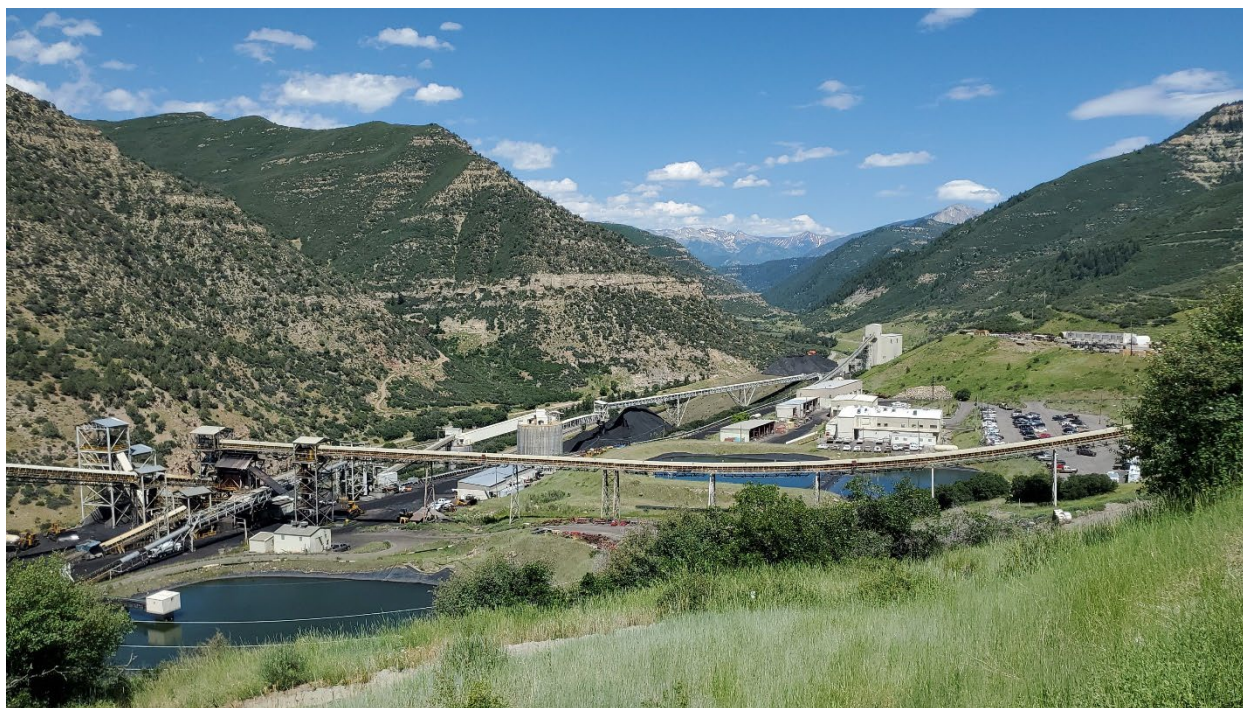
The lower facilities, including the Train Loadout, and the Sylvester Gulch facilities, including the primary escape way, were included in the tour. Owing to the volume of haul truck traffic it was not possible to visit the RPEE.

Figure 3: Overview of lower facilities

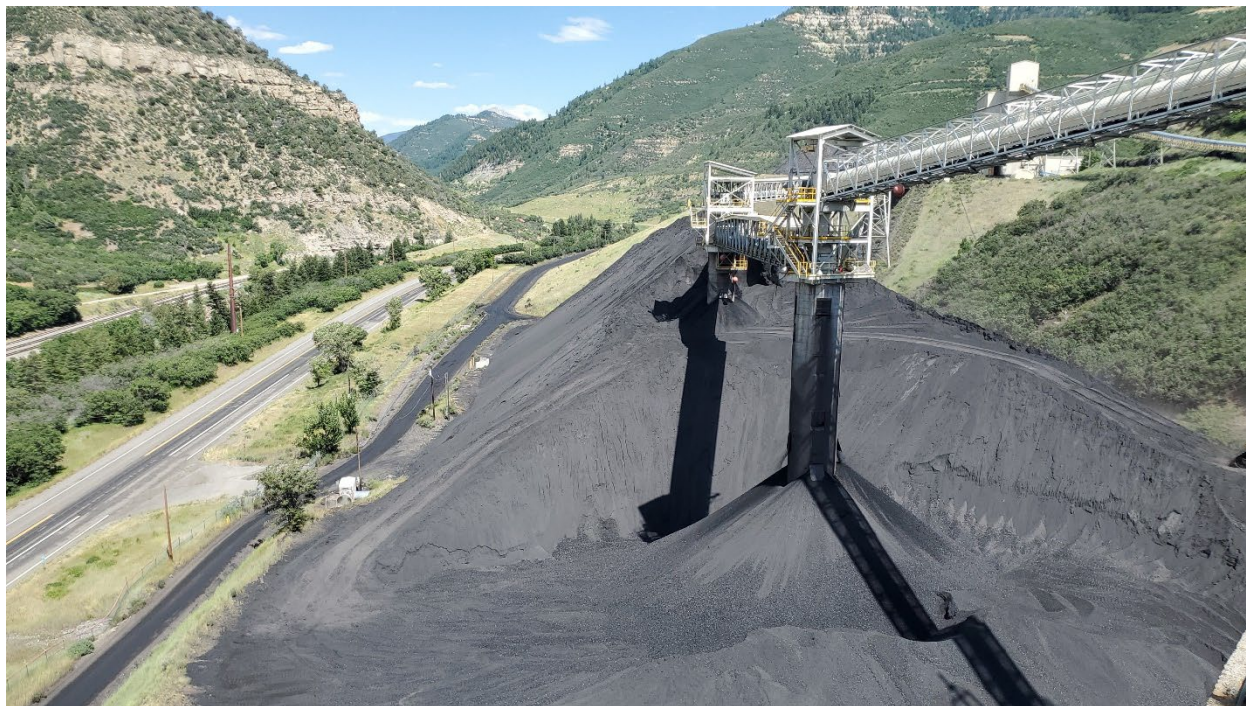
Figure 4: Clean coal stockpile pad from silo. Fines pile is to the rear.
