MINERALS PROGRAM INSPECTION REPORT
PHONE: (303) 866-3567

MINE NAME: Ensminger Pit	MINE/PROSPECTING ID#: M-2002-068	MINERAL: Gravel, sand and clay	COUNTY: Phillips
INSPECTION TYPE: Monitoring	WEATHER: Clear	INSP. DATE: May 25, 2023	INSP. TIME: 12:00
OPERATOR: Rick Ensminger	OPERATOR REPRESENTATIVE: Rick Ensminger	TYPE OF OPERATION: 110c - Construction Limited Impact	
REASON FOR INSPECTION: Normal I&E Program	BOND CALCULATION TYPE: Complete Bond	BOND AMOUNT: \$10,000.00	
DATE OF COMPLAINT: NA	POST INSP. CONTACTS: None	JOINT INSP. AGENCY: None	
INSPECTOR(S): Amber Michels	INSPECTOR'S SIGNATURE:

SIGNATURE DATE: July 17, 2023

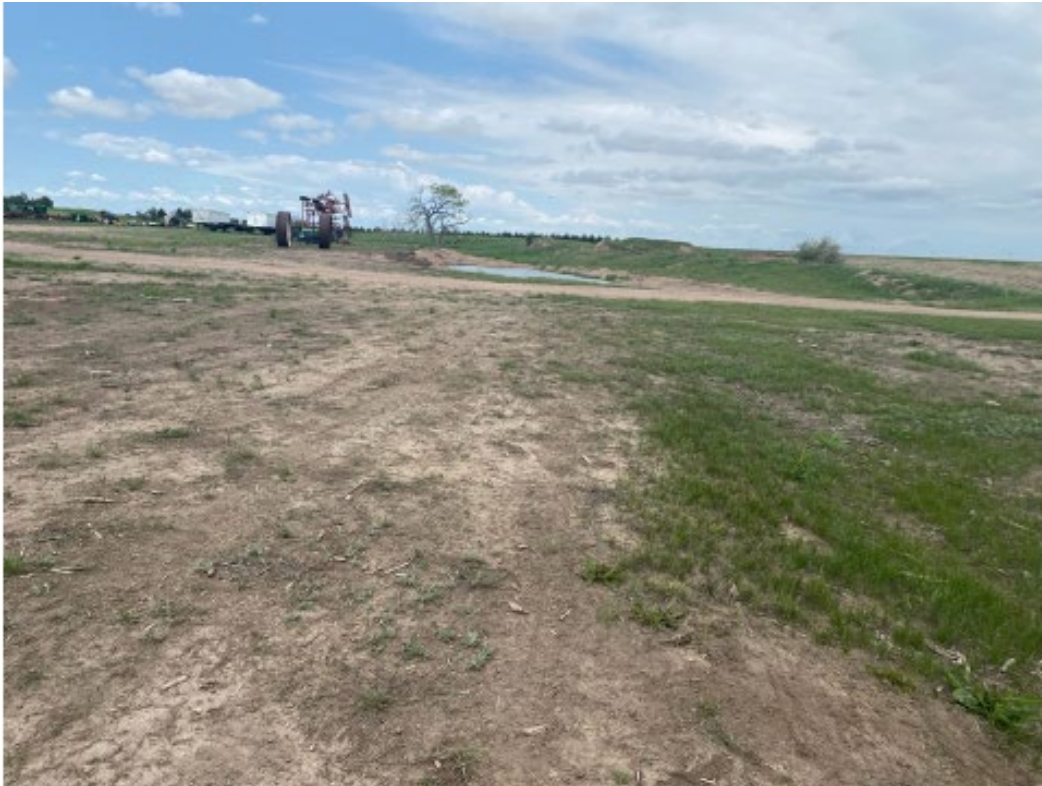
Standing water was observed onsite within the creek bed south of the main pit (Photos 2-6: Map 1(C)) and in shallow ponds within the north pit (Photos 8, 12, and 19: Map 1). As stated above, the Operator constructed a berm using clay materials to attempt to keep the water within the creek bed and out of the northern pit. The area of Haxtun, CO and surrounding areas had recently received high amounts of rainfall, and were experiencing an excess of water compared to average conditions. The Operator stated that he is aware that the water is to remain in the creek, and is actively attempting to find a solution to keep the northern pit dry.

Photo 2: Looking west from the approximate location of the south-east corner marker.

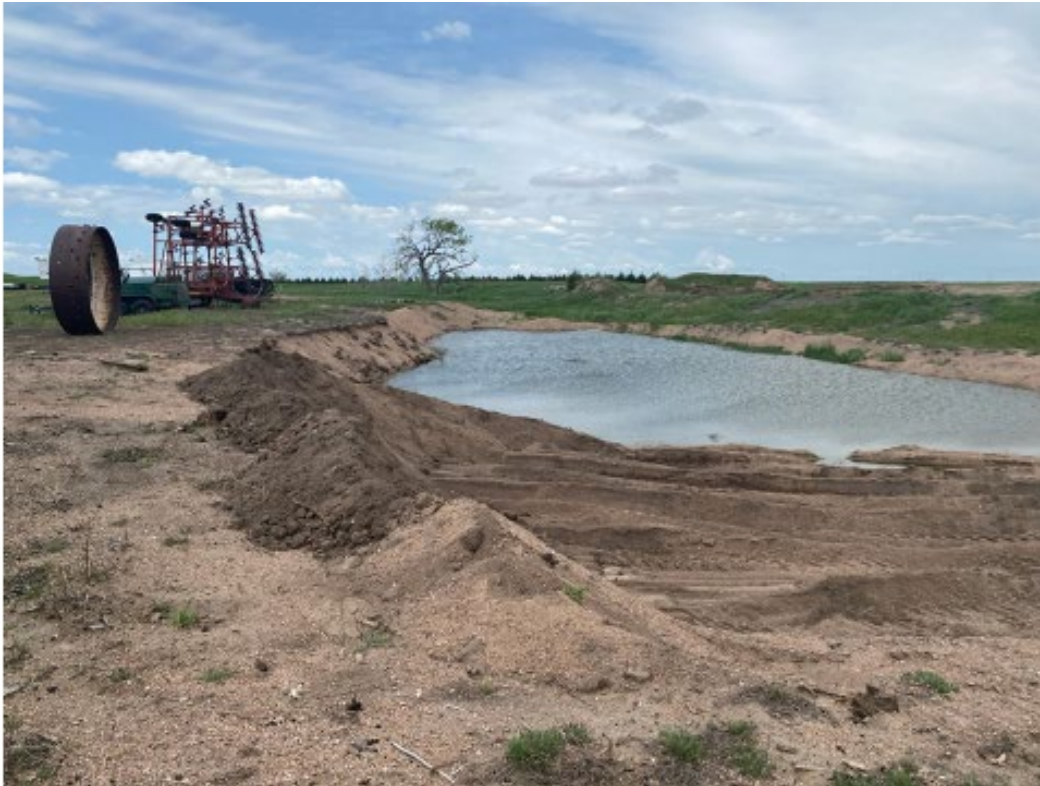
Photo 3: Looking west at the pit area located within the creek bed.

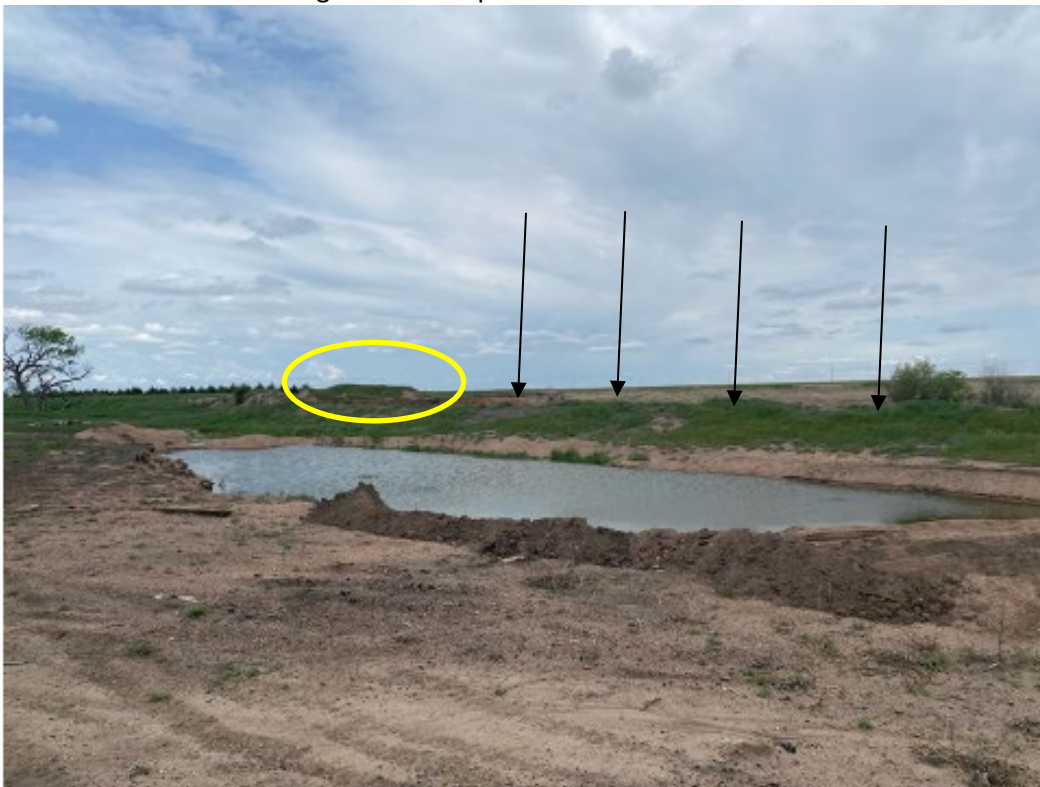
The Operator had stockpiled topsoil prior to excavation and placed stockpiles in various locations around and above the pit. During the inspection, the only remaining stockpile is placed above and to the west of the pit's western boundary (Photos 4, 5, 12, and 13: Map 1). The other topsoil piles have since been used in reclamation of the pit area. The remaining topsoil pile appeared to be well vegetated, stable, and away from mining disturbance in compliance with Rule 3.1.9(3).

Photo 4: Looking north-west at the pit area located within the creek bed. The arrow points to the south side of the separation berm built by the Operator. Circled is the topsoil pile located above the highwall in the northern pit.

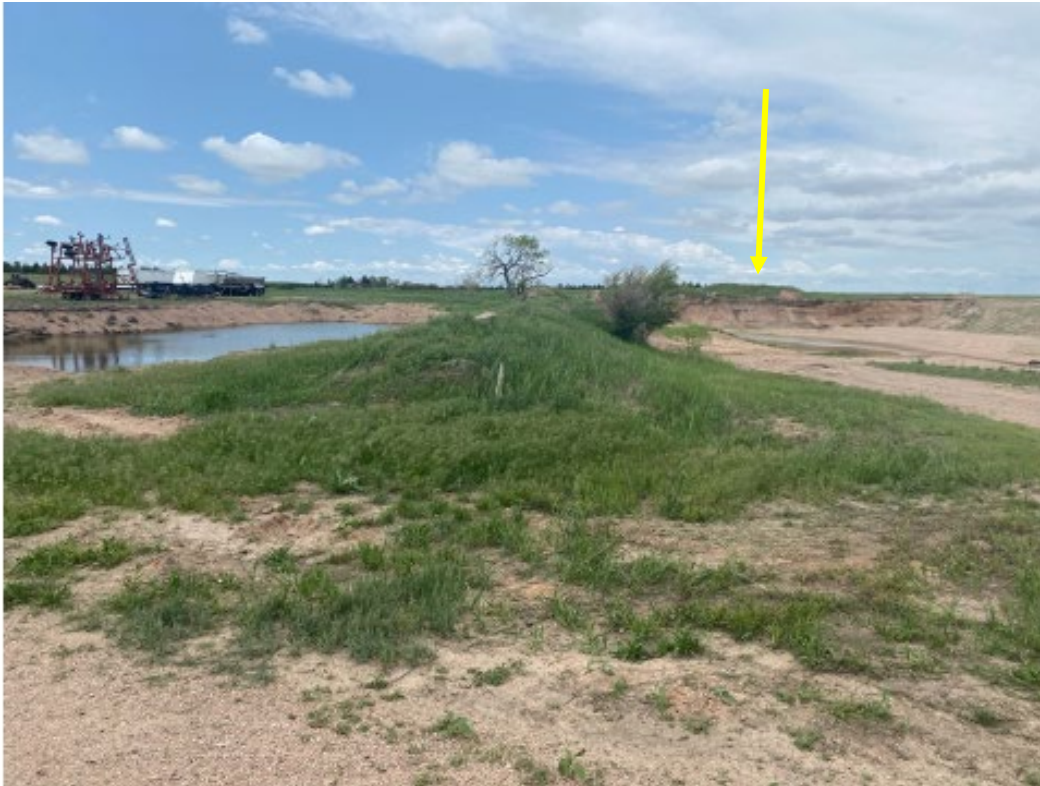
Photo 5: Looking west across the berm/divider created by the Operator in hopes of keeping water from the south side where the Frenchman Creek runs, out of the northern pit area. Yellow arrow points to the topsoil pile located above the highwall.

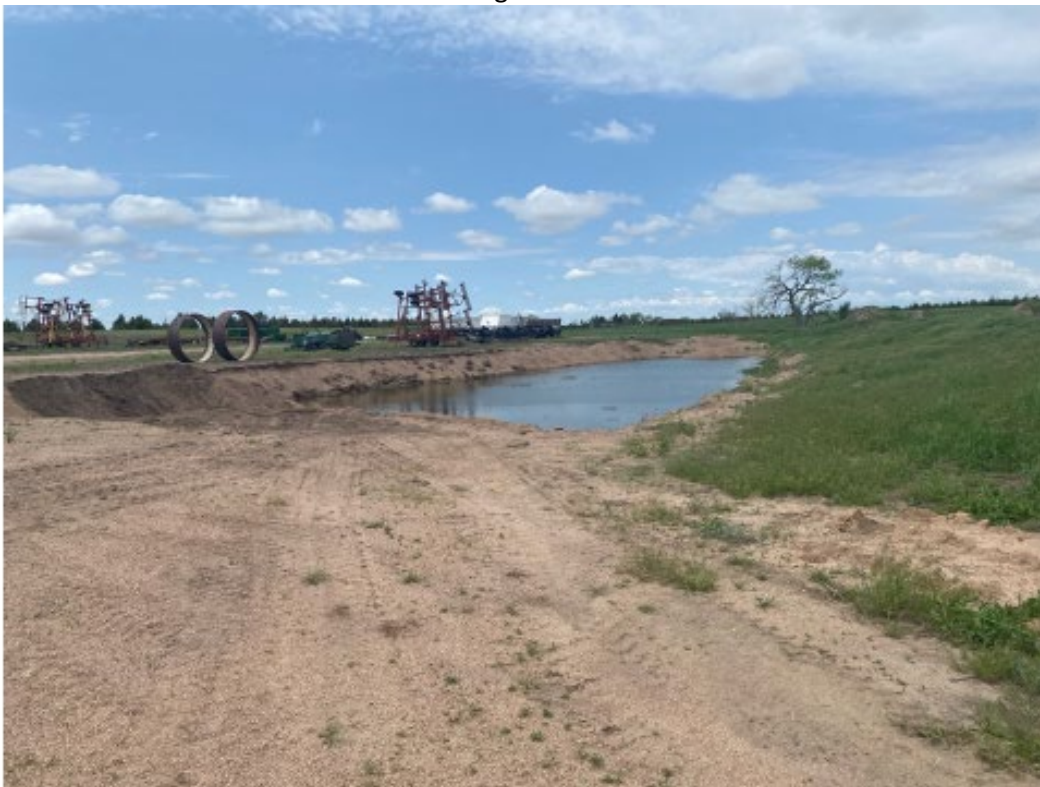
Photo 6: Looking south-west at the portion of the pit within the creek bed.

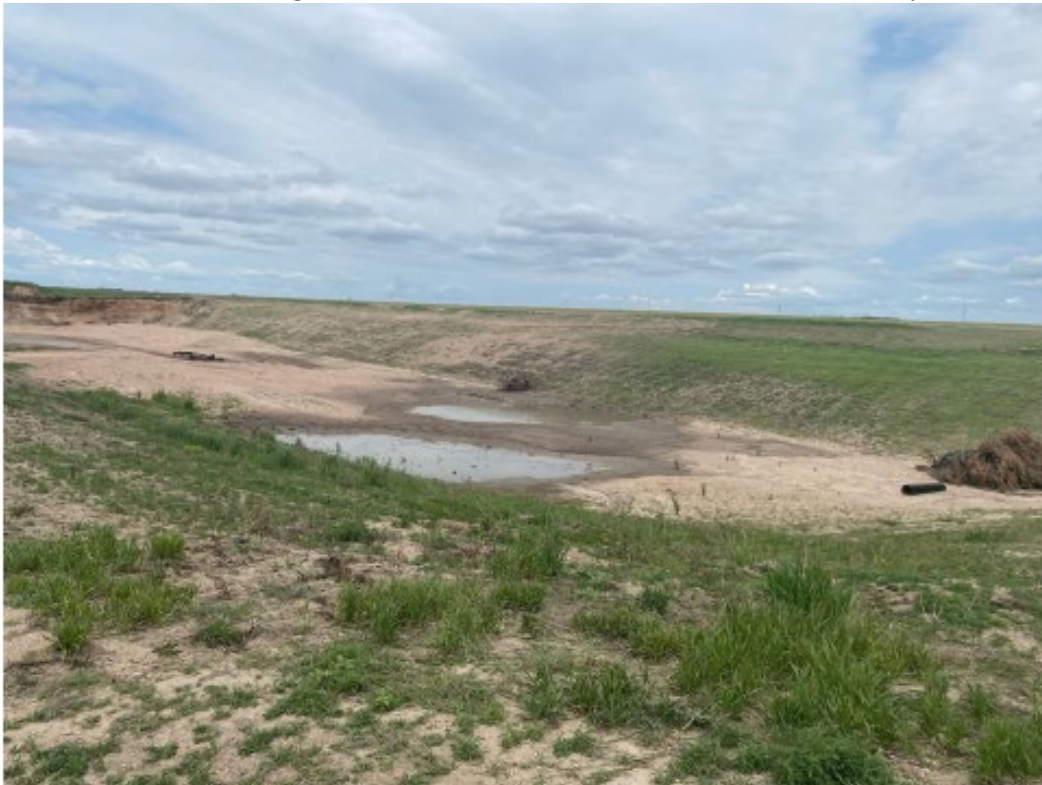
Photo 8: Looking north-west at the reclaimed northern slope.

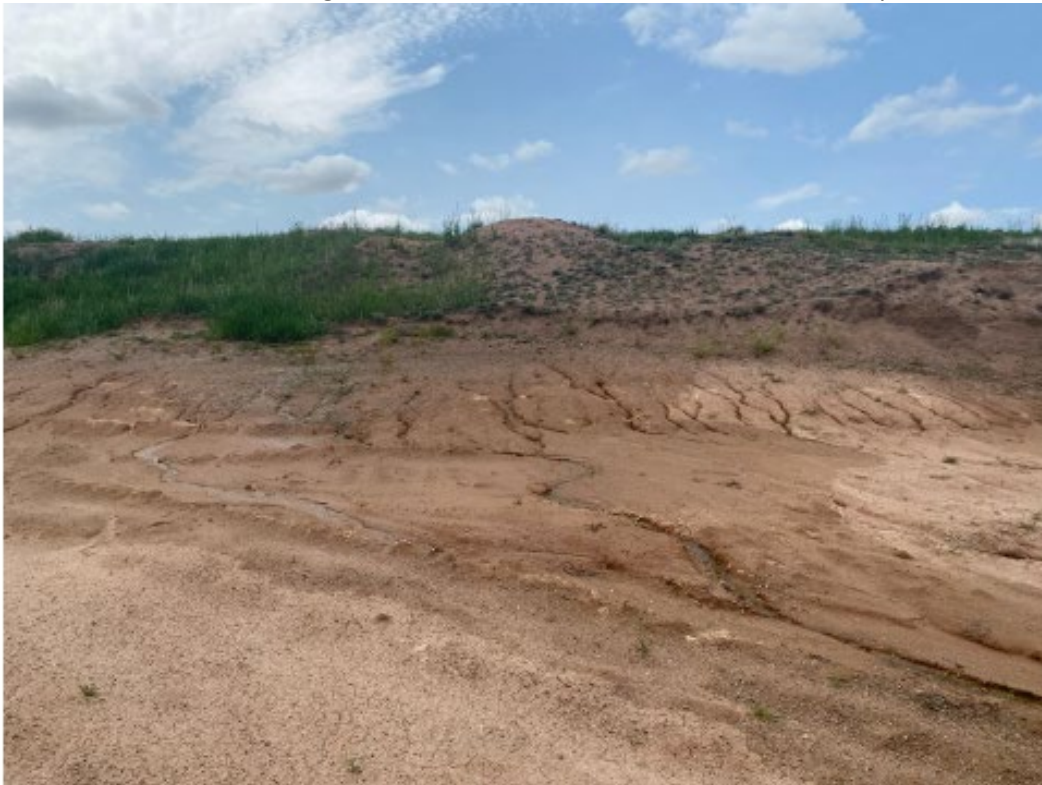
Photo 10: Looking south along the central southern border of the northern pit. This is where the Operator stated that water seeps through the berm from the creek on the south side.

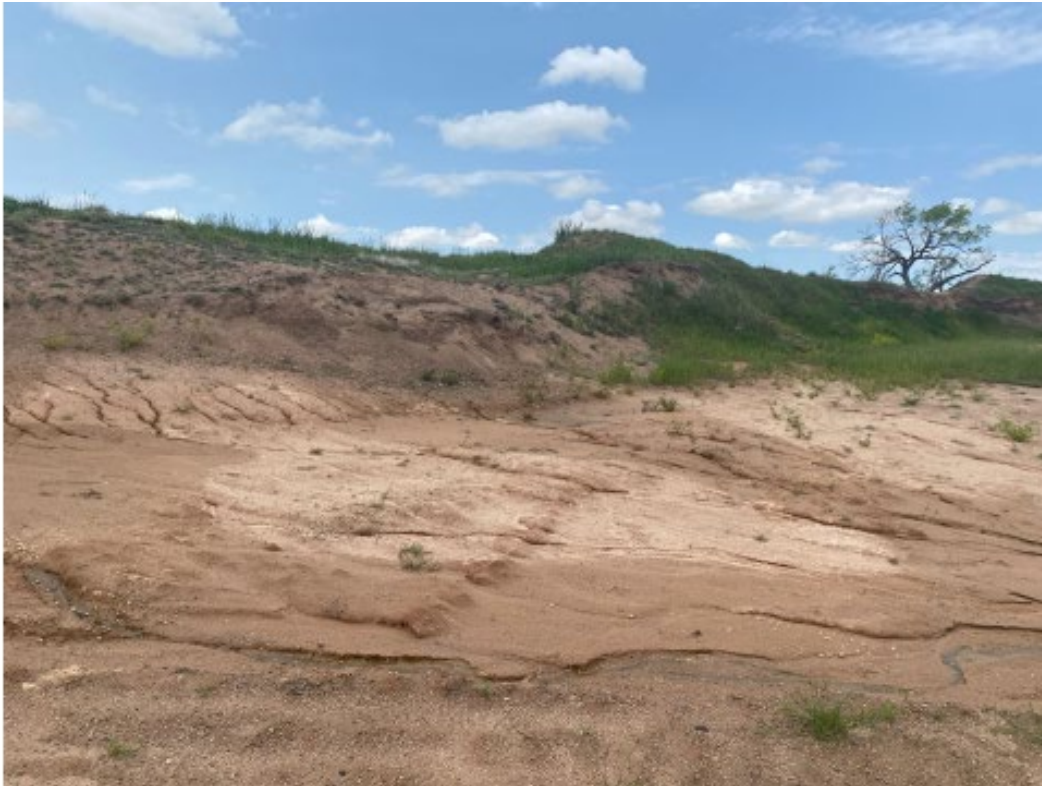
Photo 11: Looking north-west at moist sediment caused by the seepage of water from the south pit to the north pit.

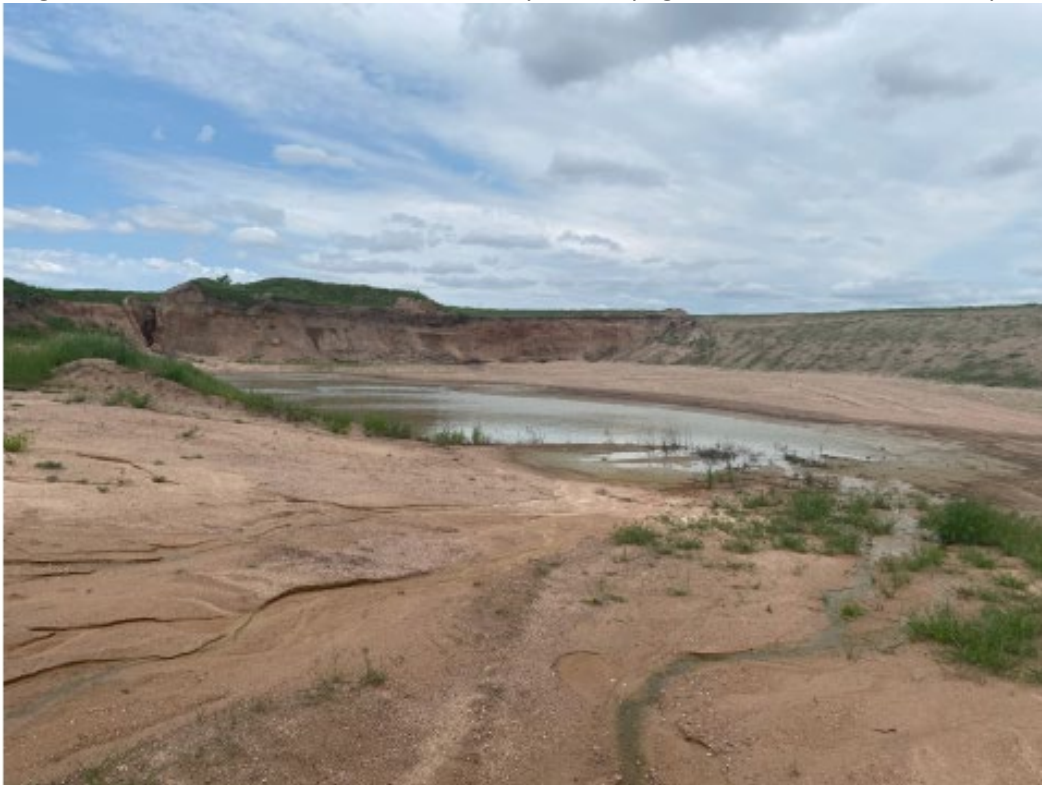
Photo 12: Looking north-west at the seepage to where it pooled in the western portion of the northern pit.

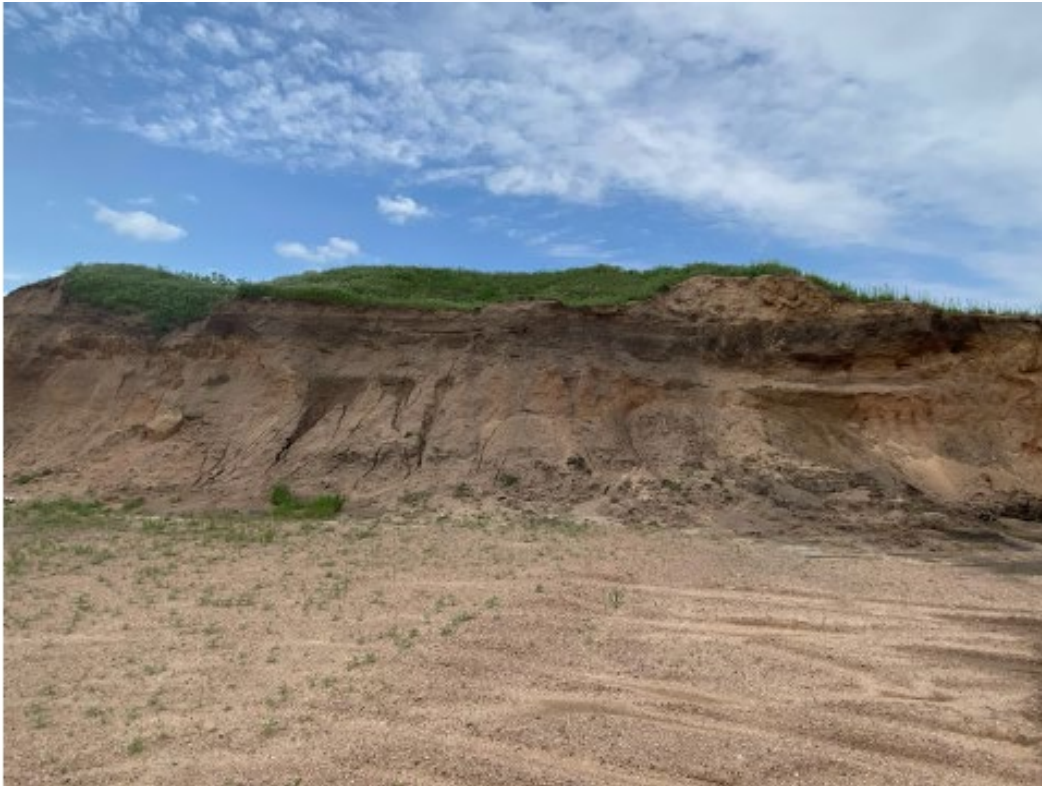
Photo 13: Looking west at the highwall along the northern pit's western border. Located above the wall is a vegetated and stable topsoil pile.

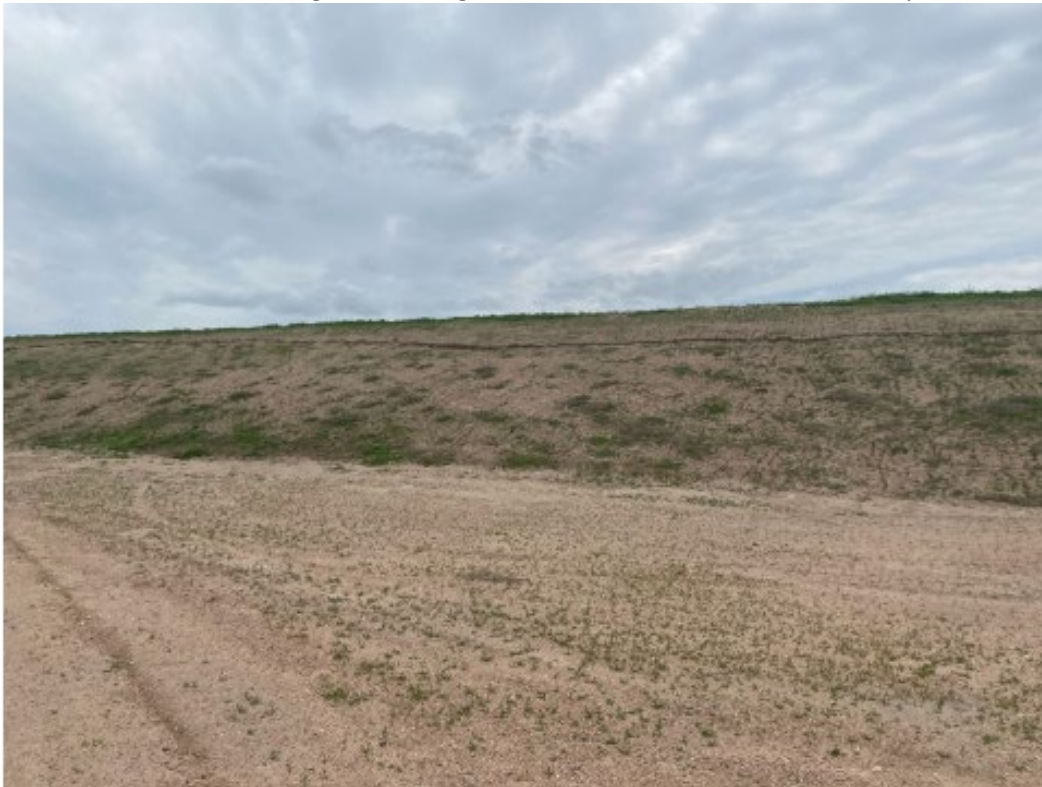
Photo 16: Looking north at the scarp that runs from the east to the west along the top of the recently reclaimed slope.

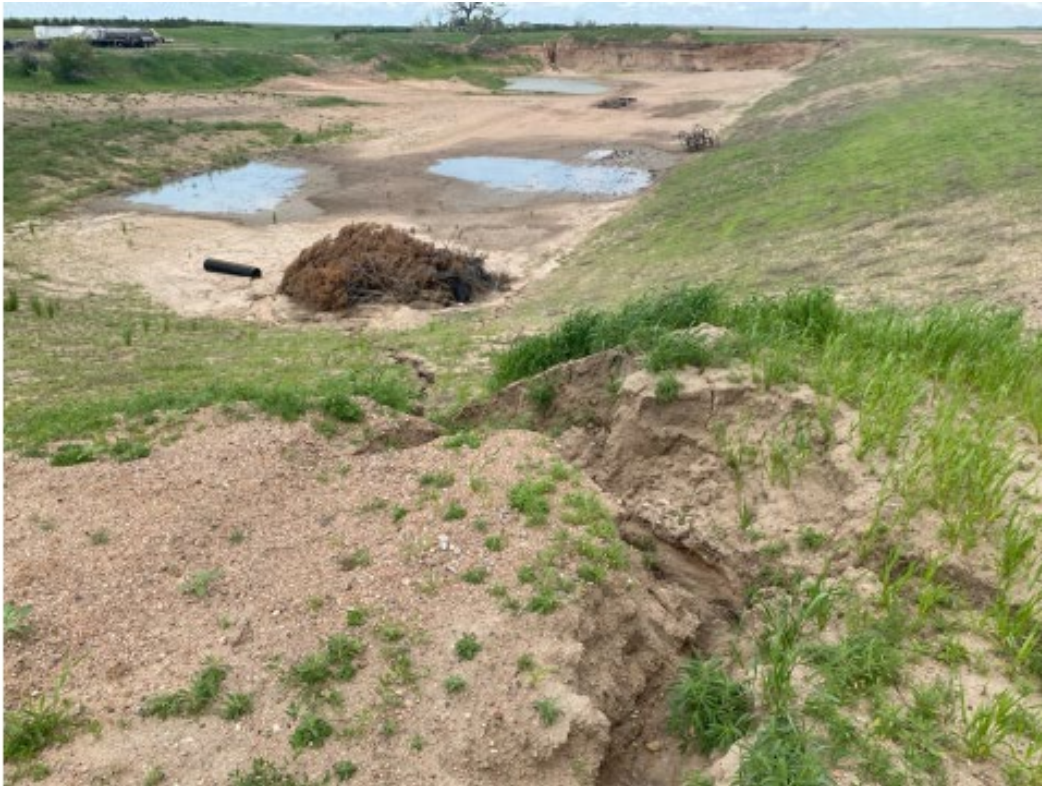
PROBLEM: An erosion gully was observed on-site. This is a problem at this time for failure to protect the affected land from erosion pursuant to C.R.S. 34-32.5-116(4)(j).

The Division did not observe excess sediment entering the creek bed. However, in the north east corner of the northern pit, there is an erosion gully that appears to have been caused from the run-off from the Operator's shop area running downslope into the pit (Photo 19: Map 1). **A problem has been cited** for erosion. The Operator will need to repair the erosion in this corner, and submit photo evidence that this has been completed by the corrective action date.

Photo 19: Looking down into the pit from the north-east corner of the northern pit. An erosion gully leads from the Operator's shop area down into the pit.

CORRECTIVE ACTIONS: The Operator shall provide photo documentation to the Division verifying erosion the gully has been repaired, and that the site has have been reconstructed and stabilized to prevent erosion damage by the corrective action date.

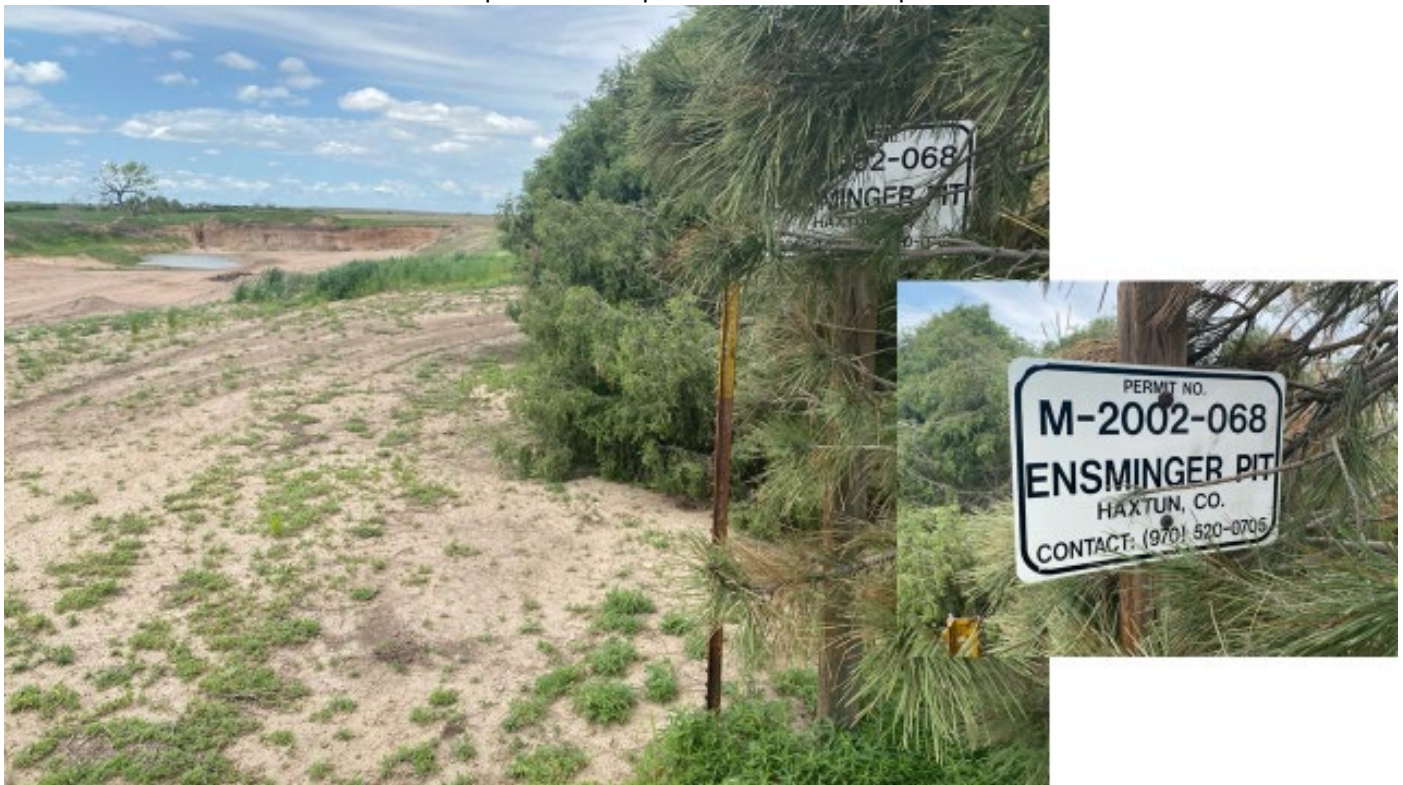
PROBLEM: The affected area boundary markers are missing or incorrectly placed. This is a problem for failure to maintain boundary markers around the affected area as required by Section 3.1.12(2) of the rule.

A mine sign was observed at the north-east corner of the site. The sign is in compliance with Rule 3.1.12(1). However, it is obscured by branches that may need to be trimmed if they continue to grow (Photo 20: Figure 1: Map 1).

Only one boundary marker was observed on-site. The north-east corner t-post was placed next to the mine sign (Photo 20: Map 1). The Operator also stated that there had been one marking the south-east corner just prior to the inspection, and that it had been knocked down. The Division took a photo from the location where the Operator stated the post had been (Photos 1 and 2: Map 1). The Operator also stated that there were t-posts for the northern boundaries prior to the inspection, but they were taken down to farm in these areas (see cropland north of active pit on Map 1, and Figures 1-2).

Photo 20: Looking west at the permit sign and north-east permit boundary marker. The sign is partially obscured by branches.

CORRECTIVE ACTIONS: The Operator shall conduct a survey and replace the boundary markers in the correct location(s). The Operator shall provide proof to the Division that this has been done by the corrective action date.

A problem was cited above for failure to maintain boundary markers delineating the approved affected area in accordance with Rule 3.1.12(2)(a). The Operator shall conduct a survey to replace the missing boundary markers. The Operator must submit photo evidence and/or GPS coordinates that indicates that boundary markers have been installed.

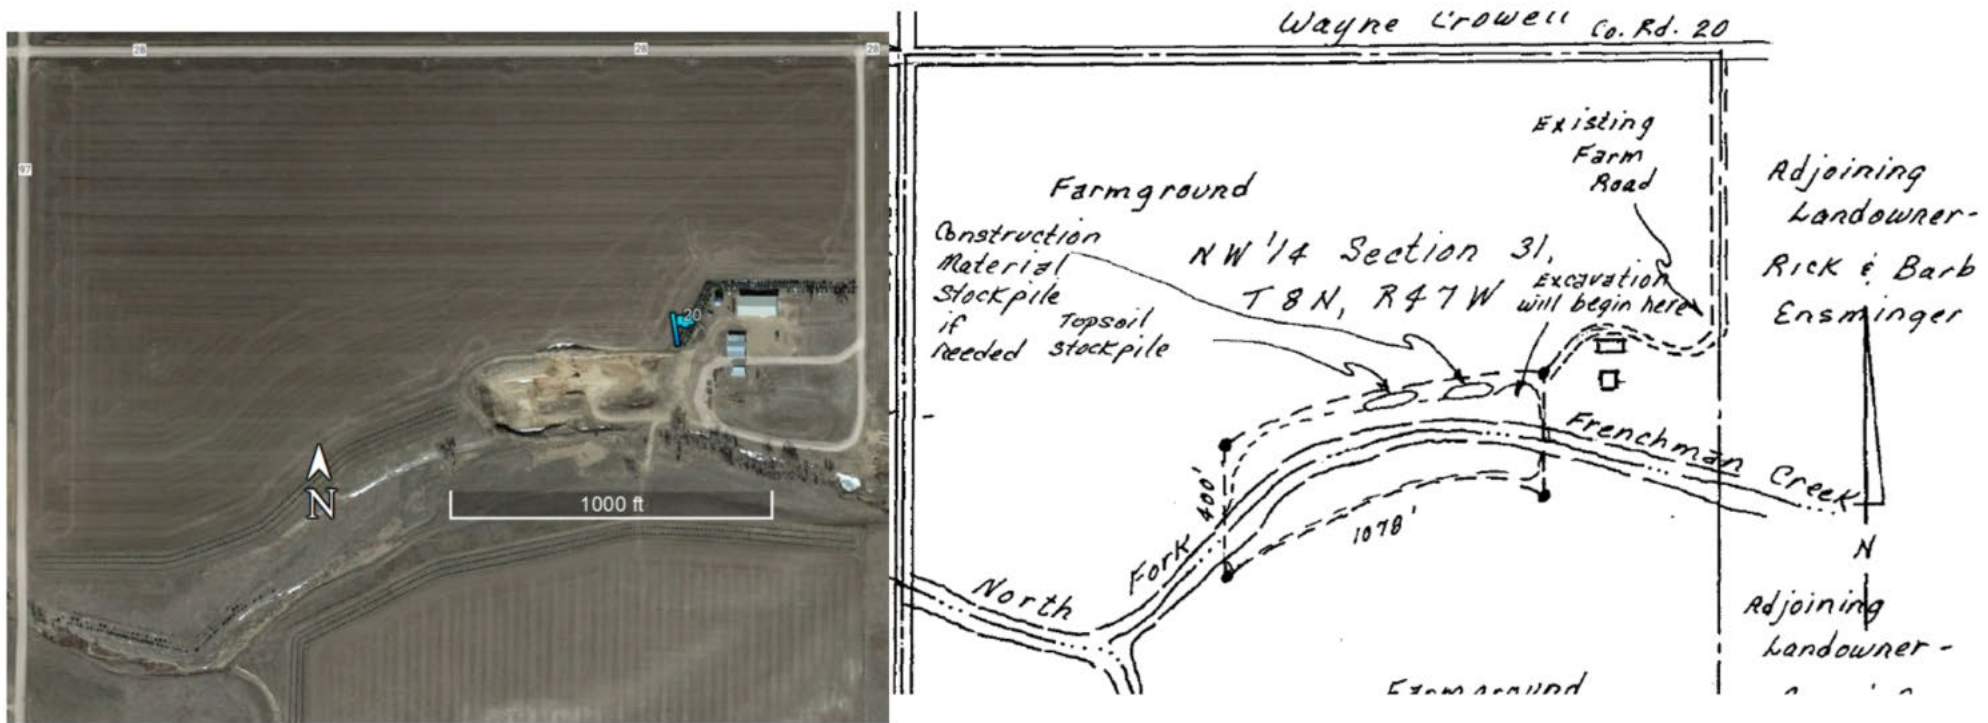
Figure 1: (Left) Areal map generated using Google Earth Pro. The Google Earth image is dated September 2016. The blue flag with the number 20 corresponds to Photo 20 and indicates the remaining in-situ t-post boundary marker on-site. (Right) A clip from the approved mining map that illustrates the approved permit boundaries (dashed polygon with dimensions of 400' x 1078').

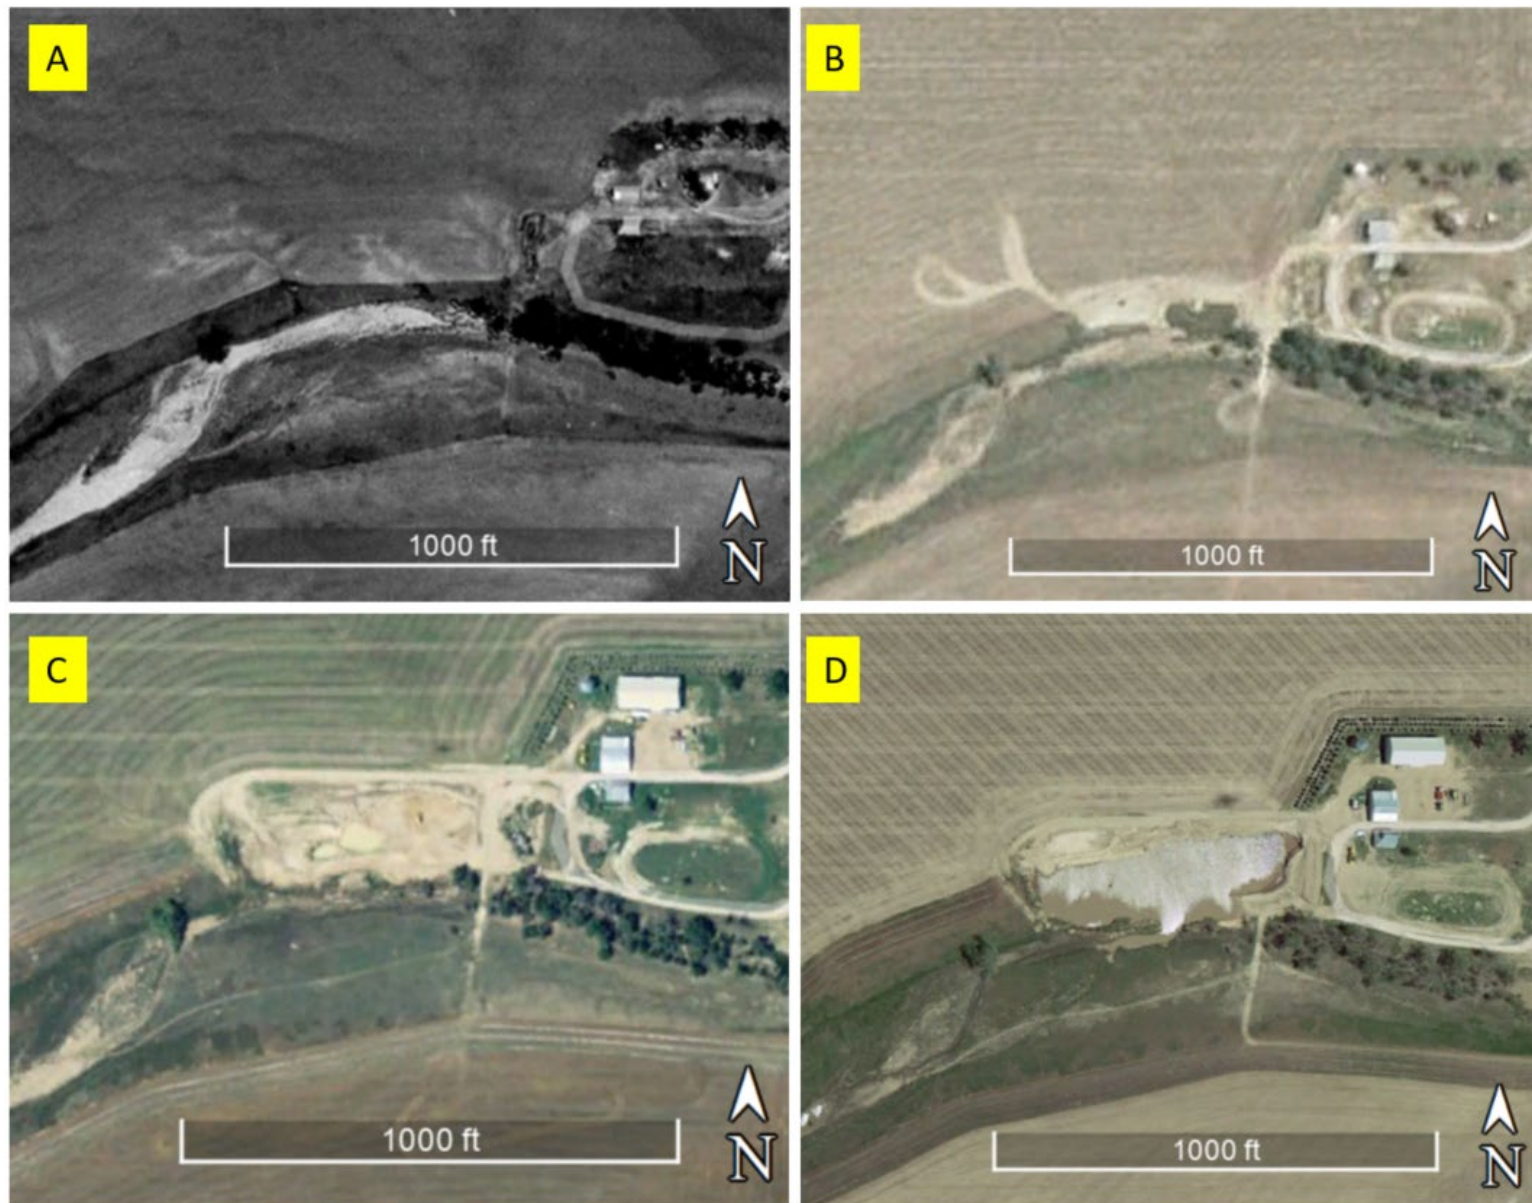
The plan for this site initially was to mine within the creek bed of the North Fork of Frenchman Creek. Excavation of the mining pit began north of the creek, and expanded northward (Figure 2). From there, mining progressed from east to west within the pit. The Operator stated that the pit would sometimes contain large amounts of water from the creek spilling into it, and the Operator has since built a berm made of primarily clay and sandy material found onsite by pushing it up against the southern wall of the pit to attempt to keep water out of the pit (Photo 4: Map 1(B)). The Operator stated that this has helped keep large amounts of water out, but water still seeps into the pit from below the berm (Photos 10-12: Map 1). Additionally, the Operator has excavated a small area south of the original pit that does lie within the creek bed (as seen in Map 1(C)). Currently, there is a highwall approximately 200' long and 10'-15' high along the western border. The Operator stated that they have finished mining, and would like to enter final reclamation.

Figure 2: Images gathered from Google Earth Pro to provide a timeline of mining activities and the separation of the main pit from the Frenchman Creek. A) 1998 aerial view depicting the site area prior to mining activities. B) 2006, early mining progress. Mining began north of the creek bed. C) 2011, mining remains north of the creek bed. D) 2013, water flows into the pit area from the creek south of the pit area.
