**COLORADO**Division of Reclamation,
Mining and Safety

MINERALS PROGRAM INSPECTION REPORT**PHONE: (303) 866-3567**

MINE NAME: Patty's Pit	MINE/PROSPECTING ID#: M-1998-103	MINERAL: Sand and gravel	COUNTY: Elbert
INSPECTION TYPE: Monitoring	WEATHER: Clear	INSP. DATE: June 15, 2023	INSP. TIME: 09:40
OPERATOR: Town of Limon	OPERATOR REPRESENTATIVE(S): Greg Tacha and Ed Grimes	TYPE OF OPERATION: 112c - Construction Regular Operation

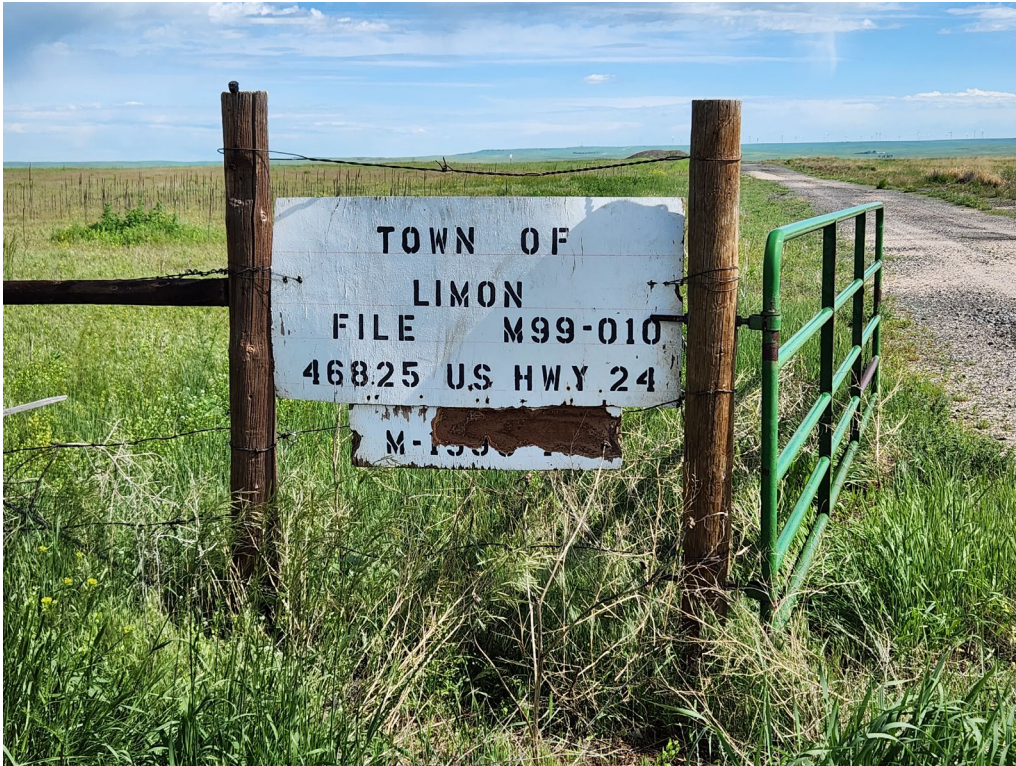
PROBLEM: The current mine identification sign posted at the entrance of the mine site is weathered and the permit number is no longer readable. The sign also does not include a statement that the reclamation permit for the operation has been issued by the Colorado Mined Land Reclamation Board (CMLRB). This is a problem for failure to meet all requirements of a mine identification sign per Rule 3.1.12(1).

The mine identification sign located at the site entrance has been weathered over time and the permit number is no longer readable. Also, the sign does not include all information required by Rule 3.1.12(1). This is cited as a problem in the report (see page 1). The operator will need to submit photo documentation that a proper sign has been posted by the corrective action due date.

Photo 1. Patty's Pit mine sign. Permit number has been weathered over and the sign does not include the operation name or a statement that the reclamation permit for the operation has been issued by the Colorado Mined Land Reclamation Board.

CORRECTIVE ACTIONS: The operator shall, at the entrance of the mine site post a sign, which shall be clearly visible from the access road, with a minimum size equaling one hundred and eighty-seven (187) square inches, such as eleven (11) inches in height and seventeen (17) inches in width, with appropriate font size, with the following: the name of the operator, the operation name, a statement that a reclamation permit for the operation has been issued by the CMLRB, and the permit number. The operator shall submit photo documentation that a proper sign has been posted by the corrective action due date.

CORRECTIVE ACTION DUE DATE: August 16, 2023

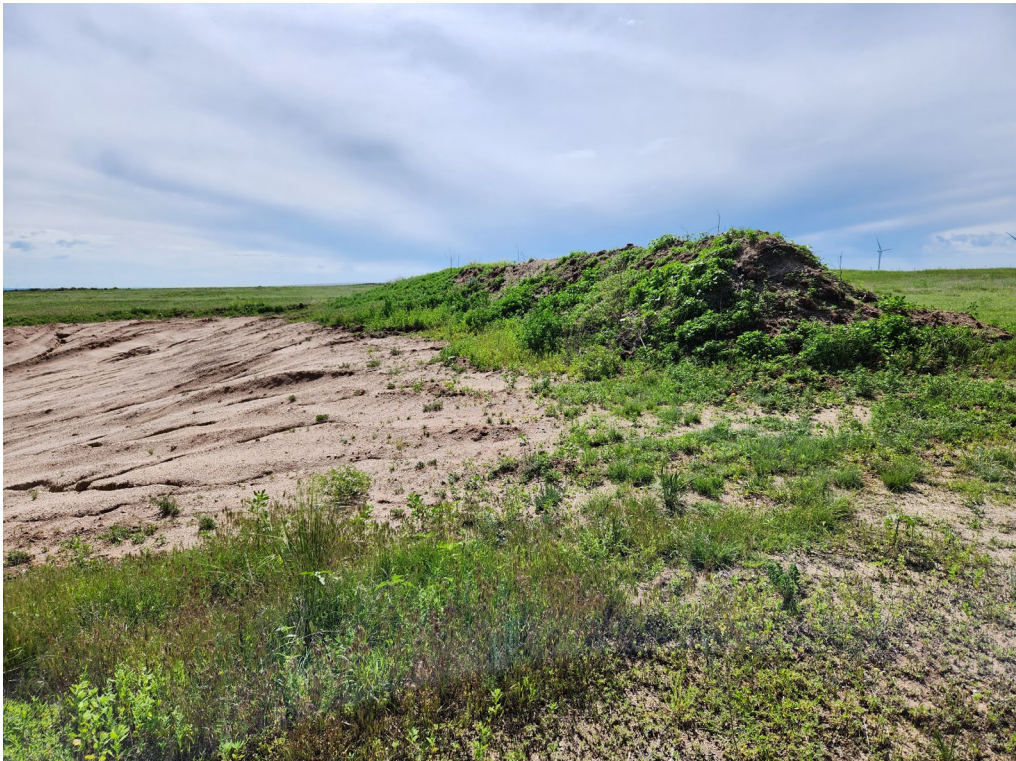
Photo 2. Topsoil stockpile stored along southern edge of active pit, looking east.

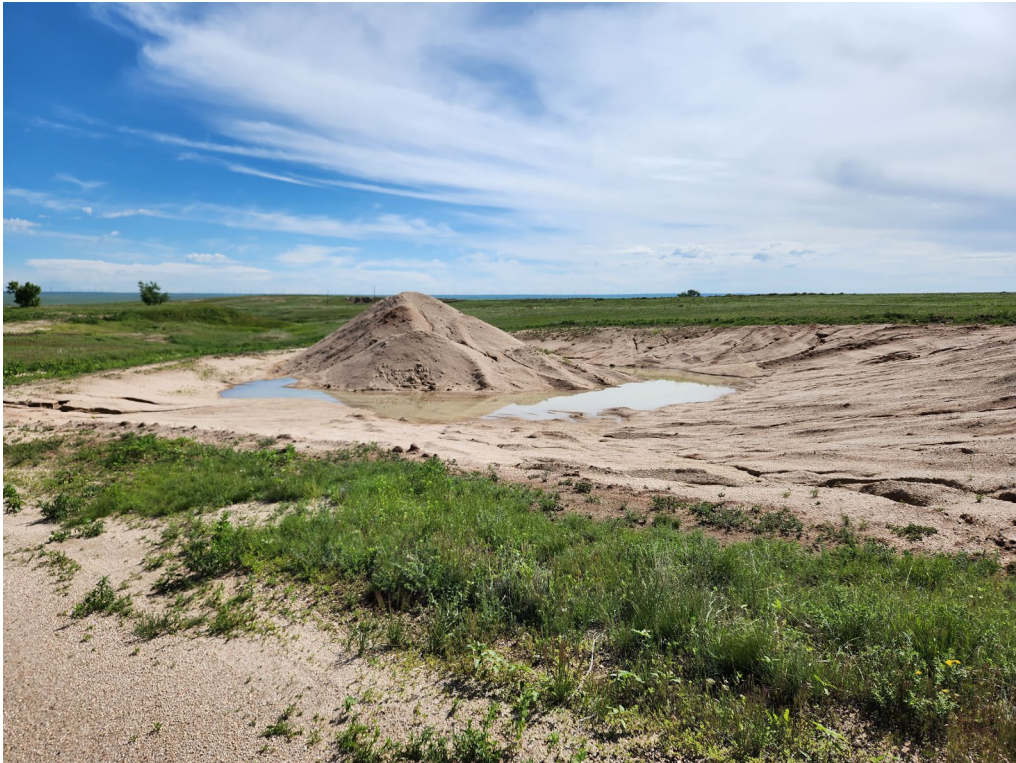
Photo 3. Product stockpile stored in active pit, looking east.

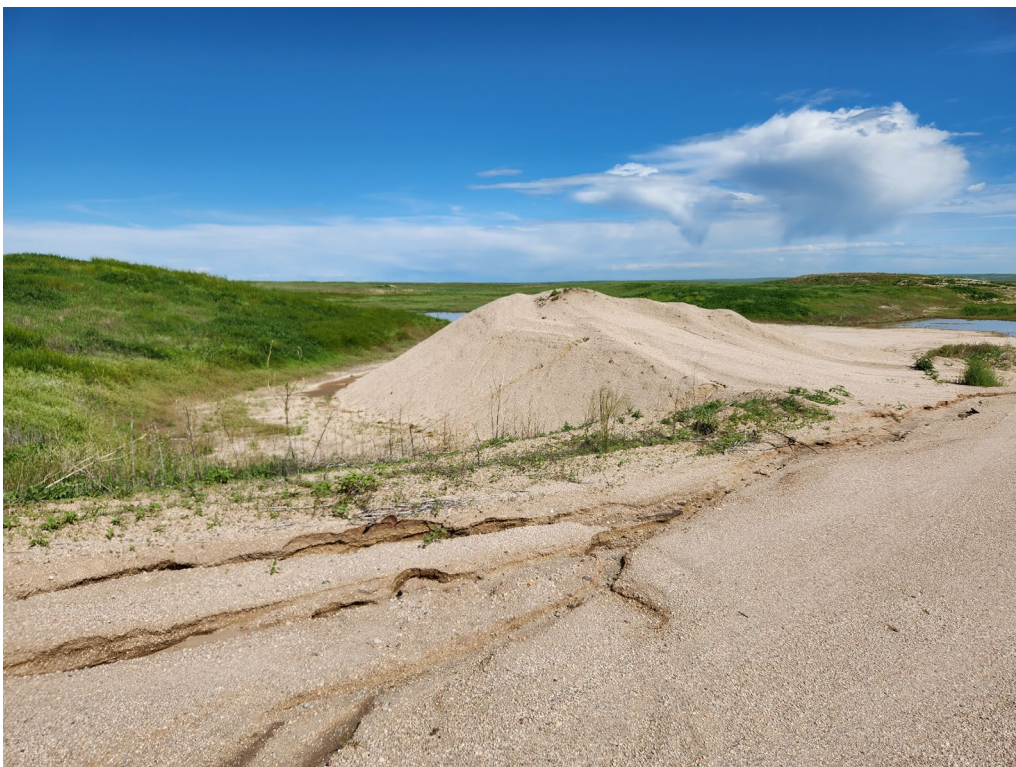
Photo 4. Product stockpile stored at south edge of larger pit, looking west.

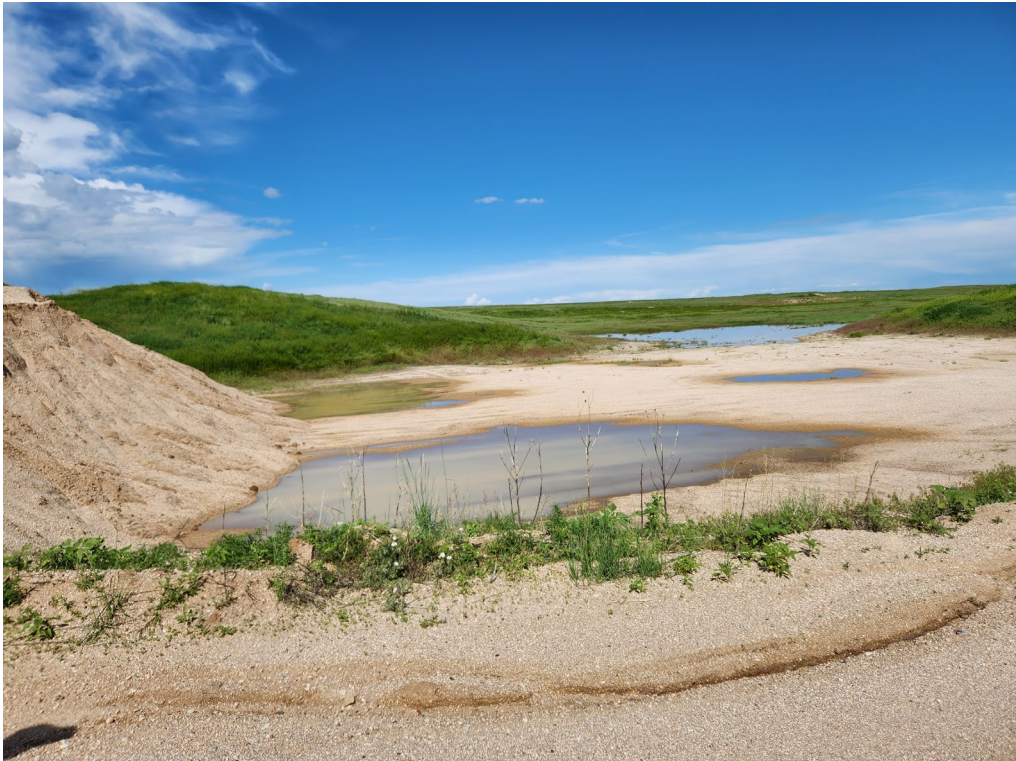
There was no mining actively occurring at the time of inspection; however, product is occasionally hauled off site according to the operator. The Division observed ponded water in low-lying areas throughout the site, including on the pit floors. This region did experience significant storm events in the days leading up to the inspection. The ponded water did not appear to be exposed groundwater or water that has been standing for a long period of time. The operator should be advised, the Division of Water Resources (DWR) requires that operators ensure water is not retained on site for more than 72 hours unless a substitute water supply plan or augmentation plan approved by water court is obtained. If the operator must pump water out of the pits in order to meet this requirement, a discharge permit may be required from the Colorado Department of Public Health and Environment (CDPHE).

Photo 5. Southern edge of larger pit, looking west. The area had experienced significant storm events in the days leading up to the inspection, as evidenced by the ponded water observed throughout the site.

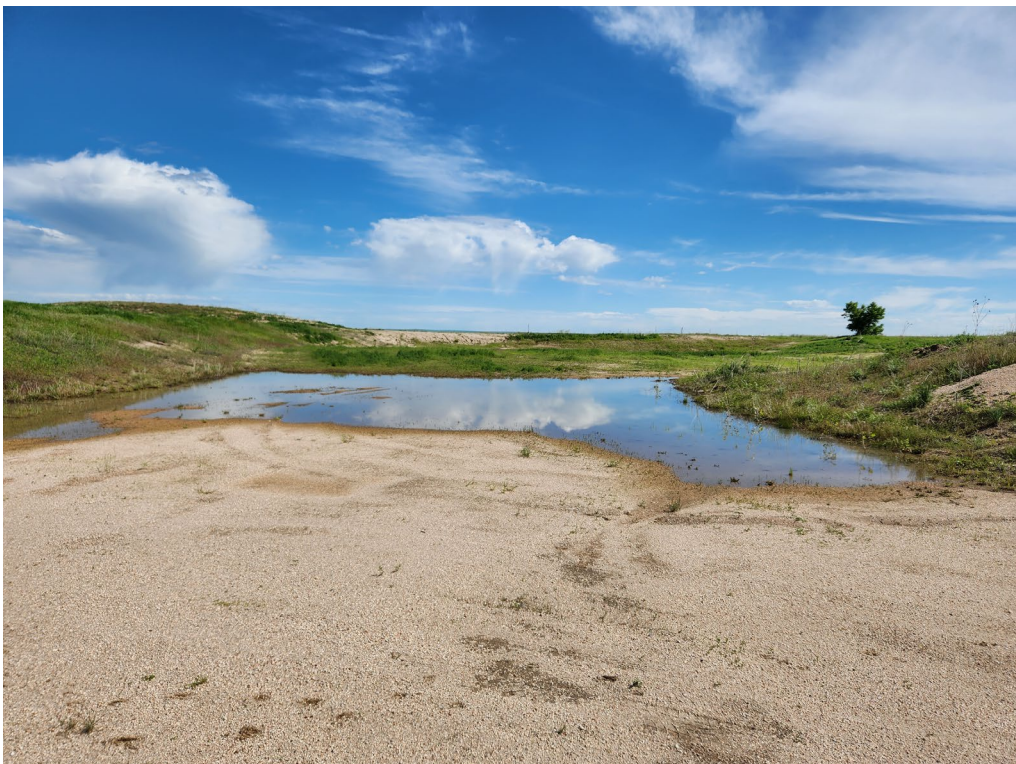
Photo 6. Eastern edge of larger pit, looking north. Pit slopes in this area have been graded to 3H:1V. However, this area has not yet been retopsoiled and seeded.

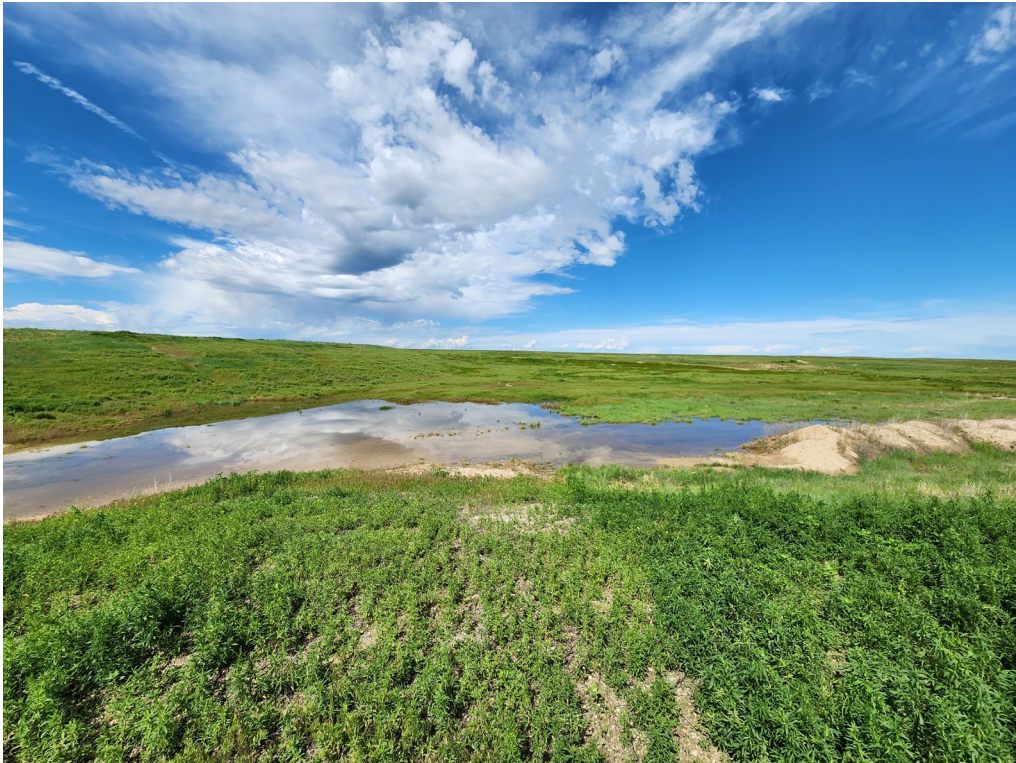
Vegetation throughout the site consisted primarily of native grasses, yucca, and cactus in undisturbed areas. The Division estimates approximately 5-6 acres of the phase 1 disturbance has been graded, retopsoiled, and seeded for reclamation. According to the operator, seeding in this area occurred sometime before 2016. The reclaimed area appeared to be stable, did not have any noxious weeds, and the grass species was fairly diverse. The unreclaimed area was comprised mostly of kochia on top of the pit slopes and downy brome (cheatgrass) along the pit slopes. Vegetation across the pit floor in the unreclaimed area was either sparse or consisted primarily of kochia and downy brome. The operator should continue to monitor these weeds and implement the approved weed management plan as appropriate, in accordance with Rule 3.1.10(6). Additionally, any disturbed lands that will not be re-disturbed by the operation need to be seeded as soon as practicable.

Photo 7. Portion of larger pit in reclamation, looking west.

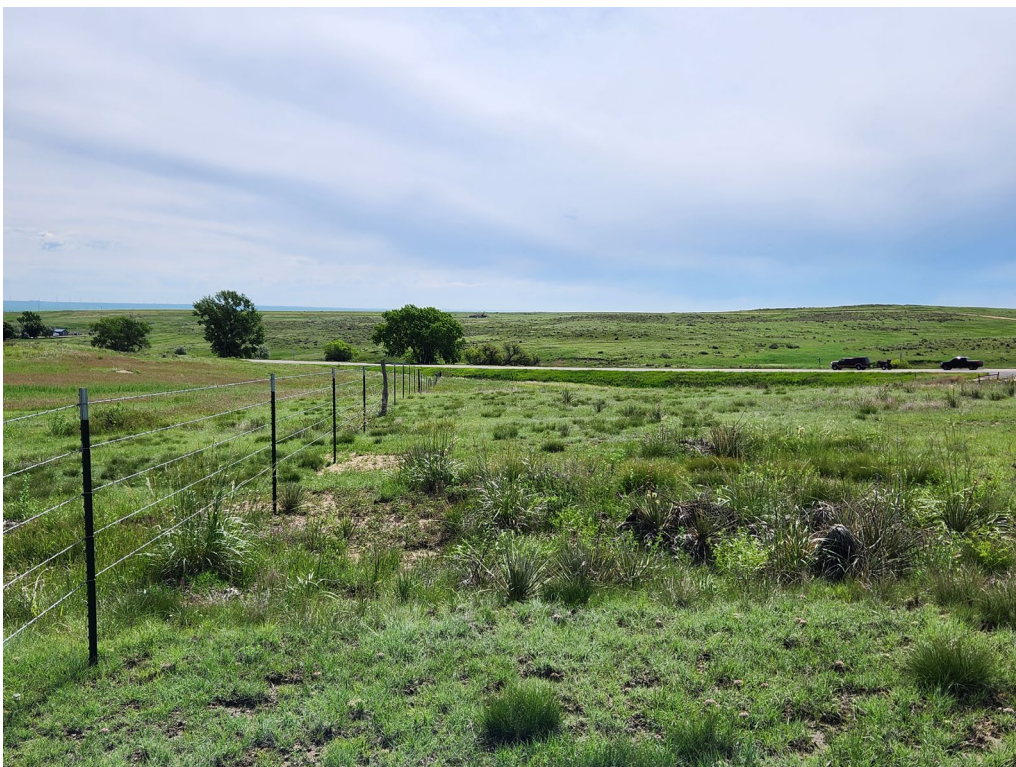
Photo 8. Northern permit boundary delineated with fencing, looking toward north east corner.

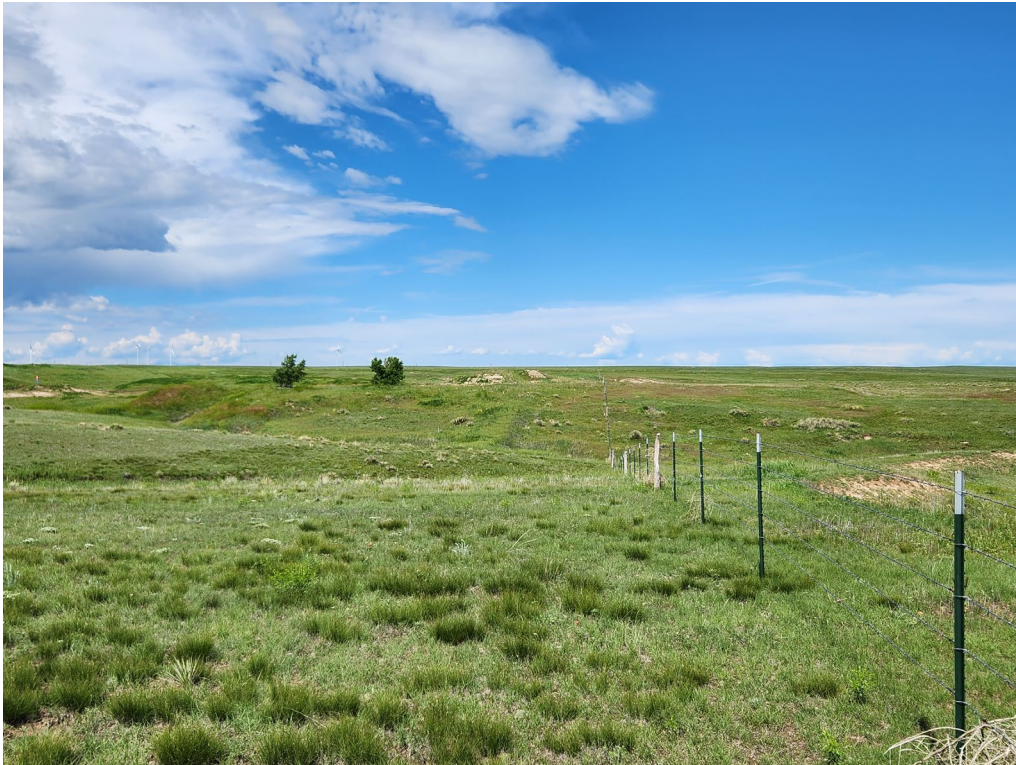
Photo 9. Northern permit boundary delineated with fencing, looking west.
