MINERALS PROGRAM INSPECTION REPORT
PHONE: (303) 866-3567

MINE NAME: Climax Mine	MINE/PROSPECTING ID#: M-1977-493	MINERAL: Molybdenum	COUNTY: Lake, Summit
INSPECTION TYPE: Monitoring	WEATHER: Clear	INSP. DATE: July 12, 2023	INSP. TIME: 11:00
OPERATOR: Climax Molybdenum Company	OPERATOR REPRESENTATIVE: Megan Graham	TYPE OF OPERATION: 112d-3 - Designated Mining Operation	
REASON FOR INSPECTION: Normal I&E Program	BOND CALCULATION TYPE: None	BOND AMOUNT: \$91,011,850.00	
DATE OF COMPLAINT: NA	POST INSP. CONTACTS: None	JOINT INSP. AGENCY: None	
INSPECTOR(S): Dustin Czapla Todd Jesse	INSPECTOR'S SIGNATURE:

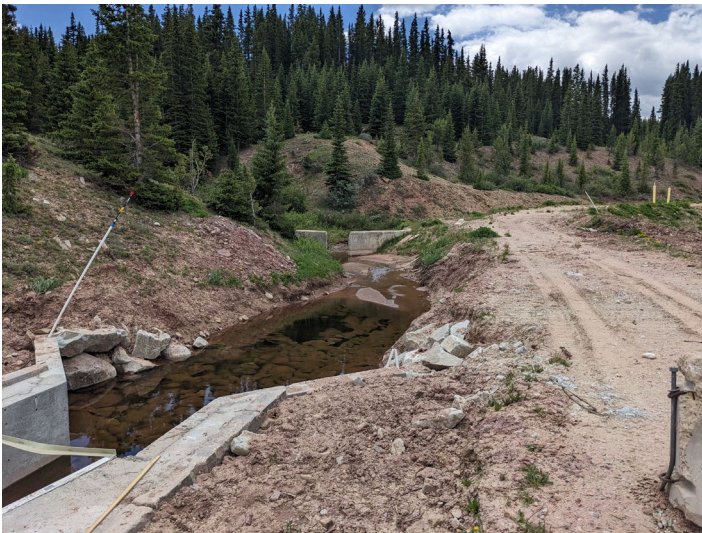
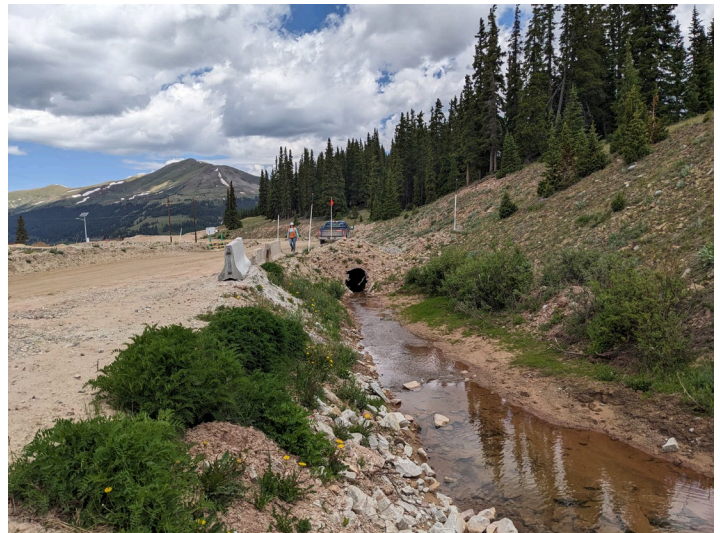
The East Interceptor conveys non-contact water to Clinton Reservoir. The interceptor consists of open channel, culverts and pipeline. Portions of the open channel were observed. No problems were noted with the East Interceptor.

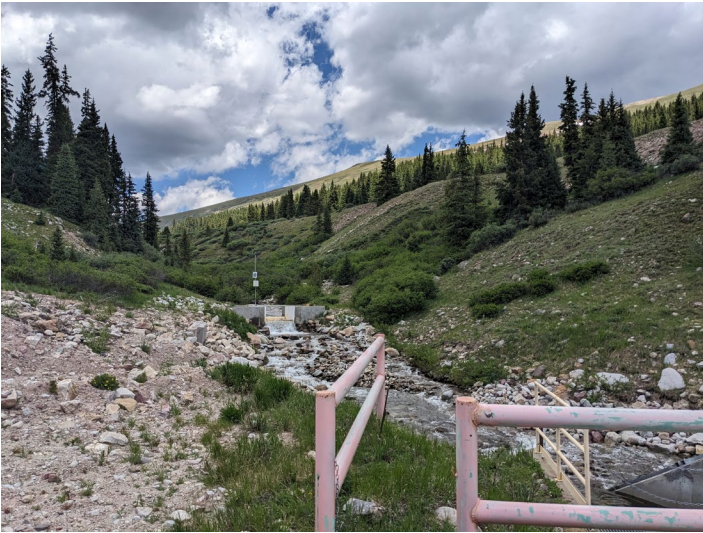
The West Interceptor captures non-contact water from the north side of the tailings ponds and conveys the freshwater east, around the mine area and into Tenmile Creek, just upstream of the PWDTP. The West Interceptor consists of open channel, pipeline and culverts. For the most part, much of the West Interceptor flows along the road on the north side of the tailings area, so much of the interceptor was observed during this inspection. No problems with the West Interceptor were noted.

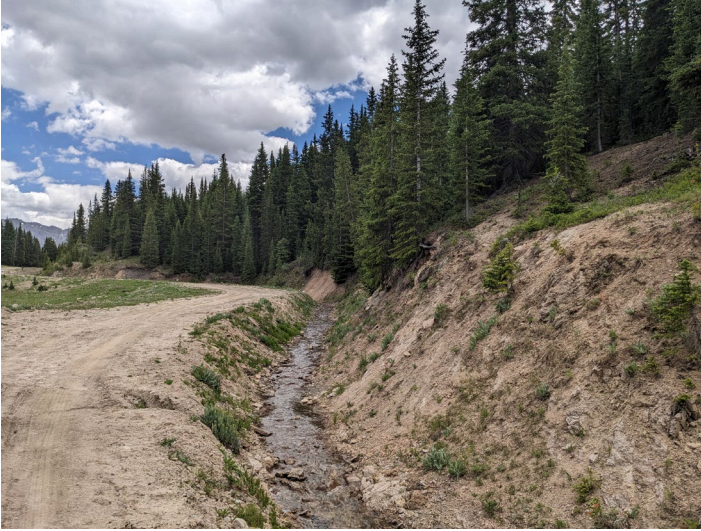
The Chalk Mountain Interceptor captures non-contact water from the Chalk Mountain drainages and conveys the freshwater to Chalk Mountain Reservoir. The Chalk Mountain Interceptor consists of open channel and culverts. The interceptor channel was observed along most of its reach, from the access road. No problems were noted with the Chalk Mountain Interceptor.
