## Gardner Pit Inspection Report, M-1979-034

**MINERALS PROGRAM INSPECTION REPORT**  
**PHONE: (303) 866-3567**

<b>MINE NAME:</b> Gardner Gravel Pit	<b>MINE/PROSPECTING ID#:</b> M-1979-034	<b>MINERAL:</b> Sand and gravel	<b>COUNTY:</b> Routt
<b>INSPECTION TYPE:</b> Monitoring	<b>WEATHER:</b> Clear	<b>INSP. DATE:</b> June 27, 2023	<b>INSP. TIME:</b> 14:30
<b>OPERATOR:</b> General Operating Company	<b>OPERATOR REPRESENTATIVE:</b> Dan Redmond	<b>TYPE OF OPERATION:</b> 112c - Construction Regular Operation

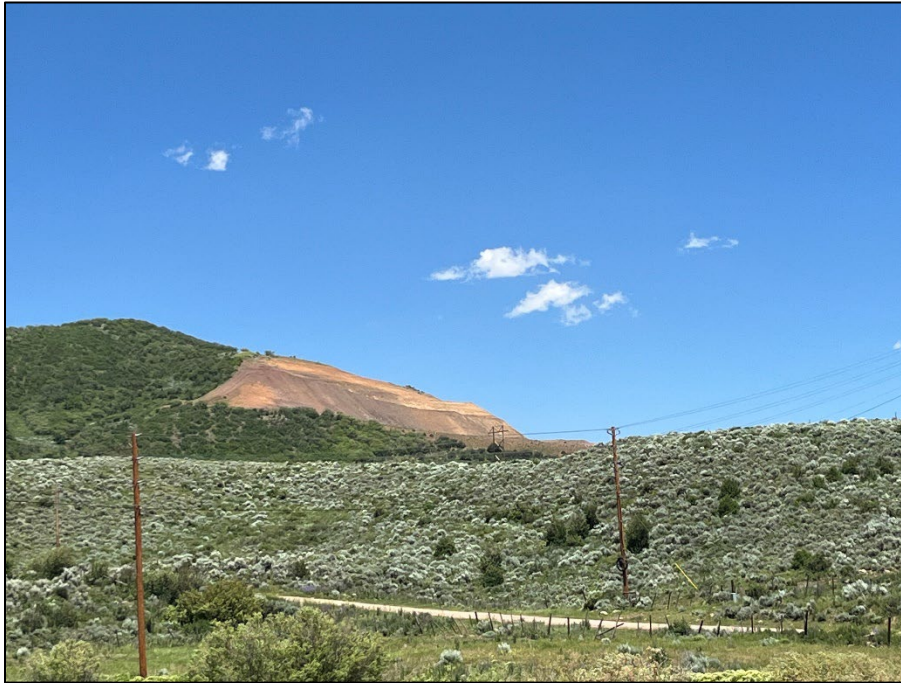
**Photo 1: View northeast of the pit highwall, taken from County Road 14.**

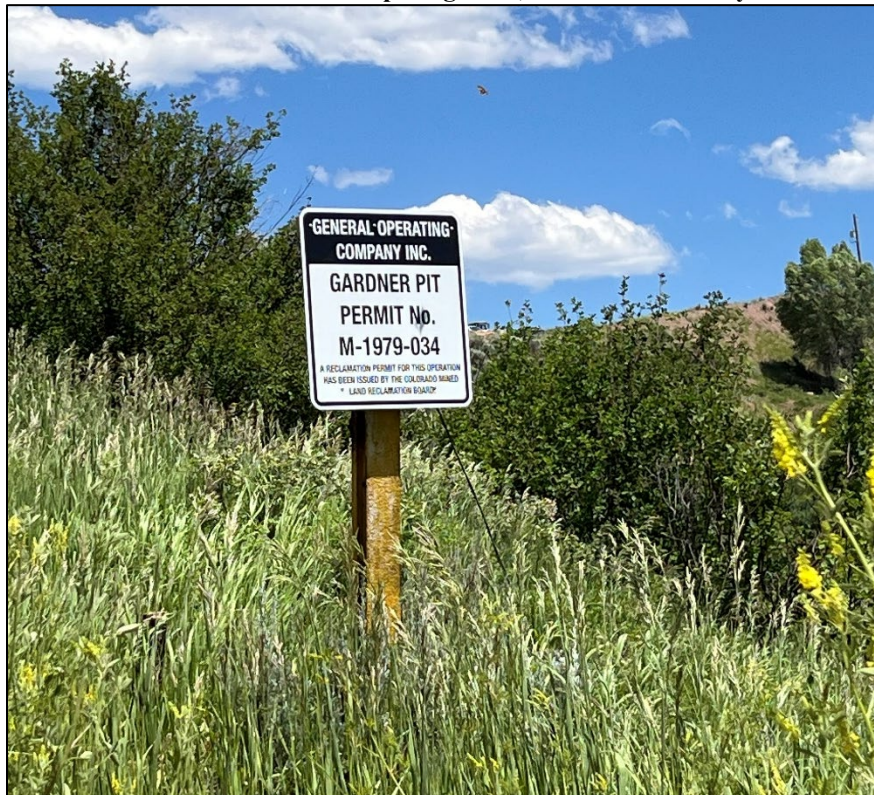
There is a mine identification sign posted at the bottom of the access road to the pit (Photo 2). This sign was updated via a problem citation from the last inspection dated 3/31/2023. The mine sign has now been appropriately amended. A wire fence delineates the permit boundary. At the entrance of the pit there is a small office and load scale. Two fuel tanks are stored in a secondary containment in the upper processing area (Photo 10).

**Photo 2: Mine sign posted at the entrance to the pit's access road, recently updated.**

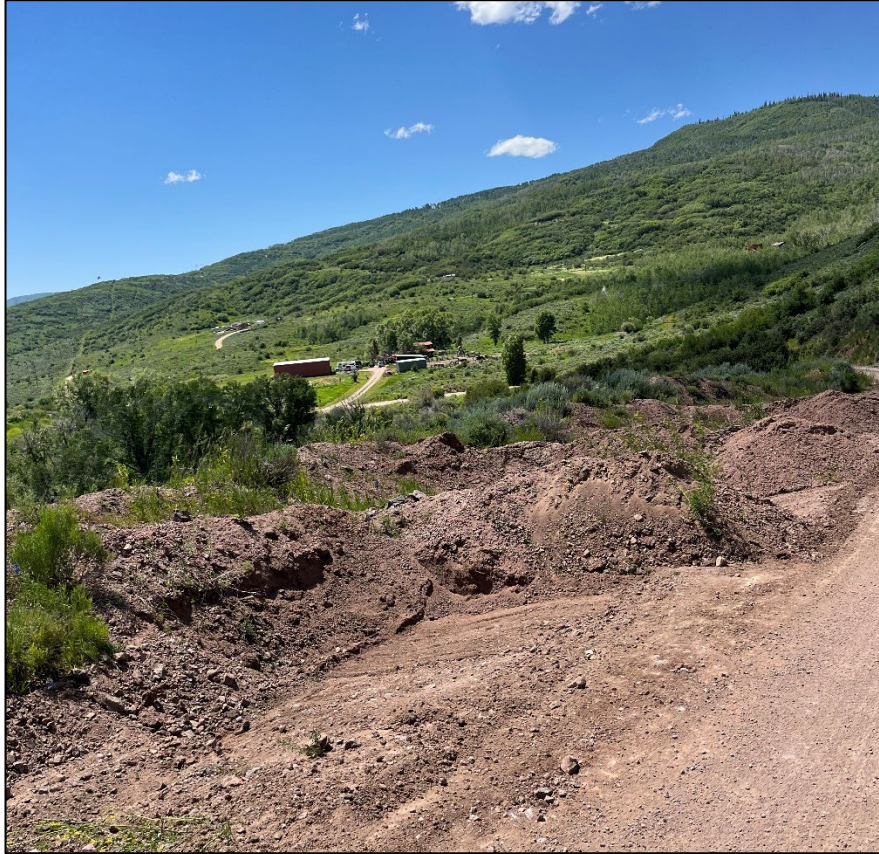
**PROBLEM/POSSIBLE VIOLATION:** Problem: Rock check dams which were previously installed in 2015 in response to a problem citation are no longer functioning properly. This is a problem at this time for failure to protect the affected land from erosion pursuant to C.R.S. 34-32.5-116 (4)(j). Rock check dams must be rebuilt properly to ensure full functionality of the dams and protection from erosion and sedimentation.

Rock check dams were installed along the site's access road in 2015 after an inspection problem was cited for failure to control sediment and erosion. The large rocks previously placed here to help slow erosion are now absent from the structures (Photos 3 and 12). **This is cited as a problem** for failure to protect affected land against erosion. To ensure full functionality, please rebuild these rock check dams to their appropriate design and submit evidence to the Division that this was completed by the corrective action due date.

**Photo 3: Check dams are in place along the access road, but in need of maintenance.**

**CORRECTIVE ACTIONS:** The Operator shall submit to the Division evidence that rock check dams have been rebuilt by the corrective action due date.

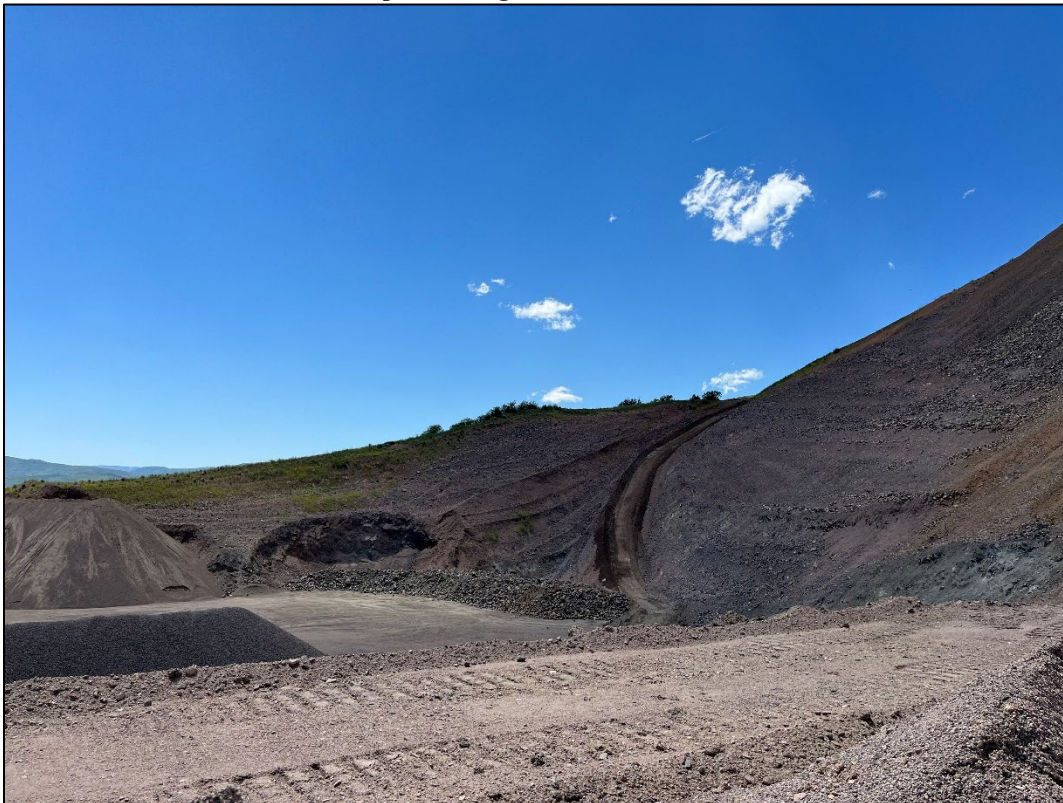
There is one topsoil pile located in the northeastern corner of the processing area, behind the fuel tanks (Photo 11). Other topsoil piles are stored on top of the highwall (Photo 9). Volunteer vegetation is noted to have been growing on various overburden stockpiles around the site (Photos 4 and 8). The operator stated that weeds are sprayed twice a season. The operator is encouraged to review their weed management plan and continually treat noxious weeds as needed. The schedule in the weed management plan is a timing guideline however noxious weeds should be treated whenever the opportunity is available and appropriate.

**Photo 4: View north of the existing highwall and truck path up to the highwall. Volunteer vegetation is seen growing on the face of material which has been stripped of topsoil.**

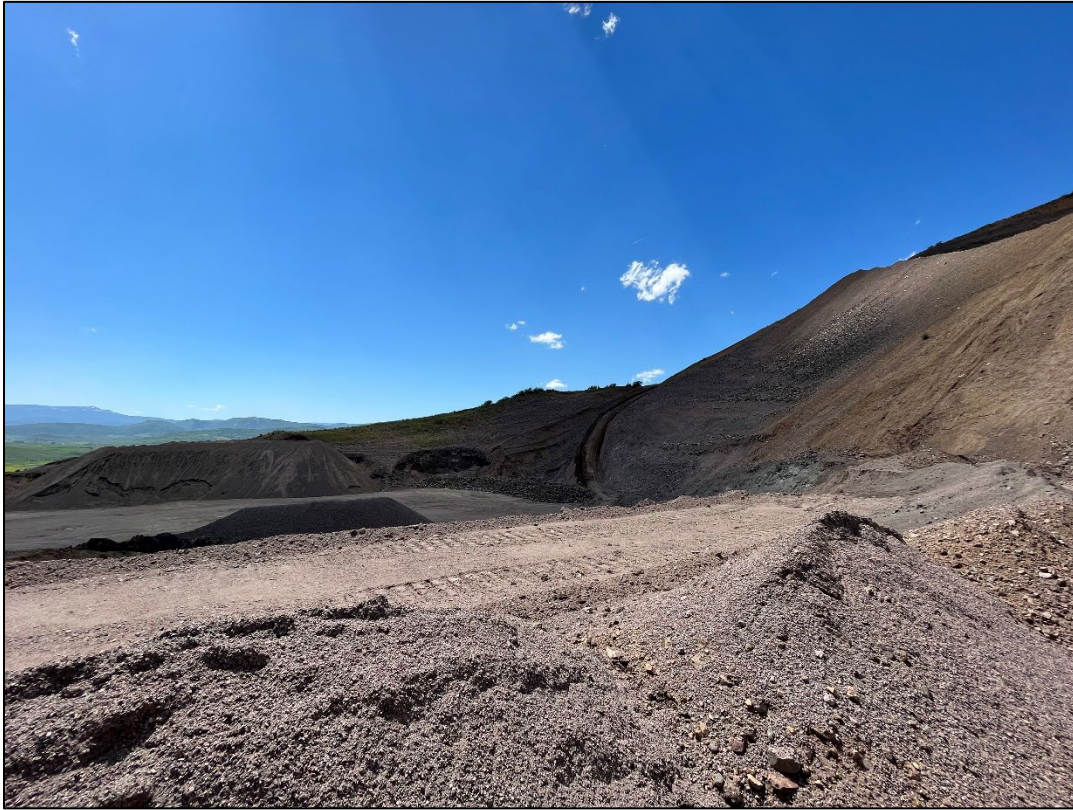
**Photo 5: Additional view of the active highwall and lower processing area.**

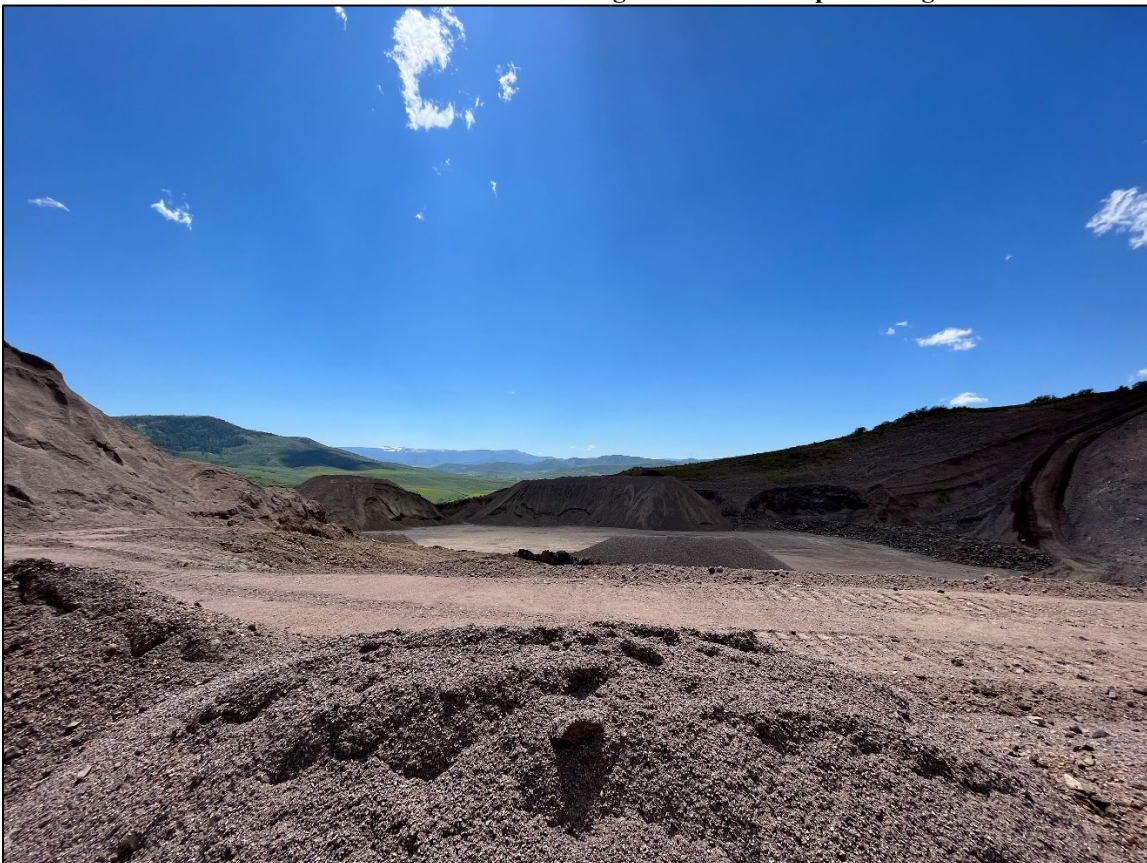
**Photo 6: View west of the lower processing area of the pit where material stockpiles are stored.**

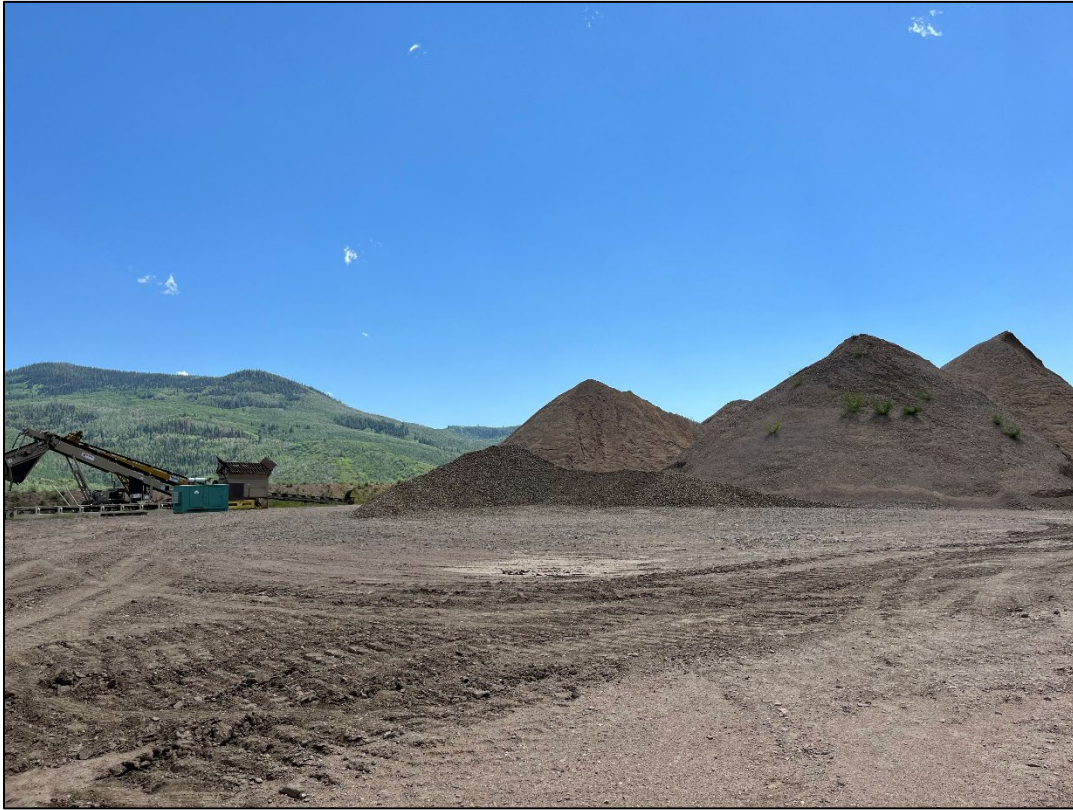
**Photo 7: Material stockpiles and shaker plant equipment is located on the upper processing area of the pit.**

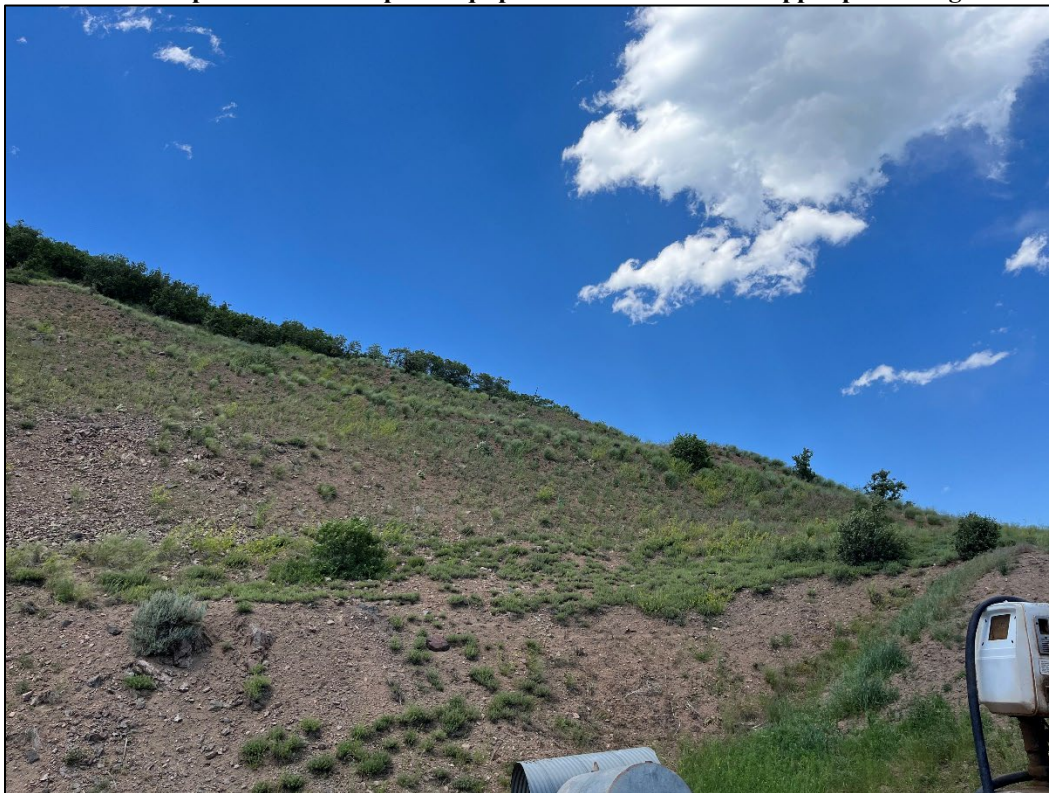
**Photo 8: View north of unexcavated hillside in the upper processing area.**

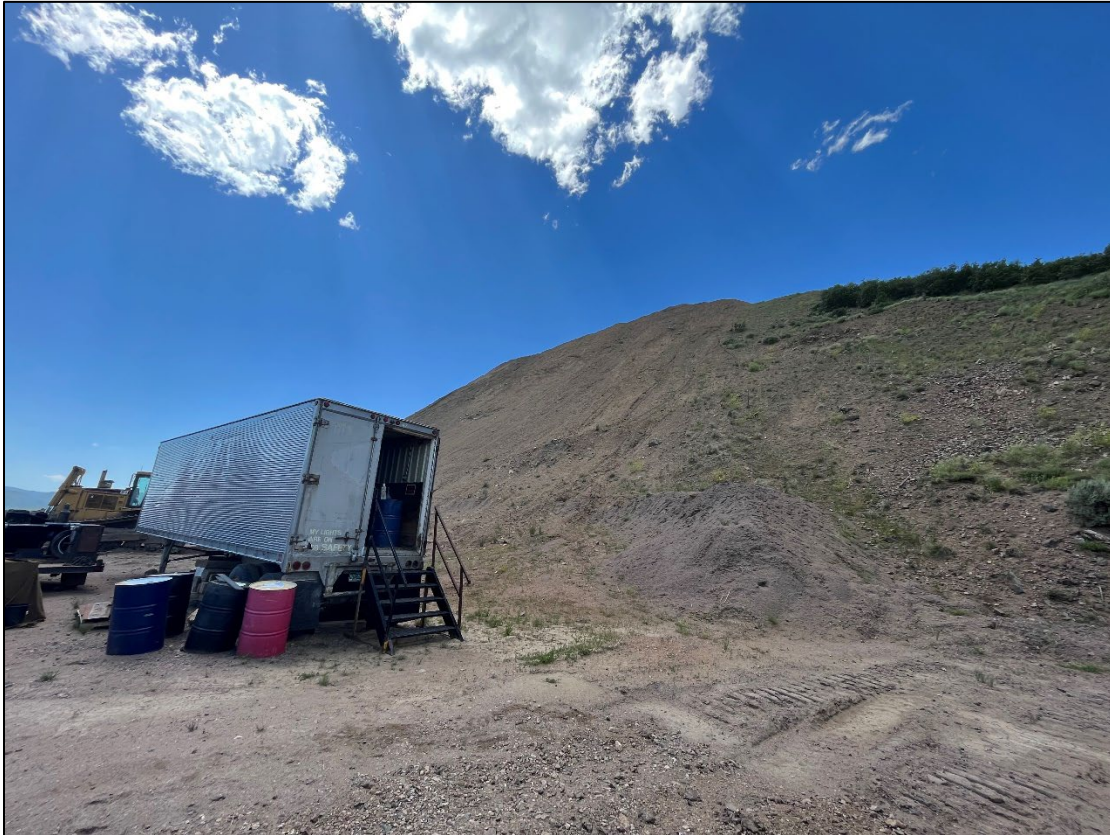
**Photo 9: View north of the eastern edge of the active highwall. This upper processing area also serves as additional machinery storage. Topsoil is stored atop the active highwall to the northwest.**

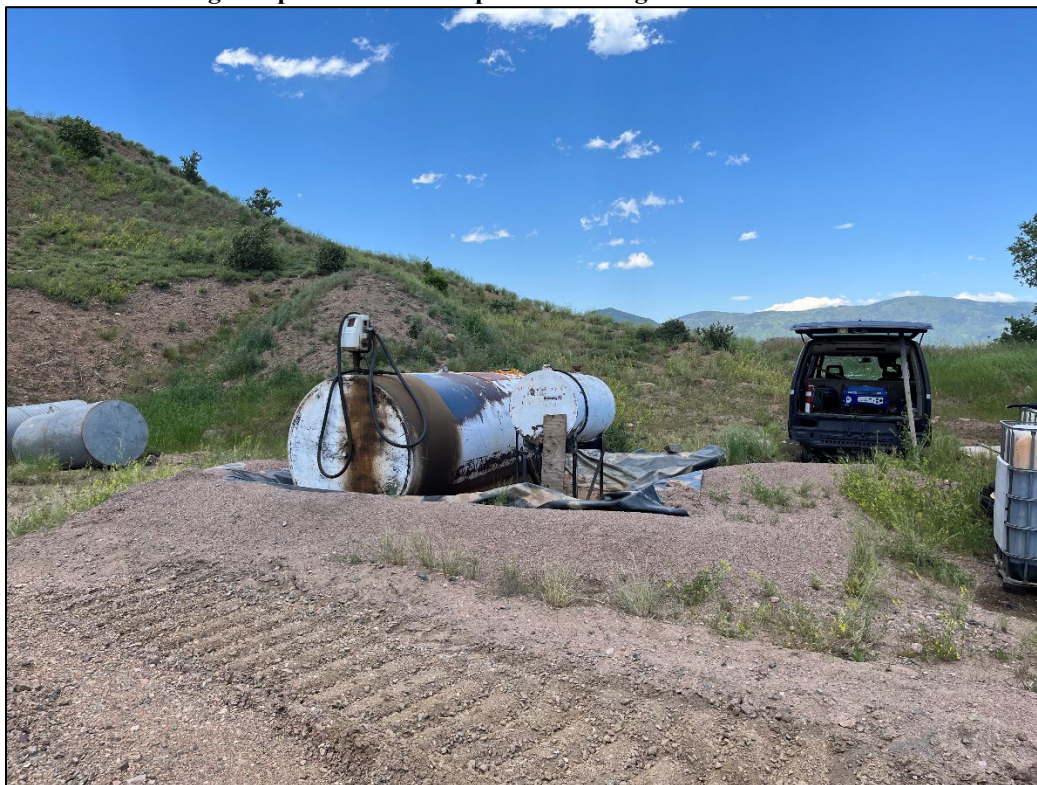
**Photo 10: Fuel stored in secondary containment.**

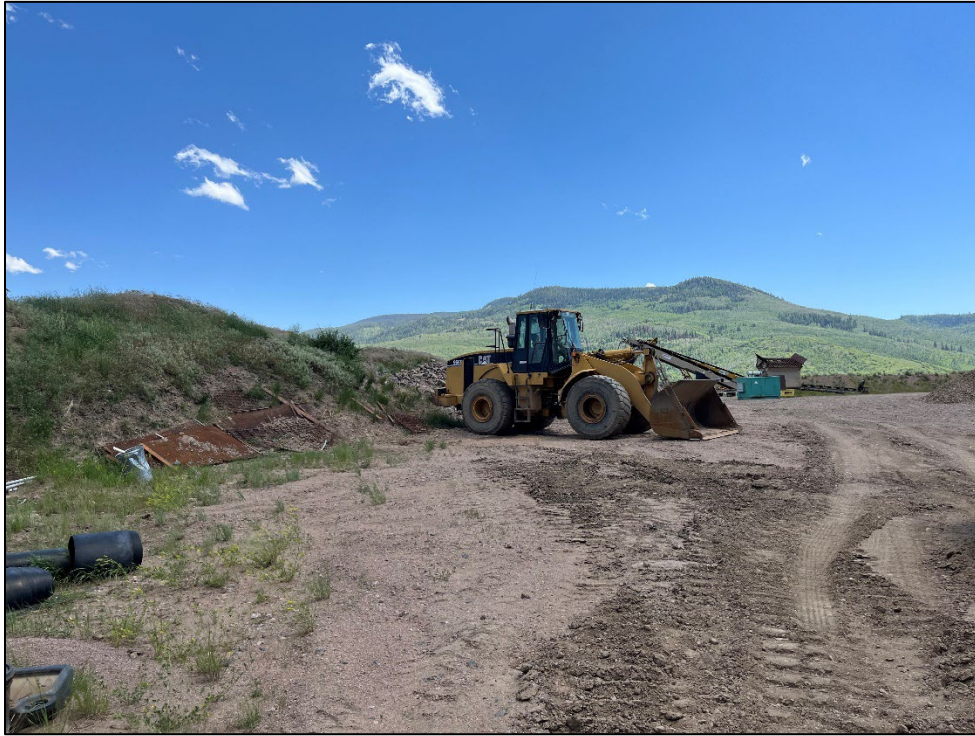
**Figure 11: View south of an existing topsoil pile located on the upper processing area.**

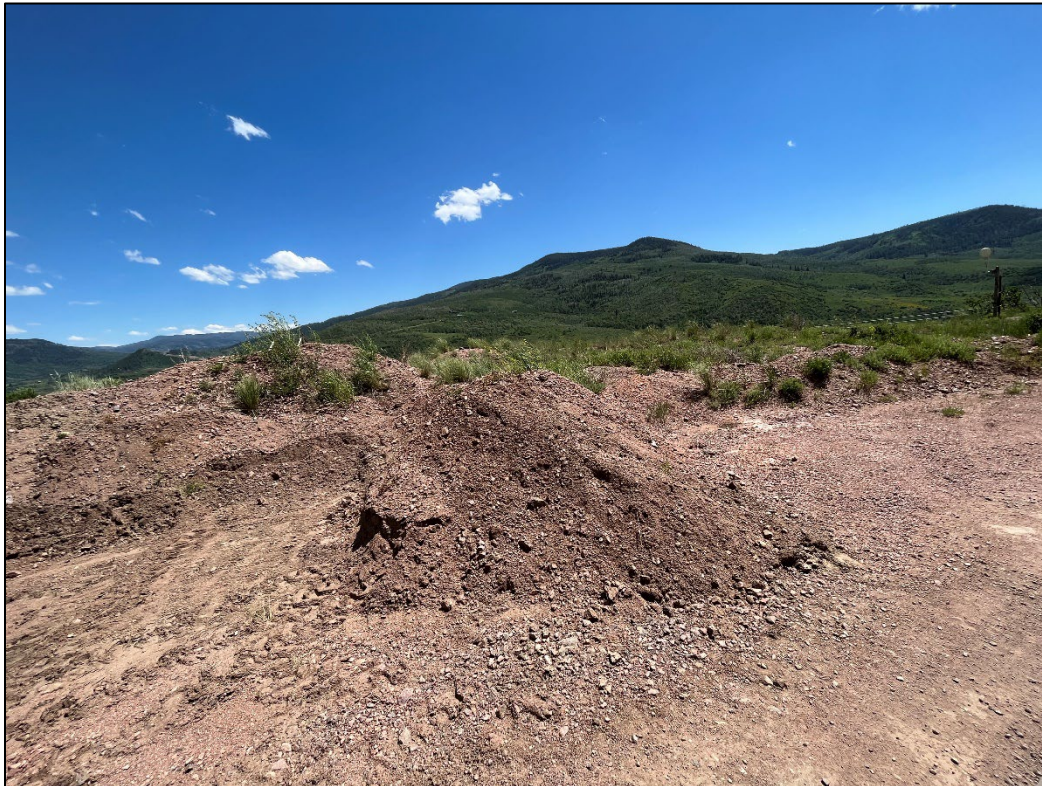
**Photo 12: Check dams have also been installed on the eastern edge of the permit to control runoff, in need of maintenance.**

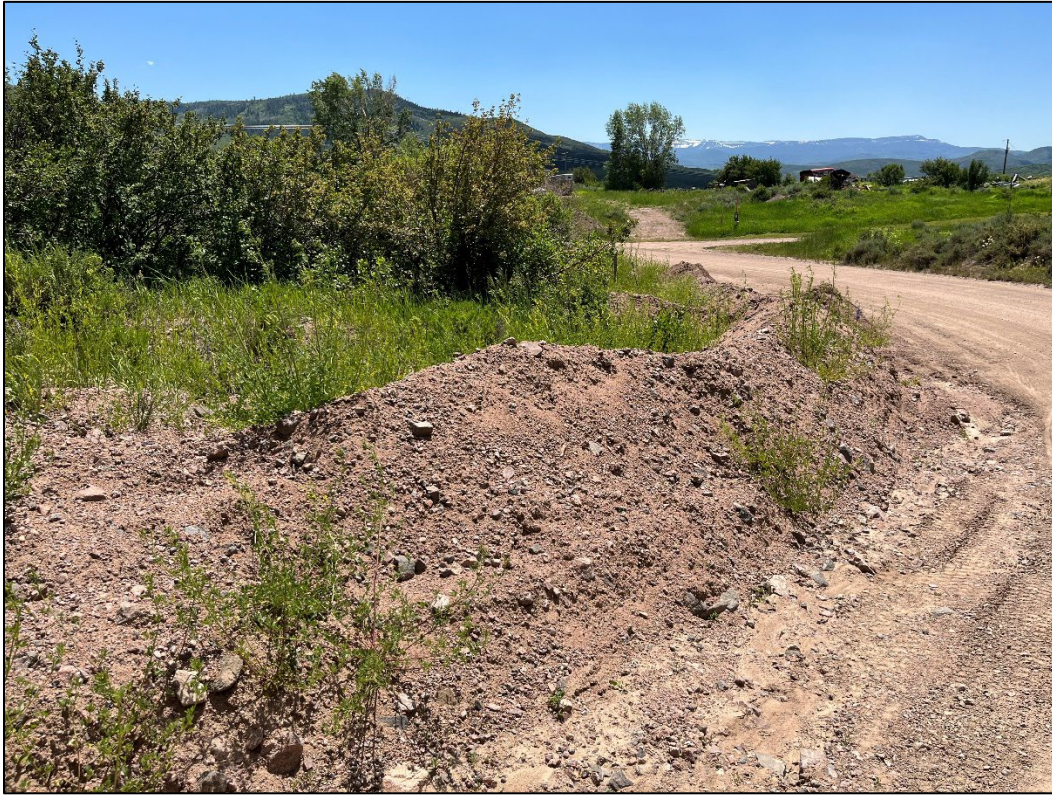
**Photo 13: A berm is in place along the bottom of the access road which leads outside of the pit boundary.**
