MINERALS PROGRAM INSPECTION REPORT

MINE NAME: Pikeview Quarry	MINE/PROSPECTING ID#: M-1977-211	MINERAL: Limestone (general), granite, granite gneiss and dolomite	COUNTY: El Paso
INSPECTION TYPE: Monitoring	WEATHER: Clear	INSP. DATE: July 18, 2023	INSP. TIME: 09:30
OPERATOR: Riverbend Industries Inc.	OPERATOR REPRESENTATIVE: Jerry Schnabel	TYPE OF OPERATION: 112c - Construction Regular Operation	
REASON FOR INSPECTION: Normal I&E Program	BOND CALCULATION TYPE: None	BOND AMOUNT: \$13,389,784.00	
DATE OF COMPLAINT: NA	POST INSP. CONTACTS: U.S.Forest Service	JOINT INSP. AGENCY: U.S.Forest Service	
INSPECTOR(S): Timothy Cazier, P.E.	INSPECTOR'S SIGNATURE:

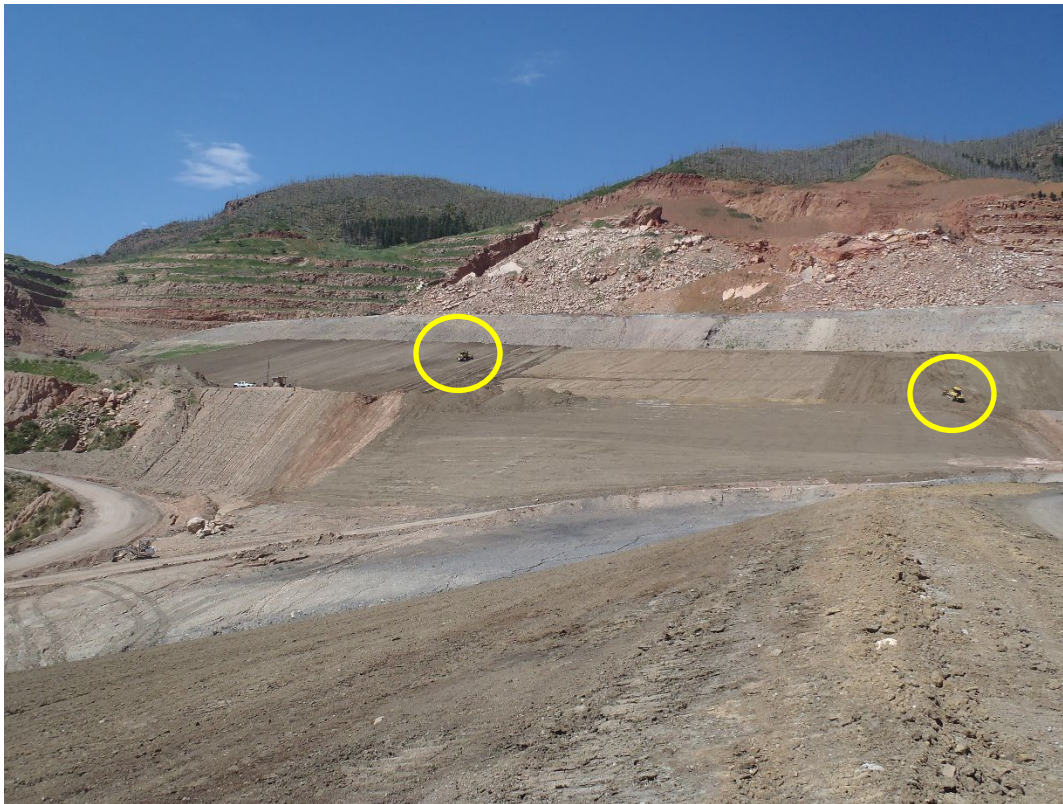
Backfilling and Grading: Dozers were observed spreading topsoil below the first bench (see **Photo 1**). Topsoil placement appeared to be complete in the former shop area (see **Photo 2**). Additional imported topsoil was observed in the topsoil stockpile area north of the office (see **Photo 3**). No active excavation was observed.

Photo 1. Dozers grading topsoil below lower backfill bench (looking SW).

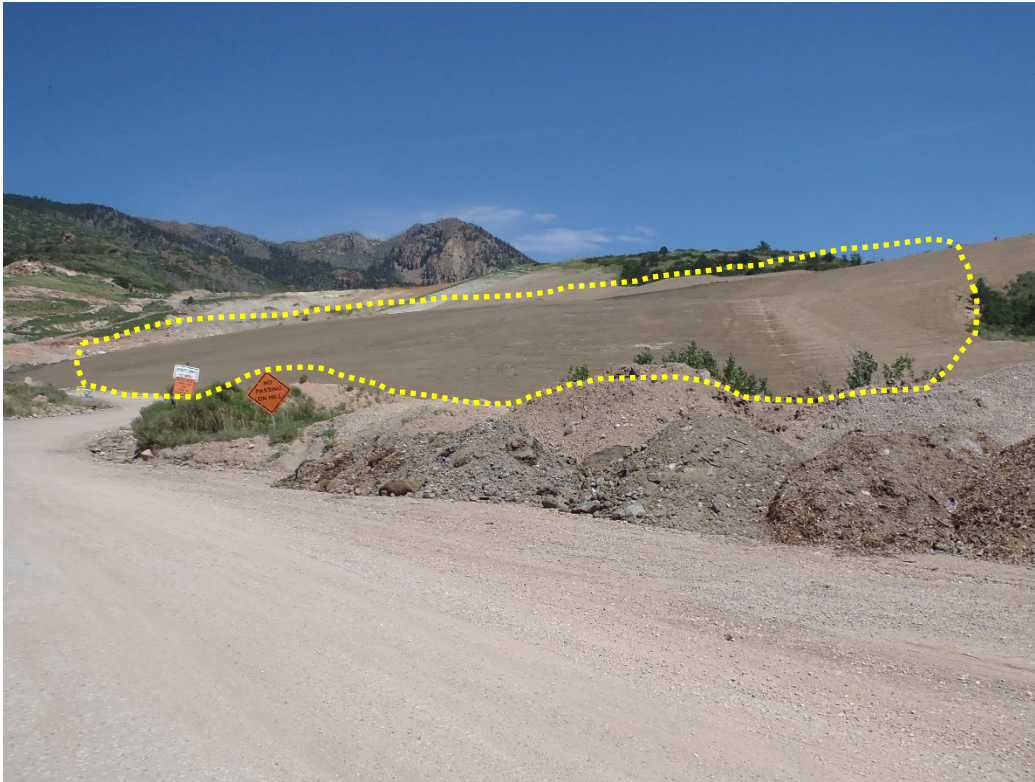
Photo 2. Placed topsoil on regraded former shop area (looking NW).

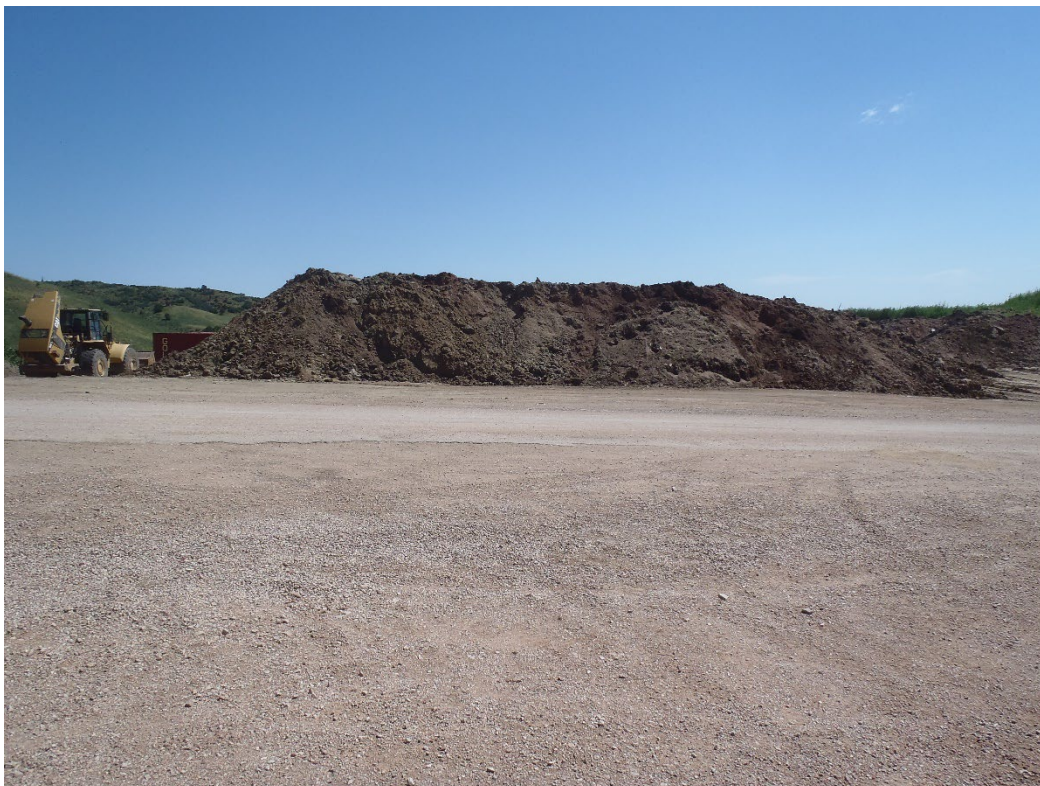
Photo 3. Additional stockpiled, imported topsoil (north of office).

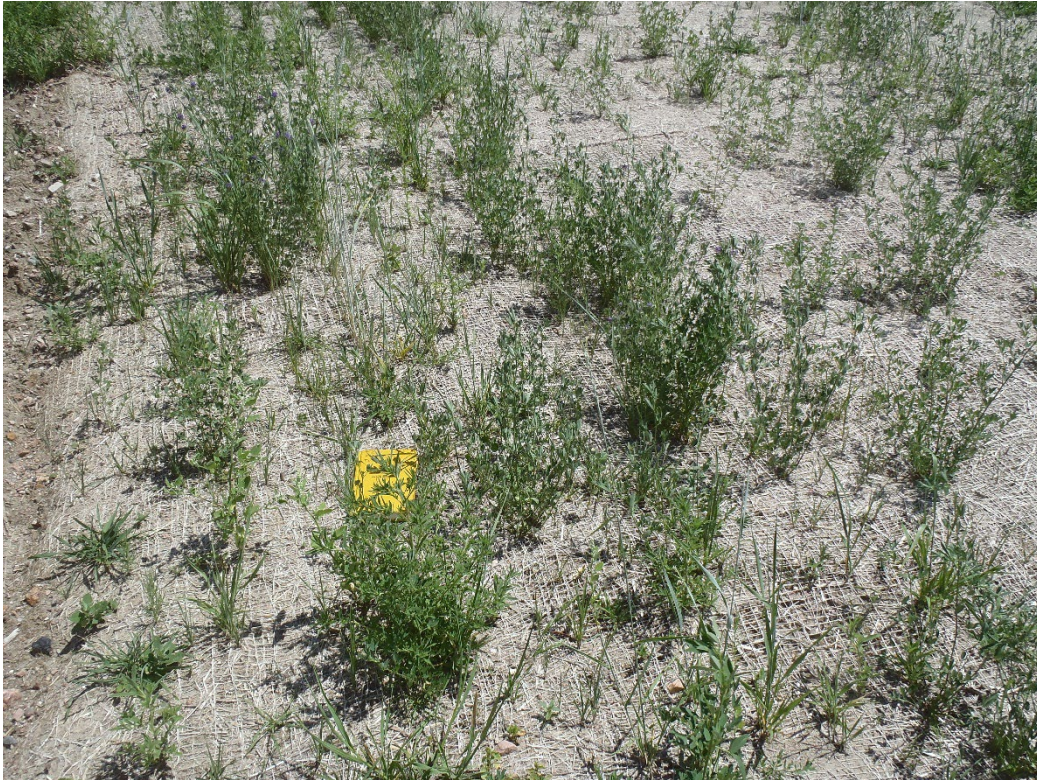
Revegetation: The DRMS inspected the plant growth emerging from the two seeded areas on the north end. The area covered with erosion control blanket (Curlex™) on the west appeared to be faring better (see **Photo 4**) than the hydromulched area (see **Photo 5**). Broadleaf plants were more dominant than grasses, but grasses were observed emerging in both areas. Scotch thistle was observed in the area near the culvert on the north end (see **Photo 6**). Most of this area will be removed as future grading for the north channel will drop the ground elevation 10 to 30 feet.

Photo 4. Emerging vegetation on Curlex™ area (yellow field book for scale).

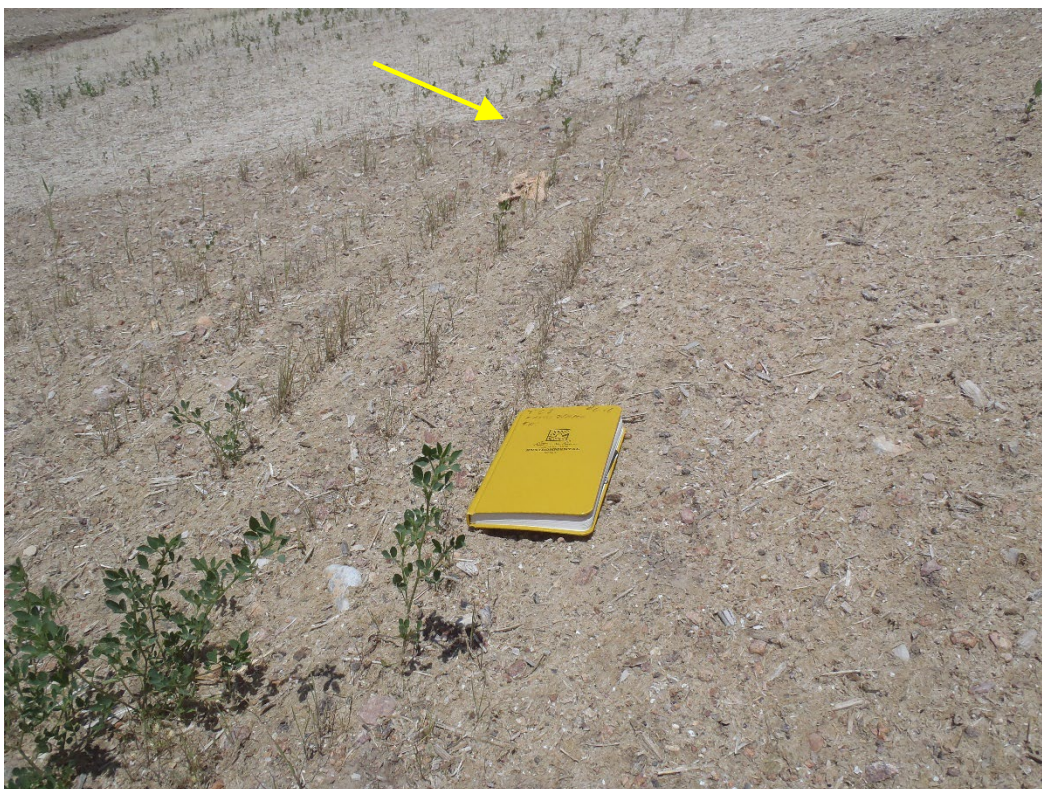
Photo 5. Emerging vegetation on hydromulched area (field book for scale, arrow indicates edge of Curlex™).

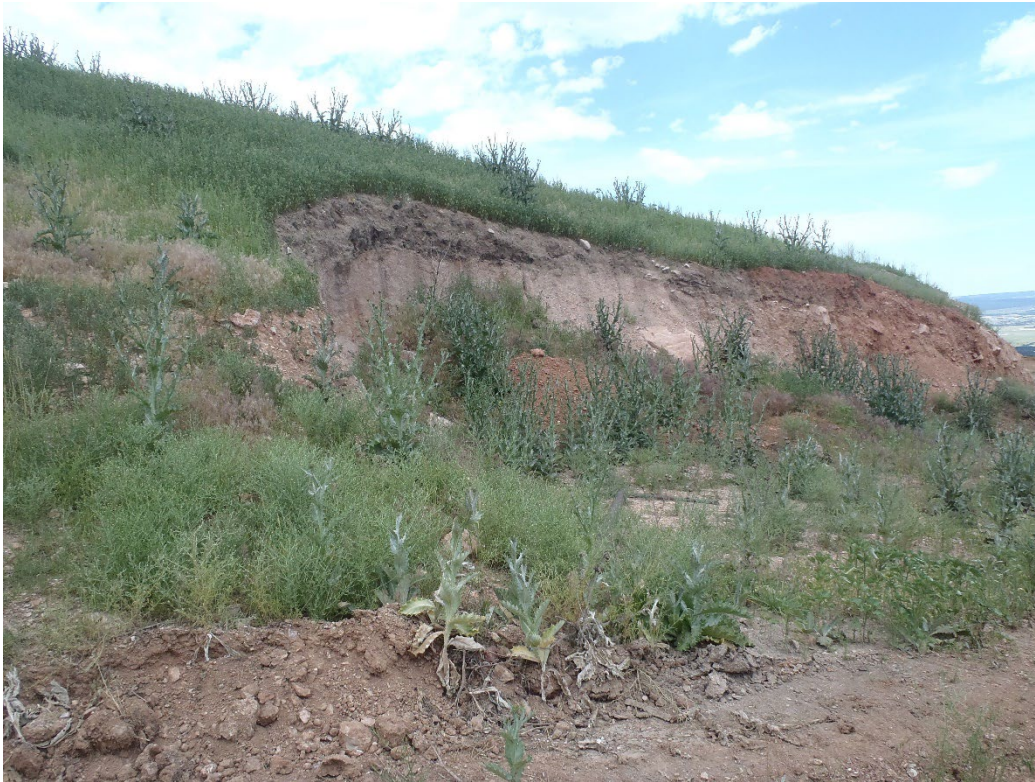
Photo 6. Scotch thistle near NW culvert (looking north at area to be regraded).

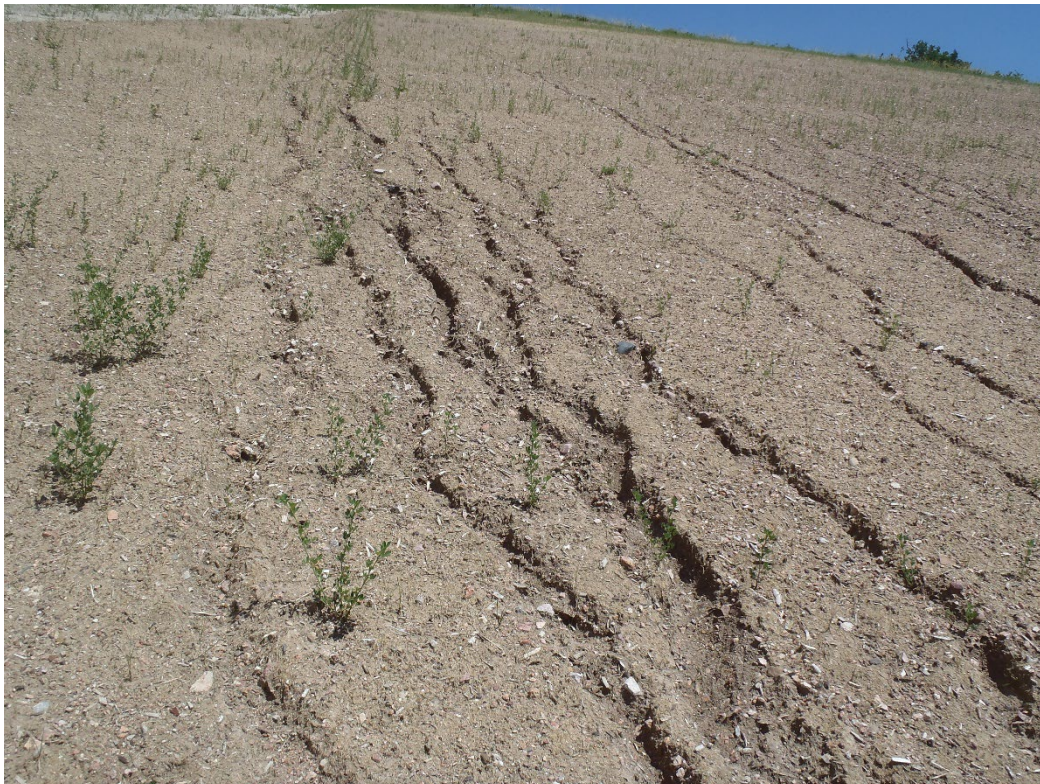
Sediment Control: Erosion rills and gullies had been repaired on the backfill lower bench slope as part of the topsoil placement. It is expected the erosion features on the upper backfill slope will be repaired as part of the topsoil placement there. Some minor erosion rills were observed in the hydromulched area (see **Photo 7**). The rills are minor but will need to be monitored and repaired if they become significant. The blocked culvert inlet had been exposed but appeared to be plugged to the top inside (see **Photo 8**). Mr. Schnabel committed to deploying some equipment to see if the former small opening at the top could be reestablished.

Photo 7. Erosion rills in hydromulch area (looking upslope) TM).

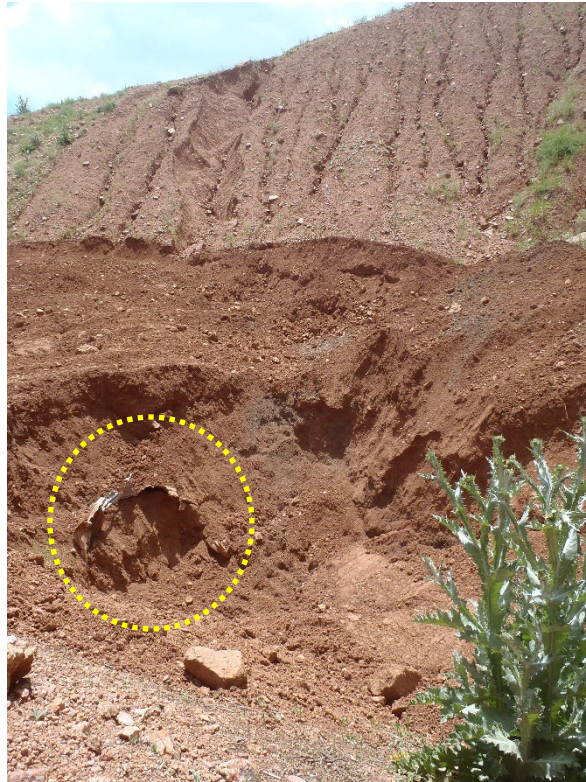
Photo 8. Re-exposed NW culvert inlet (looking SE at area to be regraded, note Scotch thistle lower left).

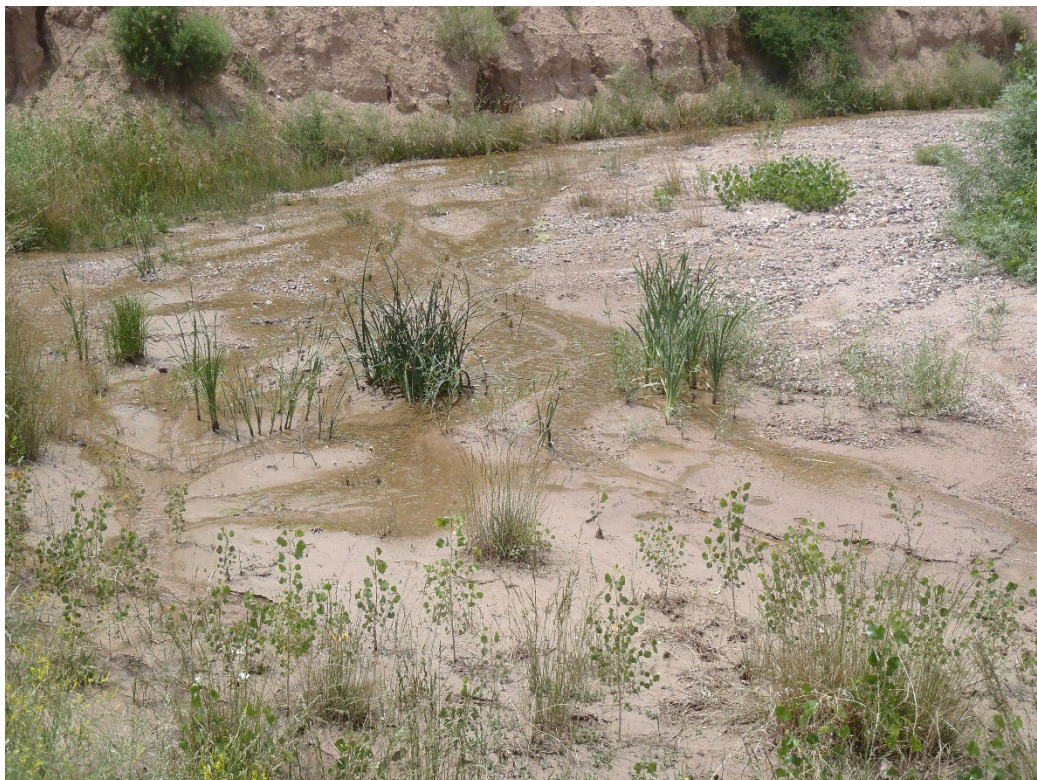
and observed to be flowing with clear water (see **Photo 9**). The status of the expected Technical Revision (TR) addressing the realignment of the stormwater drainage channels was discussed as the DRMS had not received it at the time of the inspection. Mr. Schnabel committed to seeing it get delivered to the DRMS as soon as possible.

Photo 9. Clear discharge from French drain (~350 NW of office).
