North Park Engineering & Consulting, Inc.

Subject: Geotechnical Stability Report
Fairbanks Pit (M-2003-058)
Gould, CO

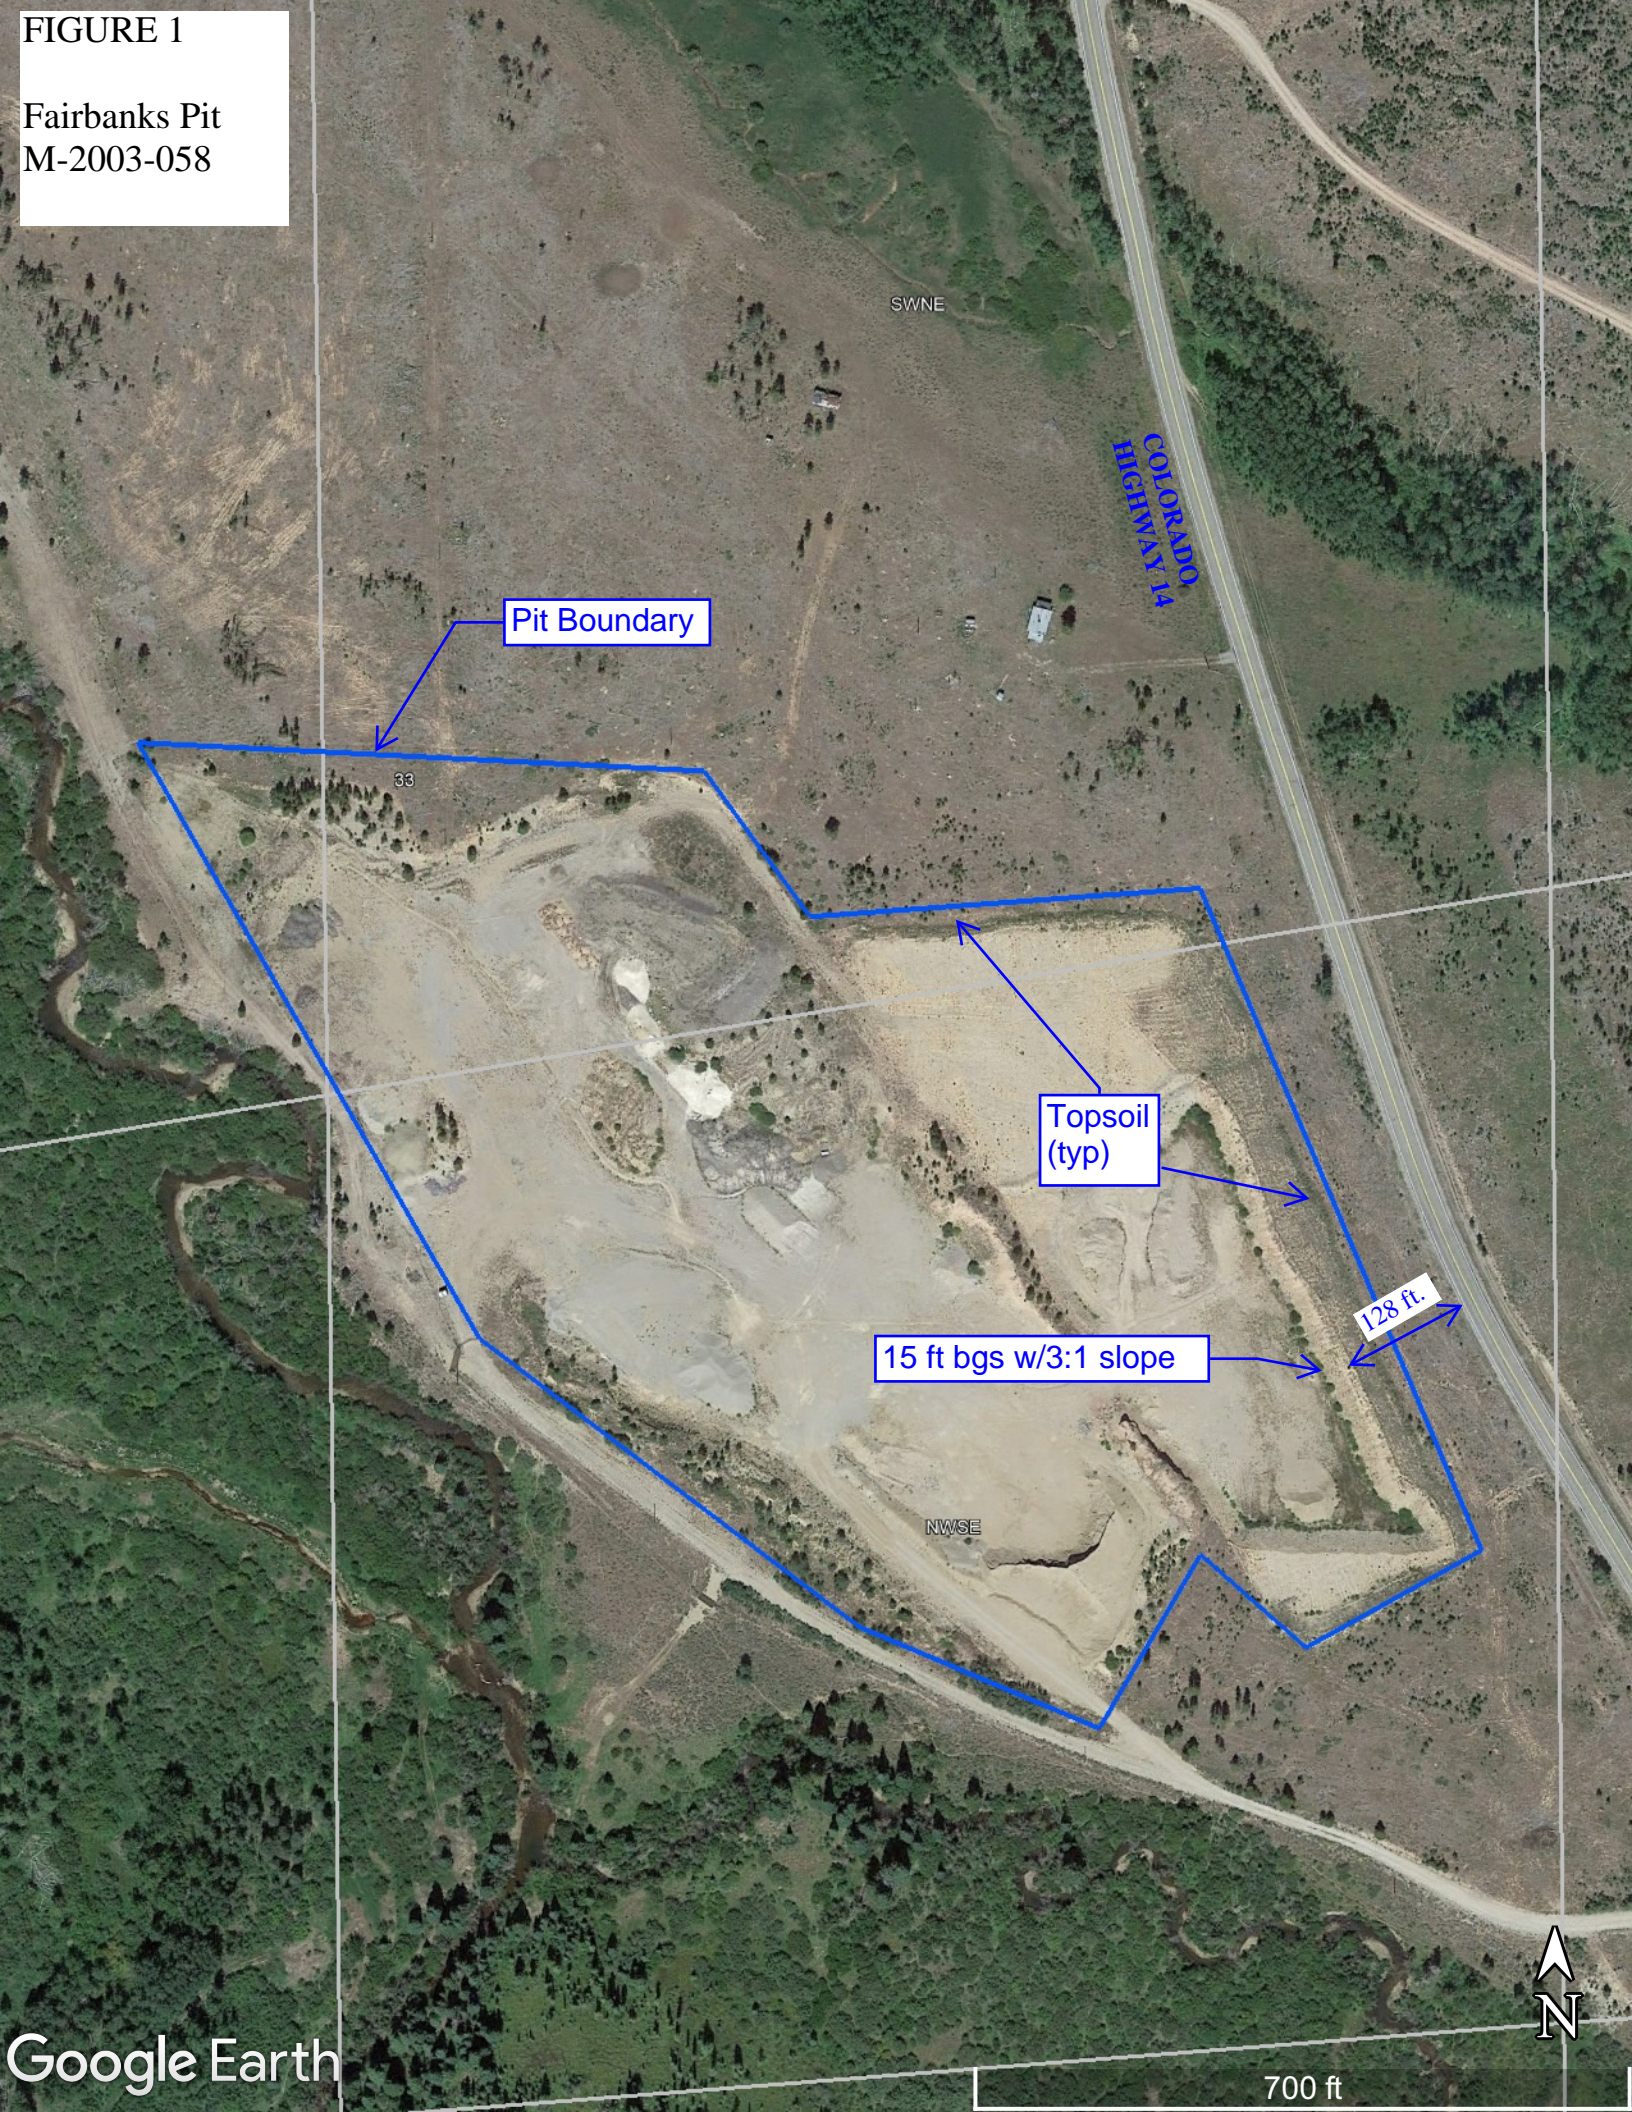
FIGURE 1

The pit is located approximately 128 feet West from the traveled road surface for Colorado State Highway 14. The depth of the pit adjacent to the highway is approximately 15 feet below the ground surface and the side slope from the bottom of the excavation is approximately 3:1 (horizontal:vertical). The topsoil from the pit area is also placed between the edge of the pit and the pit boundary. See Figure 1 for more detail.
