MINERALS PROGRAM INSPECTION REPORT
PHONE: (303) 866-3567

MINE NAME: Upland Gravel	MINE/PROSPECTING ID#: M-2001-088	MINERAL: Gravel and sand	COUNTY: Mesa
INSPECTION TYPE: Monitoring	WEATHER: Clear	INSP. DATE: July 5, 2023	INSP. TIME: 14:30
OPERATOR: Upland Gravel, LLC	OPERATOR REPRESENTATIVE: Jason Rinderle	TYPE OF OPERATION: 112c - Construction Regular Operation	
REASON FOR INSPECTION: Normal I&E Program	BOND CALCULATION TYPE: Complete Bond	BOND AMOUNT: \$61,304.40	
DATE OF COMPLAINT: NA	POST INSP. CONTACTS: DRMS	JOINT INSP. AGENCY: None	
INSPECTOR(S): Amy Yeldell	INSPECTOR'S SIGNATURE: <i>Amy Yeldell</i>	SIGNATURE DATE: July 21, 2023

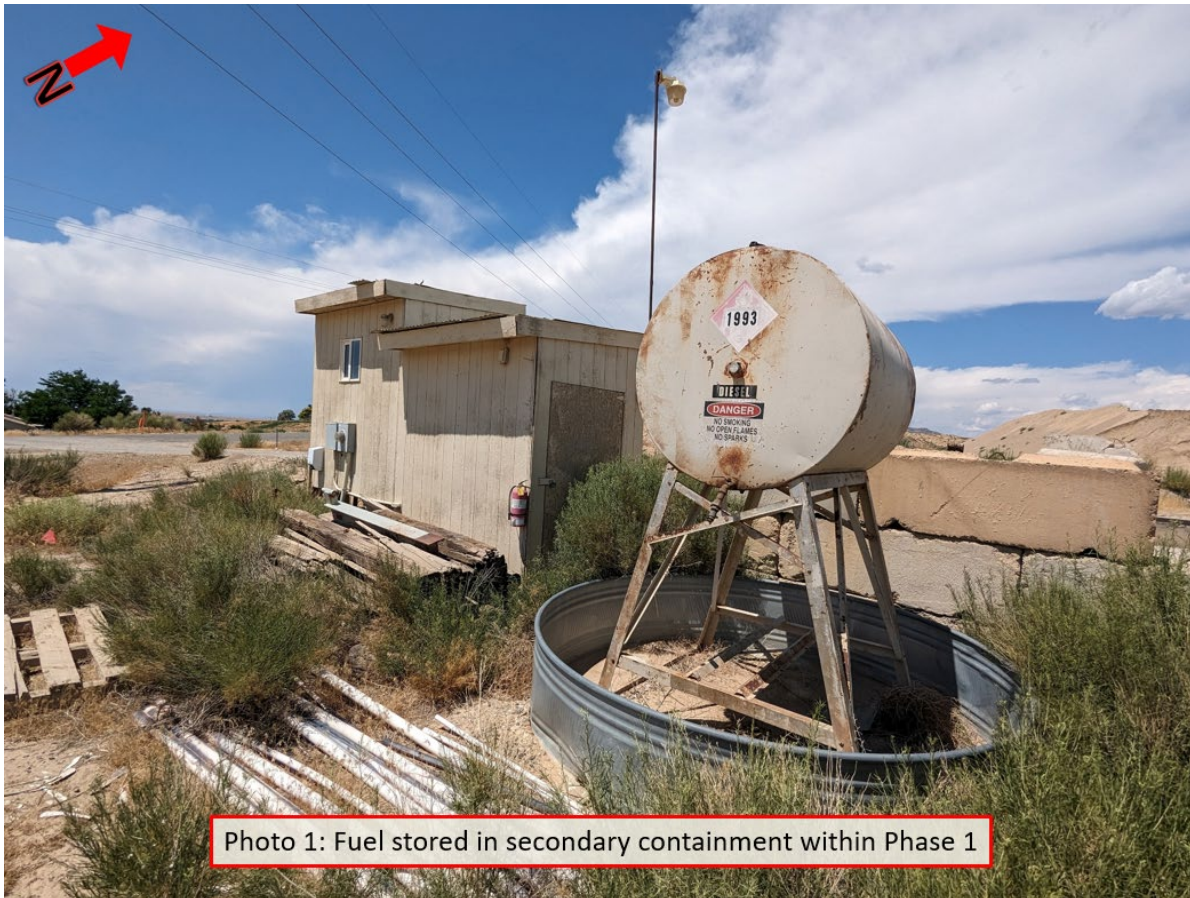
All fuel is stored within secondary containment (Photo One). The fuel storage is located in Unit 1 adjacent to the scale. No other hazardous or toxic materials were observed on site.

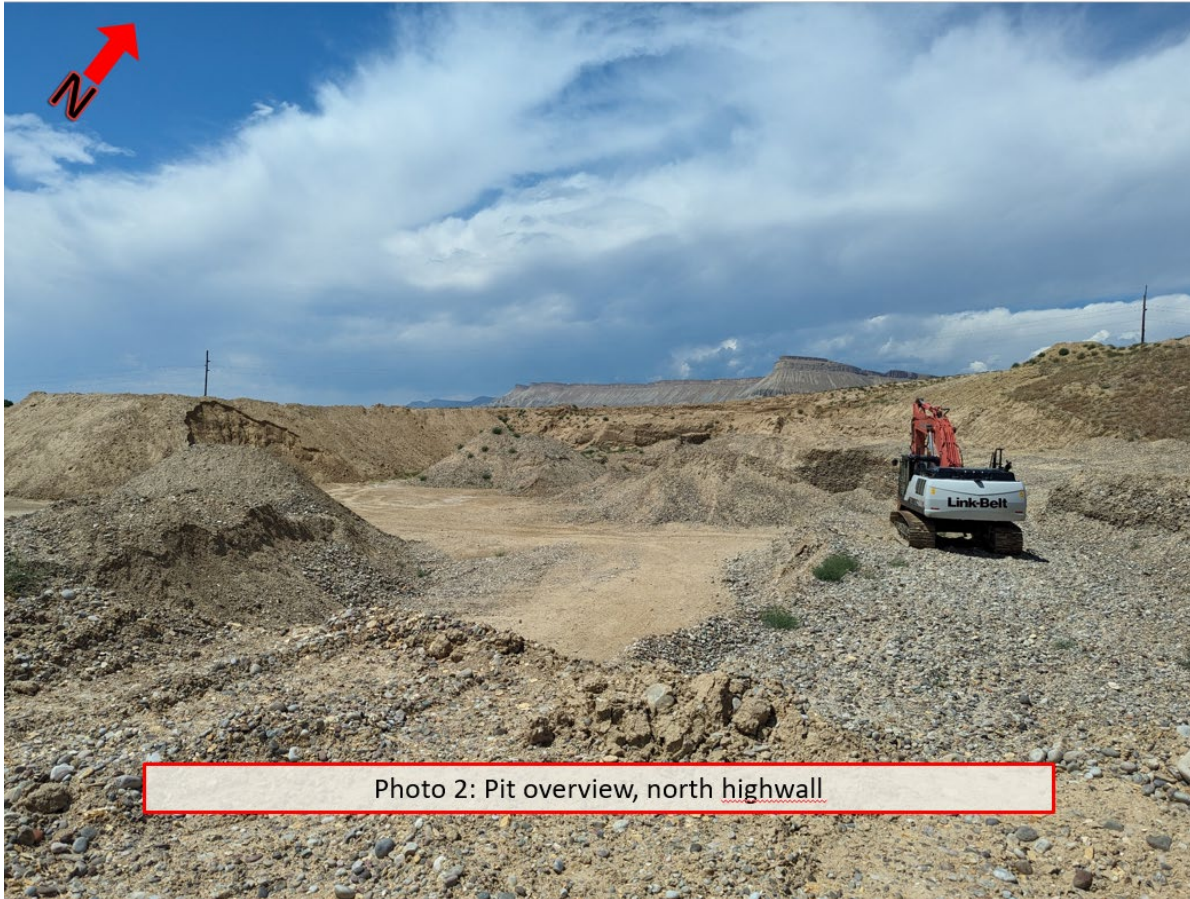
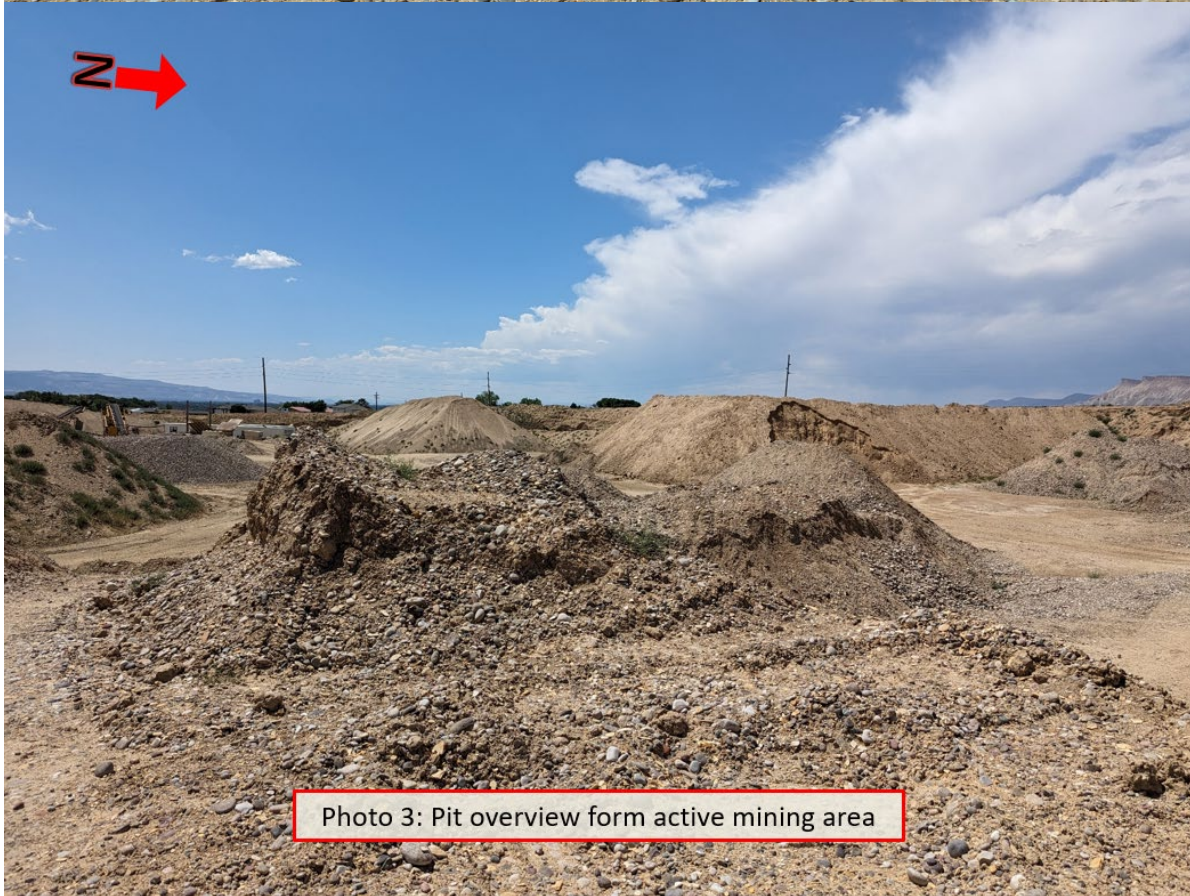
The reclaimed area includes portion within Units 1,3, 4, 5, 6 and 7. This area has gentle slopes that are no steeper than a 3H:1V. All other mining slopes are approximately 1H: 1V and average 28 feet high. Staff estimates that 1600 LF of highwall requires regrading. Most grading on site can be cut/fill with limited amounts of backfill adjacent to the permit boundary (Photos Two and Three). The south and east slopes will daylight out.

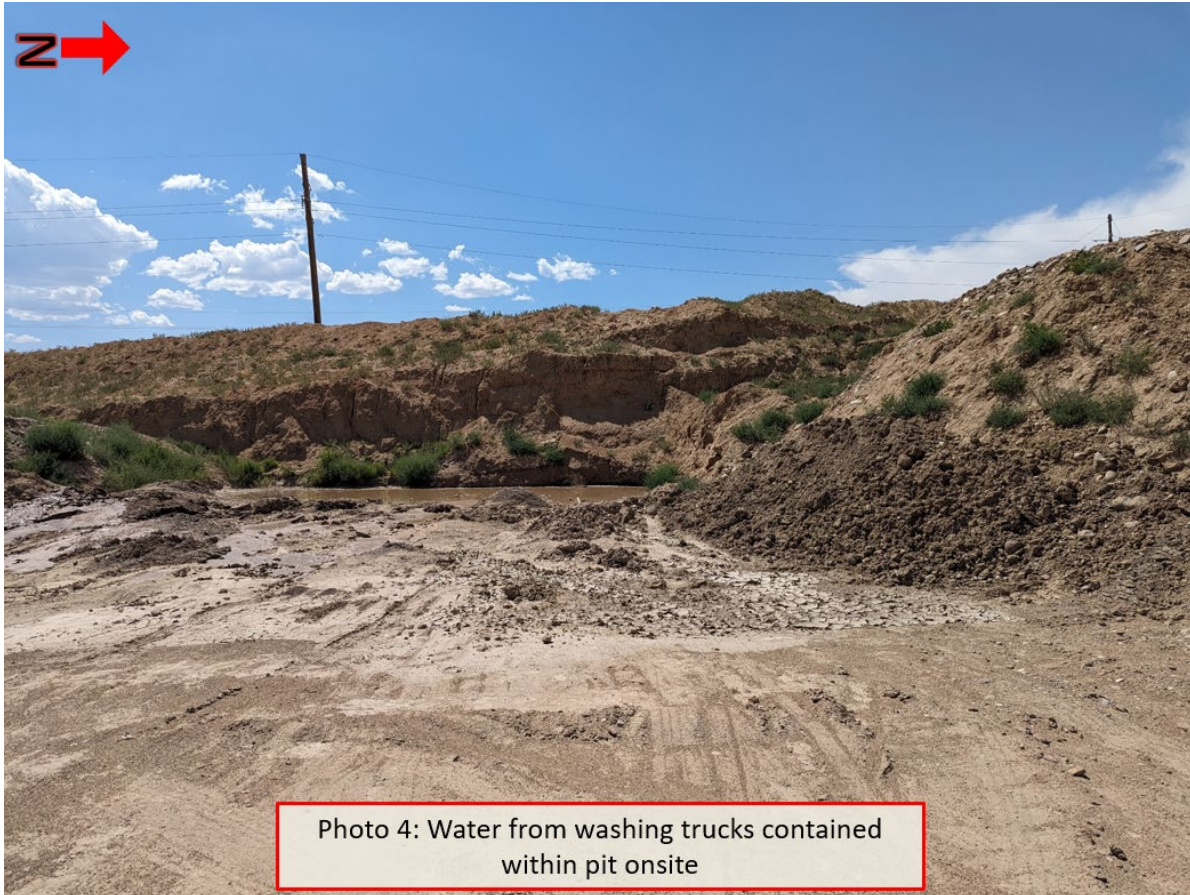
This pit is located above the water table. There is a riparian area within the permit boundary but outside of the affected lands on the southeast side. According to Mr. Rinderle some water does infiltrate from the northern highwalls which are adjacent to irrigated croplands. This water infiltrates within the pit and does not discharge. A small amount of water was observed on the western side of the pit, where trucks are washed out into and excavated pit (Photo Four).

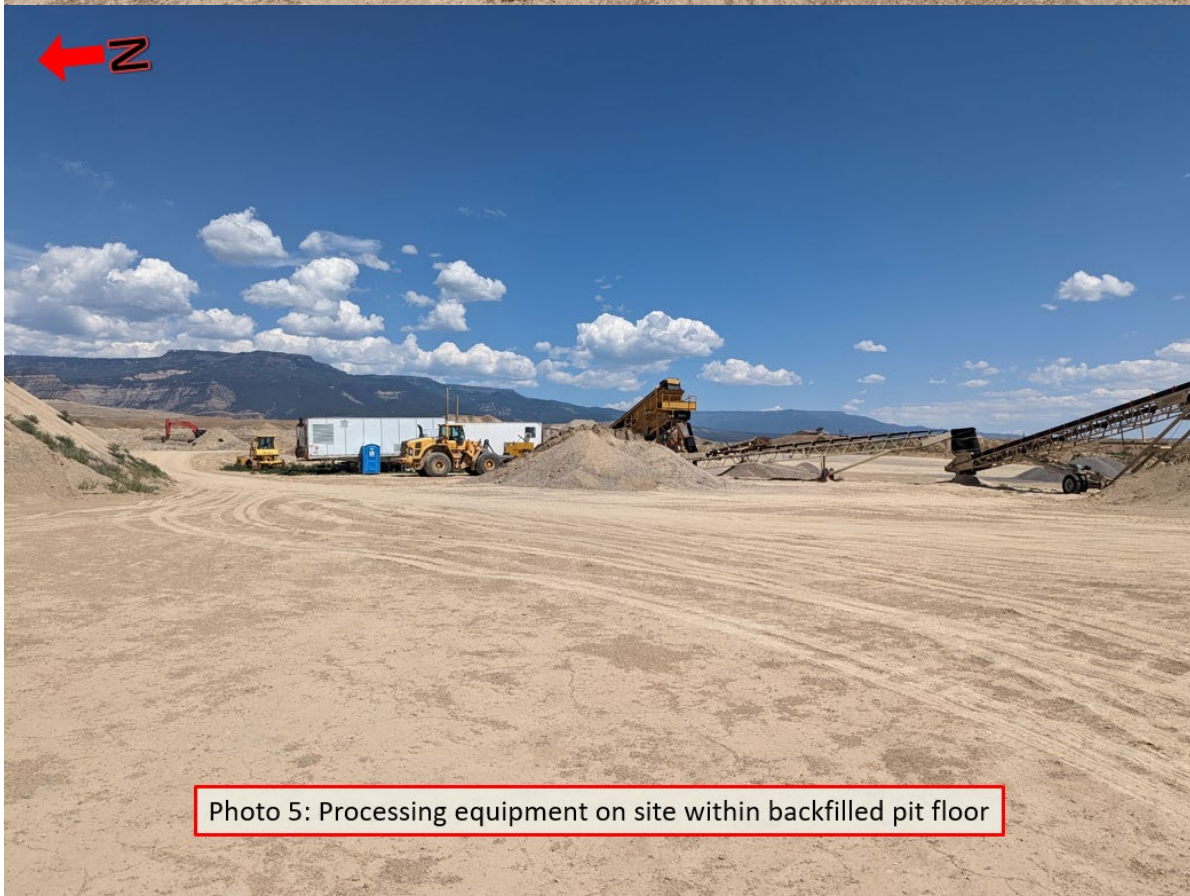
The site was inactive at the time of the inspection however evidence of recent activity was observed. The site is nearly mined out to the north. Future mining is to the northeast in Unit 9. A crusher and loader were on site (Photo Five). This site only conducts crushing and screening operations, no washing of material.

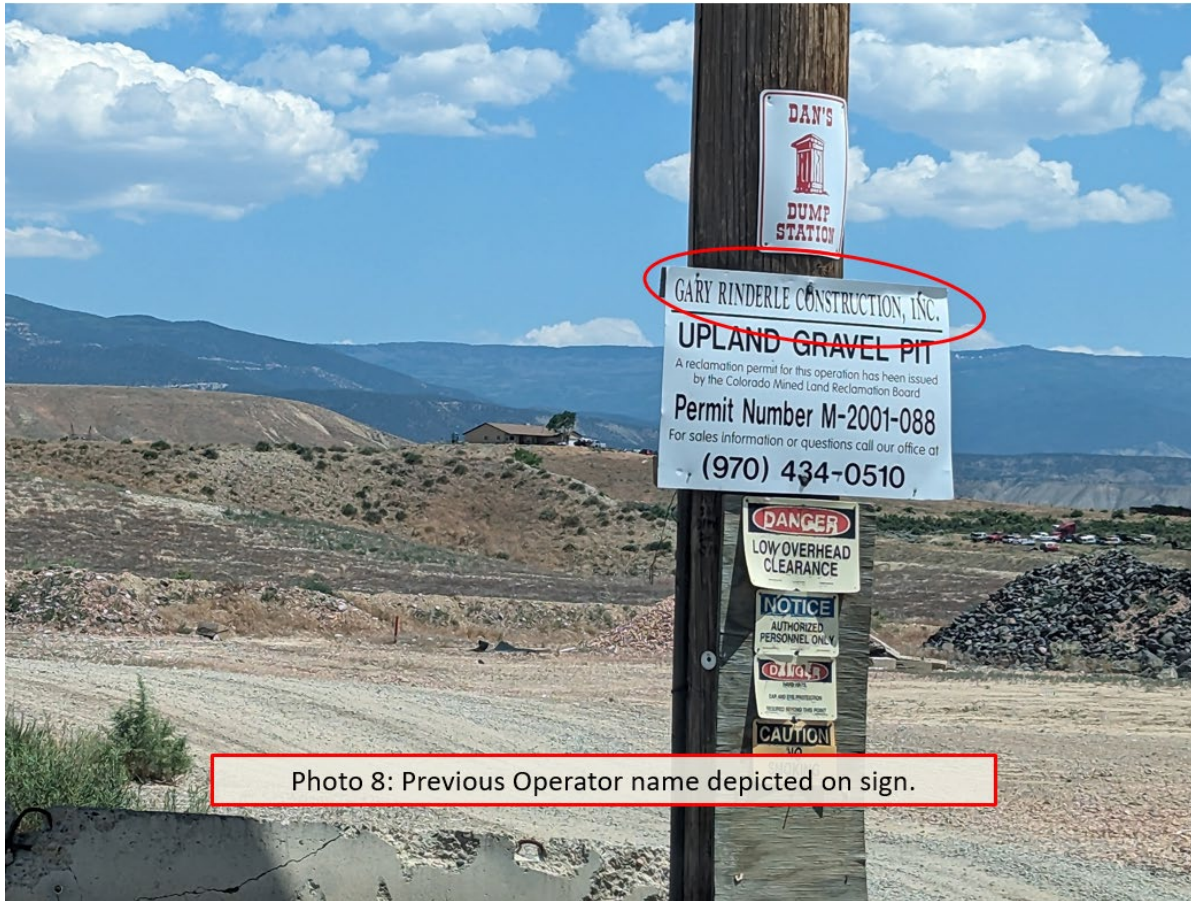
PROBLEM: The mine identification sign posted at the entrance of the mine site depicted incorrect information. This is a problem for failure to post a mine identification sign as required by Section 3.1.12(1) of the rule. The Operator shall, at the entrance of the mine site post a sign, which shall be clearly visible from the access road, with a minimum size equaling one hundred and eighty-seven (187) square inches, such as eleven (11) inches in height and seventeen (17) inches in width, with appropriate font size, with the following: the name of the Operator, a statement that a reclamation permit for the operation has been issued by the Colorado Mined Land Reclamation Board; and the permit number.

A mine sign was posted at the entrance to the mine site as required by Rule 3.1.12(1). The information depicted was incorrect, the Operator is now Upland Gravel, LLC (Photo Seven). This is cited as an inspection problem pursuant to Rule 3.1.12(1). Please update the mine sign and send in photographic documentation by the corrective action due date. The permit boundary of the affected land was clearly delineated by a wire fence and fence posts pursuant to Rule 3.1.12(2).

Photo 8: Previous Operator name depicted on sign.

CORRECTIVE ACTIONS: The operator shall, at the entrance of the mine site, post a sign which shall be clearly visible from the access road with the following: the name of the operator, a statement that a reclamation permit for the operation has been issued by the Colorado Mined Land Reclamation Board; and the permit number. The operator shall submit photo documentation that a proper sign has been posted by the corrective action date.
