**MINERALS PROGRAM INSPECTION REPORT**  
**PHONE: (303) 866-3567**

<b>MINE NAME:</b> East Sand Canyon Mine	<b>MINE/PROSPECTING ID#:</b> M-2023-021	<b>MINERAL:</b> Sand and gravel and material for construc	<b>COUNTY:</b> Baca
<b>INSPECTION TYPE:</b> Preoperation Inspection	<b>WEATHER:</b> Clear	<b>INSP. DATE:</b> July 19, 2023	<b>INSP. TIME:</b> 11:30
<b>OPERATOR:</b> W.F. Ratliff	<b>OPERATOR REPRESENTATIVE:</b> Dude Ratliff	<b>TYPE OF OPERATION:</b> 110c - Construction Limited Impact	
<b>REASON FOR INSPECTION:</b> Preoperation Inspection	<b>BOND CALCULATION TYPE:</b> None	<b>BOND AMOUNT:</b> \$0.00	
<b>DATE OF COMPLAINT:</b> NA	<b>POST INSP. CONTACTS:</b> None	<b>JOINT INSP. AGENCY:</b> None	
<b>INSPECTOR(S):</b> Brock Bowles	<b>INSPECTOR'S SIGNATURE:</b>

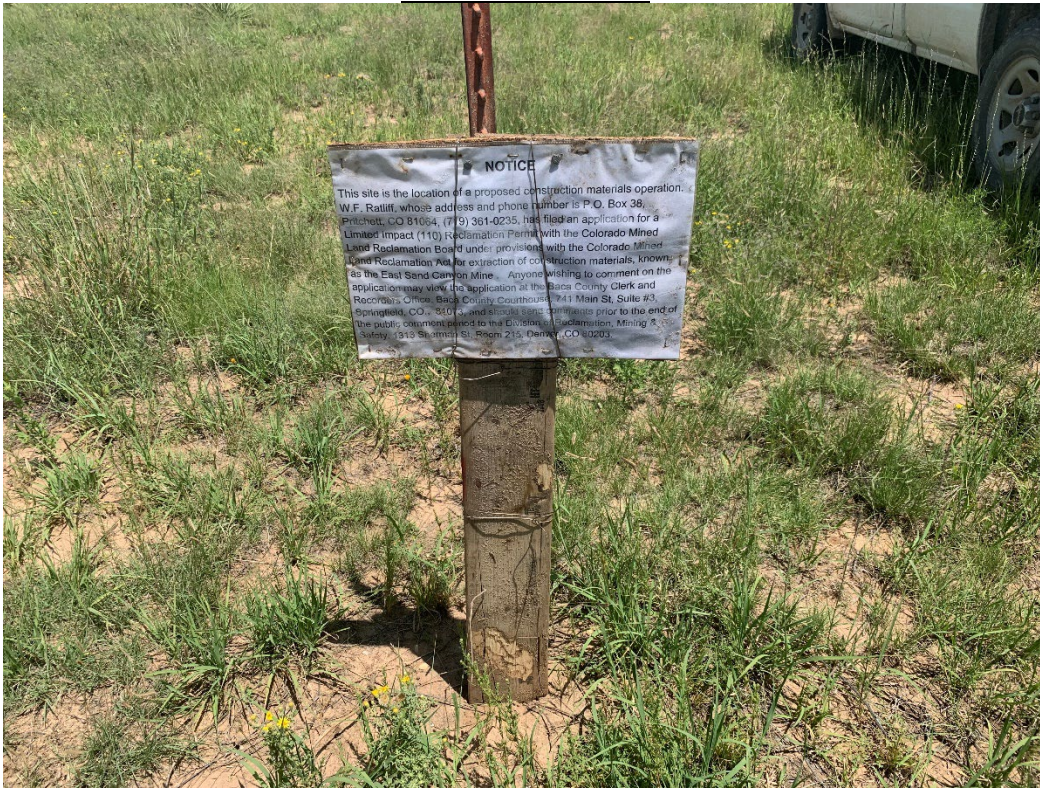
The notice sign required by 1.6.2(1)(b) was in place at the mine entrance (photo 1) and was facing CR G. The mine site is accessed from an existing ranch road off CR G. A gate was in place through the fence along CR G. The 4 permit boundary corners were clearly marked with t-posts (photo 2). The position of the posts were consistent with GPS coordinates given in the application.

Photo 1 – Mining application notification sign facing CR G

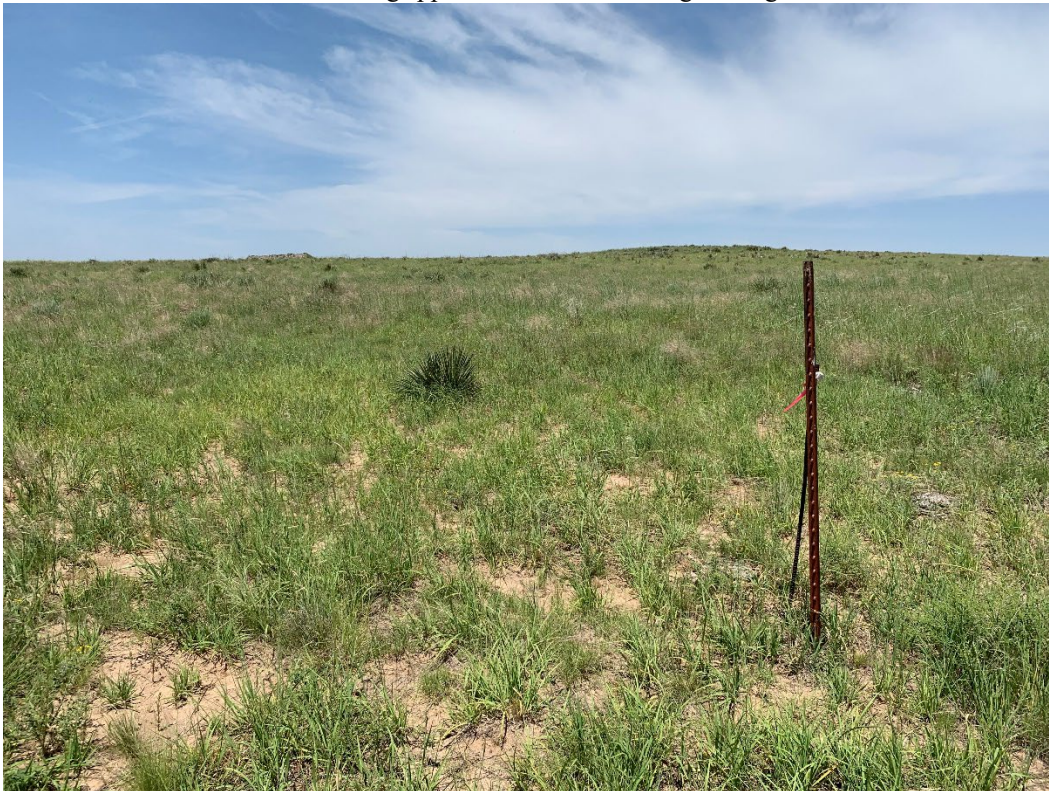
Photo 2 – Southeast corner post facing northwest

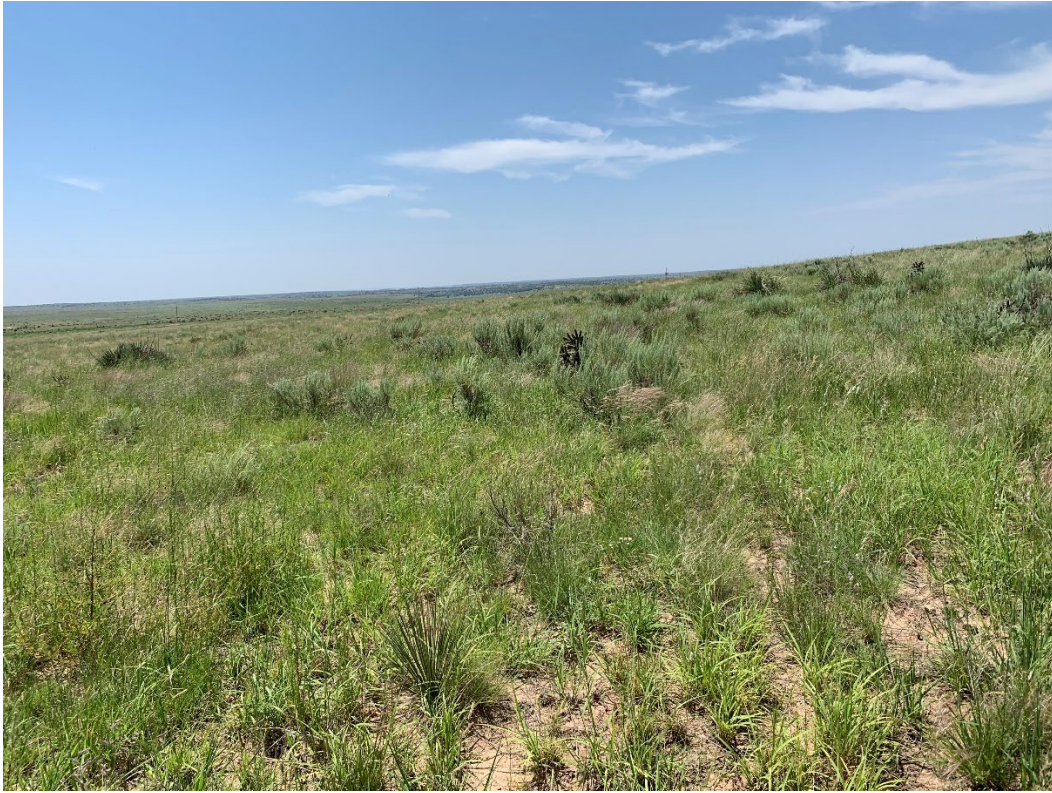
The site is situated on top of a small knoll/hill that gently slopes to the southeast (photo 3). The hill was covered with vegetation and no disturbance, mining or large erosion features were seen. The current land use is rangeland which is consistent with the surrounding landscape. The proposed post mining land use is also rangeland.

Photo 3 – Looking south from the northern boundary.

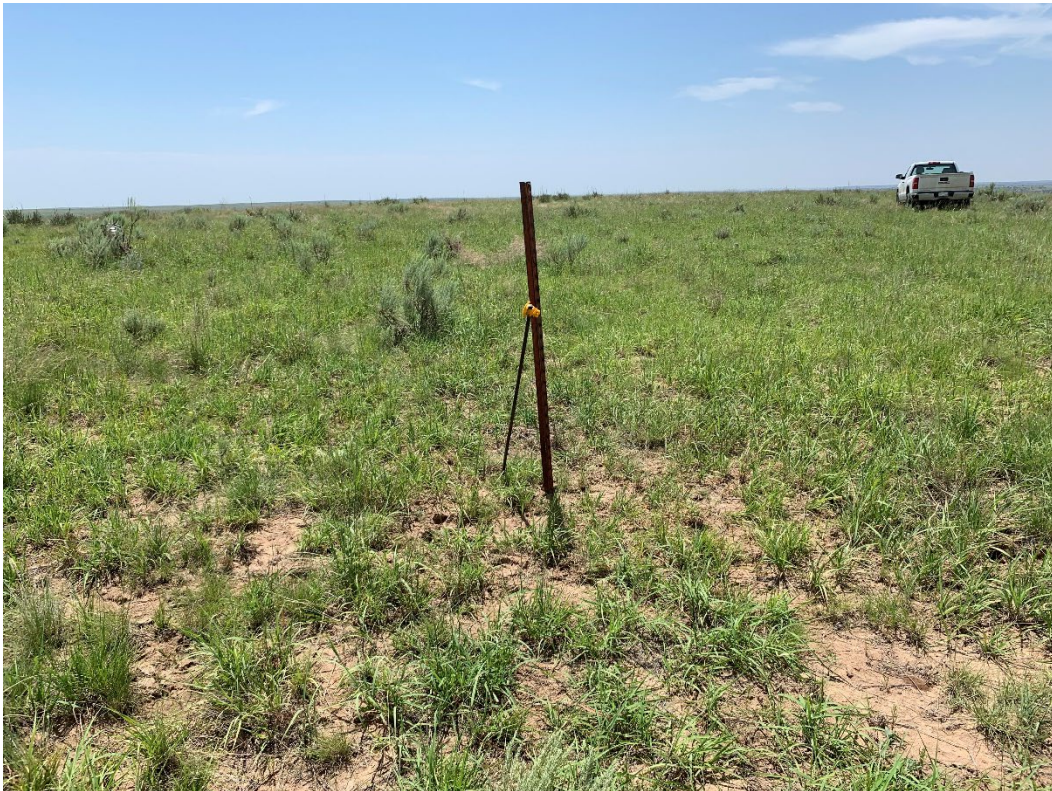
The site did not contain any water drainages, stock dams or water features. The proposed site is higher than the surrounding landscape and does not appear that it will interfere with any surface water drainages (photo 4).

Photo 4 – Northwest corner facing south.

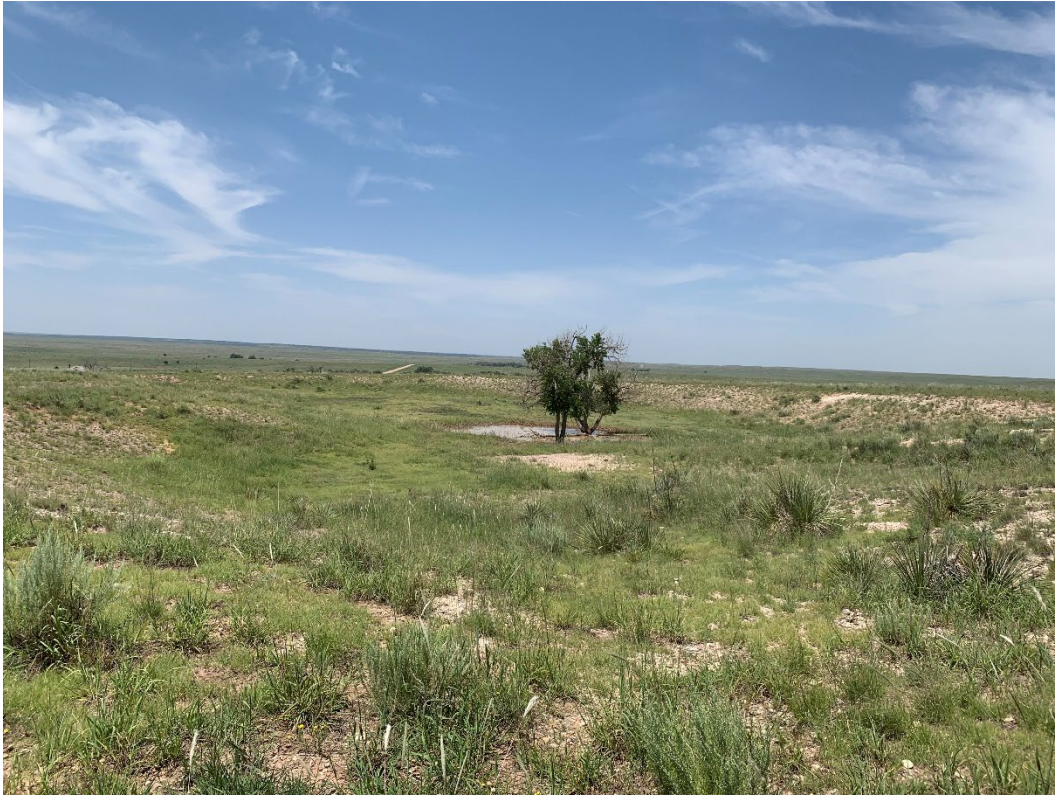
Immediately to the west of the proposed permit area is the former Gravel Pit #23, M-1985-100. This site was terminated in 2007. The site contains a reclaimed pit area and a stone stockpile (photo 5). Mr. Ratliff was informed that this area cannot be mined as part of the permitted East Sand Canyon operation until it is permitted at a future date. He was also informed that material from the #23 pit can be used for his private ranching/farming operation as long as the material does not leave the contiguous piece of land.

Photo 5 – Former Gravel Pit #23 immediately west of East Sand Canyon Pit
