**MINERALS PROGRAM INSPECTION REPORT**  
**PHONE: (303) 866-3567**

<b>MINE NAME:</b> Hartman Pit	<b>MINE/PROSPECTING ID#:</b> M-1997-087	<b>MINERAL:</b> Gravel	<b>COUNTY:</b> Pueblo
<b>INSPECTION TYPE:</b> Surety Release Inspection	<b>WEATHER:</b> Clear	<b>INSP. DATE:</b> June 29, 2023	<b>INSP. TIME:</b> 08:30
<b>OPERATOR:</b> Arnolds Custom Seeding, LLC	<b>OPERATOR REPRESENTATIVE:</b> Shawn Hesse	<b>TYPE OF OPERATION:</b> 112c - Construction Regular Operation	
<b>REASON FOR INSPECTION:</b> Surety Release Requested	<b>BOND CALCULATION TYPE:</b>	<b>BOND AMOUNT:</b> \$22,707.00	
<b>DATE OF COMPLAINT:</b> NA	<b>POST INSP. CONTACTS:</b> None	<b>JOINT INSP. AGENCY:</b> Colo. Land Board	
<b>INSPECTOR(S):</b> Amber Michels	<b>INSPECTOR'S SIGNATURE:</b>

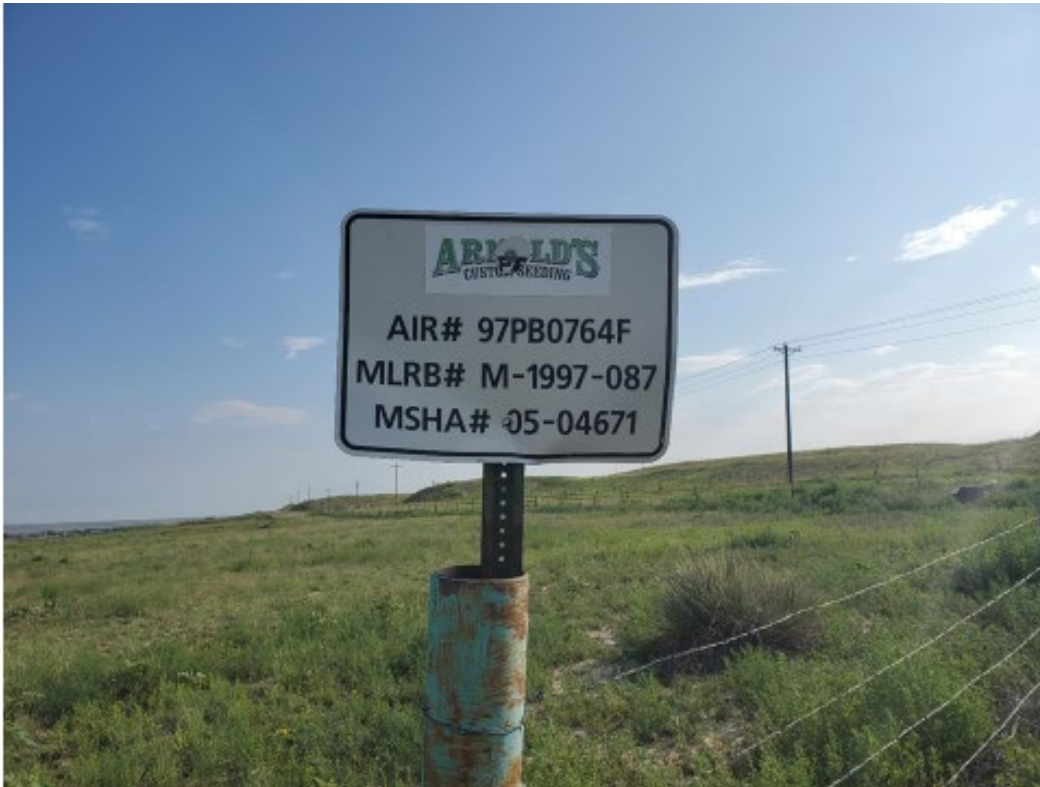
A mine sign was posted at the entrance to the site in compliance with Rule 3.1.12 (Photo 1: Map 1).

**Photo 1:** Looking north-west at the mine sign posted at the entrance to the site.

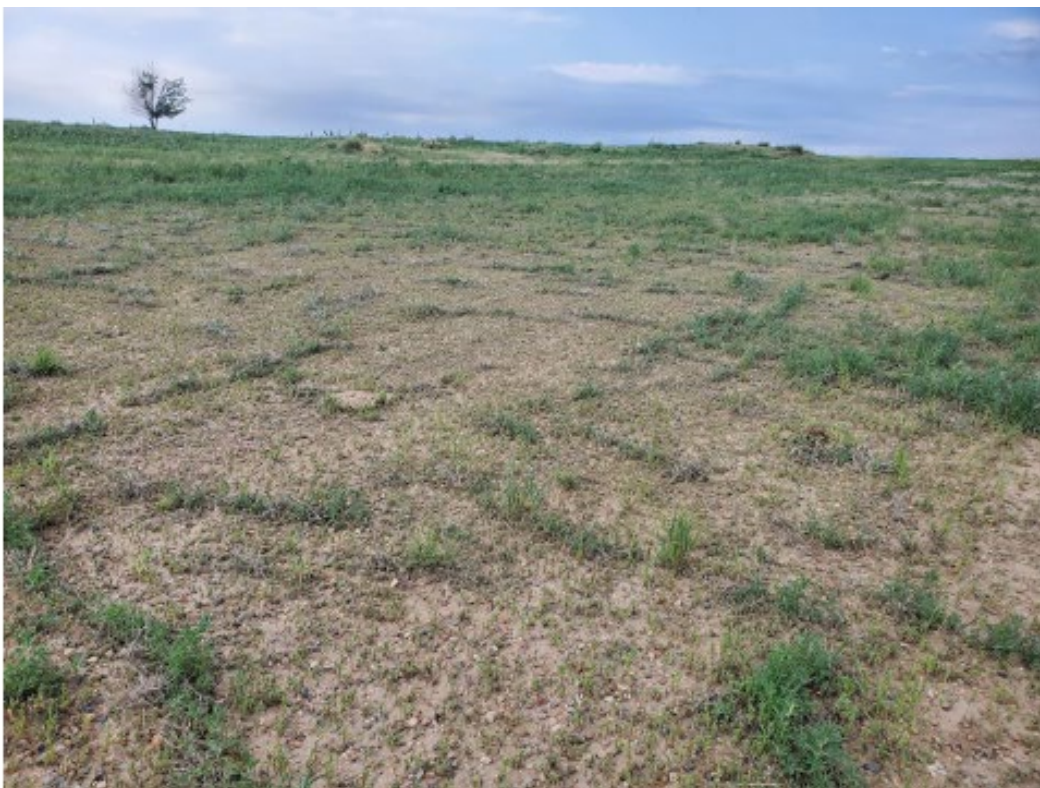
Overall, this area still is not as heavily occupied by established vegetation as its surroundings, but it does represent a diverse mixture of vegetation. The south-west portion of the 19-acre area (Photos 14-21) contains a higher density of vegetation than the eastern portion (Photos 2-13), but the area on a whole shows a stark improvement over the past few years. The State Land Board and the Division are in agreement that the site has acceptable reclamation on a whole, and the Division will **approve** the Operator's Surety Release request.

**Photo 2:** Looking west across the site from the eastern side of the 19-acre area.

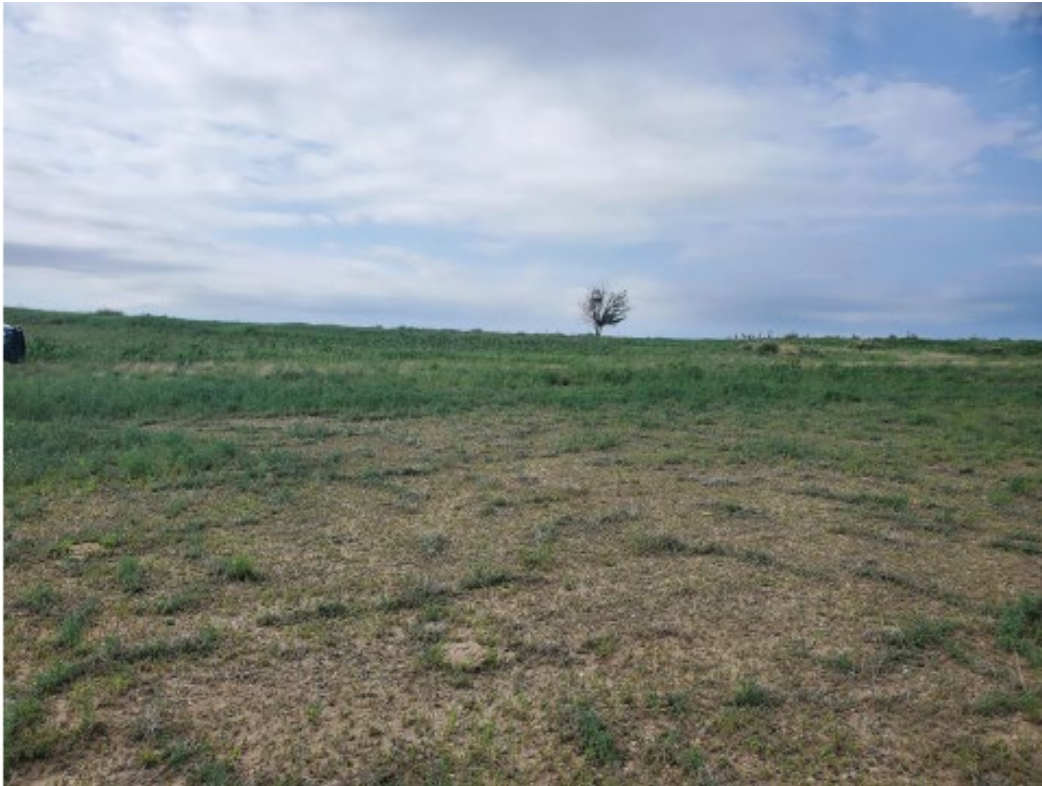
**Photo 3:** Looking south-west across the site from the east side of the 19 acre area.

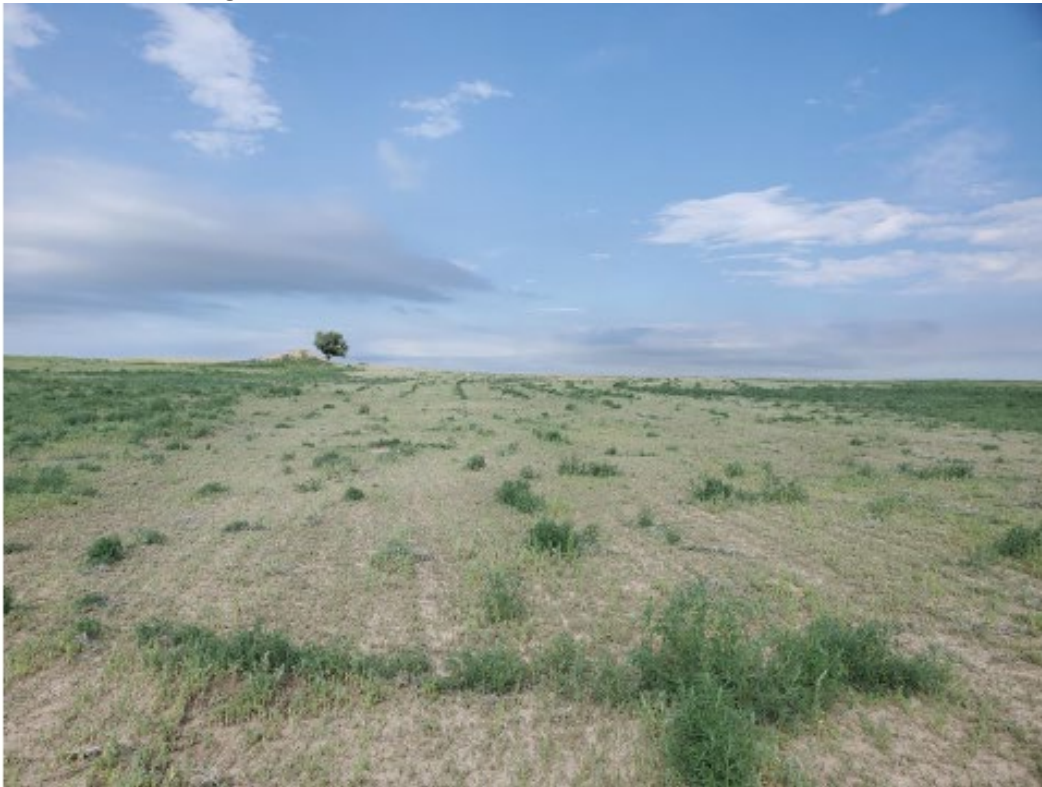
**Photo 4:** Looking west across a portion of the 19 acre area that had been bare during the previous inspection.

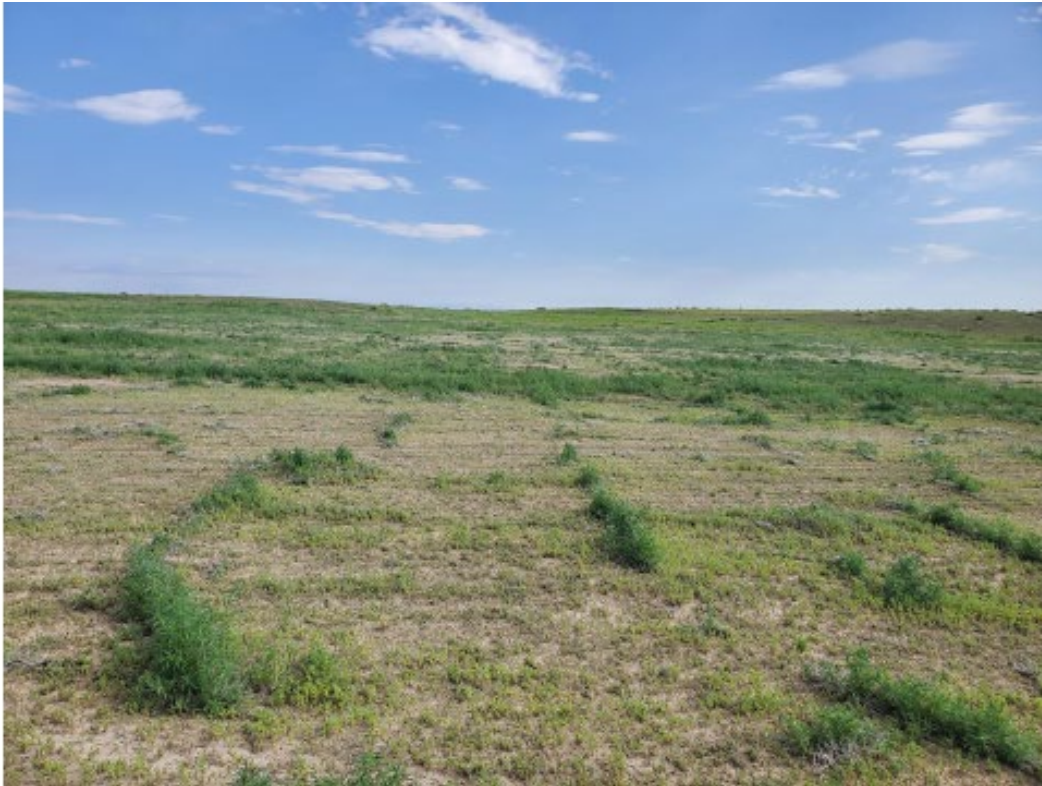
**Photo 5:** Looking north across a portion of the 19 acre area that had been bare during the previous inspection.

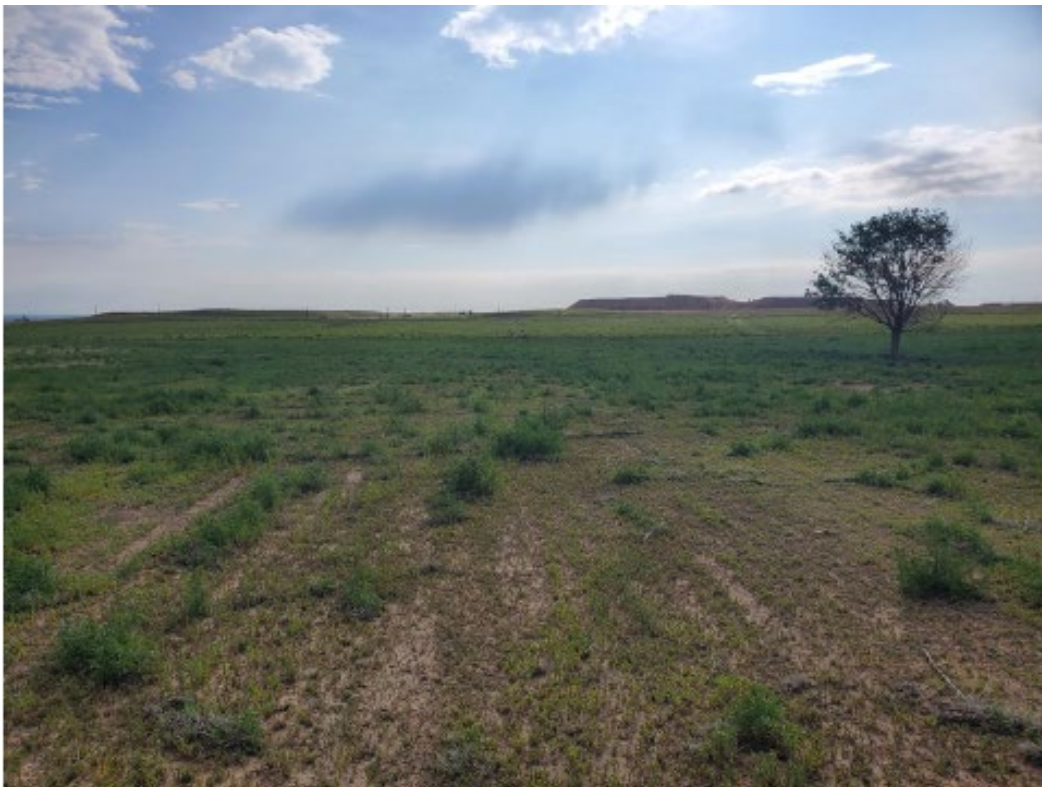
**Photo 6:** Looking east across a portion of the 19 acre area that had been bare during the previous inspection.

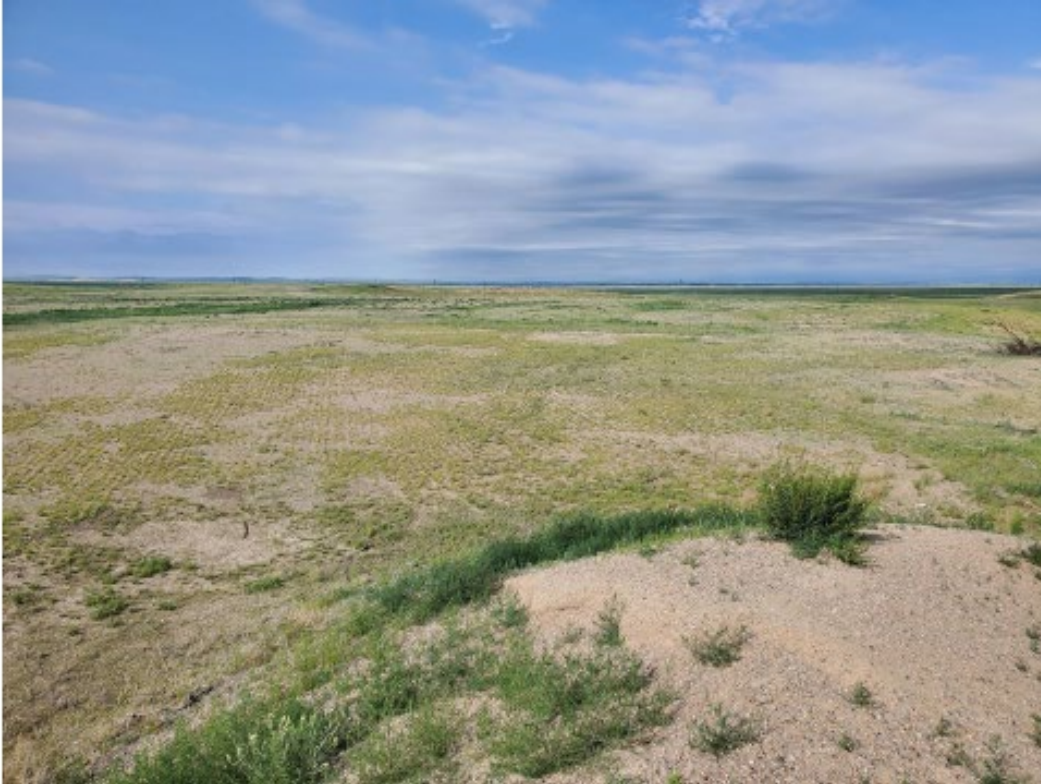
**Photo 7:** Standing on-top of a stockpile approved to remain, looking west across the site.

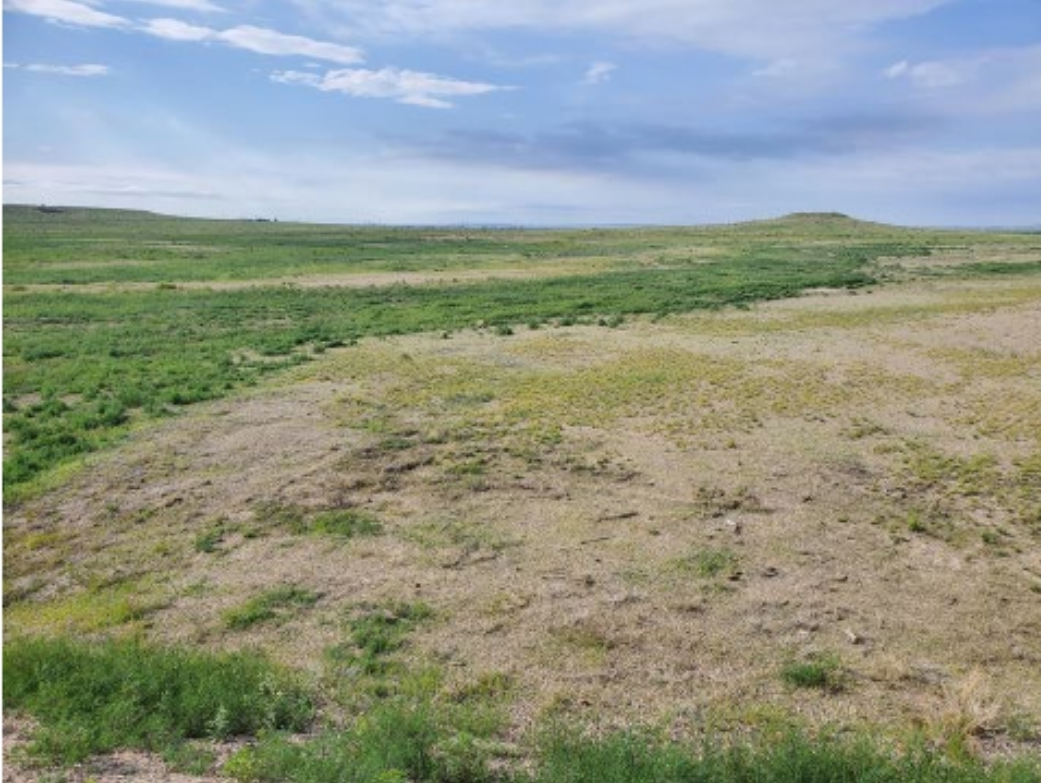
**Photo 8:** Standing on-top of a stockpile approved to remain, looking south-west across the site.

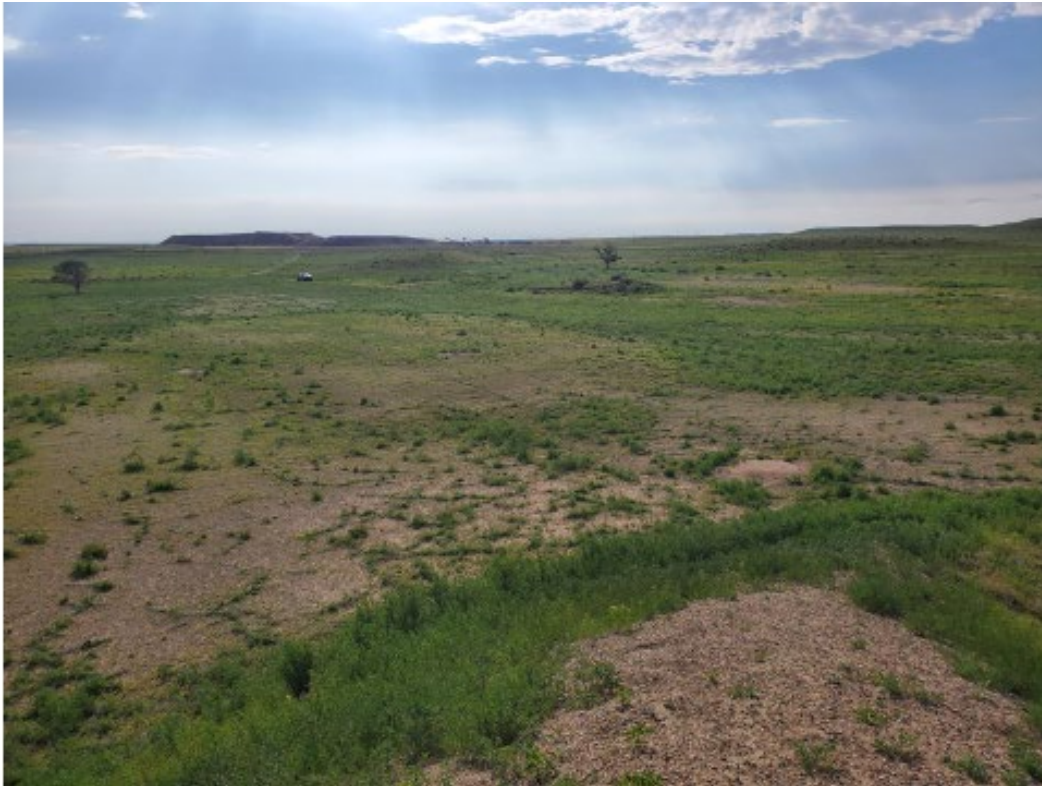
**Photo 9:** Standing on-top of a stockpile approved to remain, looking east across the site.

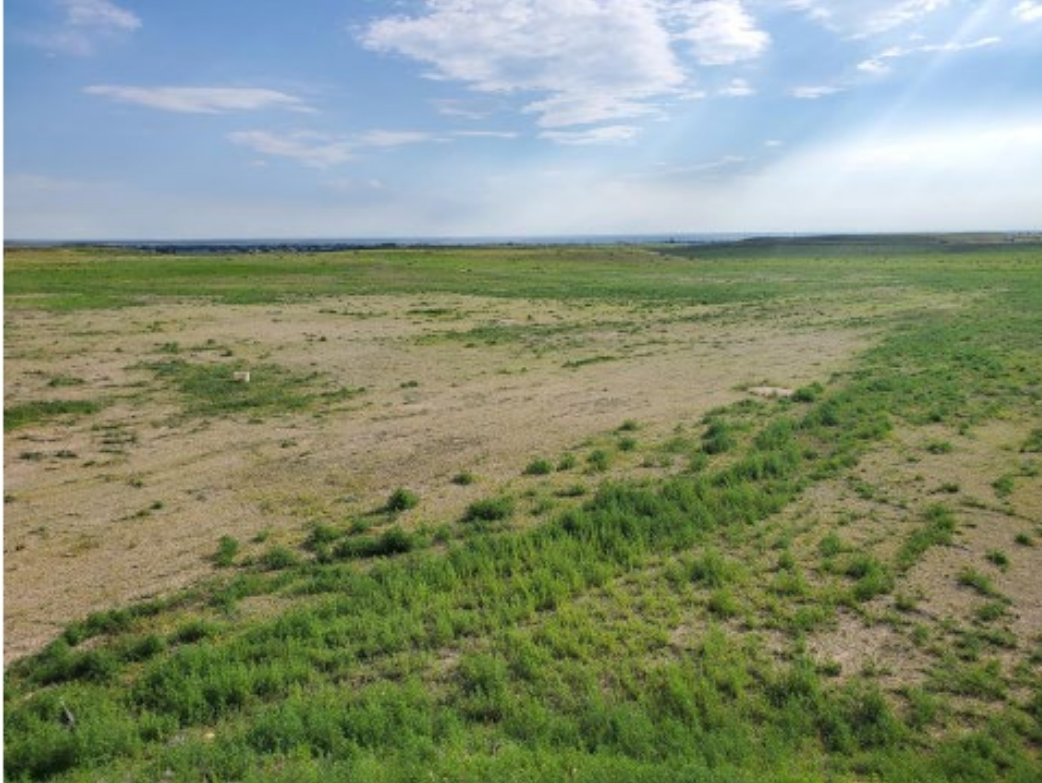
**Photo 10:** Standing on-top of a stockpile approved to remain, looking north-east across the site.

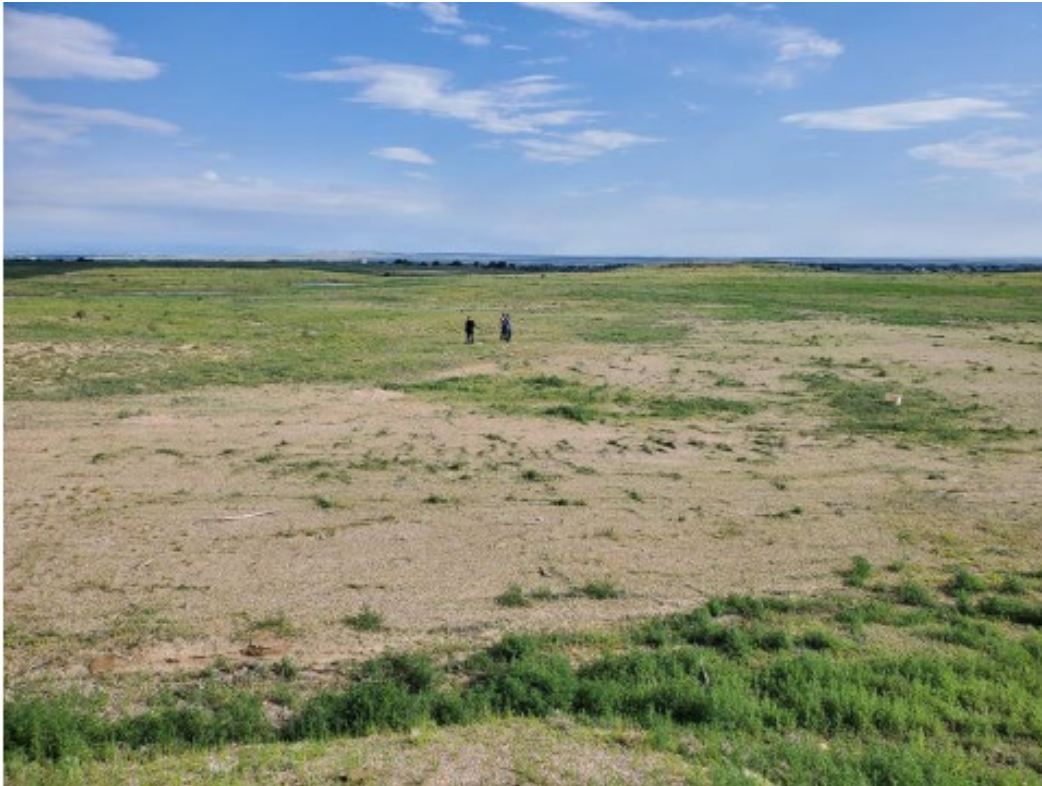
**Photo 11:** Standing on-top of a stockpile approved to remain, looking north across the site.

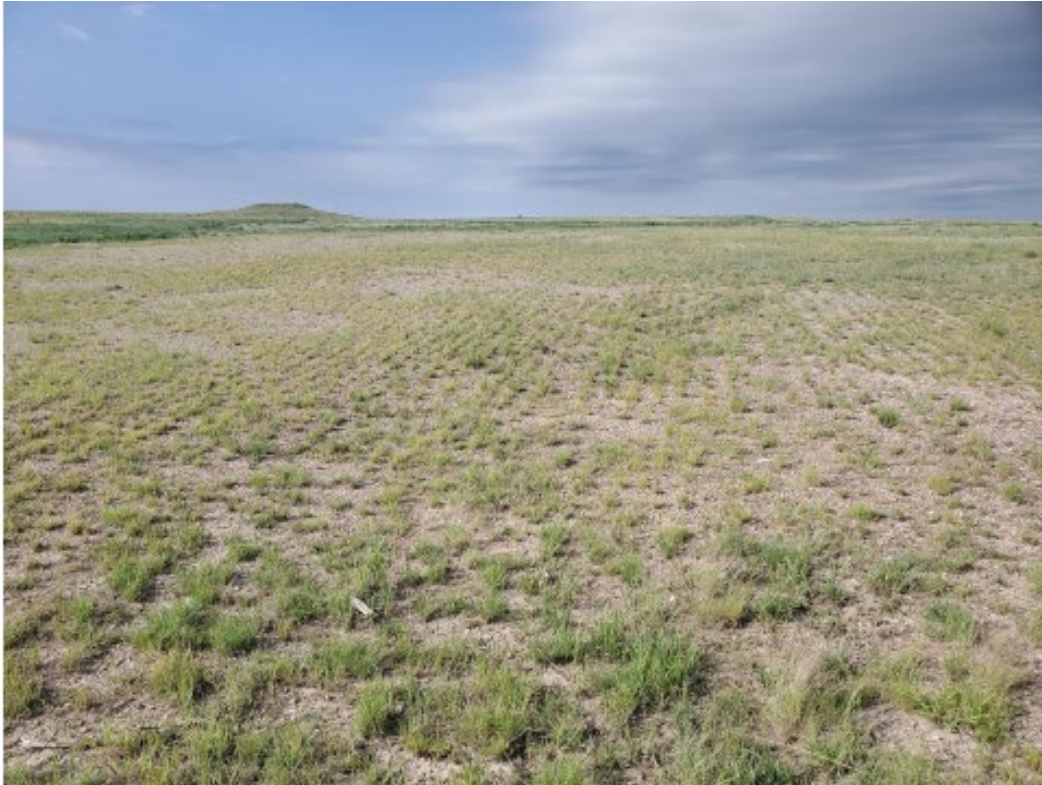
**Photo 12:** Looking north across an area in the north-west portion of the 19 acre site that was barren during the last inspection.

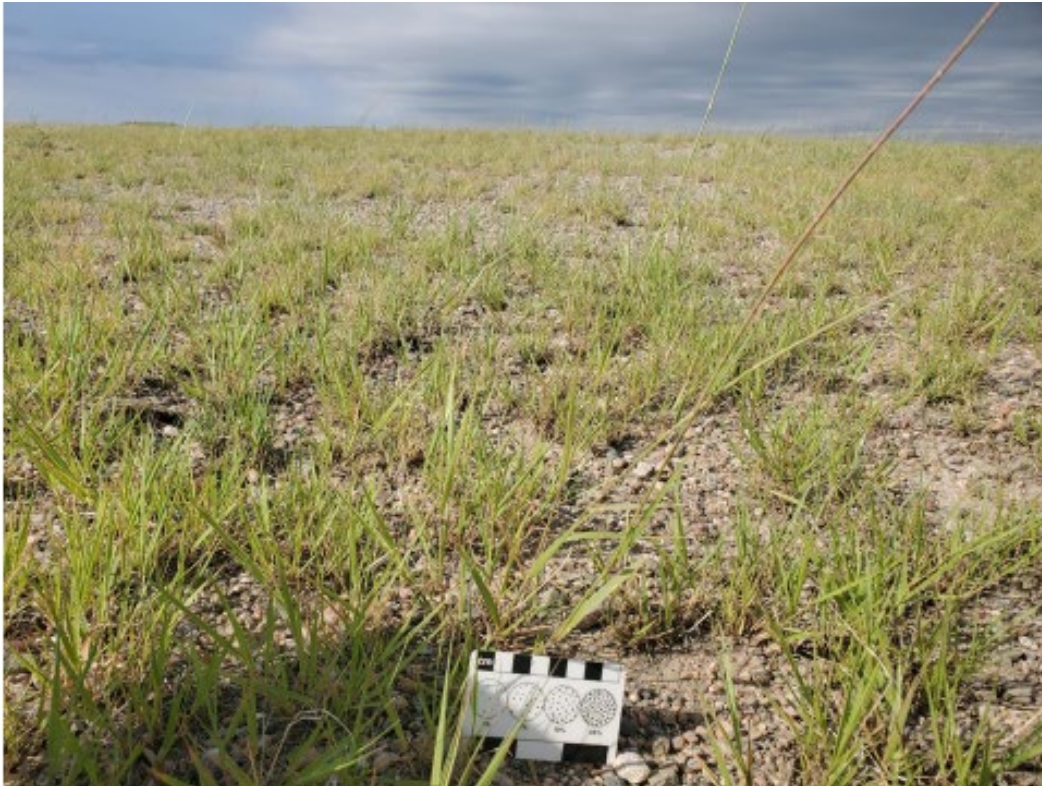
**Photo 13:** Ground level view of the location in Photo 12.

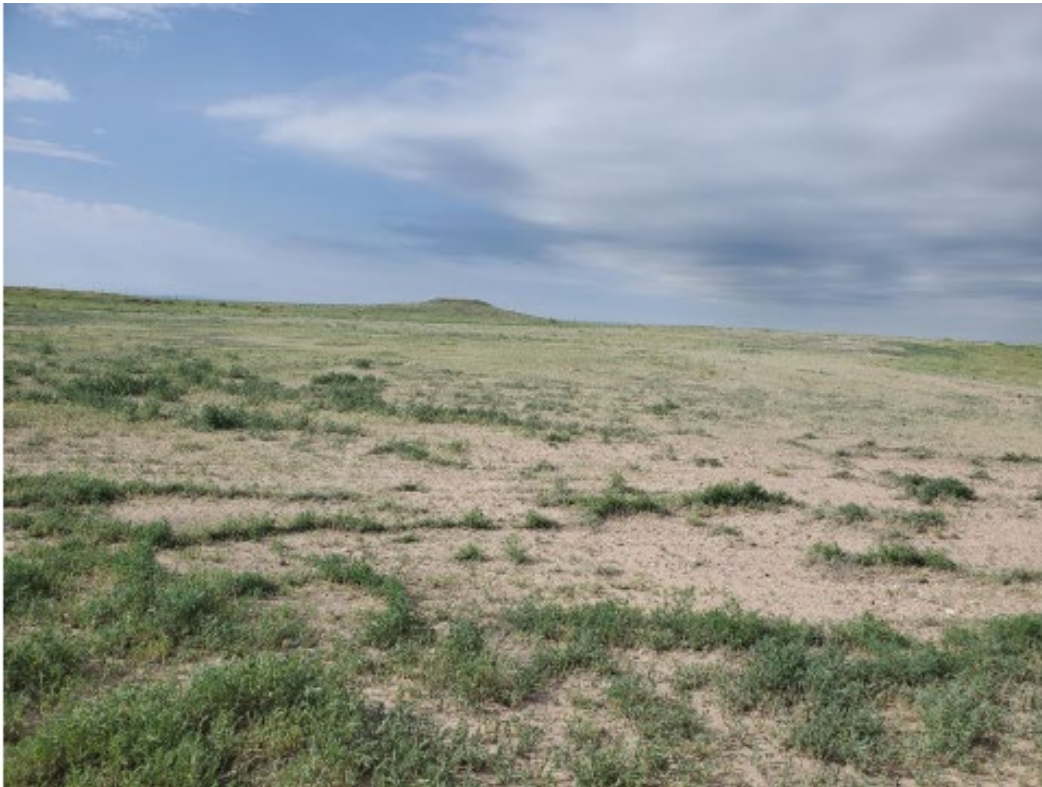
**Photo 14:** Looking west across the site from the south-west portion of the 19 acre area.

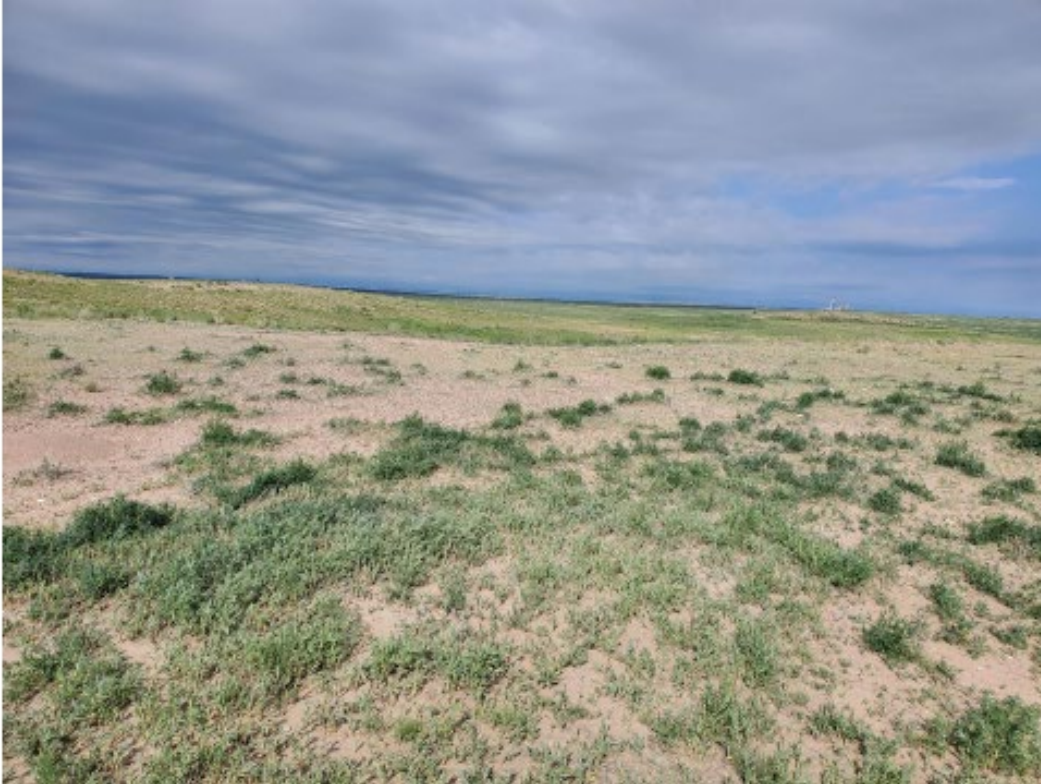
**Photo 15:** Looking north across the site from the south-west portion of the 19 acre area.

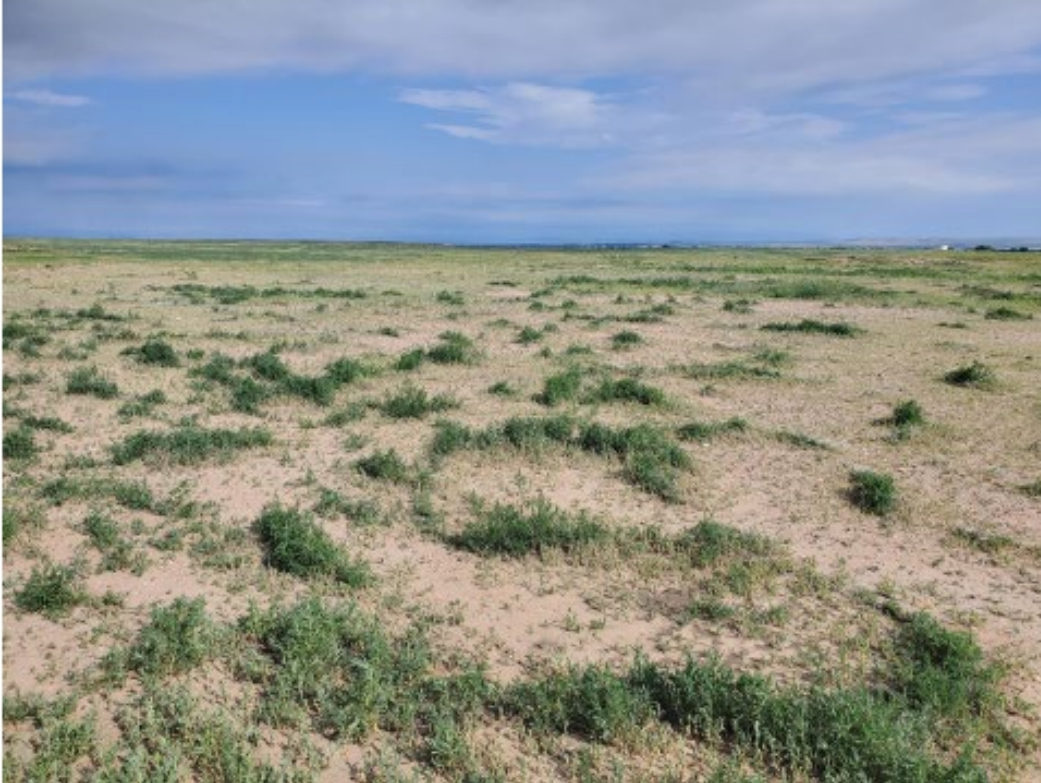
**Photo 16:** Looking north-east across the site from the south-west portion of the 19 acre area.

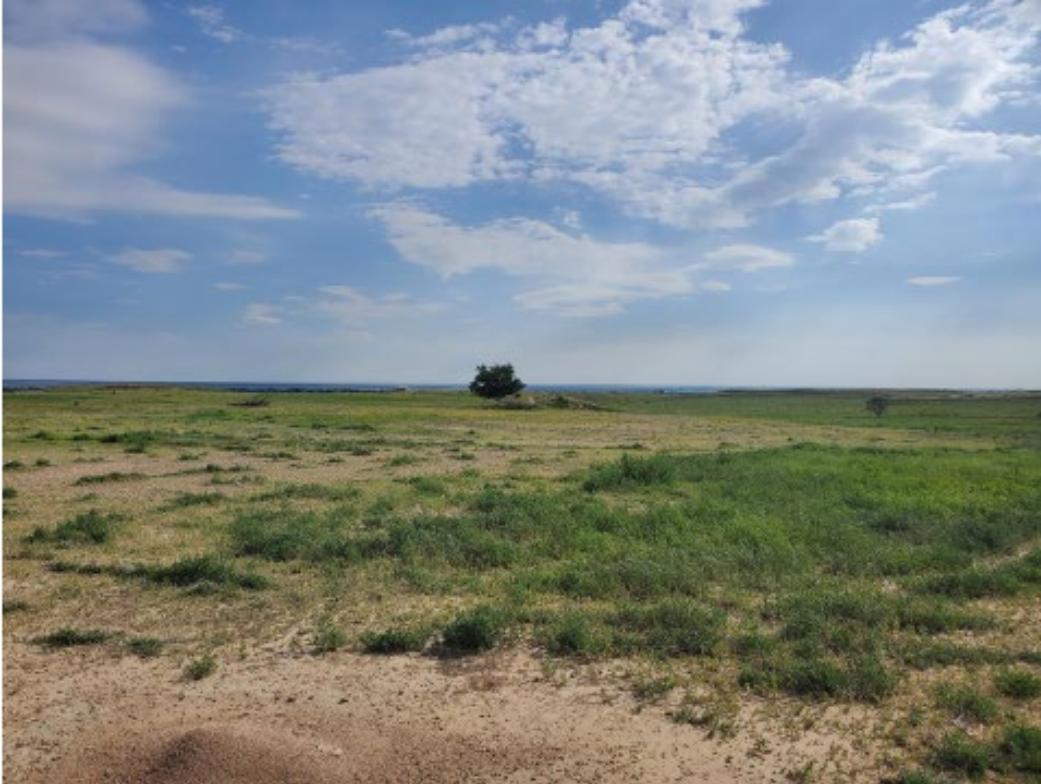
**Photo 17:** Looking east across the site from the south-west portion of the 19 acre area.

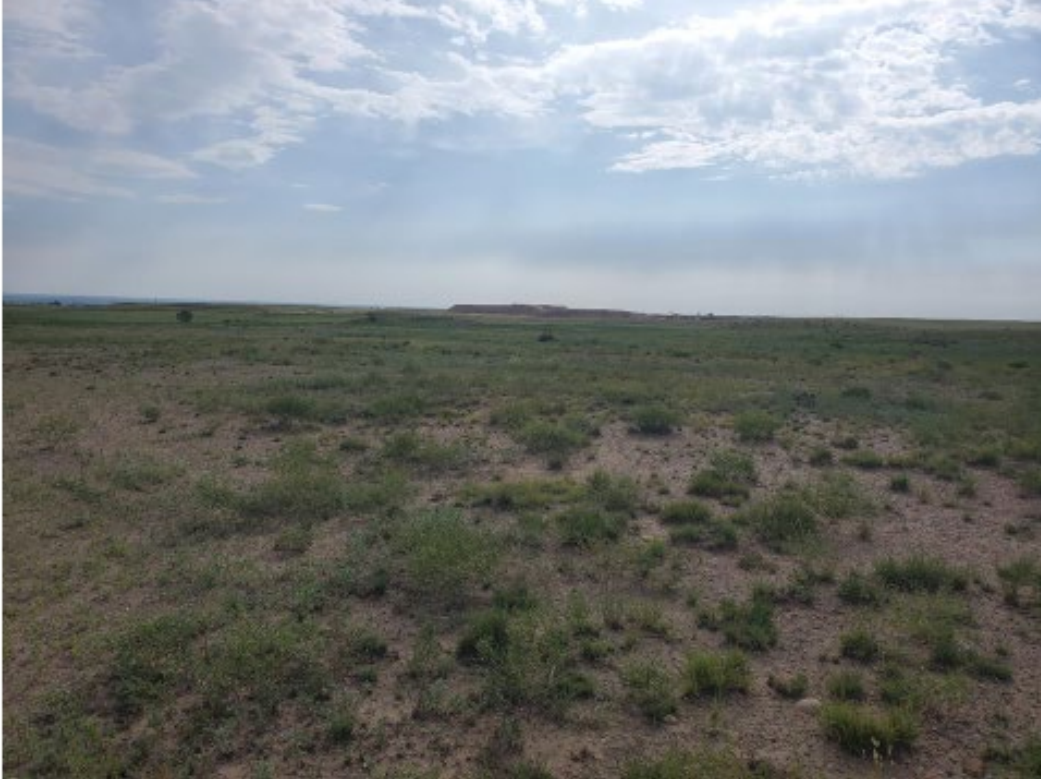
**Photo 18:** Looking east across the site from the south-west corner of the 19 acre area.

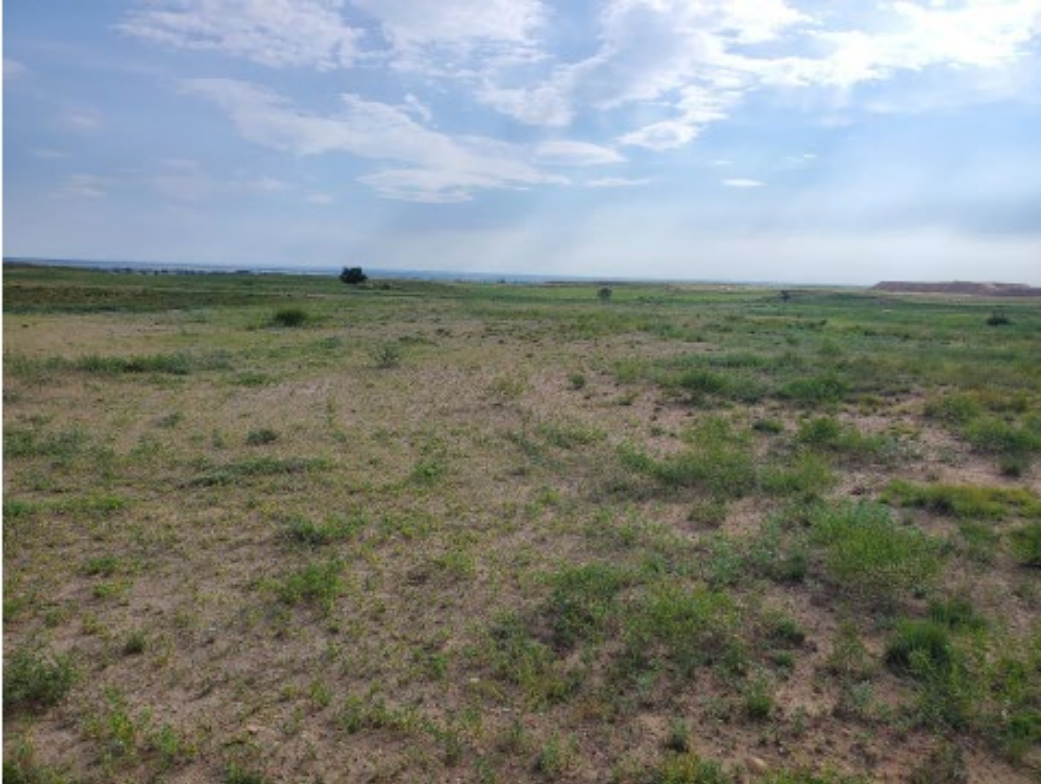
**Photo 19:** Looking north across the site from the south-west corner of the 19 acre area.

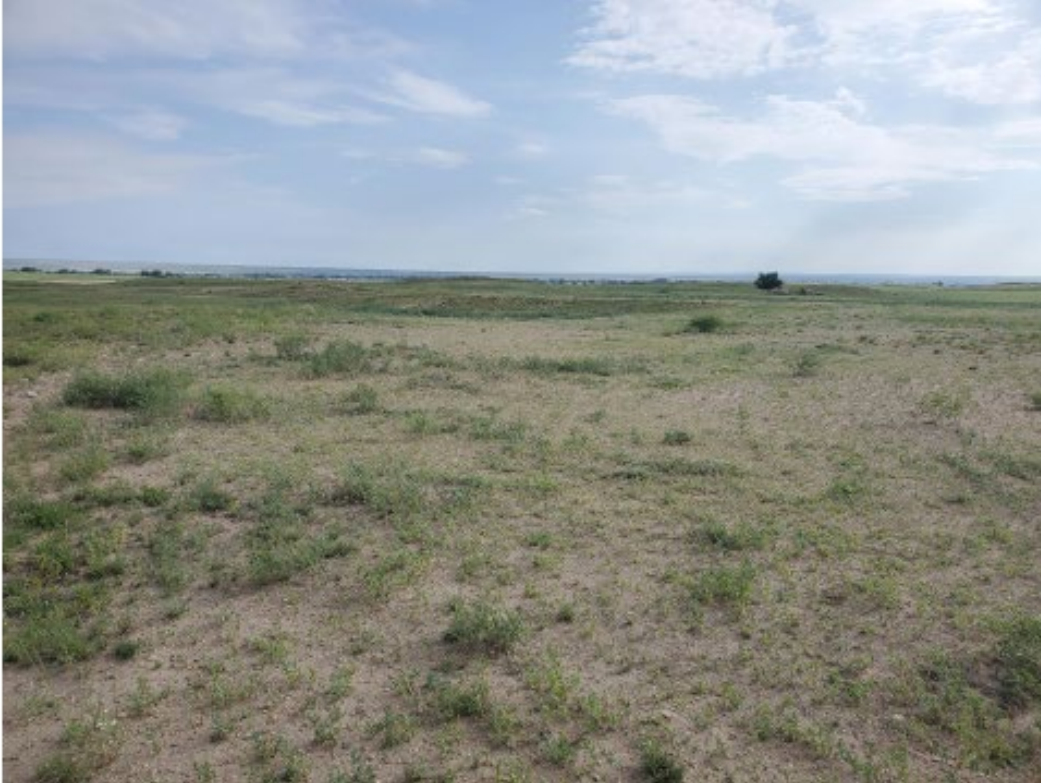
**Photo 20:** Looking north-west across the site from the south-west corner of the 19 acre area.

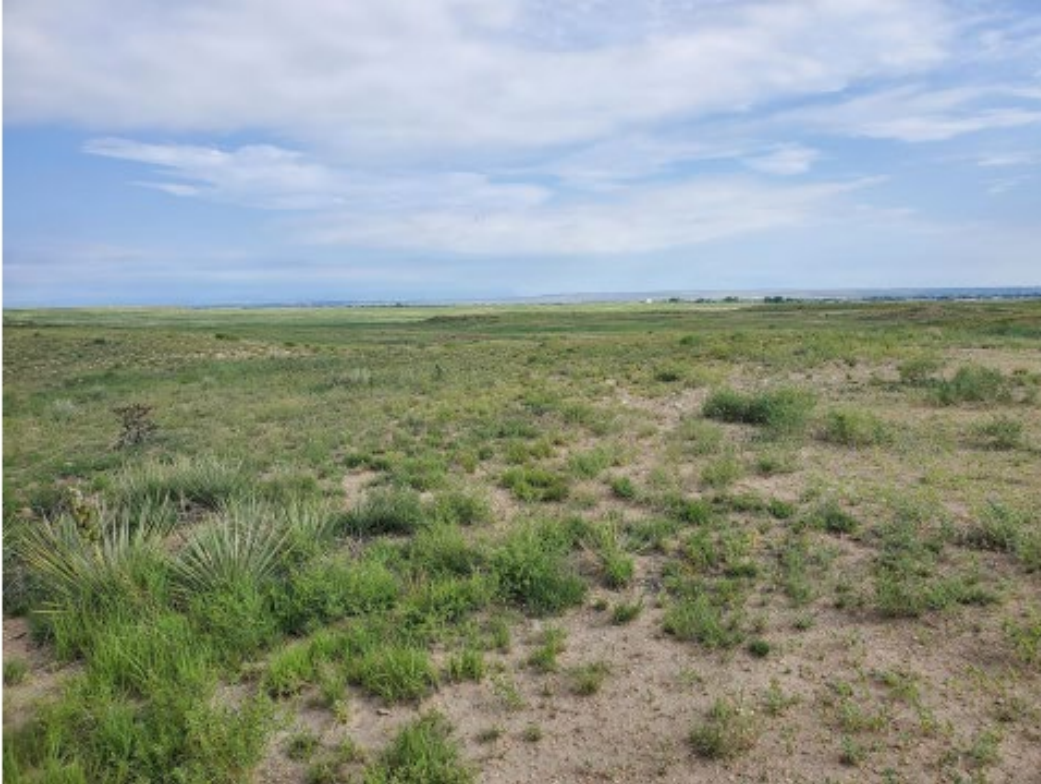
**Photo 21:** Looking west across the site from the south-west corner of the 19 acre area.

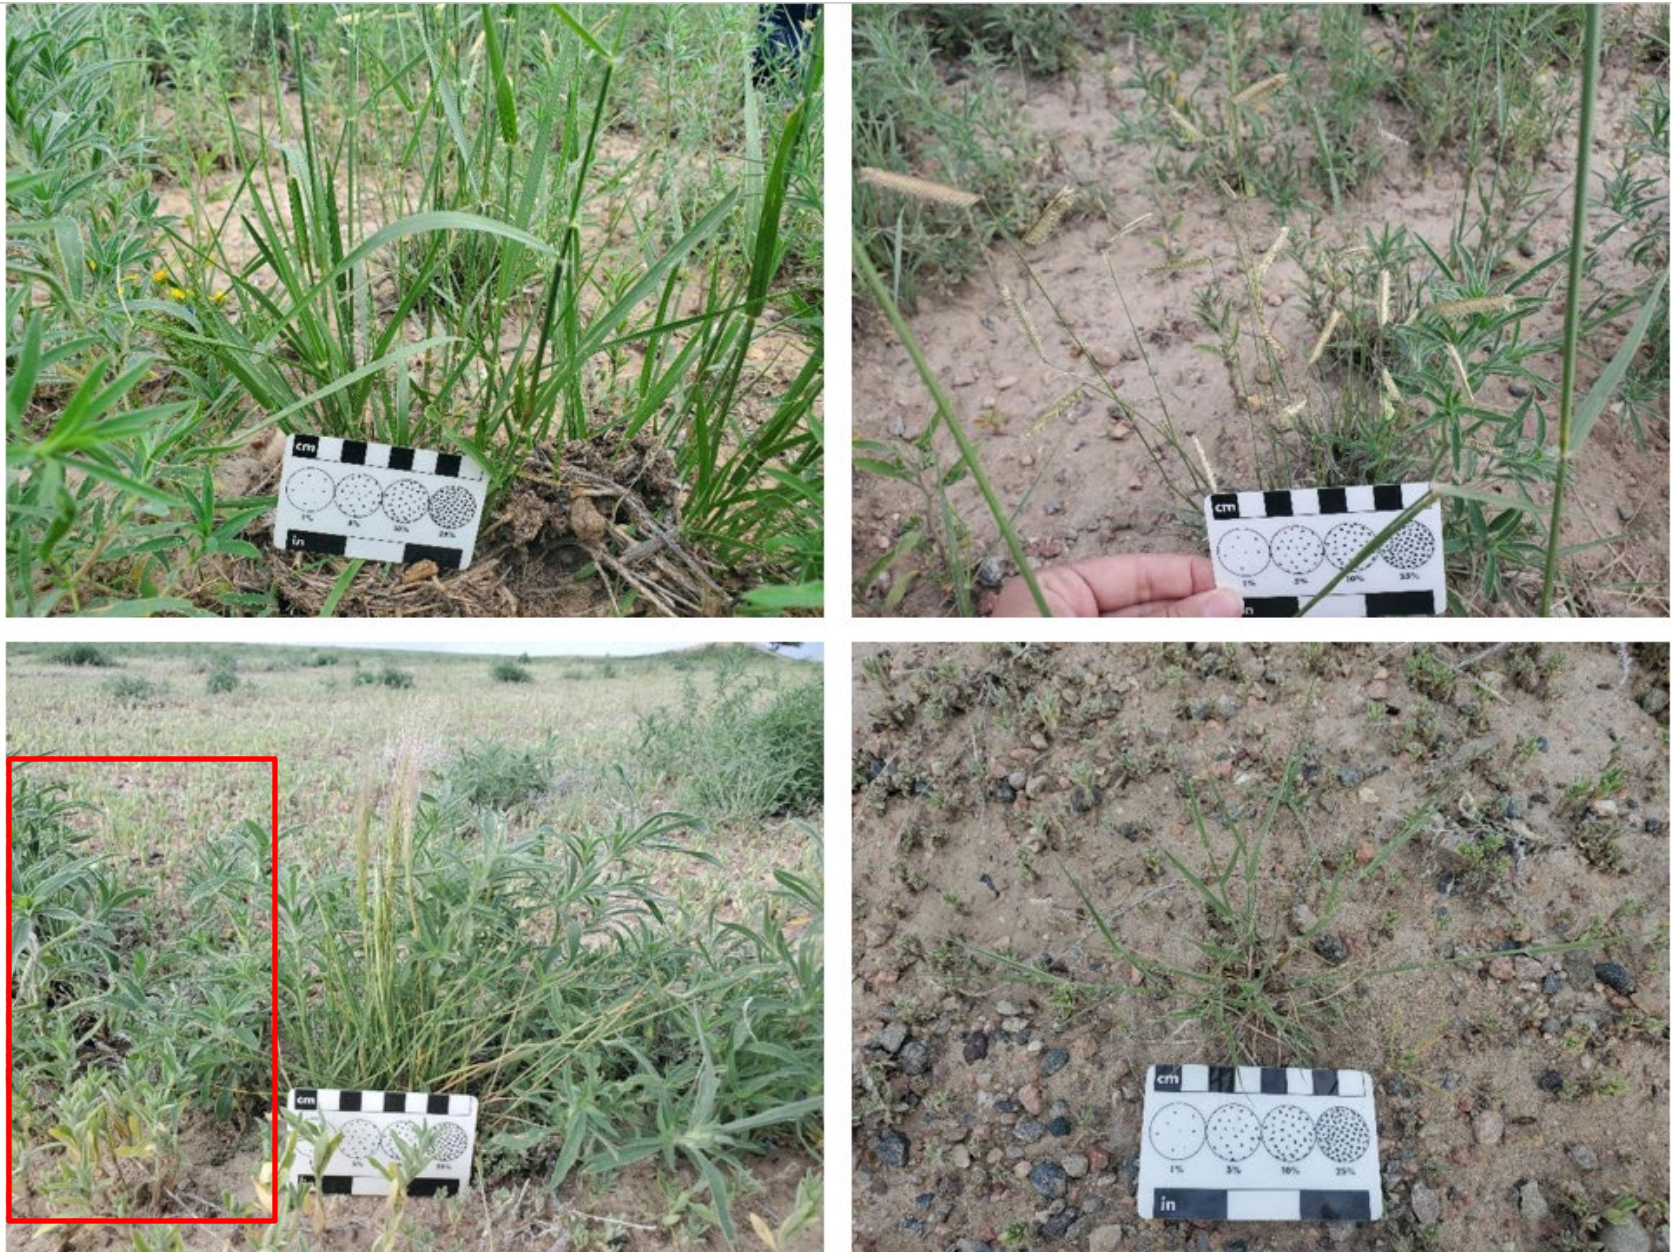
During the 2021 inspection, the State Land Board had decided to allow the Operator to put up a temporary fence to keep cattle out of the area to aid in vegetation establishment. During the 2023 inspection, the Operator was asked if they had done this and they stated that they had not. On-site, both the Operator and Mr. Teschner stated that the site looked markedly better than when they were there for the previous inspection. All parties observed a variety of grasses growing on-site (see Figures 1 and 2), which the Operator and Mr. Teschner stated were not present during the 2021 inspection in this area. The annual weed, Kochia, was also prevalent throughout the site. While Kochia is not a state listed noxious weed, it is a weed common in the Pueblo area. Because this land will be reclaimed to rangeland, and cattle eat Kochia, it was agreed that its presence is acceptable.

**Figure 1:** Various grasses observed onsite. Kochia also observed as a dominant species throughout the site (highlighted in red, but also present in the other photos as well).

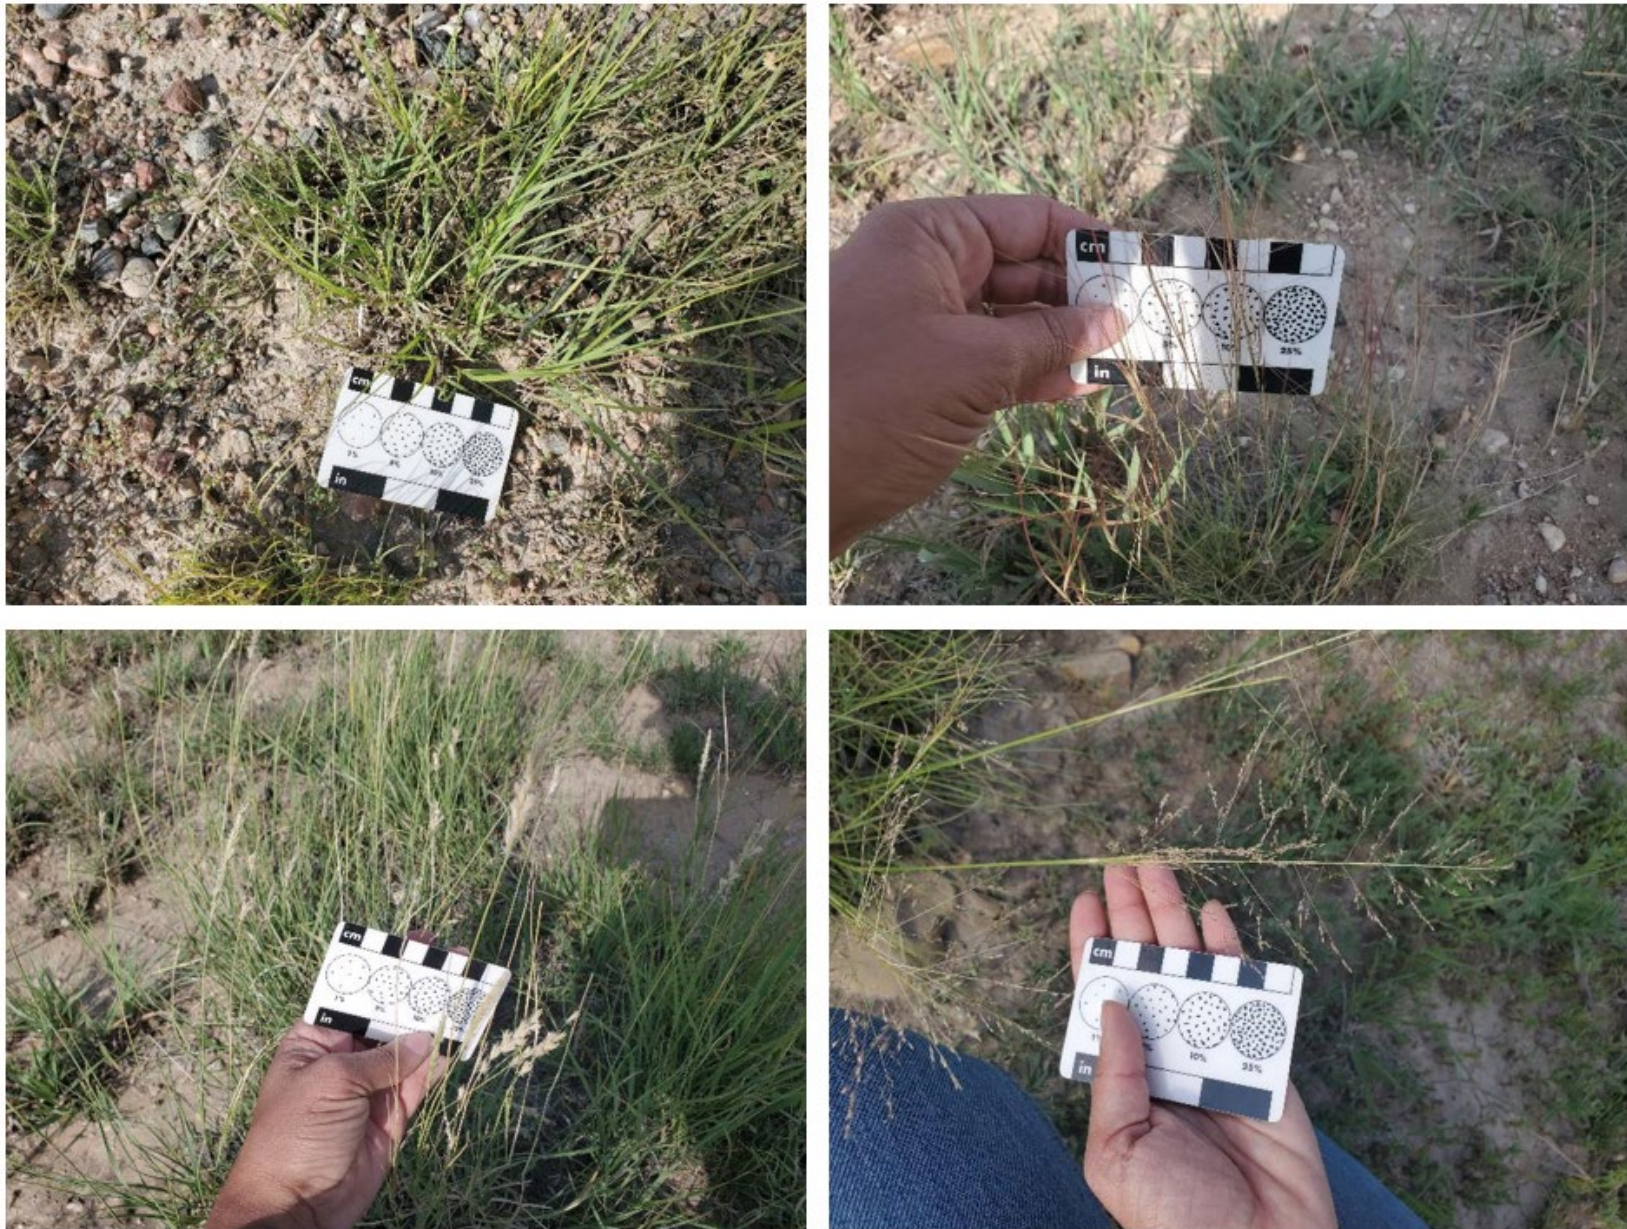
Figure 2: Additional grasses observed on-site.
