Denver Field Branch Bond Release Evaluation Report

Permittee:	Mountain Coal Company, LLC
Operator:	Mountain Coal Company, LLC
Site:	West Elk Mine
Permit No:	C-1980-007
Date of Inspection:	June 27 - 29, 2023
Inspection Type:	Partial Phase II and partial Phase III bond release
Weather:	Sunny and warm with dry ground conditions
Operator Representatives:	Garren Atchley, Mark Peirce, Nicki Poulos, Cody Rapke, and Jessica Wilczek
State Official:	Leigh Simmons
USDA - FS Official:	Dan Gray
OSMRE Official:	Tom Medlin #562

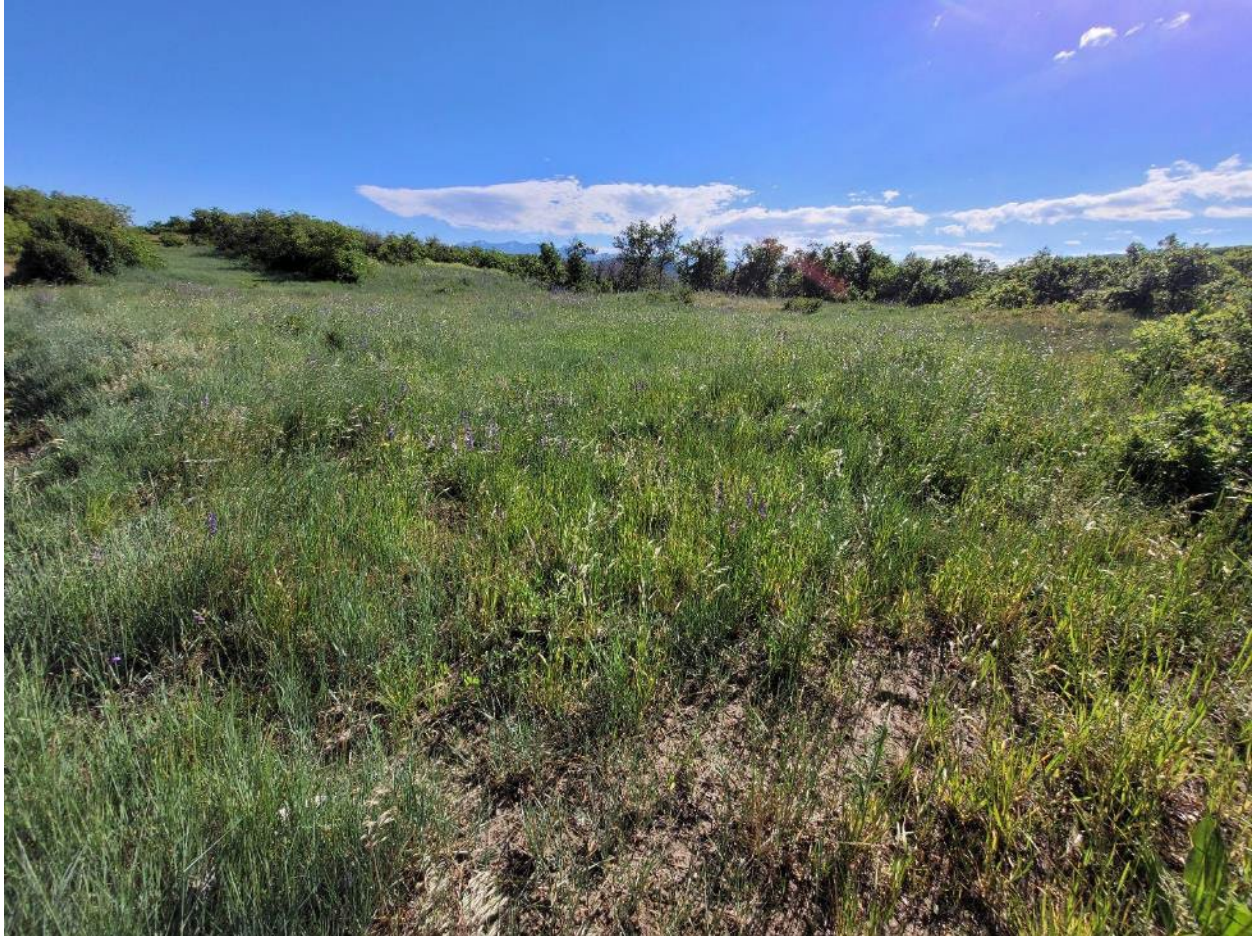
Figure 1. E4-17.

E4-17: 0.58 ac. No issues.

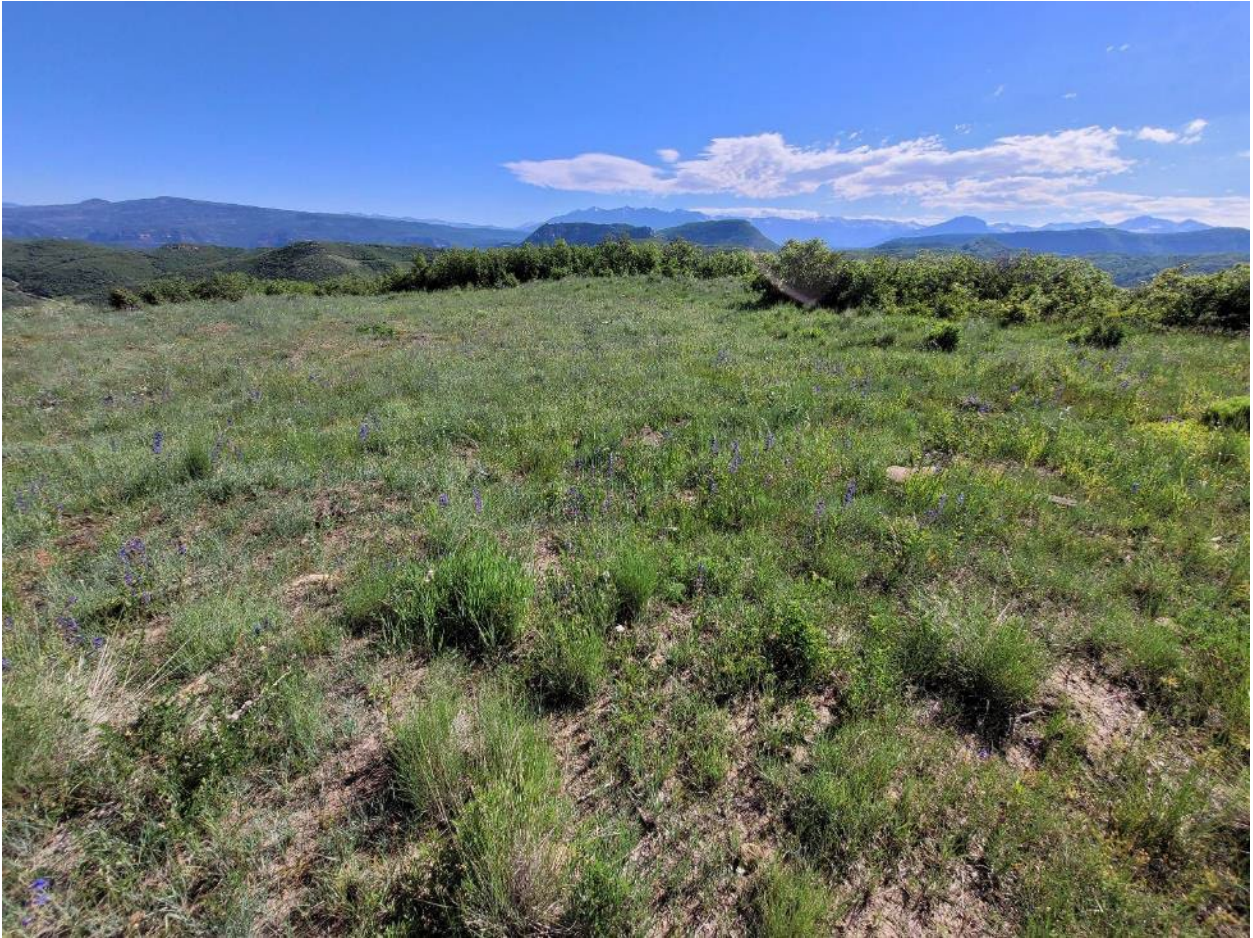
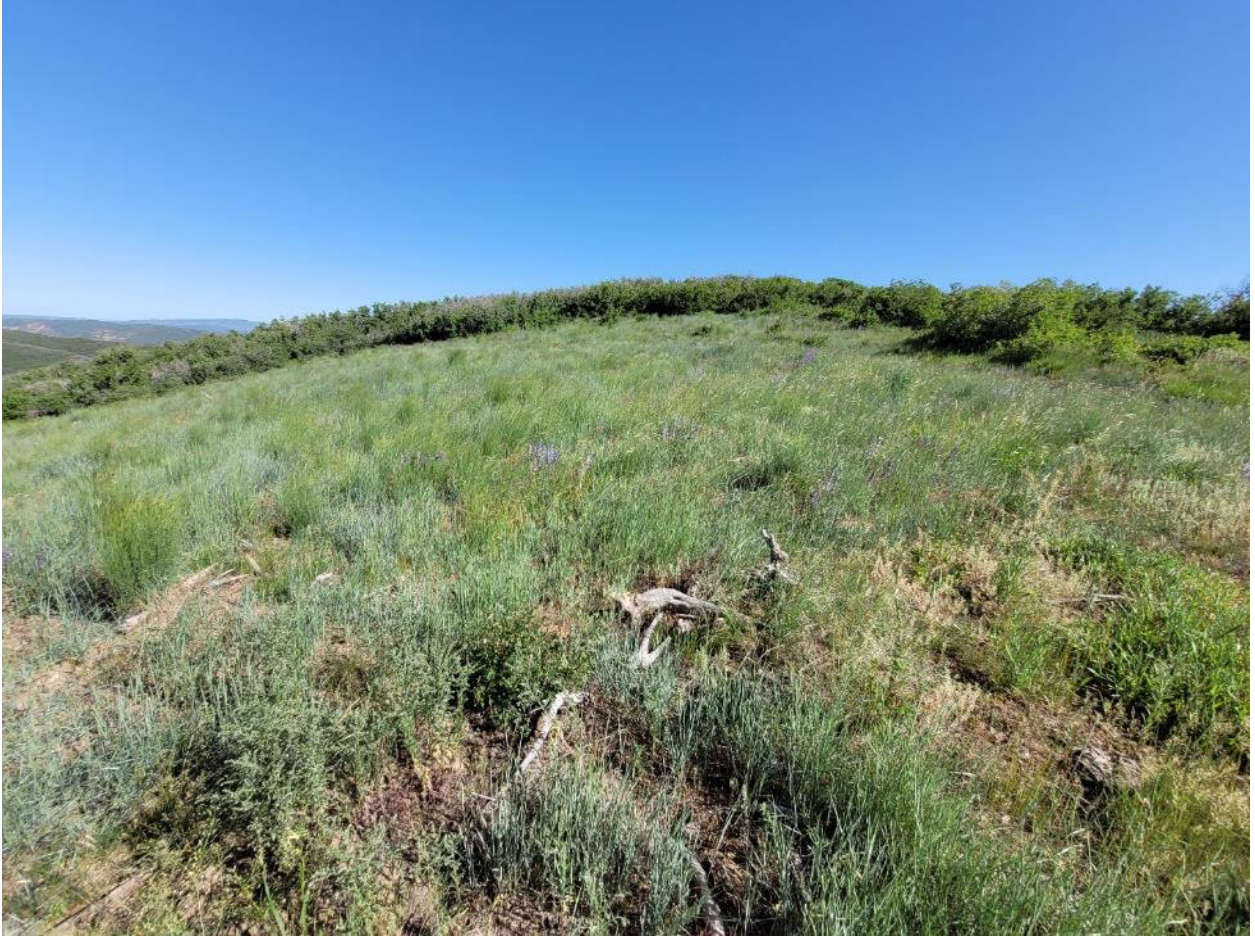
Figure 2. E4-16 and road.

E4-16 and road to E4-16: 0.69 ac. No issues.

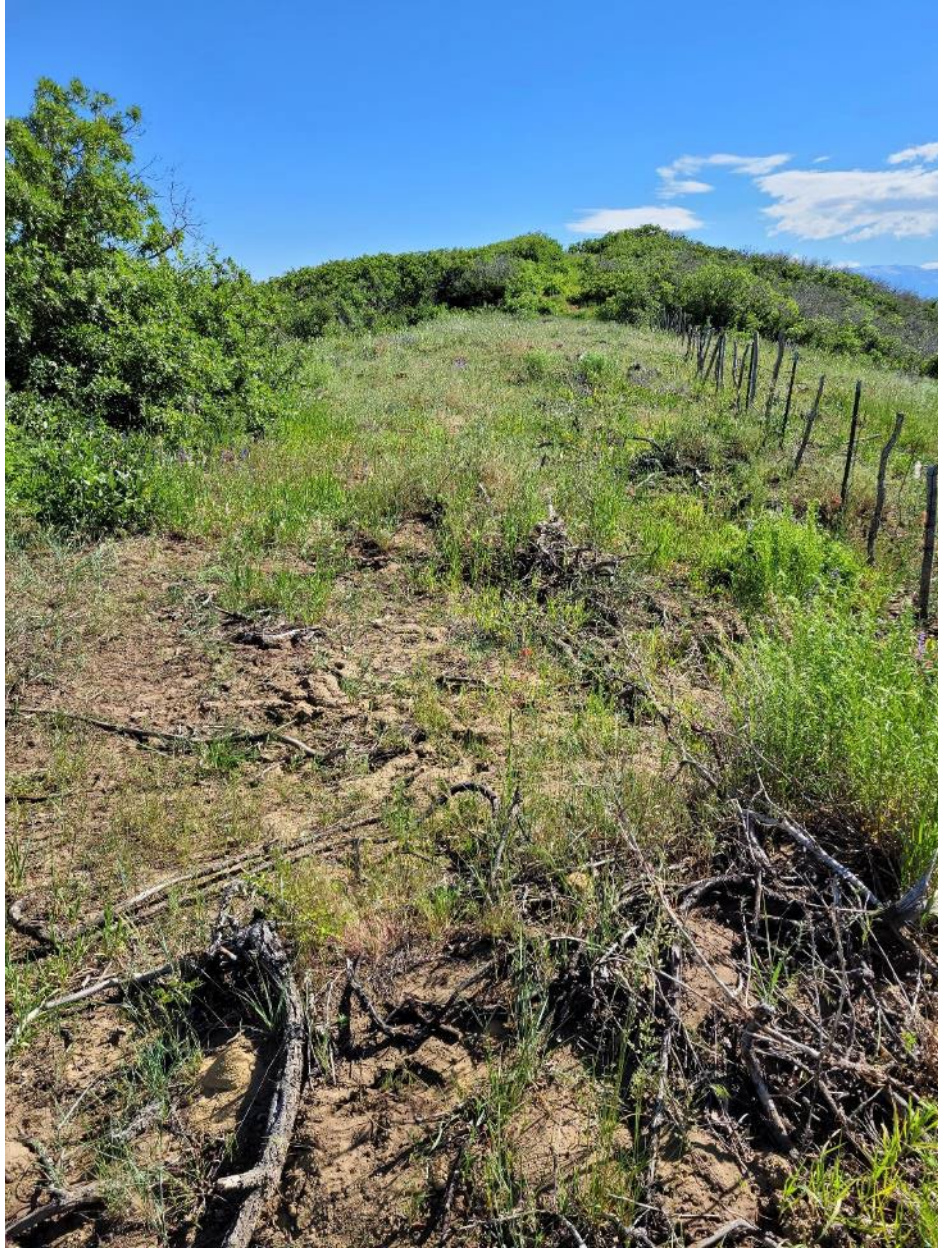
Figure 4. E5-17.

E5-17: 0.32 ac. Limited quantities of cheatgrass and Canada thistle; treat and monitor.

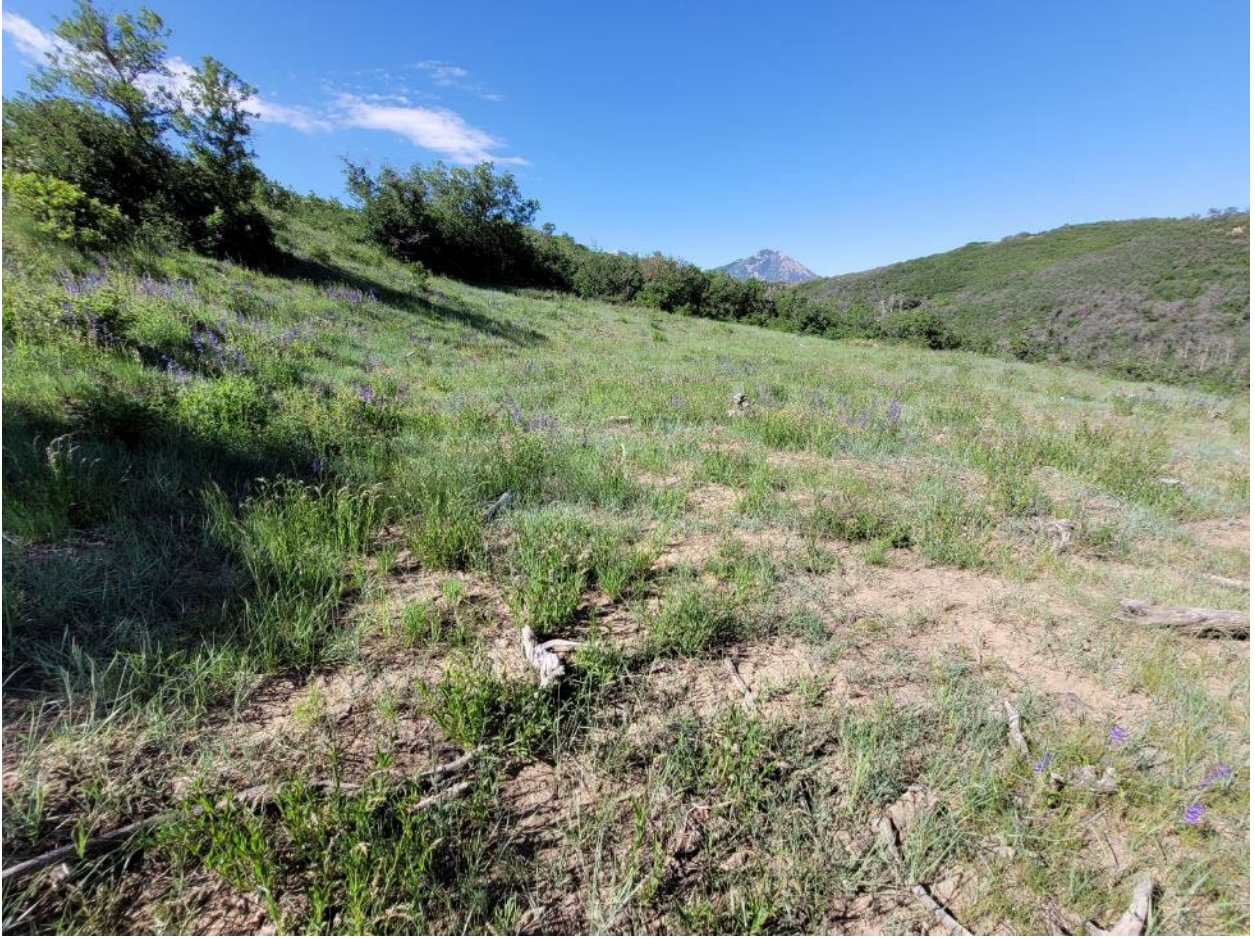
Figure 5. E4-15.

E4-15: 0.59 ac. No issues.

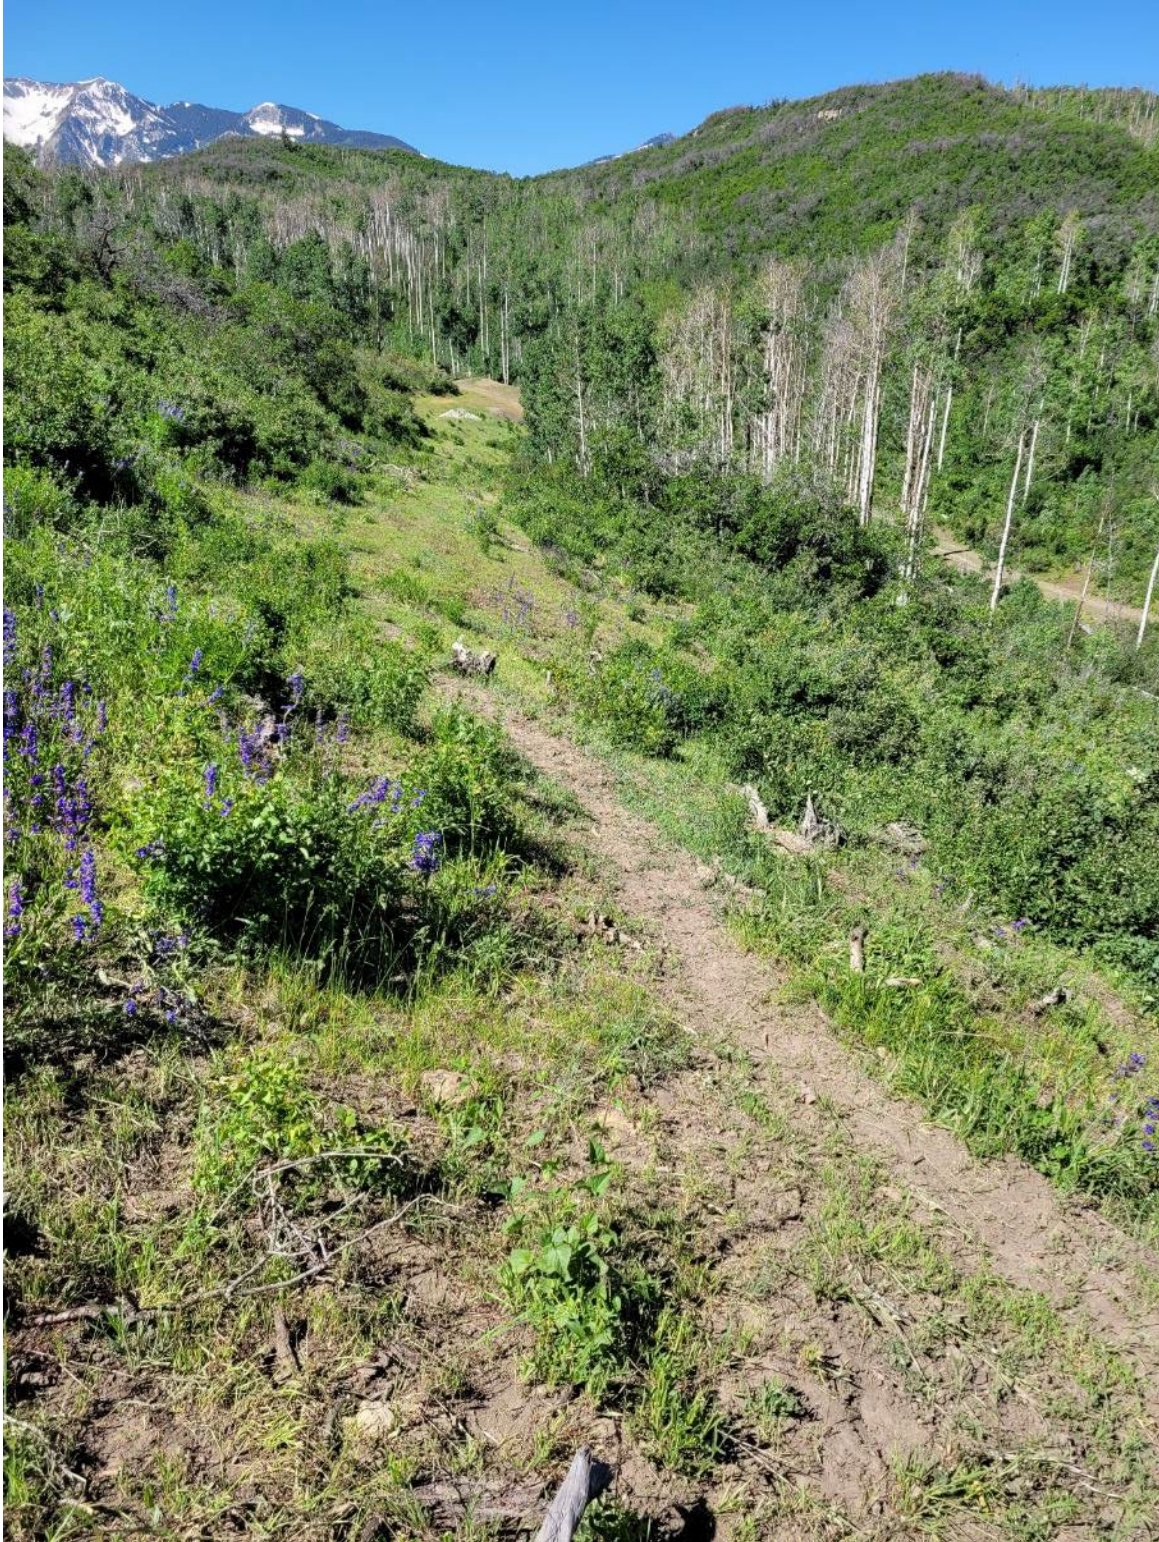
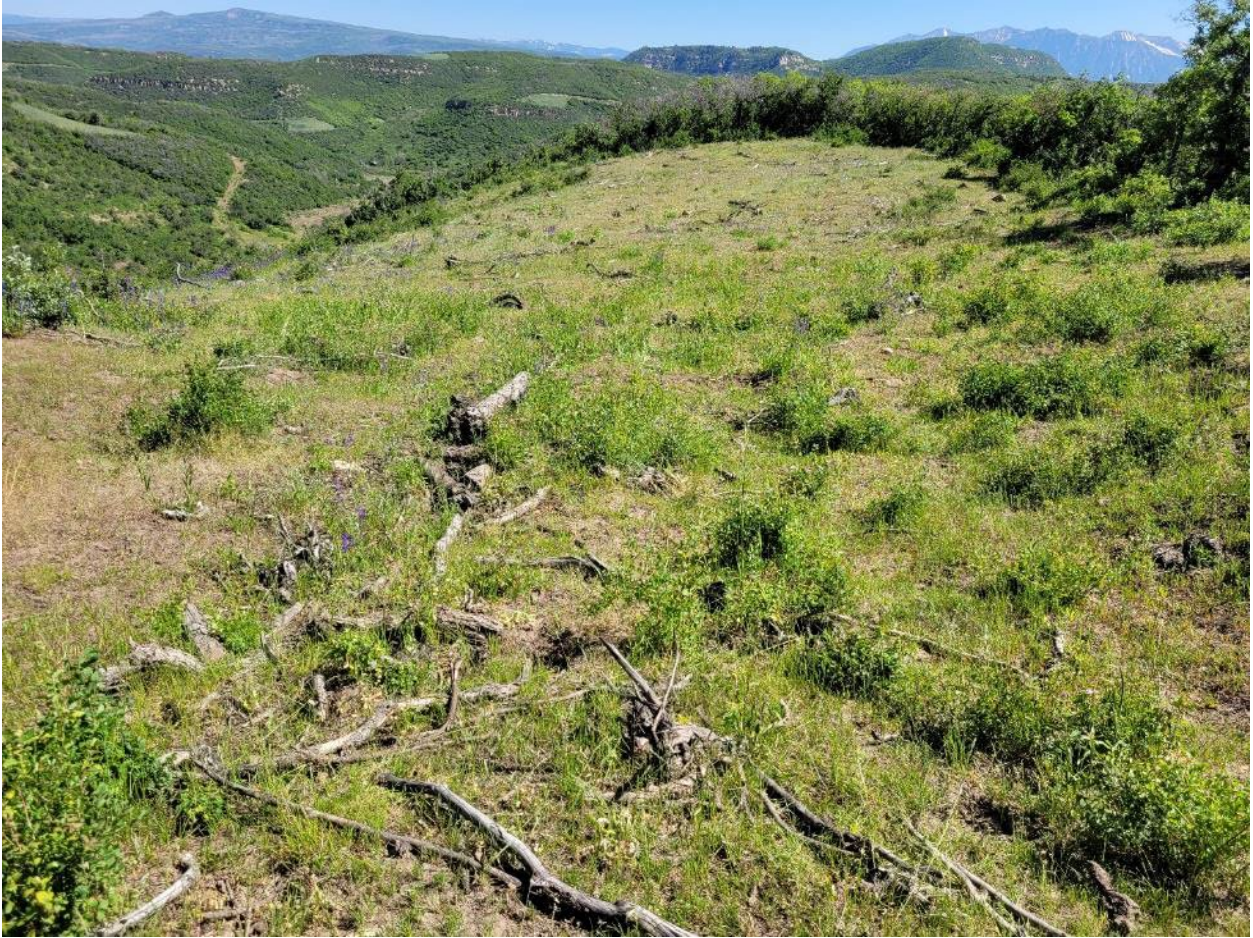
Figure 6. Road to E5-15.

E5-15 and road to E5-15: 2.06 ac. Recently treated for Canada thistle; monitor.

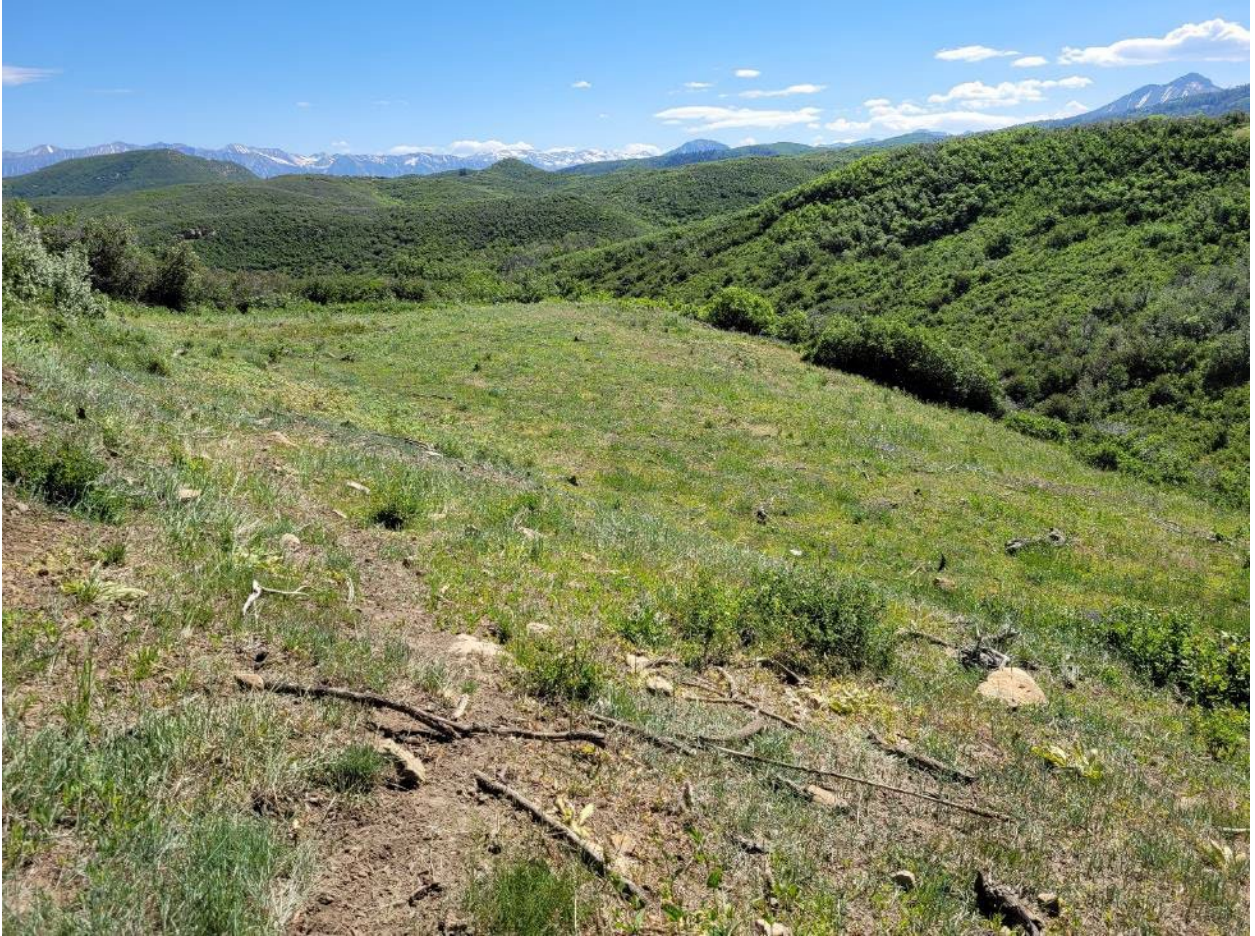
Figure 8. E5-16.

E5-16 and road to E5-16: 2.07 ac. Recently treated for Canada thistle; monitor.

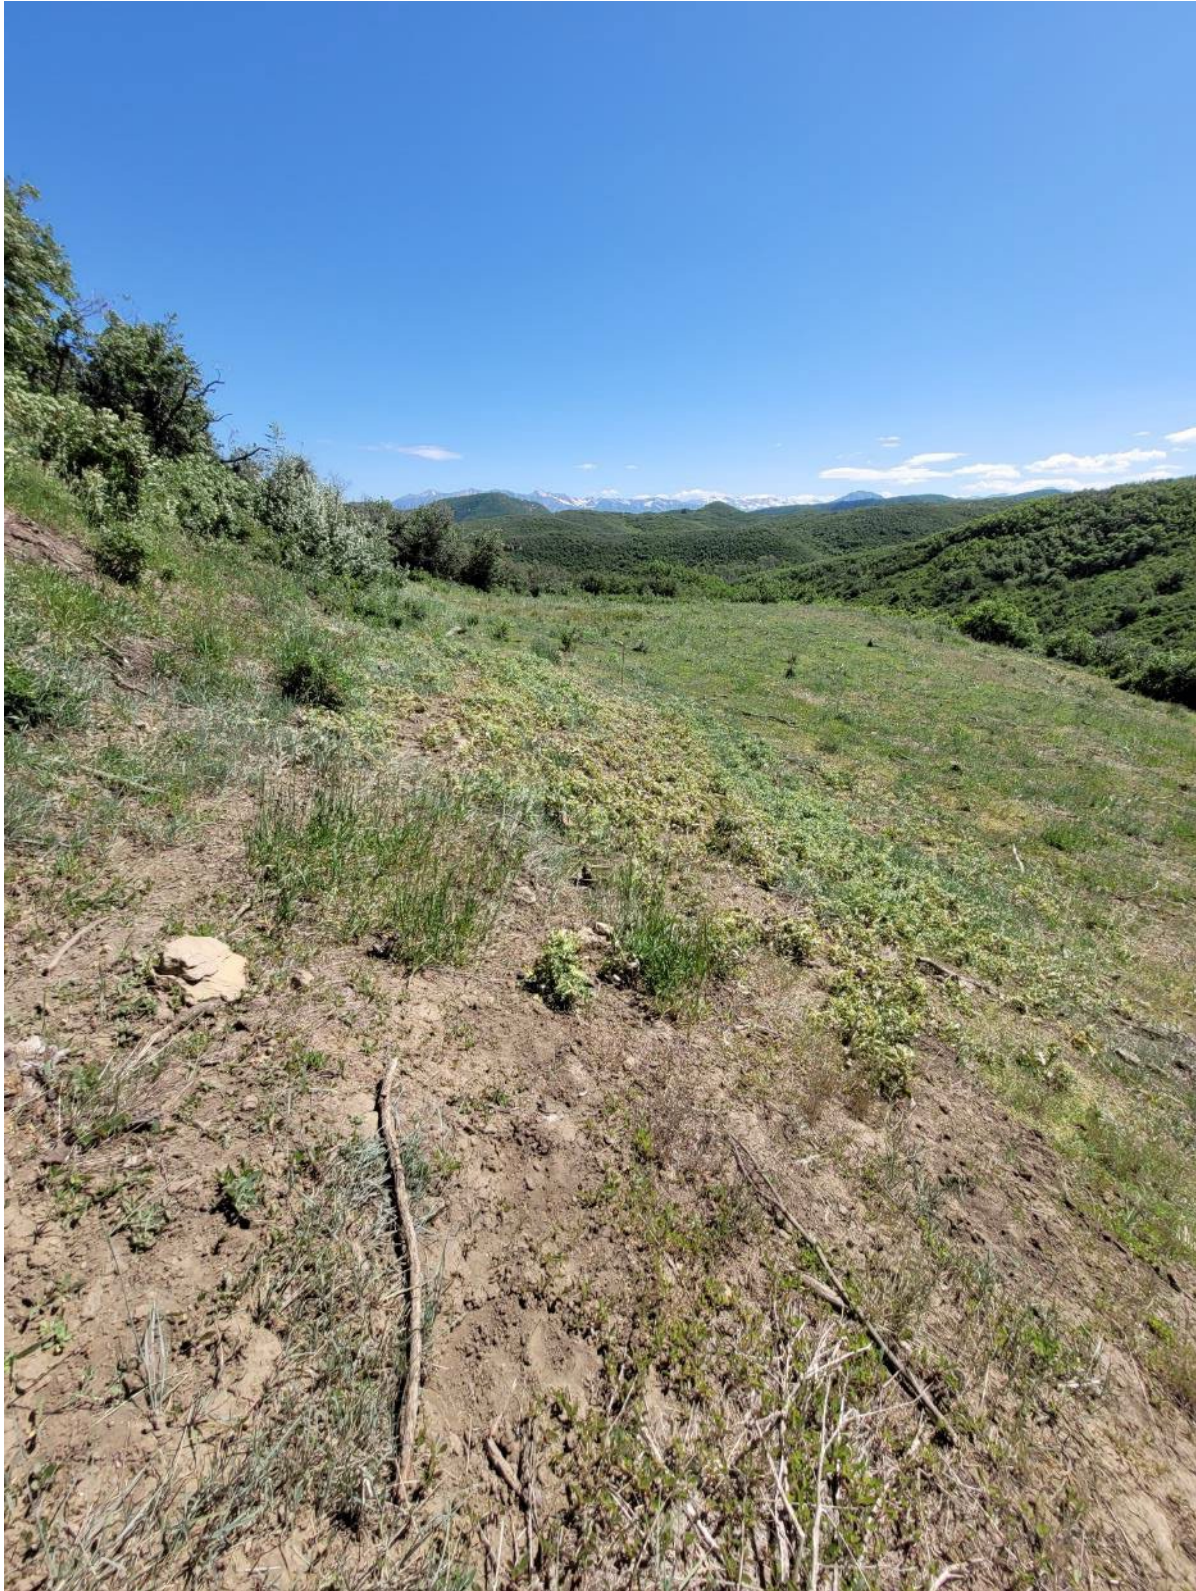
Figure 9. E5-16 with recently treated thistle, foreground.

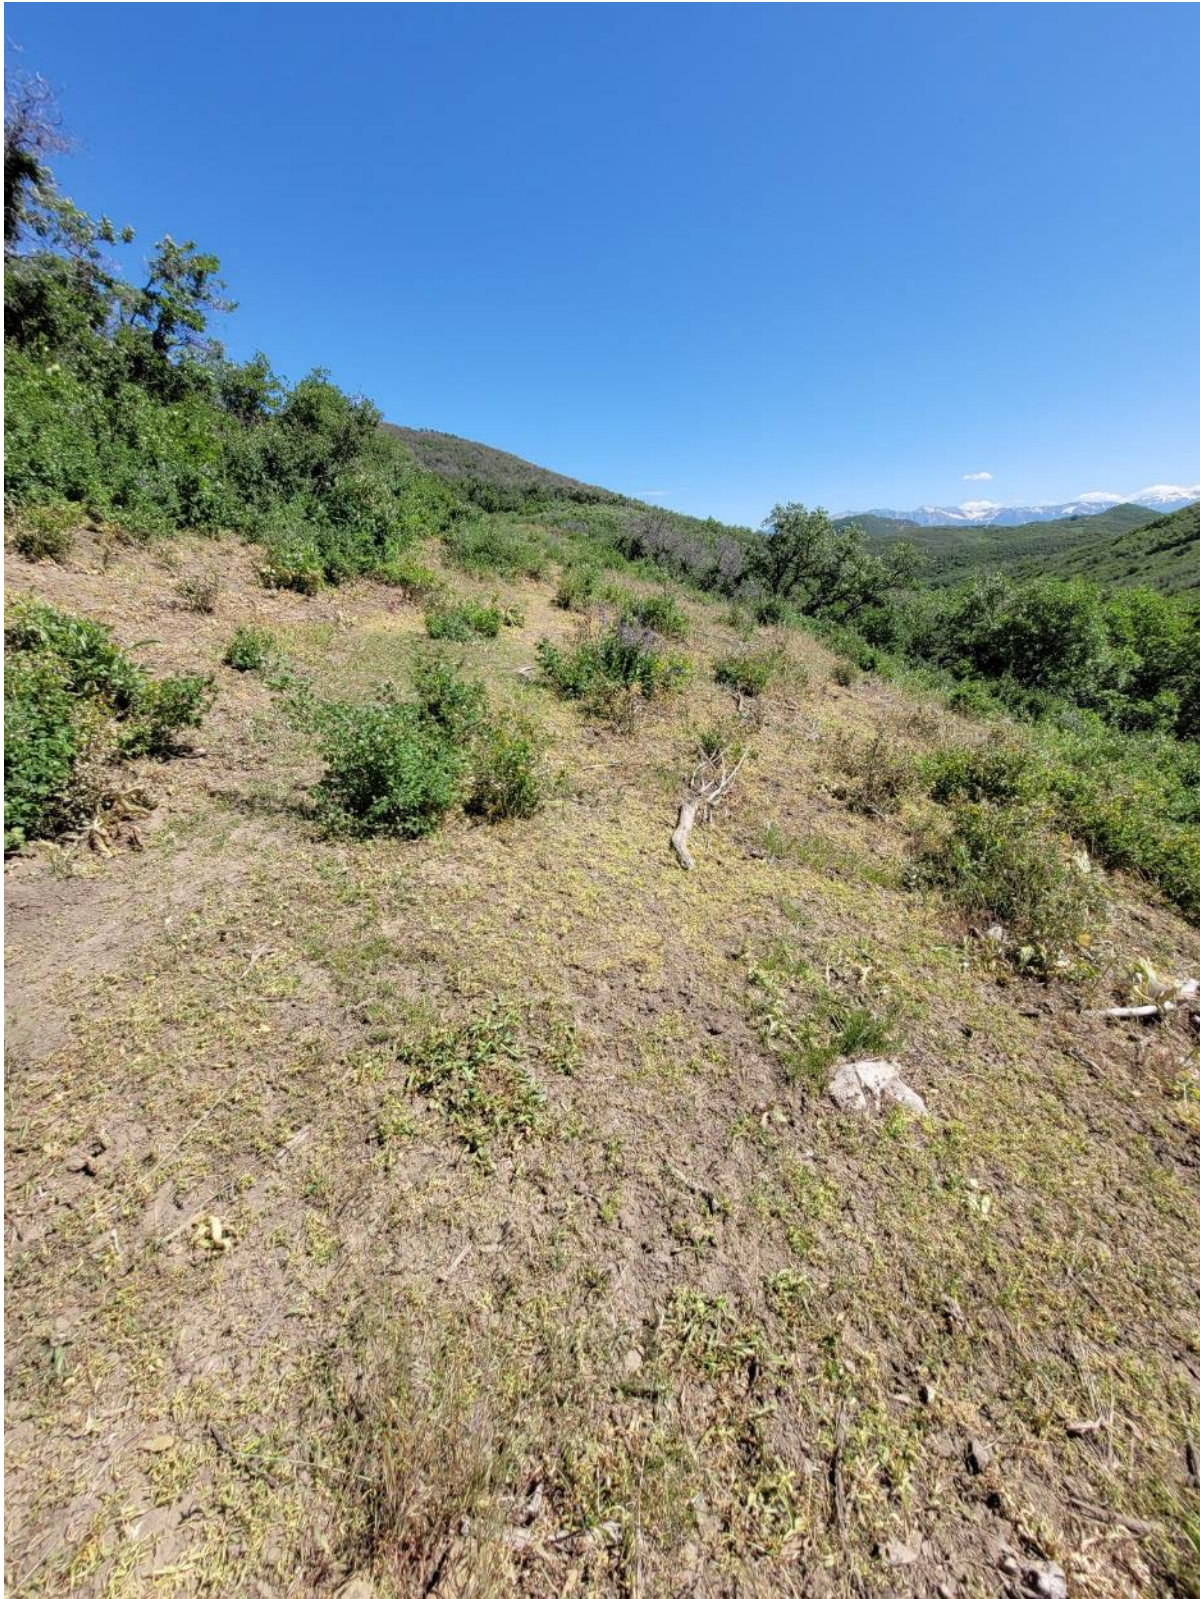
Figure 10. Road to E5-16 with recently treated thistle, foreground.

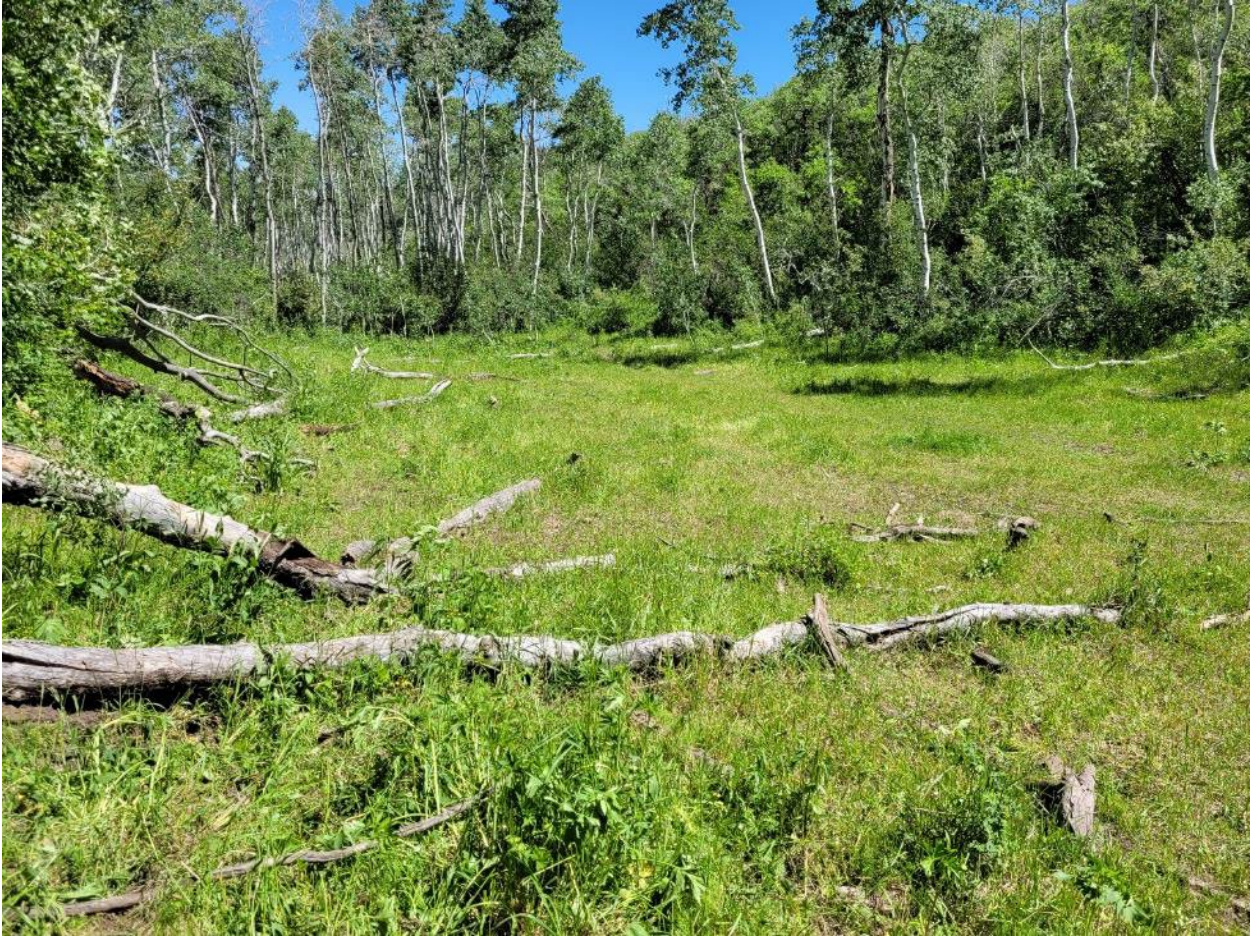
Figure 11. 10LWE5X40.

10LWE5X40: Area undefined in application. No issues.

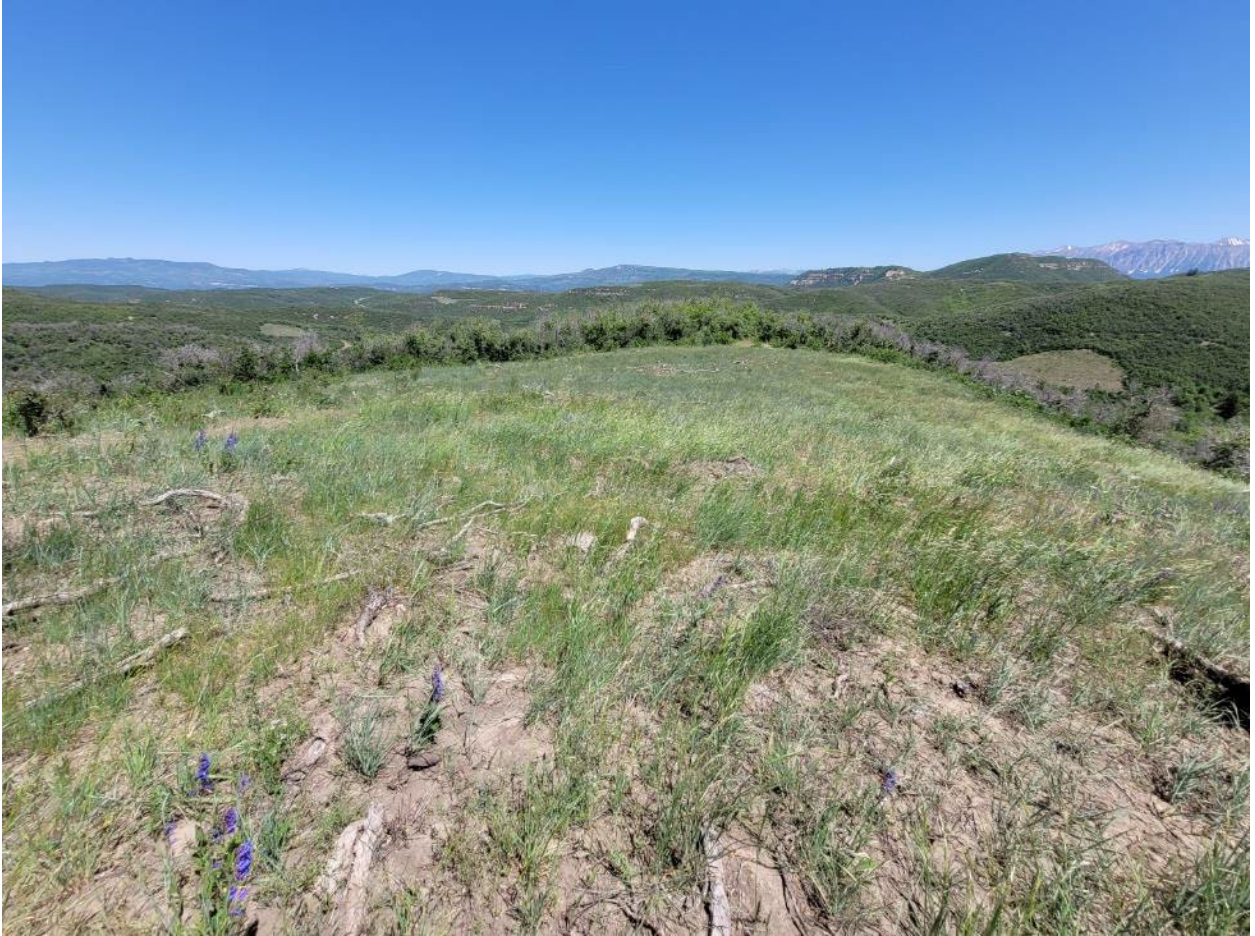
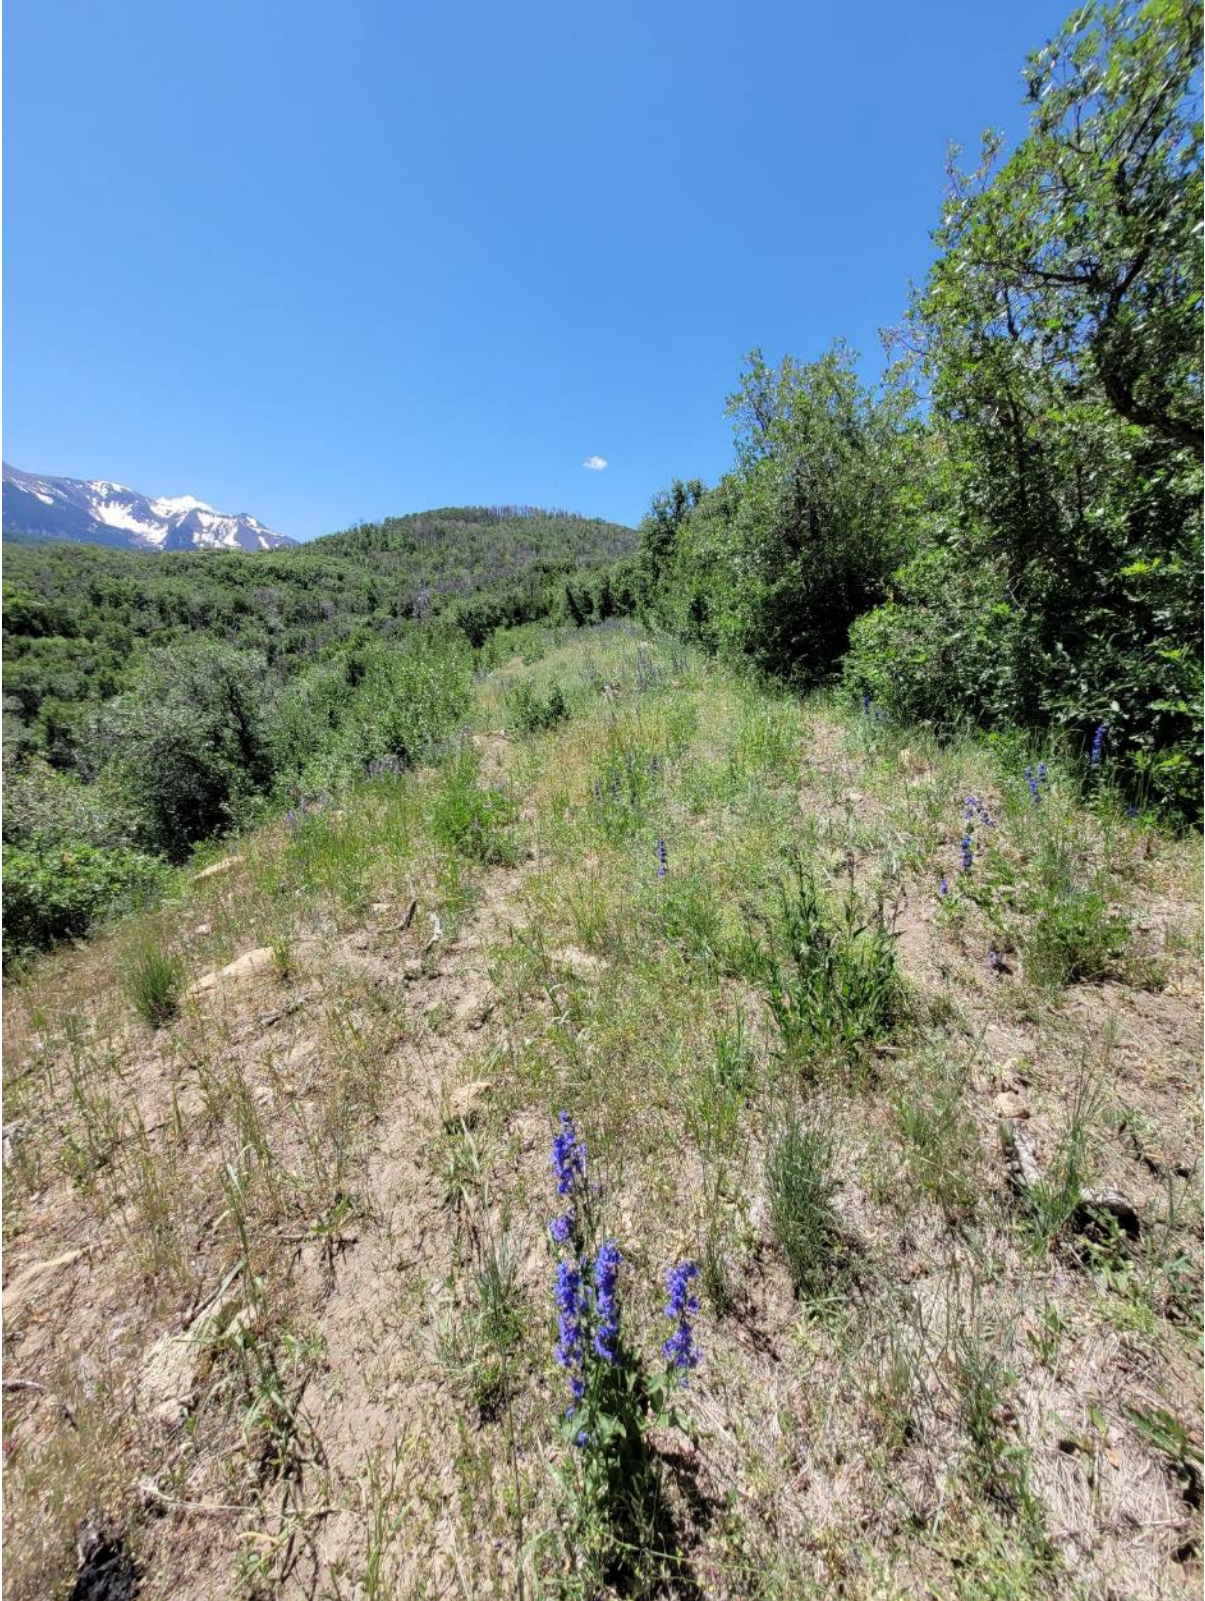
Figure 12. E5-14.

E5-14 and road to E5-14: 1.63 ac. Recently treated for Canada thistle; monitor.

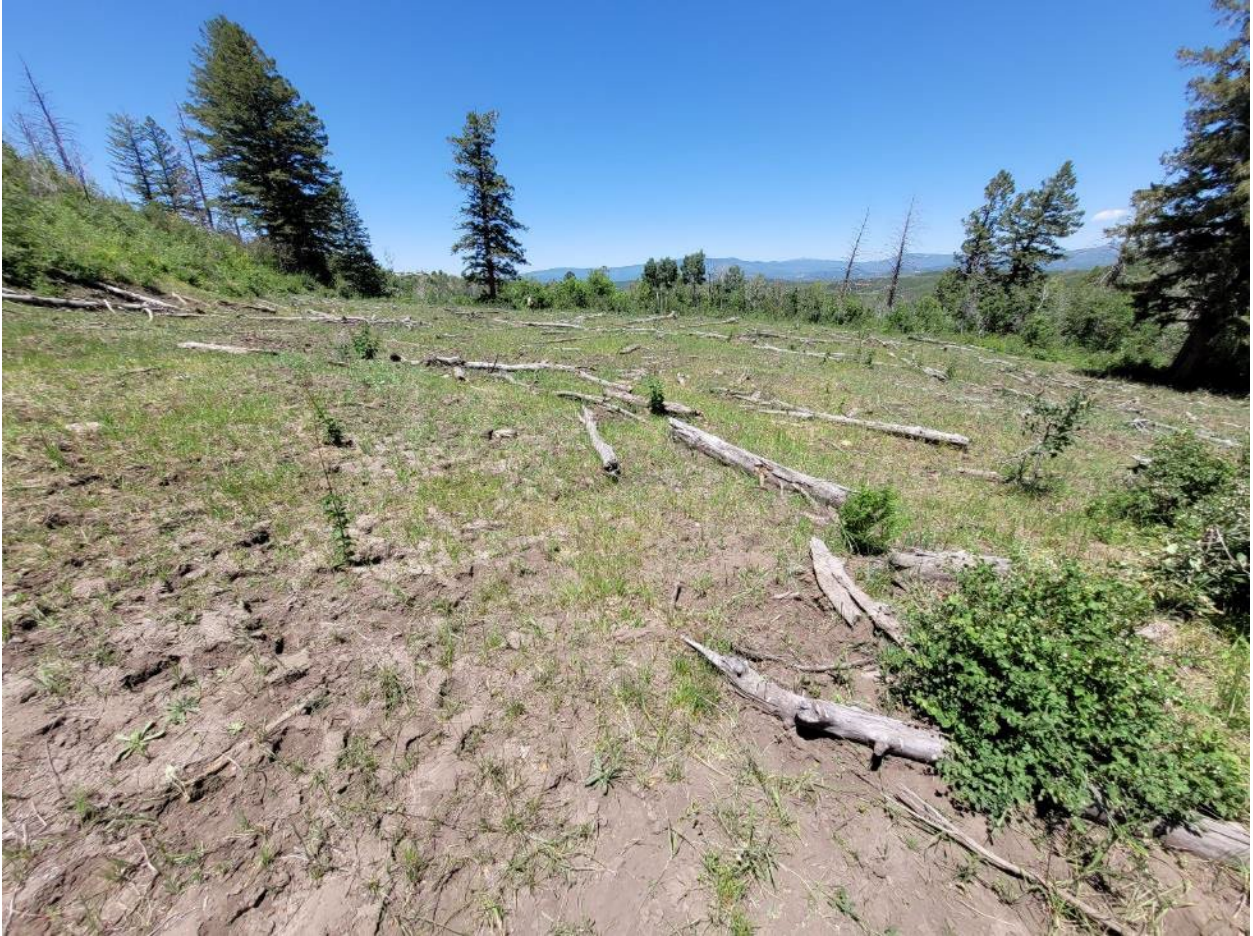
Figure 14. E5-9 and E5-10.

E5-9 / 10: 0.88 ac. Small quantities of houndstongue and Canada thistle; treat and monitor.

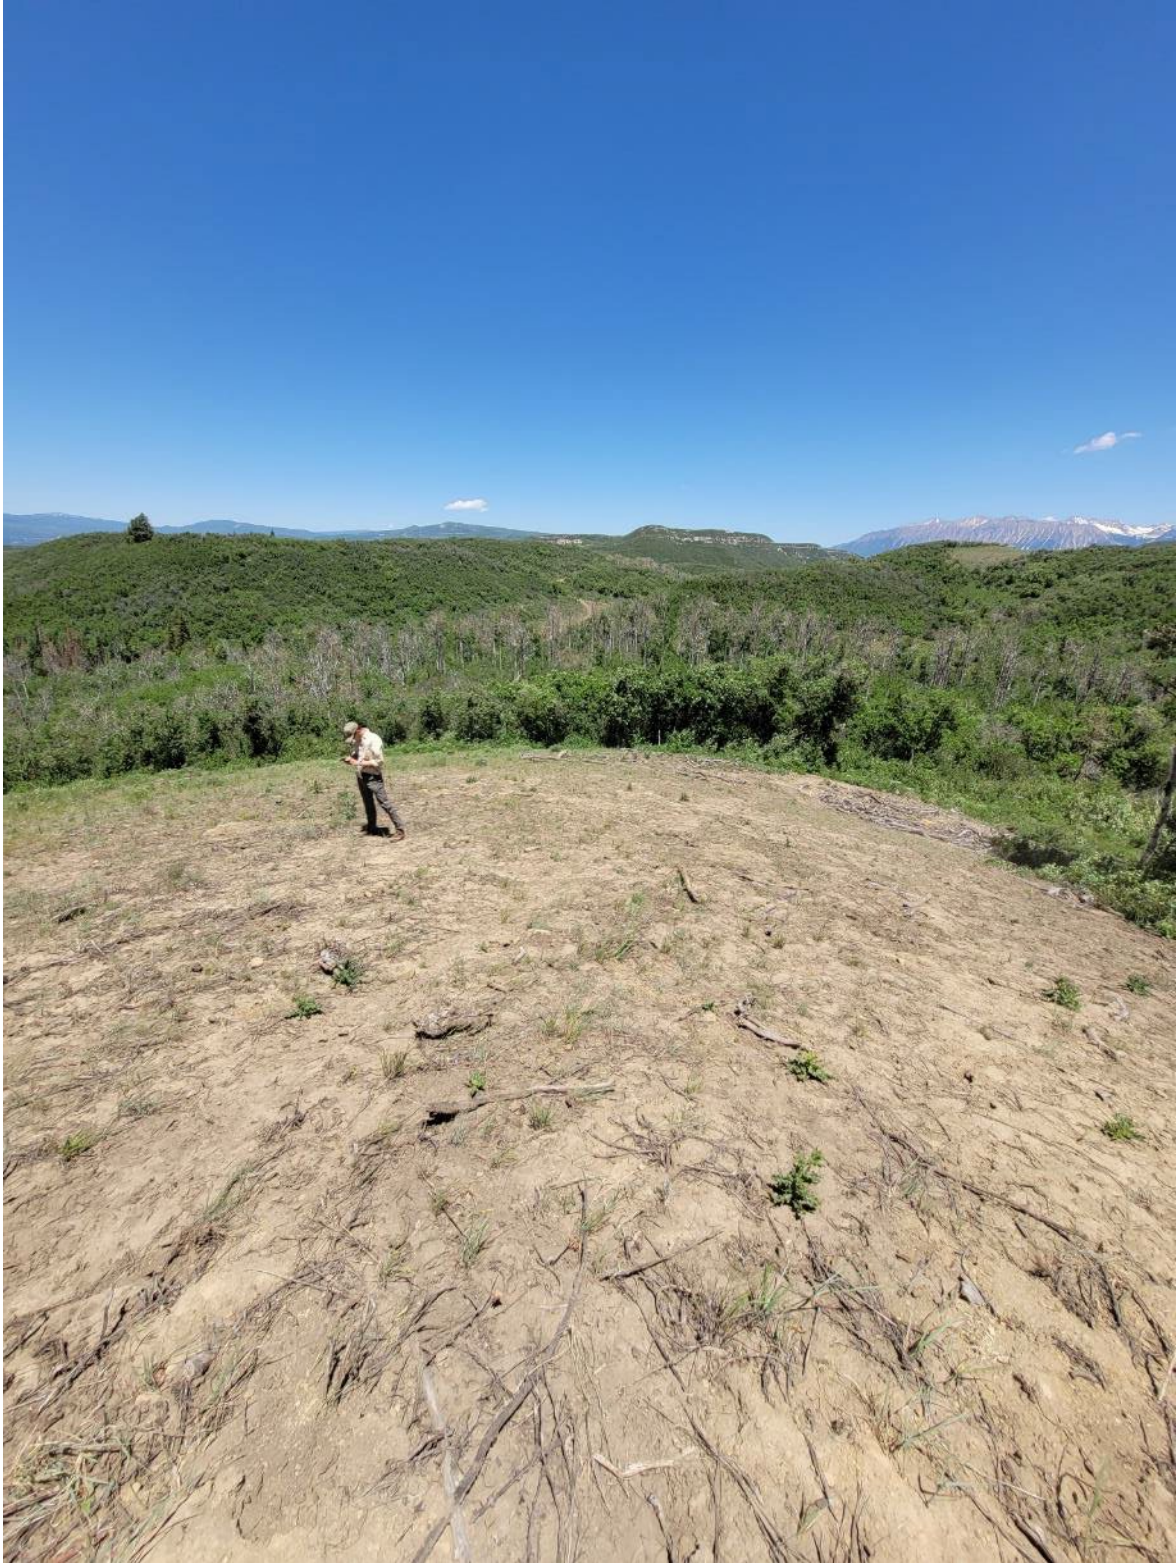
E5-8: 0.92 ac. Vegetative cover at east-northeast portion of the parcel was very sparse. Augmented seeding is recommended.

Figure 15. E5-8, sparsely-vegetated east-northeast portion of the pad.

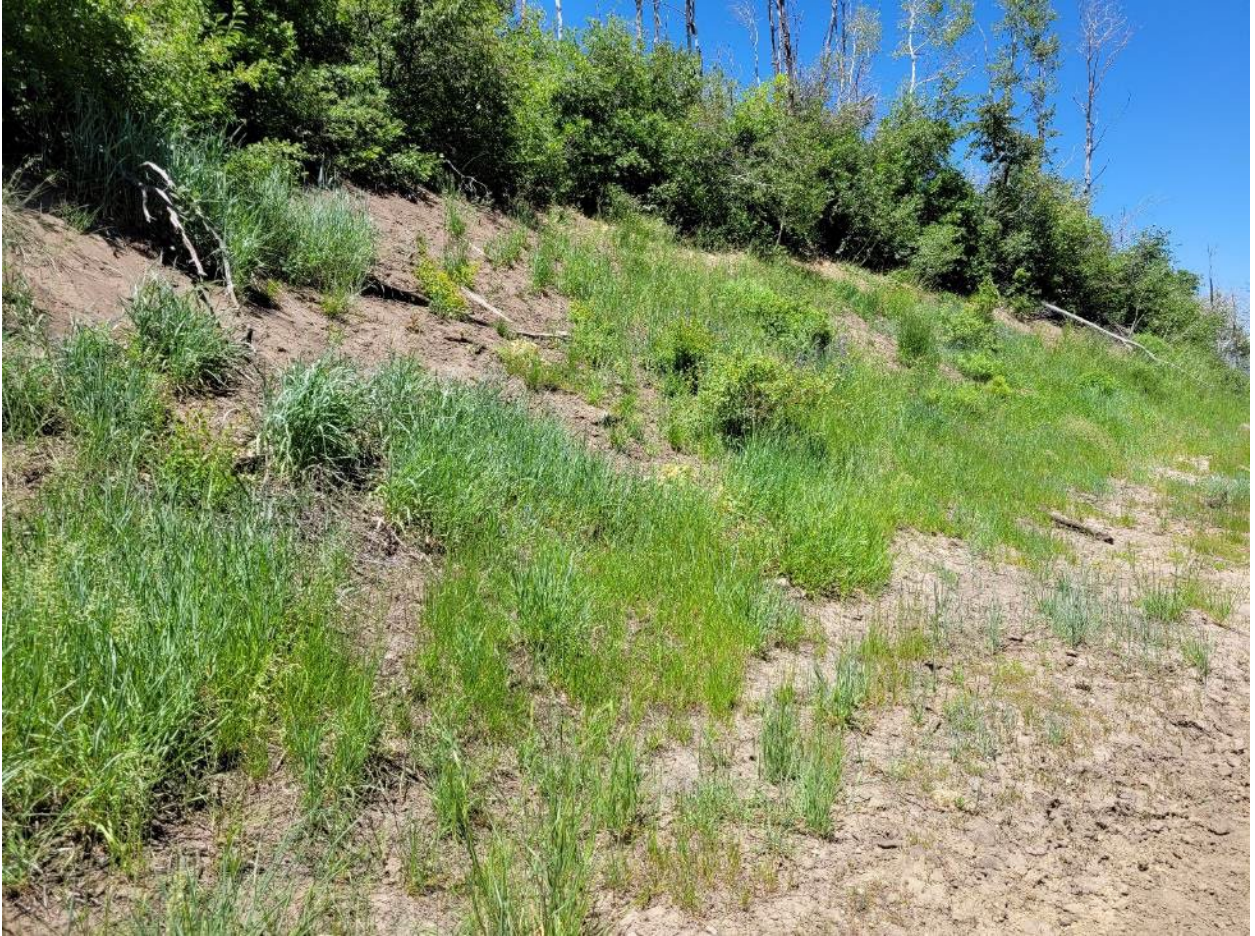
Figure 16. 10LWE6X62.

10LWE6X62: Acreage undefined in application. No issues.
