Denver Field Branch Bond Release Evaluation Report

Permittee:	Mountain Coal Company, LLC
Operator:	Mountain Coal Company, LLC
Site:	West Elk Mine
Permit No:	C-1980-007
Date of Inspection:	June 27 - 29, 2023
Inspection Type:	Partial Phase II and partial Phase III bond release
Weather:	Sunny and warm with dry ground conditions
Operator Representatives:	Garren Atchley, Mark Peirce, Nicki Poulos, Cody Rapke, and Jessica Wilczek
State Official:	Leigh Simmons
USDA - FS Official:	Dan Gray
OSMRE Official:	Tom Medlin #562

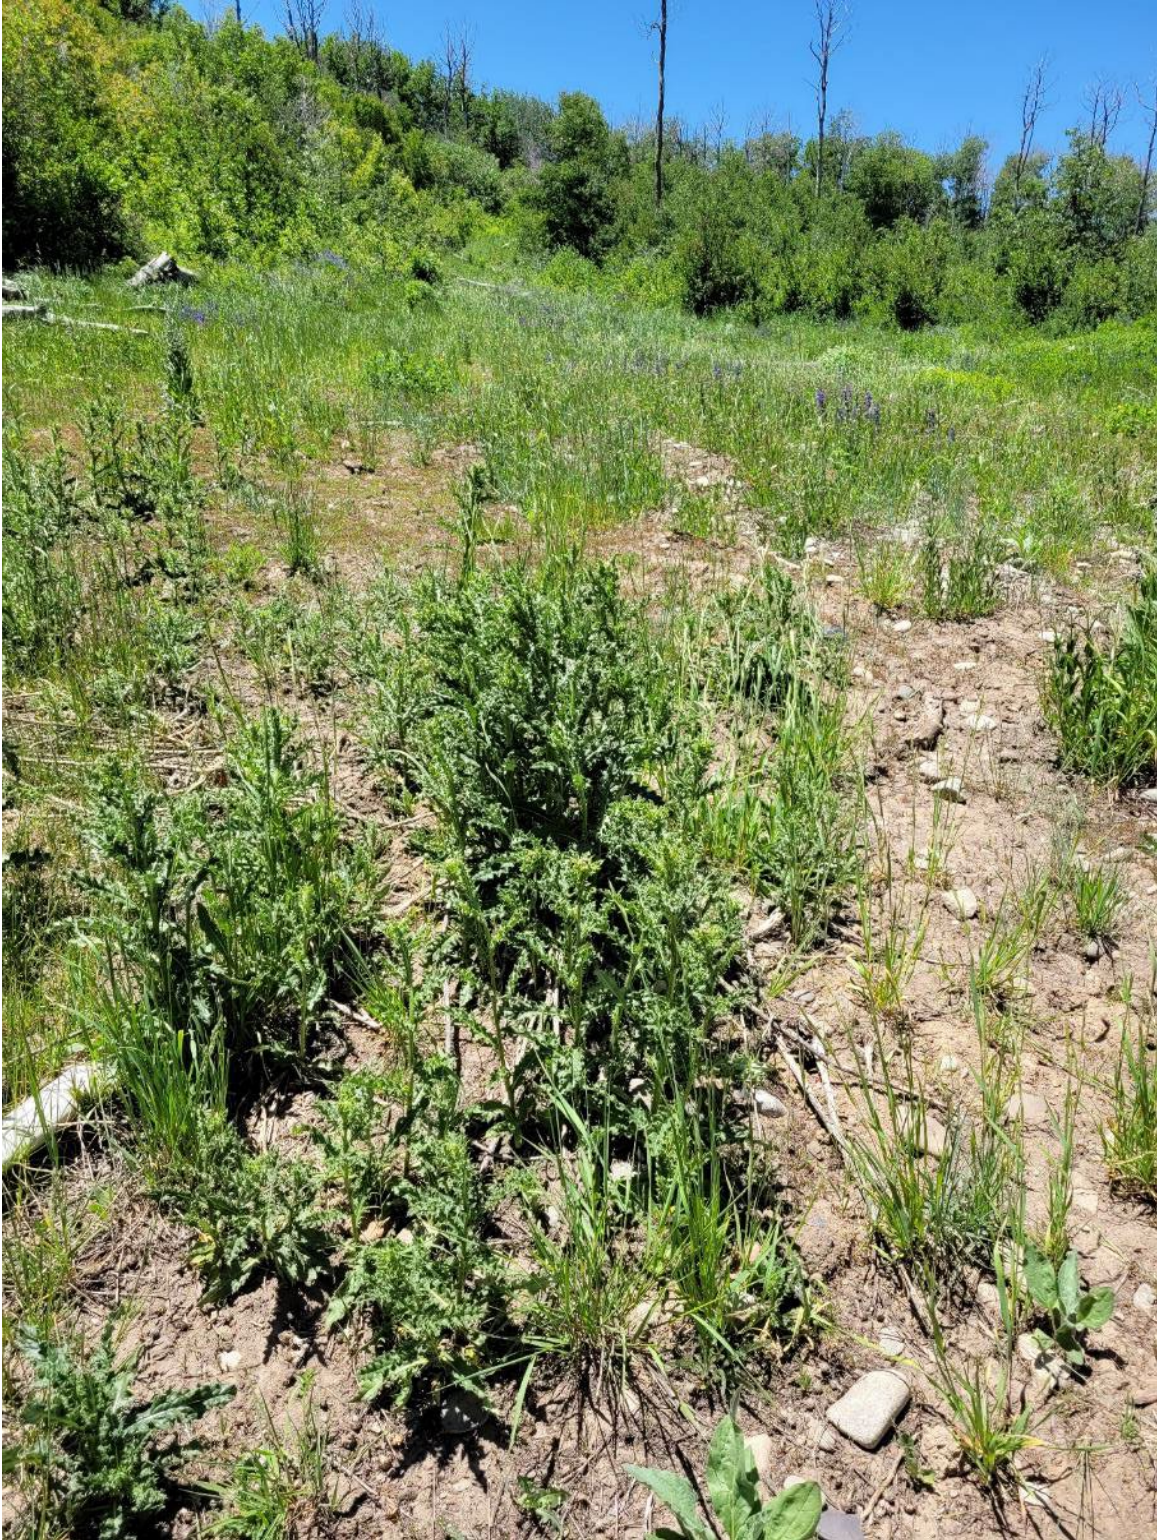
11LWE6X53: Acreage undefined in application. Modest quantity of Canada thistle; treat and monitor.

Figure 17. 11LWE6X53, thistle in foreground.

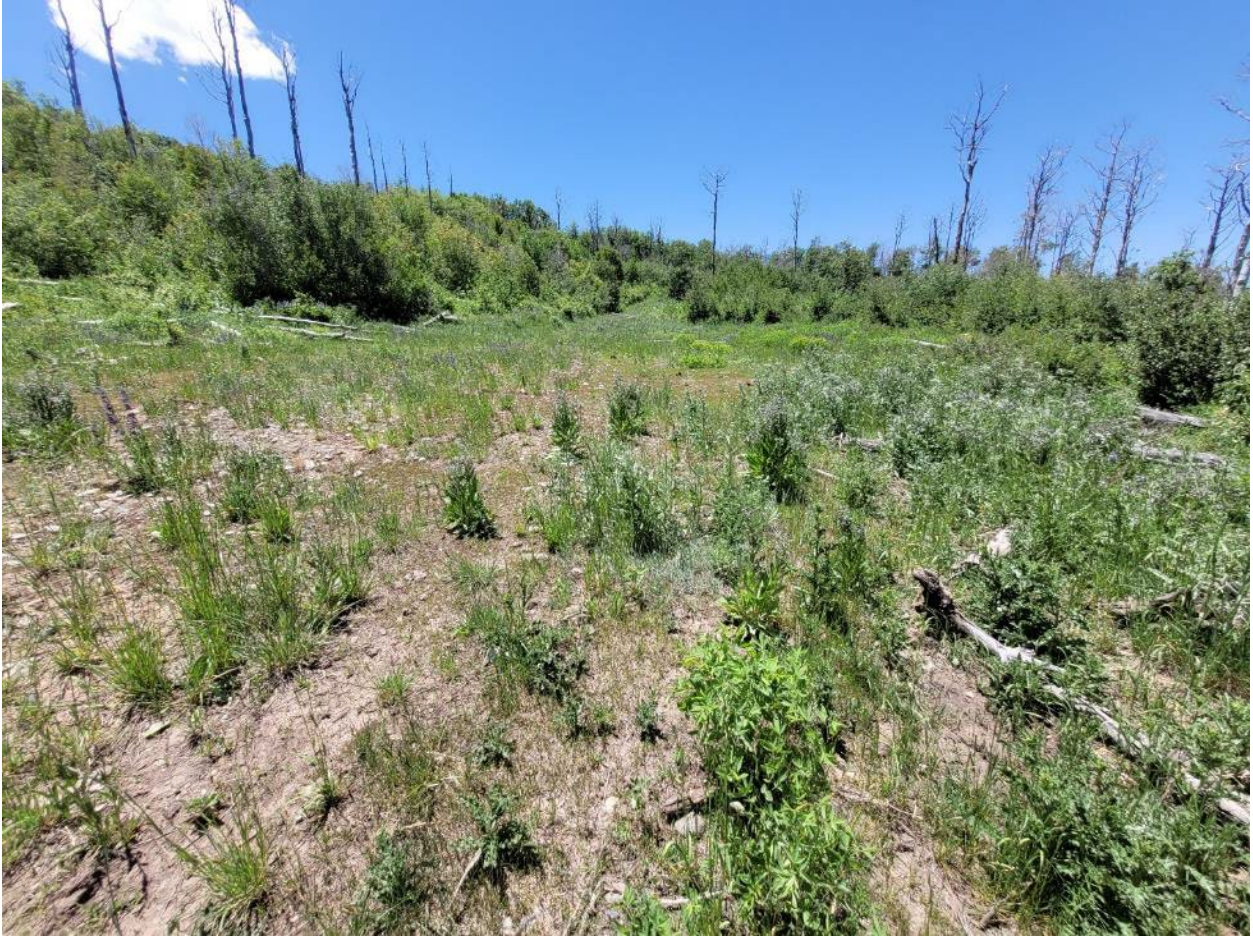
Figure 18. 11LWE6X53, moderate quantities of thistle foreground to midground, right.

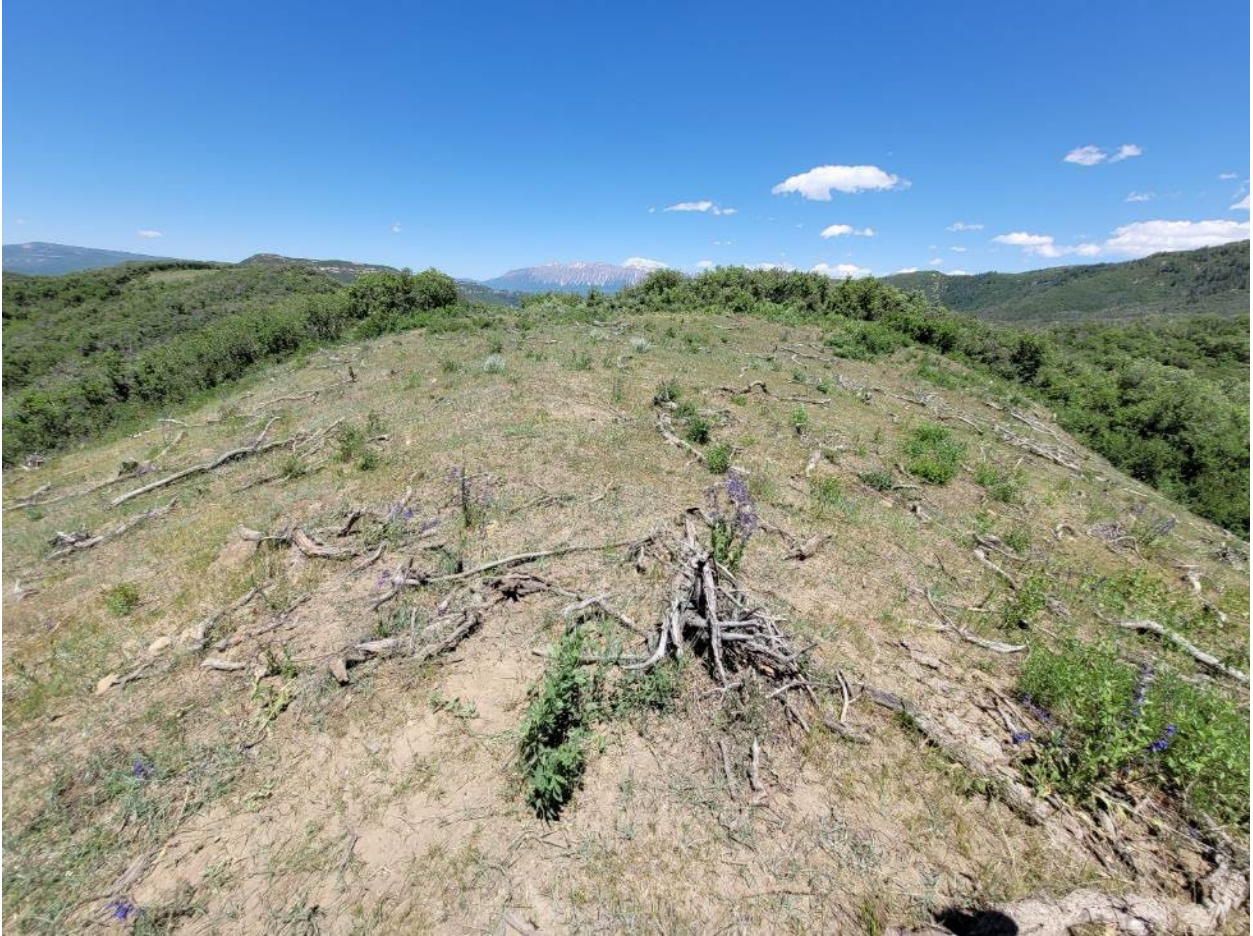
Figure 19. E5-6 and E5-7.

E5-6 / 7: 0.74 ac. No issues.

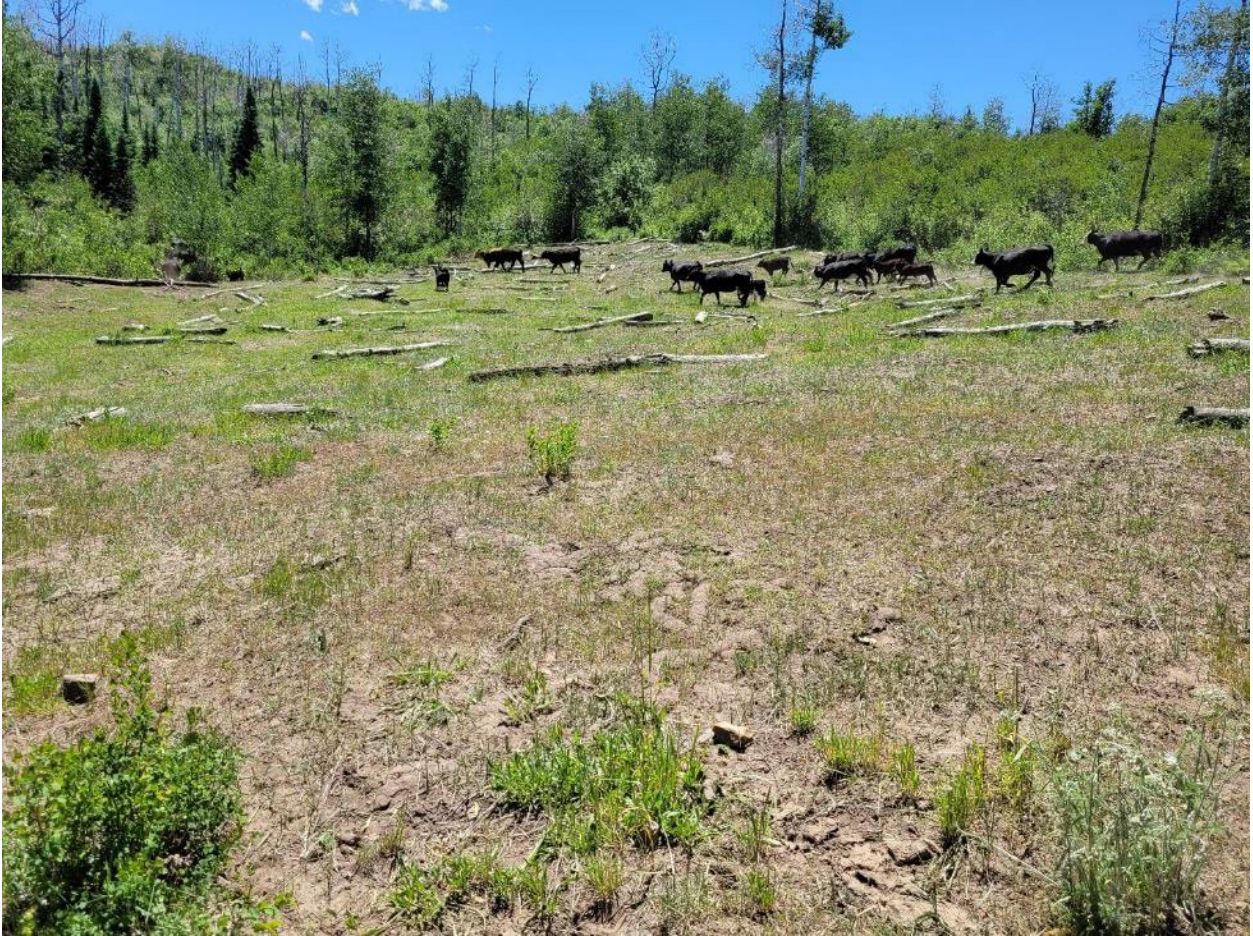
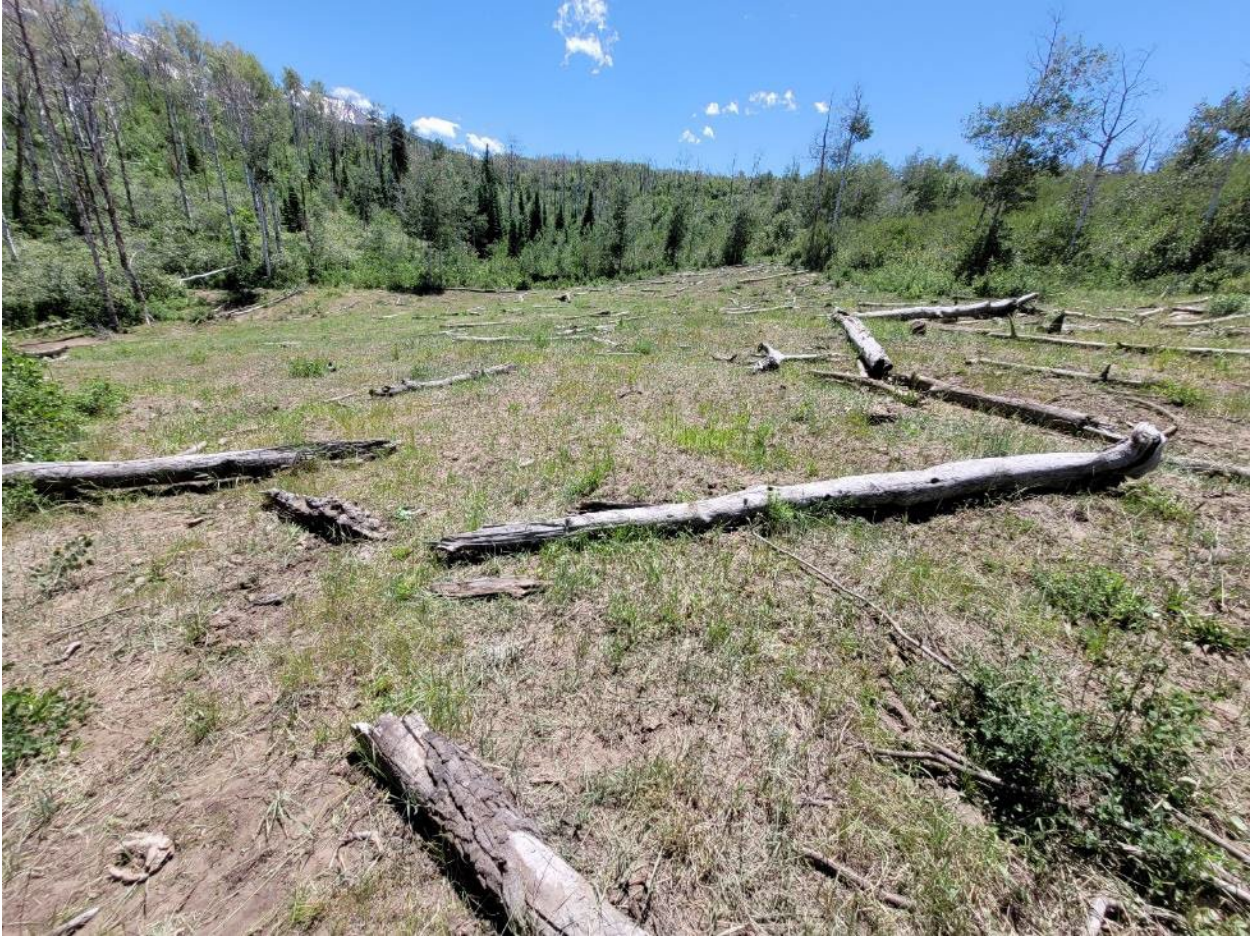
Figure 20. E5-1 / 2 / 3.

E5-1 / 2 / 3: 1.29 ac. Heavily grazed, no issues.

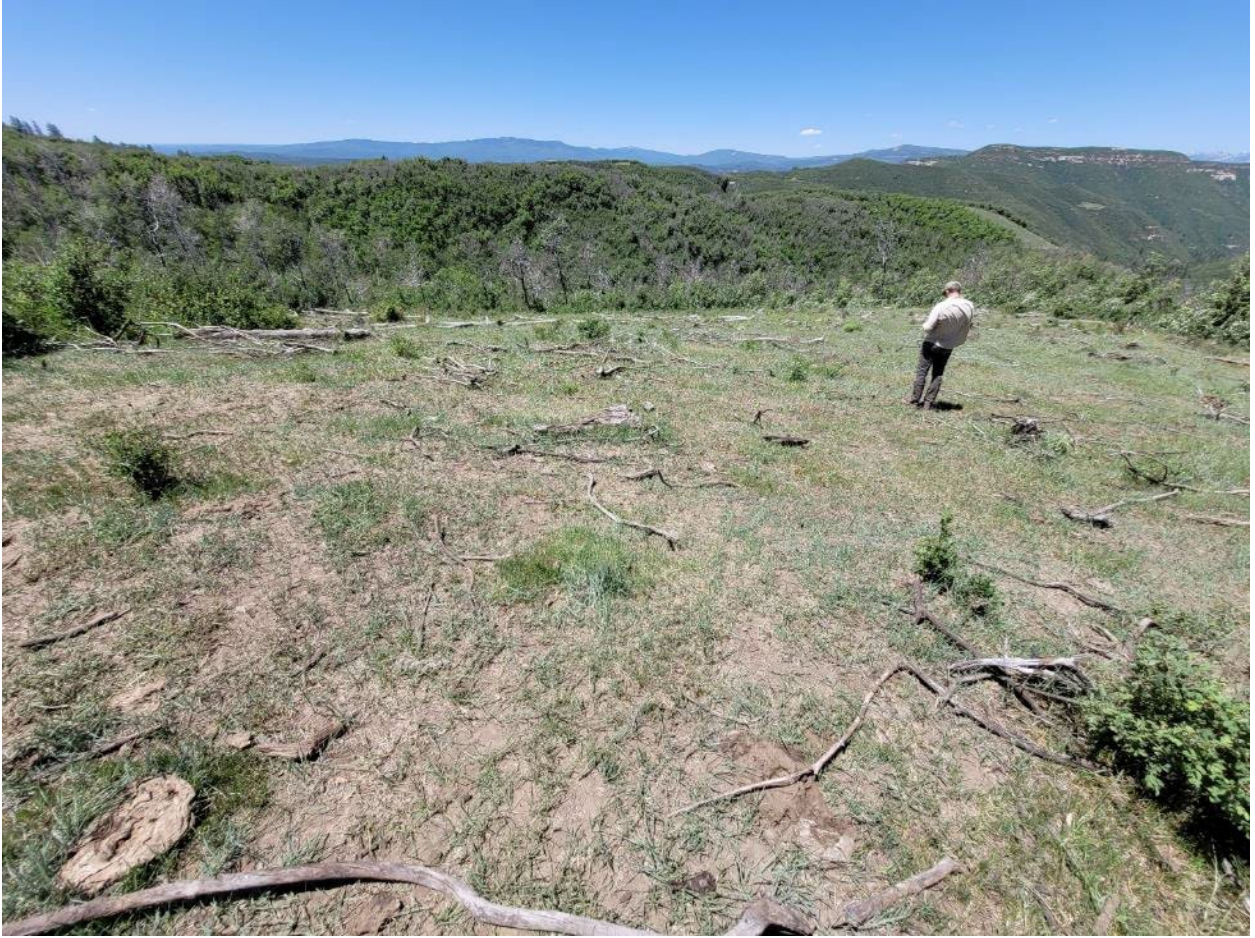
Figure 22. E5-4.

E5-4: 0.8 ac. Recently treated for Canada thistle; monitor.

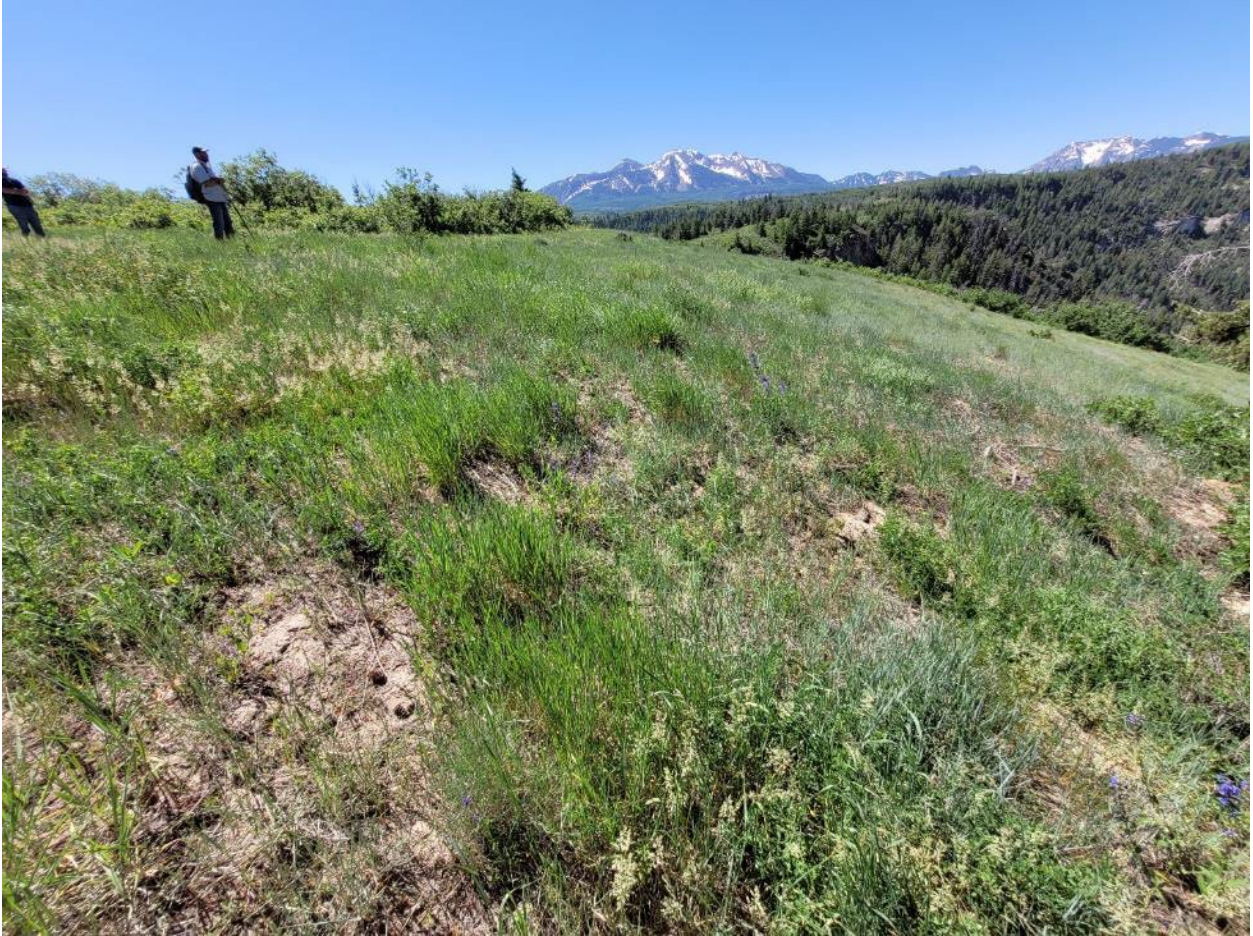
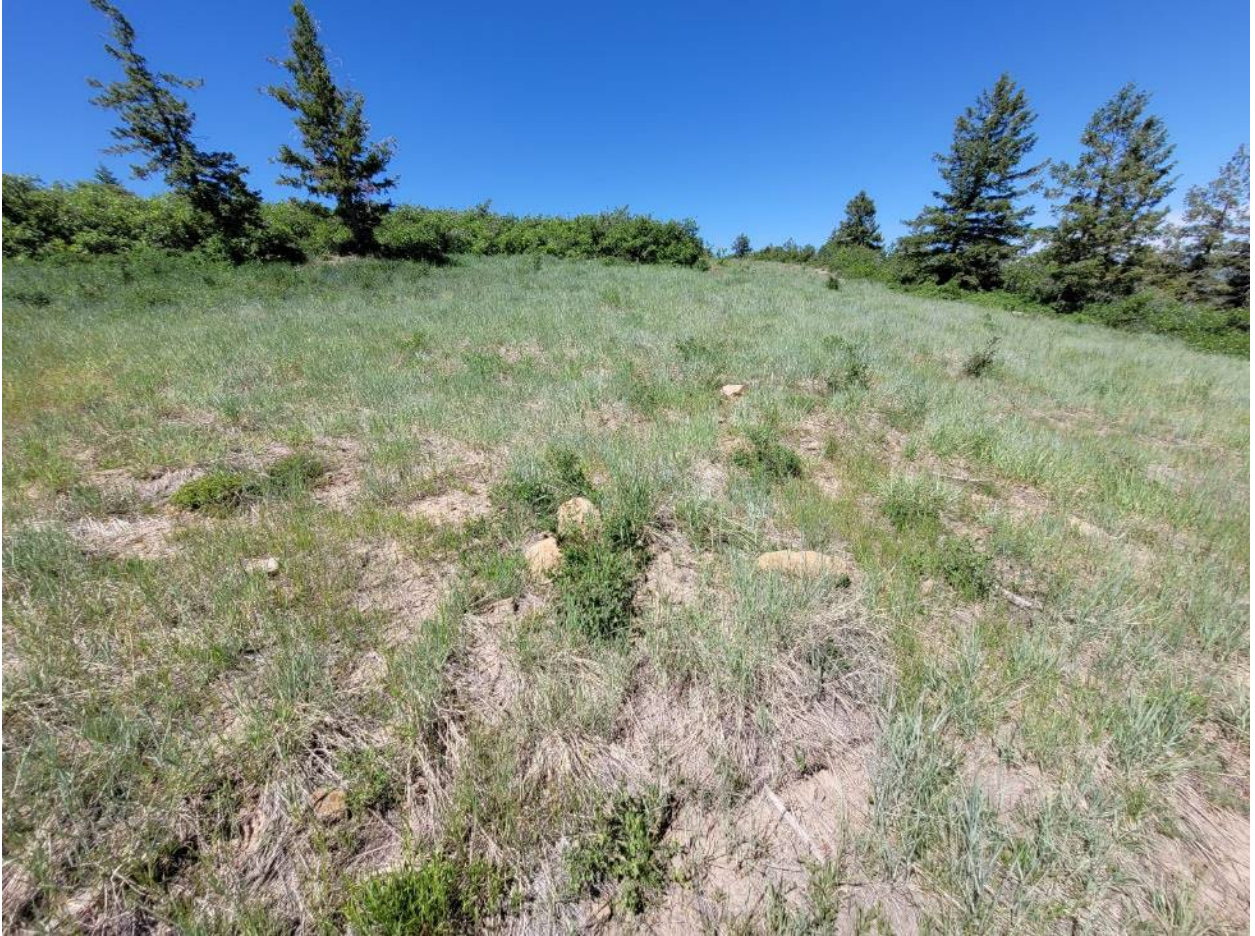
Figure 23. 18-04.

18-04, 18-05, and shared road: 0.91 ac. Referred to as 19-04 and 19-05 in application. Small quantity of Canada thistle; treat before release.

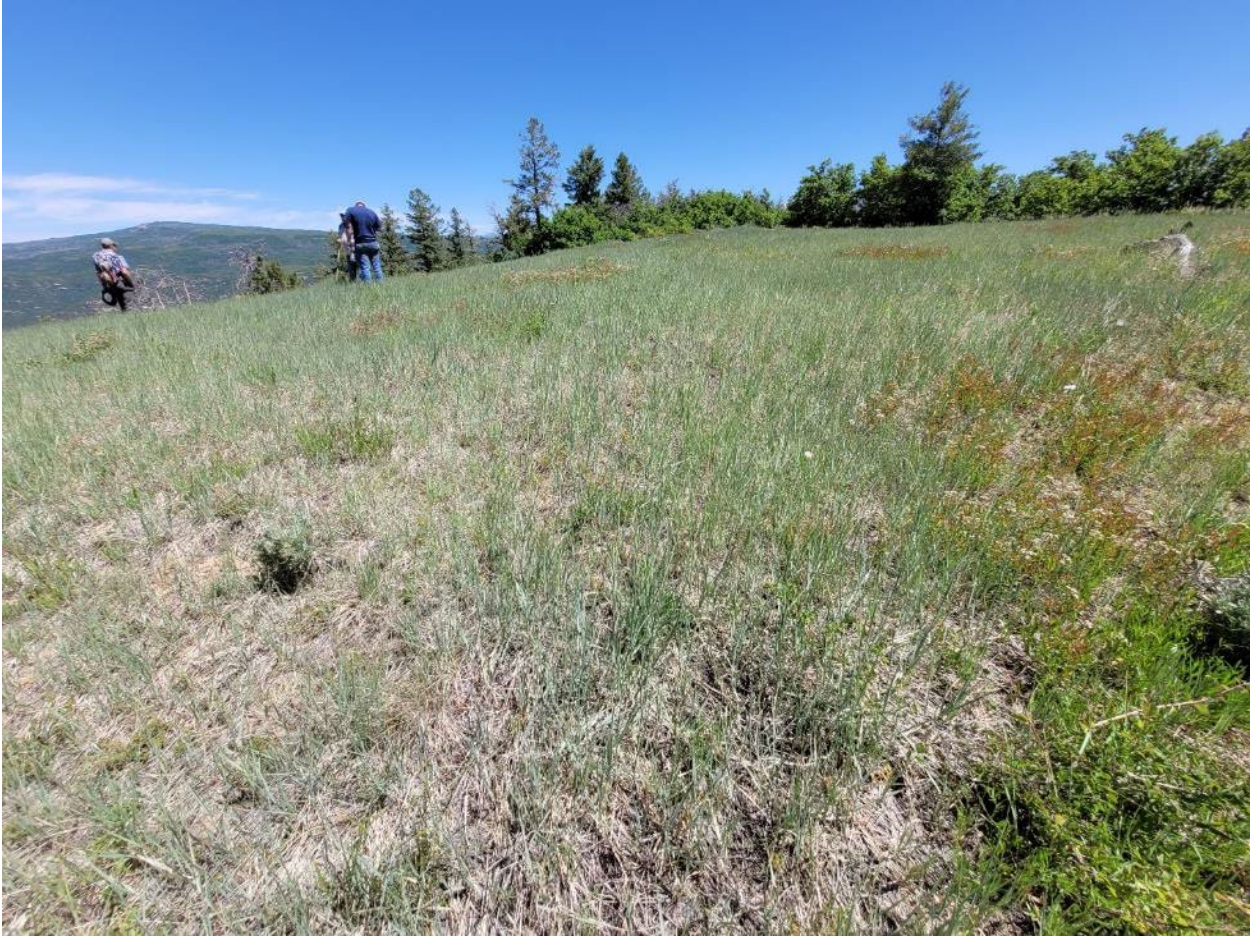
Figure 25. 20-31.

20-31: 0.58 ac. No issues.

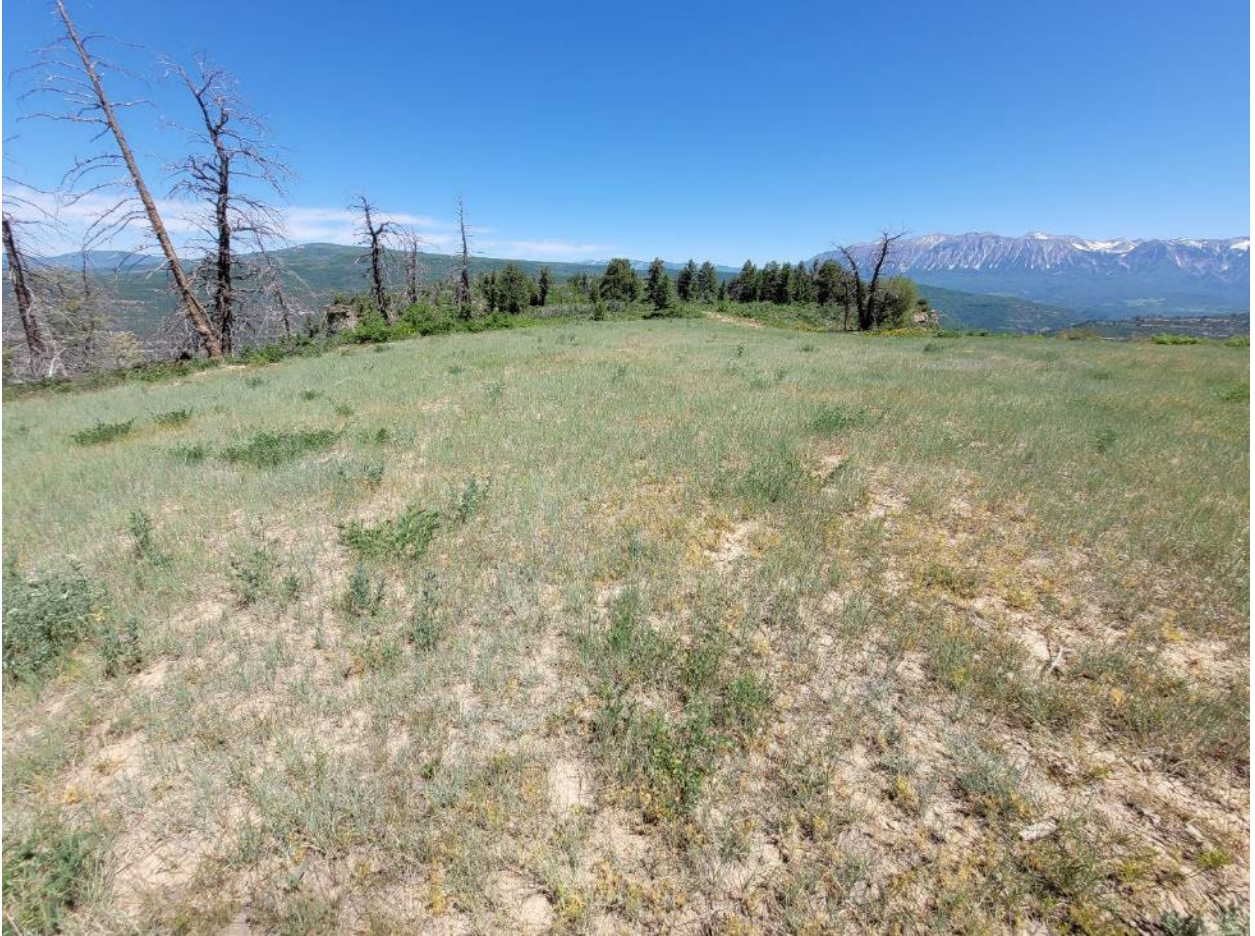
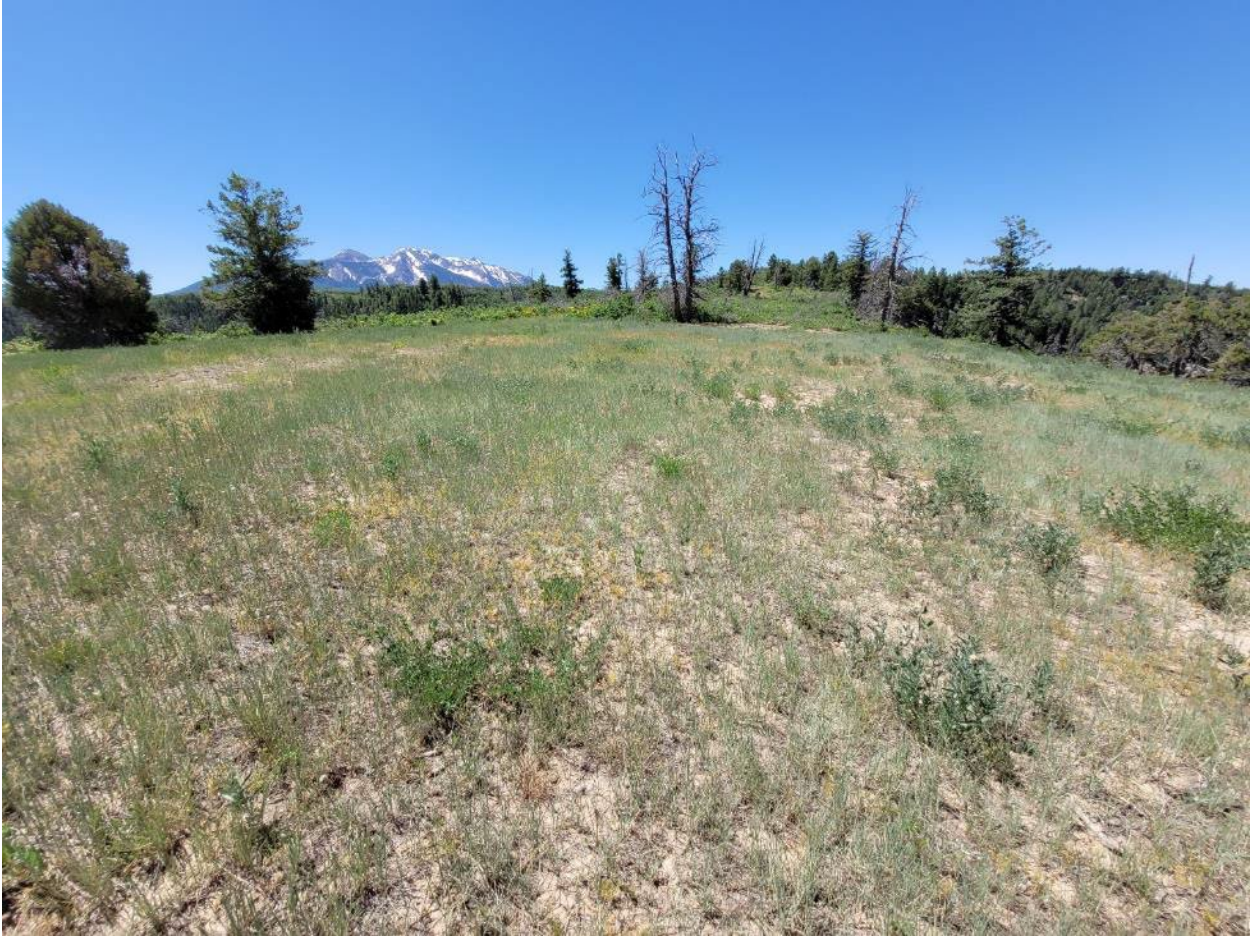
Figure 26. 4-21-32, 3-21-36, 2-21-37, and 1-21-38.

4-21-32, 3-21-36, 2-21-37, and 1-21-38: 1.23 ac. No issues.

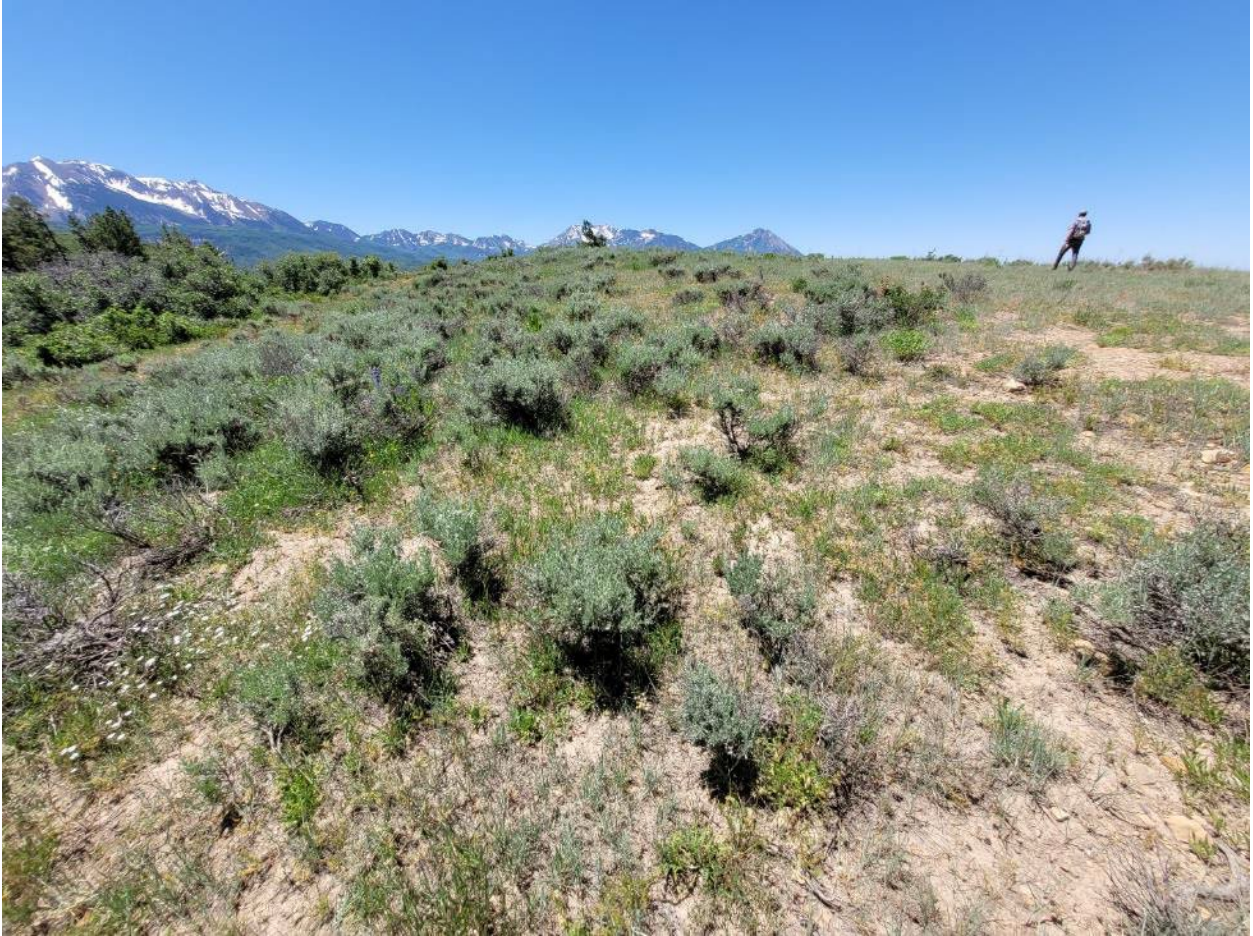
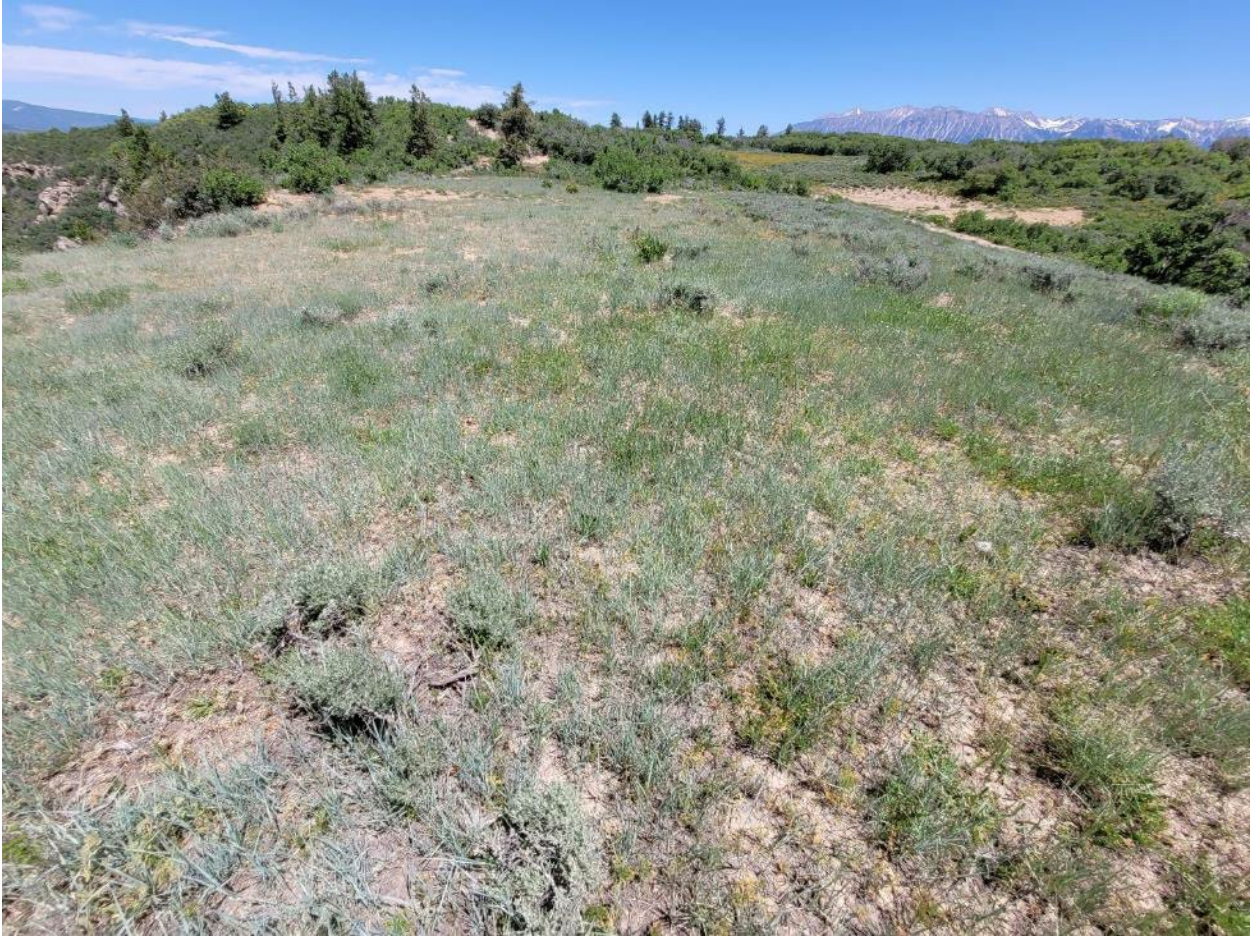
Figure 28. 24-06, 24-07, and road.

24-06, 24-07, and road: 0.94 ac. No issues.

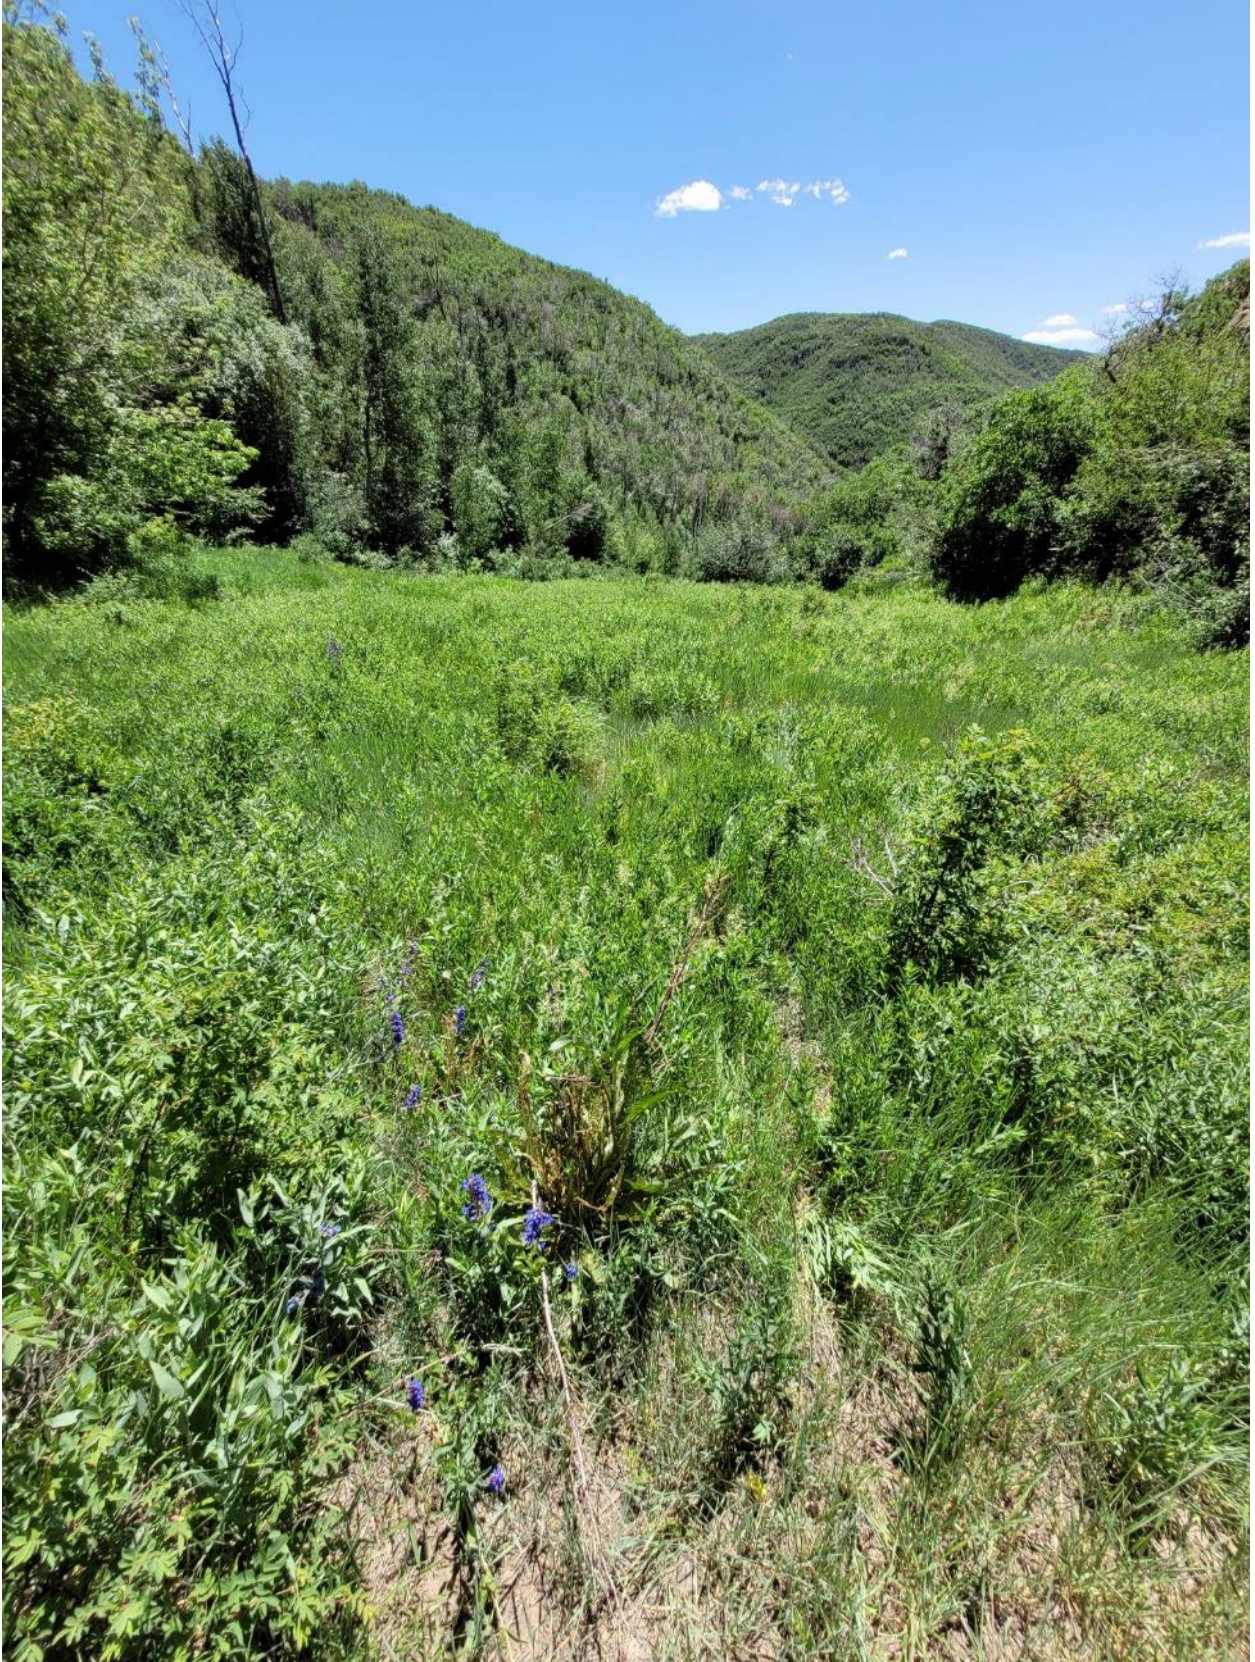
Figure 30. 15-06.

15-06: 0.24 ac. No issues.

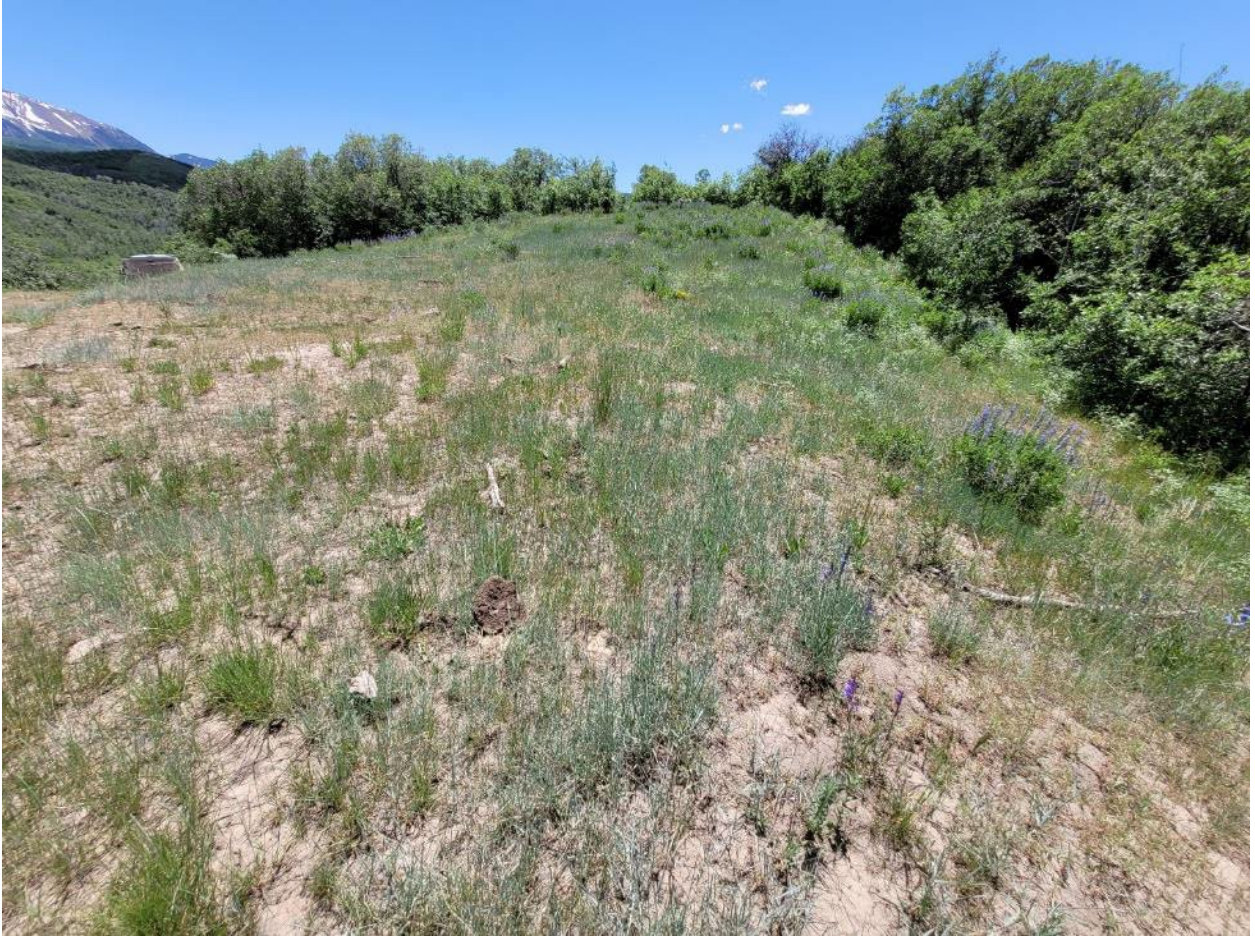
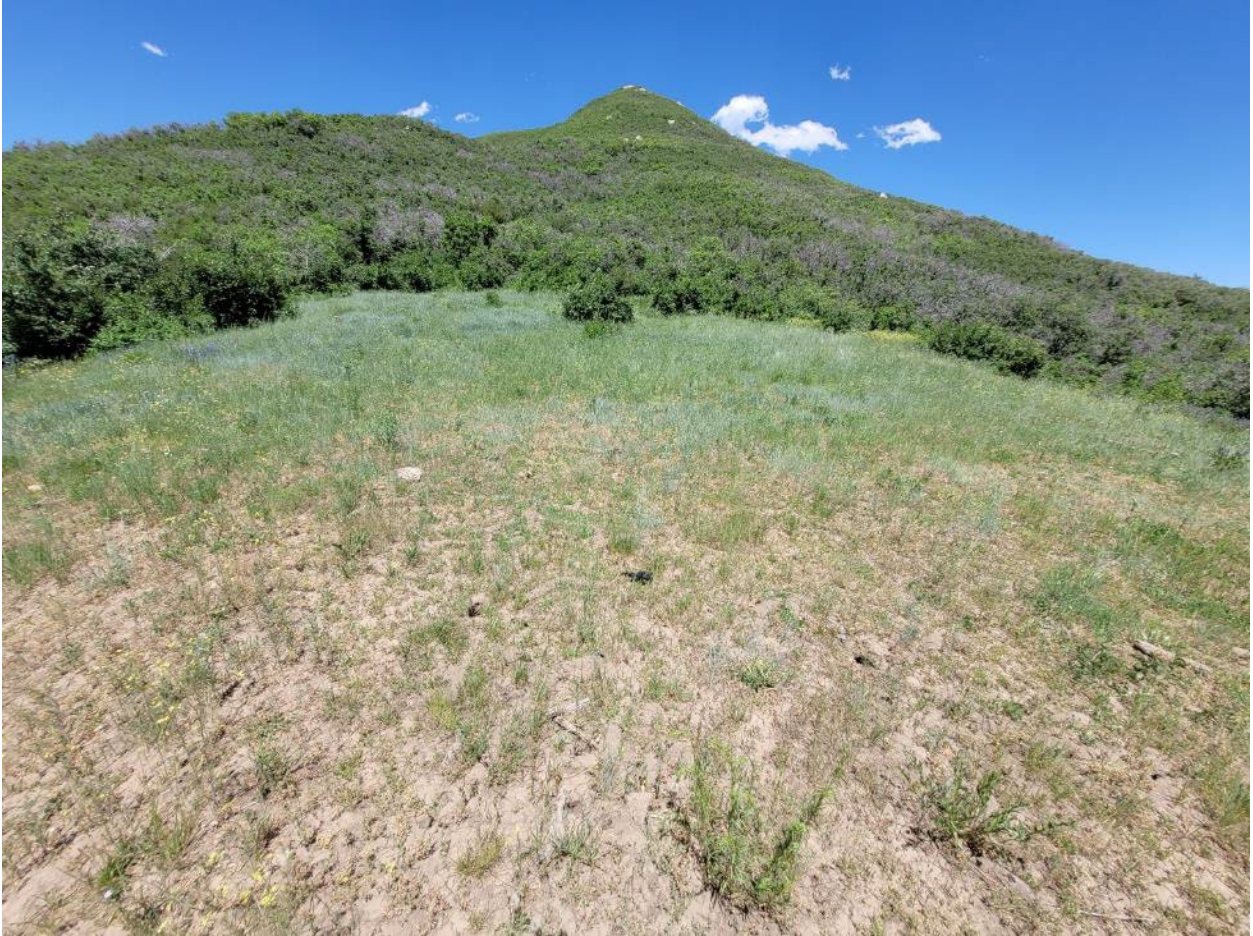
Figure 31. 15-05.

15-05: 0.62 ac. No issues.

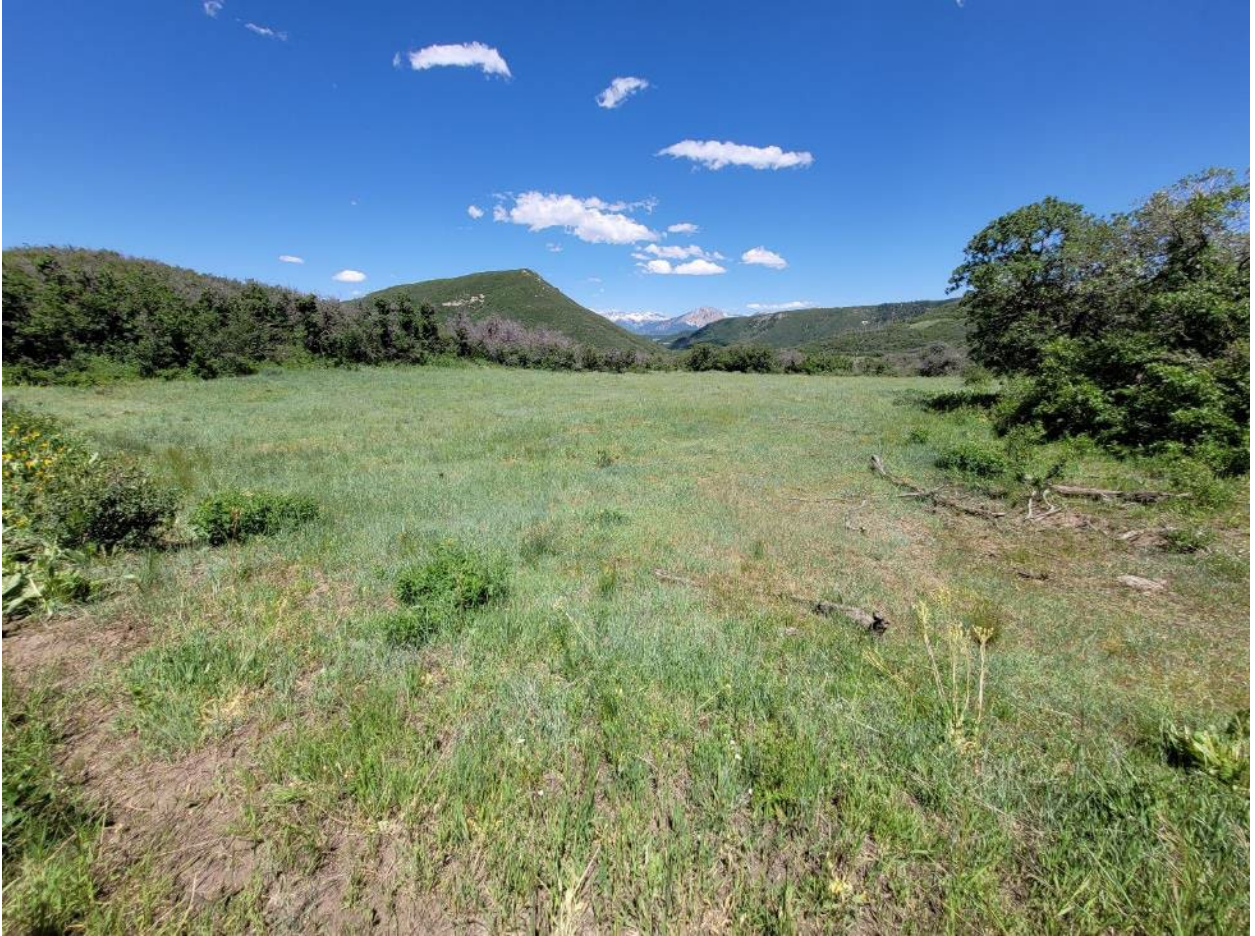
Figure 33. 17-08A & B.

17-08A & B: 0.82 ac. No issues.

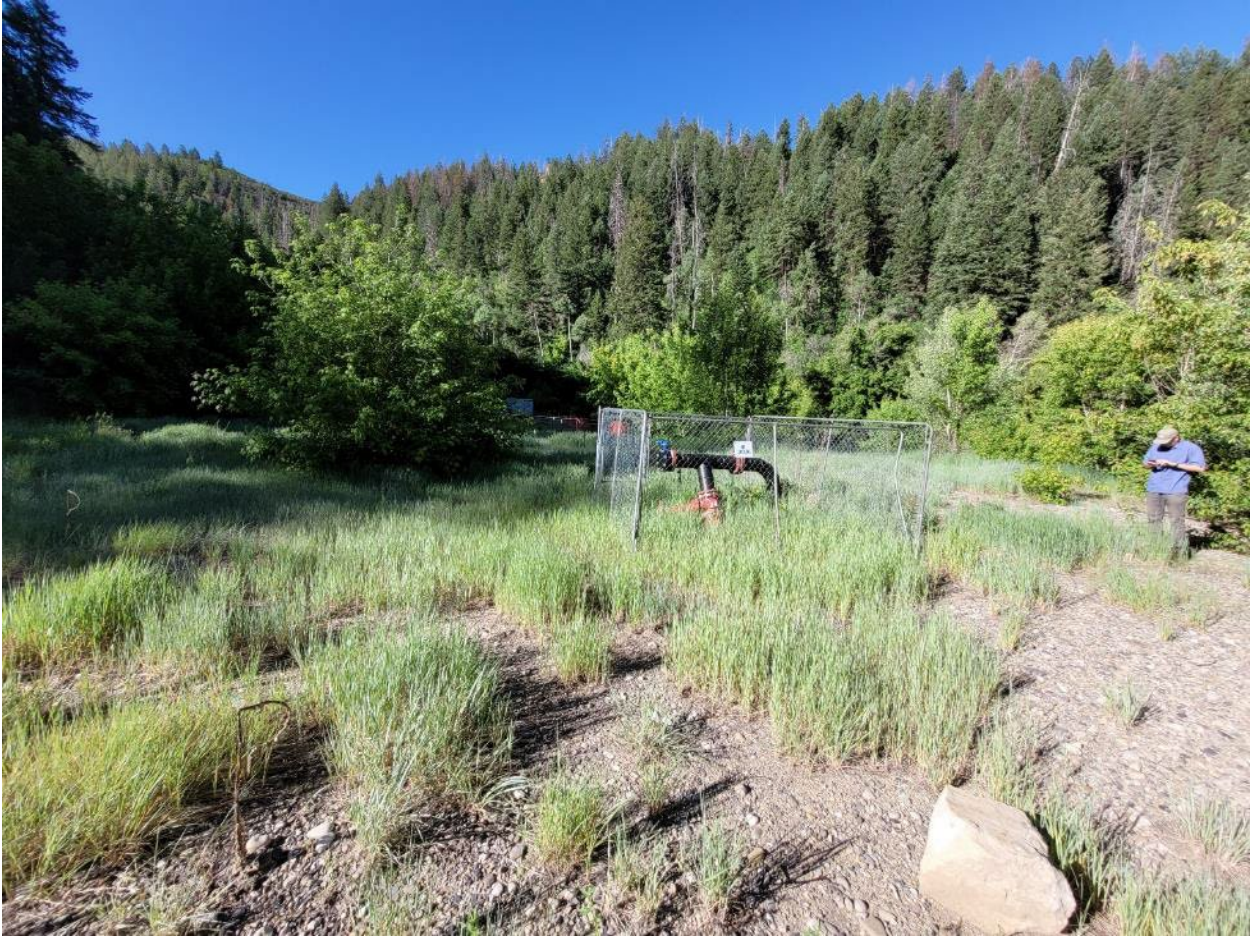
24-08: Mistakenly inspected. Not reclaimed, not included in application. Disregard.

Figure 34. 24-08, not reclaimed, not included in application.
